**Screening for Biofouling and Corrosion of Tidal Energy Device Materials:
In-situ results for Admiralty Inlet, Puget Sound, Washington**

Northwest National Marine Renewable Energy Center Technical Memorandum

University of Washington, Seattle, WA, United States

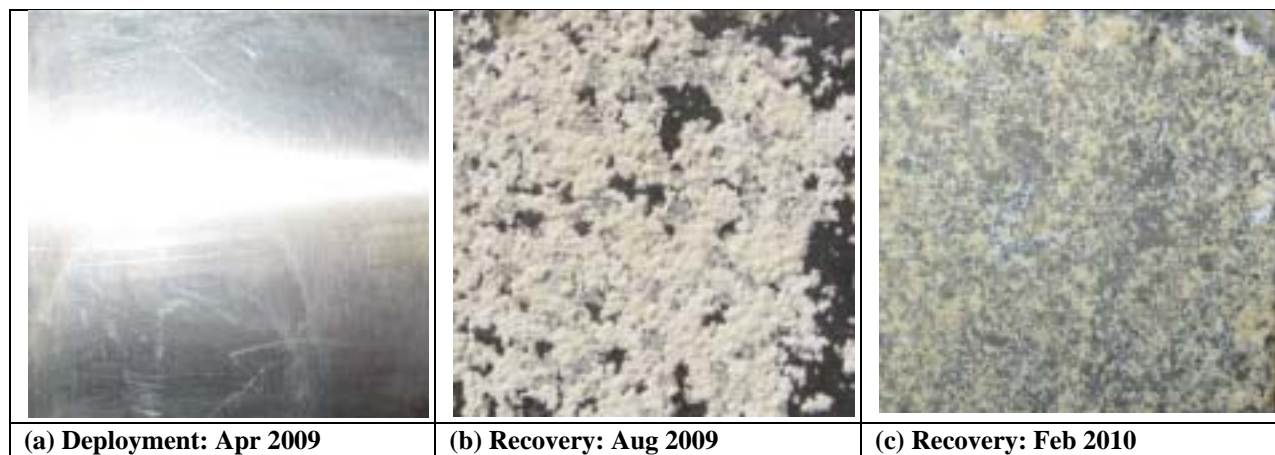
As expected, aircraft grade aluminum does not perform well in the marine environment. More than 90% of the exposed surfaces on all aluminum coupons oxidized during each 3-4 month deployment, as shown in Figure 2.1. After 10 months deployment in the marine environment, the surface is almost entirely oxidized and embrittled to the point that one corner of the coupon broke away during routine handling.

Deployment	Recovery	Duration	Changes
Aug 2009	Nov 2009	3 months	>90% surface and edge corrosion.
Apr 2009	Aug 2009	4 months	>90% surface and edge corrosion.
Apr 2009	Feb 2010	10 months	>95% surface and edge corrosion. Coupon edges embrittled.

Figure 2.2 – Aluminum (6061) coupon corrosion (Apr 2009 - Aug 2009 deployment)

2. Aircraft grade aluminum is a poor choice for the marine environment. In all tests, approximately 90% of the surface oxidized after three months of exposure to salt water.
3. Steel (both common and structural) corrodes rapidly in the marine environment. While corrosion is reduced by anodic protection, it is not eliminated. The use of marine coatings to reduce corrosion should be investigated.

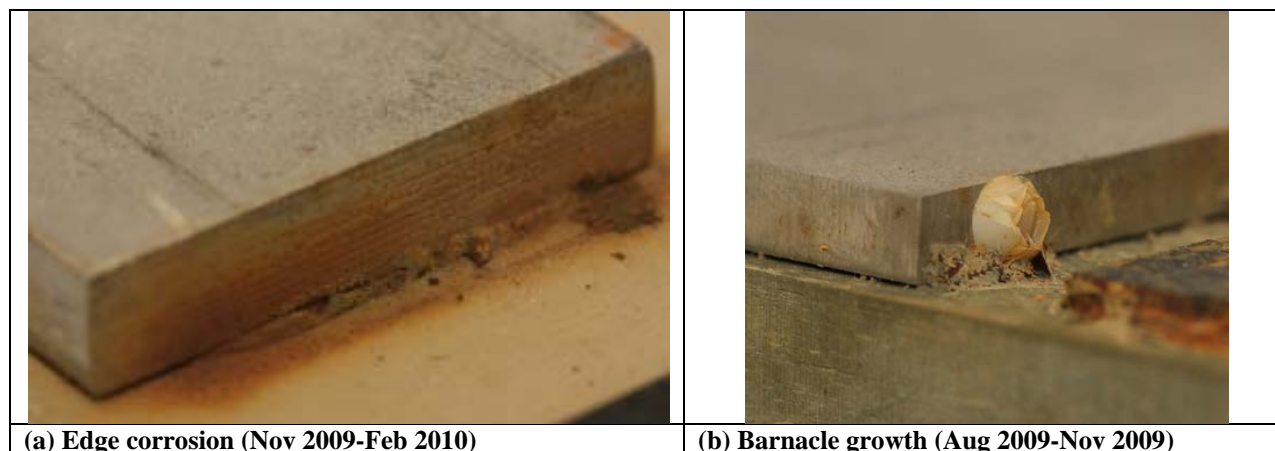
Both 314 and 316 grade stainless steel general show minimal corrosion or biofouling after prolonged exposure to the marine environment. One sample developed superficial corrosion along the contact surface between the stainless steel and fiberglass panel and a barnacle attached to one edge, as shown in Figure 2.2.

Deployment	Recovery	Duration	Changes
Aug 2009	Nov 2009	3 months	Minimal fouling on surface. One barnacle on edge.
Nov 2009	Feb 2010	3 months	Superficial corrosion on one edge, concentrated at fiberglass/steel interface.

Figure 2.3 – Stainless steel (316) edge corrosion and biofouling

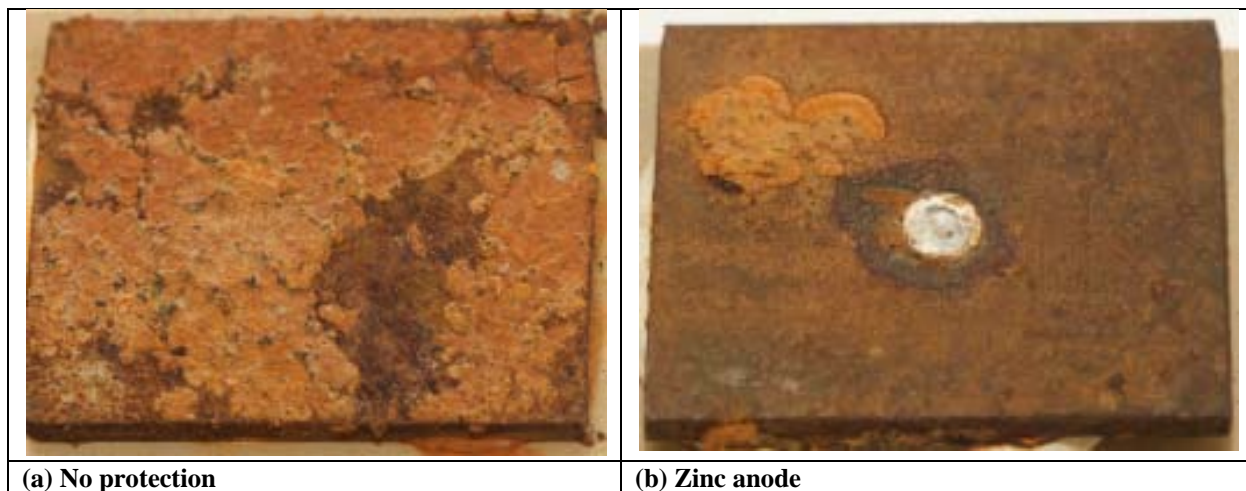
Structural steel is included in a single deployment matrix (Nov 2009-Feb 2010). As with common steel, in addition to a bare surface, protection by a zinc anode screwed into the center of the coupon was also tested. The protection significantly reduced, but did not entirely eliminate, oxidation of the structural steel. The anode was missing upon tripod retrieval and presumed to have been dislodging during retrieval operations.

Deployment	Recovery	Duration	Protection	Changes
Nov 2009	Feb 2010	3 months	No protection	Heavy surface oxidation (85% coverage).
Nov 2009	Feb 2010	3 months	Zinc anode	Corrosion on 15% of surface and edges.

Figure 2.6 – Structural steel (539) coupon corrosion (Nov 2009 - Feb 2010 deployment)

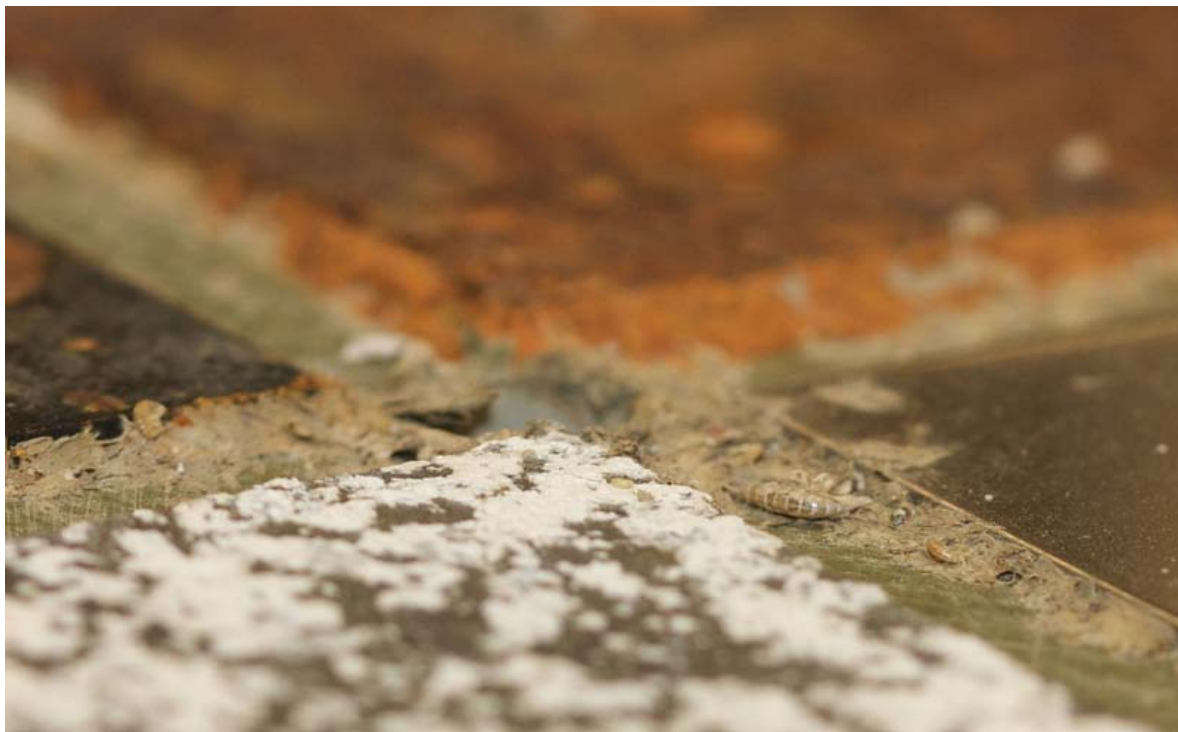
4. Biological fouling is seasonal. In particular, the crevices between all coupons and the substrate plates were heavily fouled with sediment and krill after the April-August and August-November, 2009 deployments (Figure 4.2), coinciding with annual period maximum of biological productivity.

Figure 4.2 – Fouling and sediment deposition along edges and in crevices
