EXTERIOR REDWOOD PRESERVATION AT SCOTTY'S CASTLE DEATH VALLEY NATIONAL PARK

PILOT TREATMENT of SELECT REDWOOD ELEMENTS

Prepared for

National Park Service

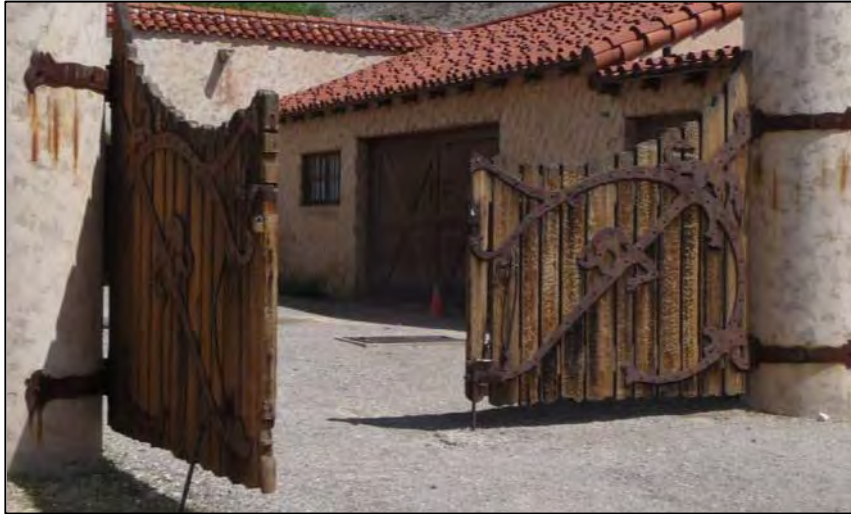
110W1GA001 & 110W1GA002, view NE.

The west gates are significantly weathered on all faces, though surfaces that face south in the opened position are more severely deteriorated. Finishes, where they survive, are characterized by loss of sheen, yellowing, crazing, and detachment, and the wood substrate is characterized by bleaching, iron- and water-staining, surface erosion, checking, and mechanical losses. The level of erosion in most cases is particularly severe, with preferential erosion of early wood by UV exposure and wind-borne grit leaving a distinctive 'washboard' surface. Tops of vertical elements show significant erosion and deep checking. There are traces of red paint that survive in deep asperities on these top surfaces, suggesting a protective paint layer was applied at some time in the past to slow further loss (the park might consider reinstating this opaque coating on just these surfaces). It is not known whether this is an historic treatment.

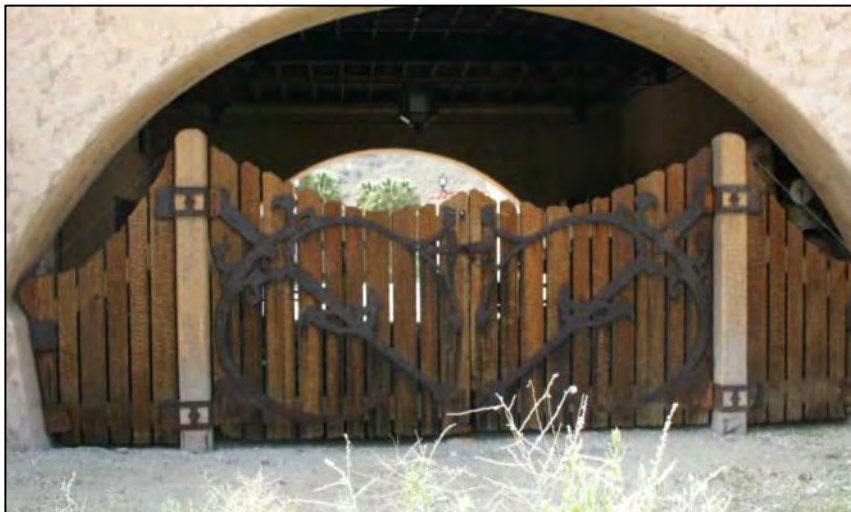
110E1GA001, 110E1GA002, 110E1GA003, & 110E1GA004, view W.

The east gates, which are sheltered on the west by the interior courtyard roof and are rarely opened, retain their historic finish and color on the west (courtyard side) face. The east face, which

is exposed to the weather, shows similar deterioration of substrate and finish as is found on the west gates, though in general conditions are not as severe. Two of the vertical elements show evidence of an earlier termite attack, a condition that is relatively rare at Scotty's Castle. There is evidence of a protective paint layer on the ends of vertical elements; the brown color matches paint used elsewhere on the site and suggests a relatively recent application date.

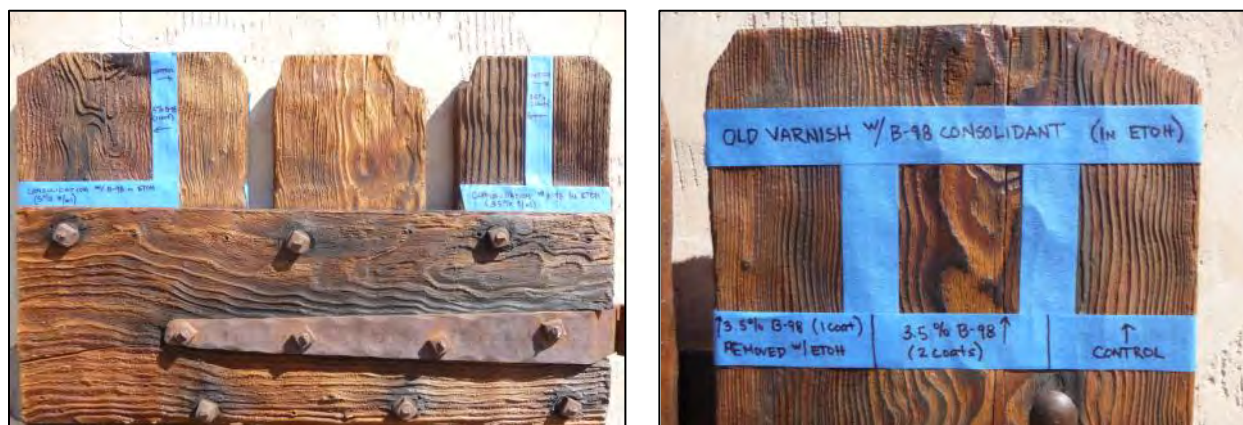
Test treatment areas on 010E1SH002

5% (one coat): left a saturated appearance and looked like a film rather than a consolidant; level of consolidation was good: the loose fibers on the surface were laid down and consolidant was visible in some of the fissures; there was a consistent color between the high and low points; wood felt smooth, rather than rough in texture, to the touch. The surface was strengthened (rubbing a finger

across the grain of the untreated wood, resulted in lifted fibers whereas on the treated wood rub did not result in any breakage or splintering.

3.5% (two coats): Improvement of the surface strength similar to the 5%; less saturation of the surface and no obvious film or build up of consolidant on the surface. The disgregate surface was consolidated but there was obviously less material on the surface than the 5%. Consolidant penetrated the wood, rather than sitting on the surface, and all the fibers were laid down.

3.5% (one coat): the visual impact was most like the untreated wood, but the consolidation of the surface was incomplete (i.e. there were still loose fibers in both the high and low sections).

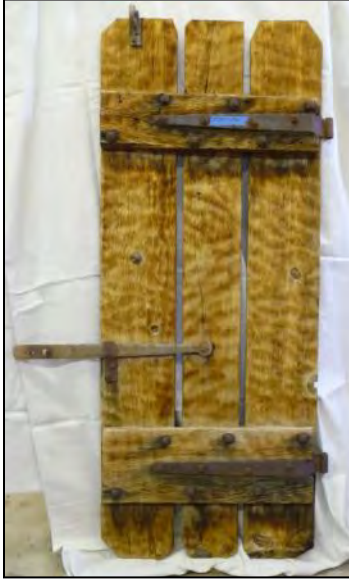
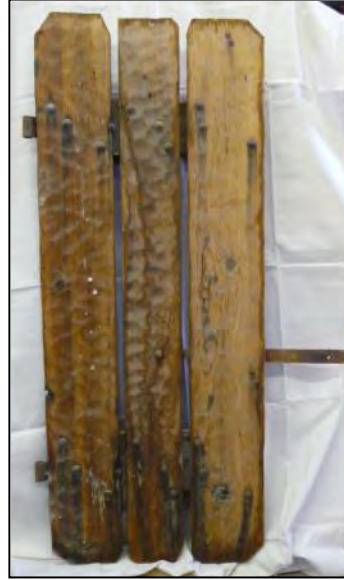
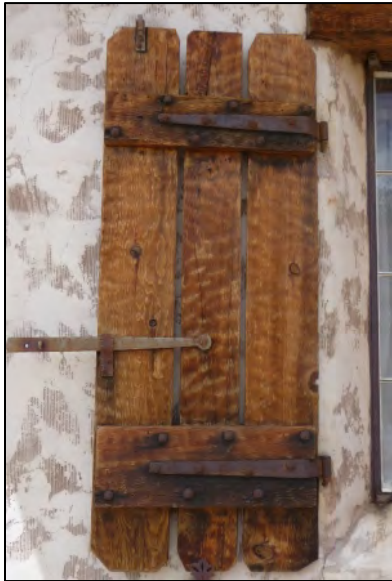
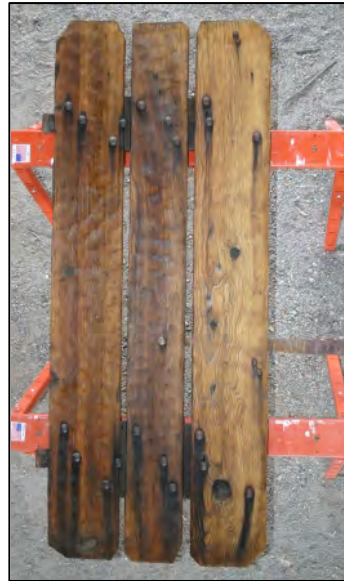
010E1SH001, exposed face, before treatment

010E1SH001, wall face, before treatment

010E1SH001, exposed face, after treatment

010E1SH001, wall face, after treatment

- 3.5% B-98 (g/ml) in ethanol (ETOH) w/ 8% Tinuvin 5151 (2 coats) on both sides
- (N.B. Tested at 3.5% on bare wood, which did not produce a change in wood color or gloss)

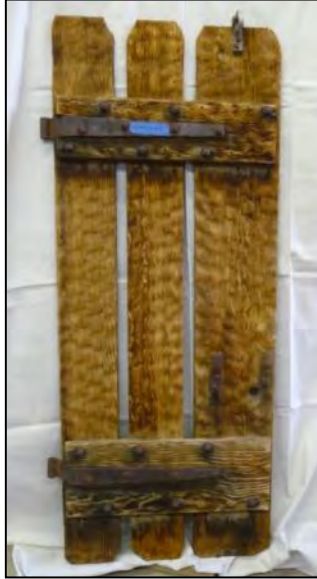
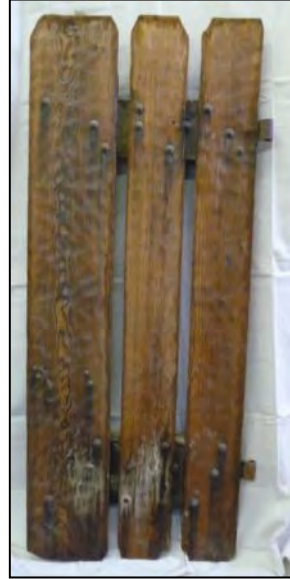
010E1SH002, exposed face, before treatment

010E1SH002, wall face, before treatment

Cleaned with Acetone spray (no gel)

- 2.5% B-98 (g/ml) in Ethanol (ETOH) w/ 8% Tinuvin 5151 (2 coats) on varnished wood
- 2.5% B-98 (g/ml) in Ethanol (ETOH) w/ 8% Tinuvin 5151 (3 coats) on bare wood

(N.B. Tested a 5% on bare wood, but it produced a glossy film, so 2.5% was used)

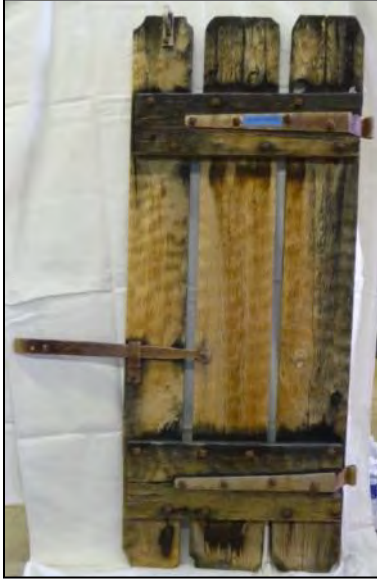
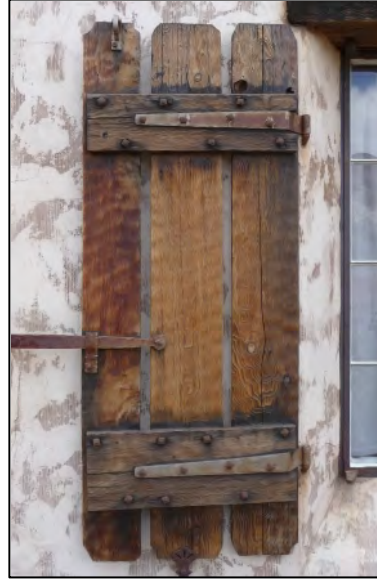
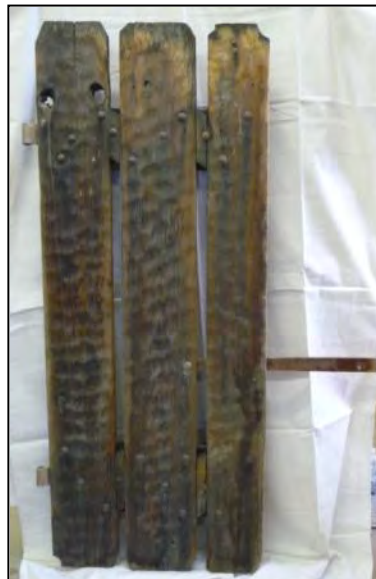
010N1SH001, exposed face, before treatment

010N1SH001, exposed face, after treatment

010N1SH001, wall face, before treatment

- 33% GF450 (2 coats) on two bare wood boards
- 25% GF450 (2 coats) on varnished side of boards and on both sides of the smaller, varnish saturated plank

(N.B. bare wood tested with 50% produced a glossy film; 33% did not. A varnished section tested w/33% resulted in too high a sheen; reducing it to 25% produced better results.)

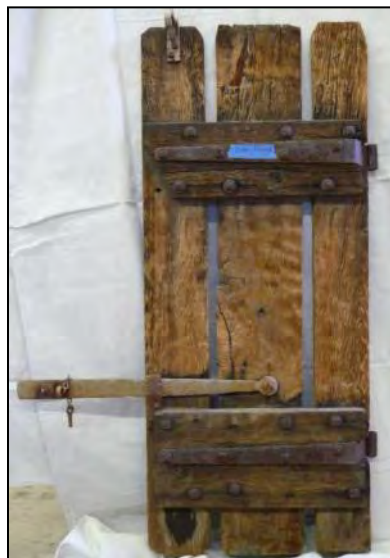
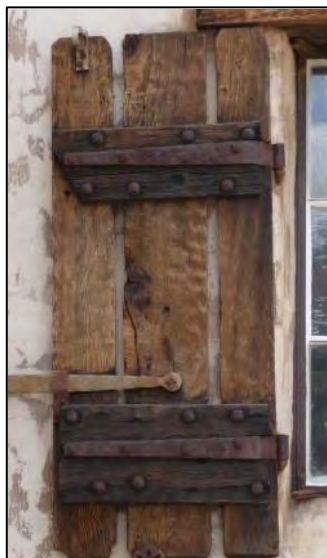
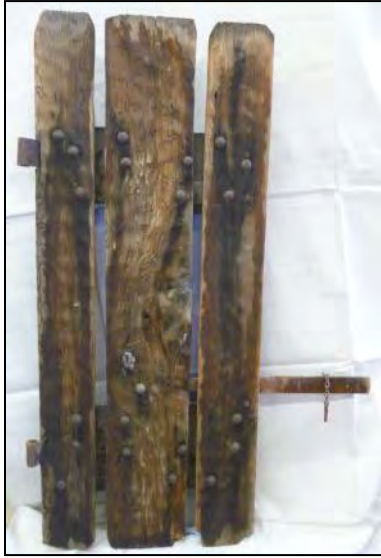
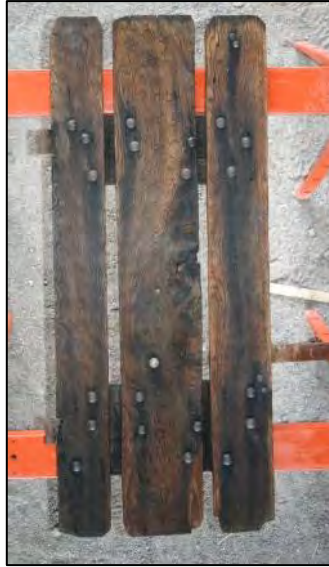
010E1SH003, exposed face, before treatment

010E1SH003, exposed face, after treatment

010E1SH003, wall face, before treatment

010E1SH003, wall face, after treatment

- 2.5% B-98 (g/ml) in Ethanol (ETOH) w/ 5% Tinuvin 292 and 5236 (2 coats) on varnished wood
- 3.5% B-98 (g/ml) in Ethanol (ETOH) w/ 5% Tinuvin 292 and 5236 (2 coats) on bare wood and edges

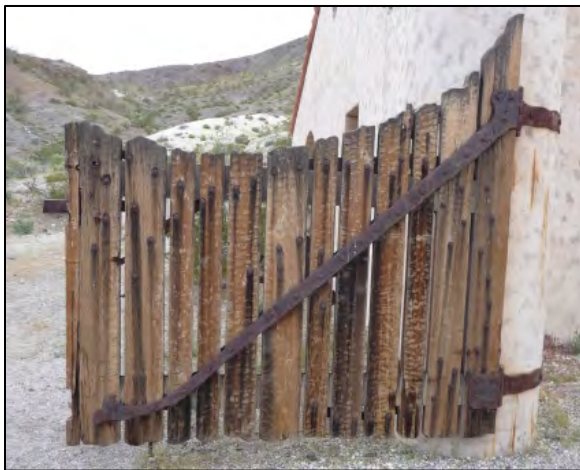
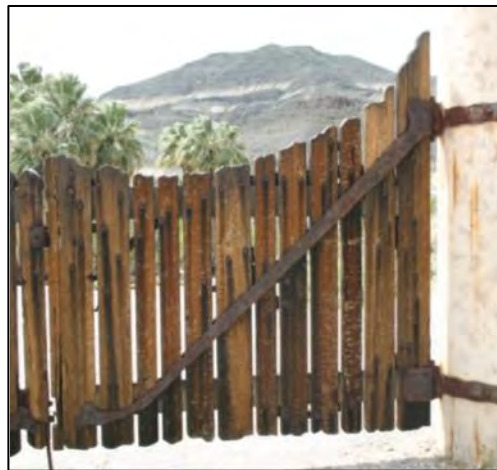
110W1GA001, east face before treatment

110W1GA001, east face after treatment

- 3.5% B-98 (g/ml) in Ethanol (ETOH) w/ 8% Tinuvin 5151 (1 coat) on all wood surfaces.
- 3.5% B-98 (g/ml) in Ethanol (ETOH) w/ 5% Tinuvin 292 and 5236 (1 coat) on all wood surfaces

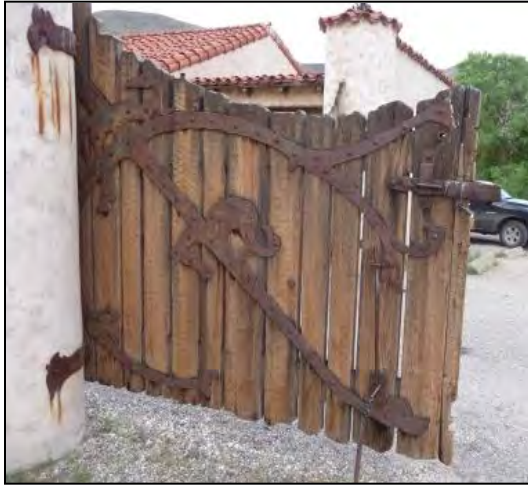
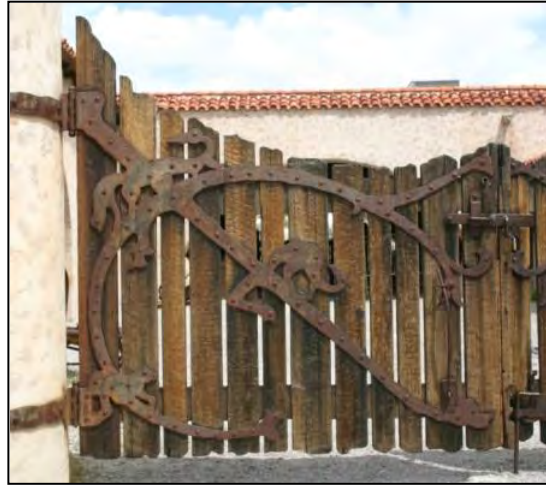
110W1GA001, west face before treatment

110W1GA001, west face after treatment

- 3.5% B-98 in Ethanol (ETOH) w/ 5% Tinuvin 292 and 5236 (2 coats).⁷

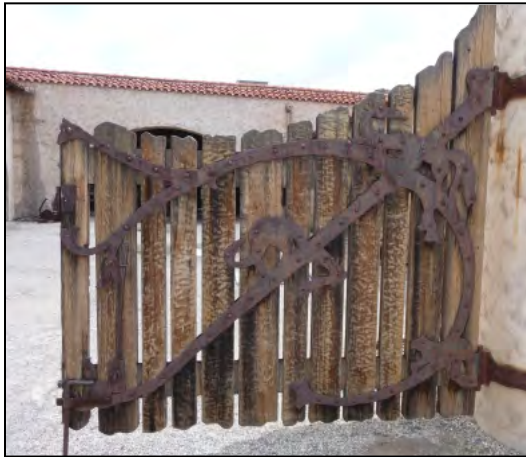
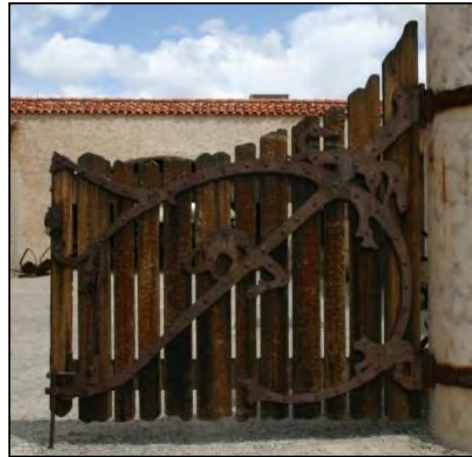
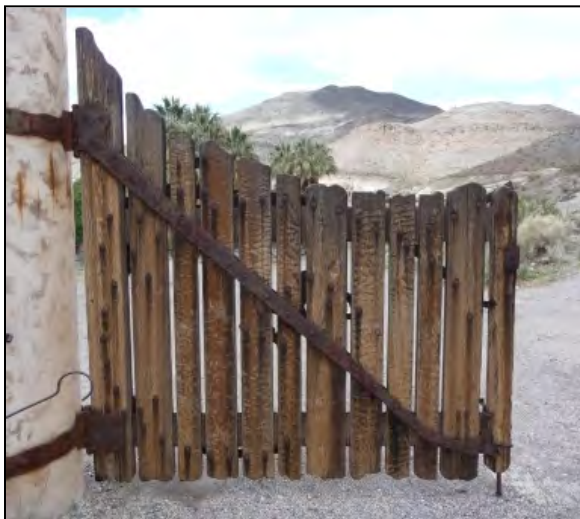
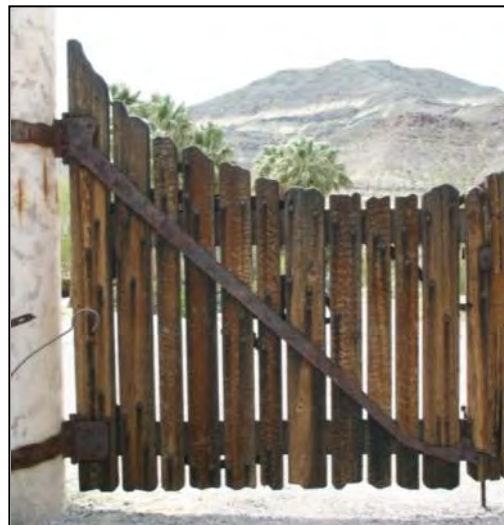
110W1GA002, West face before treatment

110W1GA002, West face after treatment

110W1GA002, East face before treatment

110W1GA002, East face after treatment

- Blend of 25% B-98 in Ethanol (ETOH) w/ 8% Tinuvin 5151 and 50% B-98 in Ethanol (ETOH) w/ 8% Tinuvin 5151 on top faces of vertical boards.⁸
- 3.5% B-98 (g/ml) in Ethanol (ETOH) w/ 8% Tinuvin 5151 (1 coat) followed by 3.5% B-98 (g/ml) in Ethanol (ETOH) w/ 5% Tinuvin 292 and 5236 (1 coat) on all remaining wood surfaces.

⁸ This was applied during the afternoon, in direct sunlight. The B-98 bubbled and dried to a thick crust with a heavy sheen. This was subsequently brushed first with ETOH then Acetone until a more appropriate appearance was achieved.

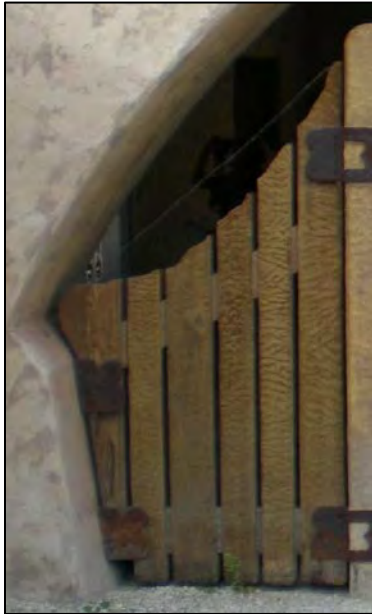
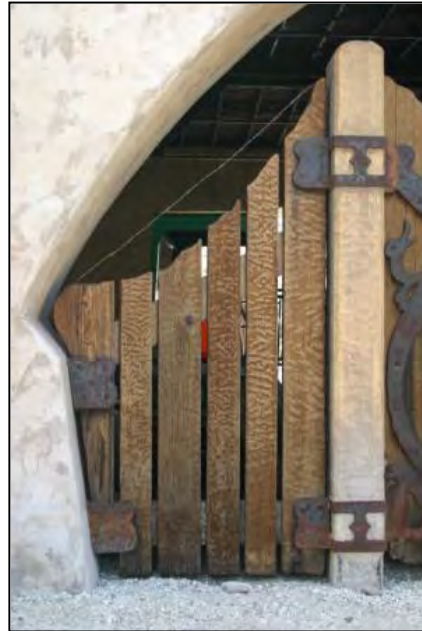
010E1GA01 before treatment

010E1GA01 after treatment

- 25% B-98 in Ethanol (ETOH) w/ 8% Tinuvin 5151 on top faces of all vertical boards.
- 3.5% B-98 (g/ml) in Ethanol (ETOH) w/ 5% Tinuvin 292 and 5236 (2 coats) on all wood surfaces.

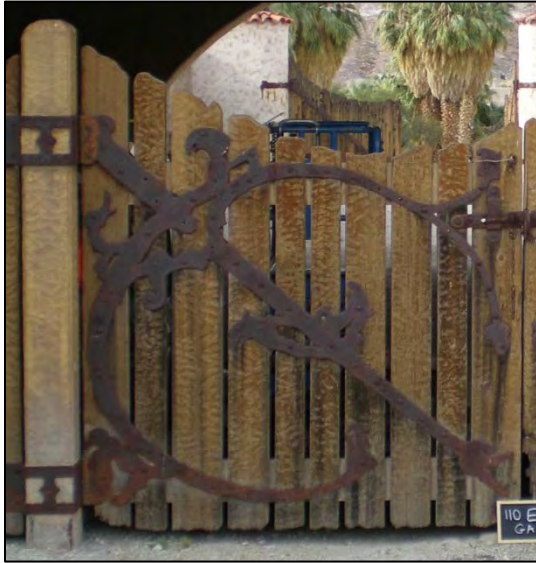
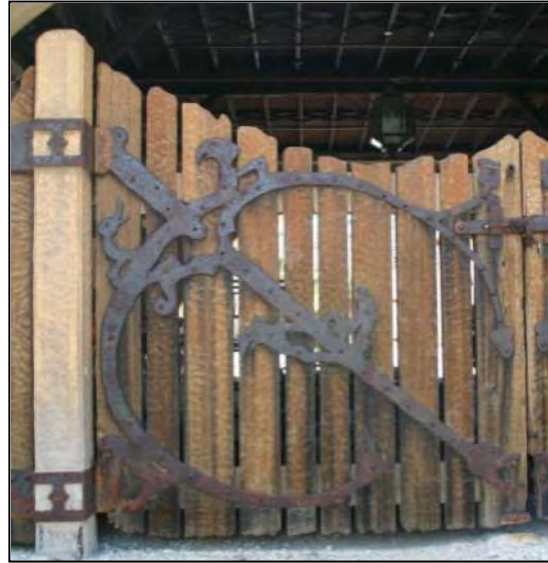
010E1GA02 before treatment

010E1GA02 after treatment

- 25% B-98 in Ethanol (ETOH) w/ 8% Tinuvin 5151 on top faces of all vertical boards.
- 3.5% B-98 (g/ml) in Ethanol (ETOH) w/ 5% Tinuvin 292 and 5236 (1 coat by HVLP spray and 1 coat by brush) on all remaining wood surfaces

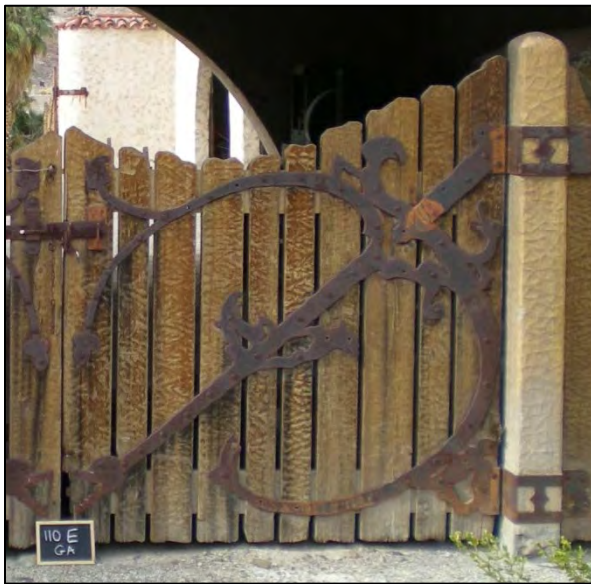
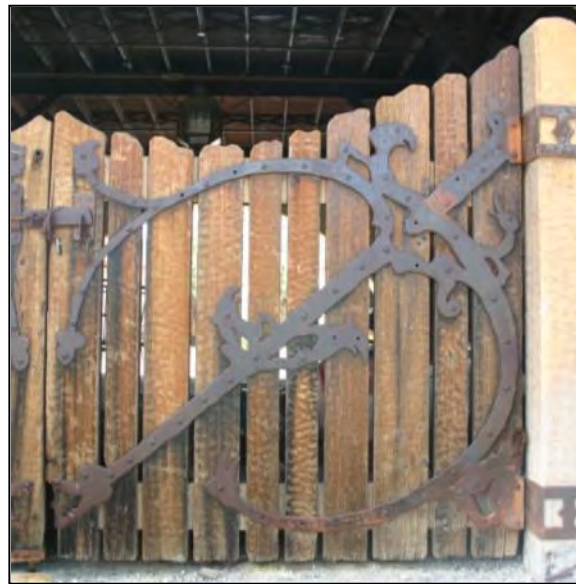
010E1GA03 before treatment

010E1GA03 after treatment

- 25% B-98 in Ethanol (ETOH) with 8% Tinuvin 5151 on top faces of all vertical boards.
- 3.5% B-98 (g/ml) in Ethanol (ETOH) w/ 5% Tinuvin 292 and 5236 (4 light coats by HVLP spray and final, heavier coat by HVLP spray, brushed) on all remaining wood surfaces.

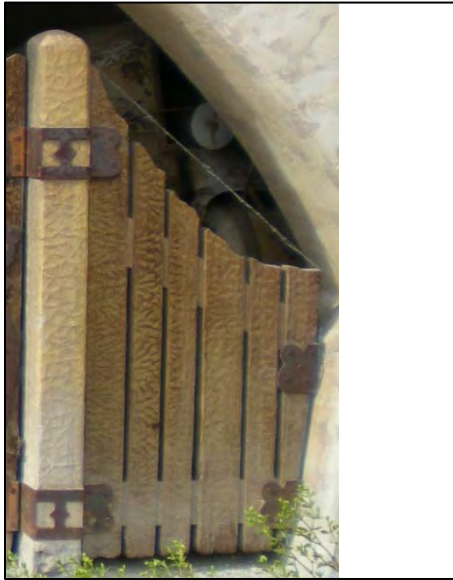
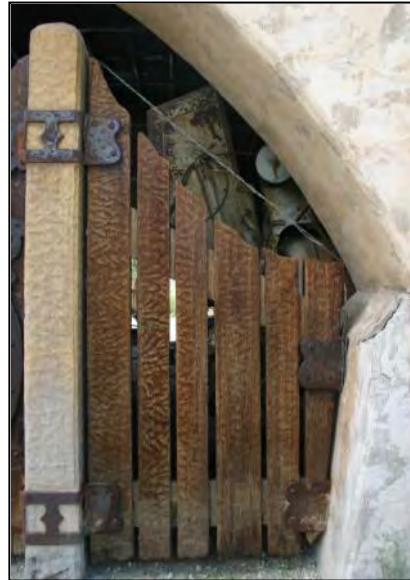
010E1GA04 before treatment

010E1GA04 after treatment

- 25% B-98 in Ethanol (ETOH) on top faces of all vertical boards.
- 3.5% B-98 (g/ml) in Ethanol (ETOH) w/ 5% Tinuvin 292 and 5236 (4 light coats by HVLP spray and final, heavier coat by HVLP spray, brushed) on all remaining wood surfaces.

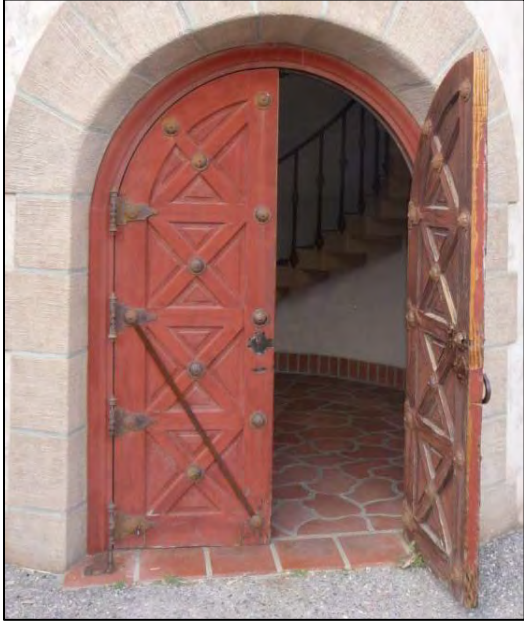
02AE1DO004 before repair

- Left hand (west) leaf in an arched door pair.
- Stock is 10-quarter redwood.
- Mortise waste was removed with auger and the ends of the mortises were chopped out by hand.
- Tenons are 7/8-inch thick and were originally haunched.
- X-munts in each of the paneled openings have stub tenons that engage the panel groove
- Hardware is one-off package consisting of rosettes (cast), wrought surface latches, bolts, pulls and hinges, all decoratively profiled. Made of iron that is rusting.
- Constructed without adhesive; hardware studs function as draw pins.
- Door has been shortened so that all the relish has been removed below the bottom rail (undermining the bottom rail tenons)
- West stile (the shorter stile) has large losses at bottom rail joinery
- Bottom rail has large area of decay, losses around hardware

Consolidated soft (incipient decay) wood at lower ends of stiles with:

- Blend of 12% B-98 in ethanol (ETOH)

Relish at right-hand (east) stile replaced with dutchman insert
Dutchman extension of left-hand (west) stile to replace decayed wood
Dutchman repair of bottom rail to replace decayed / fractured wood

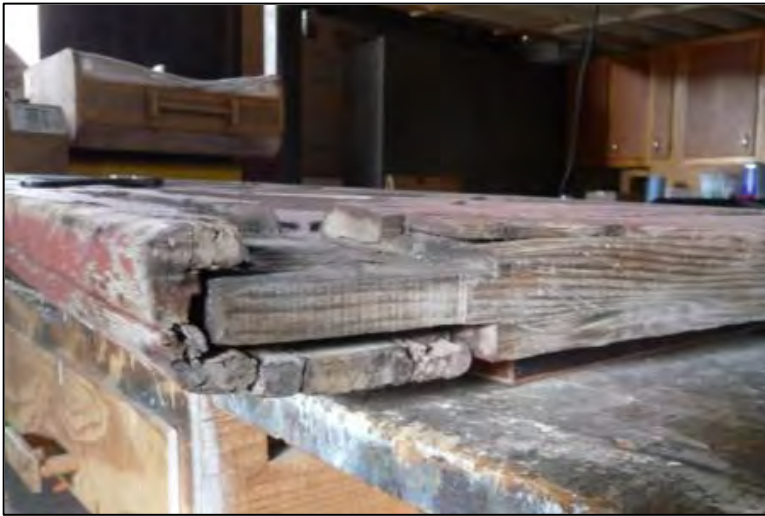
Loss of relish in stiles at bottom rail location due to trimming of the door. This undermines support for bottom rail tenons.

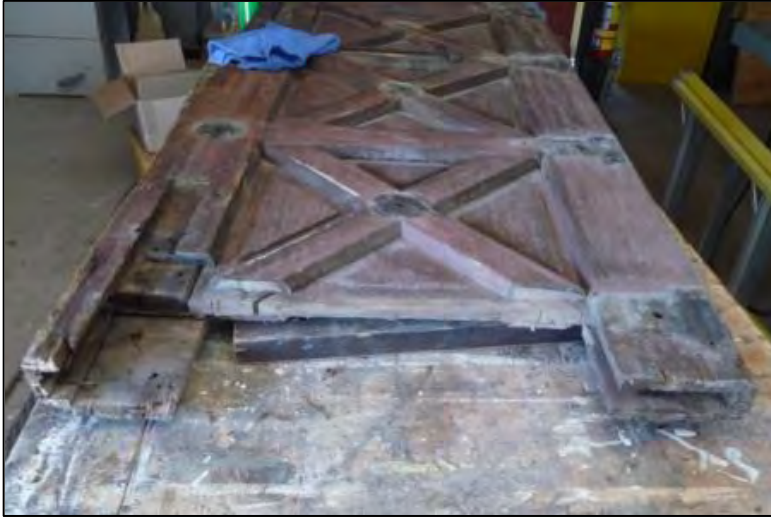
Large loss at east stile-bottom rail connection (bottom left). Bottom rail has been removed.

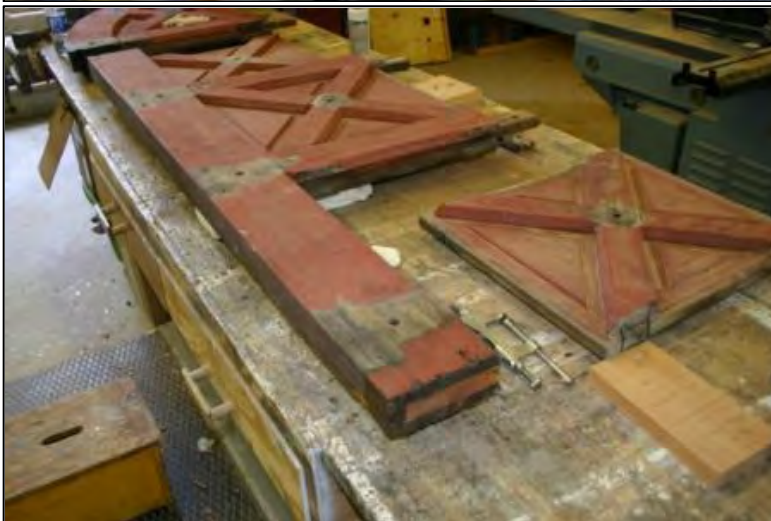
Right-hand (east) stile and bottom rail removed. Stub tenon at lower end of X-munt visible (lower right).
