The Fort Davis National Historical Site Post Hospital Restoration Program 2008

COMPLETION REPORT

PREPARED FOR THE NATIONAL PARK SERVICE
BY
THE SCHOOL OF ENGINEERING
UNIVERSITY OF VERMONT

July 2009

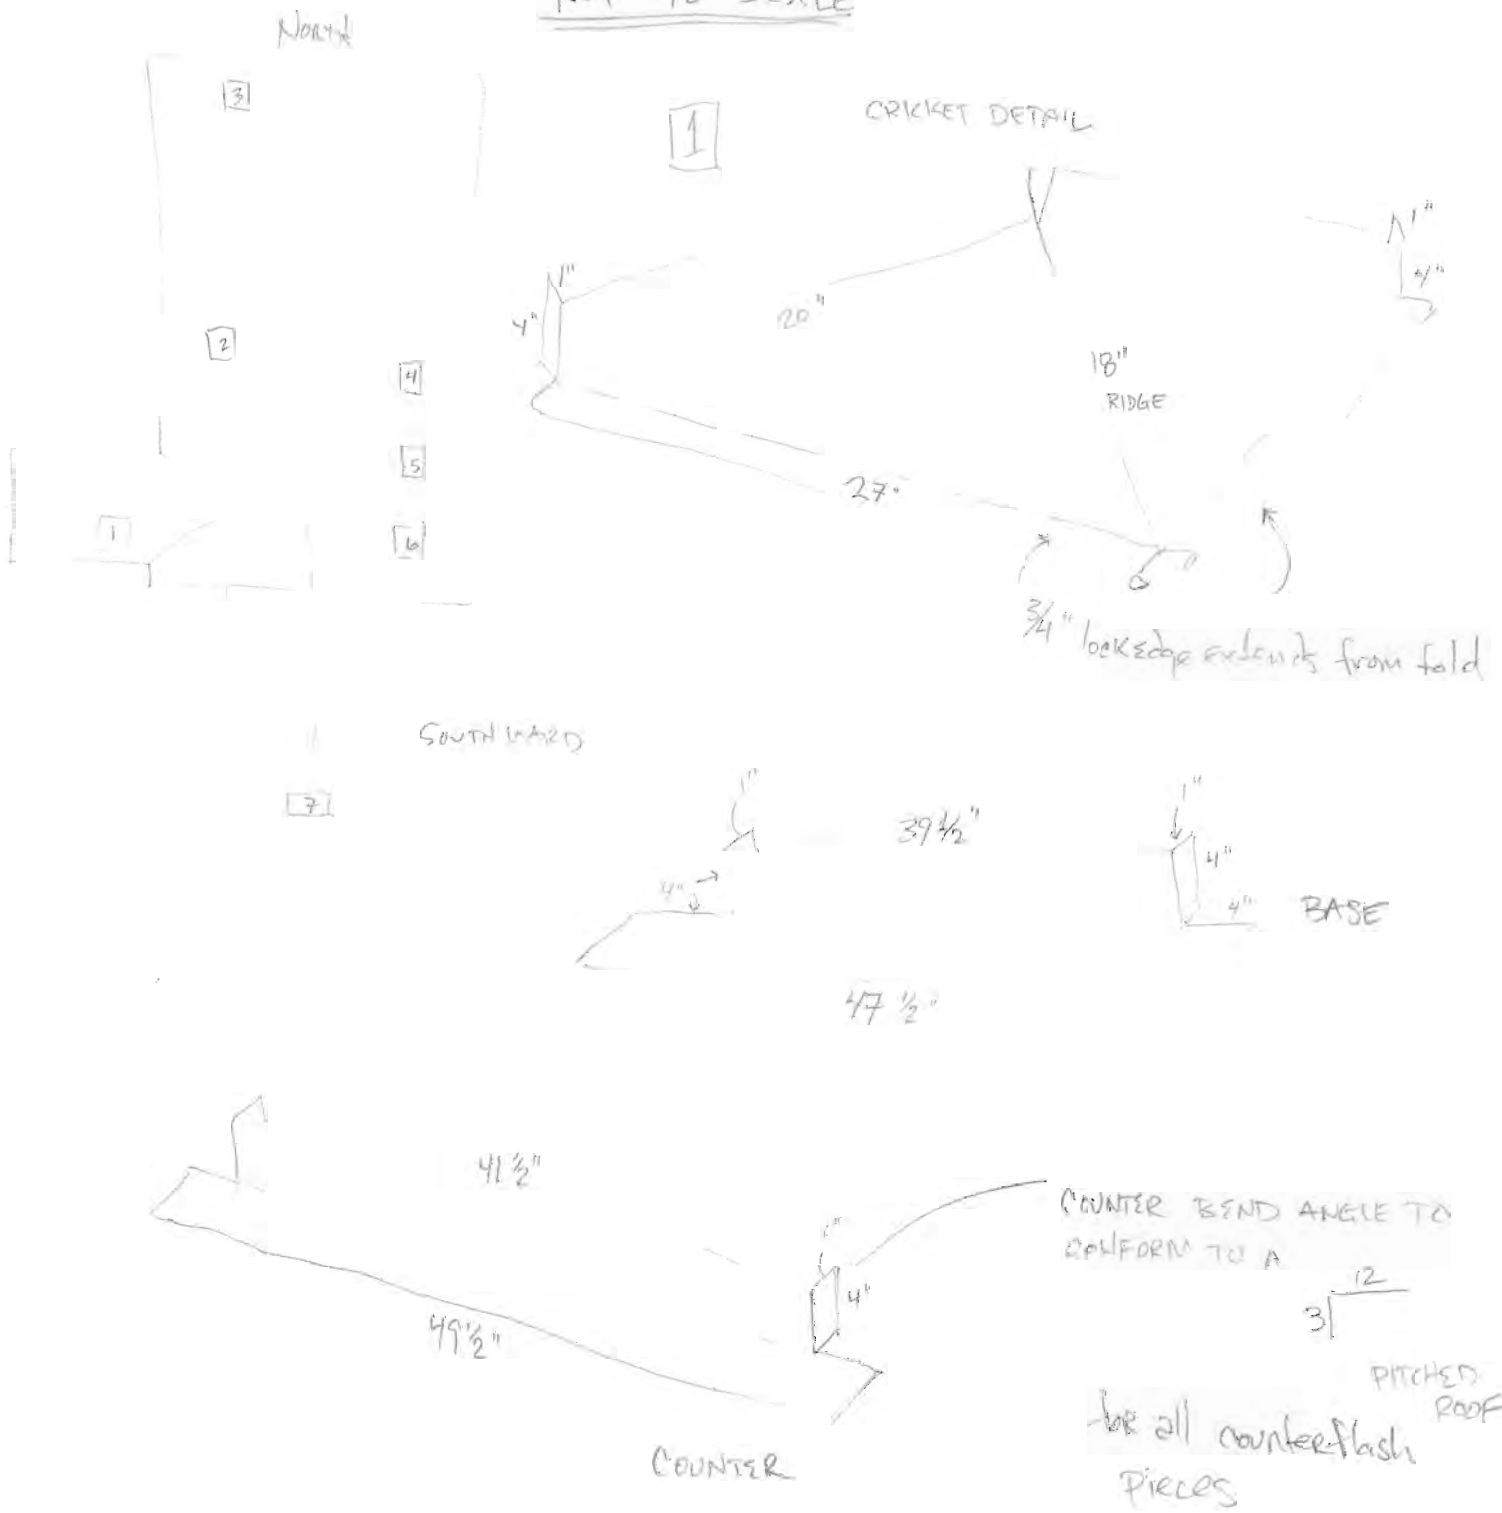
FODA POST HOSPITAL CHIMNEY FLASHING DETAILS

During the course of the previous project, leaks had been discovered around the six chimneys of the North Ward and the Administration Building. The impact of this water infiltration, most notable during heavy rainstorms, was the erosion of the historic adobe and plasters below. Of special concern is the Kitchen chimney, which appears to include early (possibly 19th century) brickwork. In 2008 the goal was to survey these chimneys and begin to design flashings capable of halting the water infiltration and subsequent destruction. Flashing design was derived primarily from two sources, “Standing Seam Roofing” (Follansbee Steel) and “The Architectural Sheet Metal Manual” (Sheet Metal and Air Conditioning Contractors’ National Association, Inc.), and is represented in a series of site-drawn sketches (see Appendix I).

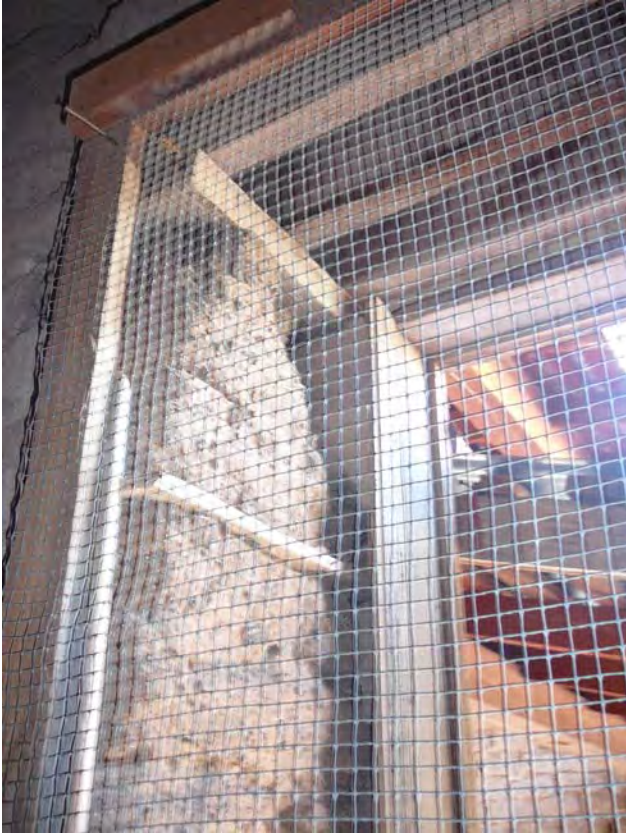
Figure 1.

Ventilating screens were fabricated and installed in several window openings, including in the Kitchen shown here.

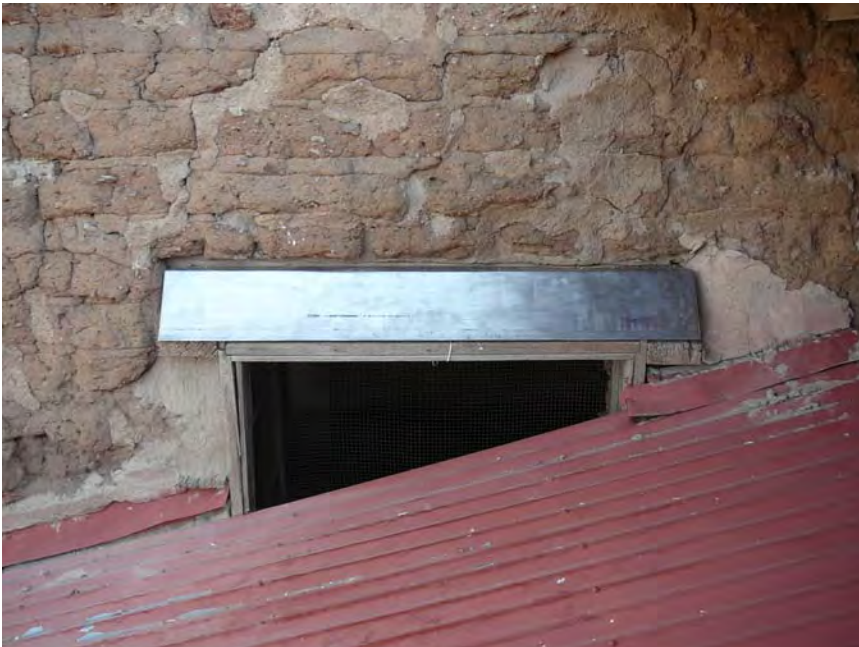
Figure 2. On the exterior of the Kitchen window, a new drip cap was installed.

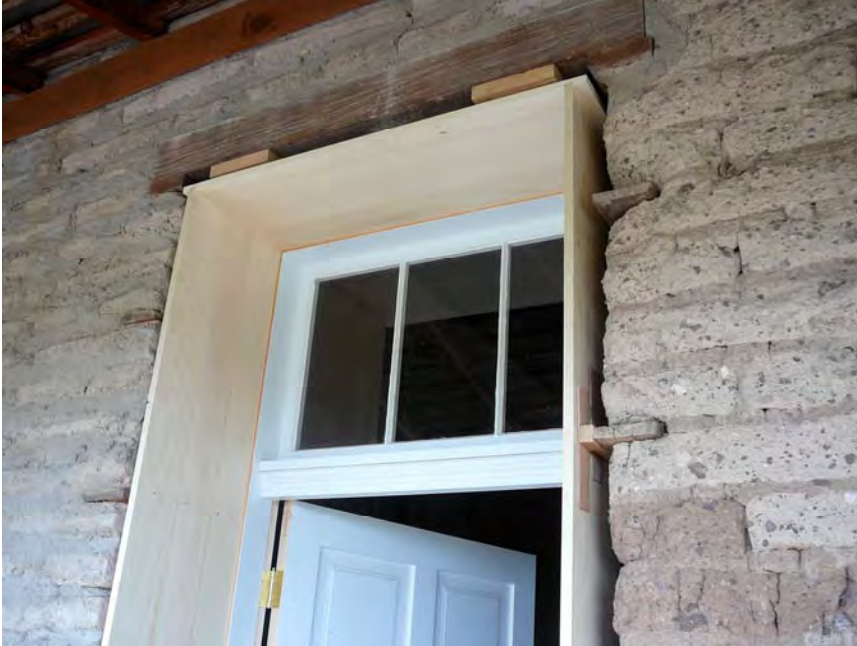
Figure 3. Several remaining door casings were completed, including this one on the north wall of the Surgeon's office in the Administration Building.

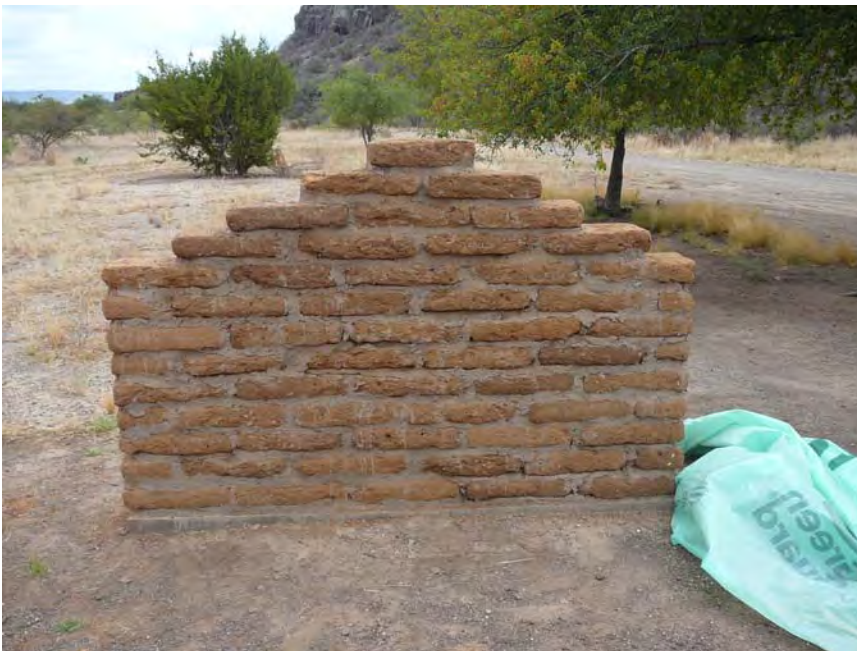
Figure 4. Construction of an adobe test wall.
