Development of Guidelines for Cuts in Loess Soils

WA-RD 69.1

**Final Report
June 1985**

**Washington State
Department of Transportation**

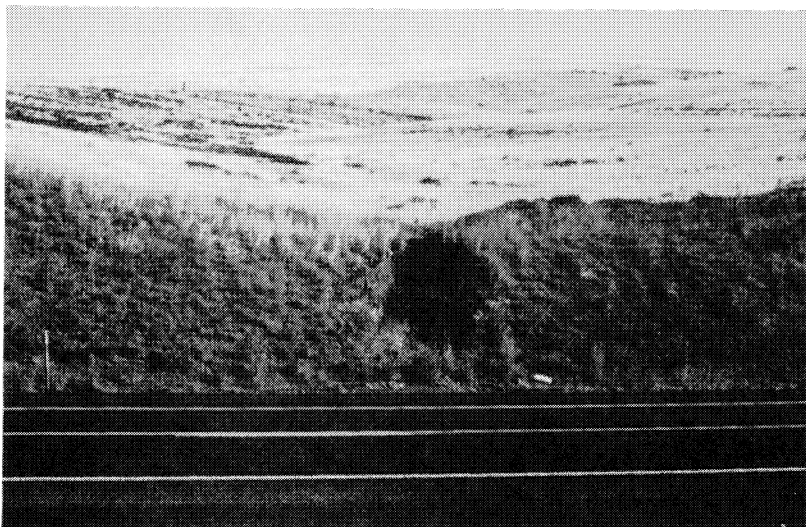
Figure 21. Gully erosion resulting from truncation of a small drainage basin (near LaCrosse).

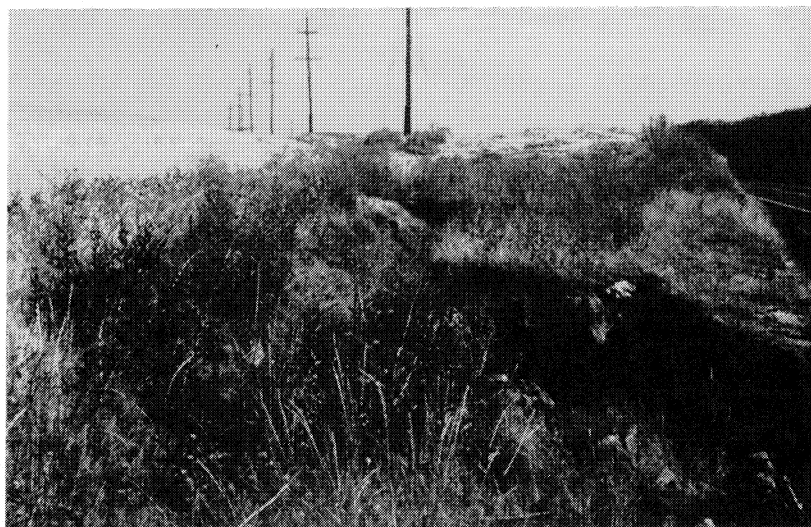
Figure 22. Gully erosion in a side ditch due to insufficient channel protection.

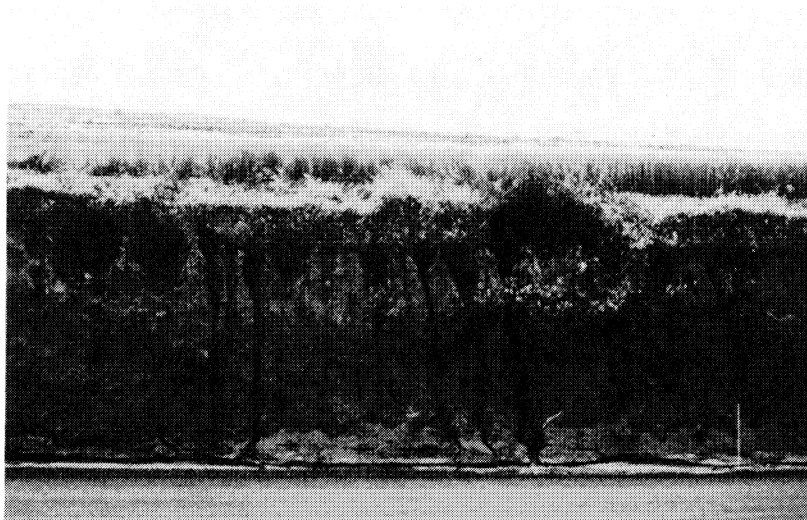
Figures 23 and 24 illustrate two separate points. In Figure 23 the majority of the erosion in the left portion of the photo is due to piping. To the right of the small pipes, gully erosion is beginning to develop. Vegetation in the base of the depression as well as the shape of the developing gully indicate the gully originated as a pipe. When the pipe enlarged to the point where the overlying material could no longer be supported, caving occurred and the overlying vegetation was deposited in the depression. This is a very common mechanism in the formation of erosion gulleys in silty loess.

Figure 23. Piping erosion developing into gulley erosion (Highway 12 N.E. of Walla Walla).

erosion probably could have been prevented by constructing a drainage ditch or dike behind the cut face to divert the surface flow.

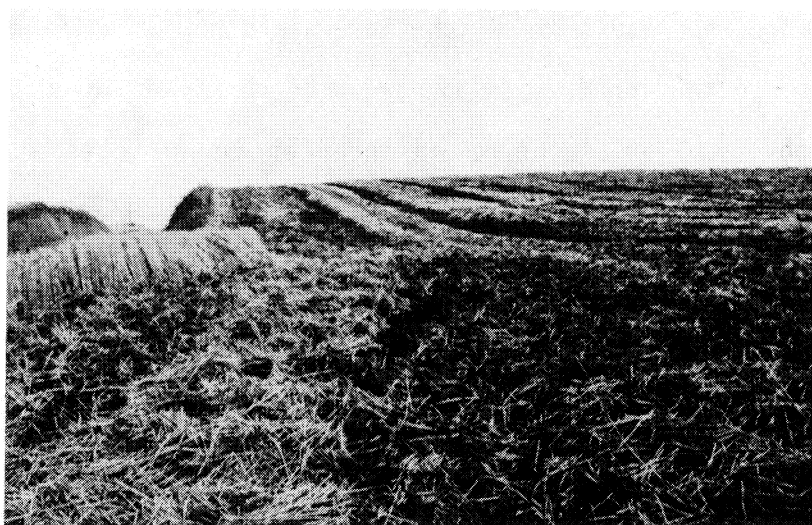
The second point that should be noted is how small a drainage basin can be and still initiate erosion. Figure 24 shows the drainage area above the erosion in Figure 23. When first examined in June 1984, prior to harvesting, there was no indication that drainage was concentrating flow toward the problem area. Upon re-examination following tillage, the photograph in Figure 24 was taken which clearly shows the minor basin draining to the existing erosion. Thus, extensive erosional problems may develop from extremely small drainage basins. In this particular case

Figure 24. Small depression at center is the runoff source causing erosion in the previous photograph.

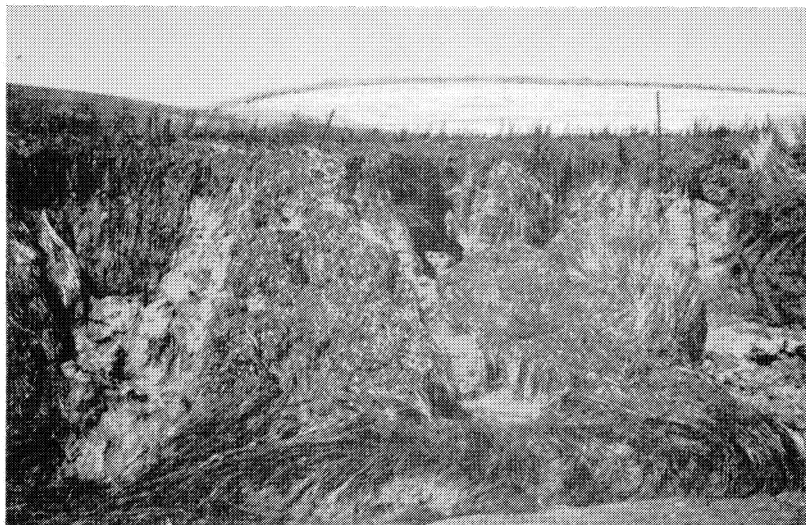
Figure 25. Area of large scale piping near Endicott. Flattened vegetation indicates flow over the slope as well as piping.

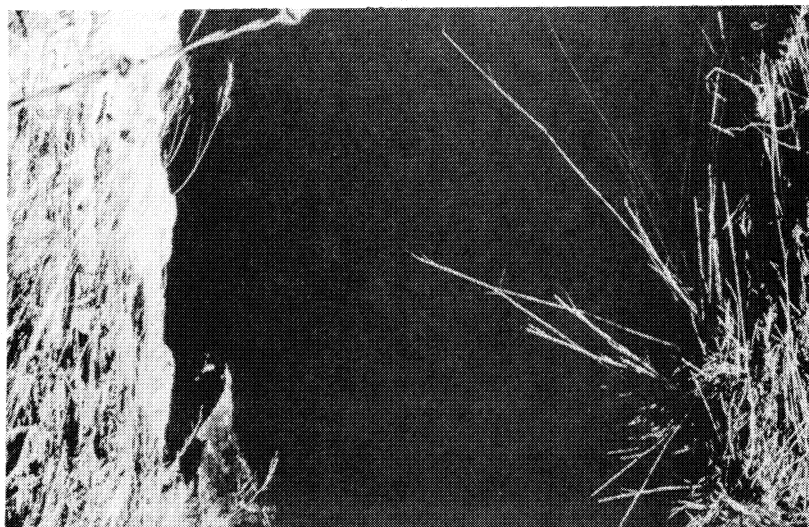
Figure 26. Close-up of a major pipe from previous figure.

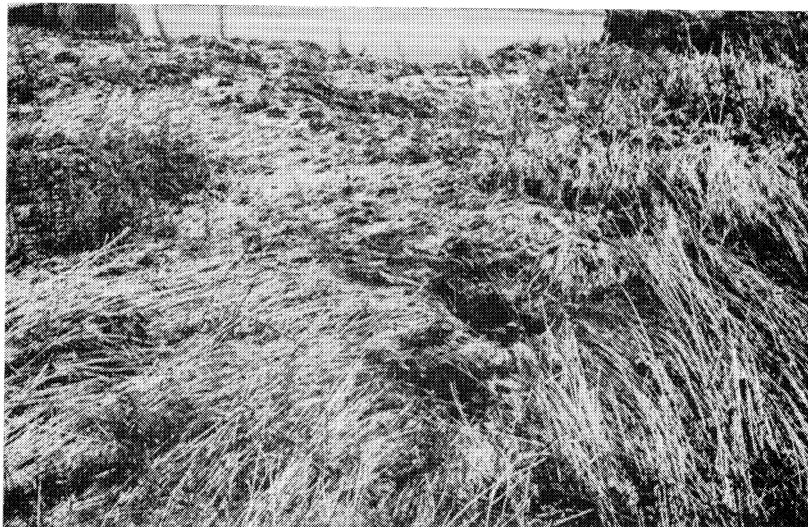
Figure 27. Dark areas below center are piping inlets located approximately 10 feet behind the cut.

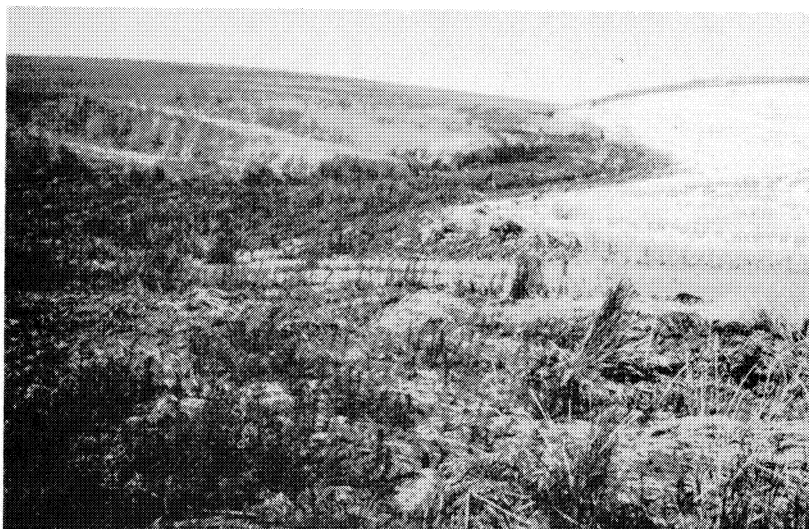
Figure 28. The drainage basin above the piping is relatively large. The lack of an adequate drainage system explains the extensive damage.

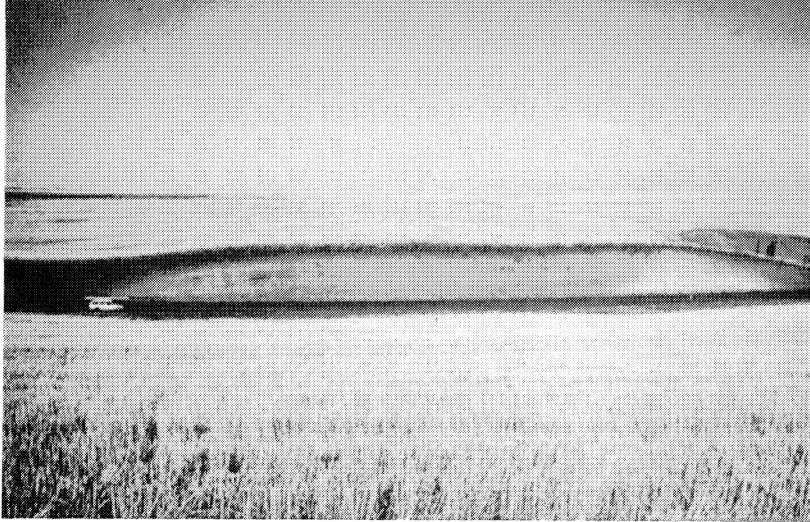
Figure 29. The natural surface drainage is away from the slope face. Little erosion damage has occurred.

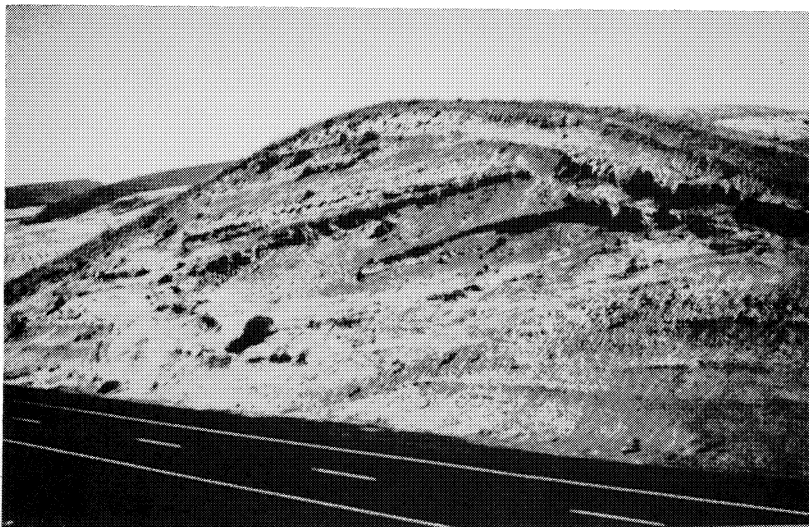
Although only a minor problem, wind erosion was observed in the western sections of the study area. Figures 30 and 31 illustrate the most common form of wind erosion in the field area. The ridges in the photographs are the result of caliche layers and not stratification.

Figure 30. Wind erosion near Washtucna.

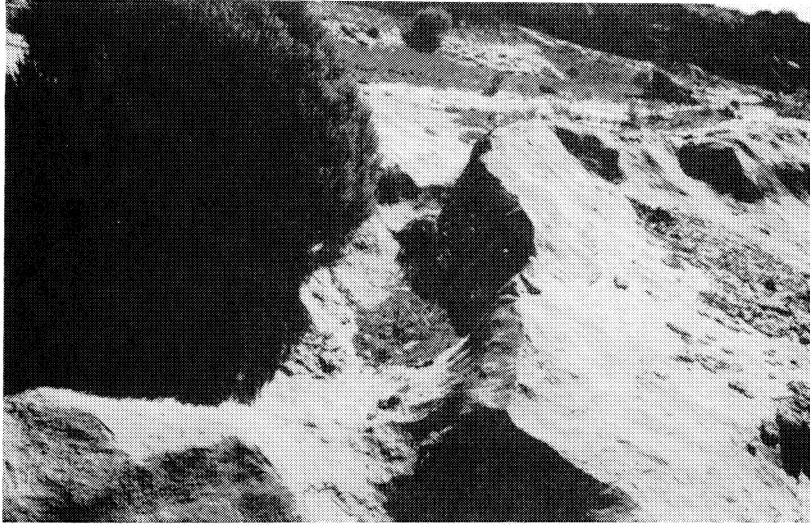
Figure 31. Close-up of wind eroded slope illustrating ventifact-like faceting.

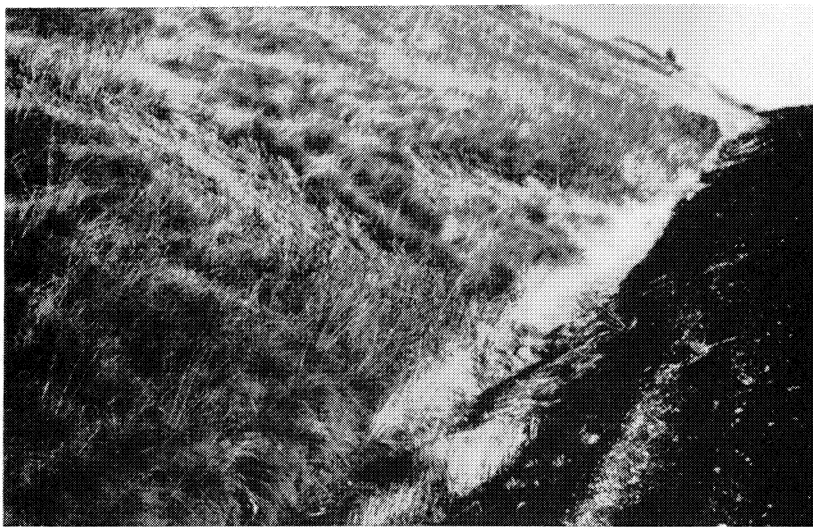
Figure 32. Shallow failures with arcuate scarps are fairly common in silty loess near the eastern extremity of the study area.

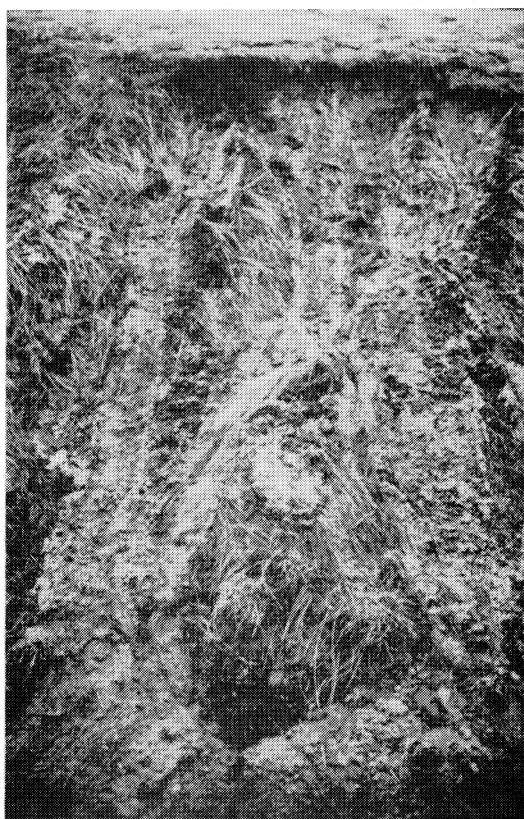
Small scale slides and/or flows, such as in Figure 33 are the most common form of failure. Failures are typically 1 to 10 ft. wide with the depth of failure ranging between inches and 3 to 4 ft. In most cases the initial failure is followed by increased erosion due to the loss of vegetative cover with severe gully erosion a common result. Observations in the spring of 1985 indicate that in some cases failure may be due to saturation of the soil under the snowpack as well as due to weight of the snowpack on underlying saturated slope (Figure 34).

Figure 33. Small scale mudflow in highway cut on highway 195 (near Pullman, WA).

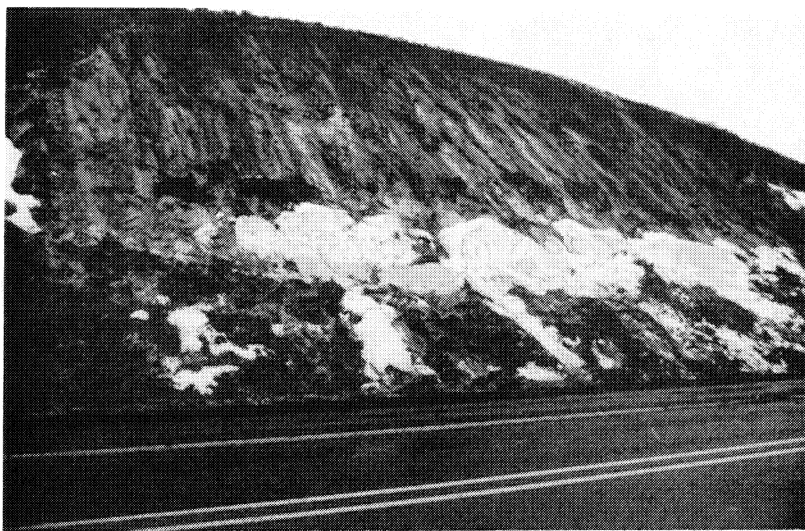
Figure 34. Failure of slope under melting snow drifts (near Pullman, WA).

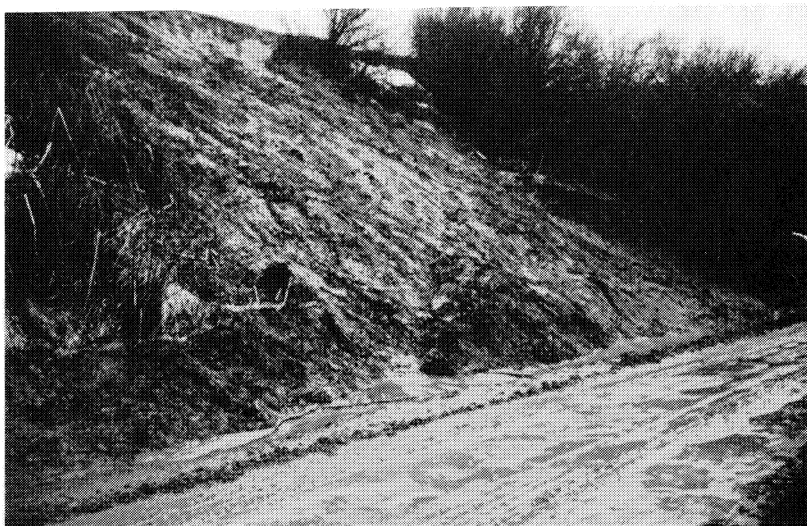
Figure 35. Relatively large scale mudflow located near Pullman. Undisturbed soil to the right of the photograph indicates the depth of failure at approximately 3 feet.

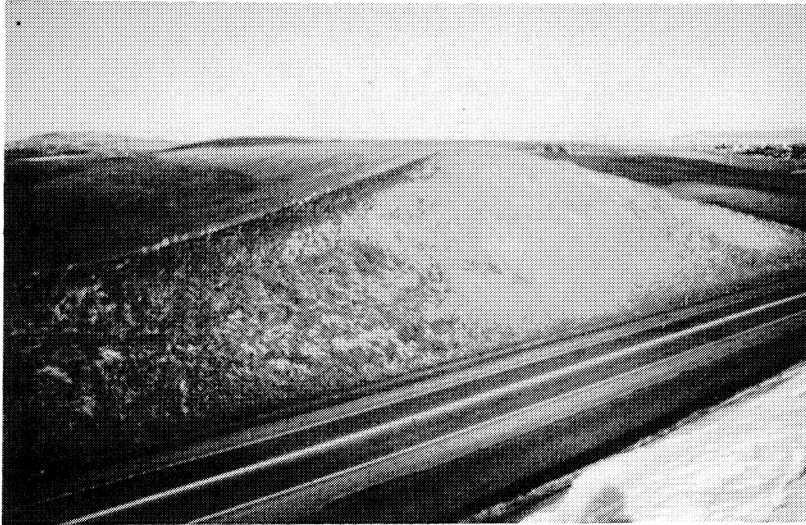
Exposure definitely has an influence on these shallow slides and flows. It is not uncommon to find two opposing cuts with similar slopes and drainage, one facing north and the other south, to exhibit extremely different performance. The north facing slope will invariably demonstrate a greater degree of degradation due to shallow slides and flows than the south facing slope. This is not surprising as slopes facing to the north typically have higher average water contents than any other orientation. Figures 36 and 37 show south and north facing slopes (respectively) cut in clayey loess at approximately 2:1. Note in Figure 36 that some erosion has occurred where small patches of vegetation and soil have slipped away. However, the north facing slope (Figure 37) has experienced numerous shallow failures which have stripped the vegetation. Obscured by the snow drift are scarps from larger failures, which have occurred over the past several years, that have significantly steepened the crest of the slope. The result of the shallow slides is exposure of bare soil and rapid formation of erosion gulleys, some of which range up to 2 ft. in depth (Figure 37).

Figure 36. South facing slope shows little degradation (Pullman, WA).

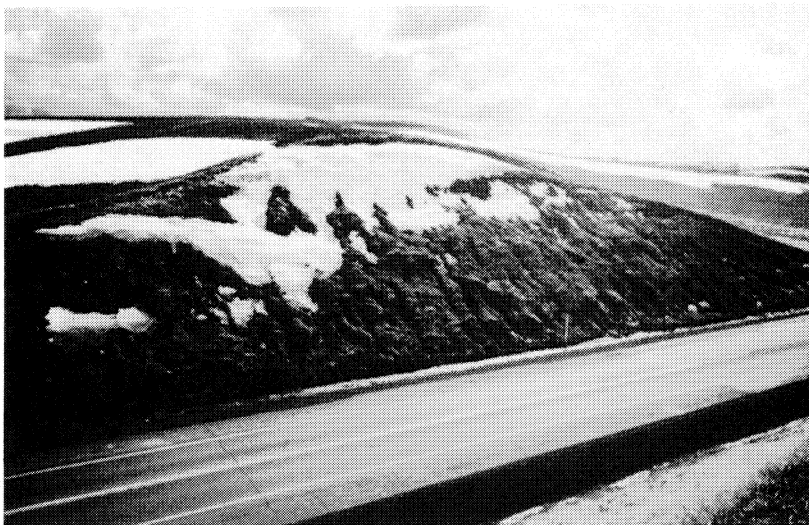
Figure 37. North facing slope opposite the cut in Figure 36 exhibits severe gulley erosion.

The practice of constructing drainage ditches immediately below the toe of slopes appears to contribute to this type of failure. Periodic highway maintenance requires removal of sediment from the ditches which may result in undercutting the toe. Additionally, drainage ditches directly adjacent to the toe often raises the water content, further encouraging failure conditions. This problem may be reduced by placement of drainage ditches 10 to 15 ft. away from the toe of the slope.
