Effectiveness Of  
Concrete Bridge Deck  
Asphalt-Membrane Protection

WA-RD 75.1

Final Report

September 1985

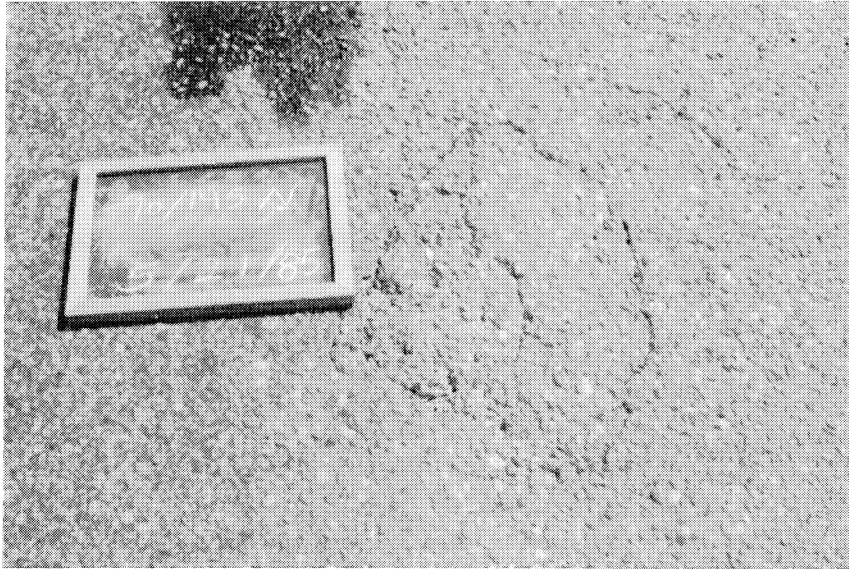
Figure 2. Local Pattern Cracking in AC Caused by Underlying Concrete Deterioration.

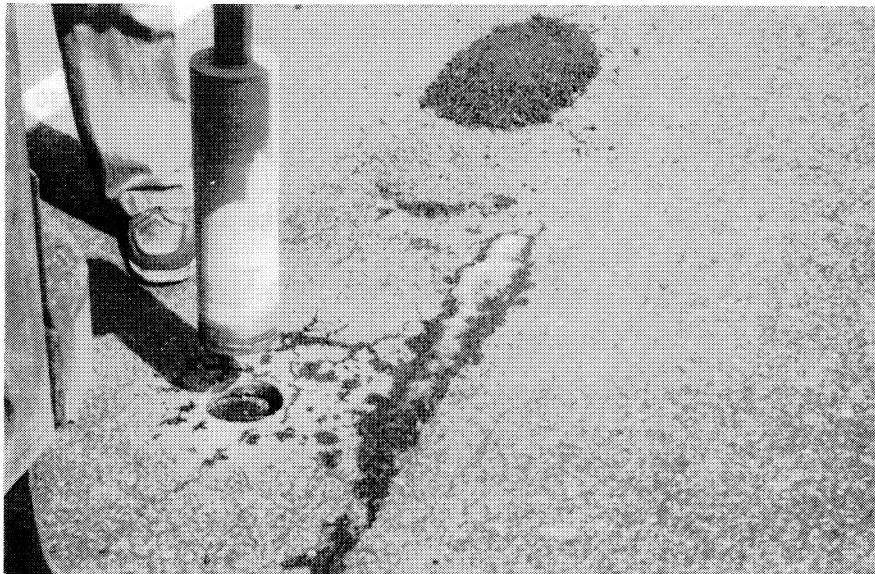
Figure 3. Stripped Aggregate in the Bottom of AC in a Core Location in the Cracked Overlay (Bridge 82/20 N).

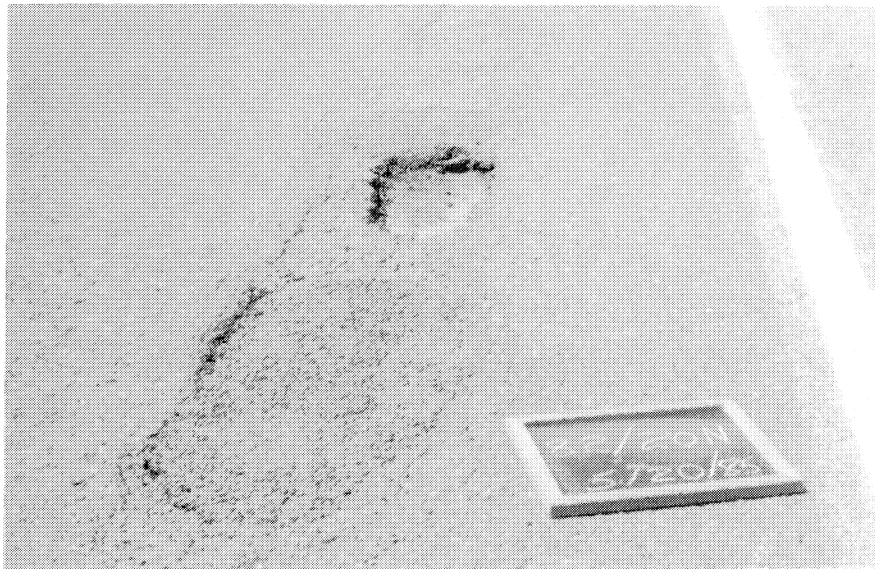
Chain dragging the AC in conjunction with a coring operation detected defects in the AC in the vicinity of the interface. Where the problem had occurred, the coring clearly revealed that the asphalt binder in the bottom layer of the AC was completely stripped, resulting in no integrity between the mixture elements or adhesion between them and the membrane. This phenomenon resulted in the presence of pattern cracking and depression of the AC surface and, ultimately, stripping of the overlay.

Where the problem had occurred on 82/20 N, an AC construction joint had coincided with the wheel path. Under this condition water can easily penetrate into the

Figure 4. Stripped AC Caused by Defects in the Bottom of the Overlay

AC and accumulate above the membrane. Repeated hydraulic pressure exerted by traffic action can then strip the asphalt. However, regardless of the presence of a joint, water can penetrate AC to some extent and accumulate on top of the membrane. This in turn weakens the bottom layer of the overlay. This was confirmed during coring. Most of the approximately 65 AC core samples were easily chiseled out along a plane slightly above the membrane, indicating the existence of a plane of weakness in that depth.

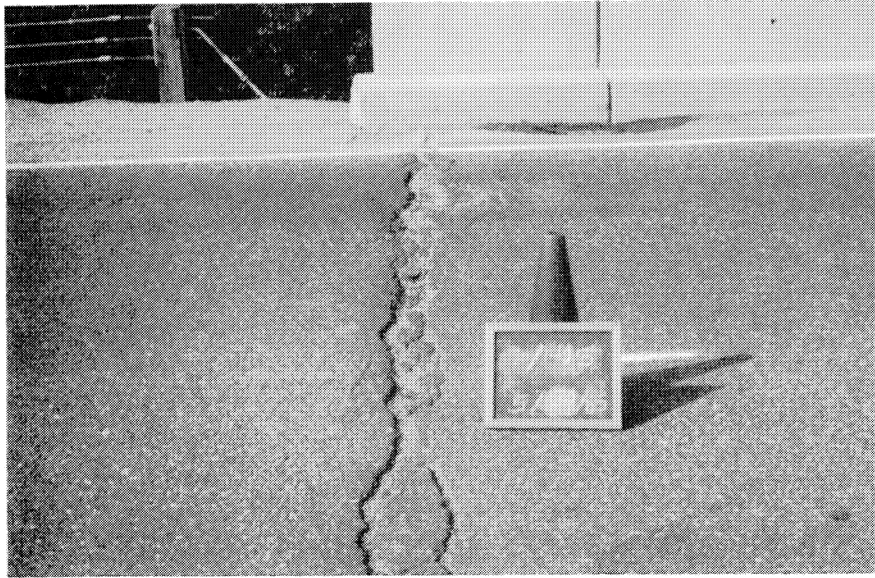
Pavements on the joints covered with asphalt overlay were generally cracked (see Figure 5). Damage to the asphalt overlay was minimal when paved next to an elastomeric expansion device (see Figure 6).

Figure 5. AC Deterioration in the Vicinity of the Abutment Joint.

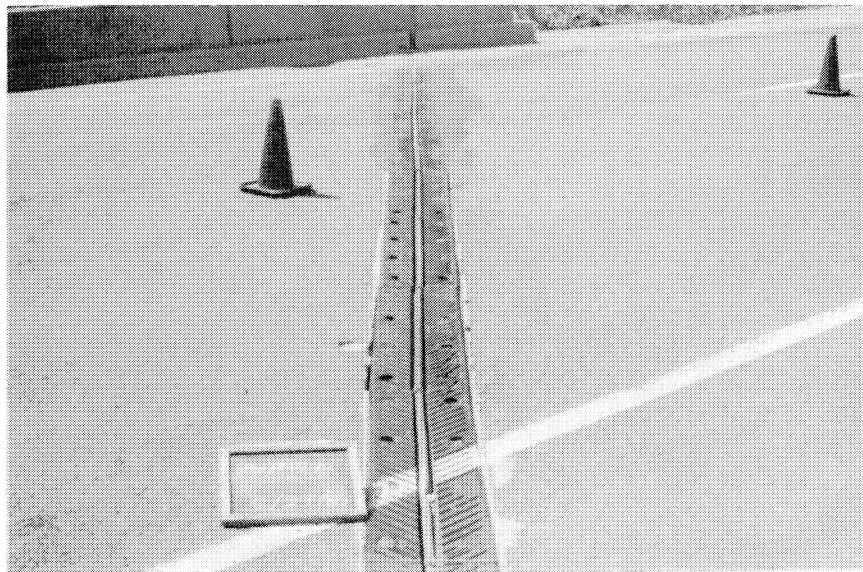
Figure 6. Present Condition of an Elastomeric Expansion Device and Asphalt Overlay Paved Next to It.

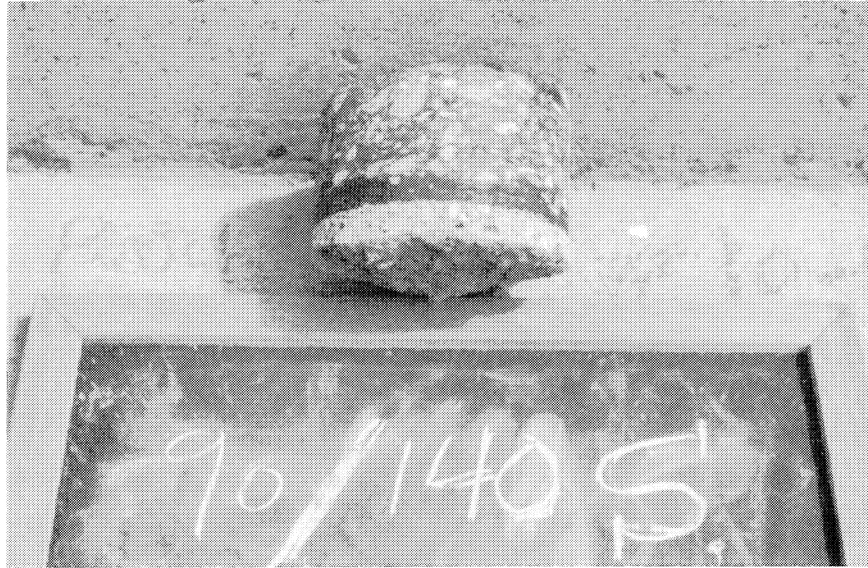
Figure 7. Concrete Delamination (Patch) Under Sound AC Overlay and Membrane.

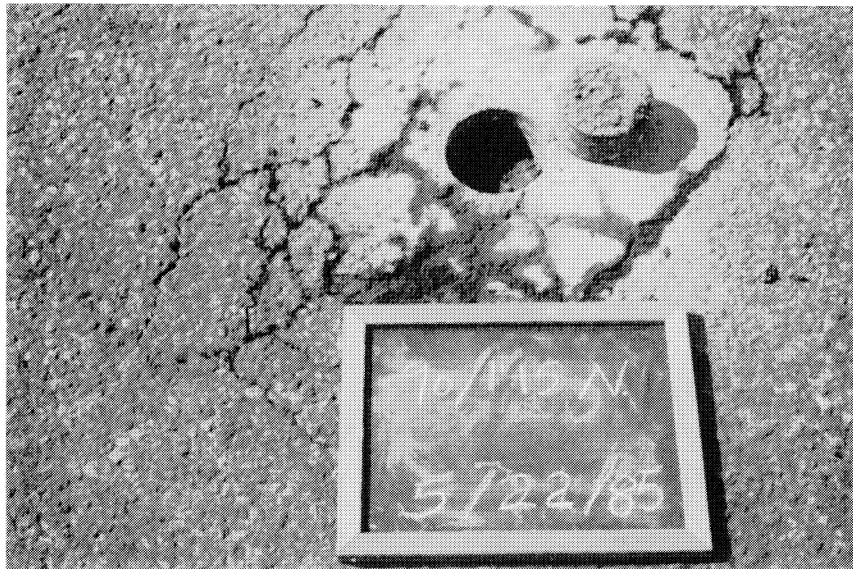
Figure 8. Severe Disintegration of Concrete (Patch) Associated with Pattern Cracking of AC.

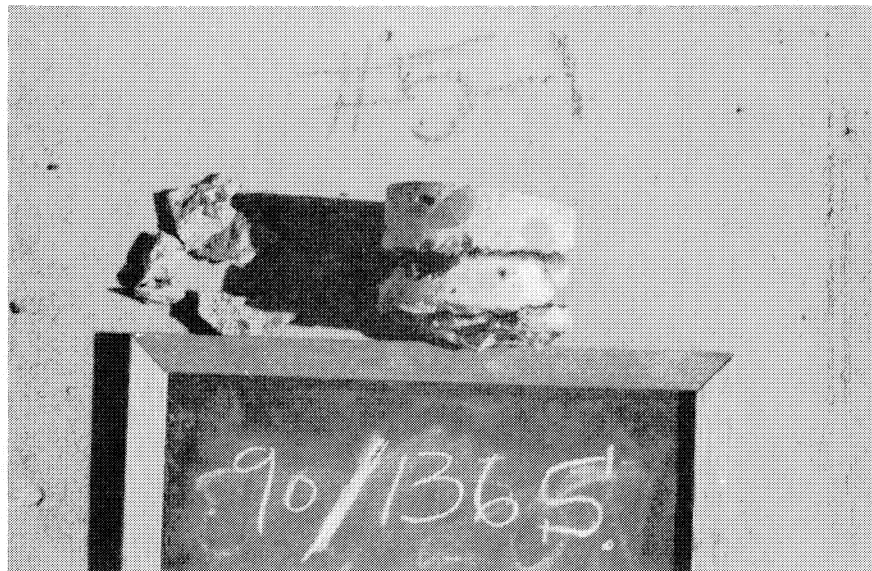
Figure 9. Concrete Delamination (Original)  
Around a Patched Area.

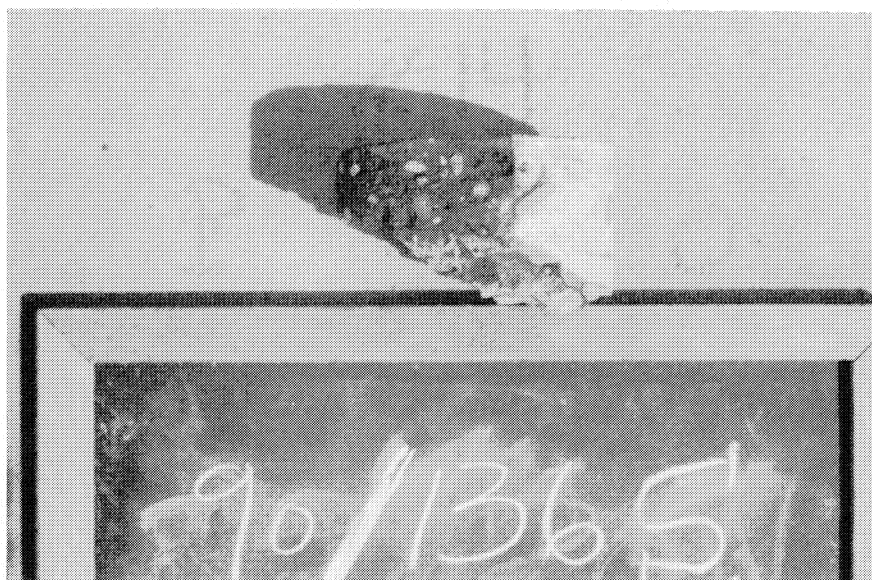
Figure 10. Concrete Delamination (Half Patch, Half Original)  
in the Boundary of a Patched Area.

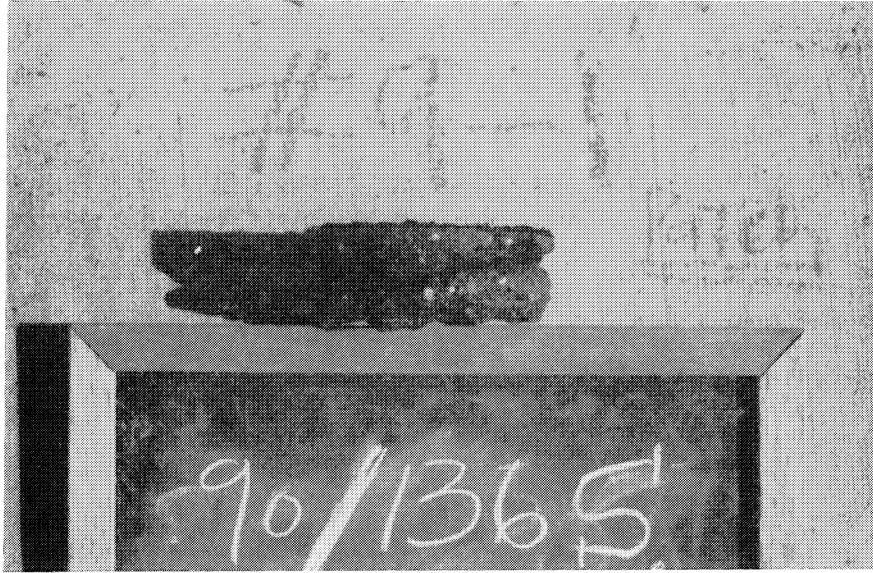
Figure 11. Delamination of Patched Concrete.

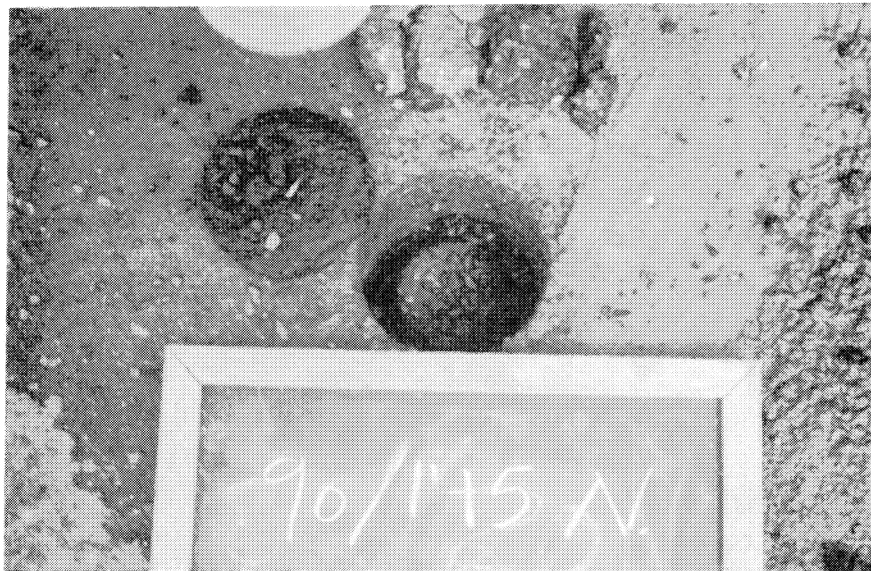
Figure 12. Severe Cracking of AC and Disintegration of Patched Concrete. Note the Conical Shaped Patched Material Left in the Core Location After Drilling Through Concrete.

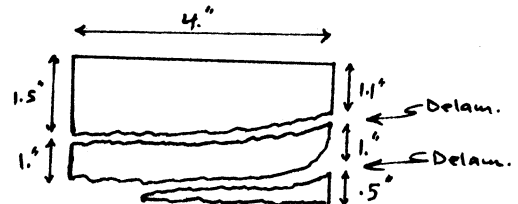
The nature of concrete is original. Two layers of delaminations were detected in the core sample which became free after drilling the perimeter of the core. The delaminated concrete came out in the coring bore.

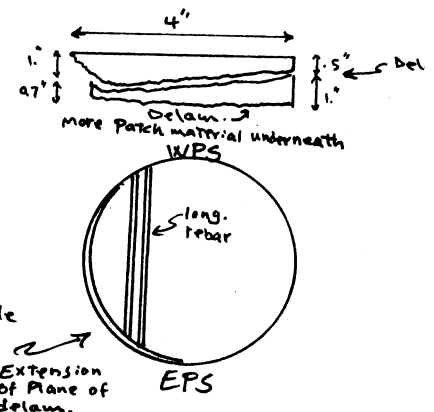
The concrete's nature is patch, darker in color (brownish) and with finer aggregate. The delaminated part was freed while coring and came in the coring bore. Two planes of delaminations can be detected. More patch material is left in place indicating delaminations not debonding. The patch material looks inferior in quality and strength. After the remainder of the concrete in place was chiseled out, two longitudinal rebar could be seen in the core location. No corrosion on the long rebar could be visually detected. Extension of the plane of delam is visible in the circumference of the core.

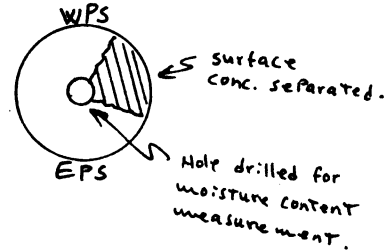
A 0.5" thick surface layer of concrete was partially separated in the core location next to the hole drilled in the concrete for moisture content.

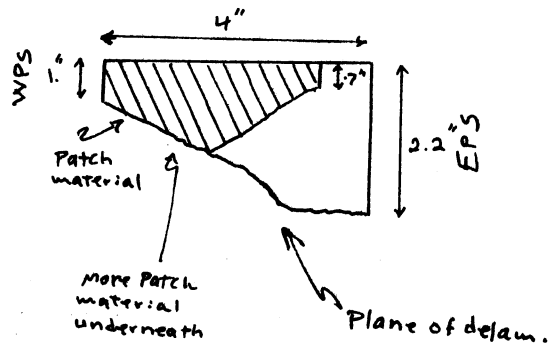
The delaminated was freed while drilling and came out in the coring bore. The plane of delam extends from the original concrete into the Patch getting closer to the surface.

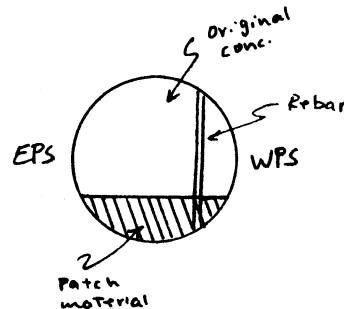
Concrete was delaminated and was easily freed by drilling and broke in pieces. The patch material was feather edged in this location. After removing the remainder of the concrete by chisel (mainly original concrete in that depth), transverse rebar was exposed having rust all over.

Rebar actually @ 3.8" from AC surface, actual conc. cover thickness = 3.8" - 2.1" = 1.7"

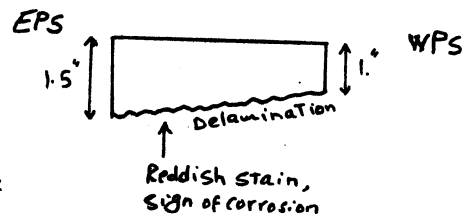
The top layer of concrete came out in the coring bore indicating delamination. Concrete is patch material darker in color and mixed with the finer aggregate.

The material does not seem to be very strong when wet as hit by chisel. A reddish stain, sign of corrosion is visible in the bottom of the delaminated piece in transverse direction. The remaining concrete in core is also patch material. Extension of the plane of delam visible in the circumference of the core.

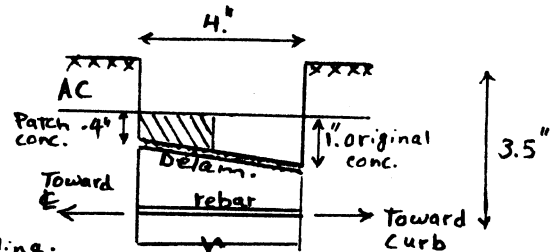
The top layer of concrete came out in the coring bore indicating delamination. Concrete left in place was removed by chisel and rebar exposed in core location. Corrosion was not detected visually. Nearby rebar could be corroding. Rebar hit @ 3.5" from AC.

Actual conc. cover thickness = 3.5" - 1.9" = 1.6"
