Materials Report

WA-RD-117.1

Asphalt Concrete Class D

Bridge Deck Overlays

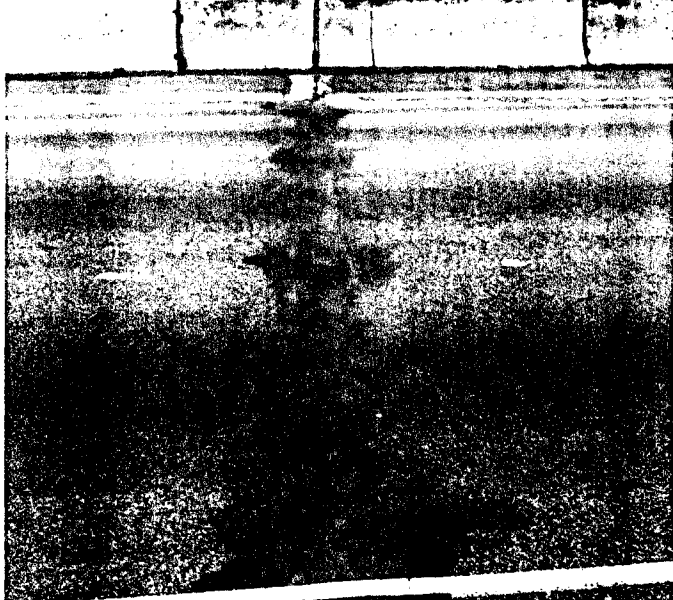
5/433 - Shows some tire wear but is in serviceable condition. Patching at pavement seat. Heavy, high speed traffic. Paved 1979. Rated 6.

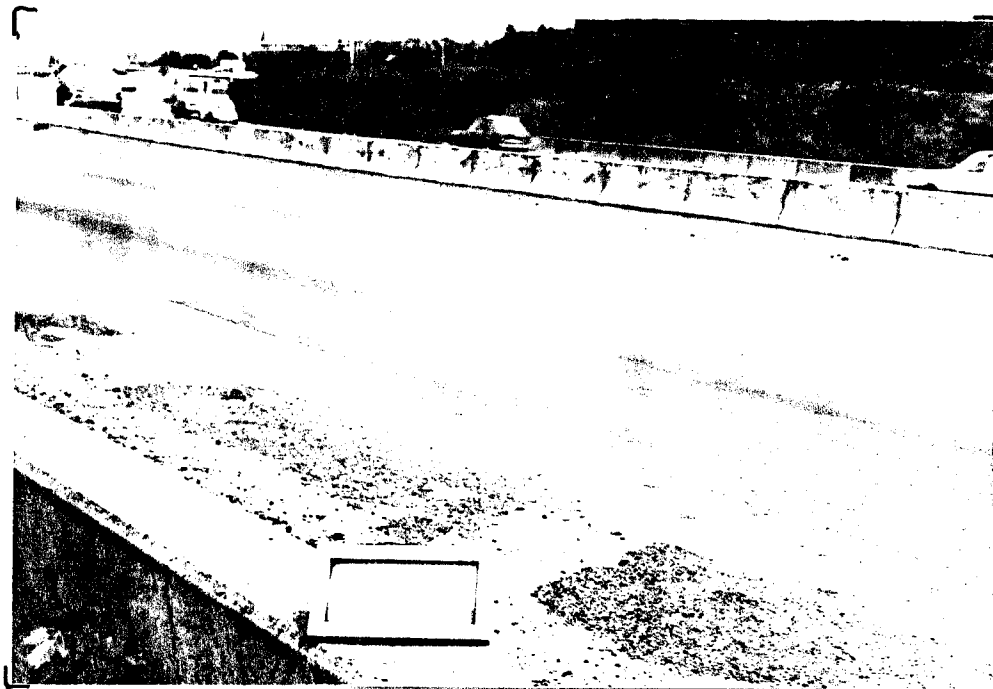
5/434 - Shows some tire wear. Some patching which appears caused by failure of the substrate. Heavy, high speed traffic. Paved 1979. Rated 6.

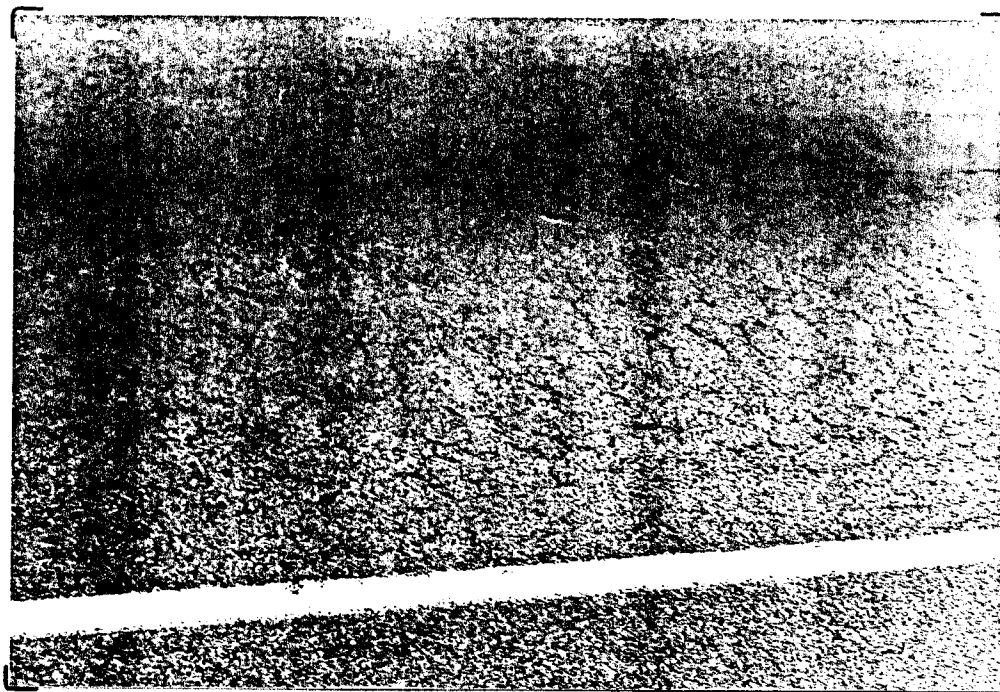
5/434 - Some alligator cracking in wheel path.

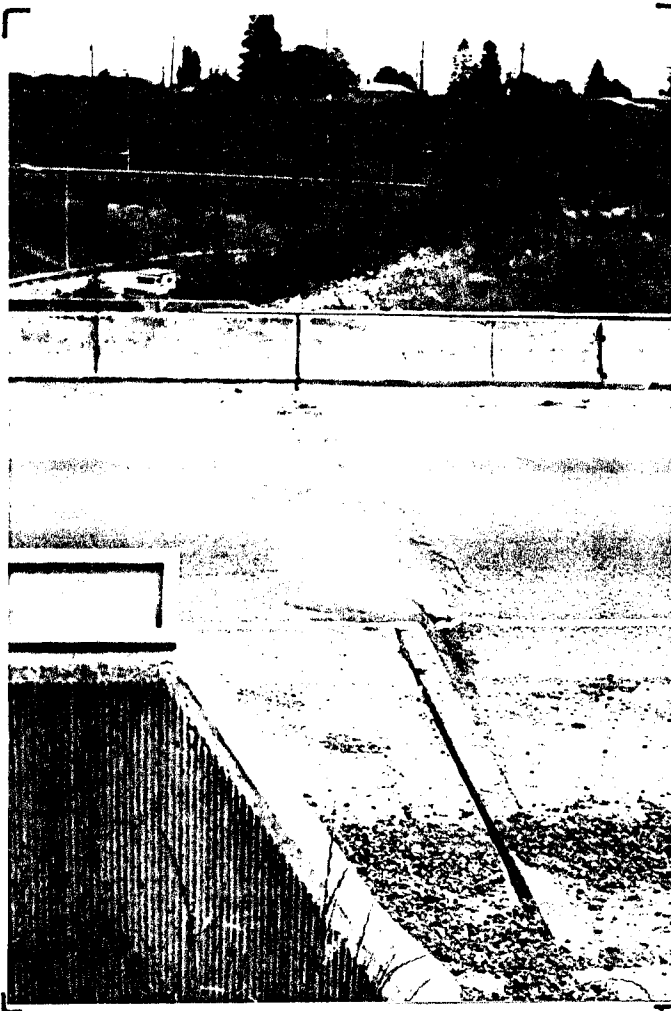
5/434
Cracks and patching at
pavement seat.

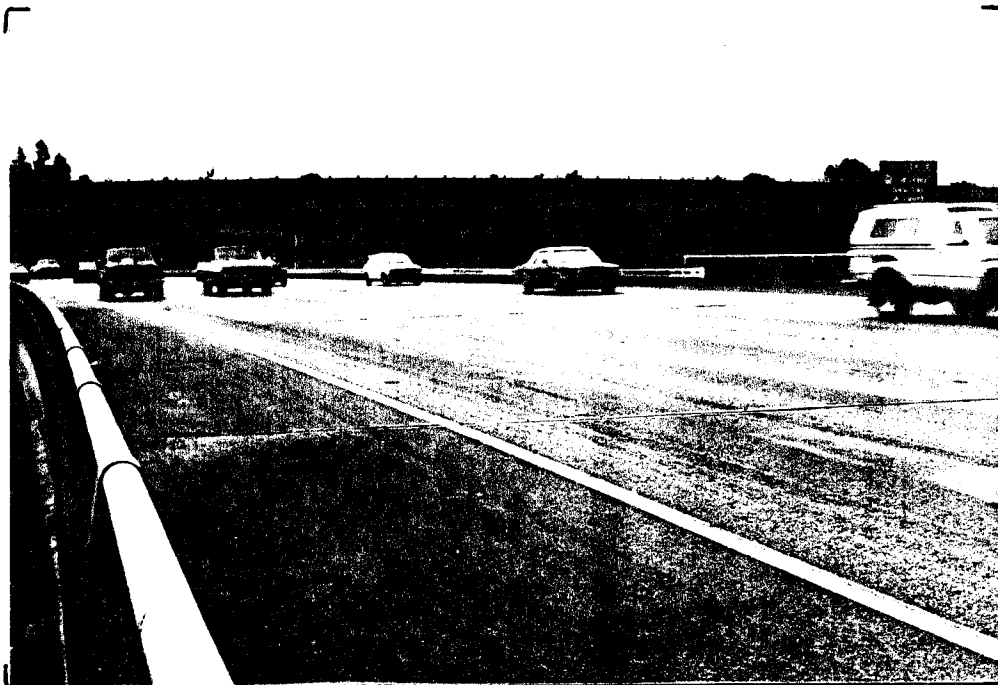
5/525.5 E - Surface shows some signs
of raveling and rutting. Heavy, high
speed traffic. Paved 1982. Rated 10

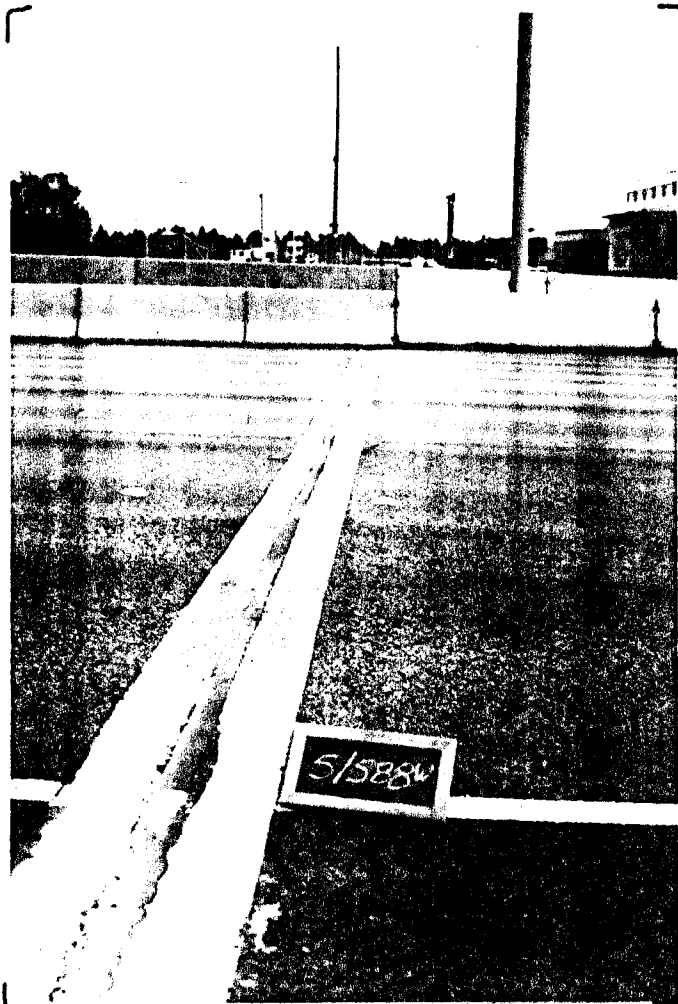
5/588 W - Surface in fair condition. Some minor signs of raveling. Heavy, high speed traffic. Pave 1983. Rated 5

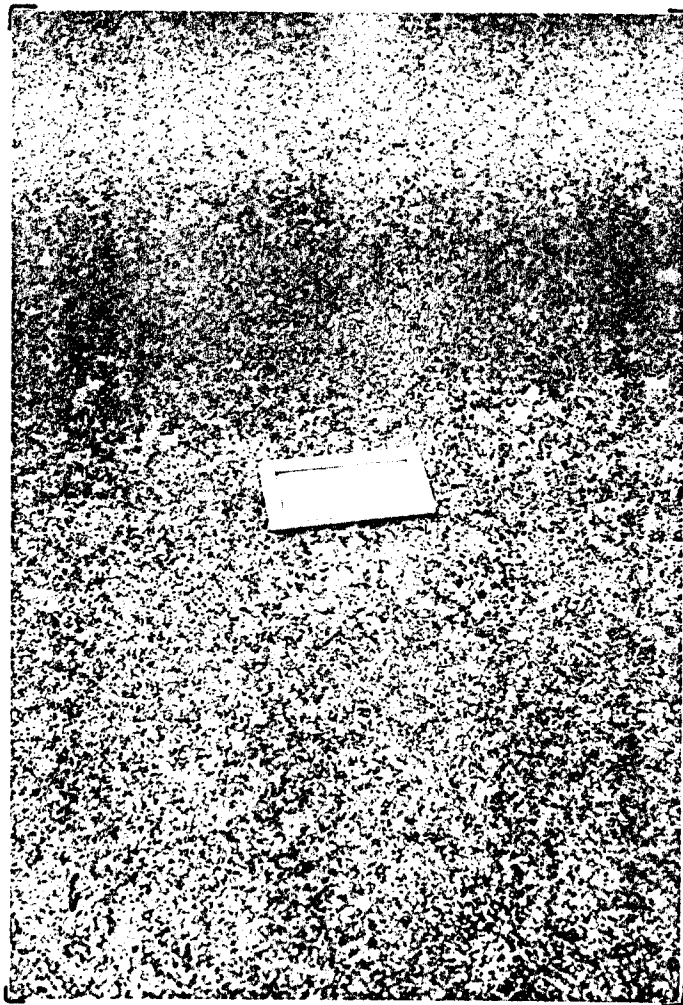
5/602 - Surface open and shows little or no wear. Moderate to light slow speed traffic. Pave 1983. Rated 0.

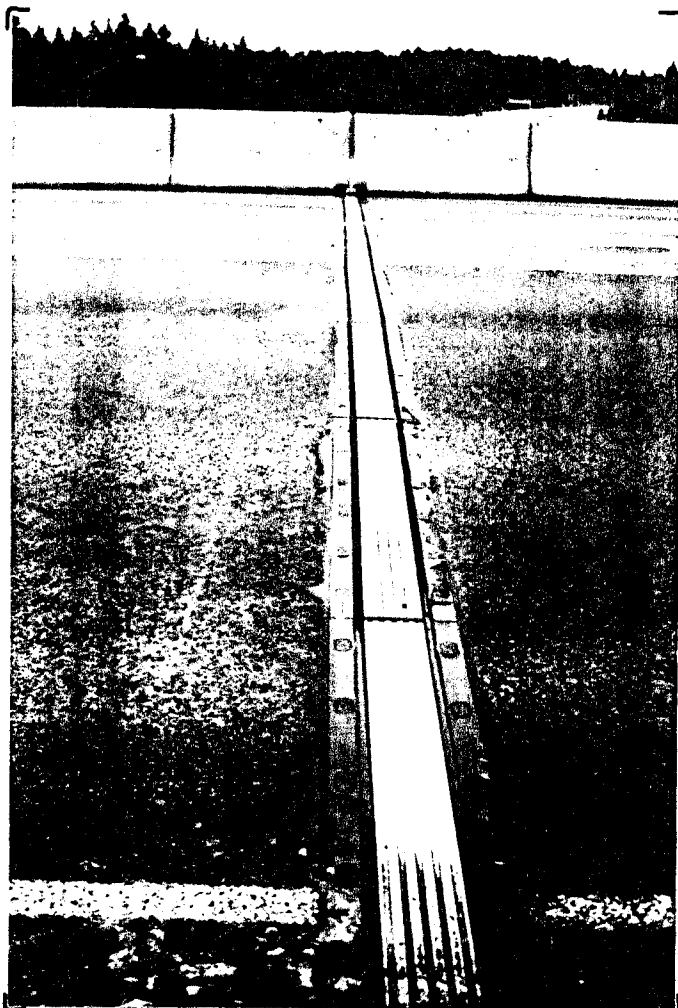
5/602 - Mid-span joint cut into overlay.

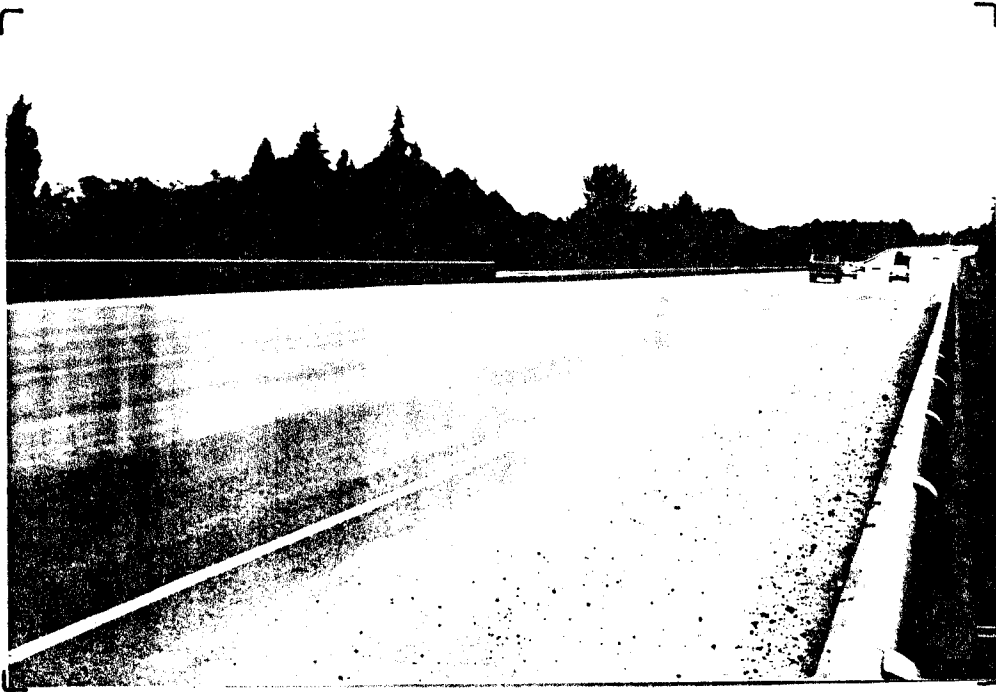
5/626 W - Surface open and shows little or no wear. Heavy, high speed traffic Paved 1983. Rated 4

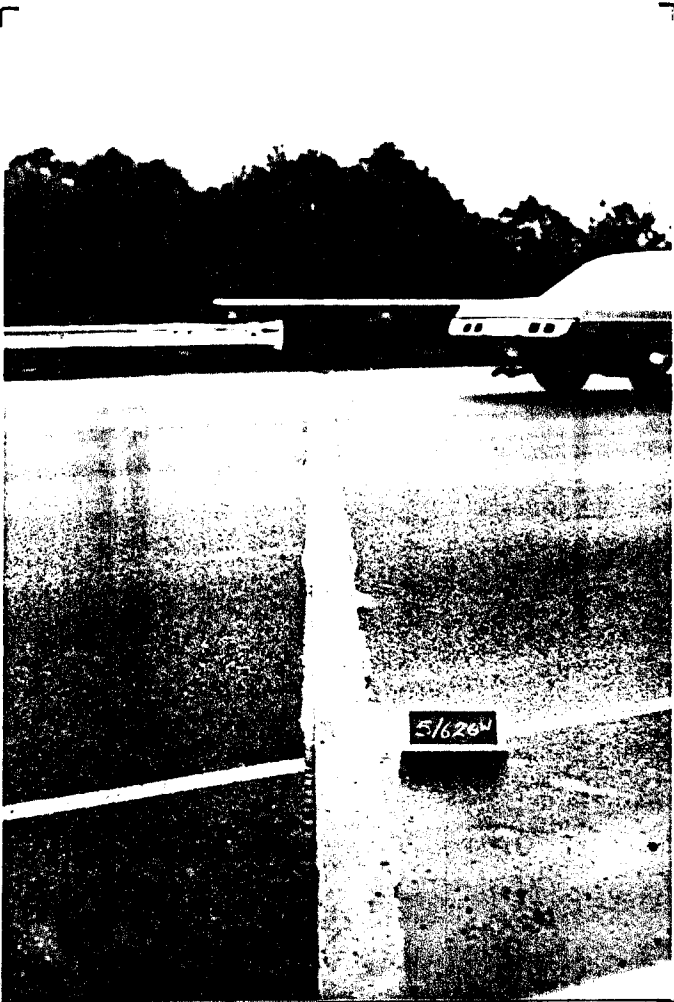
5/626 W - Some minor raveling at joints.

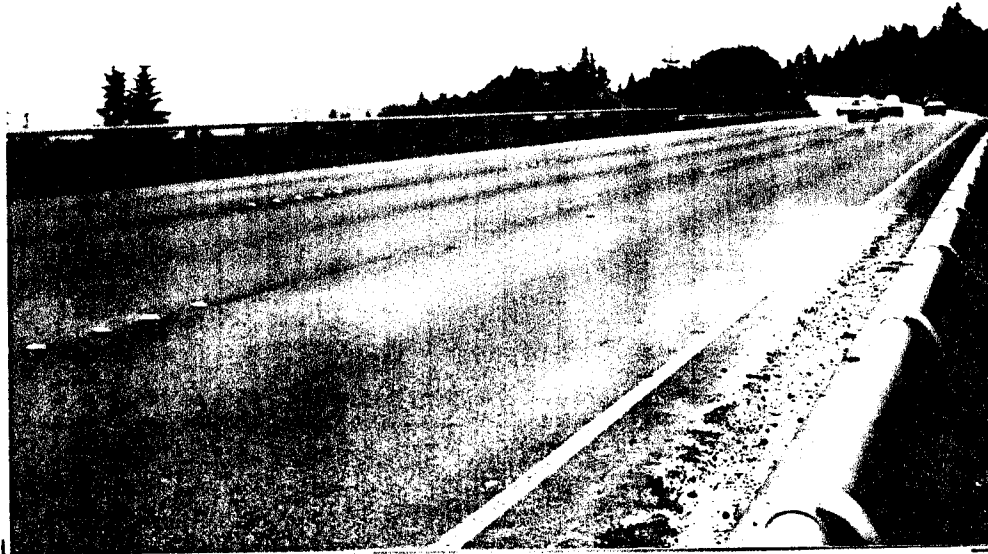
5/628 W - Surface open and shows little or no wear. Heavy, high speed traffic. Paved 1983. Rated 4

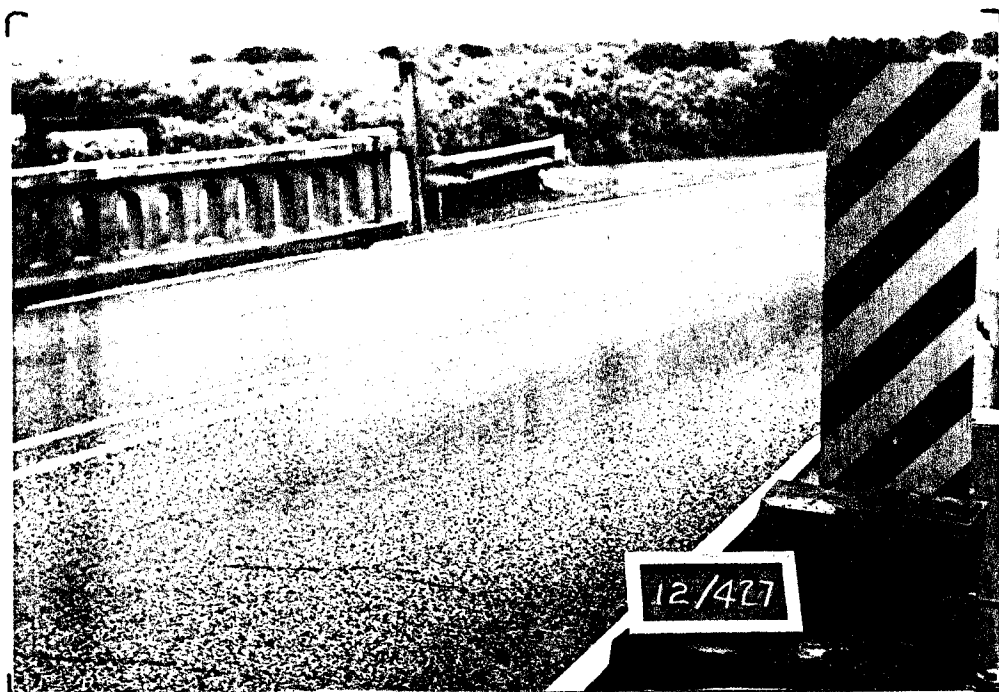
12/427 - Some studded tire wear. Moderate to heavy, high speed traffic. Paved 1982. Rated 4

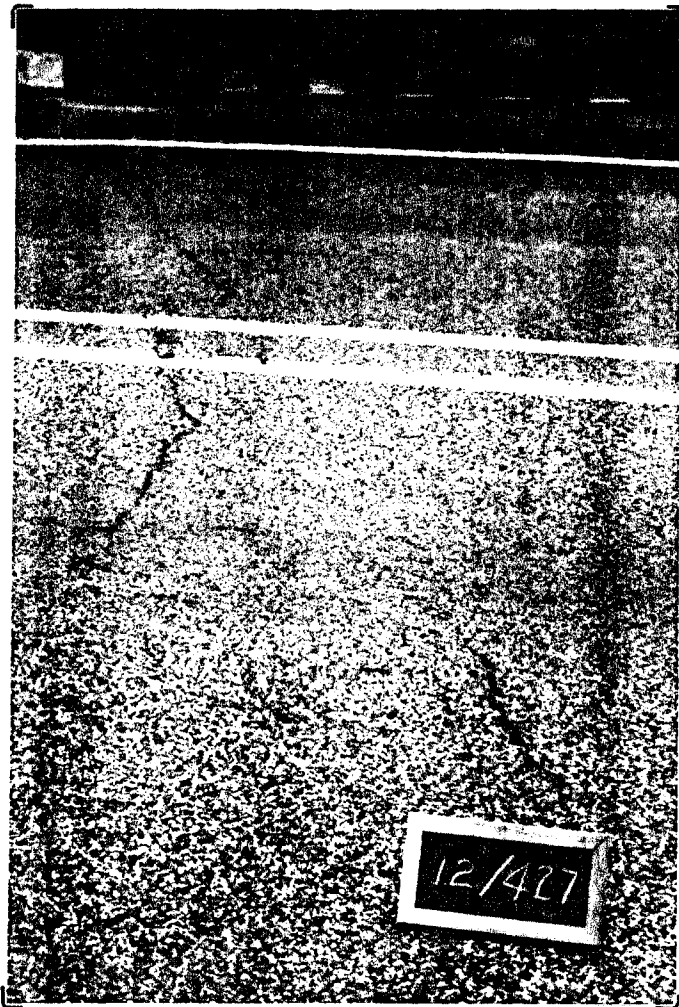
12/427 - Cracks at pavement seat.

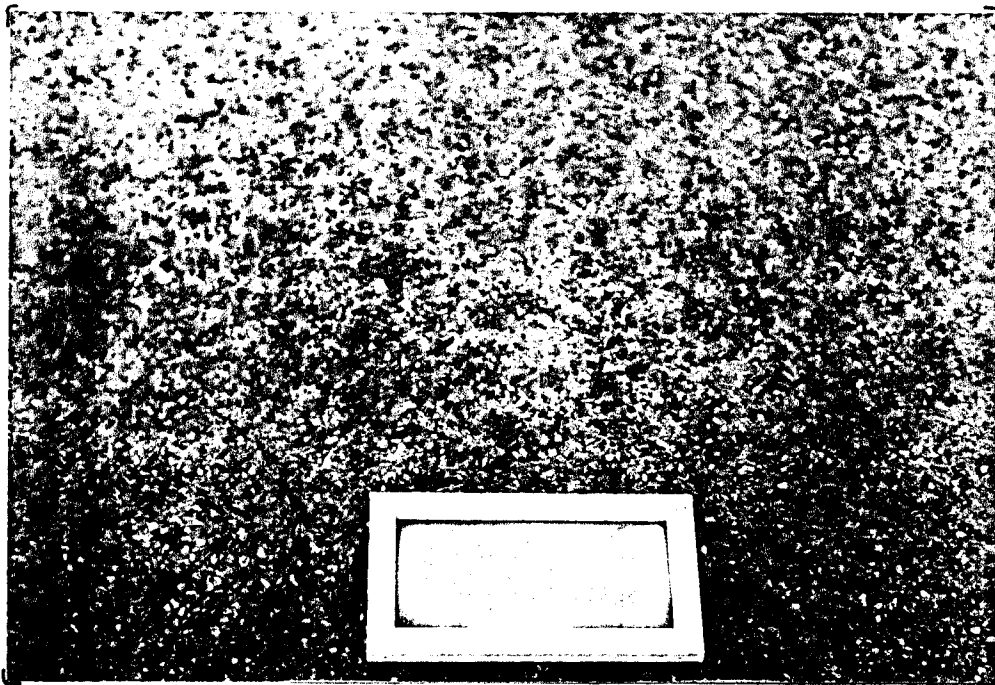
12/606 - Surface open and shows little or no wear. Moderate high speed traffic. Paved 1982. Rated 1

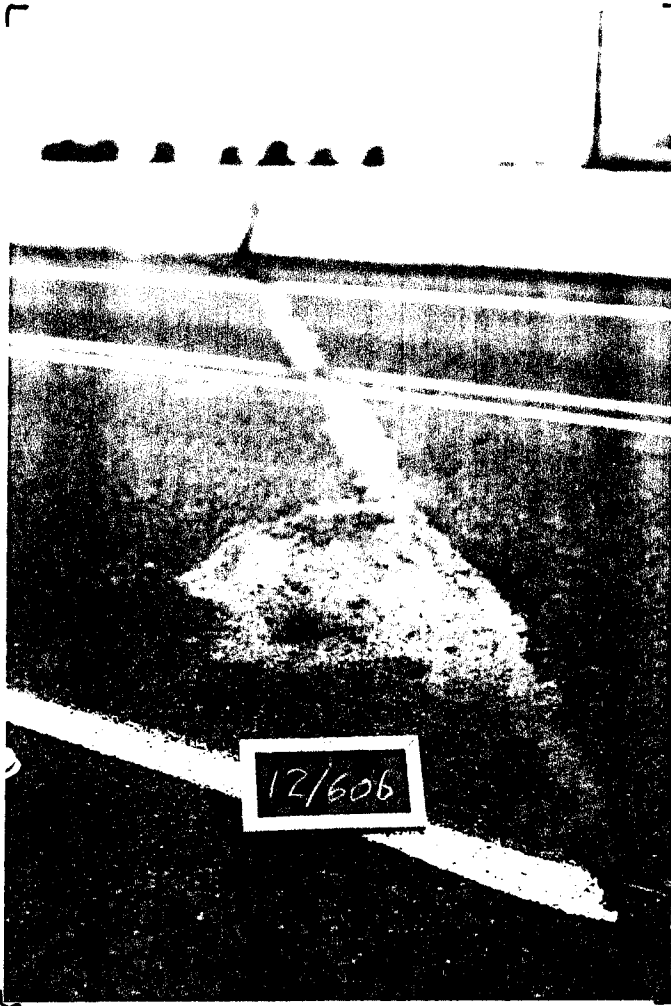
12/606 - Crack at pavement seat.

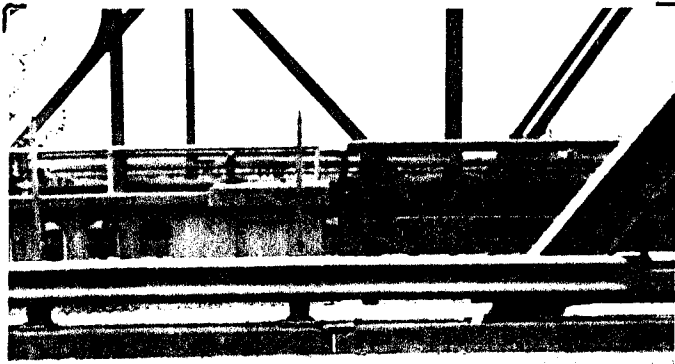
82/115 N - Surface open and shows little or no wear. Heavy, high speed traffic. Paved 1983. Rated 4

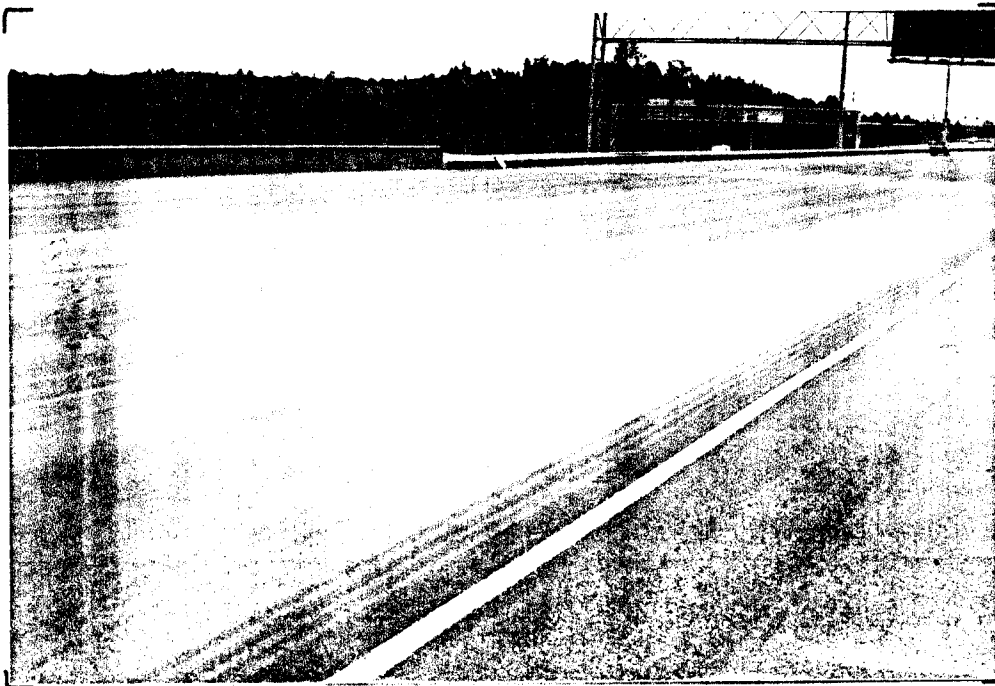
90/50 S- Surface has been sealed with asphalt and sand. Deck condition identical to adjoining roadway. Paved 1983. Sealed ? Rated 0

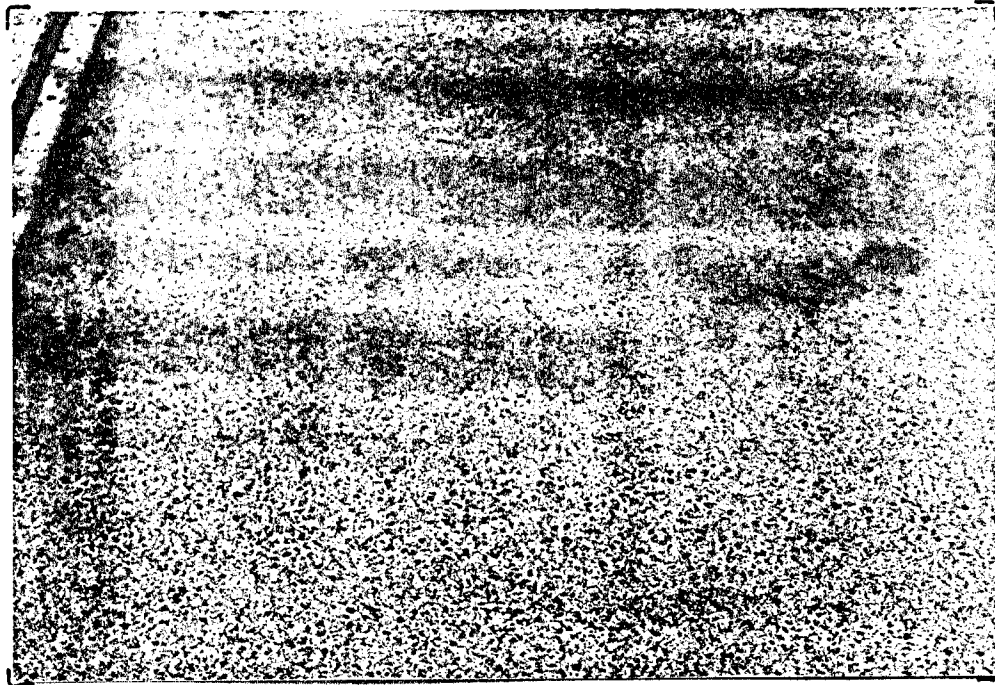
90/50 S- Striations produced by surface seal.

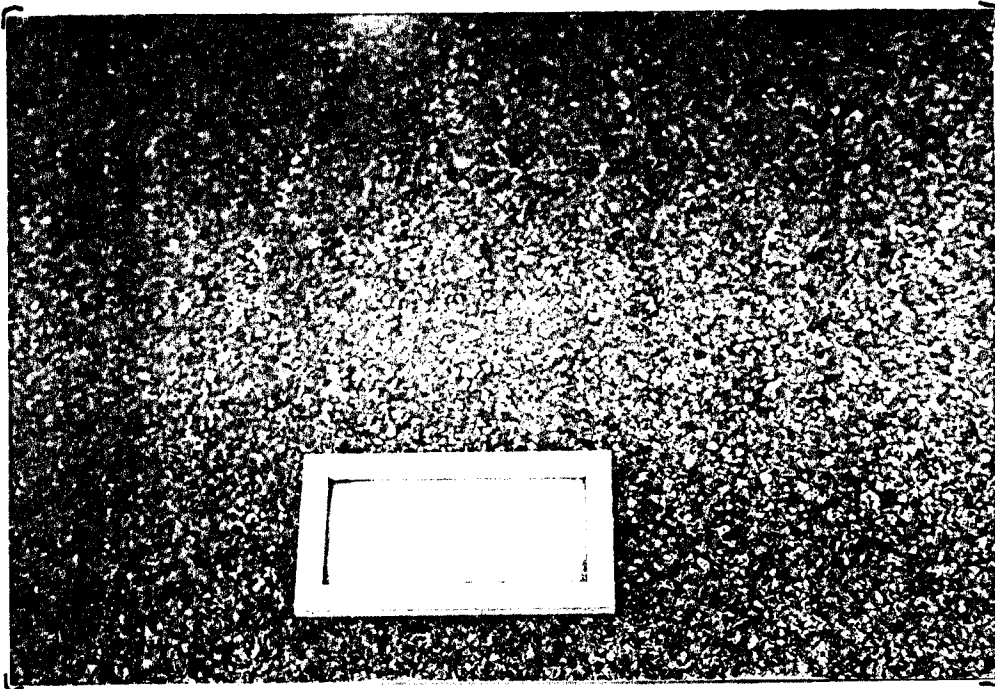
90/52 - Coarser surface texture than observed on other bridge decks.

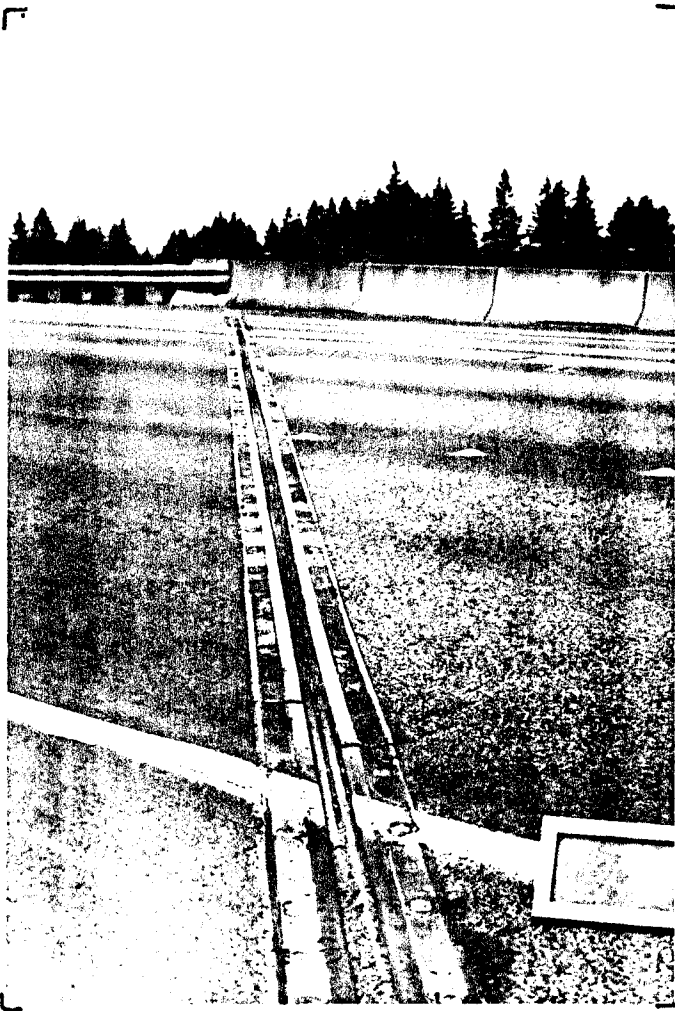
90/59 S - Surface open and shows little wear. Comparing to adjacent ramp structure (next photo) paved under same contract is somewhat deceiving. Paved 1983. Moderate high speed traffic. Rated 0

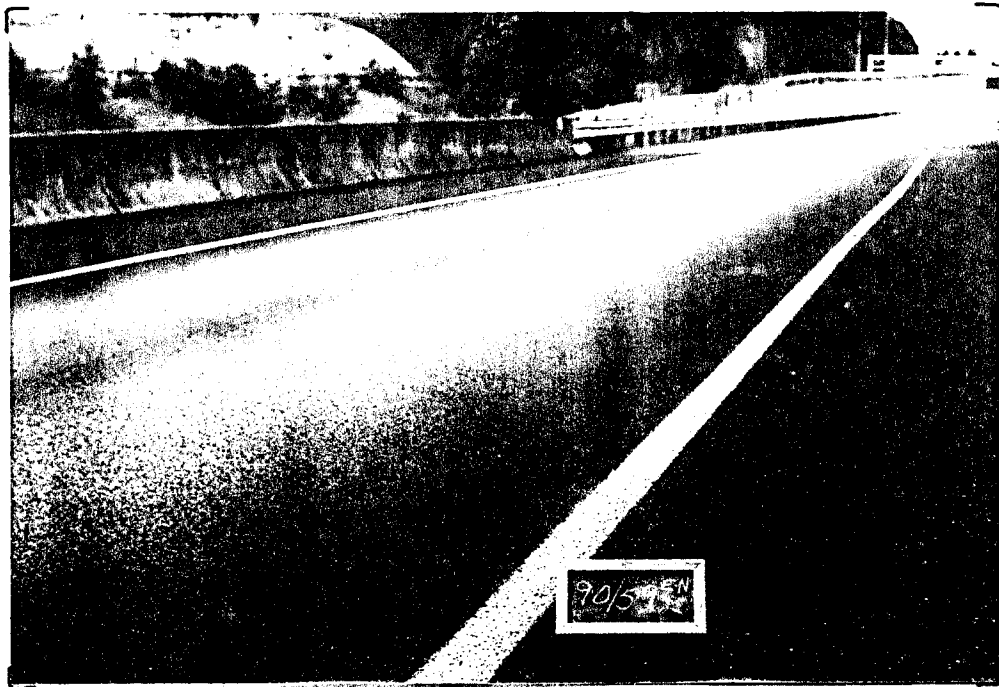
90/59 E-N - Surface open and shows no wear. Moderate, decelerating traffic. Paved 1983. Rated 0.

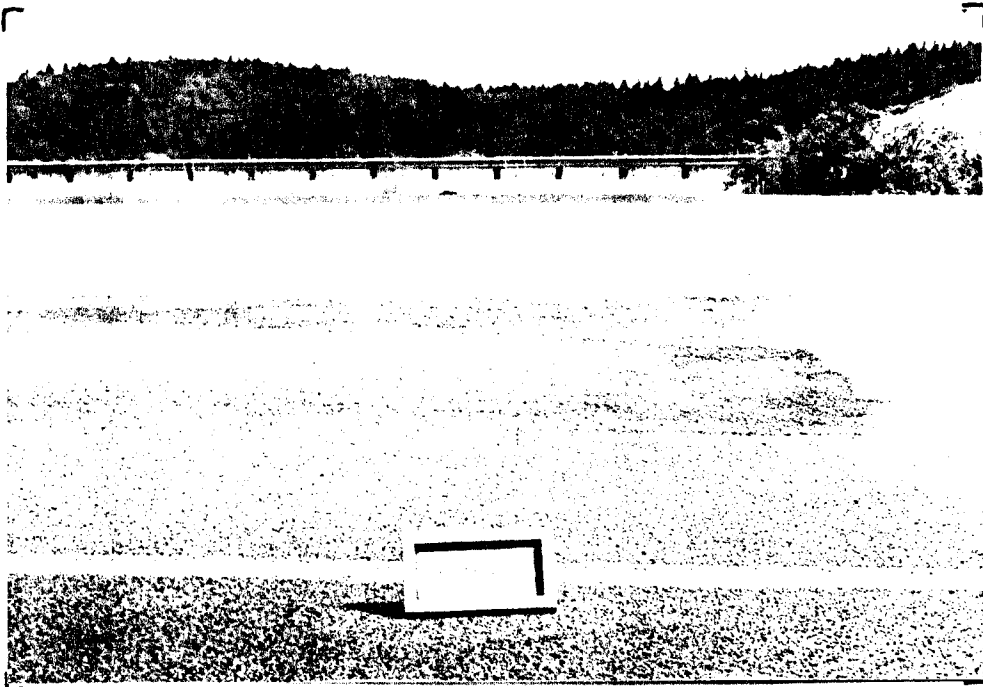
90/63 S - Some flushing and raveling at east end.
Moderate high speed traffic. Paved 1983.
Rated 5

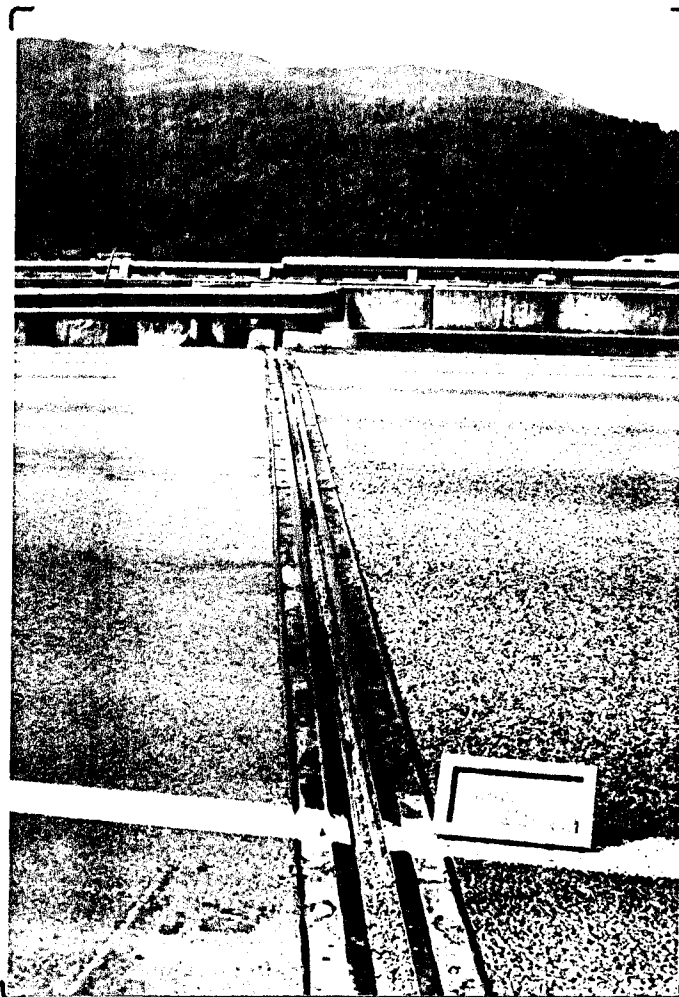
90/65 N - Surface open and
shows little or no wear.
Some diving at the joints.
Paved 1983. Rated 0

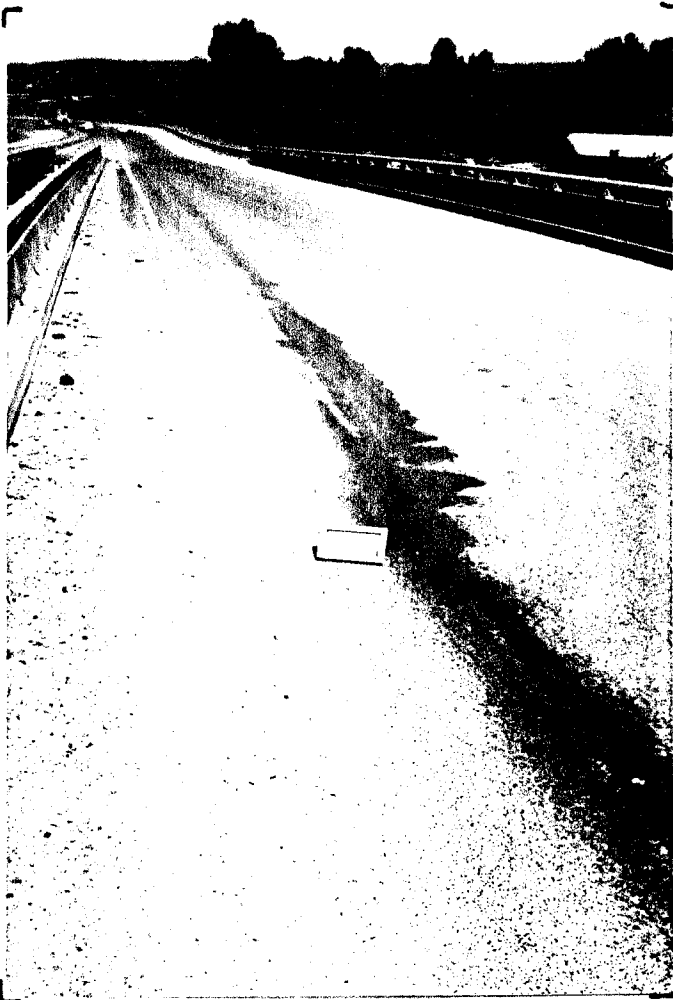
90/65 W-W - Surface generally open but has one large flushing area in wheel path. Structure is subjected to concrete ready-mix truck traffic. Paved 1983. Rated 0

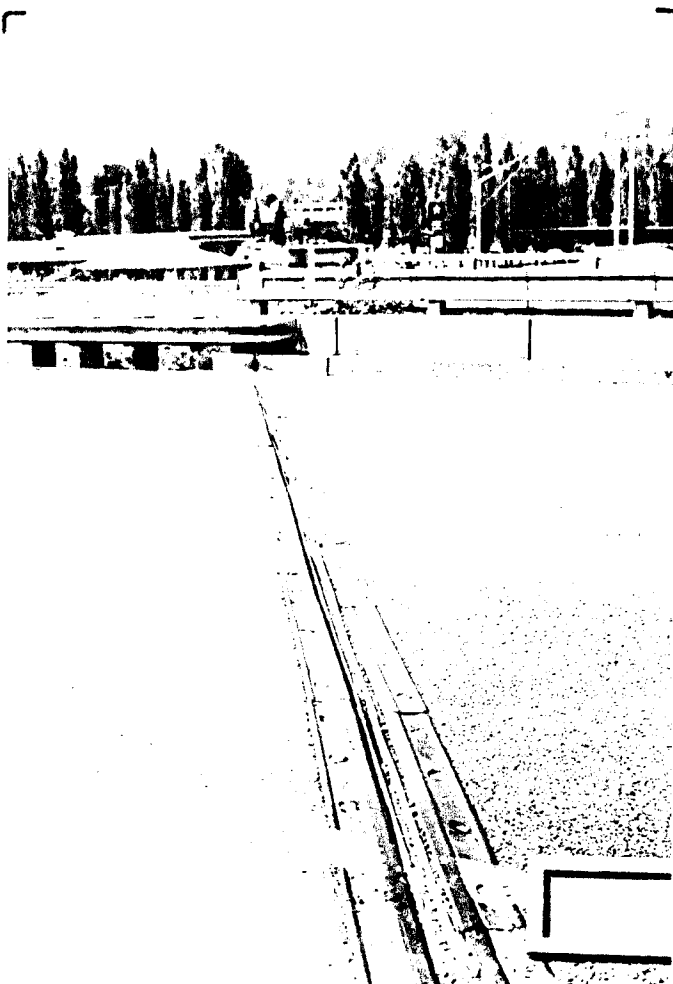
90/66 N - Surface open and shows little or no wear. Some diving at the joints. Moderate high speed traffic. Paved 1983. Rated 0

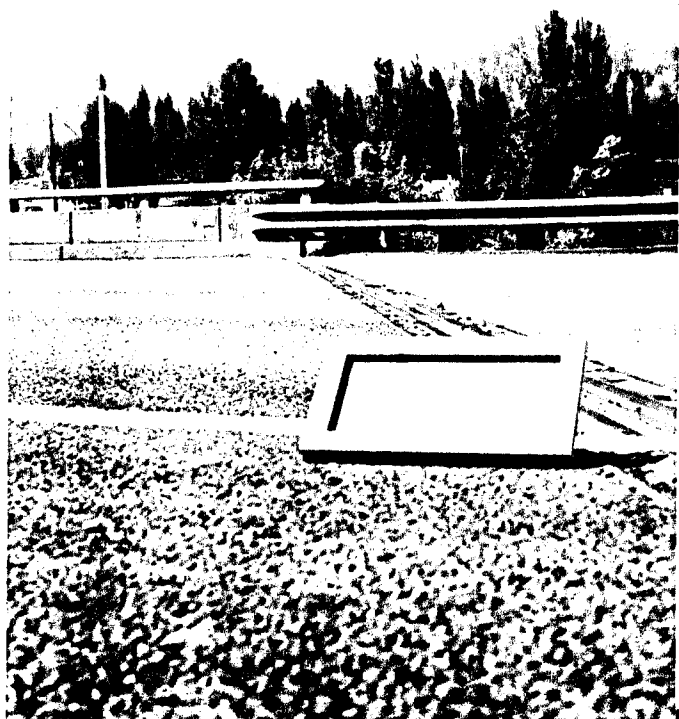
90/66 S - Some diving at the joints.

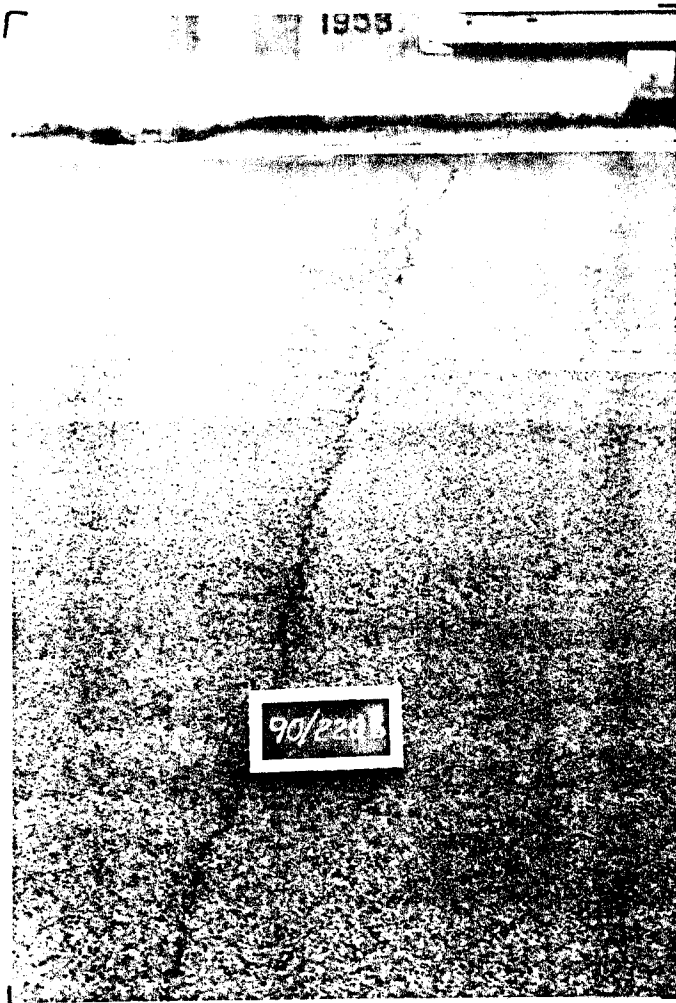
90/220 S - Surface open and shows little or no wear. Cracks at pavement seats. Moderate high speed traffic. Paved 1983. Rated I

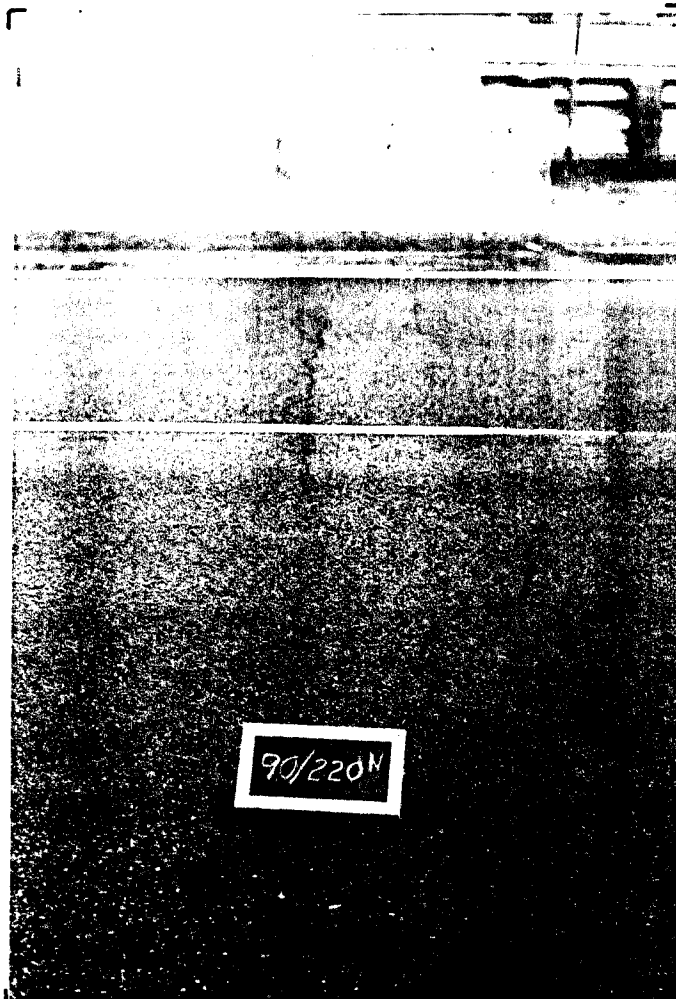
90/220 N - Surface open and shows little or no wear. Cracks at pavement seats. Moderate high speed traffic. Paved 1983. Rated I.

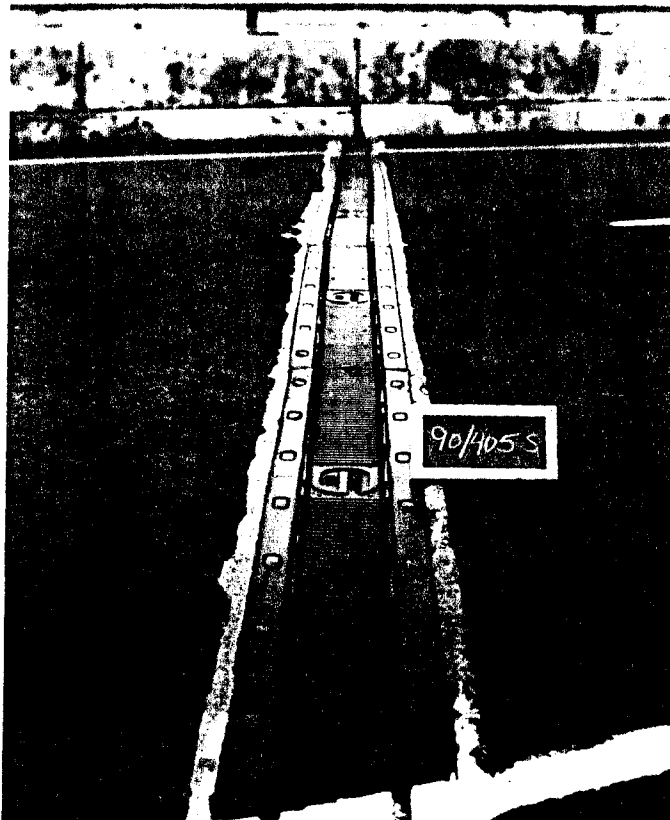
90/405 S - Surface open and shows little wear. Minor rutting at expansion joints. Moderate, high speed traffic. Paved 1982. Rated 4.

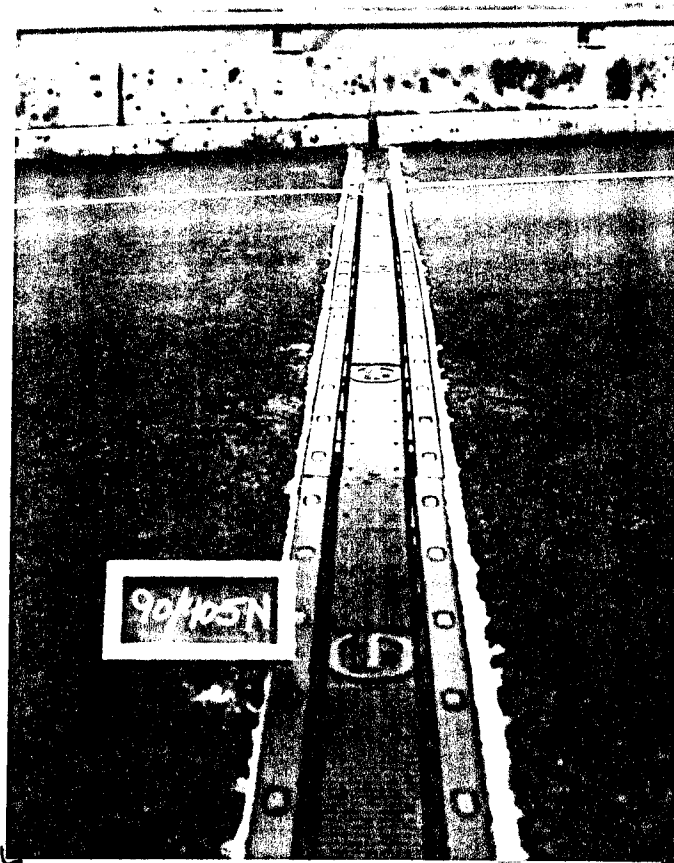
90/405 N - Surface open and shows little wear. Minor rutting at expansion joints. Moderate, high speed traffic. Paved 1982. Rated 4.

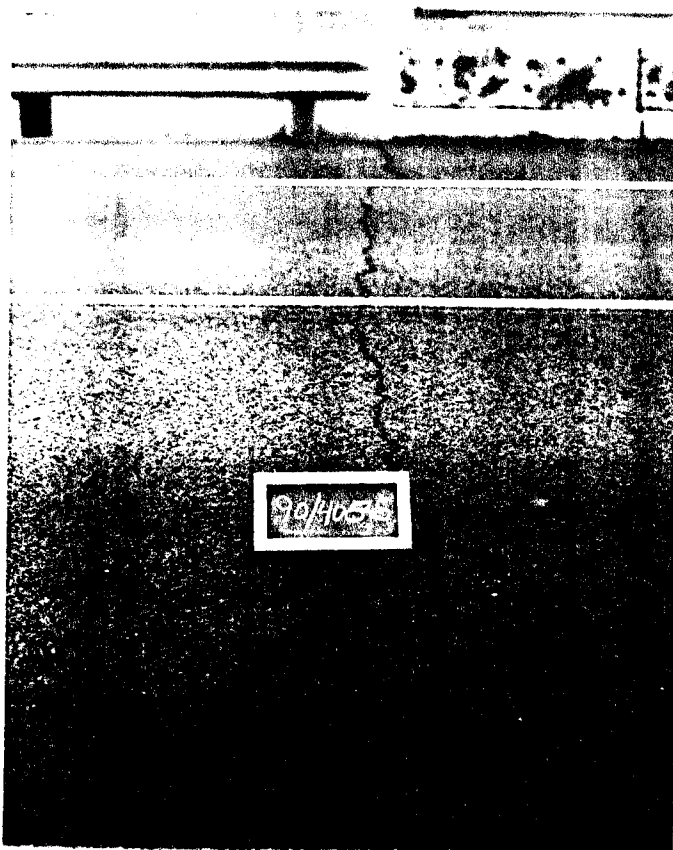
90/408 S - Surface open and shows little or no wear. Crack at downstream pavement seat. Moderate high speed traffic. Paved 1982. Rated 1.

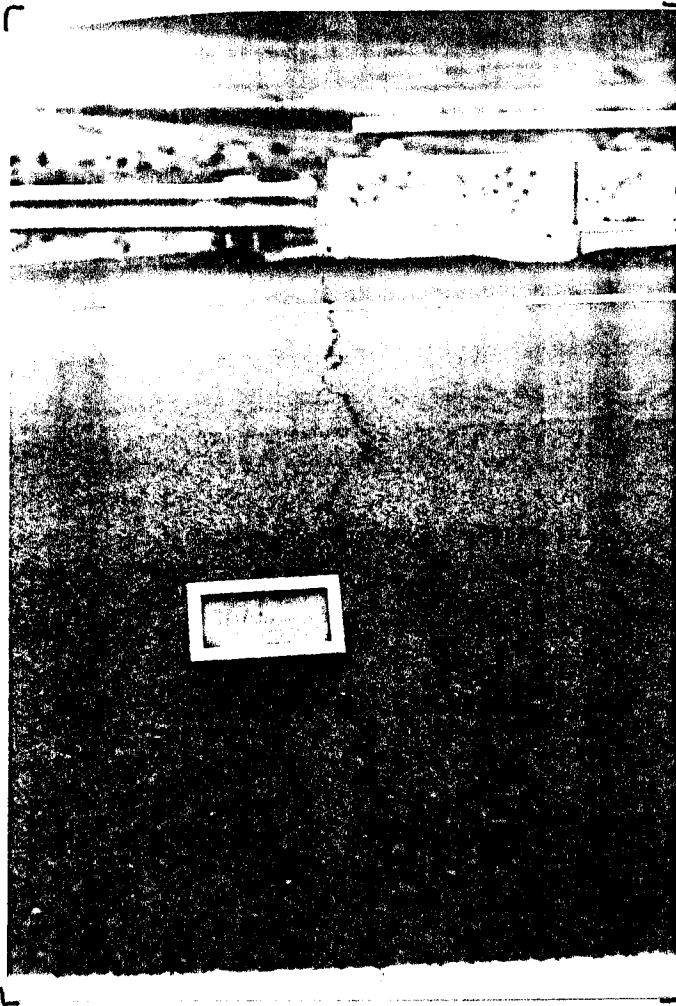
90/408 N - Surface open and sho
little or no wear. Crack at
downstream pavement seat.
Moderate high speed traffic.
Paved 1982. Rated I.

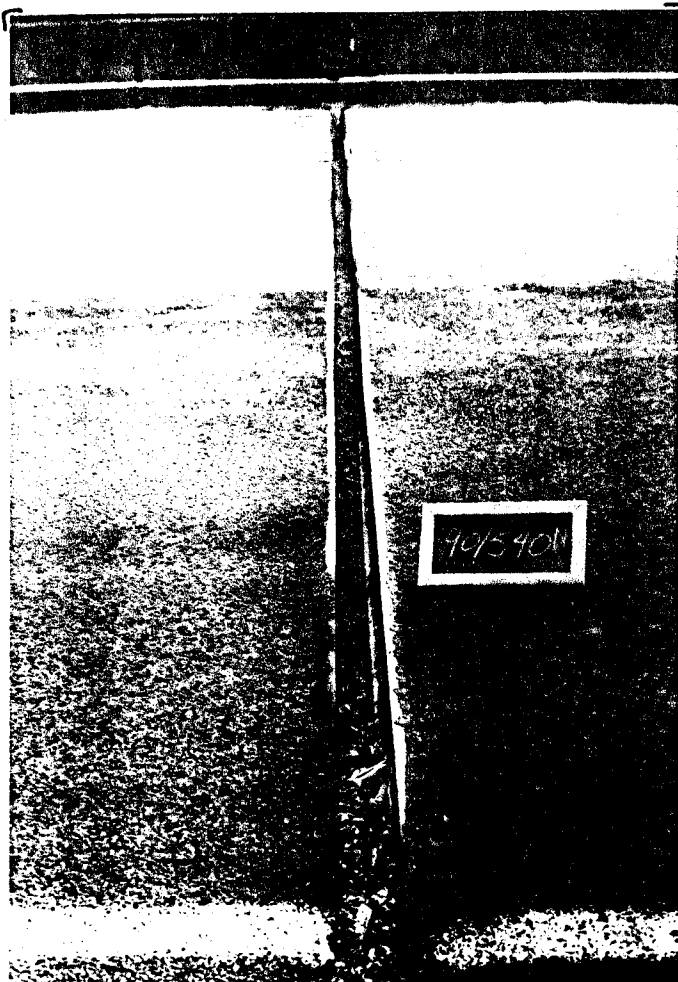
90/540 N - Surface showing
acute distress. Raveling and
rutting at joints.

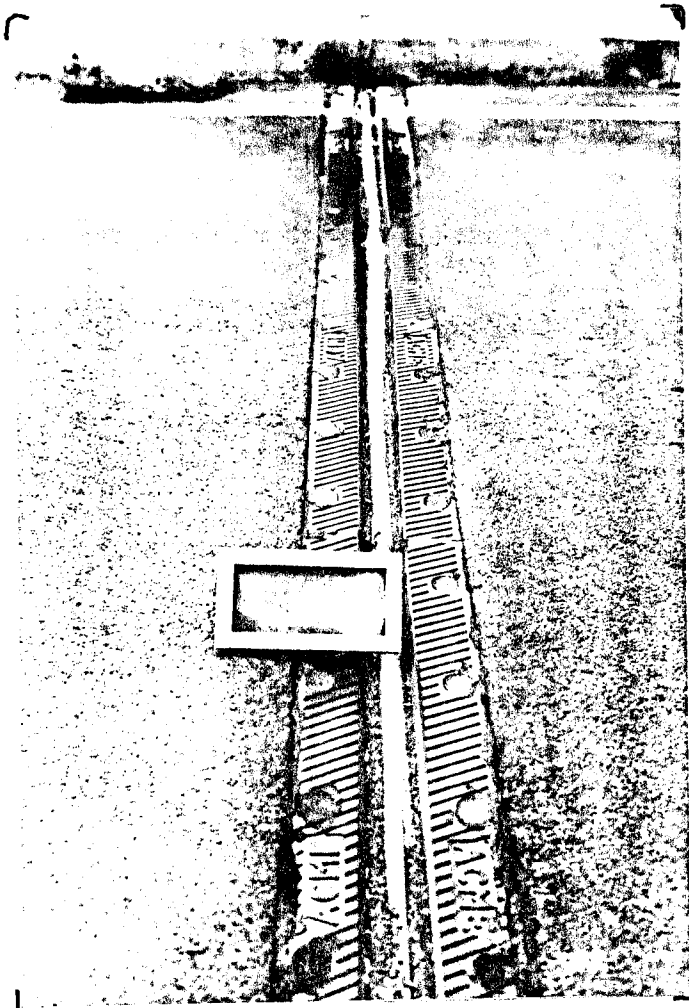
171/5 - Surface open and shows little wear. Moderate, medium speed traffic. Paved 1983. Rated 1
