Materials Report

WA-RD-117.1

Asphalt Concrete Class D

Bridge Deck Overlays

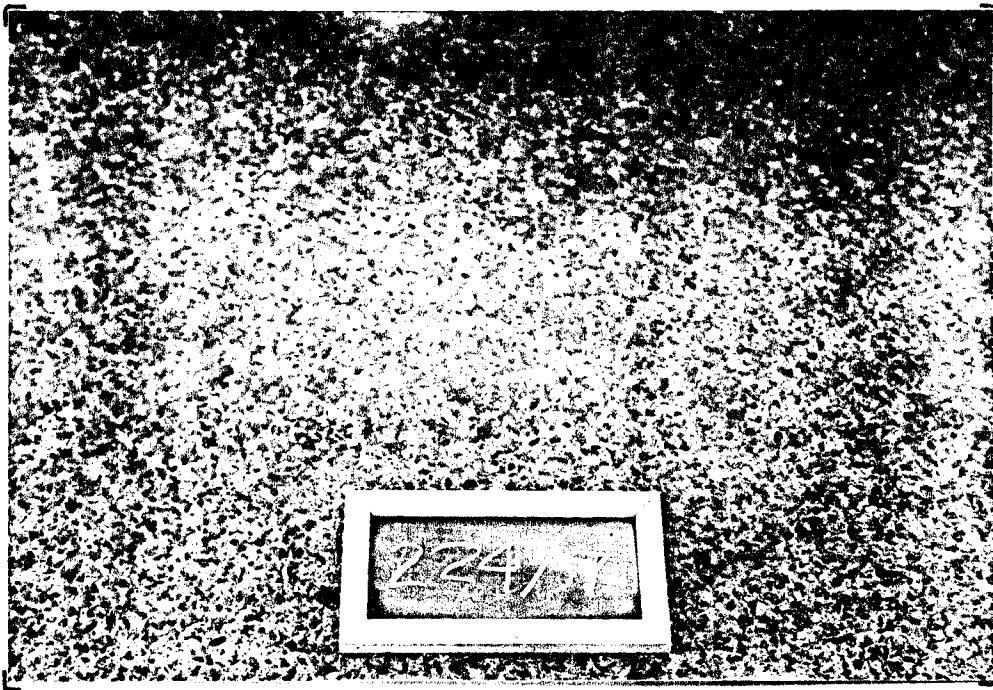
224/7 - Surface appears to be closed but no other signs of distress. Light, slow speed traffic. Paved 1982. Rated 4.

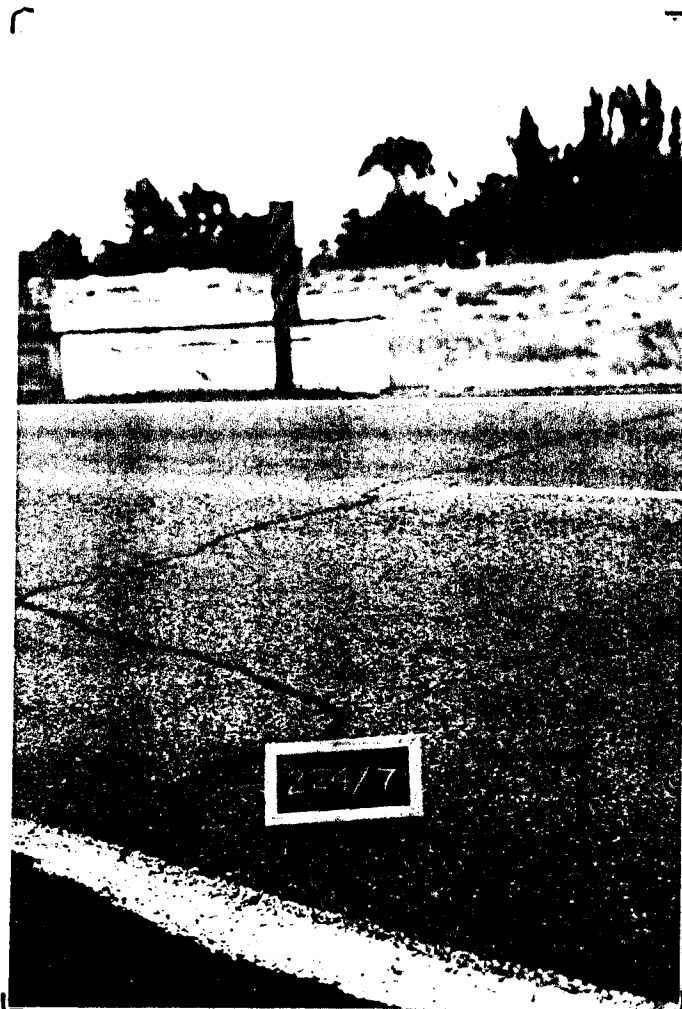
224/7 - Crack at pavement seat.

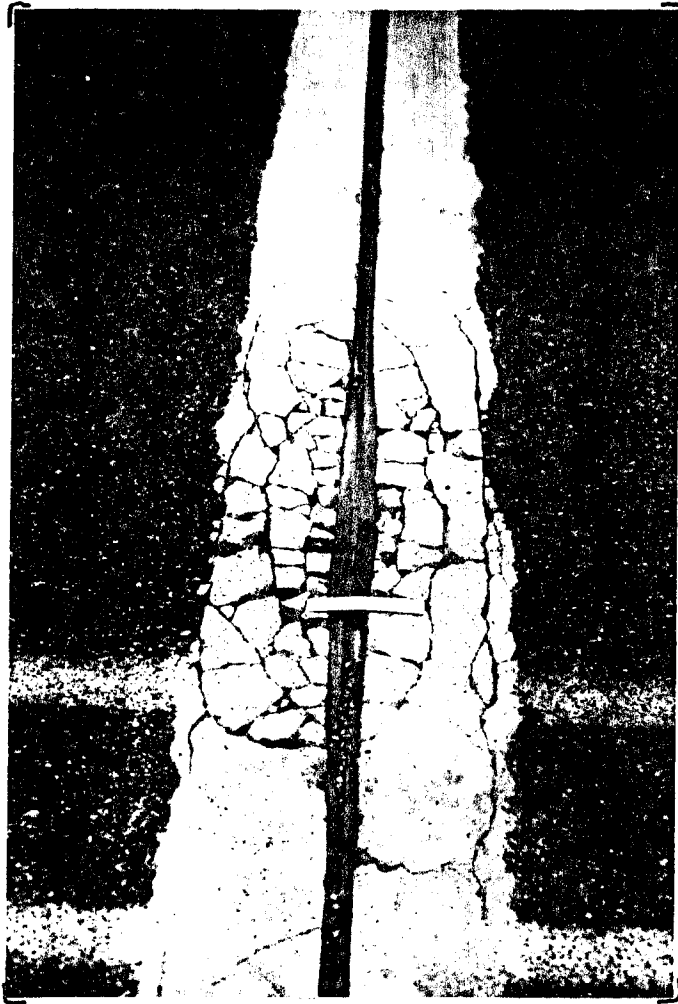
530/124 - Joints coming apart.
Moderate, high speed traffic.
Heavy log truck traffic.

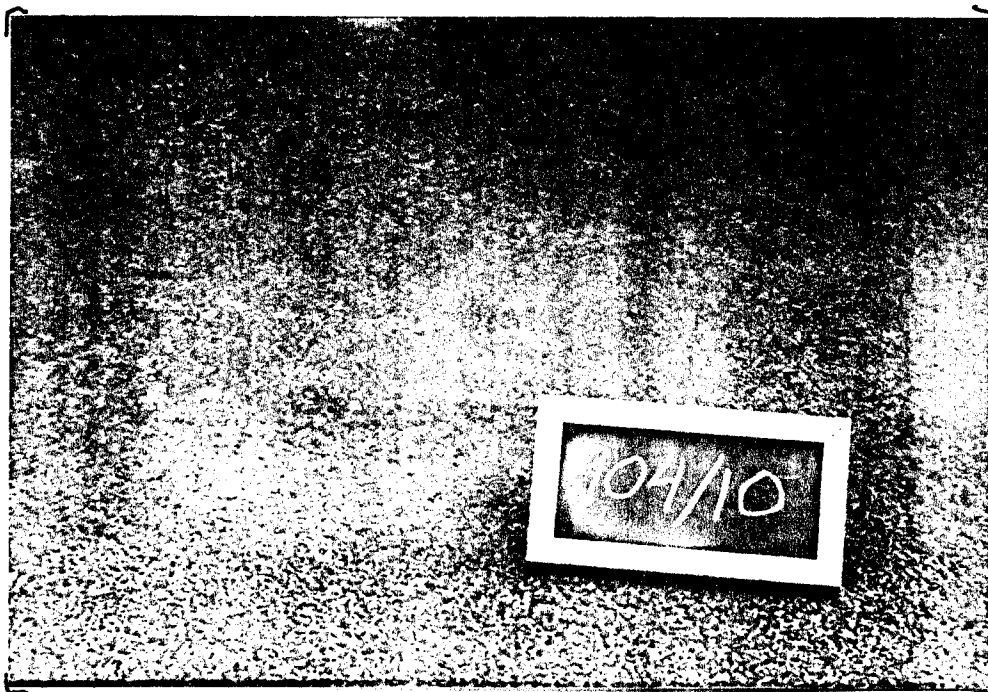
904/10 - Surface generally in good condition. Few over-rich spots. Moderate medium speed traffic. Paved 1980. Rated 1

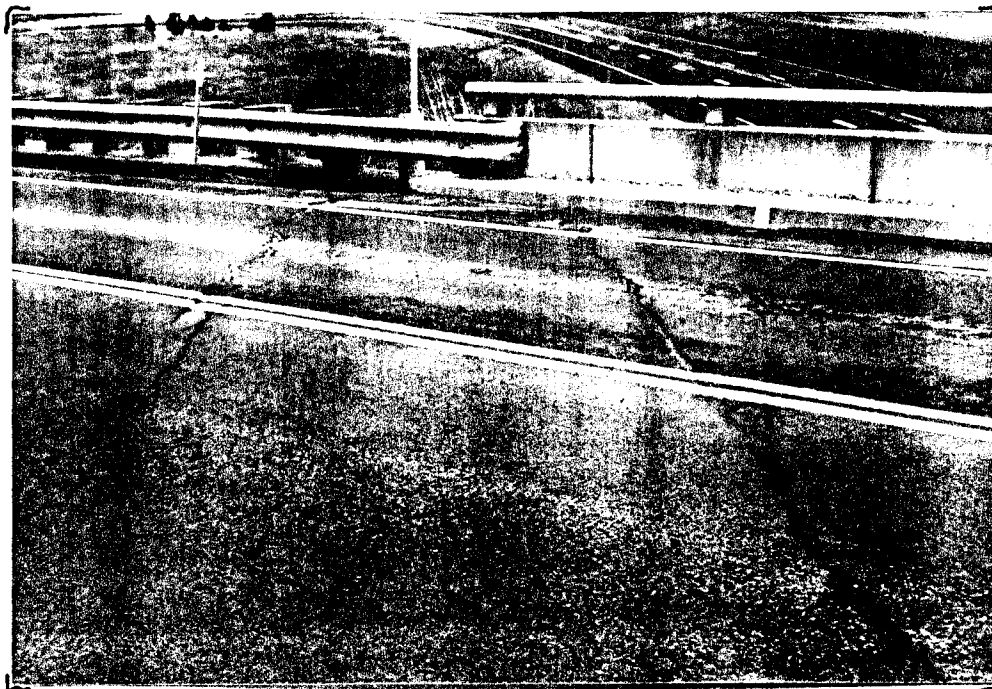
904/10 - Unusual crack pattern at north end of bridge.

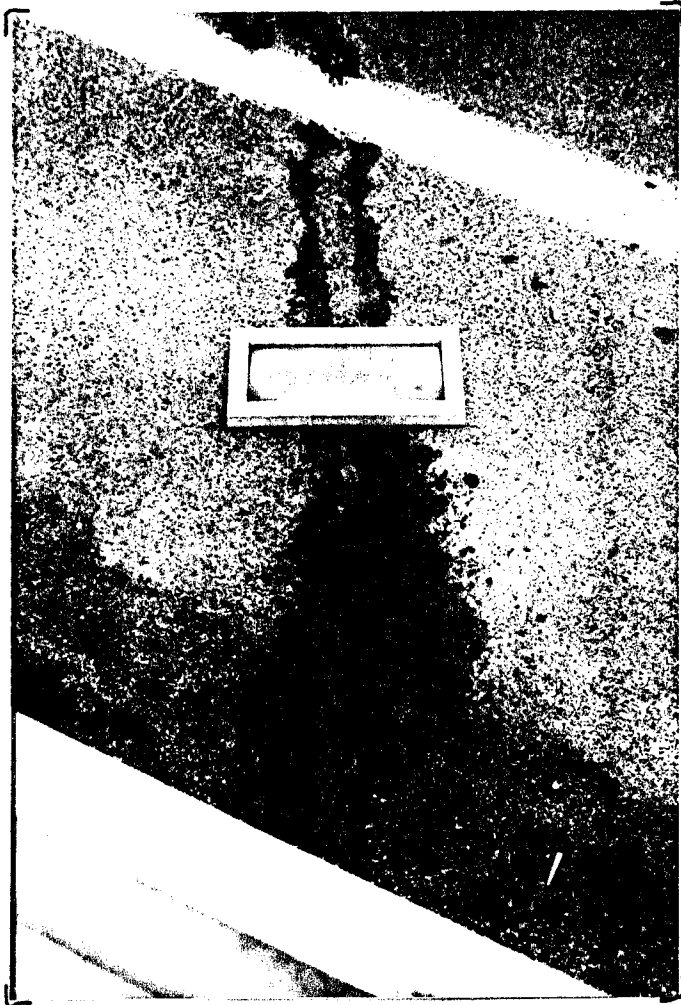
904/10 - Northerly crack of previous photo.

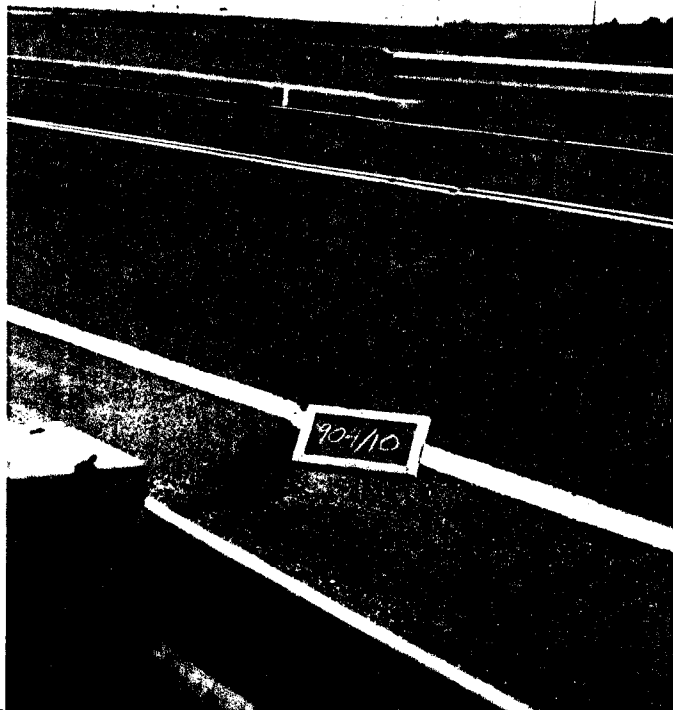
904/10 - Unusual crack pattern repeated at south end of bridge.

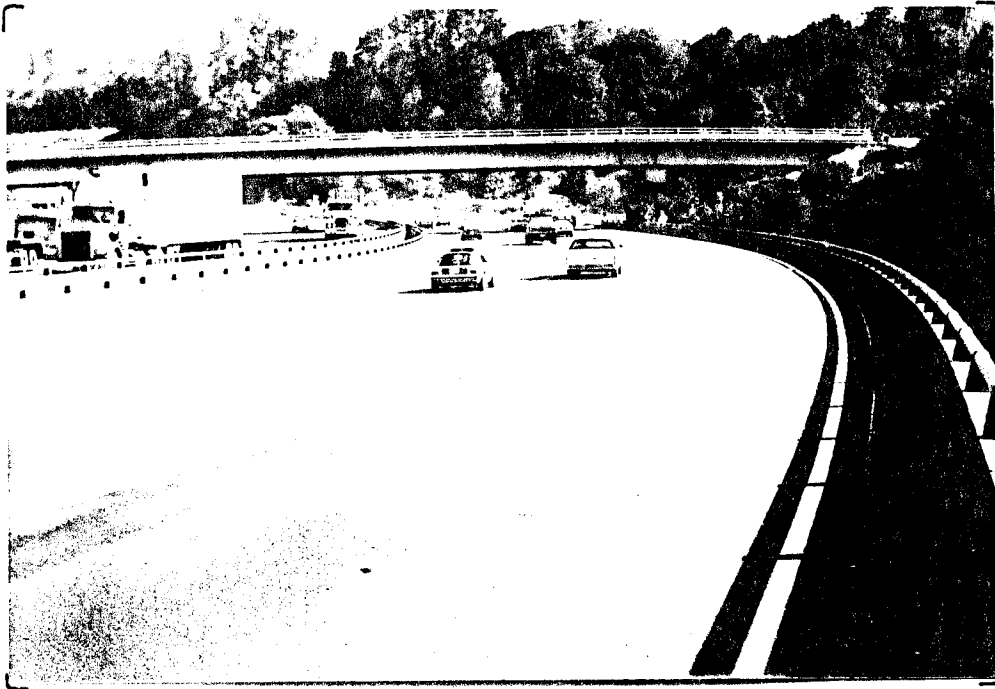
The Duwamish Bridge is experiencing severe ravelling in the left wheel path in three of four lanes. We speculate that this was caused by improper compaction techniques when the deck was overlaid. The ravelled areas have been repaired and are holding up well. This bridge was rated 11.

5/526 - Severe raveling in left wheel path. Heavy high speed traffic. Paved 1976. Rated 11

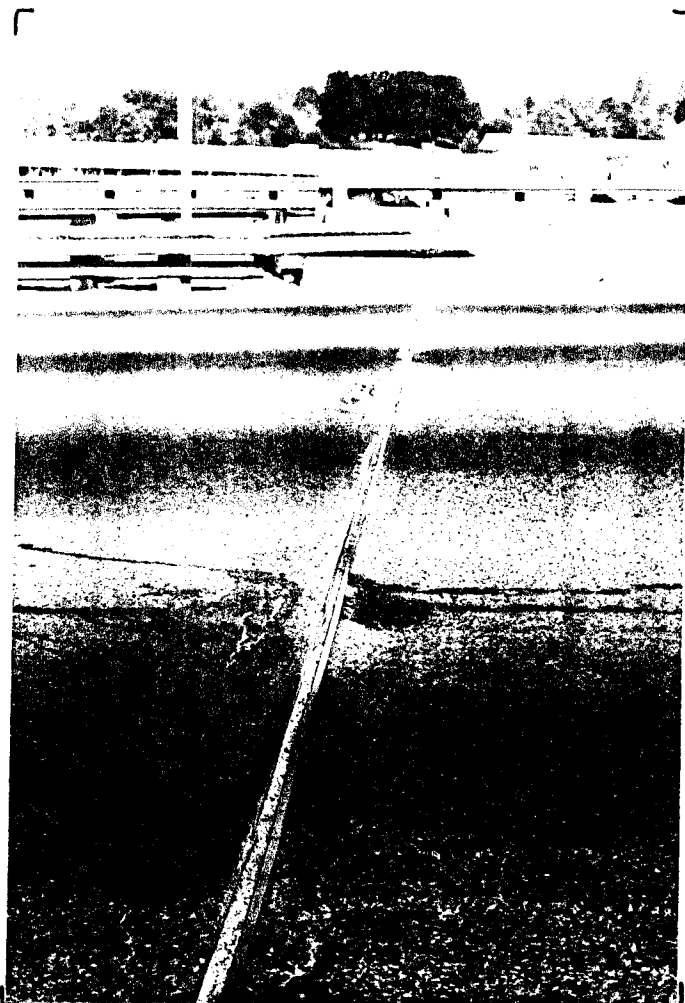
5/526 - Some rutting and settling at pavement seat.
