Bridge Approach Slab Effectiveness

WA-RD 227.1

Final Report
December 1991

**Research Project GC 8286, Task 35
Bridge Approach Slab Effectiveness**

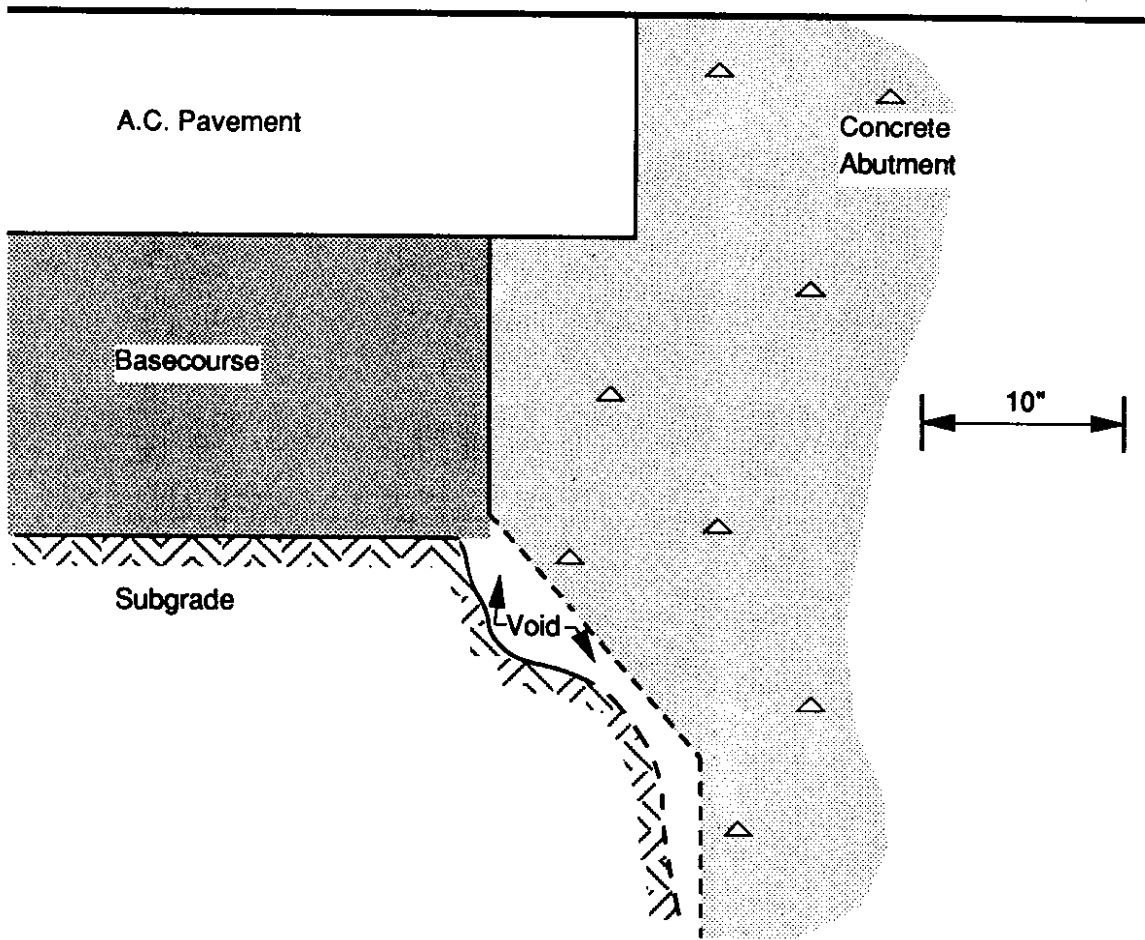
Figure 7. Profile through Sidney Road Overcrossing Abutment

Using a digging bar as a probe, the crew encountered a large void in an area behind the abutment backwall near the "corbel," as shown in Figure 7. This void appeared to have formed along the entire backwall, since it was nearly impossible to compact soils under the

The primary cause of approach distress at the Sidney Road overcrossing appears to be the void that had formed under the corbel of the abutment backwall. Abutment backwalls designed with corbels that project from the abutment wall create an area in which proper soil compaction is difficult. Excavation into the corbel area clearly displayed a large void at this bridge. The void may have been enlarged by erosion due to water infiltration, particularly if compaction around the abutment and corbel had not been as rigorous as required.

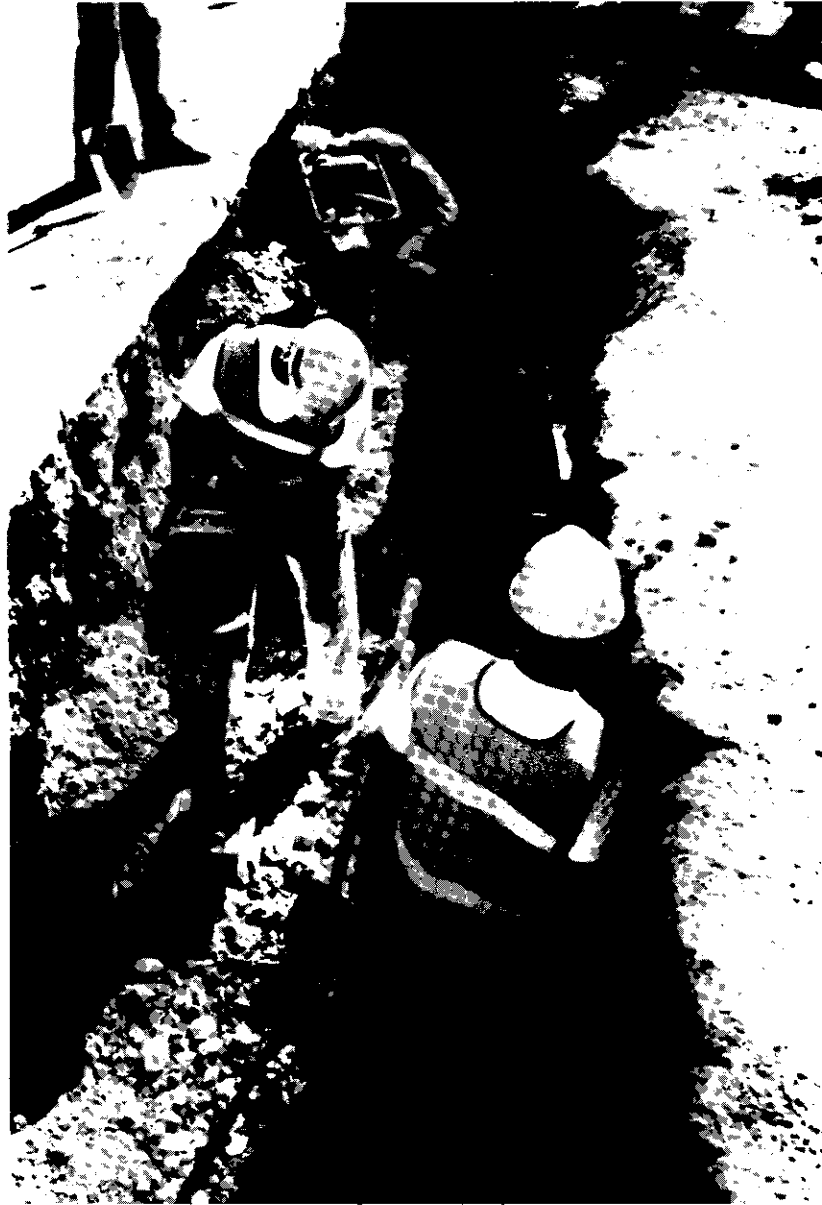
Figure 32. Repair of Erosion Damage Behind Abutment of Bridge at M.P. 124

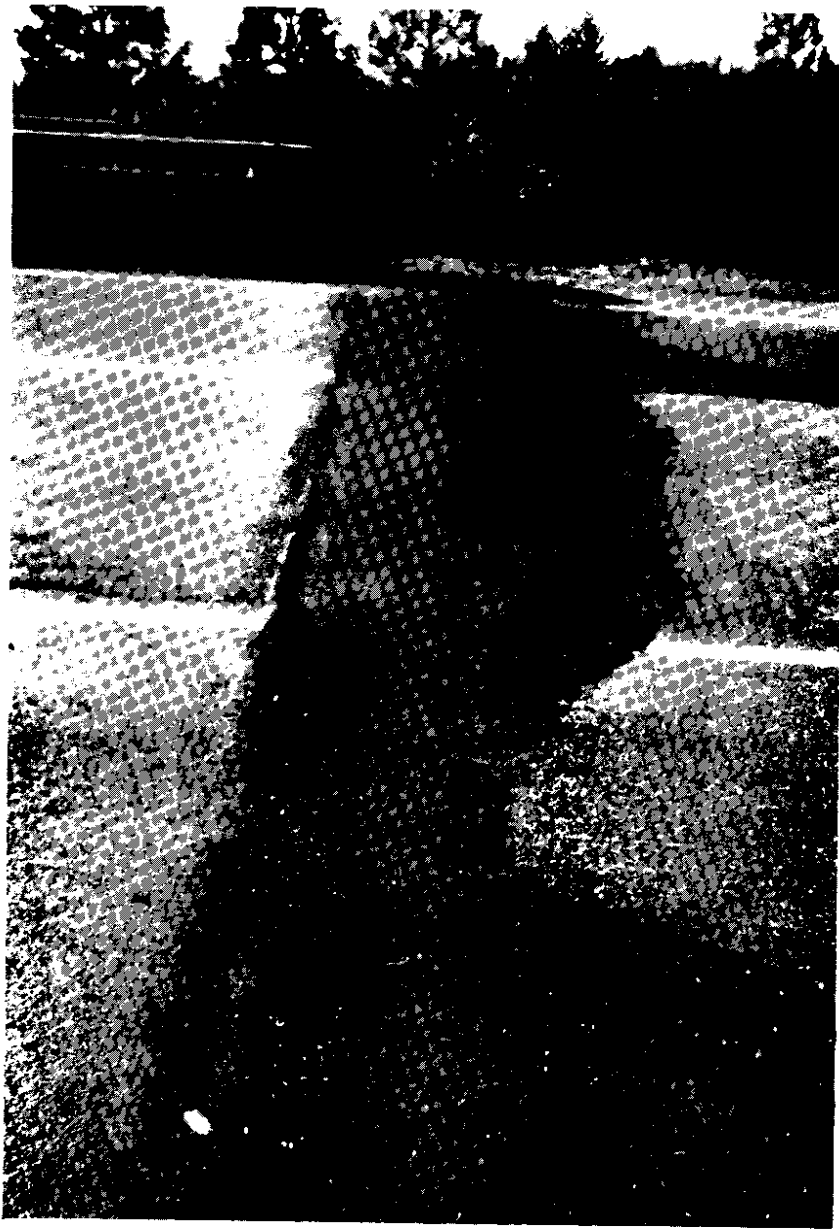
Figure 59. Approach Patching on the North First Street Overcrossing Structure

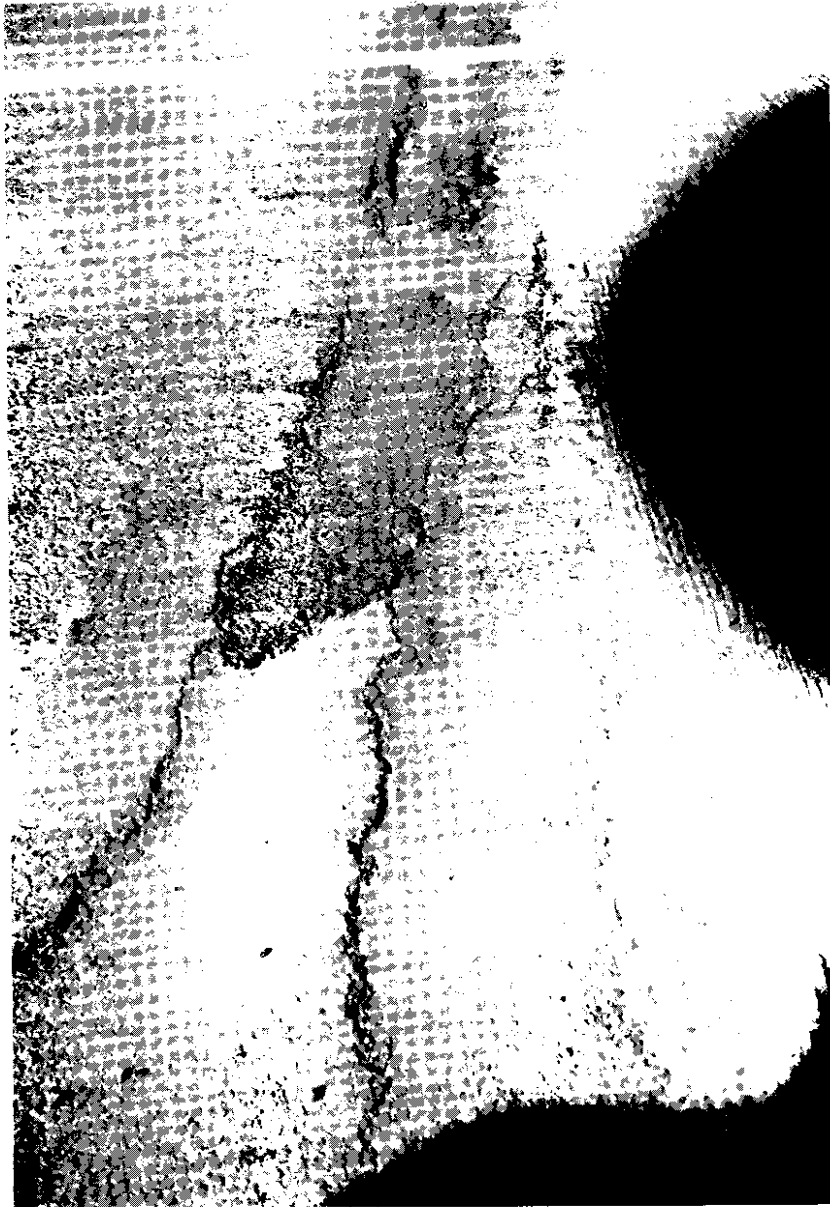
Figure 72. Approach Cracking at the Johnson Road Bridge

Approach problems at the Johnson Road Undercrossing have occurred from the settlement of approach fills. Bridge settlement is unlikely, since the bridge is founded on competent basalt. The cause of the localized approach fill settlement is not apparent, but is most likely the result of poor compaction, which may have resulted in part from the bridge design. The bridge girders, which rest on the abutment, extend beyond the abutment backwall; hence, areas under and adjacent to each of the protruding girders would have been very difficult to compact. Densification of the under-compacted soils is the most likely cause of the observed distress. Thermal bridge movements may have exacerbated the problem.
