PERFORMANCE OF GEOTEXTILE SEPARATORS IN WESTERN WASHINGTON

WA-RD 321.1

Final Technical Report
May 1994

Final Technical Report
Research Project T9233, Task 13
Geotextile Separator Performance—II

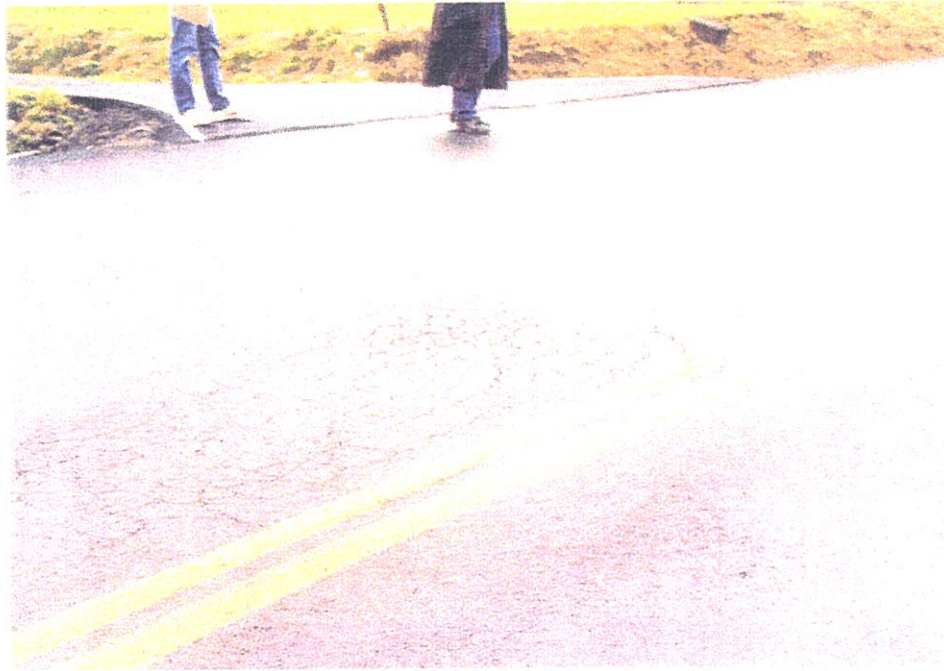
Figure 5.1 - Distressed pavement on Columbia Heights Road.

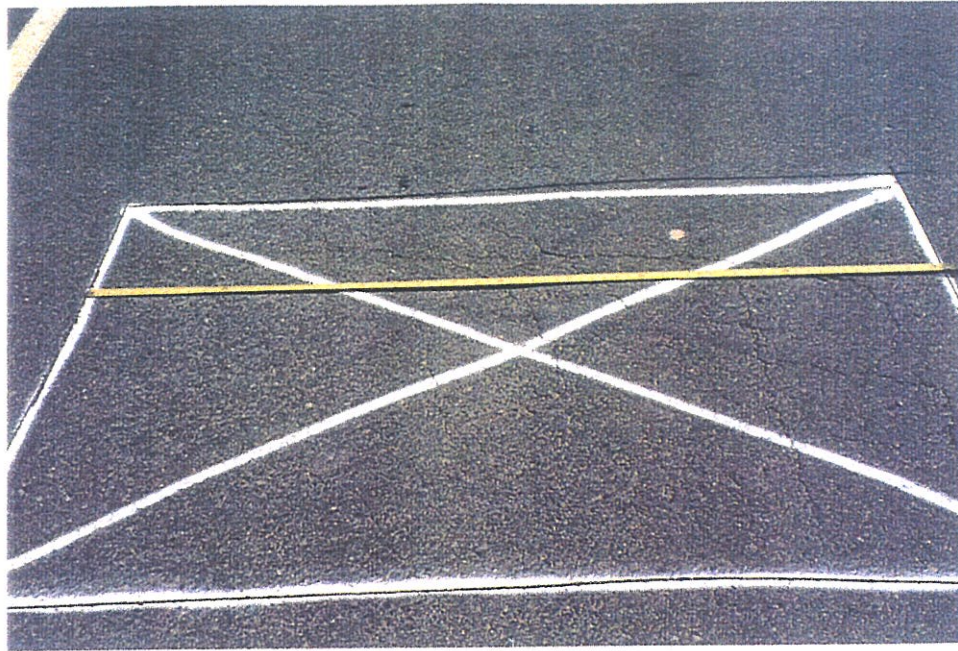
Figure 5.3 - Fatigue cracking in pavement surface, test pit 1a.

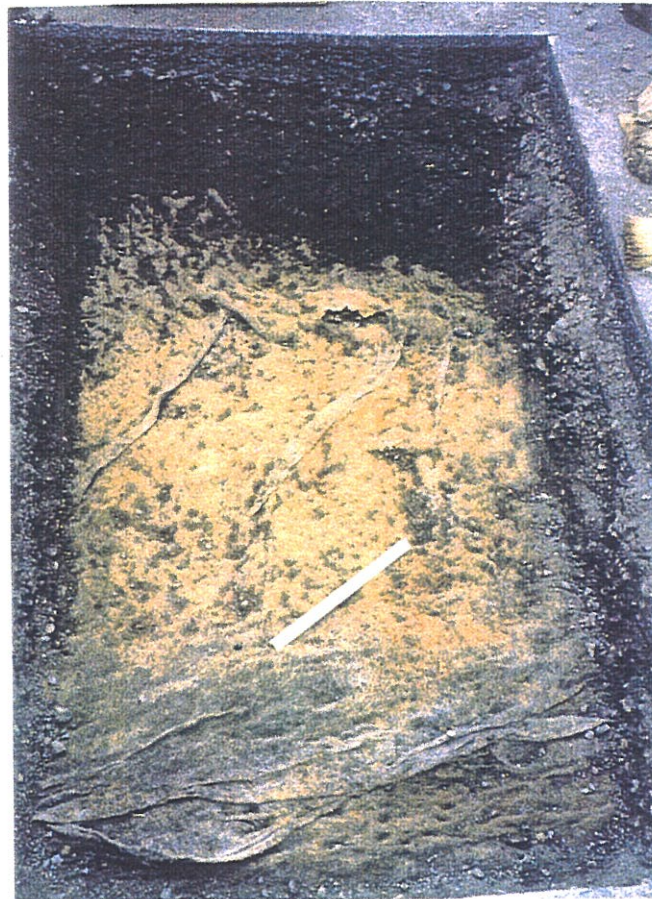
Figure 5.4 - Surface of the exposed geotextile showing folds and overlap (bottom).

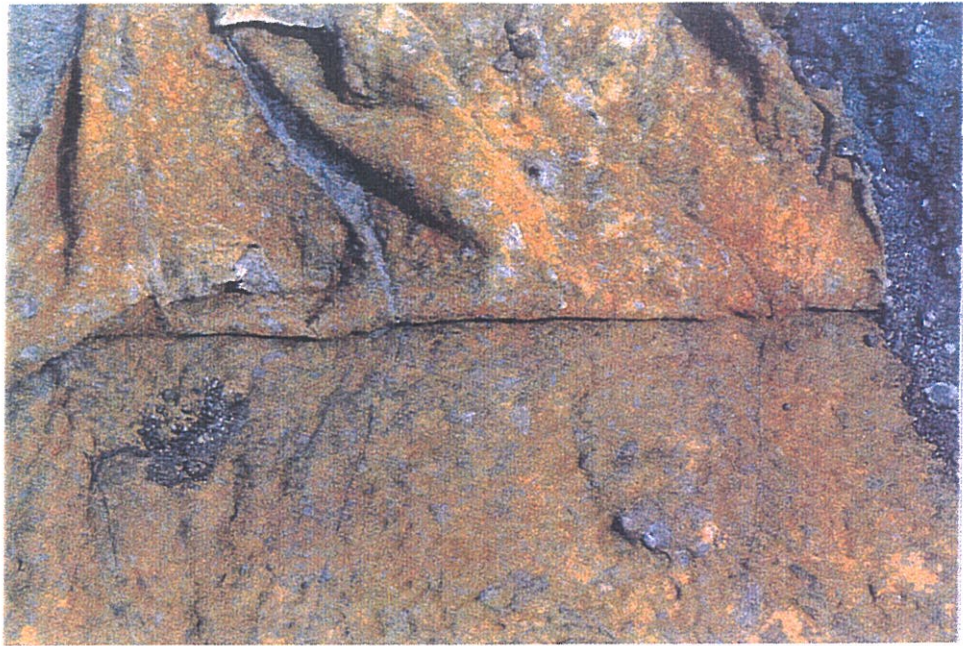
Figure 5.5 - Geotextile folded back exposing the heavily iron stained geotextile underside and subgrade, testpit 1a.

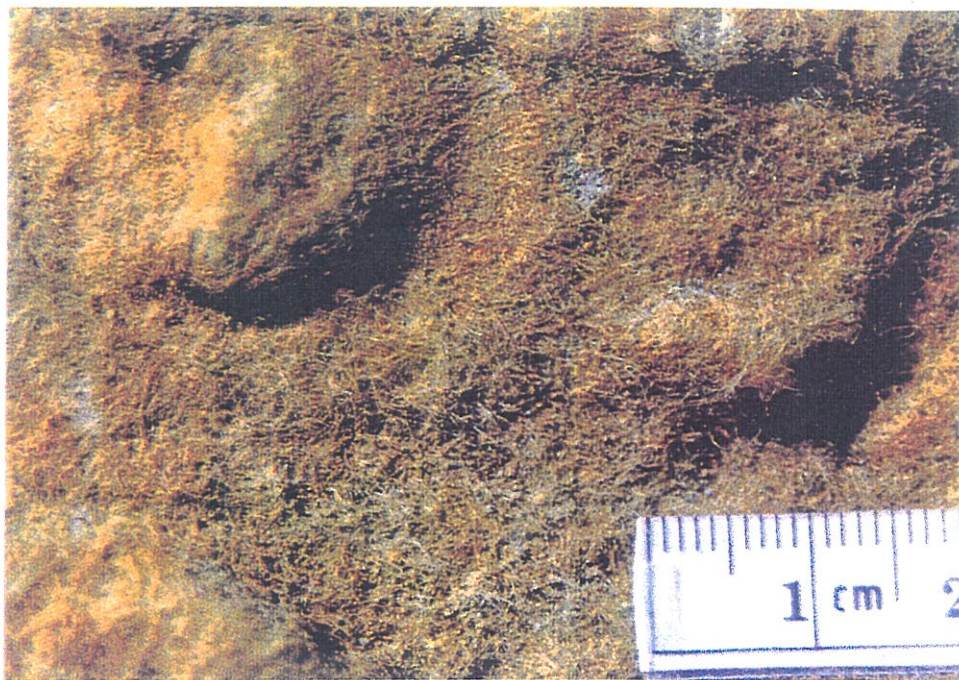
the overlap existed. The gravel indentations in the subgrade above the scale are more numerous and much more pronounced, and should be expected since there is only one layer of geotextile in this area. Upon closer observation when the underlying thicker geotextile was removed, there was a large number of very small, approximately 2 to 3 mm in diameter, holes in the overlapping geotextile which was in contact with the base course. Surprisingly, fewer holes were found in the fabric where it was only one layer thick and where there were deeper indentations in the subgrade. Figure 5.7 shows a photograph of the bottom surface of the exhumed geotextile placed on a light table, with the section in contact with the subgrade on the right side and the overlap on the left side. Note the sharp color contrast due to the iron staining and the fewer holes on the right side. Figure 5.8 shows a magnified (~2X) photograph of some of the holes in the overlapping geotextile. Note the very rounded appearance of the holes. Figure 5.9 is a close-up (magnified ~2X) of the bottom surface of the geotextile showing the iron staining and gravel indentations. The geotextile appeared to be moderately clogged with the fine-grained subgrade soils.

Figure 5.9 - Magnified (~2X) close-up of the bottom surface, showing the gravel indentations and iron staining, testpit 1a.

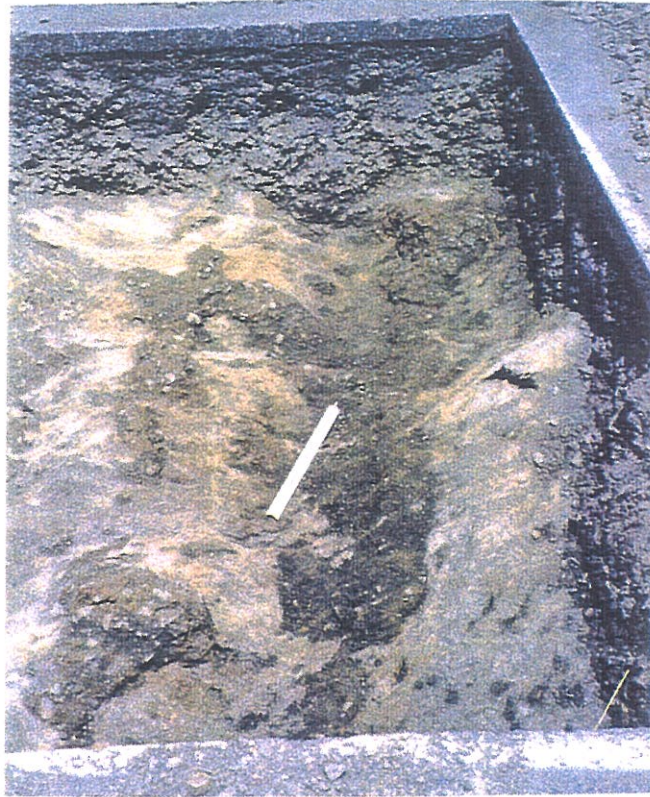
Figure 5.12 - Exposed geotextile and clay protrusions, testpit 1.

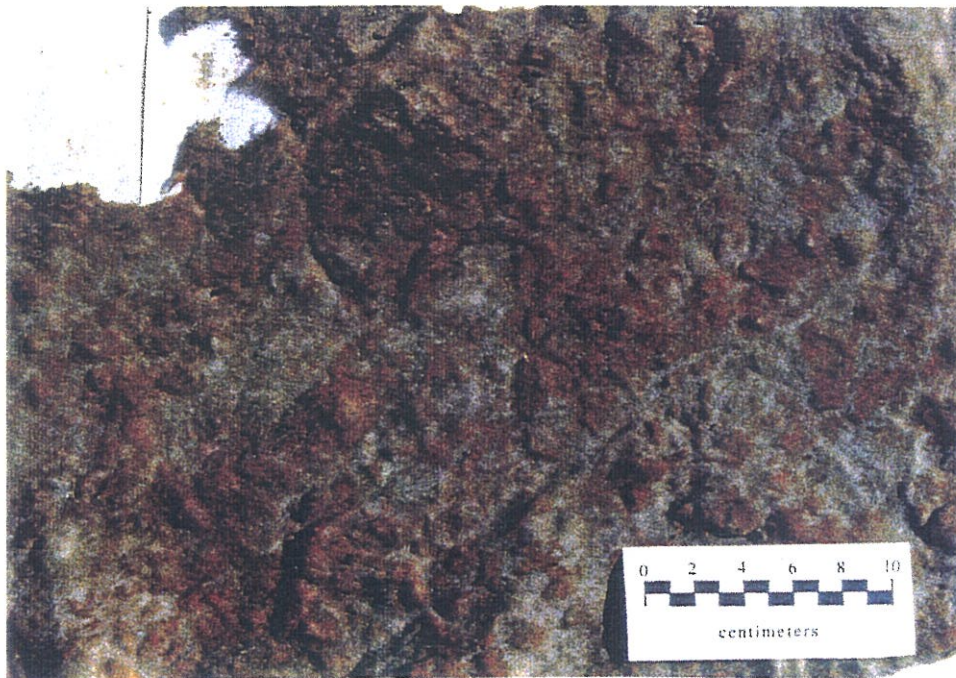
Figure 5.15 - Photograph of iron staining and condition of a relatively undamaged area on the bottom surface of the geotextile, testpit 1.

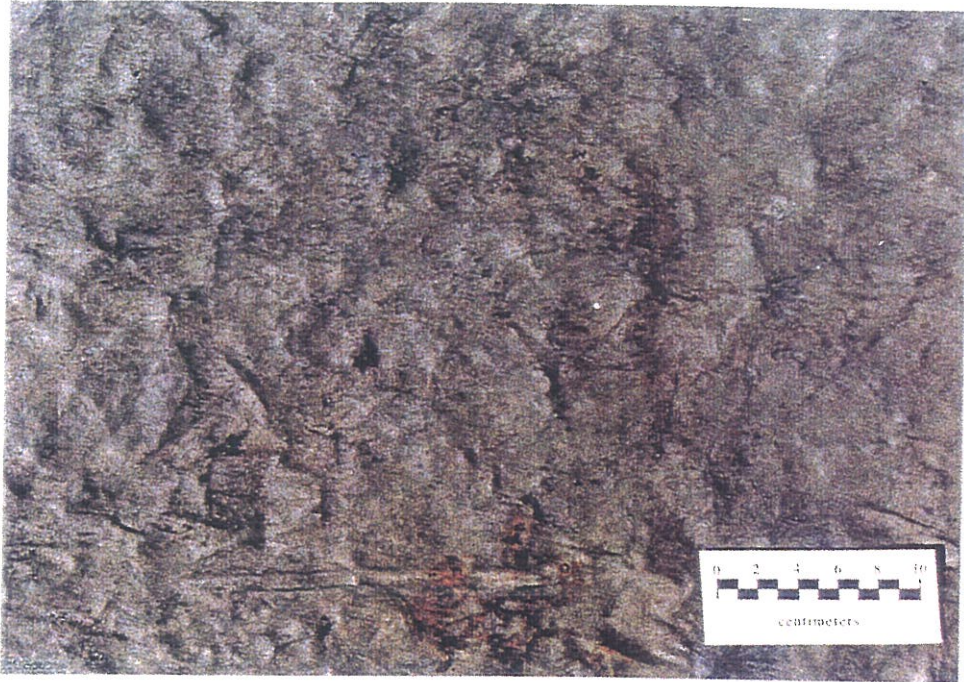
The exhumed geotextile had tears in it up to 75 to 100 mm long. Figure 5.22 shows a laboratory photograph of the bottom surface of the geotextile with a small iron stained spot (bottom middle). Figure 5.23 shows a photograph of the geotextile over a light table in the laboratory. The heaviest damage was generally on the north side of the exhumed geotextile. The geotextile appeared to be minor to moderately clogged with silt and fine wood particles. The geotextile was typically moderately damaged, although it was severely damaged in local areas.

Figure 5.22 - Laboratory photograph of the bottom surface of the geotextile with a small iron stained area.

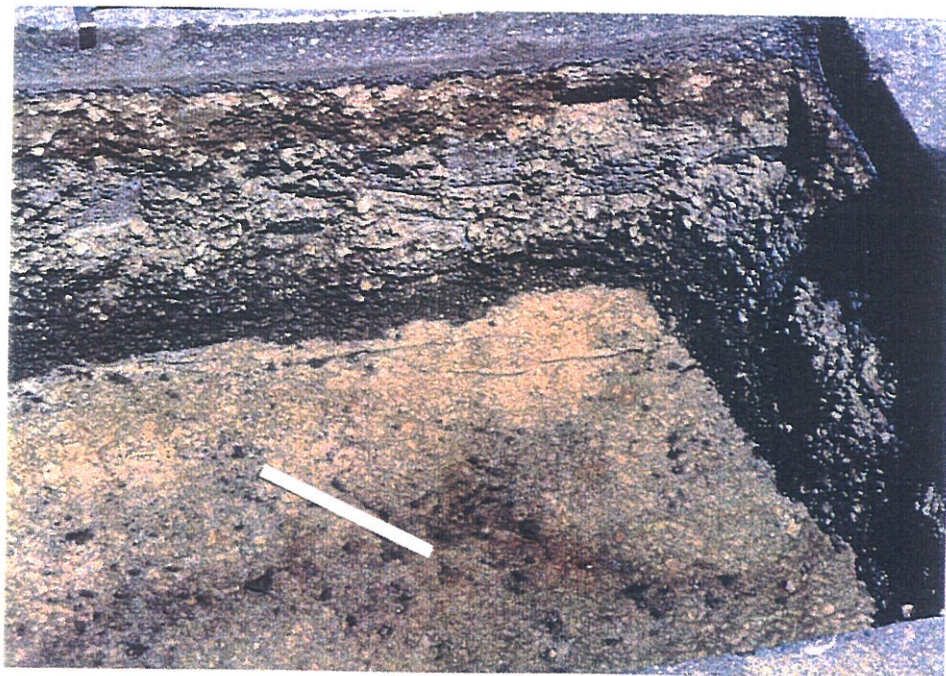
Figure 5.27 - Exposed geotextile surface. Note the iron staining on the fabric and the wet base rock immediately above the geotextile.

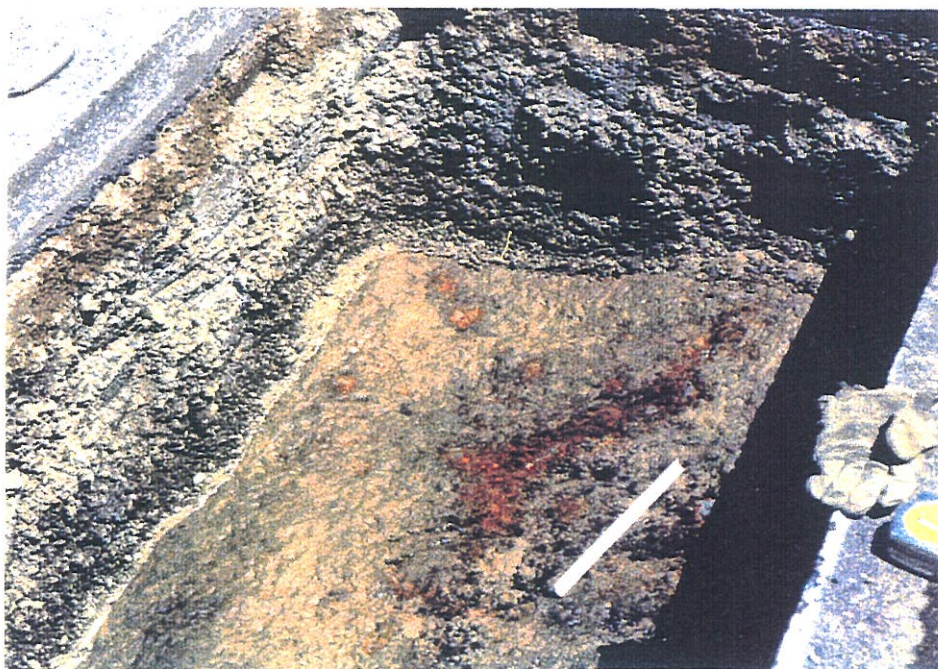
Figure 5.29 - Subgrade surface with iron stained patterns.

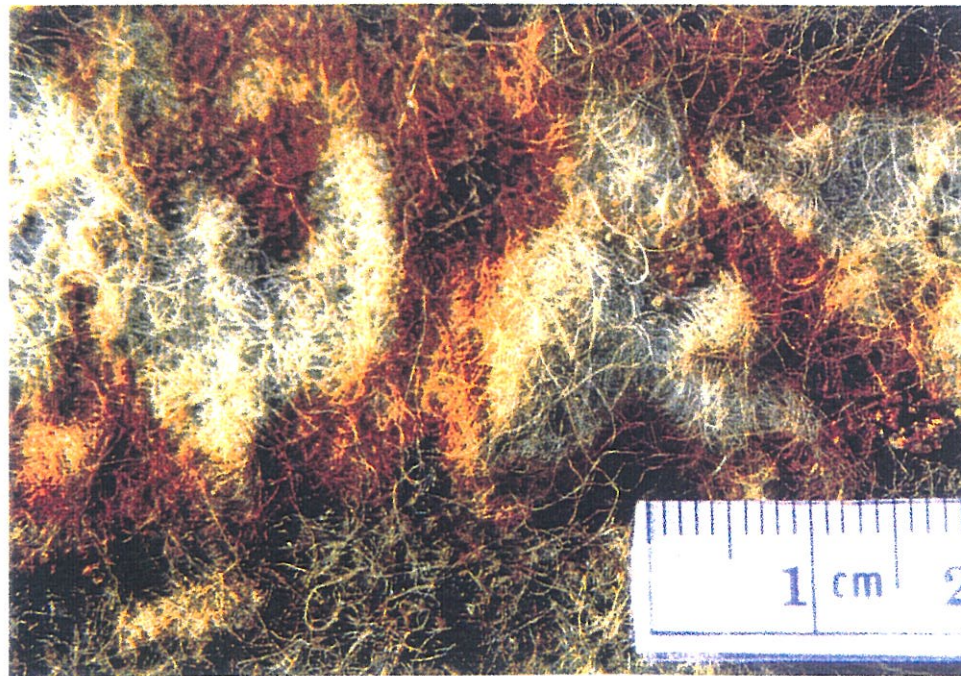
Figure 5.31 - Close-up (~2X magnification) of an iron stained area on the bottom surface of the geotextile.

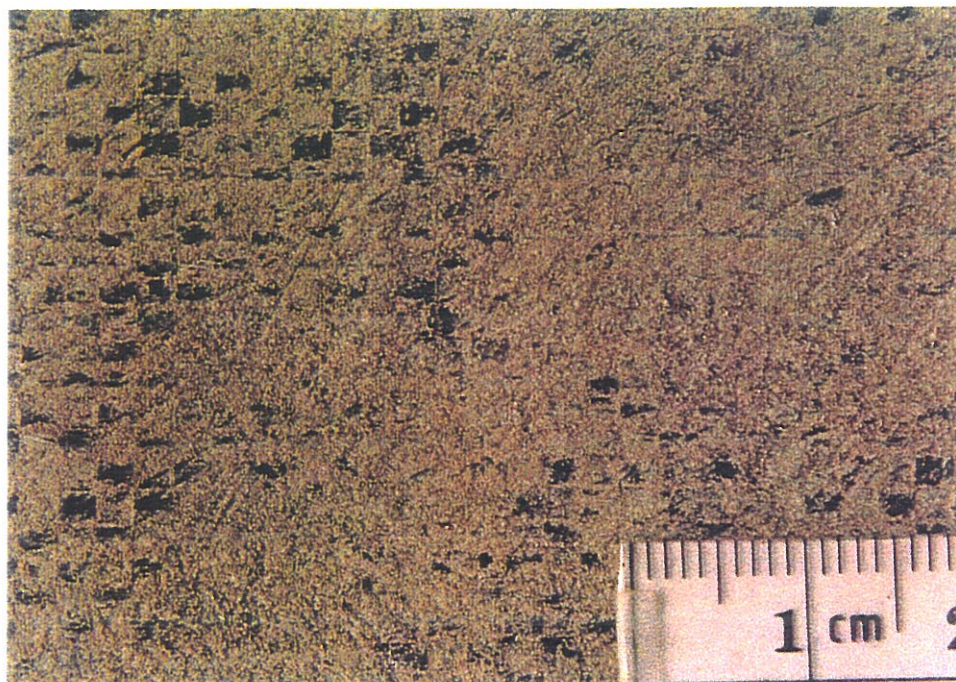
Figure 5.34 - Typical photograph of caked upper geotextile surface (magnified ~2X).

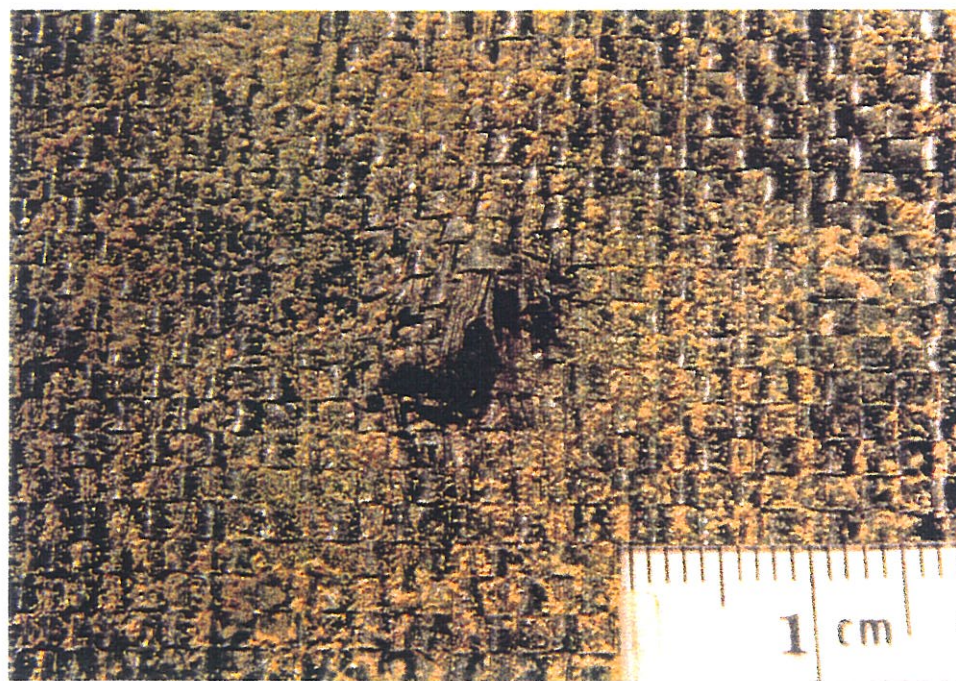
Figure 5.35 - Photograph of a typical puncture in the geotextile (magnified ~2X).
The bottom surface is shown.

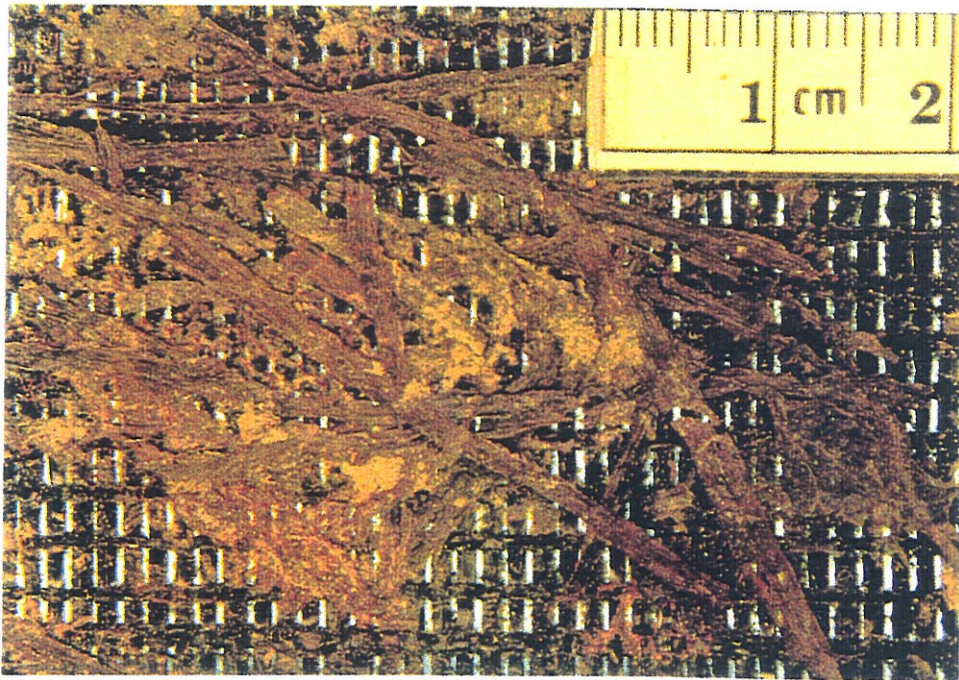
Figure 5.39 - Close-up (magnified ~2X) of the organics on the geotextile. Illuminated behind by a light table.

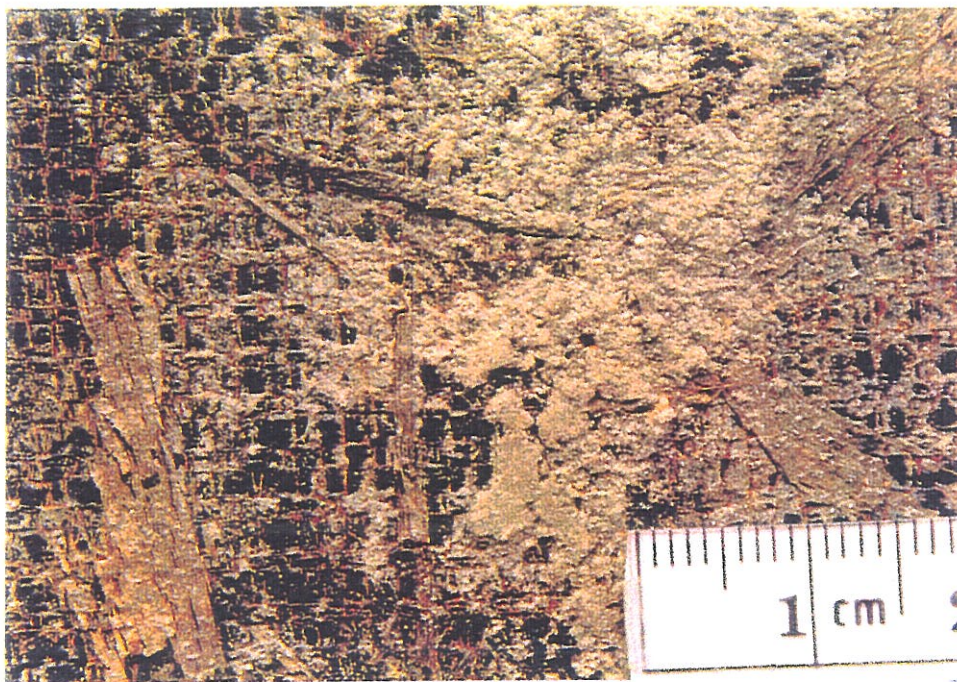
Figure 5.40 - Close-up (magnified ~2X) of organics and silt particles blinding the bottom geotextile surface.

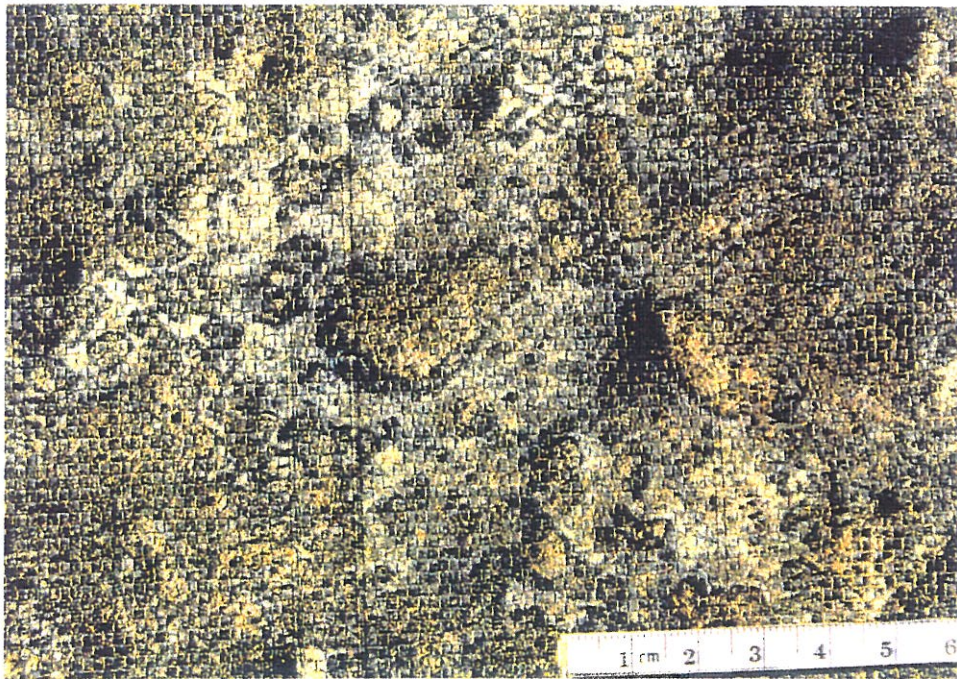
Figure 5.48 - Water stained patterns on the bottom surface of the geotextile.

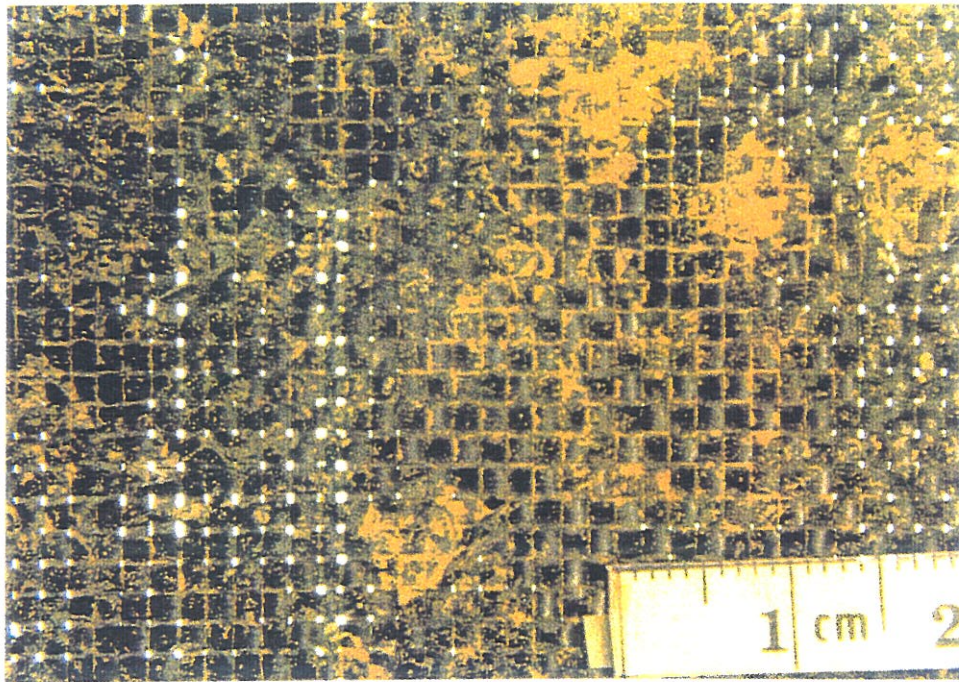
Figure 5.49 - Typical blinding of the bottom surface (magnified ~2X).
Illuminated behind by a light table.

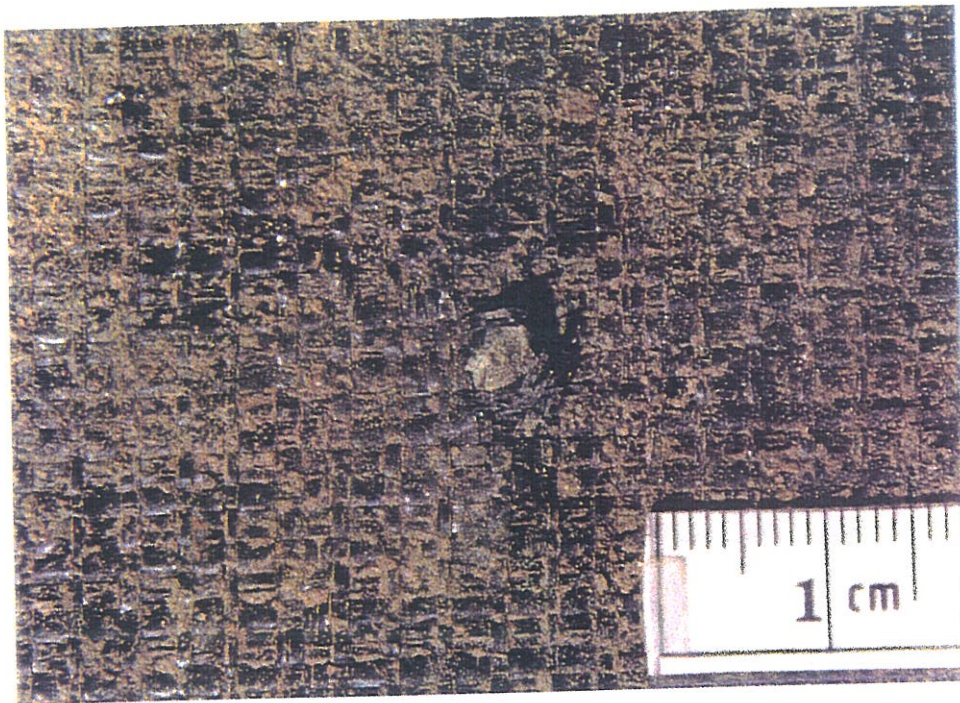
Figure 5.68 - Typical blinding on the bottom surface of the geotextile, and typical damage caused by the overlying base material (magnified ~2X).

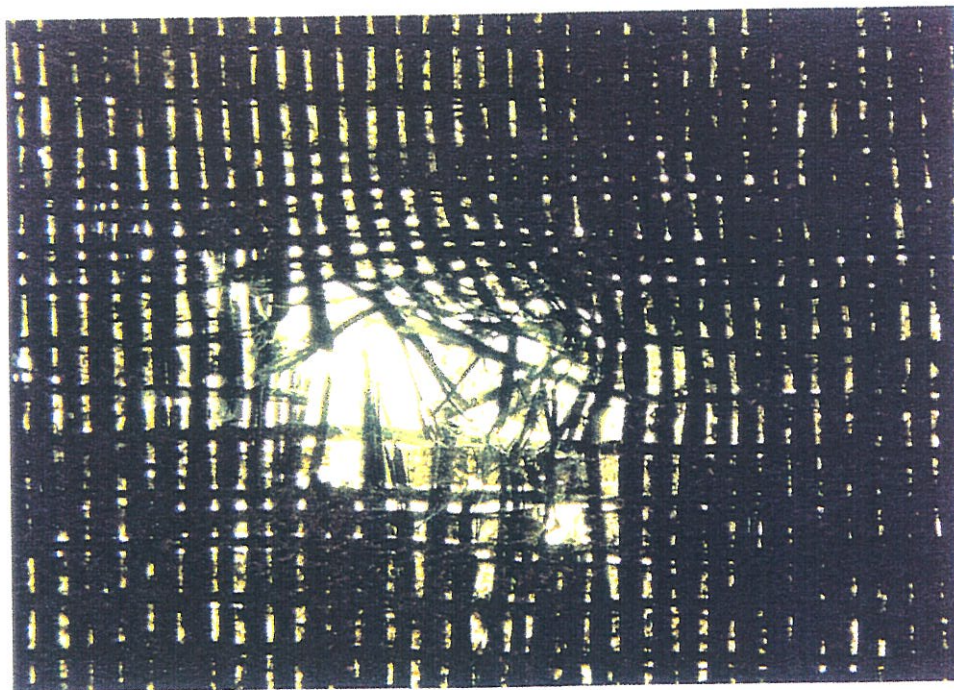
Figure 5.69 - Laboratory photograph over a light table showing typical damage (magnified ~2X).

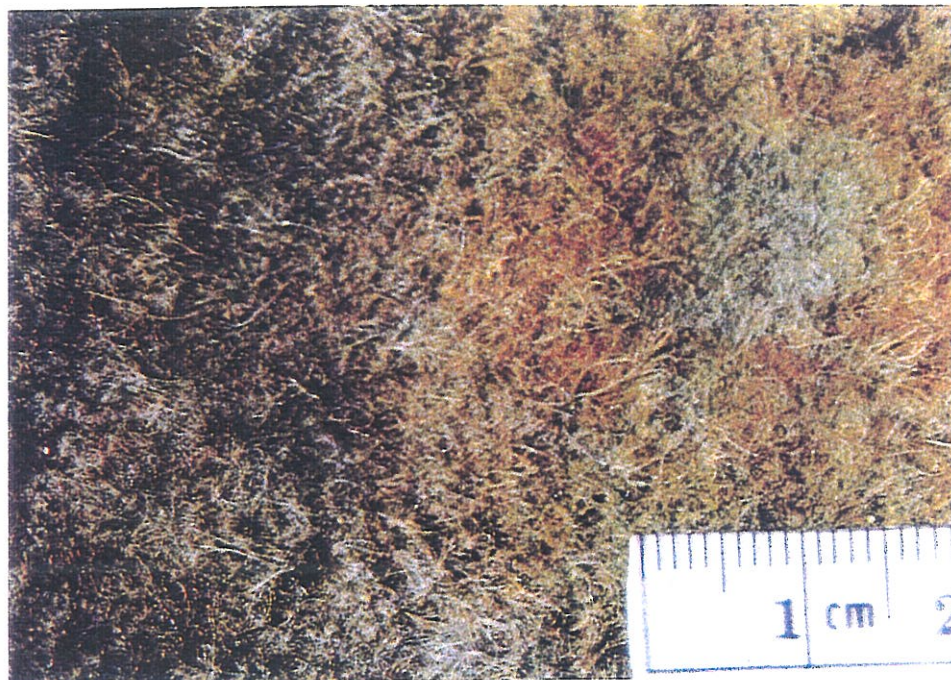
The bottom surface of the geotextile was heavily stained with orange to rust and dark brown colors, Figure 5.86 (magnified ~2X). Figure 5.87 is a photograph over a light table of the top surface of the exhumed geotextile. The geotextile was in good condition, but in several areas there appeared to be thin spots in the fabric where there were relatively few fibers. Figure 5.88 shows a close-up (magnified ~2X) of a typical thin area. Generally the geotextile appeared to be minor to moderately clogged with a few smaller areas of moderate to heavy clogging.

Figure 5.86 - Dark brown and rust colored staining on the bottom surface of the geotextile (magnified ~2X).

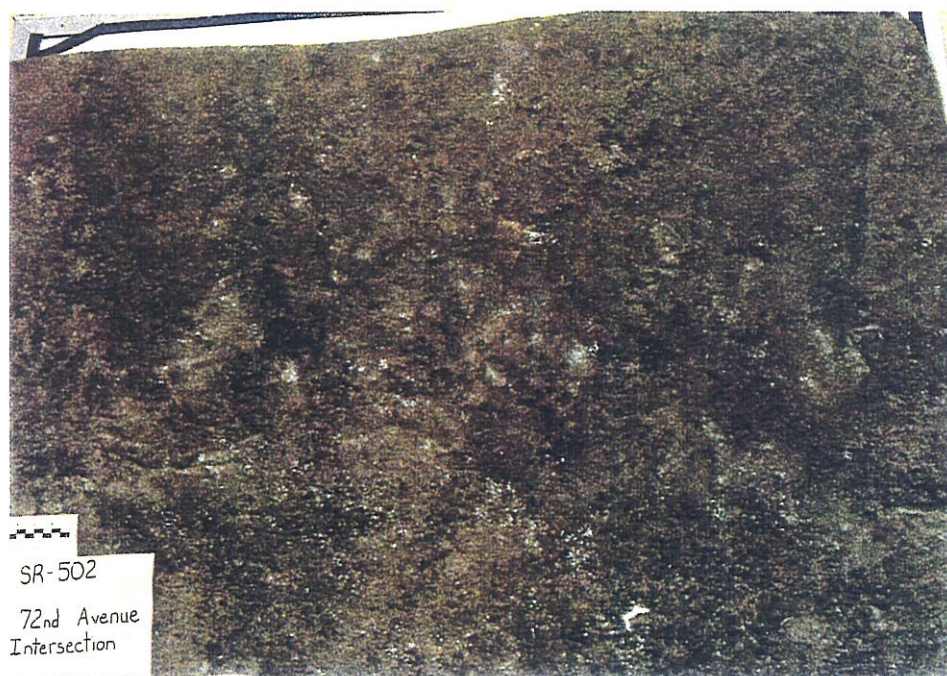
Figure 5.87 - Laboratory photograph of the geotextile over a light table.

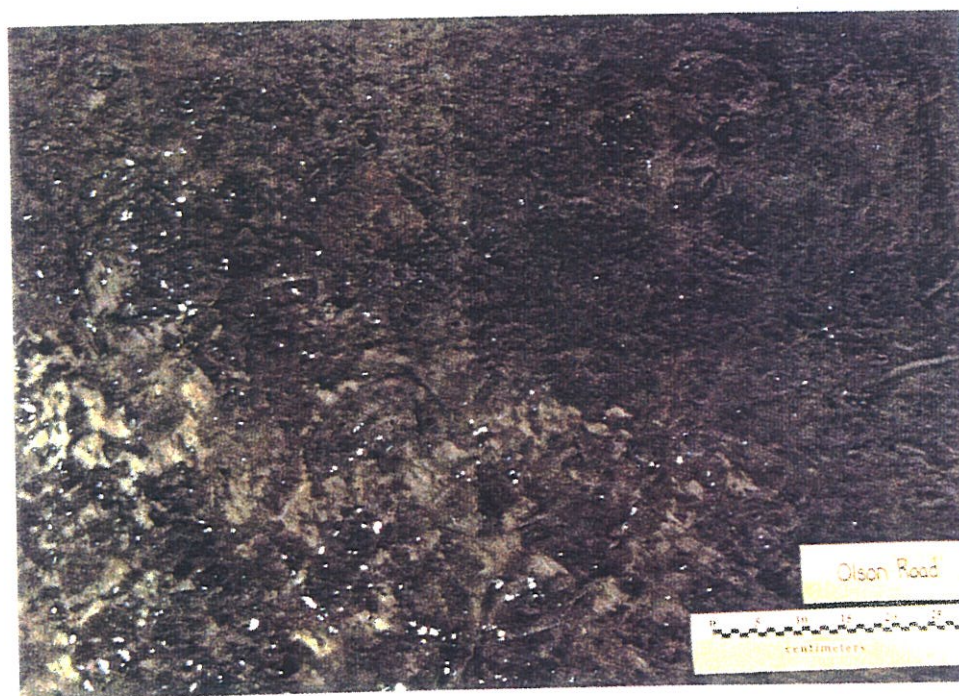
Figure 5.96 - Middle area of the bottom surface of the geotextile showing the degree of damage. The top of the photo is the north side, right is west. Illuminated from behind.
