Final Summary Report
Research Project Agreement No. T9233, Task 41
Seismic Vulnerability of the Alaskan Way Viaduct Phase II

**SEISMIC VULNERABILITY OF THE ALASKAN
WAY VIADUCT: SUMMARY REPORT**

July 1995

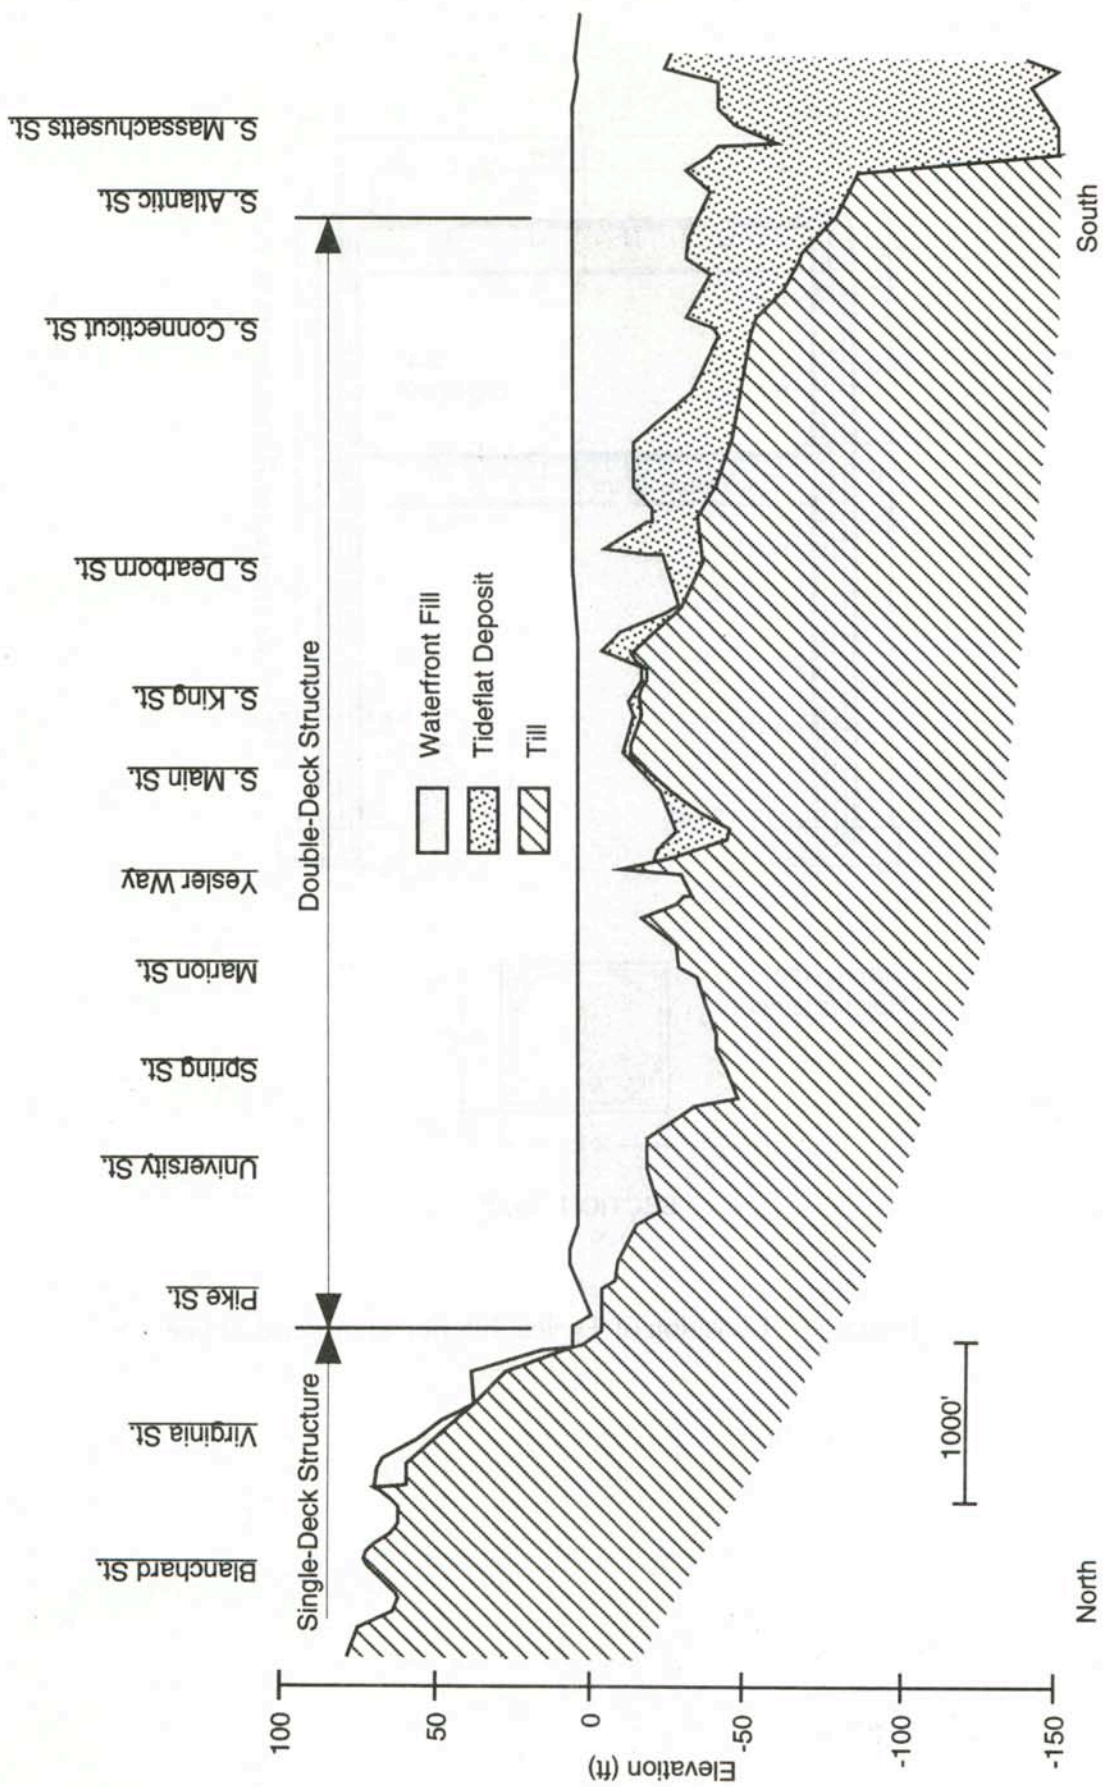
Figure 1. Soil Profile along the Length of the Alaskan Way Viaduct

From the standpoint of geological/geotechnical conditions, the Alaskan Way Viaduct site is dominated by thick deposits of loose, saturated soil. Most of the loose soils were placed as fill during reclamation of the area's tideflats and extension of the waterfront toward Elliot Bay in the late 1800s and early 1900s. Some of the loose soils, particularly those south of about Yesler Way, are natural tideflat soils. The loose soils are underlain by very dense natural soils. The thicknesses of these loose soils vary along the length of the viaduct, as illustrated in Figure 1.

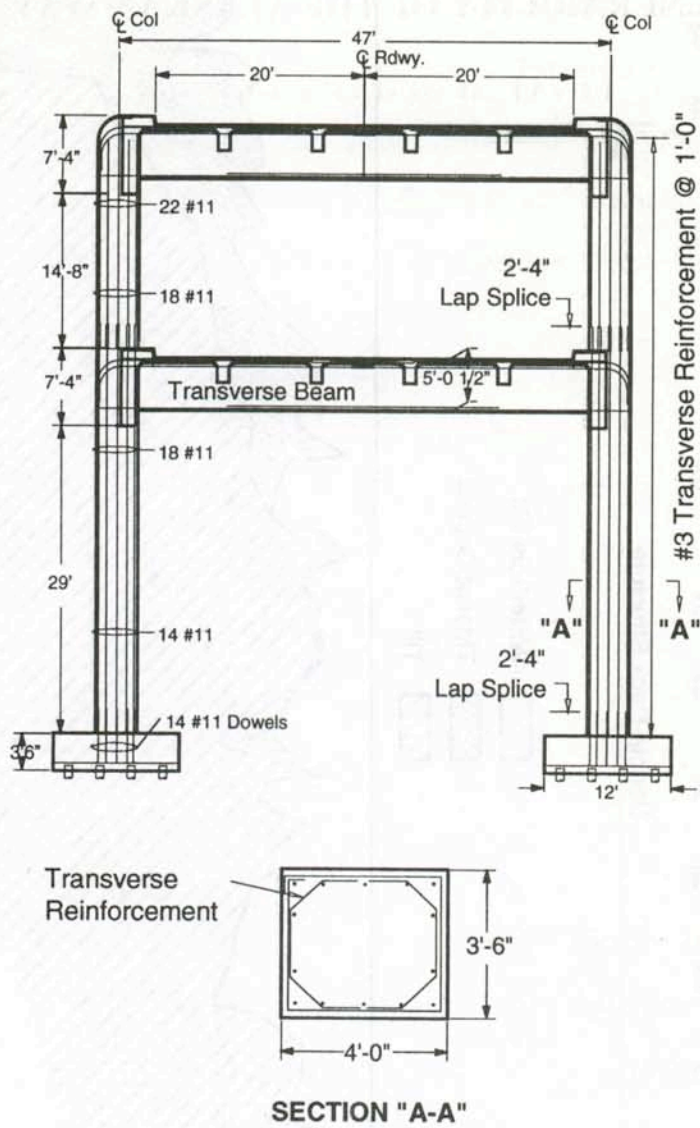
Figure 2. Elevation of Typical Interior Transverse Frame

Another difference between the Alaskan Way Viaduct and modern construction is the presence of longitudinal column reinforcement splices at the column bases and directly above the first deck (Fig. 2). The lap splices are much shorter than those required by current standards, are enclosed by inadequate transverse reinforcement, and are

located in regions that are likely to undergo large flexural demands during an earthquake. Other significant differences between the viaduct and new construction are that the bottom transverse beam and longitudinal girder reinforcement extends into the columns only a short distance, and the footings have no top reinforcement.

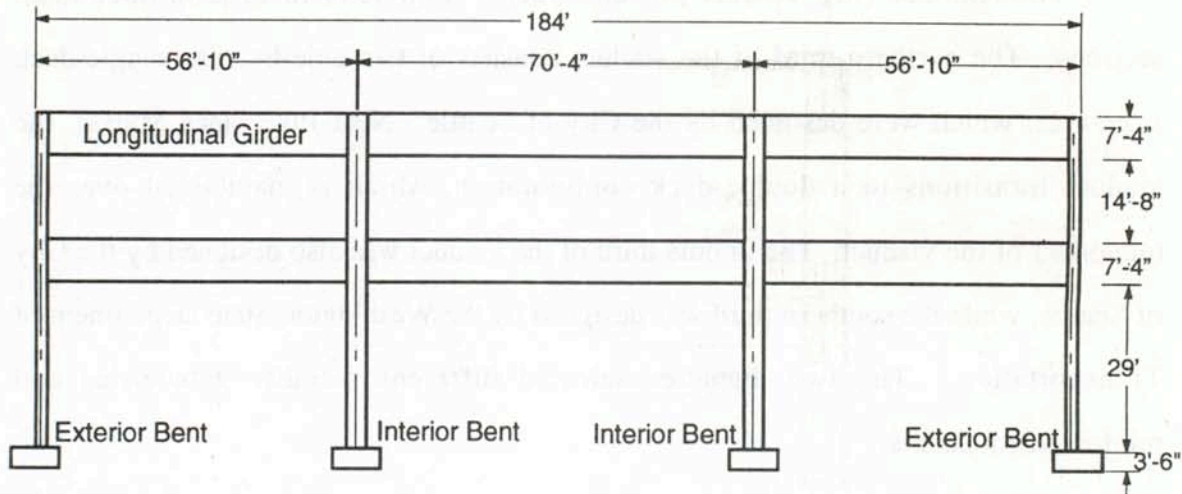
Figure 3. Elevation of Typical Longitudinal Frame

Despite variations to accommodate off-ramps, superelevations and curves, the double-deck portion of the viaduct consists mainly of three-span units that are separated from adjacent units by 2-inch expansion joints. The two decks are supported by beams that run in the transverse direction (perpendicular to traffic) and deep girders that run in the longitudinal direction (parallel to traffic). Unlike many other bridges, the beams and girders frame directly into the columns. In the transverse direction, the beams and columns form four frames that provide the lateral-force resistance of the three-span unit (Fig. 2). The girders and columns form two frames that provide the unit's longitudinal lateral-force resistance (Fig. 3).

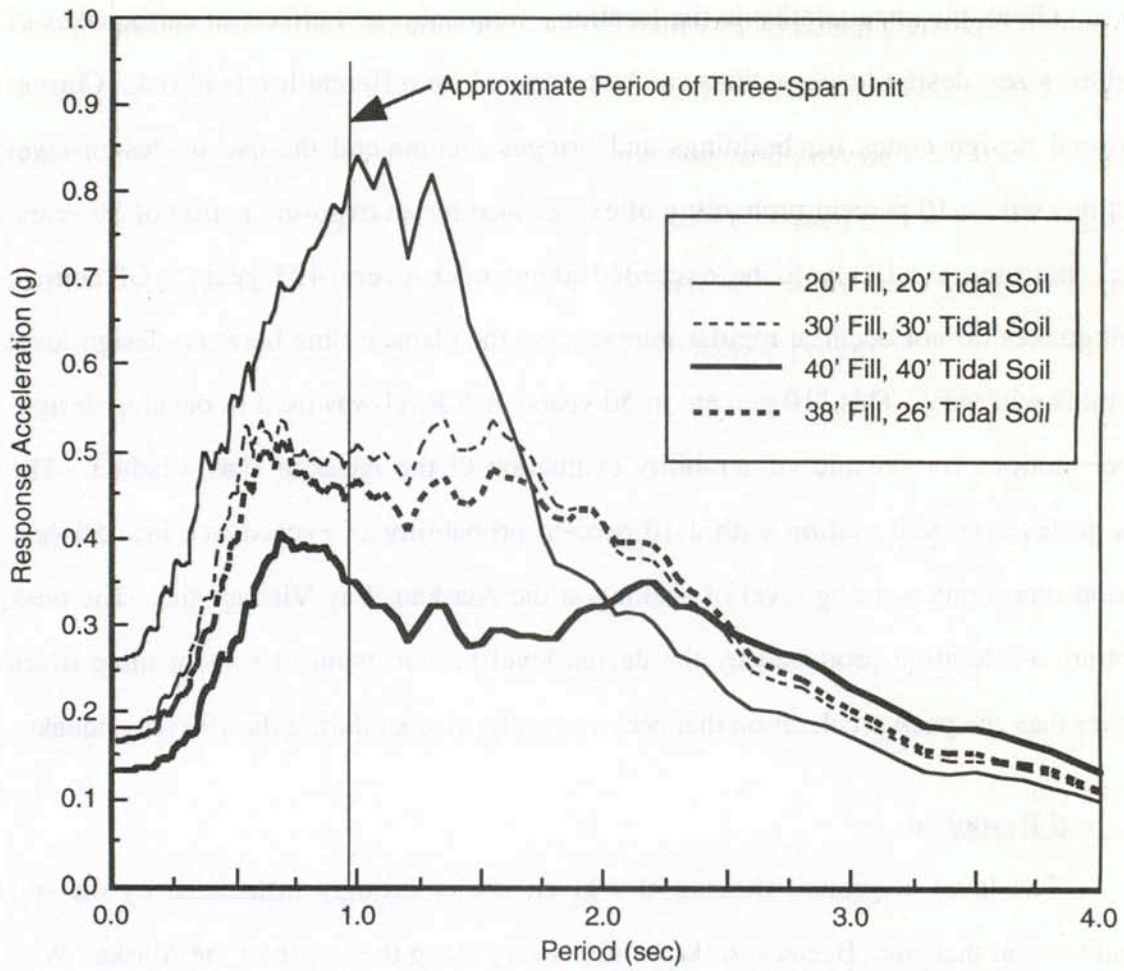
Figure 4. Acceleration Response Spectra

The level of ground shaking at a given site is strongly influenced by the soil conditions at that site. Because soil conditions vary along the length of the Alaskan Way Viaduct, various portions of the viaduct will be subjected to various levels of ground shaking. The viaduct's acceleration levels will likely be highest at locations underlain by 10 to 20 feet of fill; most of these locations are north of about Dearborn Street. South of Dearborn Street, acceleration levels will generally be lower, but larger ground displacements are likely to occur. The variation of the acceleration response for four soil profiles along the length of the viaduct is illustrated in Figure 4.
