RESEARCH REPORT
Agreement T2695, Task 90
DBR Evaluation

**EVALUATION OF DOWEL BAR RETROFIT
FOR LONG-TERM PAVEMENT LIFE
IN WASHINGTON STATE**

May 2009

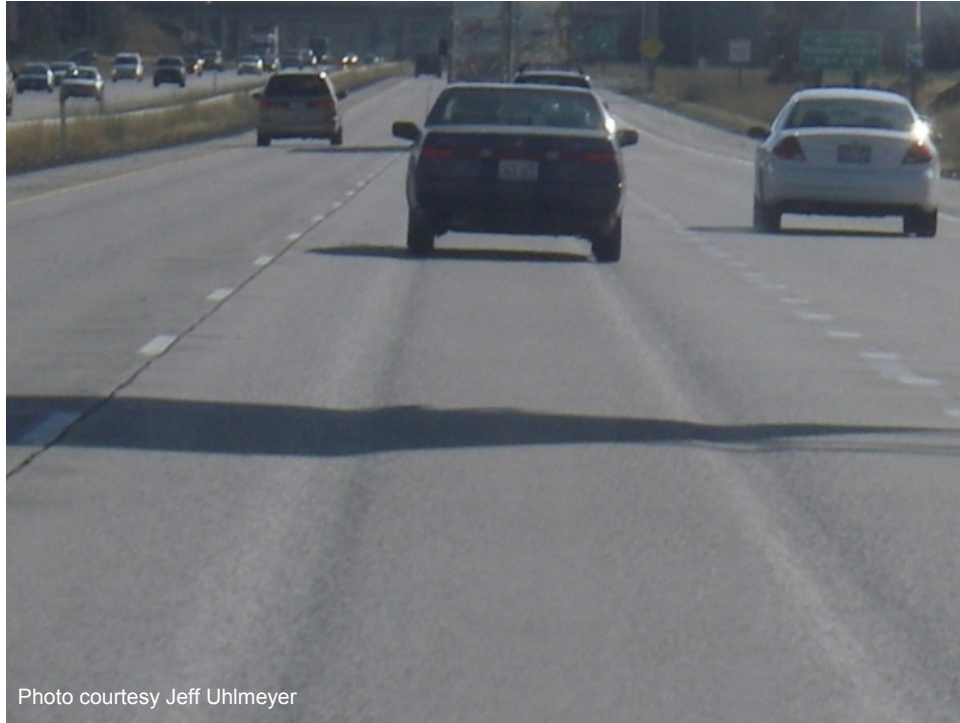
Figure 164 Studded tire wear on I-90, Spokane, Washington (2008).

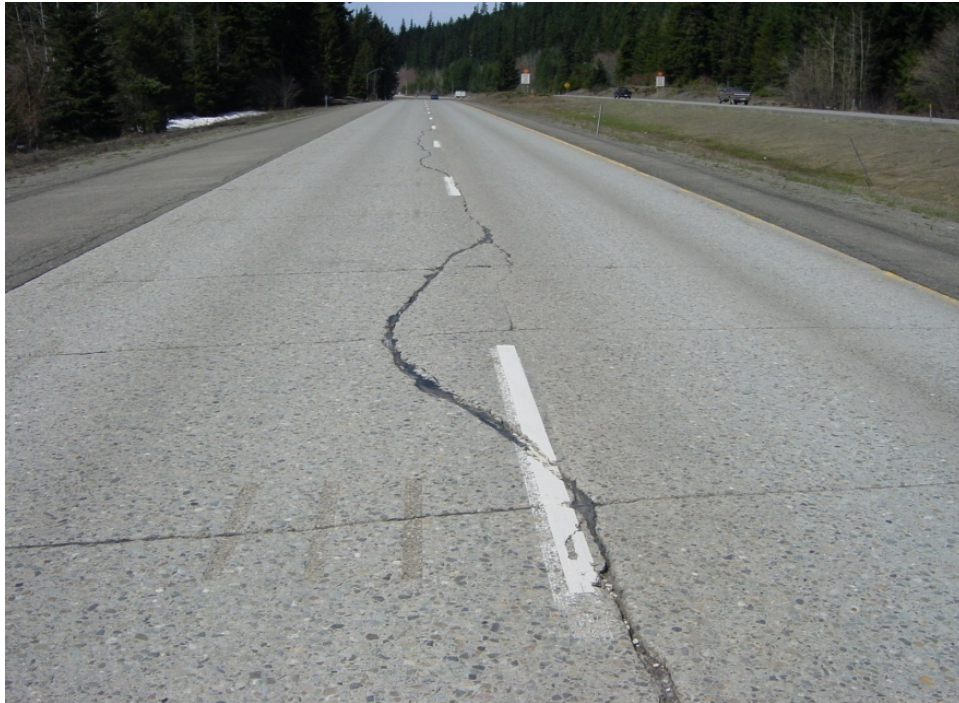
Figure 179 Failed longitudinal tape resulting in longitudinal cracking.

On Contract 6520 D, panel replacement construction included over-excavation of the underlying material which was then replaced with shoulder ballast or quarry spalls. In isolated areas it is difficult to obtain adequate compaction of the shoulder ballast material (Uhlmeier, 2008). If settlement of the shoulder ballast material continues to occur due to vehicle traffic, there is an increased potential for uneven support beneath the concrete panel. The lack of underlying support can lead to increased panel cracking.

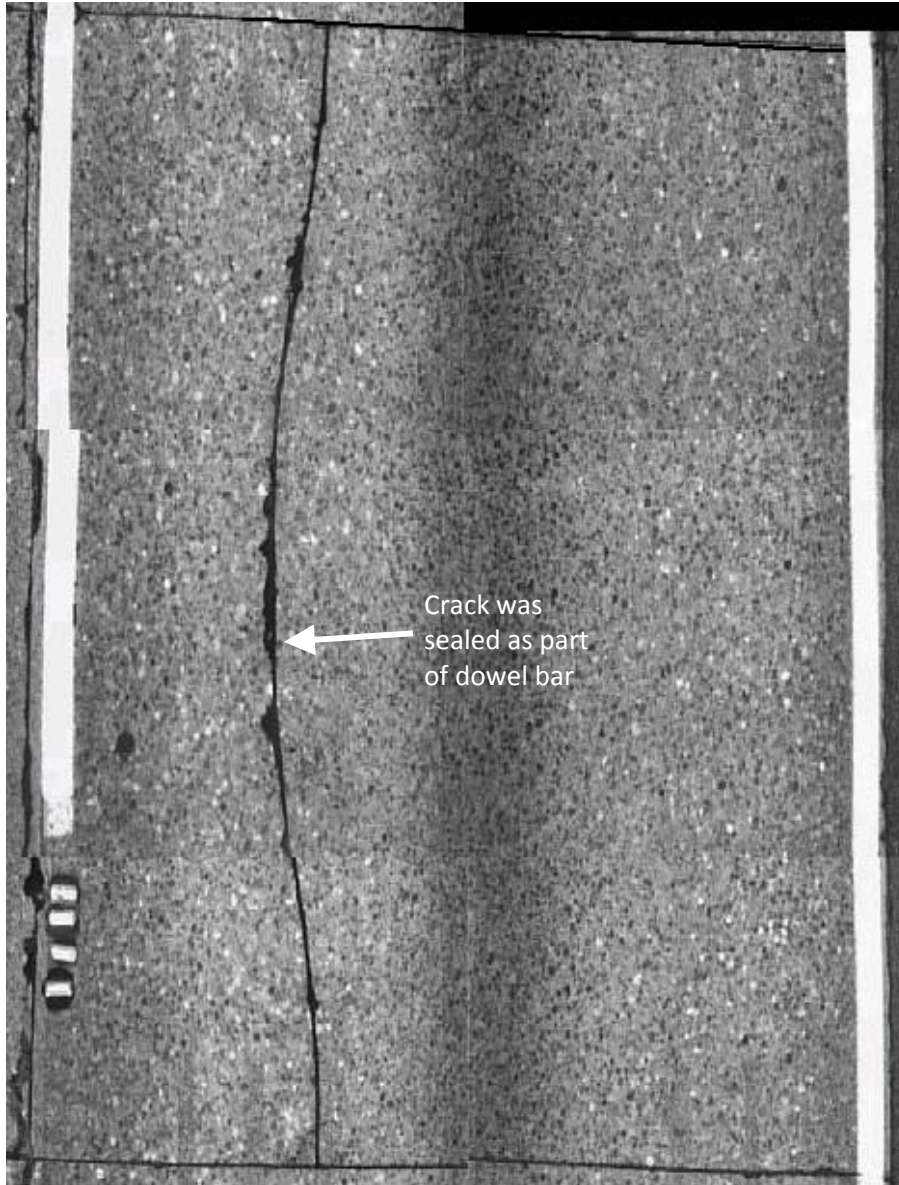
Figure 196 Pre-existing sealed longitudinal crack.

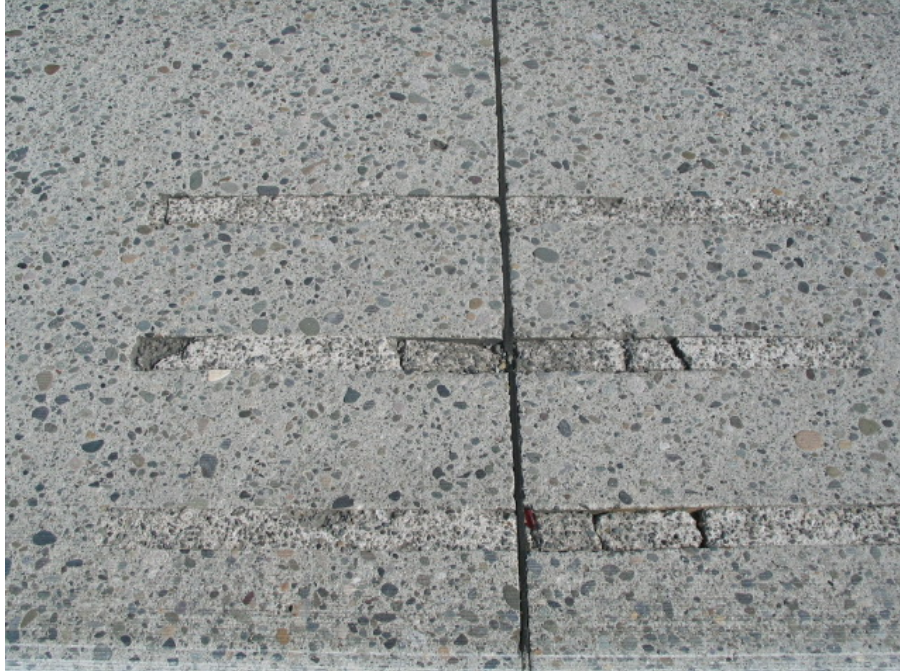
Figure 200 Patching material cracking.

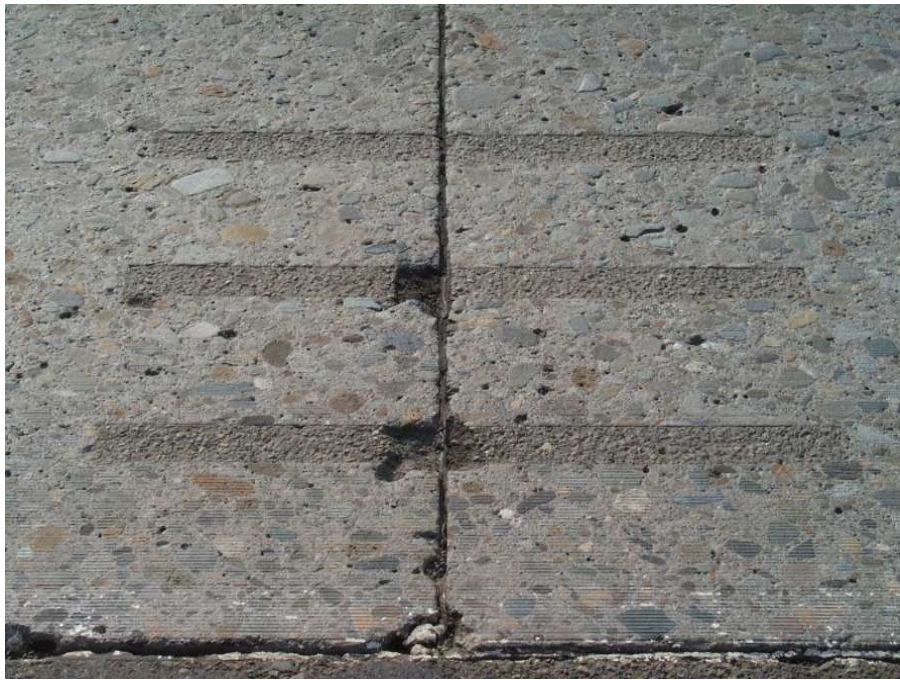
Figure 204 Spalling of patching material.

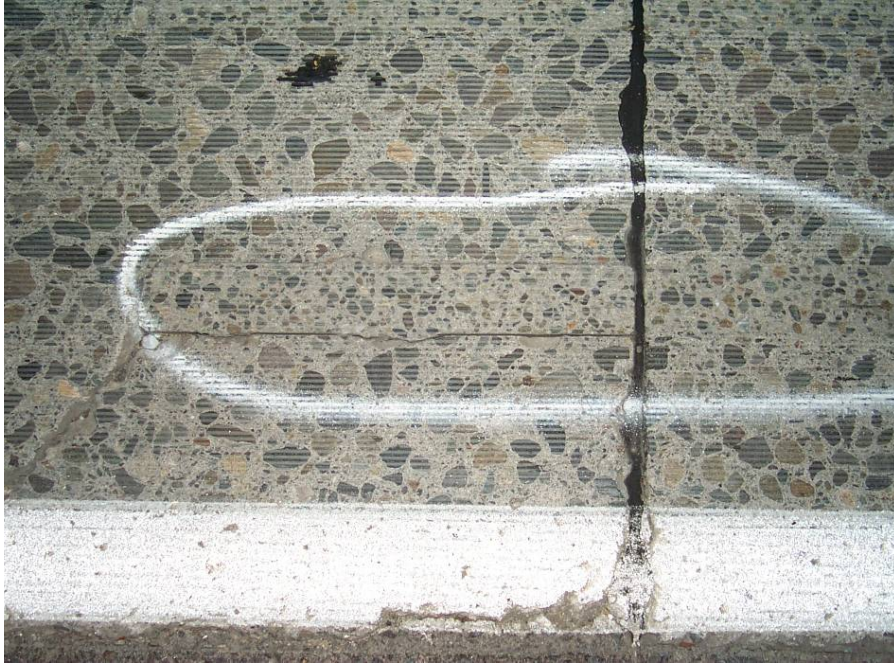
Figure 207 Debonding of patching material.

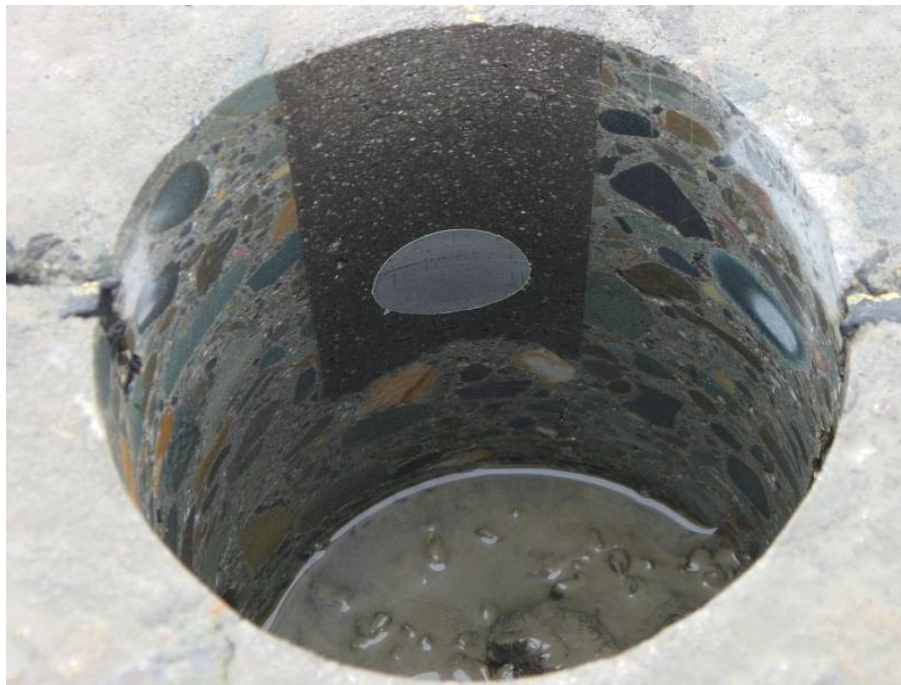
Figure 212 Good consolidation of patching material in dowel bar retrofit slot.

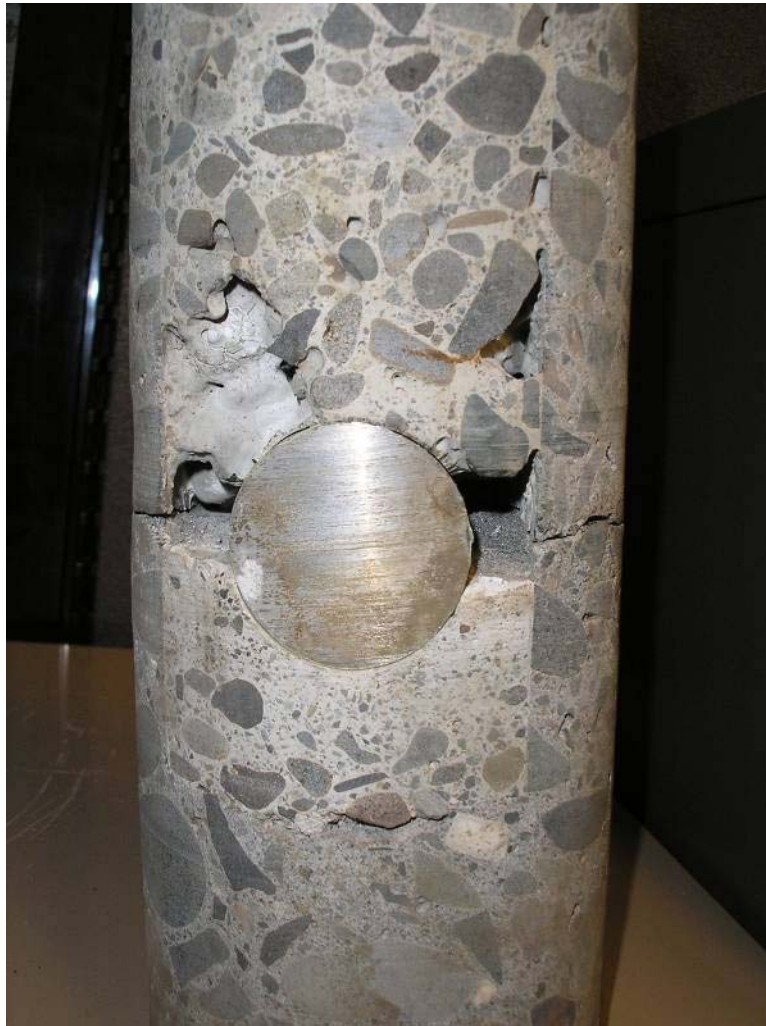
Figure 213 Poor consolidation of patching material around dowel bar.

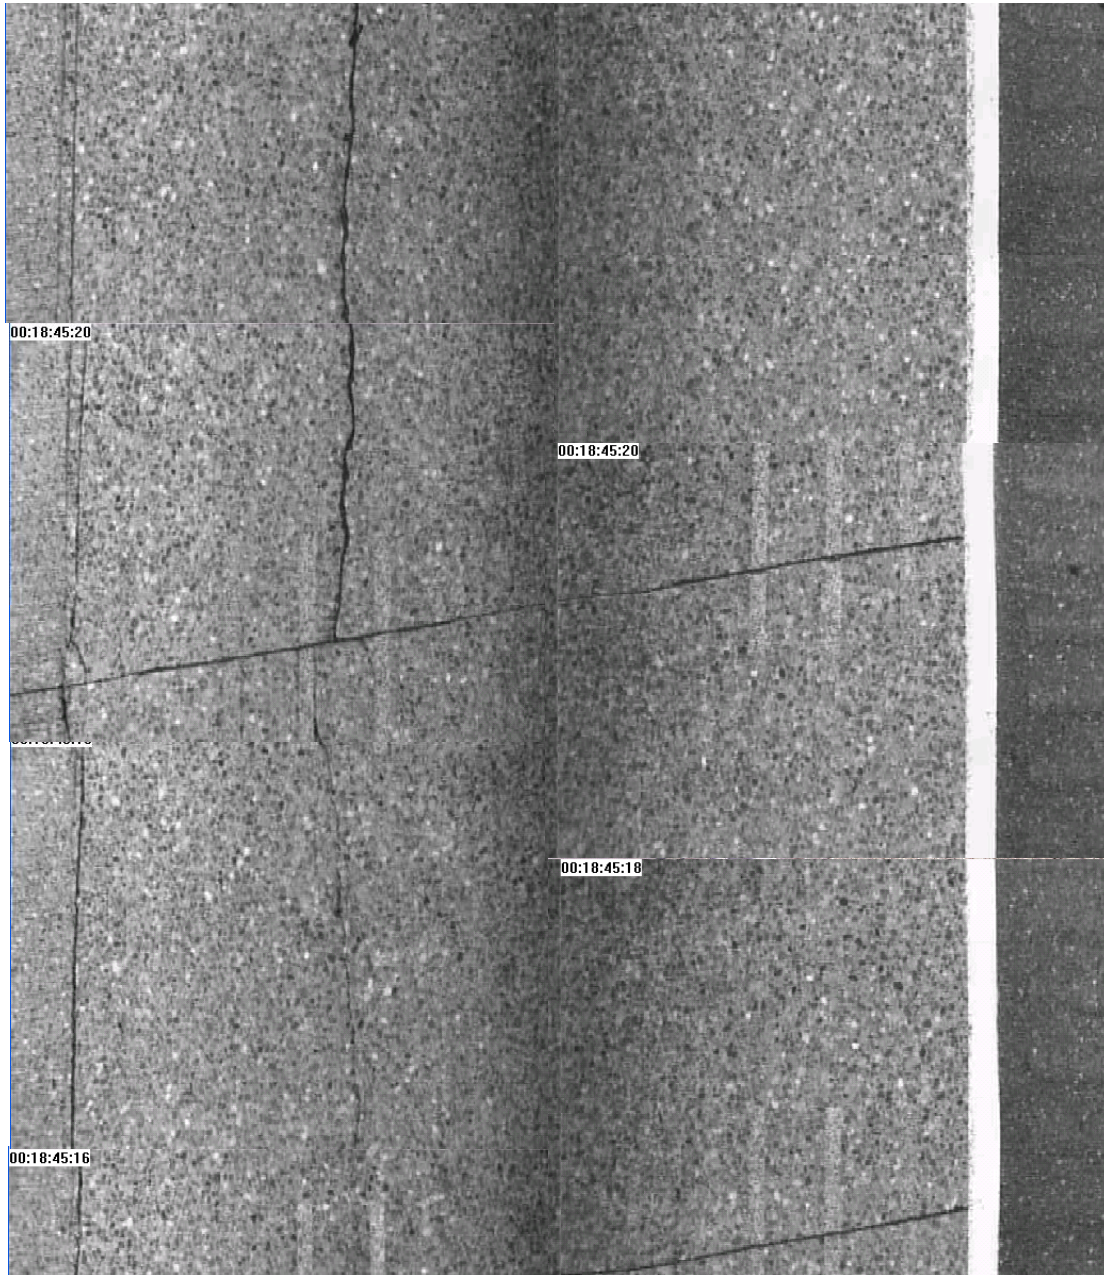
Figure 221 Propagation of existing longitudinal crack after dowel bar retrofit.

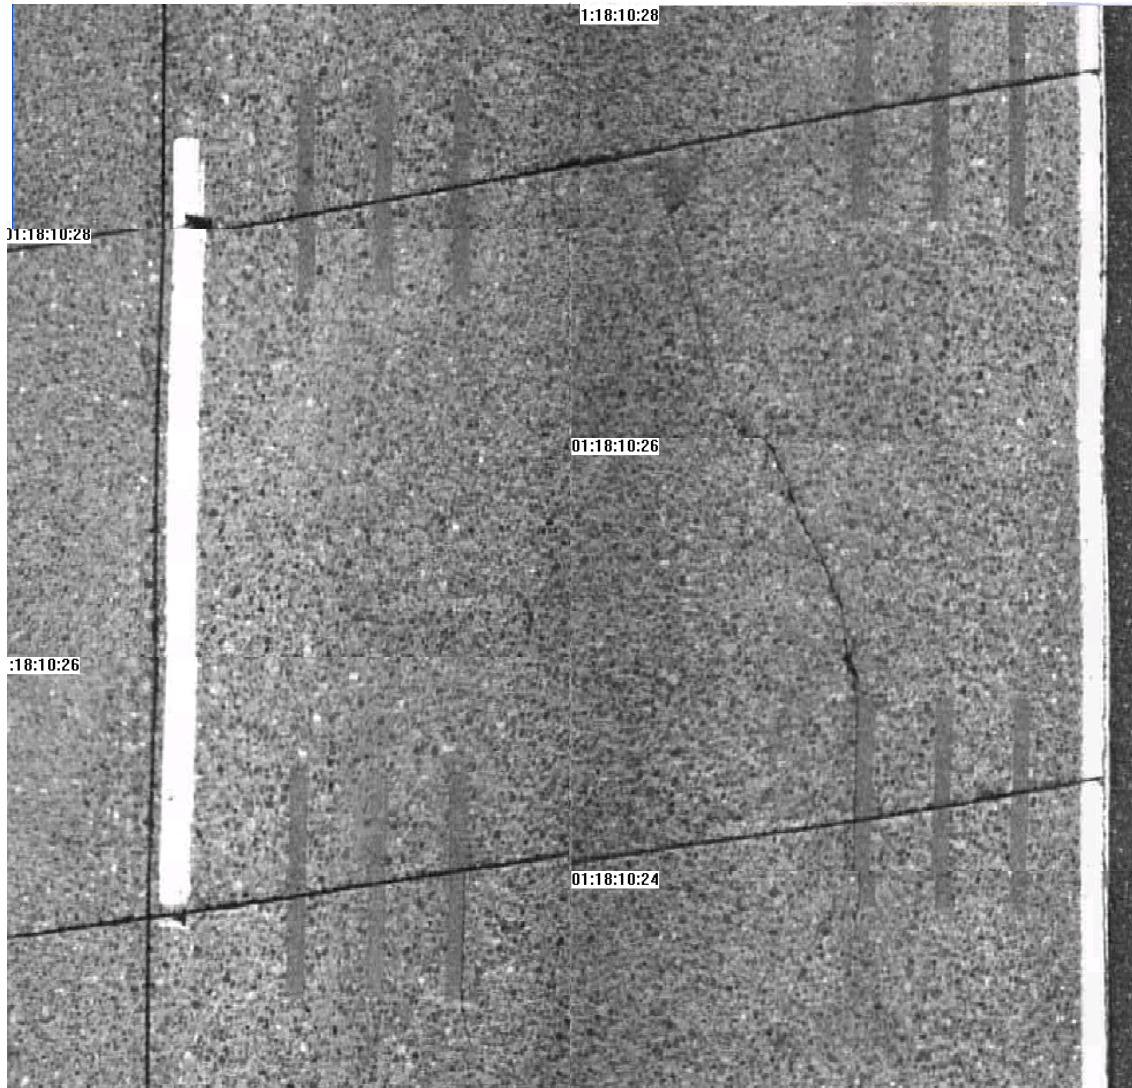
Figure 222 Longitudinal cracking after dowel bar retrofit.

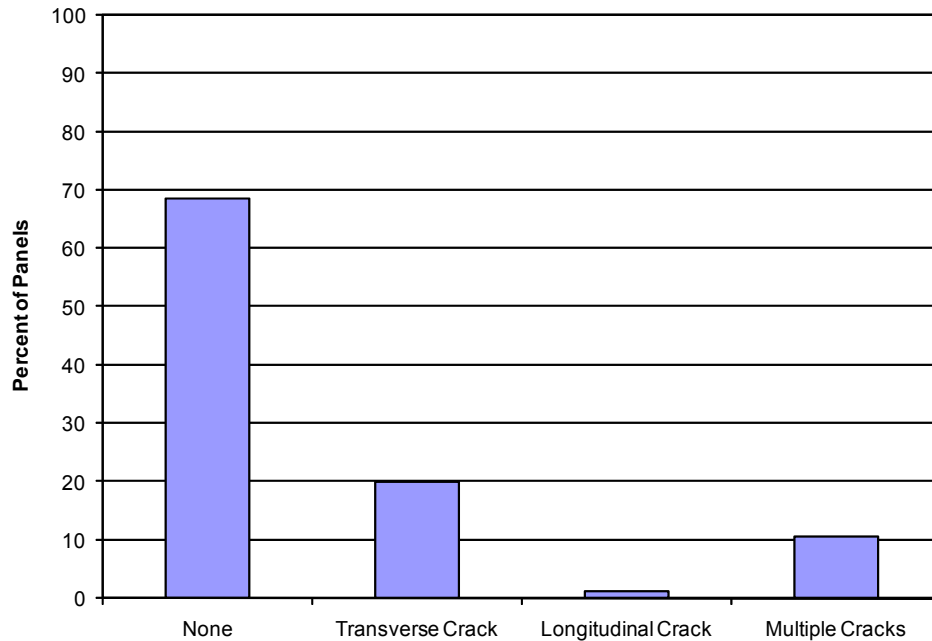
Figure 231 Cracking in panel replacements.

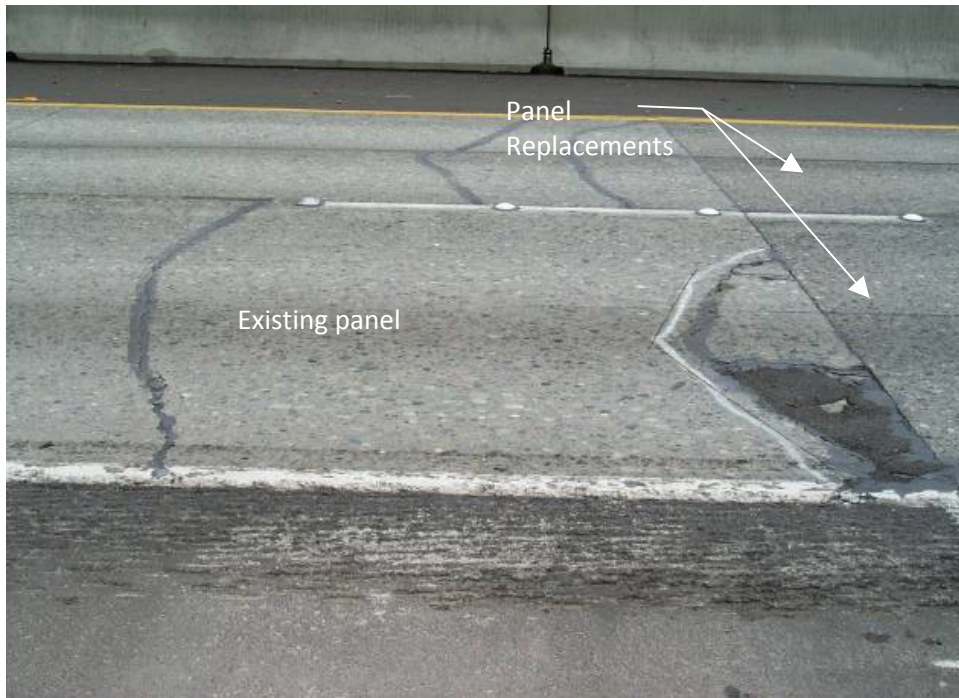
Figure 235 Typical failure of existing panels adjacent to panel replacements.
