# Field Analysis of Wood Guardrail Post Decay

WA-RD 890.1

WSDOT Research Report

Research Project T1462, Task 16

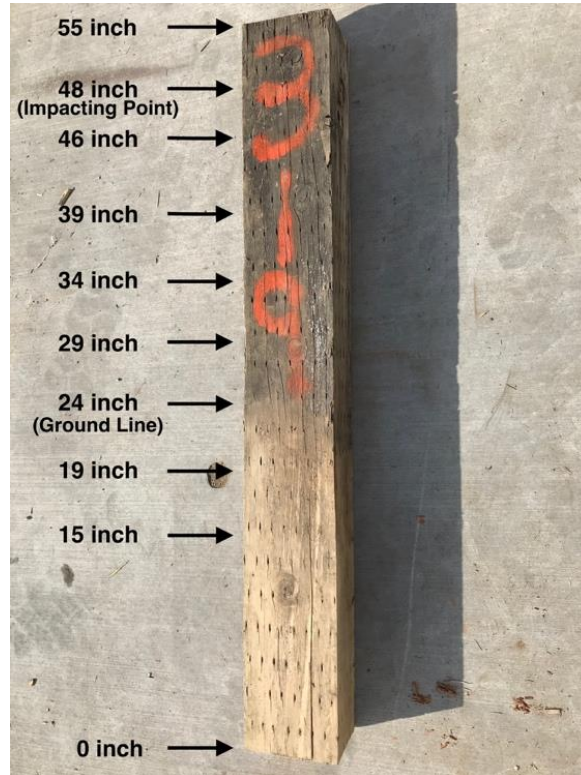
**Figure 7.** Specimen preparation and SWT testing locations (Post 319)
