CMH-17
COMPOSITE MATERIALS HANDBOOK

Inspection and Teardown of Aged In-Service Bonded Repairs

May 23, 2018

Waruna Seneviratne, John Tomblin, and Brandon Saathoff

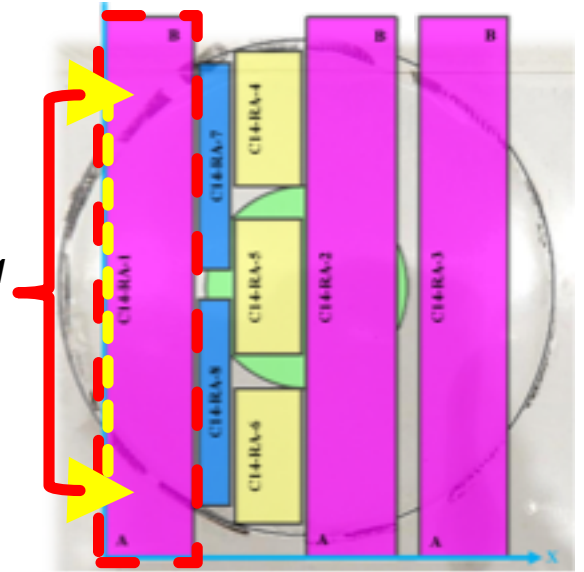
Specimen: C14-RA-1 (Side A)

Material of Concern

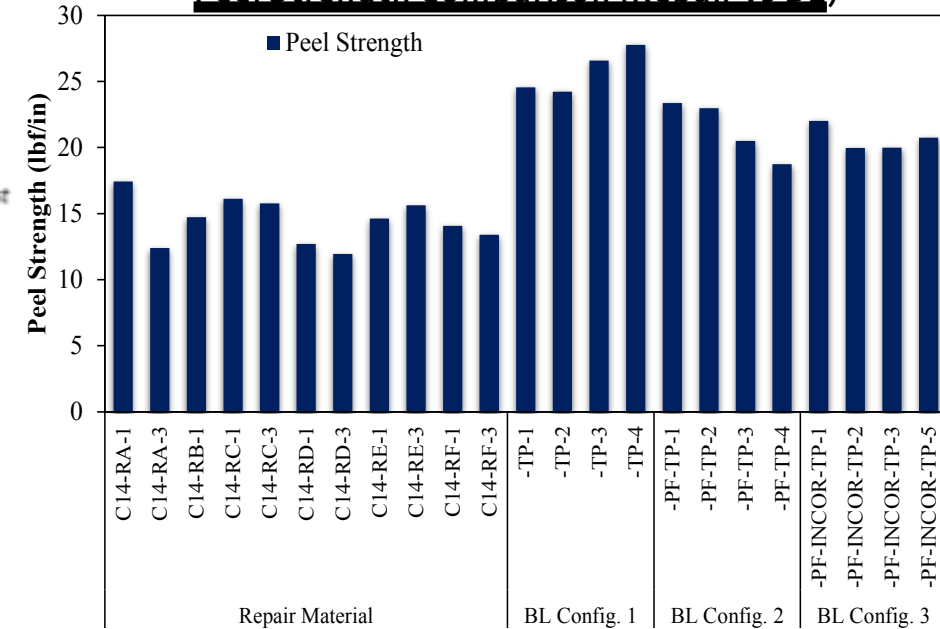
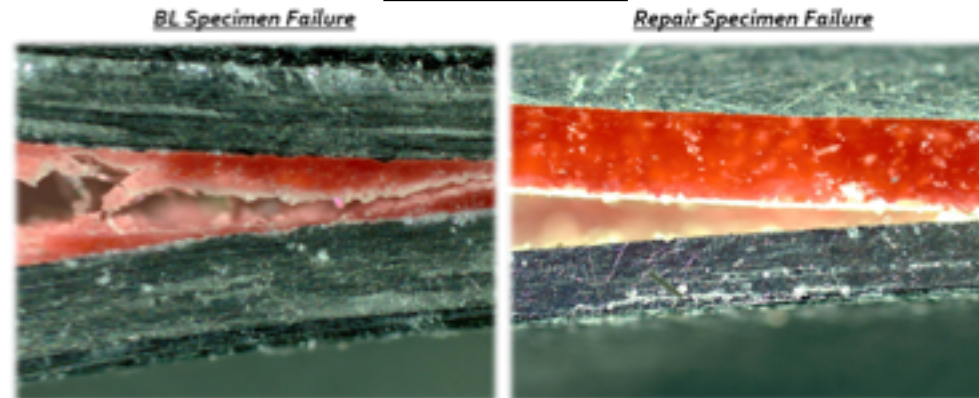
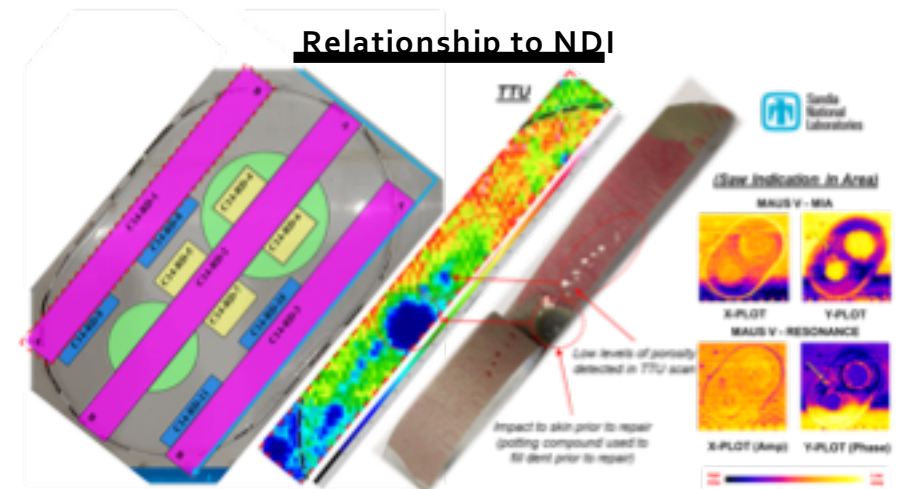
Peel Strength Comparison (Repair vs BL)

- T-Peel (ASTM D1876)
 - Repair Peel Strength: $\approx 64\%$ of BL panels
 - Repair failure along interfacial anomaly
 - BL specimens: Cohesive failures

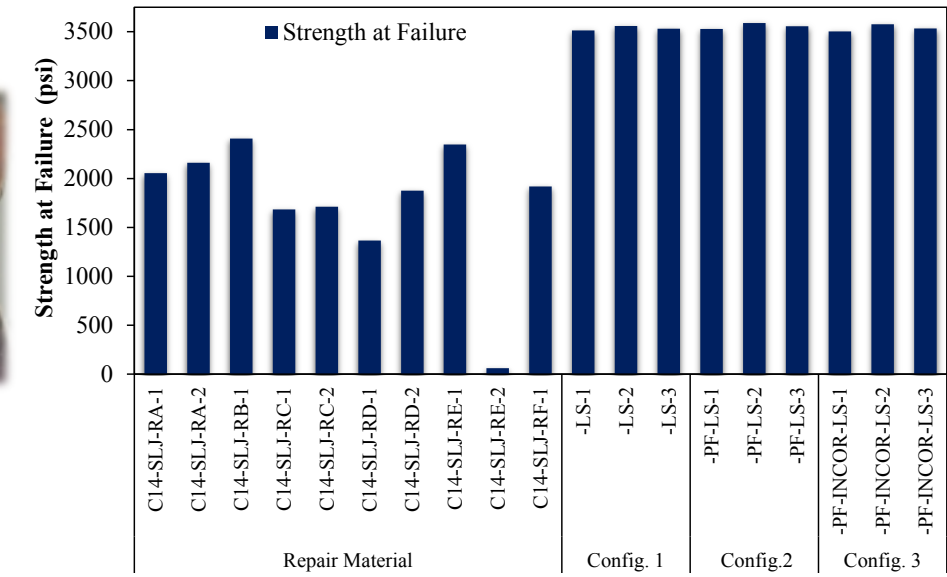
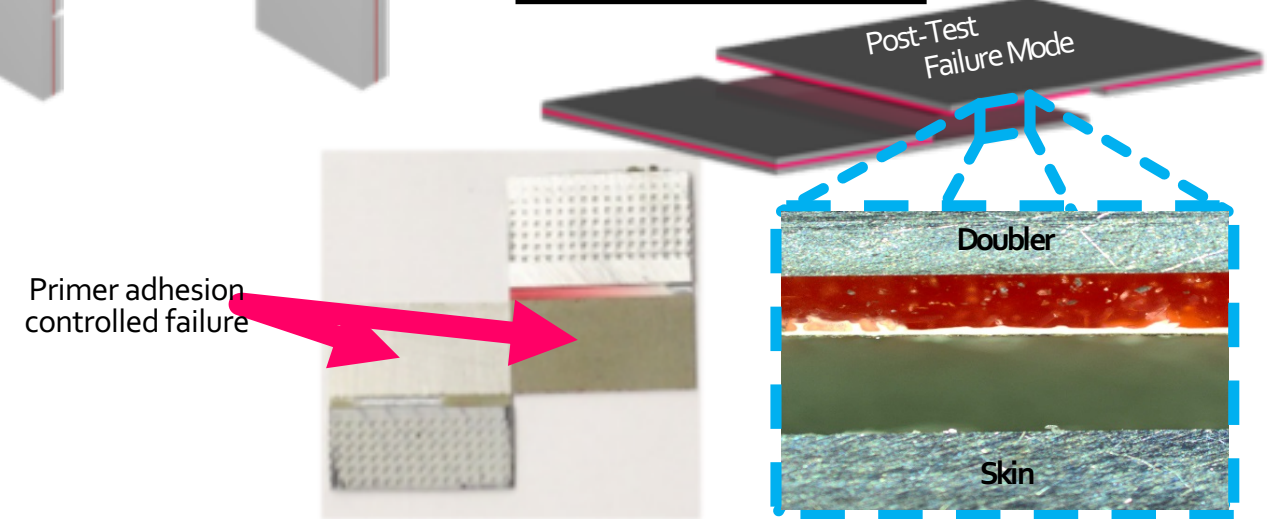
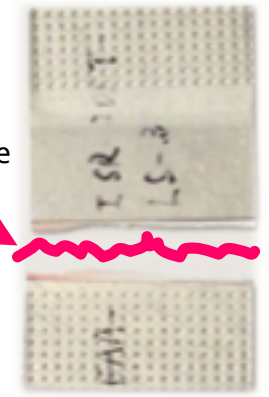
Shear Strength Comparison (Repair vs. BL)

- Lap-Shear Testing (ASTM D3165)
 - Repair Shear Strength at failure: $\approx 50\%$ of BL panels
 - BL specimen failure controlled by adherend tensile strength
 - Repair specimens: Adhesive failure (primer)

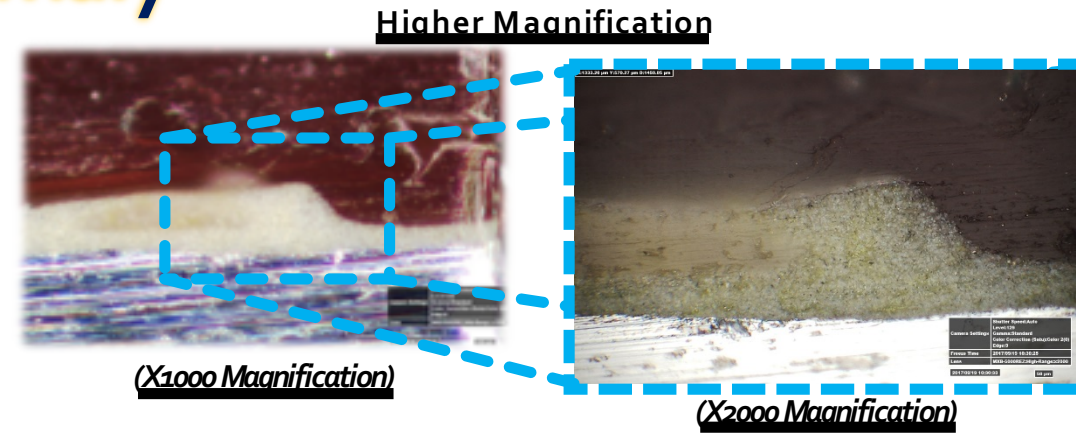
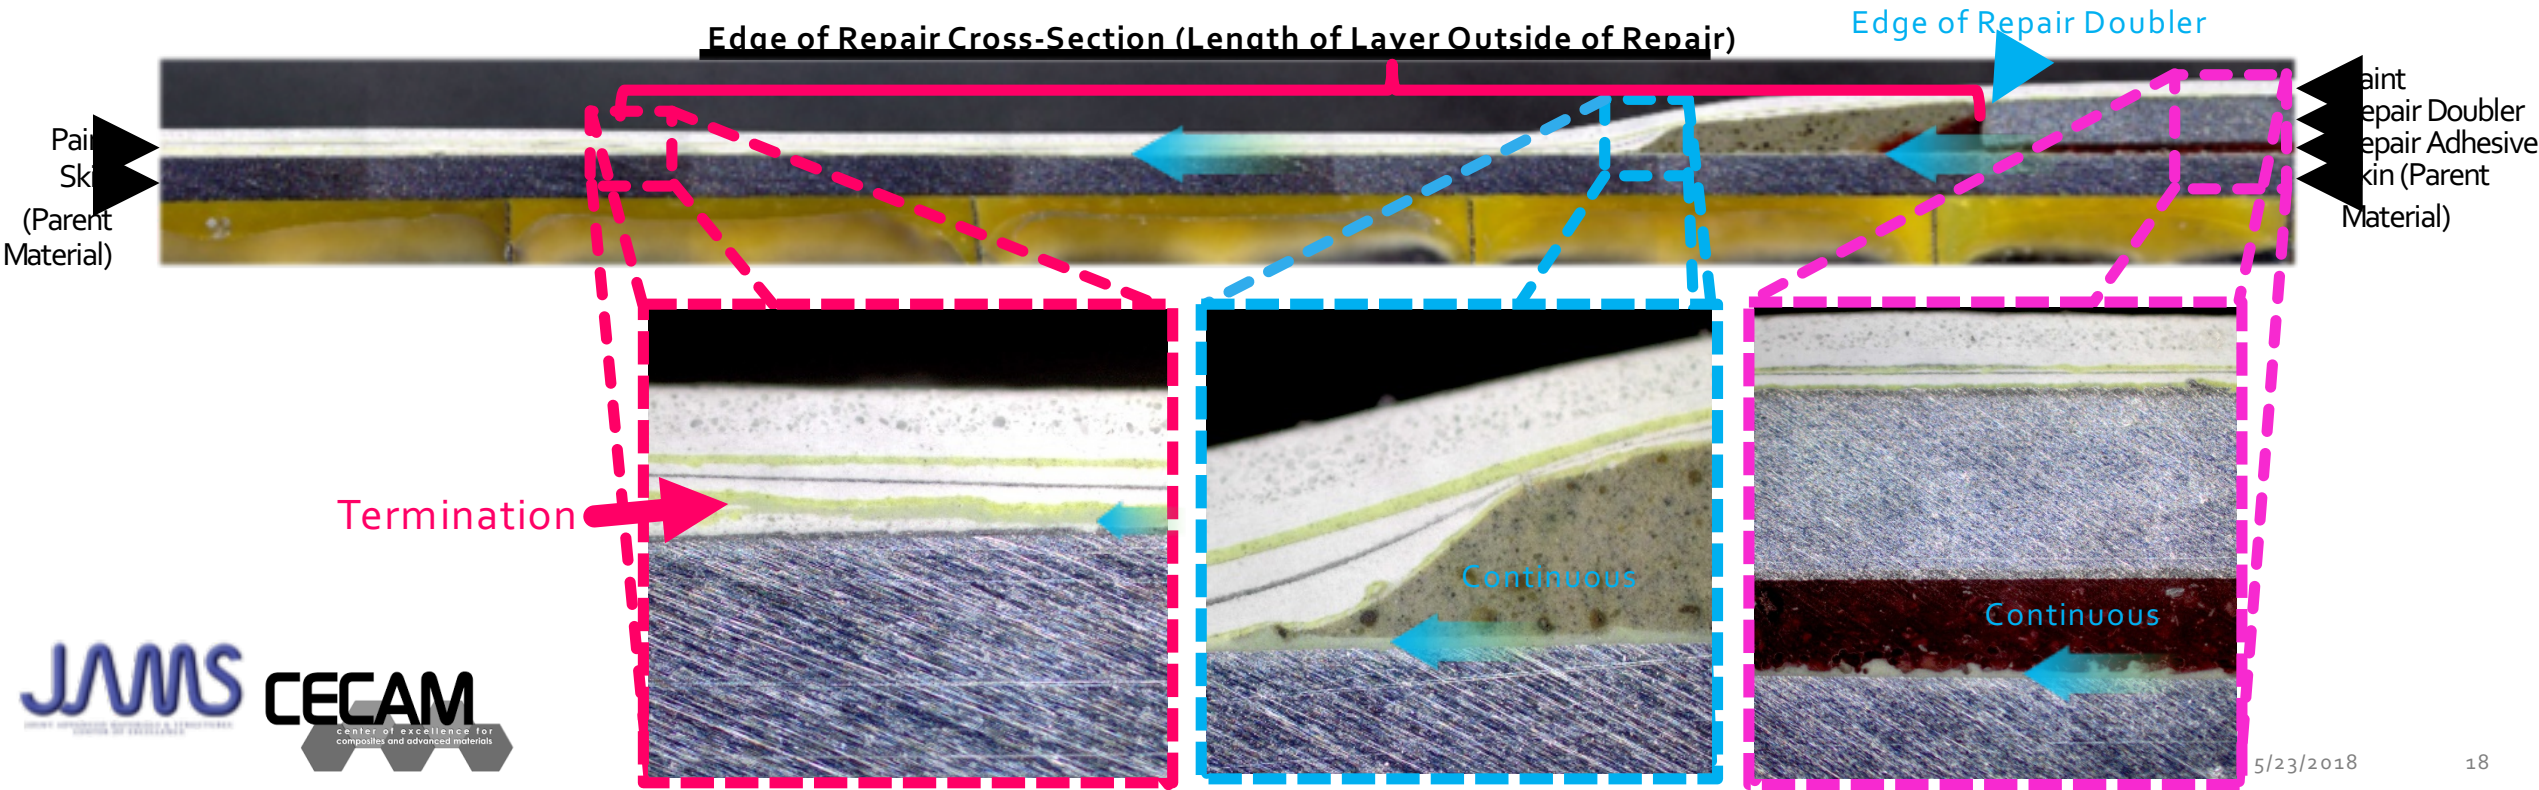
Interfacial Anomaly

- Component 13/14
 - Noticed in 8 out of 9 repairs
 - Repair on lower surface of C13 (likely different damage event – repaired separately)
 - Controlled performance of bond
 - EDS on surface of failed T-peel specimen
 - Chrome present
 - Layer terminates outside of repair region (≈0.5-inches outside repair doubler)
 - Induced from surface preparation for repair

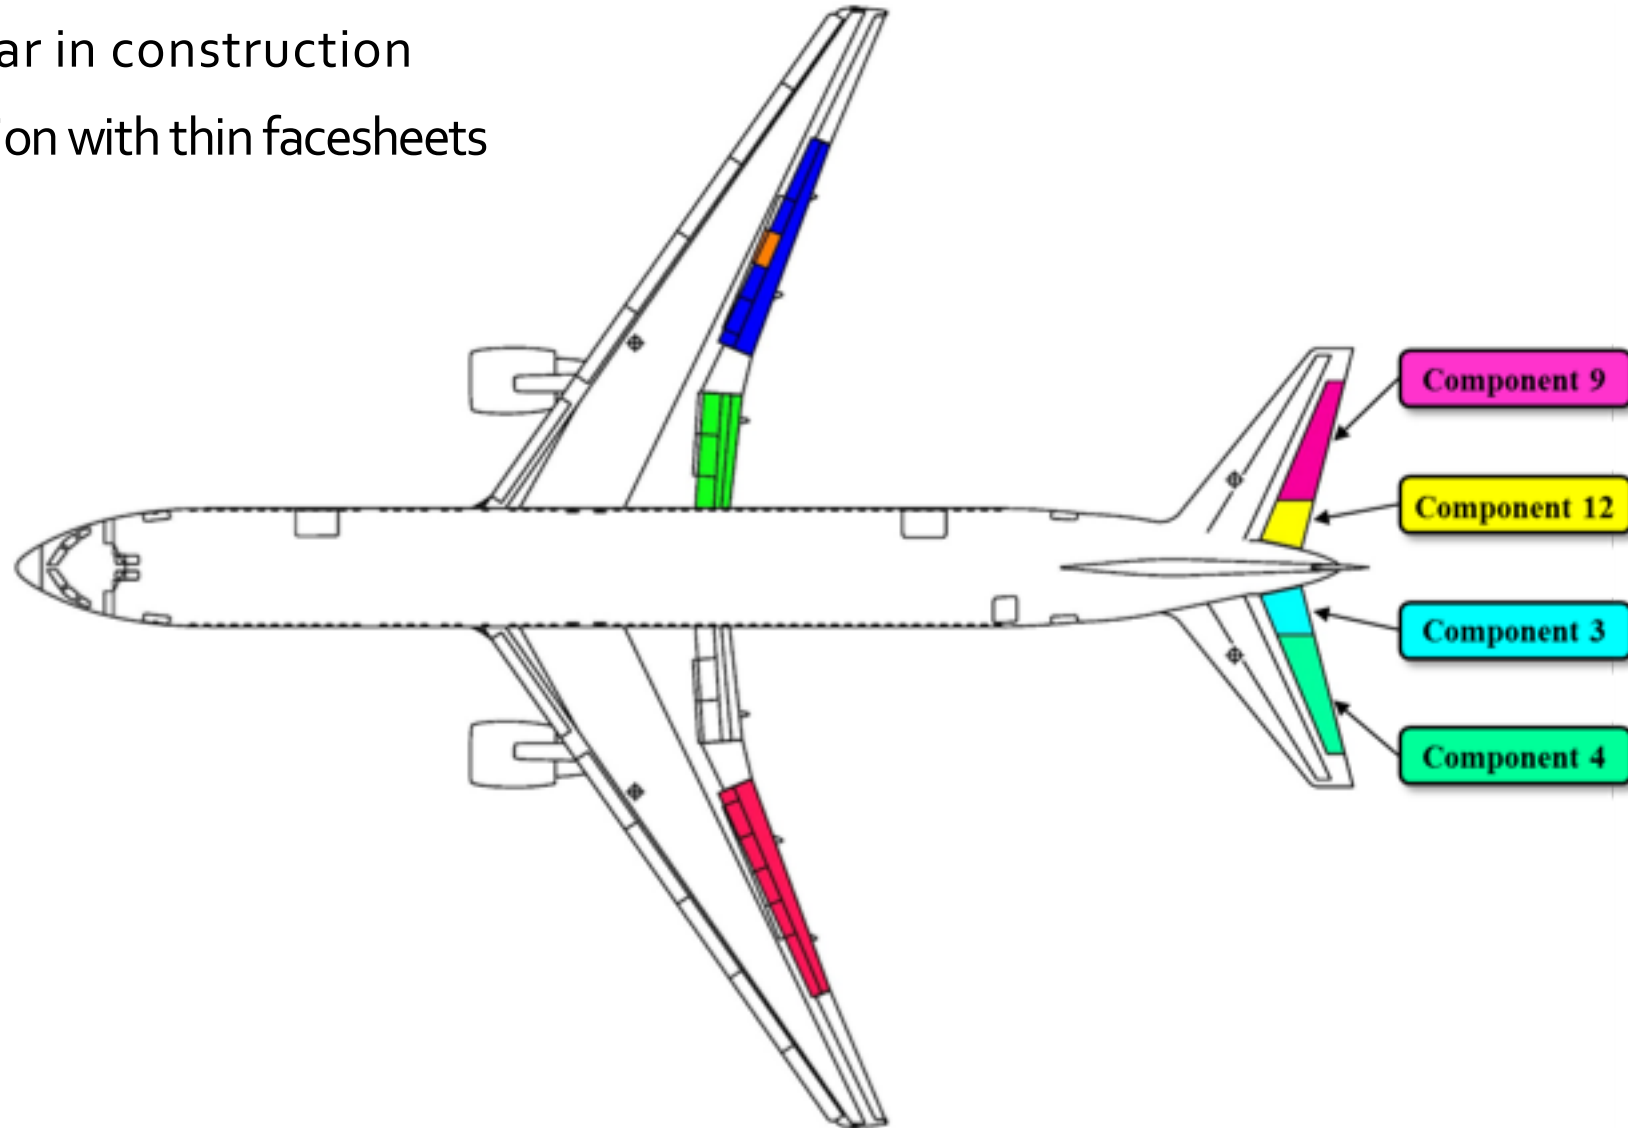
- Structural Level Inspection Findings
 - Visual
 - Repair extended away from surface (not fully flush)
 - Paint Cracking
 - Speckling pattern noticed in many repairs and surrounding structure (Component 4 & 9)
 - Known that honeycomb structure can exhibit long-term degradation due to thermodynamic effects of trapped moisture in the honeycomb cells
 - Note that this can be evaluated away from the repair as it is seen in parent structure

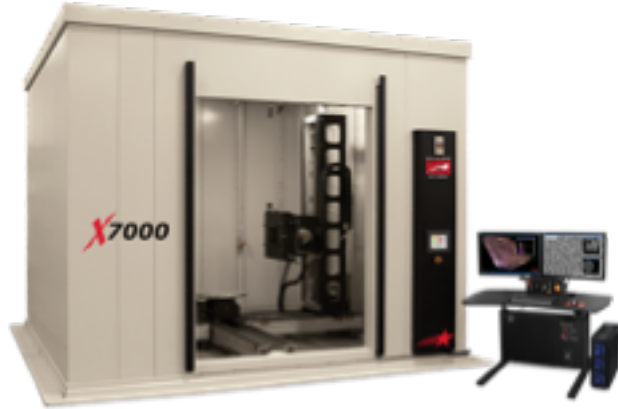
- Repair gb
 - X-ray Computed Tomography

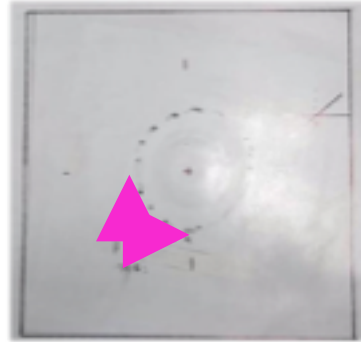
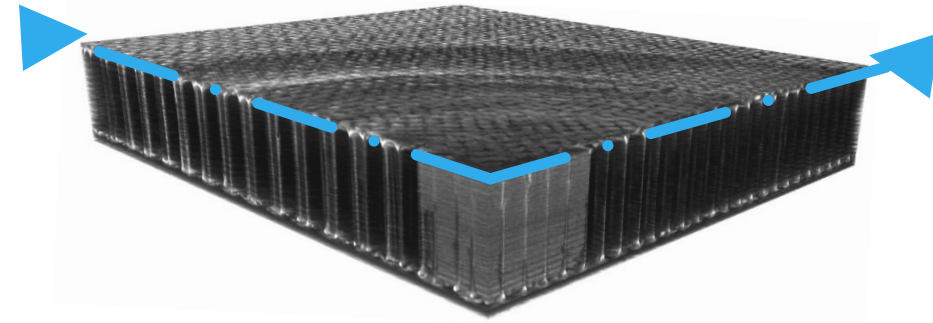
- Repair 3e
 - X-ray Computed Tomography
 - No indication of speckling
