RESEARCH REPORT
Agreement T4118, Task 02
Pavement Deterioration

**ASSESSMENT OF THE I-5
PORTLAND CEMENT CONCRETE PAVEMENTS
IN KING COUNTY**

December 2007

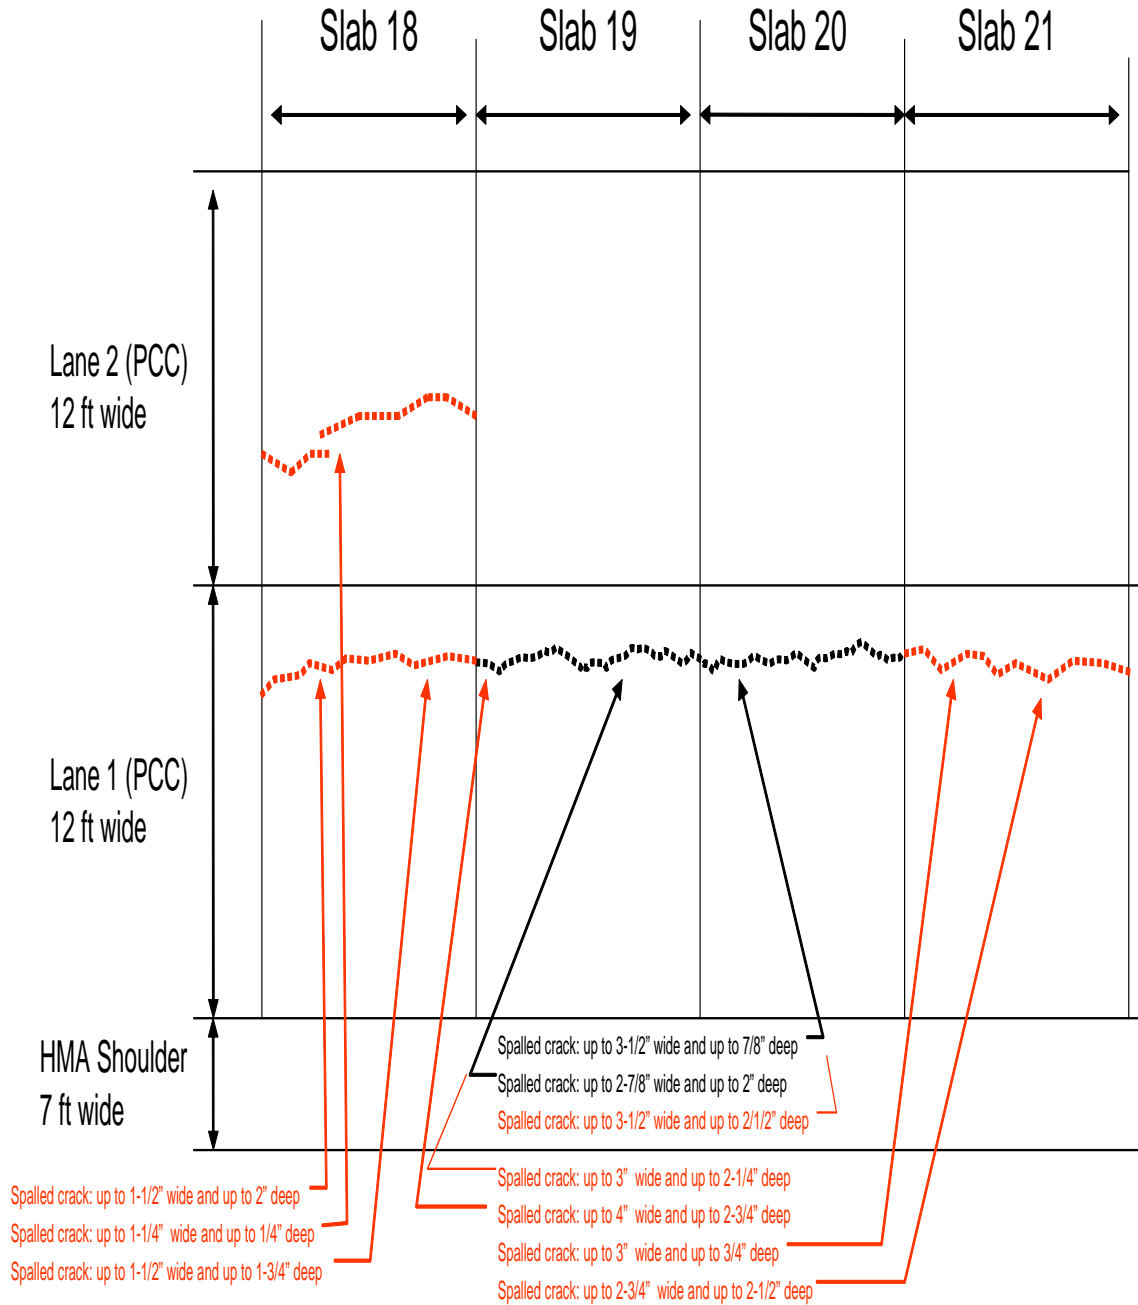
I-5, MP 175+ Northbound

Crack Survey

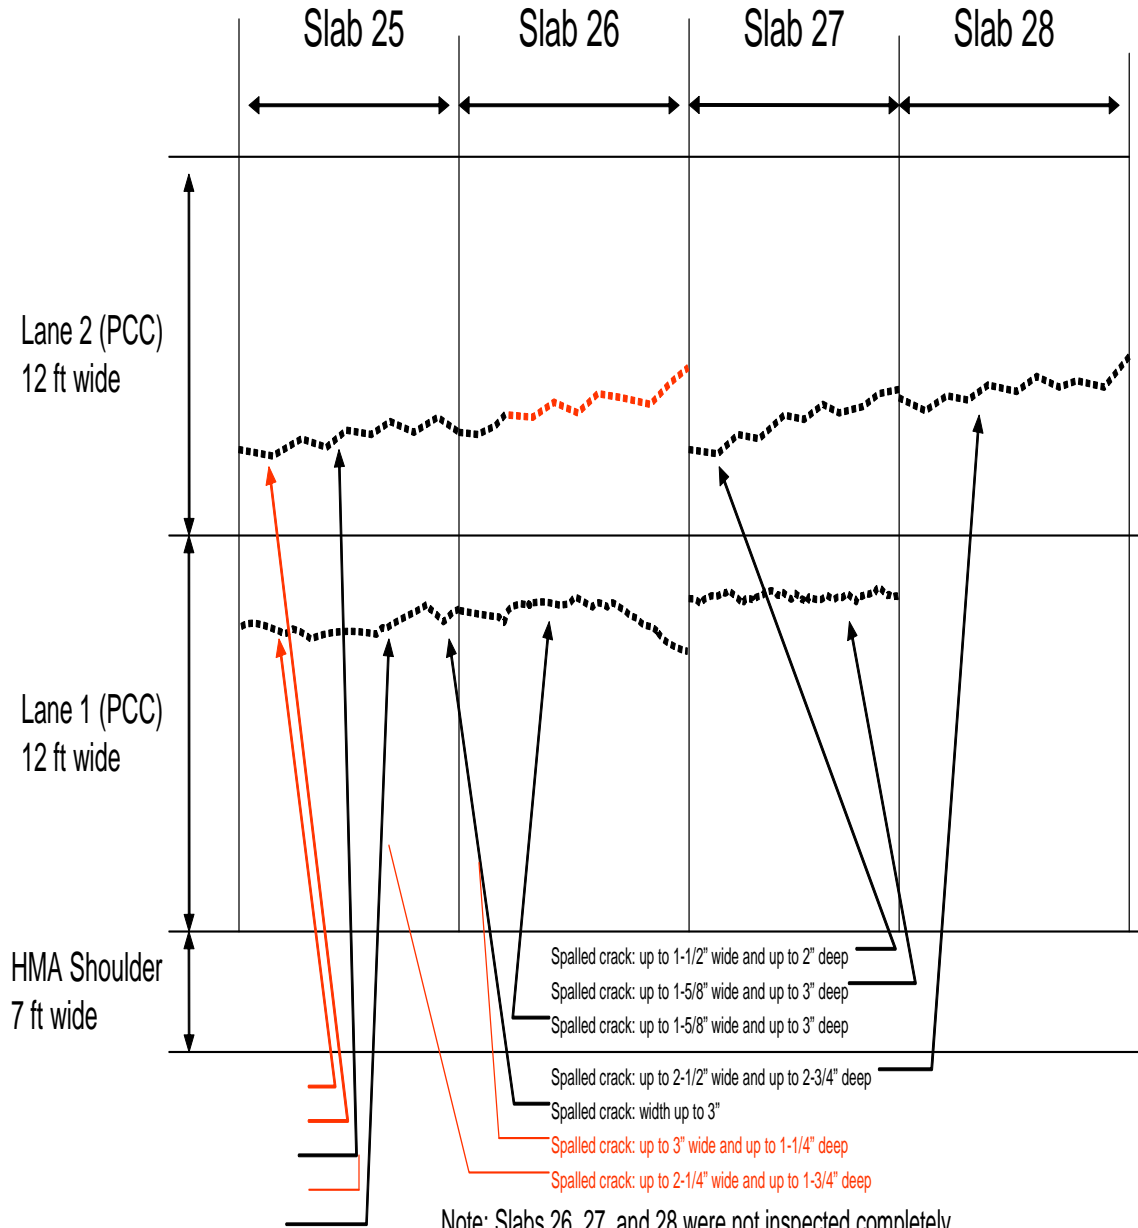
I-5, MP 175+ Northbound

Crack Survey
