**Assessment of the I-5
Portland Cement Concrete Pavements
in King County**

Executive Summary

December 2007

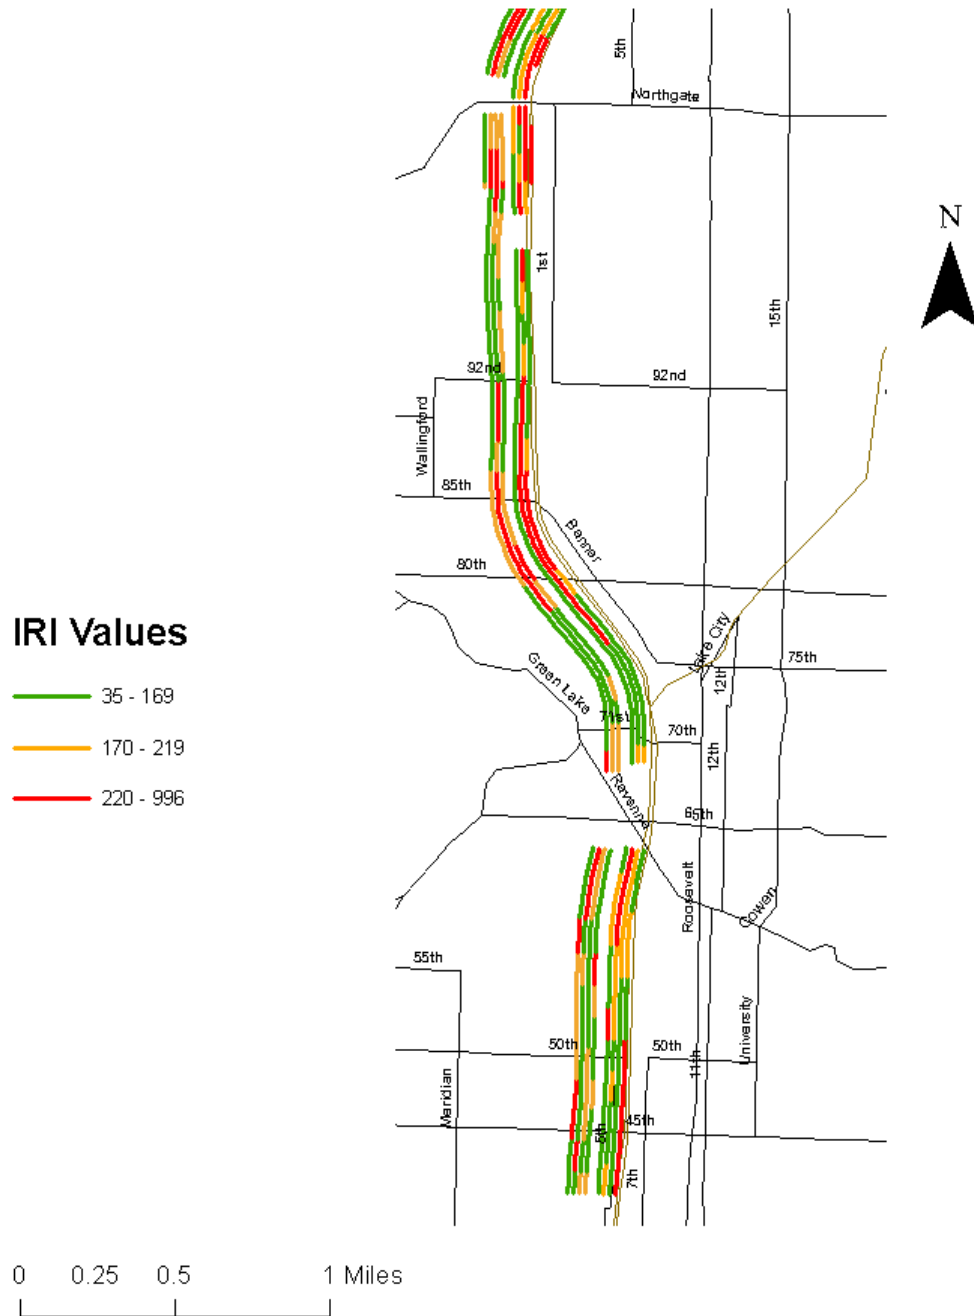
Figure 1. IRI Values, Ship Canal Bridge to Northgate Way

- An International Roughness Index (IRI) of greater than 170 inches/mile is the upper threshold at which drivers perceive the roughness of the pavement as unacceptable (i.e., a higher IRI is worse). Much of the unrehabilitated I-5 PCCP in King County is near or above that threshold value.

Plan views were prepared that illustrate existing conditions. Figures 1 through 4 show IRI (roughness), transverse joint faulting, wheelpath wear depths, and slab cracking for a section of I-5 from the Ship Canal Bridge to Northgate Way. As expected, the conditions of the separate lanes are not uniform. The orange and red portions indicate conditions that are marginal to critical. The full report (WA-RD 682.1) contains similar illustrations but for all of I-5 within King County.

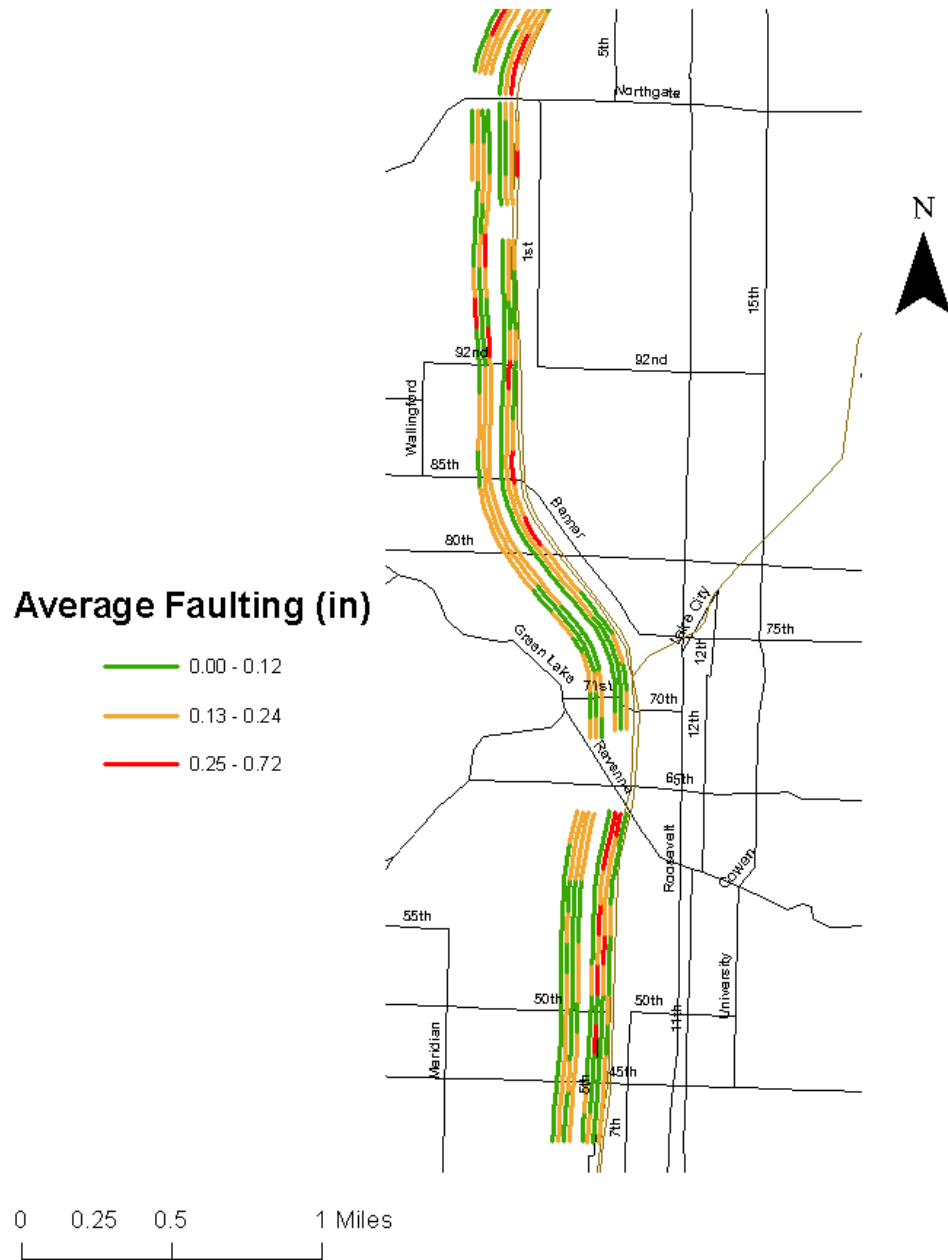
Figure 2. Average Faulting, Ship Canal Bridge to Northgate Way

- Faulting at transverse joints of greater than 0.125 inches is perceivable to motorists and faults of more than 0.25 inches are very uncomfortable. Faulting effects are more noticeable to truck operators than to occupants of passenger cars. Many of the non-rehabilitated portions of I-5 are approaching or exceed the 0.125-inch level.

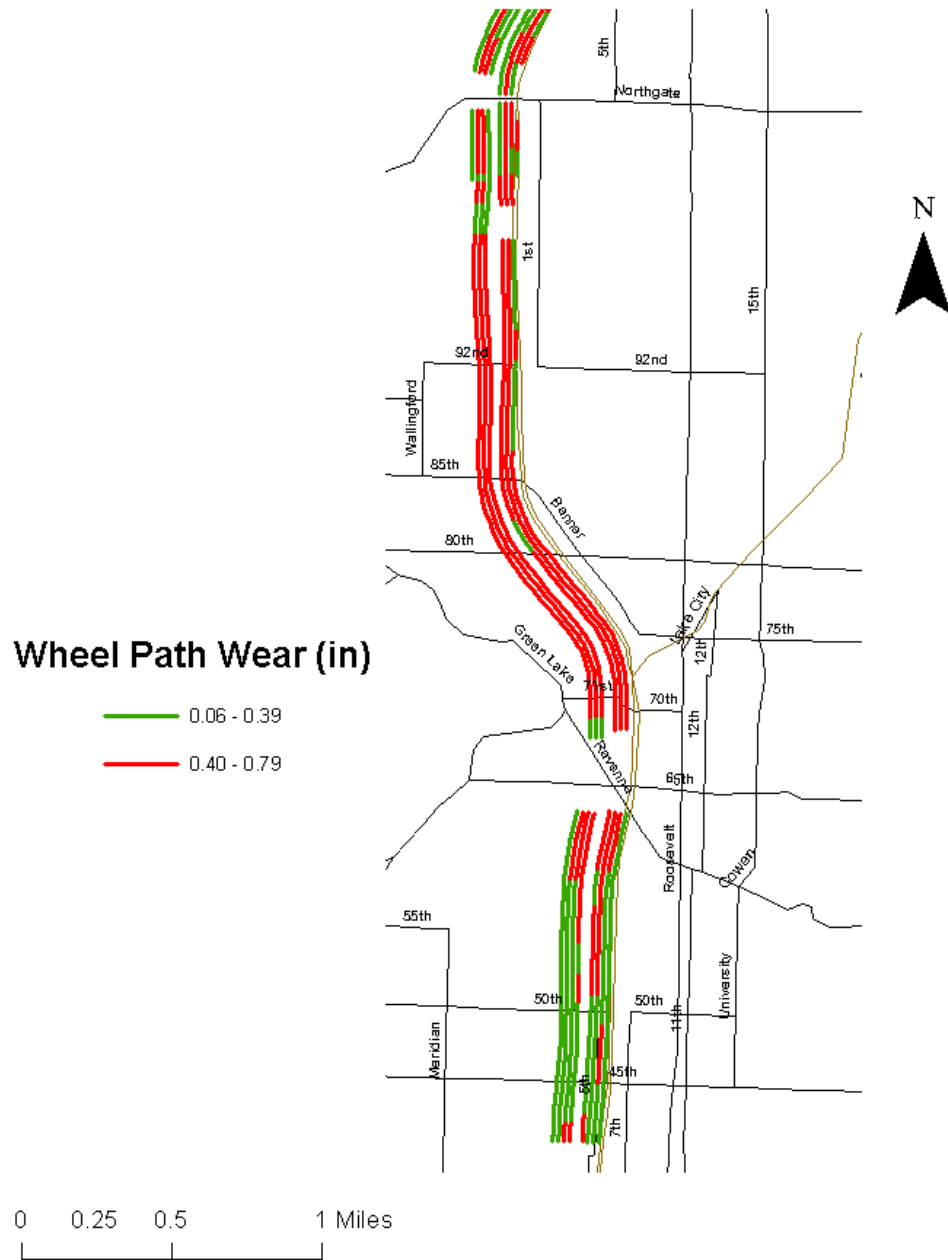
Figure 3. Wheel Path Wear, Ship Canal Bridge to Northgate Way

- Wheelpath wear depths of about 0.4 inches and greater create the risk of hydroplaning. The non-rehabilitated portions of I-5 average 0.34 inches, with about 40 percent greater than 0.4 inches. This wear is due to studded tires. The surface friction of the non-rehabilitated portions of I-5 is at low to modest levels.

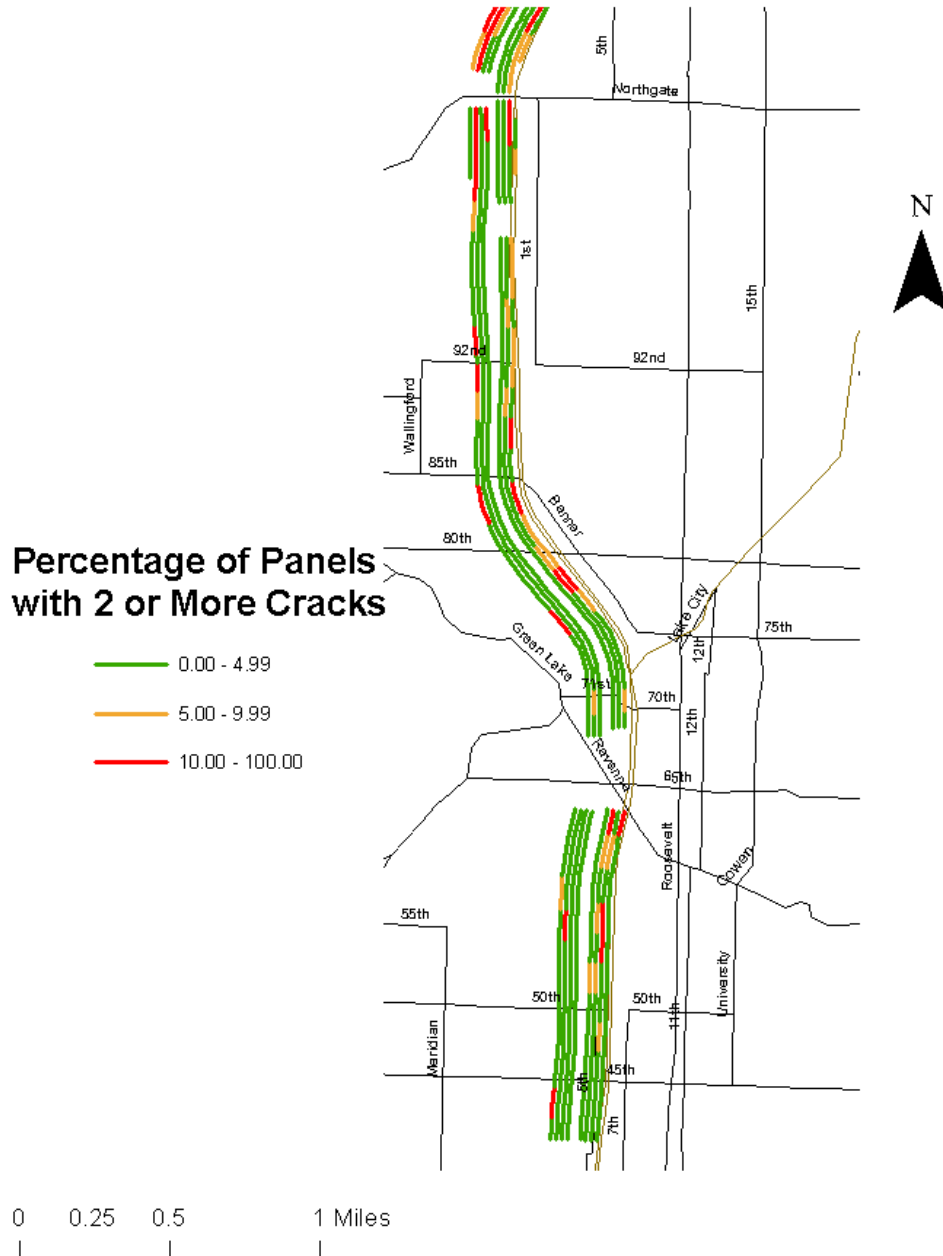
Figure 4. Percentage of Panels with Two or More Cracks, Ship Canal Bridge to Northgate Way

- PCC panels (typically 15 ft. long and 12 ft. wide) that exhibit cracking are precursors for major structural failure. When 10 percent of the PCC panels are cracked, WSDOT typically considers PCCP replacement or major rehabilitation. Much of I-5 currently exceeds that level.

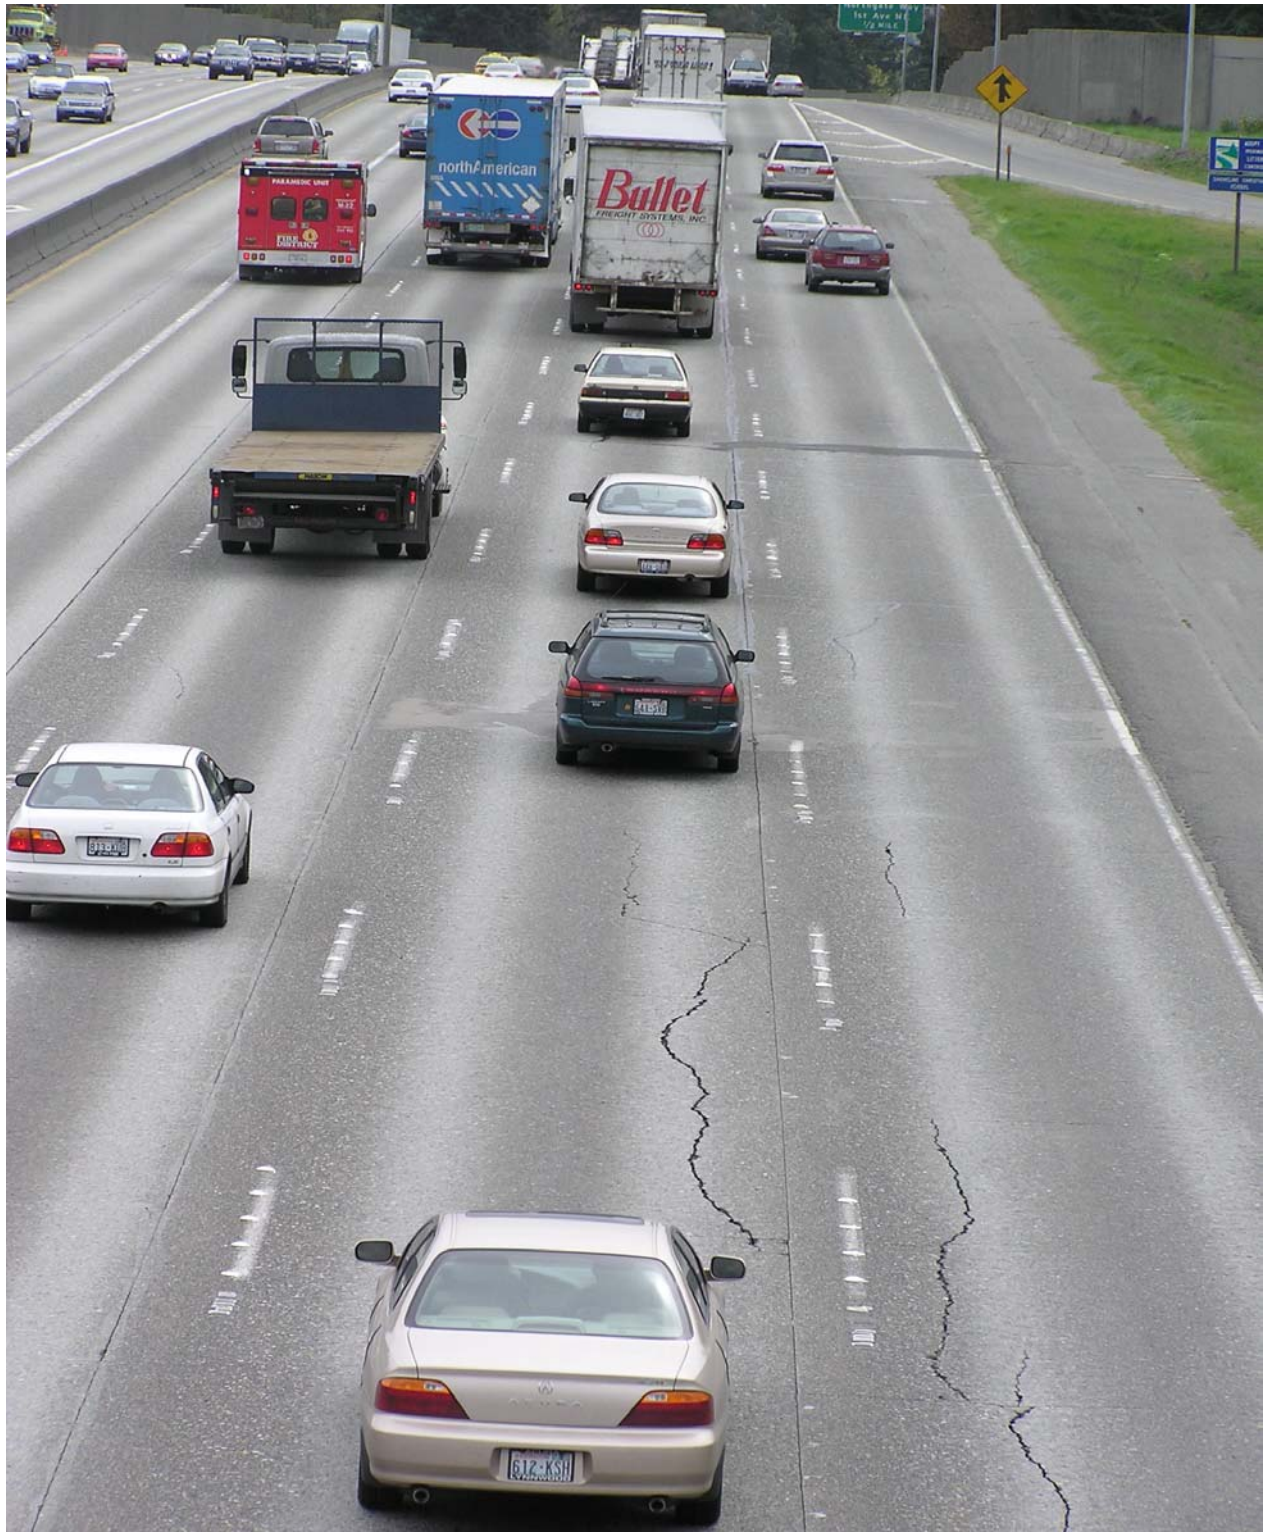
Figure 6. I-5 at NE 130th in Seattle—view is to the north.

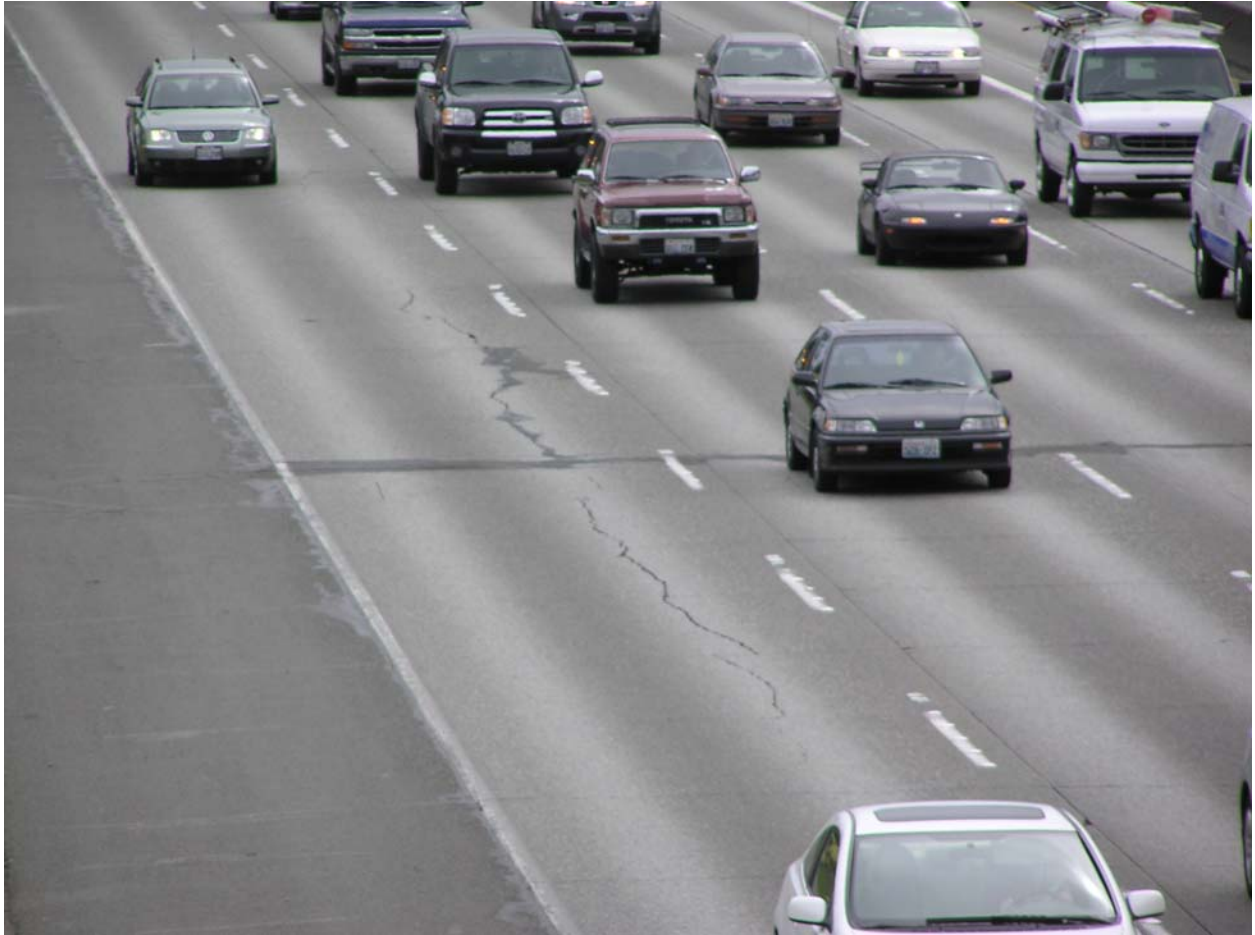
Figure 7. I-5 at NE 130th in Seattle—view is to south.

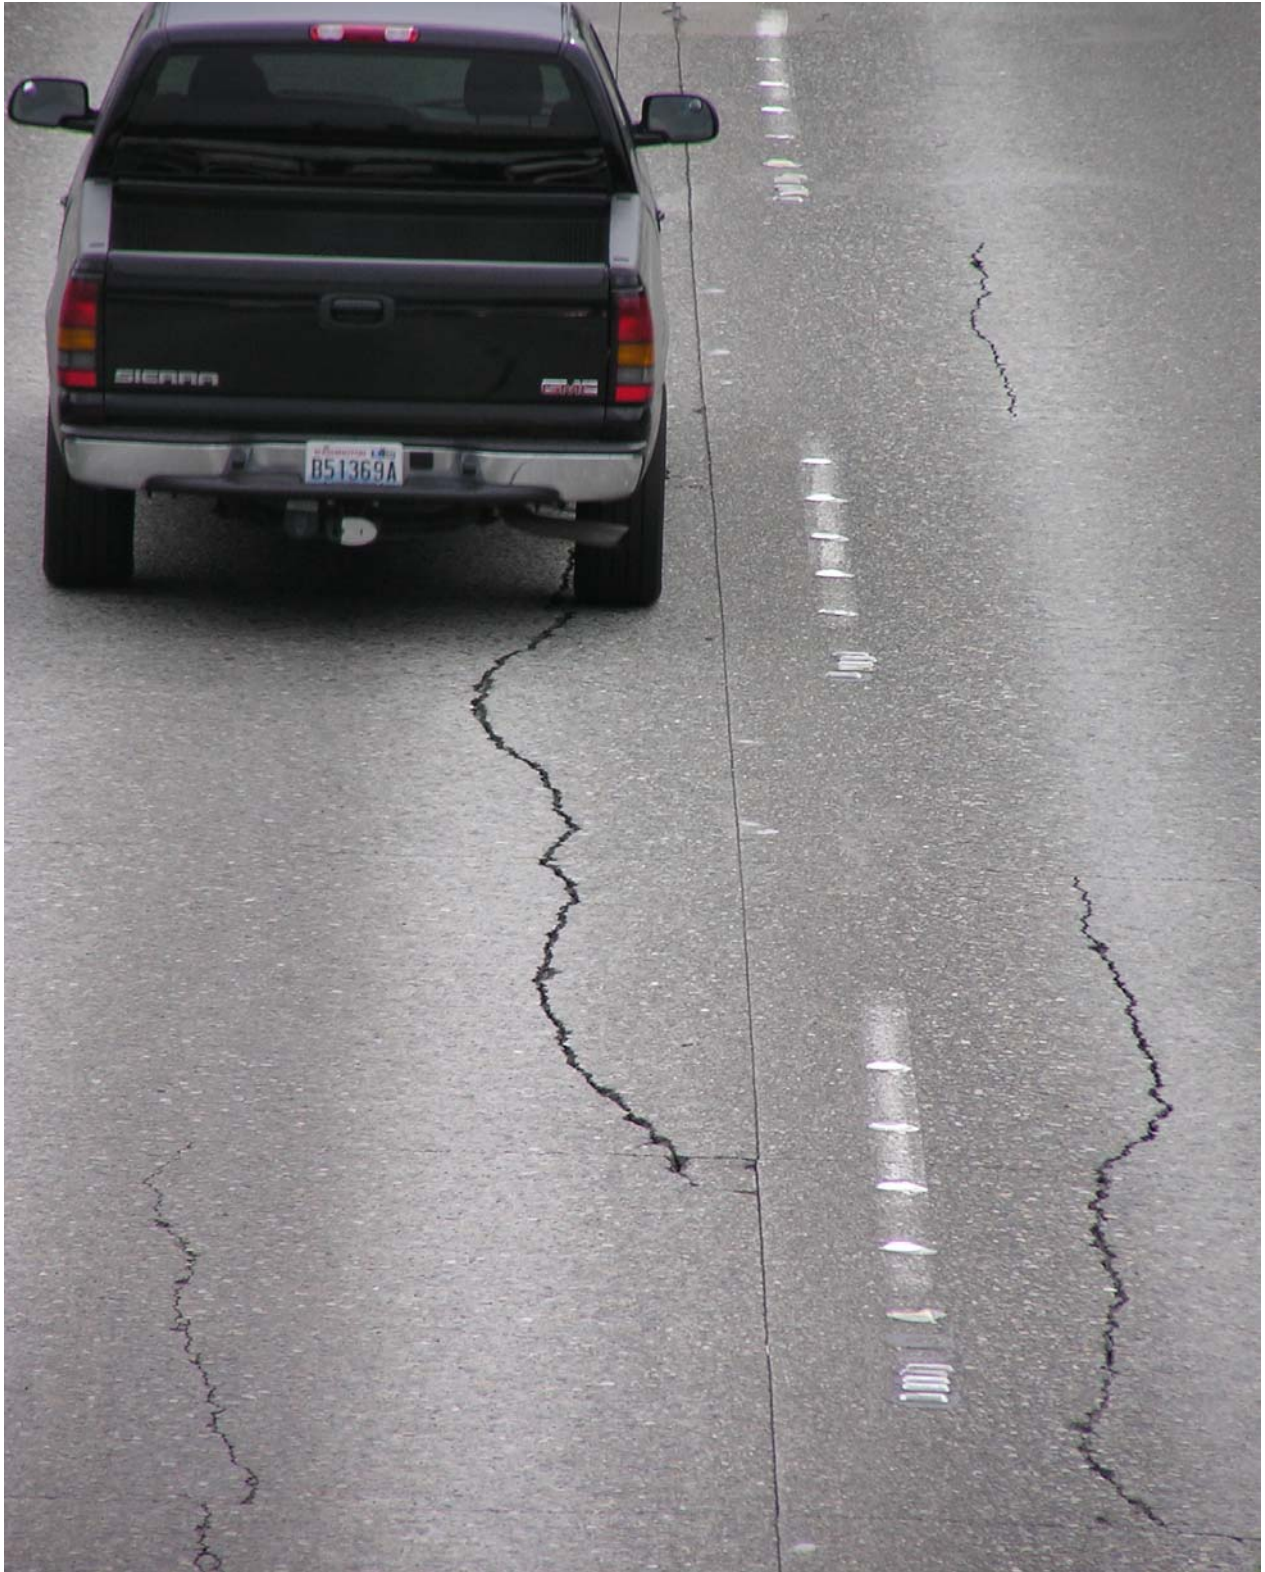
Figure 8. I-5 at NE 130th in Seattle—view is to the north.
