Helicopter Logging in Alaska – Surveillance and Prevention of Crashes

Jan C. Manwaring, and MPH; George A. Conway, M.D., M.P.H.

The International Mountain Logging and 11th Pacific Northwest Skyline Symposium 2001

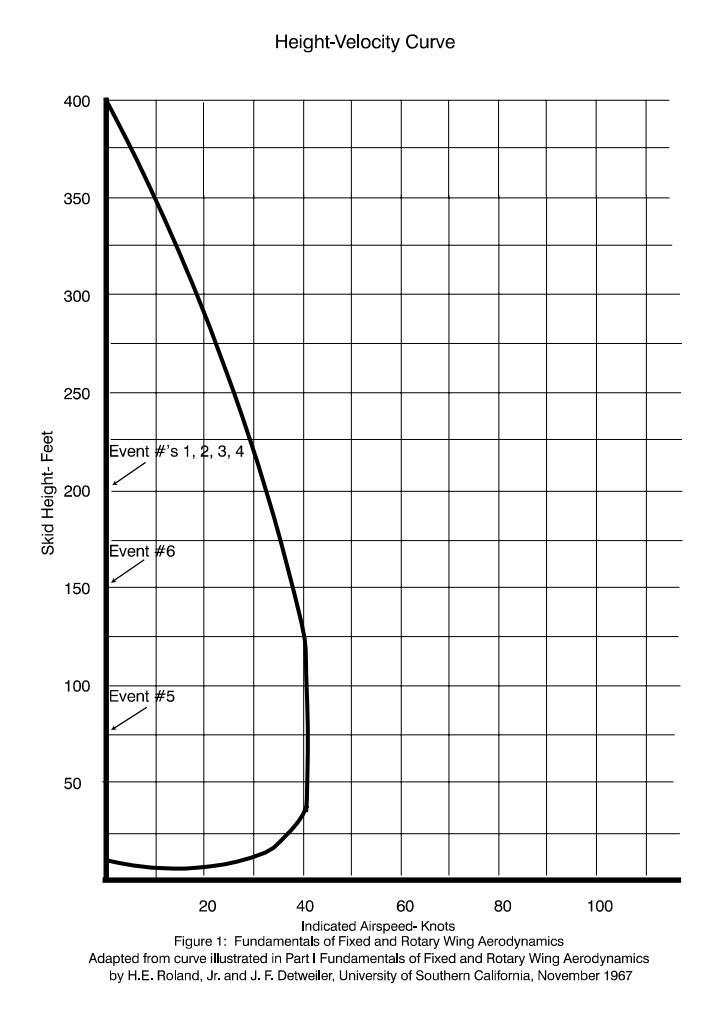
the rate of descent. However, successful autorotation depends on helicopter airspeed and altitude when the maneuver is attempted (see Figure 1, Height-Velocity Curve [often referred to as the "Dead Man's Curve"] for Autorotation).¹³ Most helicopter logging operations are conducted at an altitude of less than 500 feet while at a hover or very slow airspeed, which is dangerously within the height-velocity curve for single-engine helicopters, as illustrated. This chart also displays the location of the six previously mentioned crashes, all dangerously inside this curve.
