Impact Damage Formation on Composite Aircraft Structures

Hyonny Kim, Gabriela DeFrancisci, Zhi Ming Chen, Jennifer Rhymer, and
Jeff Tippmann

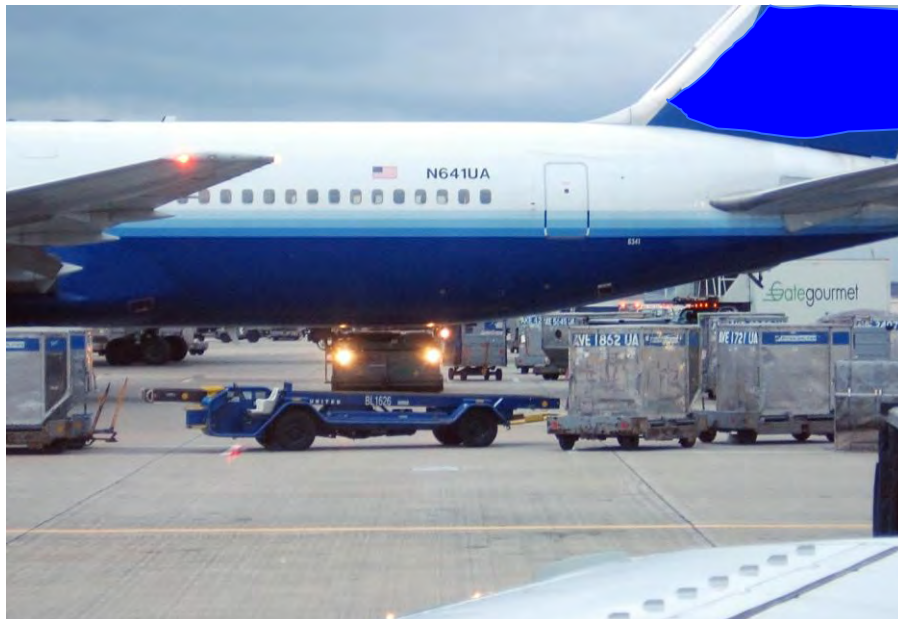
Figure 1. Maintenance/Service Threat Sources: Ground Vehicles, Luggage Carts, Cargo Containers, etc.

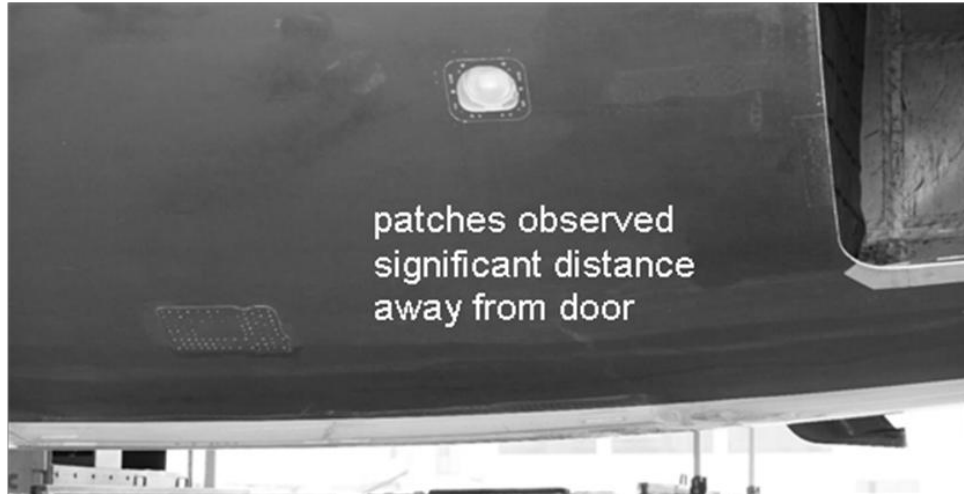
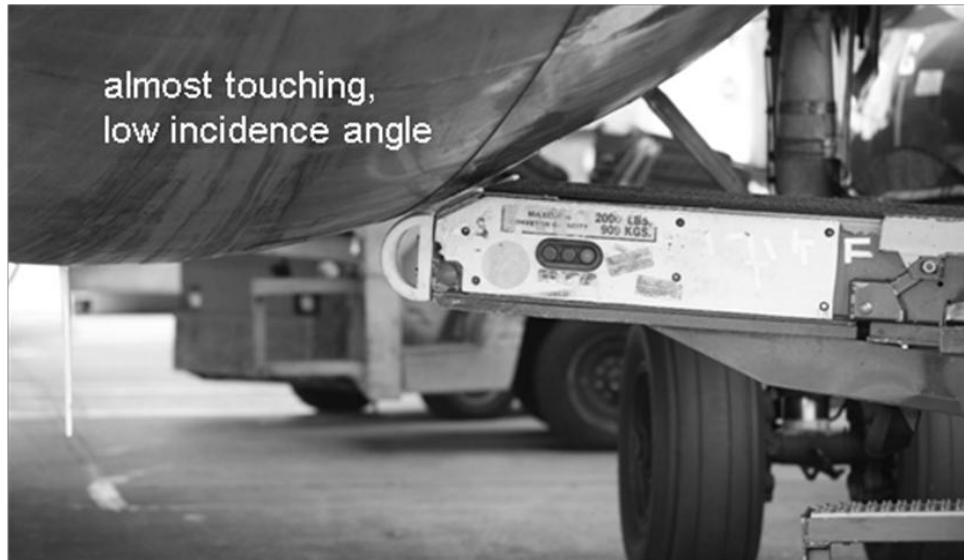
Figure 2. Examples of Damage Occurring in Acreage of Aircraft (i.e., Away from Doors) and Interaction Between Belt-Loader and Fuselage

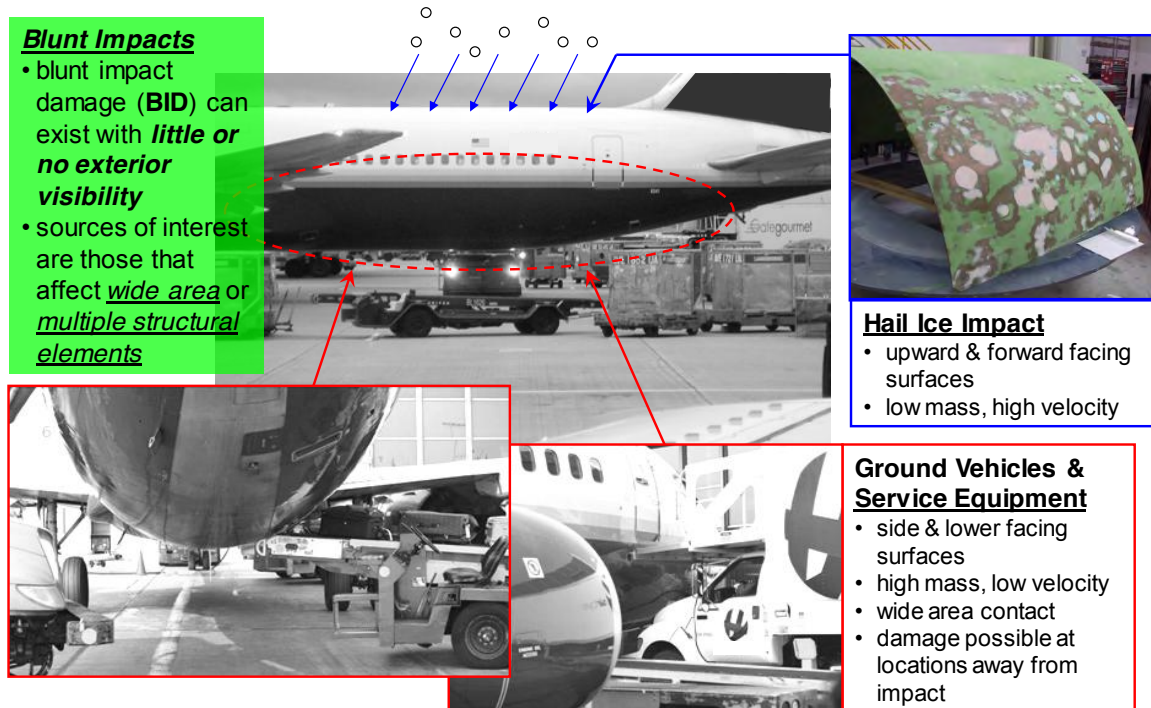
Figure 3. UCSD Blunt Impact Focus: Hail Ice and Ground Service Equipment

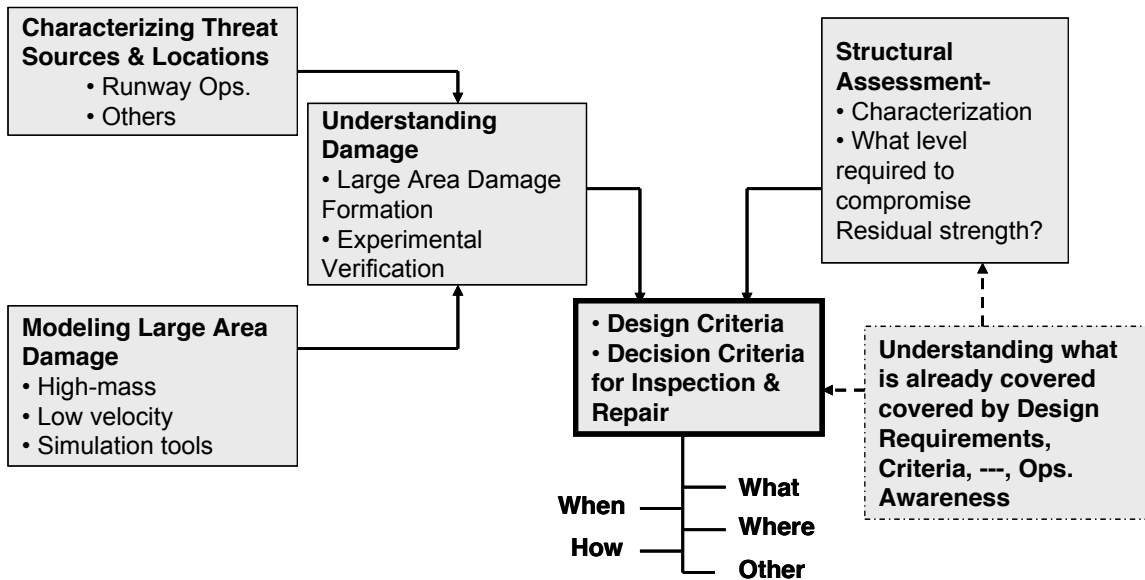
Figure 4. Logic Diagram for Low Velocity High-Mass Wide-Area Blunt Impact

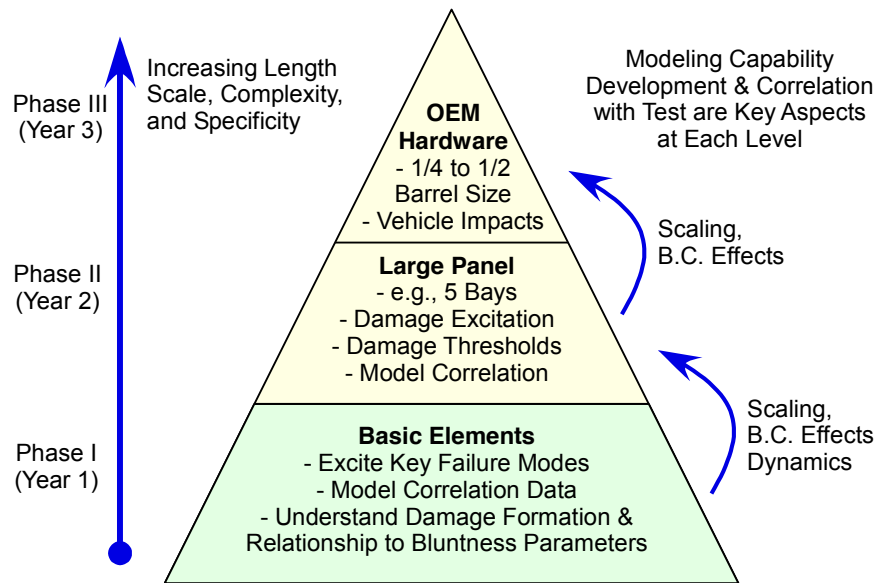
Figure 5. Blunt Impact Testing Building Block

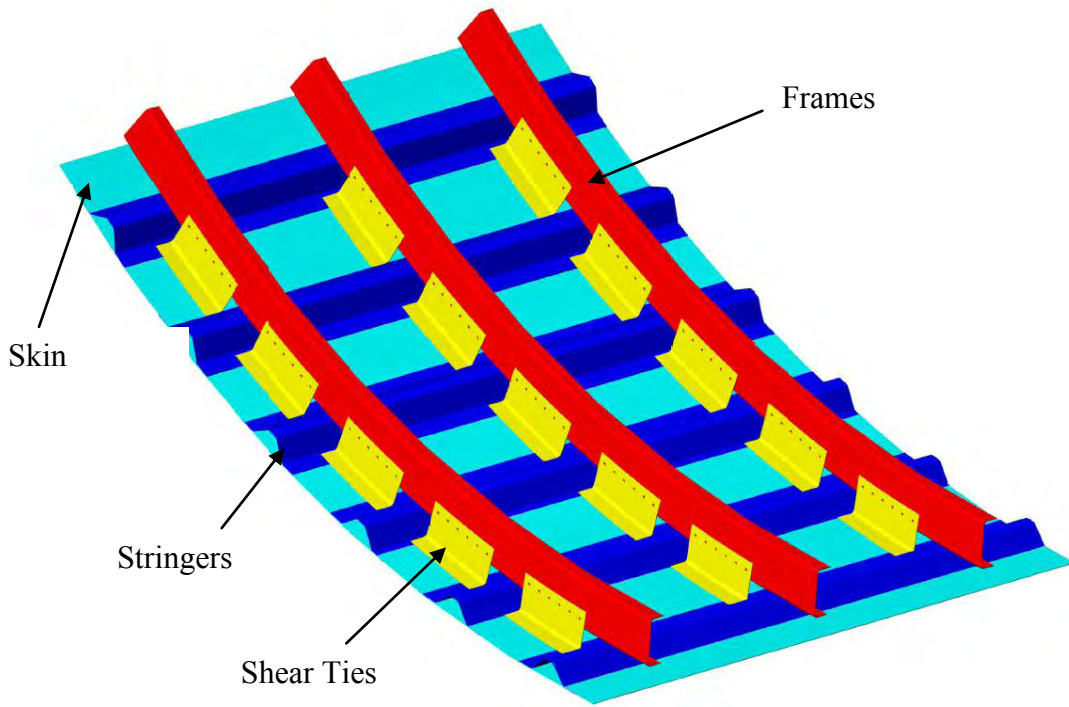
Figure 6. Frame Focused Test Specimen (Series ID: FrameXX)

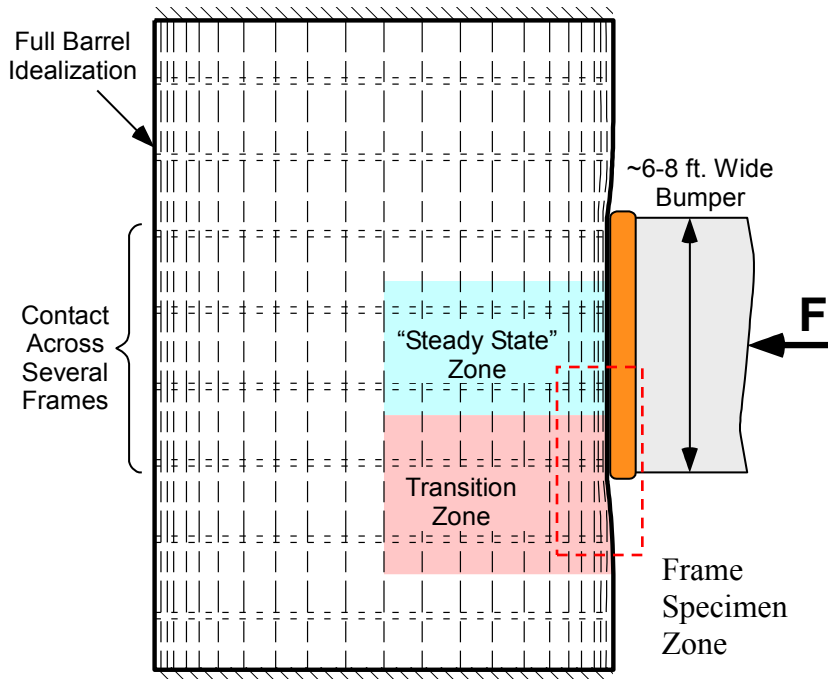
Figure 7. Deformation Zones for GSE Bumper Impact onto Full Barrel

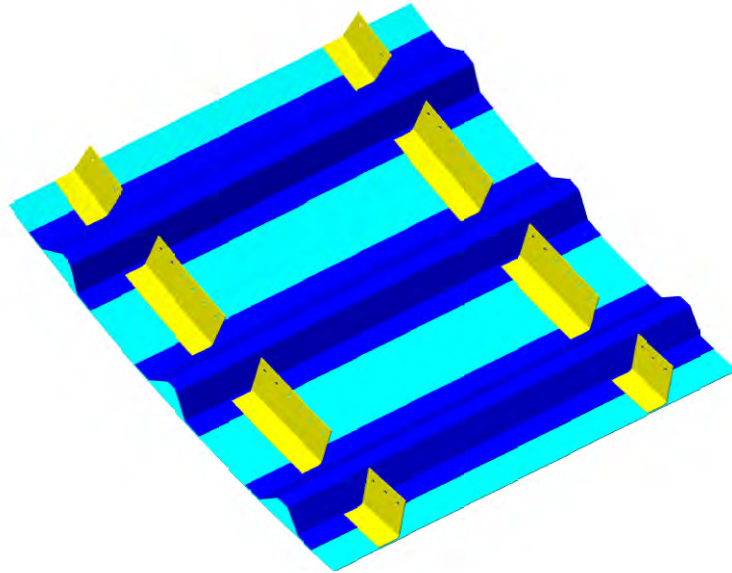
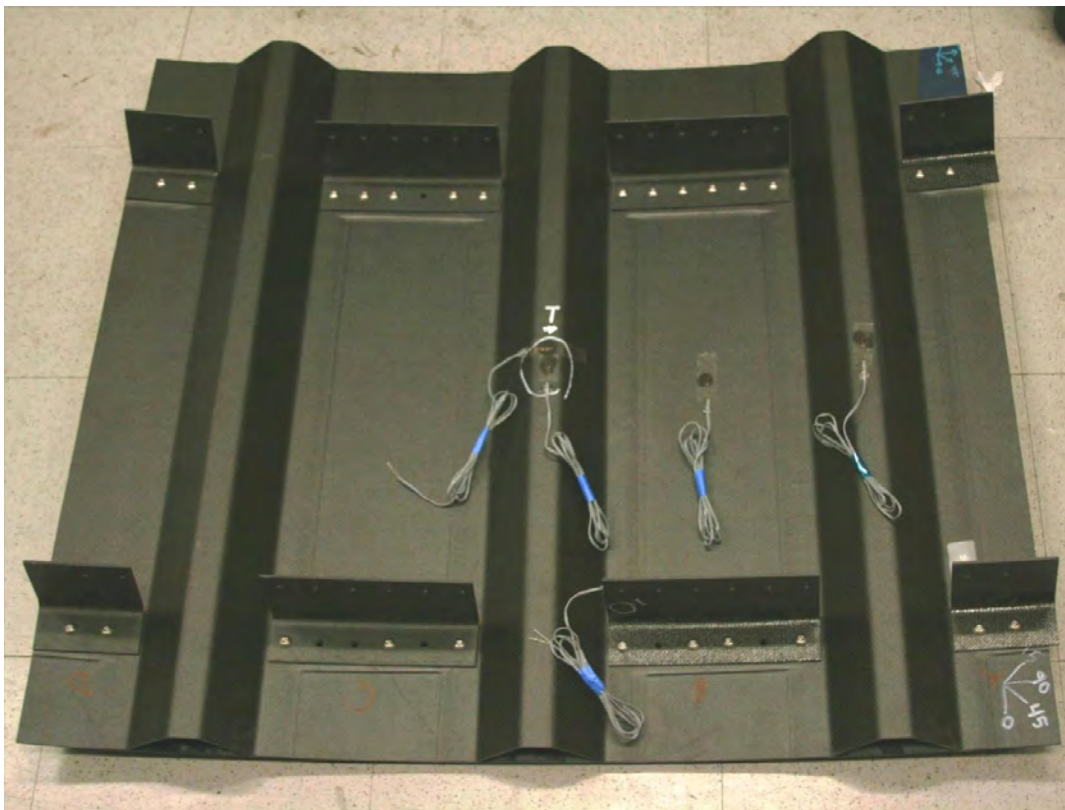
Figure 8. Stringer Focused Test Specimen (Series ID: StringerXX)

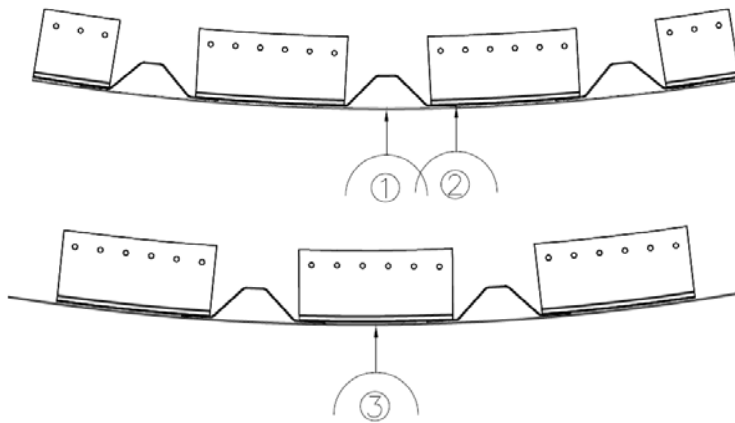
Figure 9. Stringer Impact Locations

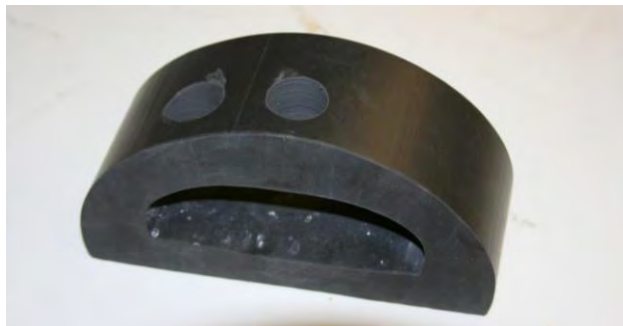
Figure 12: OEM Rubber Bumper for Stringer Specimen Tests

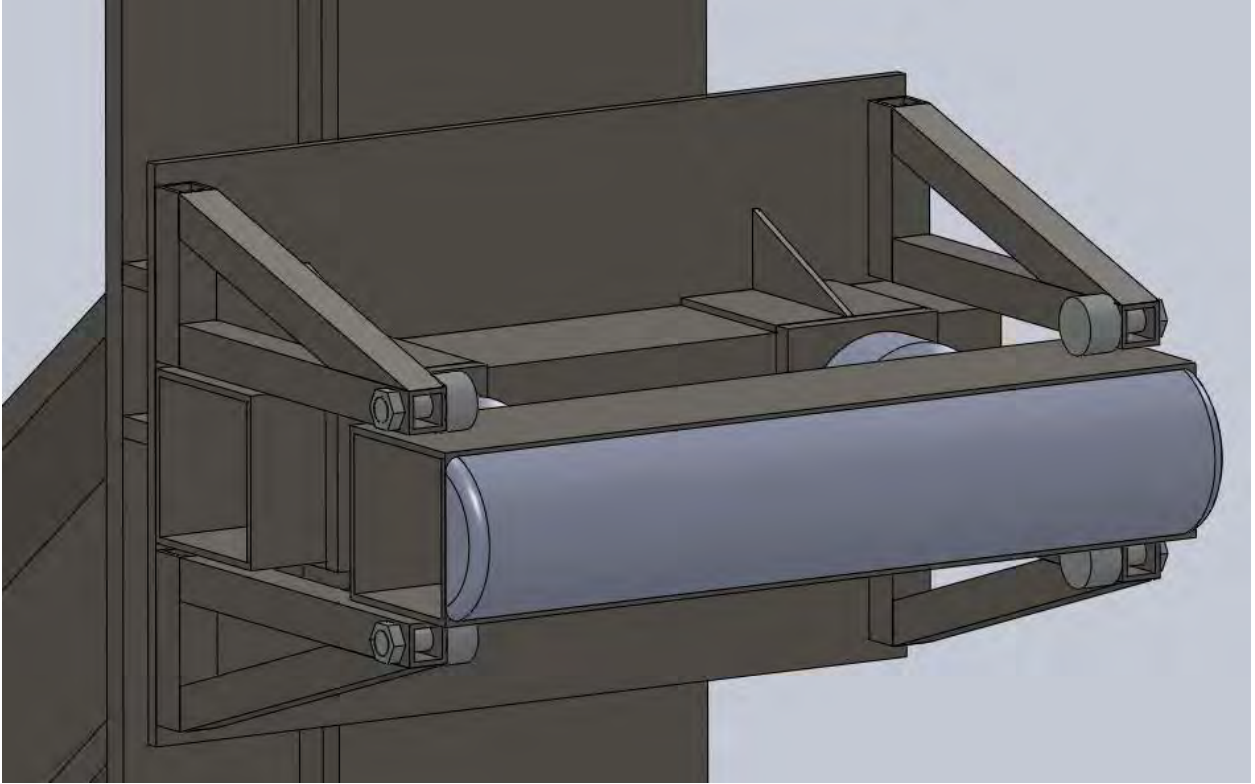
Figure 13: 3 in. Radius "Rigid" Indentor for Frame Specimen Tests

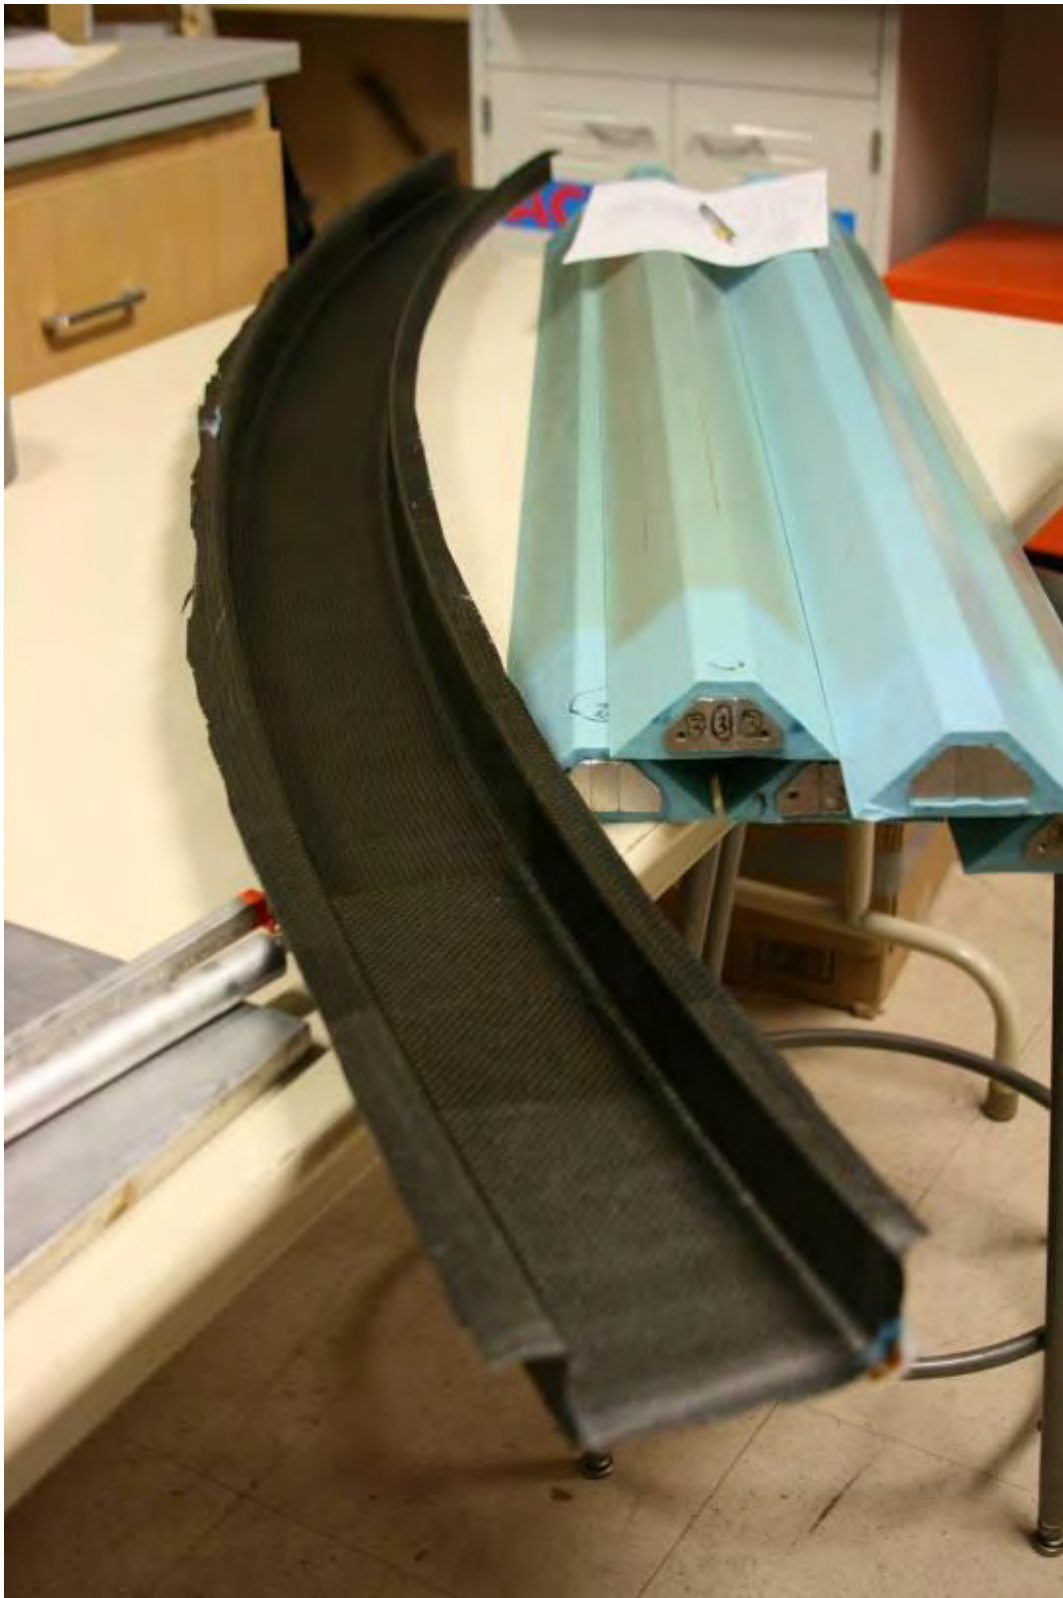
Figure 18: Untrimmed C-Channel Frame; Stringer Internal Silicone Molds

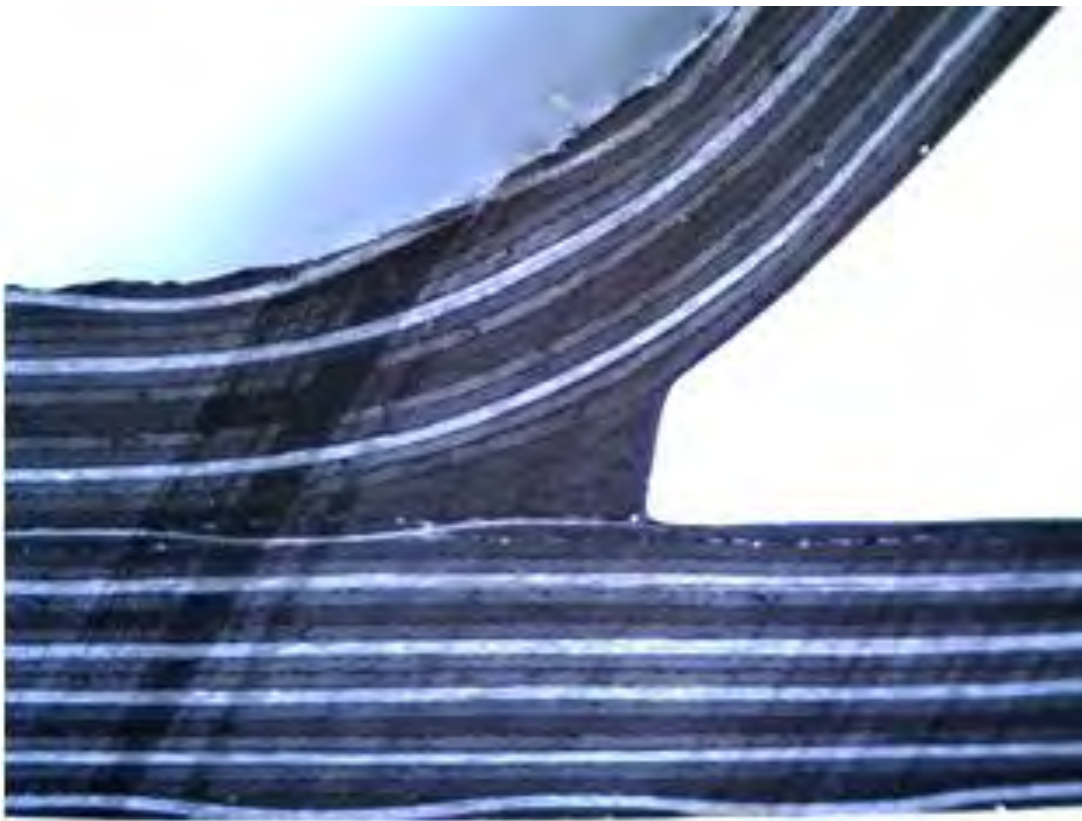
Figure 19. Corner Detail of Stringer-to-Skin Connection

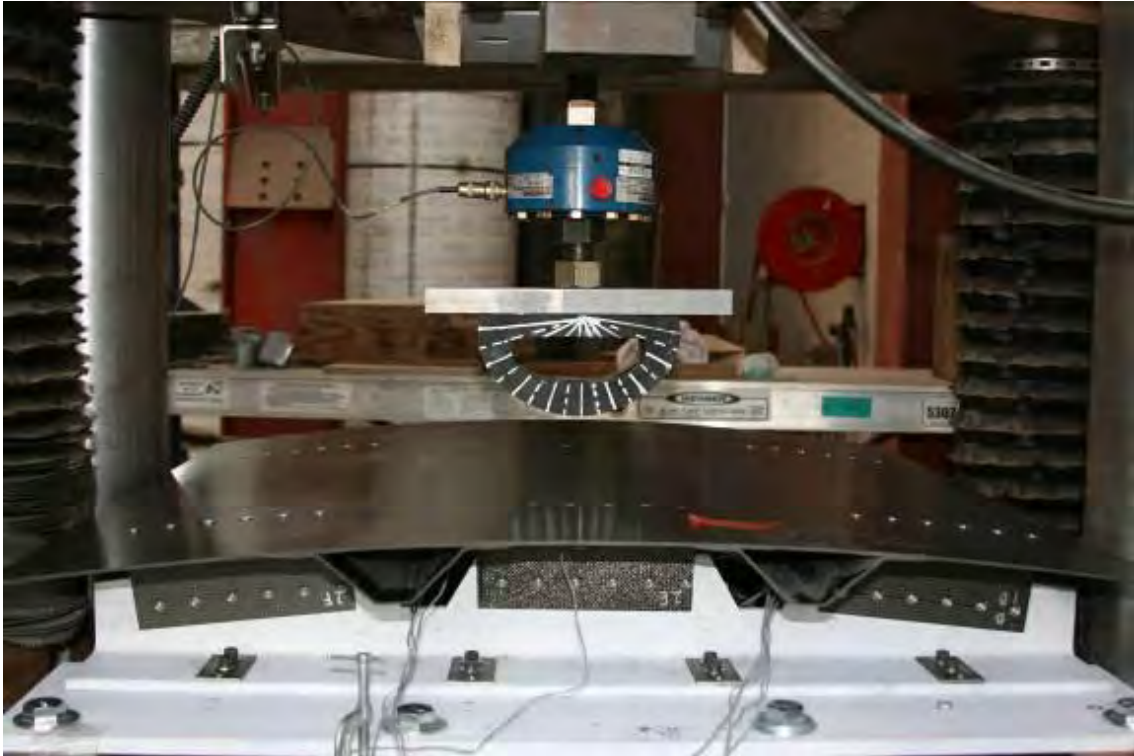
Figure 20: Specimen Stringer02 test setup in SAETEC Machine

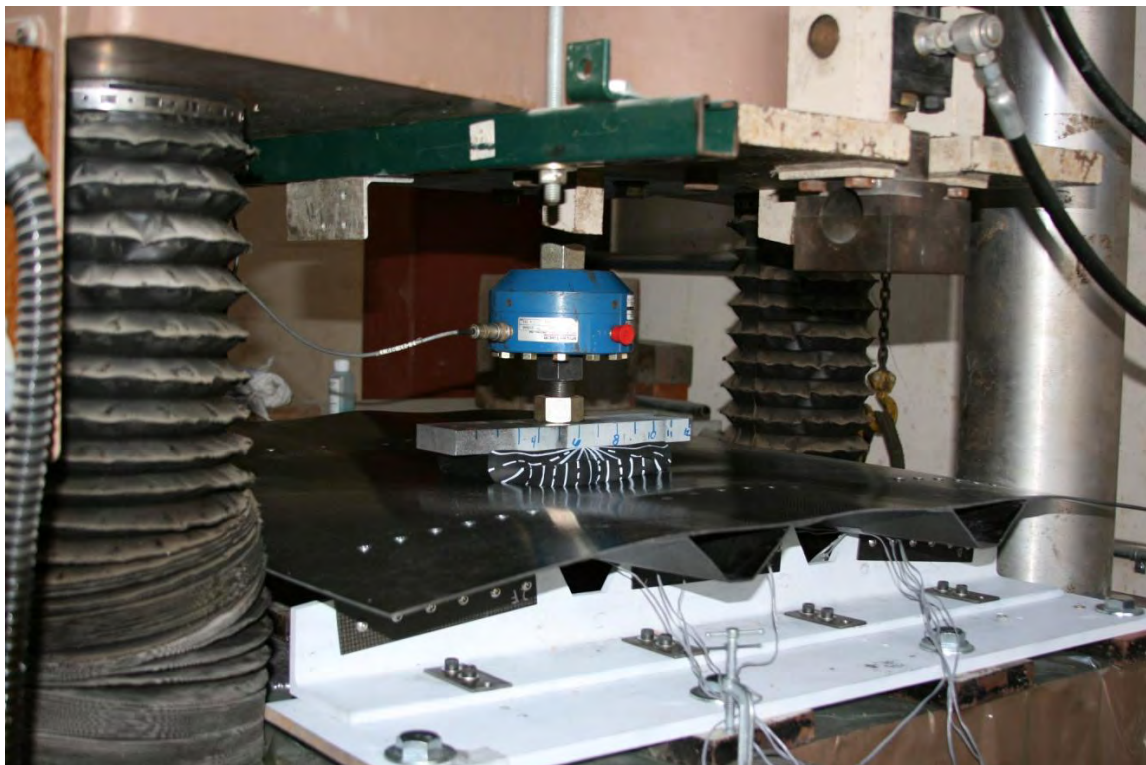
Figure 21. Specimen Side View of Stringer02 Under Compression Loading

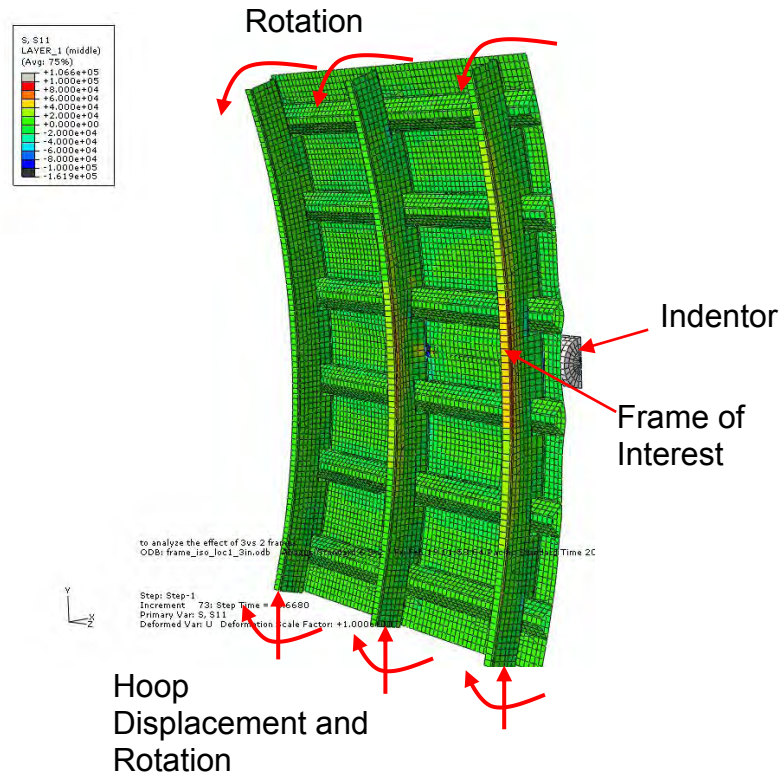
Figure 26. Frame Specimen with Applied Spring Properties at Boundary Conditions Found from the Quarter-Symmetric Model

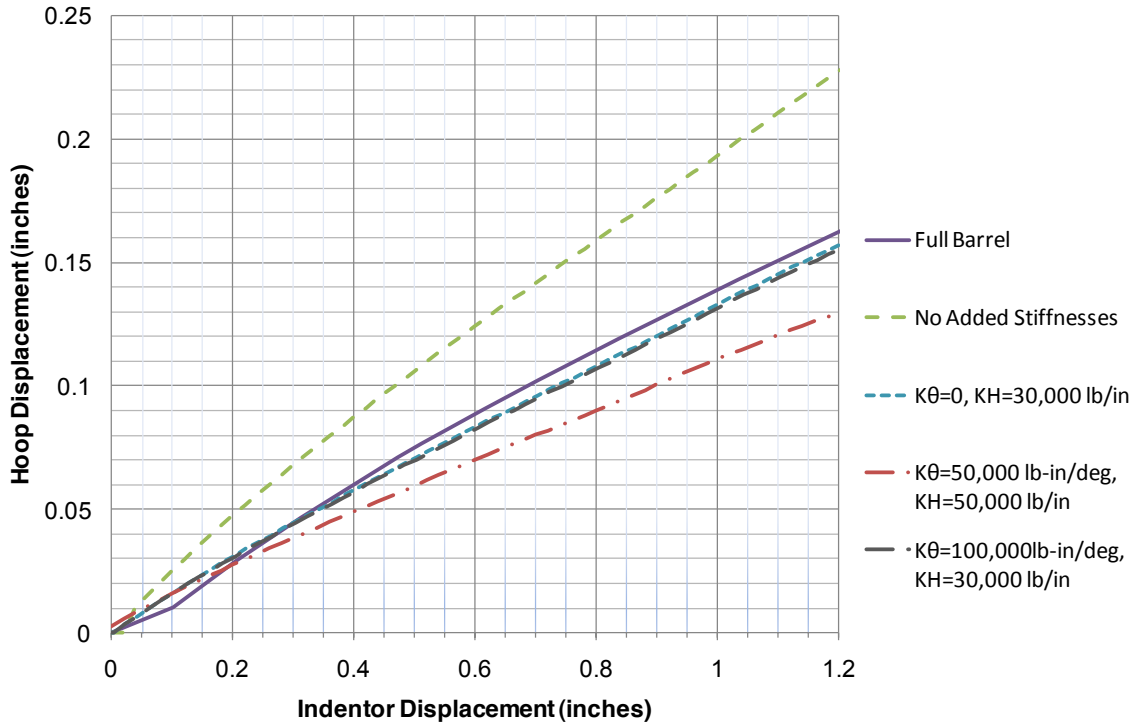
Figure 27. Hoop Displacement for Various Translational Stiffnesses of Frame Specimen and Full Barrel Model

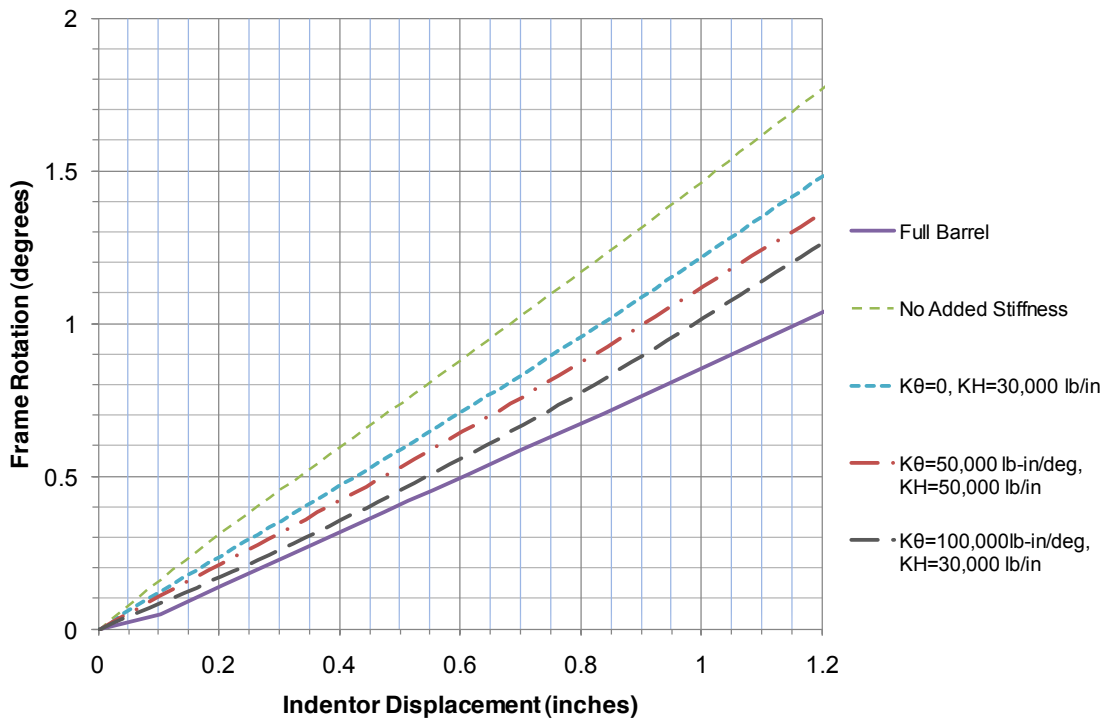
Figure 28. Rotation at Support Location Due to Indentation at Frame of Interest for Both the Frame Specimen and Full Barrel Model

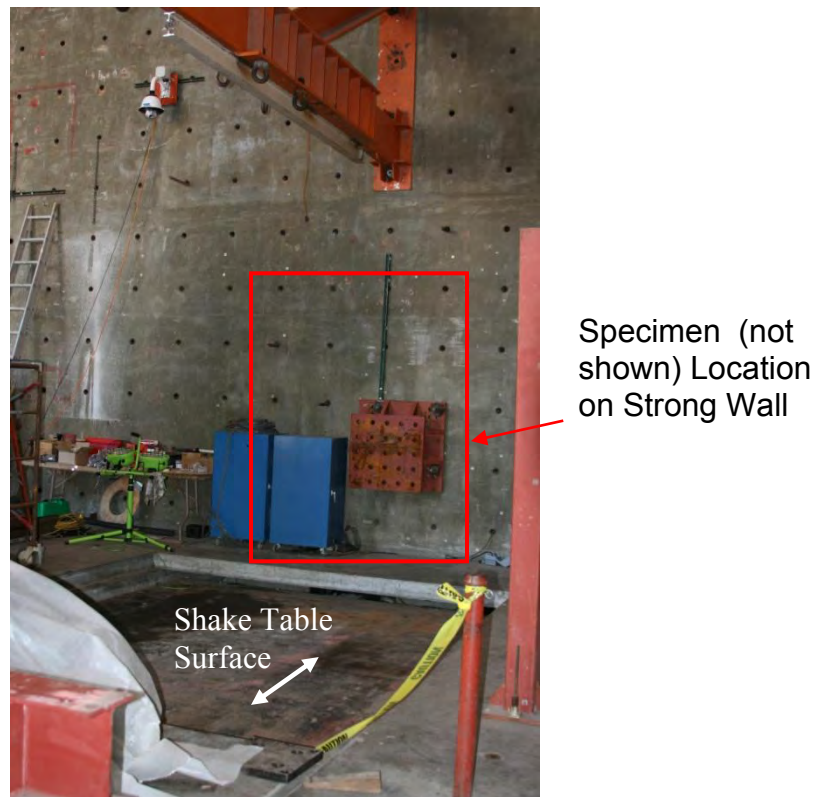
Figure 29. Shake Table and Strong Wall for Frame Specimen Test; Scale Information: Mounting Holes on Wall are 24 in. Apart

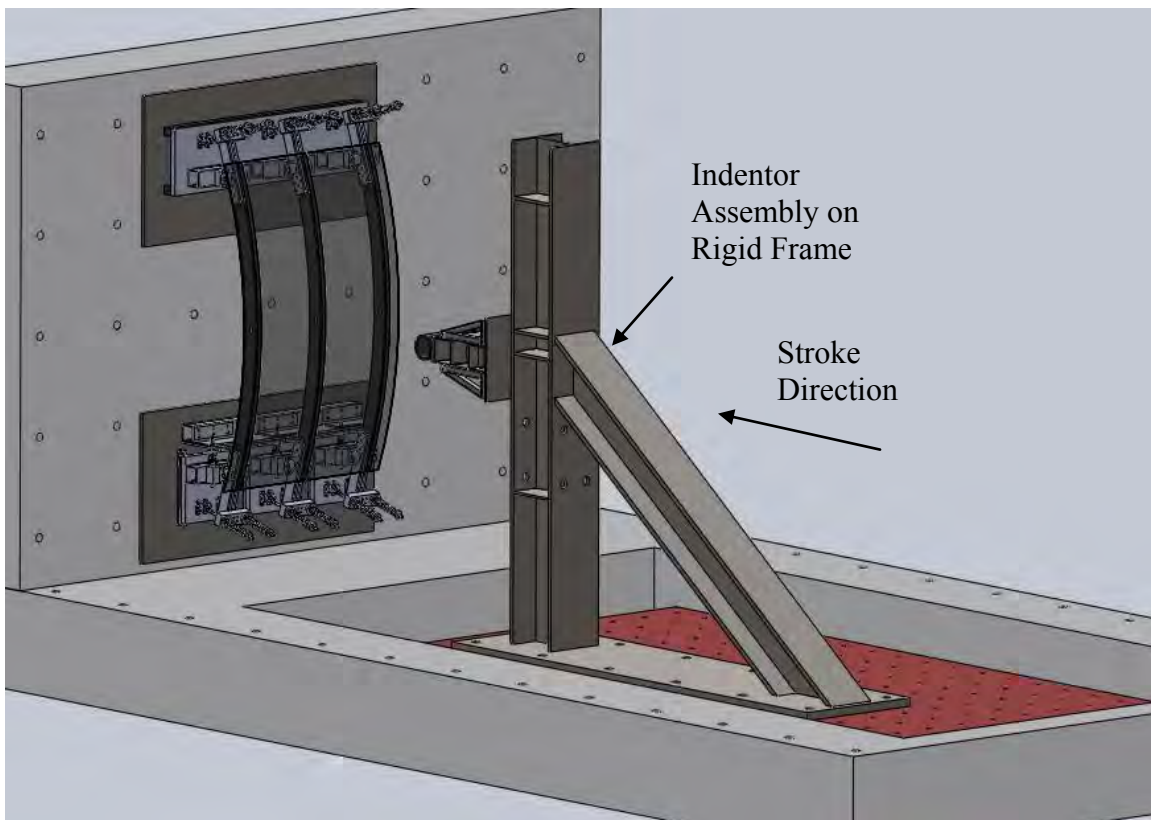
Figure 30. Planned Test Set Up for Frame Specimen on Dynamic 1-D Shake Table to be Run in Displacement Control; Note Entire Strong Wall Not Depicted

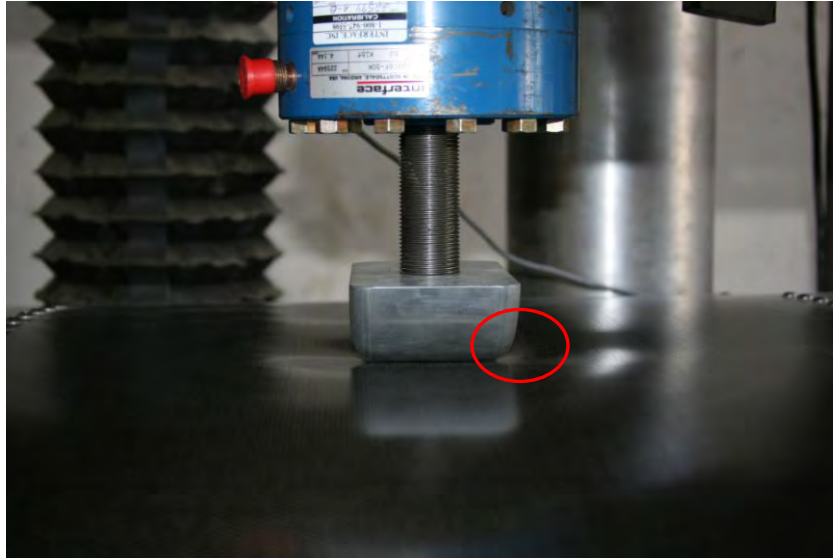
Figure 33. Localized Deformation of Panel Caused by 3 in. Radius Rigid Impactor During 1st Loading of Stringer00. Note Edge of Impactor Causing Biaxial Bending

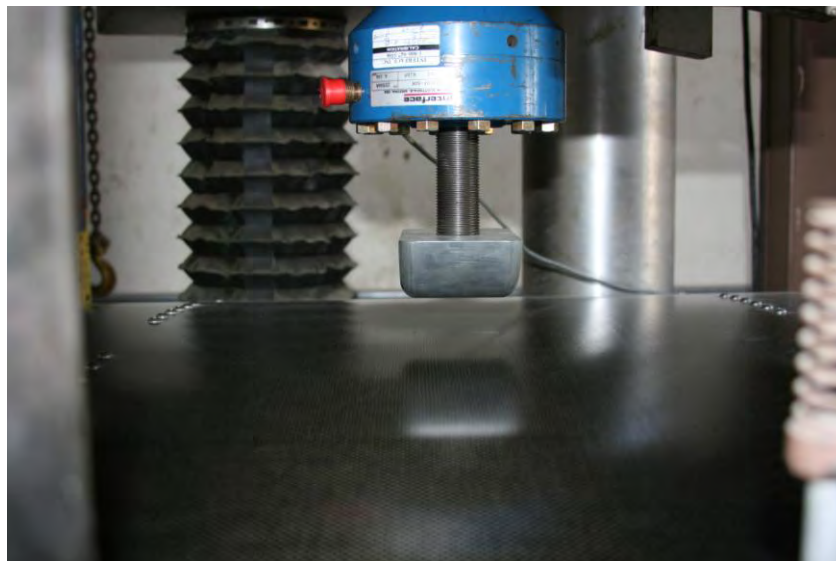
Figure 34. No Visible Permanent Deformation After 1st Loading of Stringer00 Despite Formation of Delamination

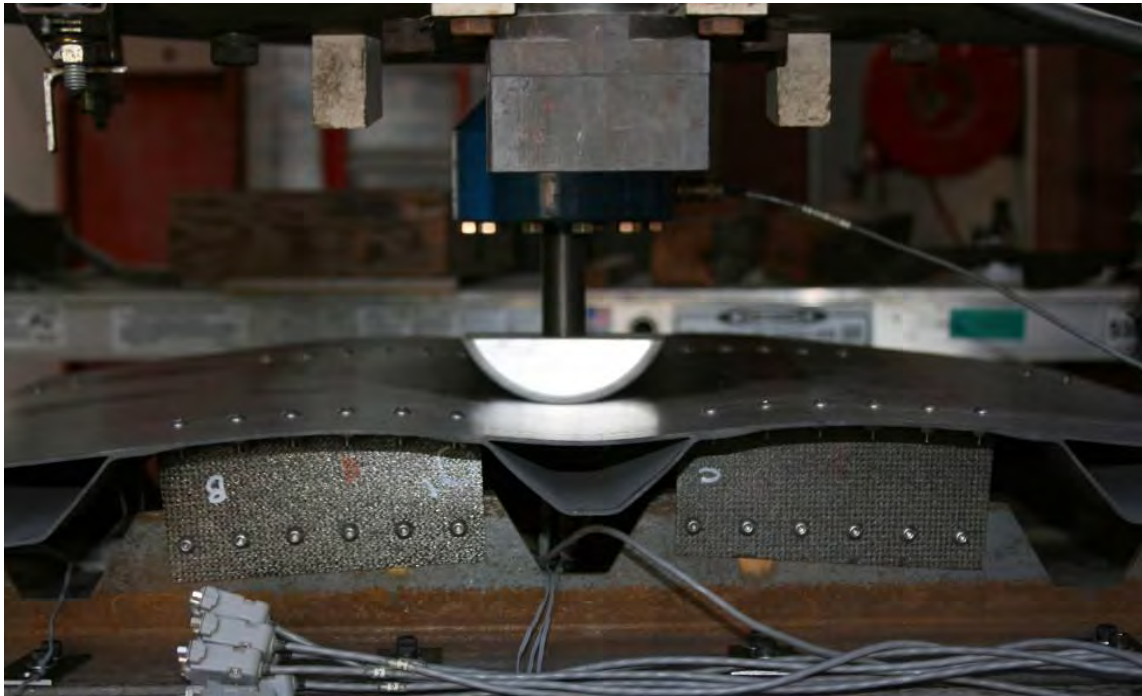
Figure 35. Large Deformation During 2nd Loading of Stringer00

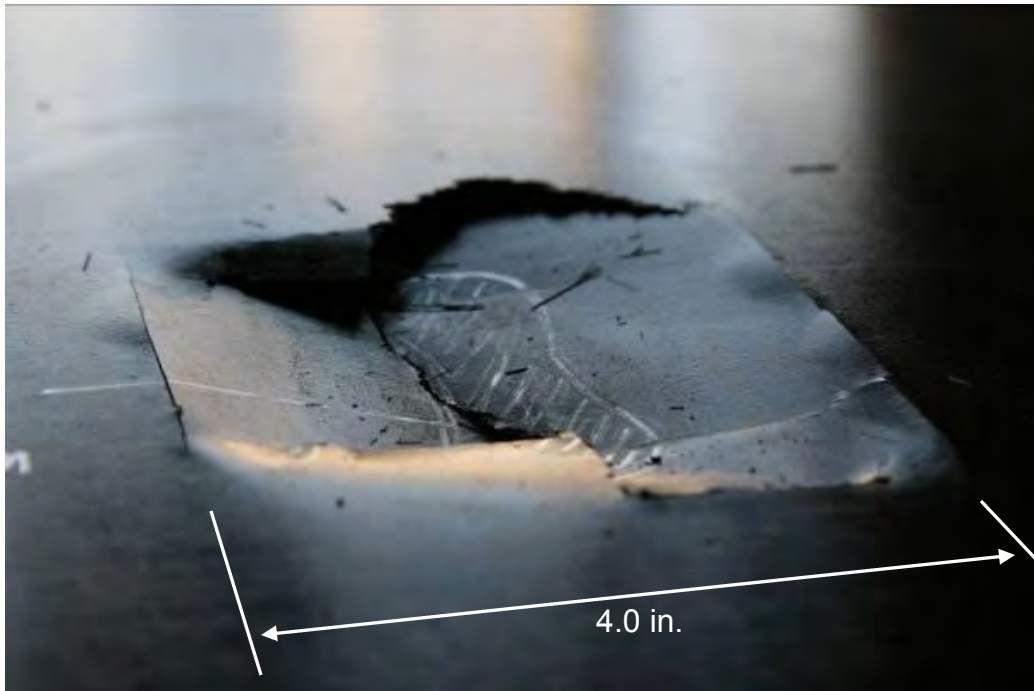
Figure 36. Stringer00 after Final Failure Following 2nd Loading; Initial Peanut Shaped Delamination is Indicated by the Hatch Pattern Zone; Straight Cracks on Left and Right Sides of Photo Spaced at 4 in. Define Stringer Inside Flange Edges

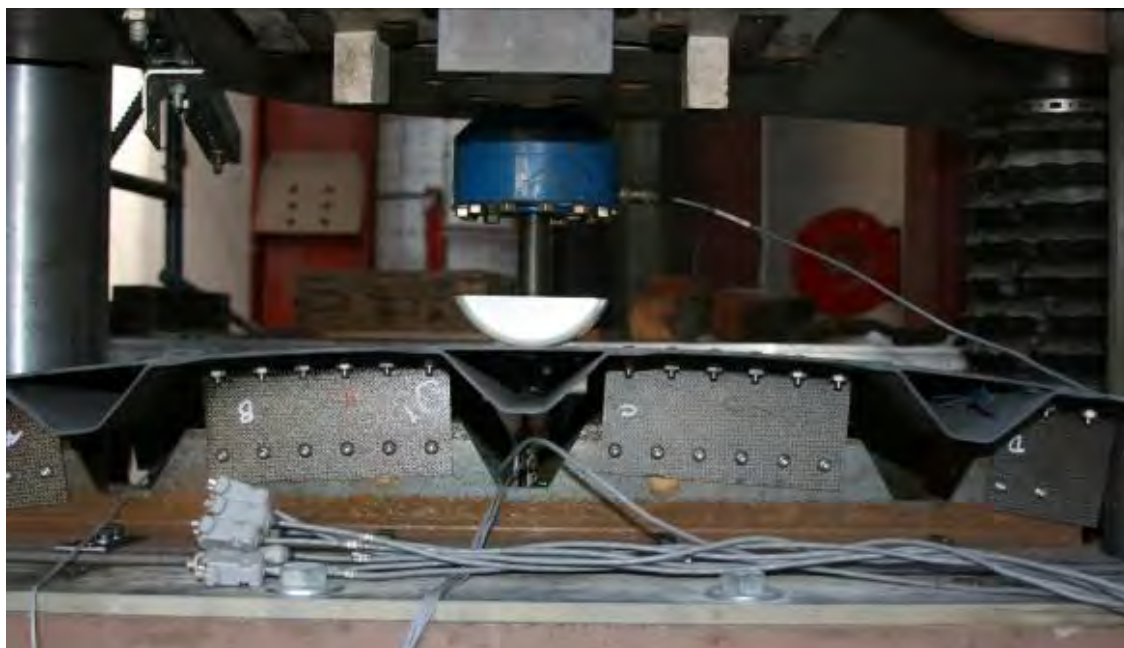
Figure 37. Stringer00 after Final Failure Following 2nd Loading; Panel Rebounds to Original Overall Shape Despite Penetration Damage

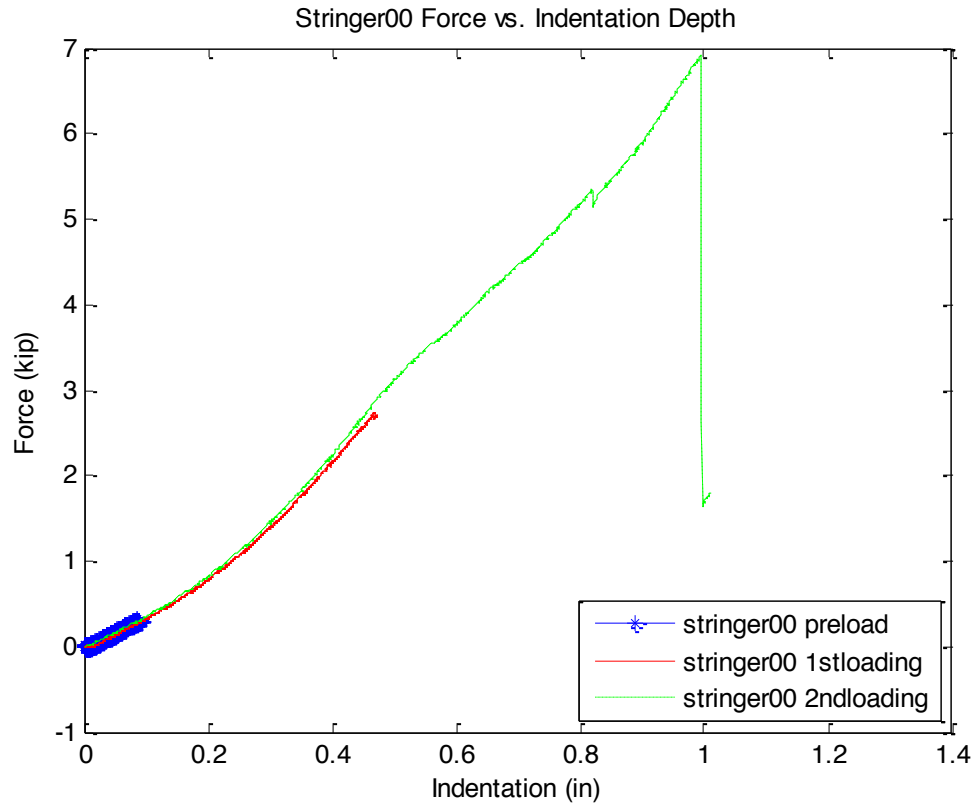
Figure 38: Stringer00 Force vs. Indentation Curves

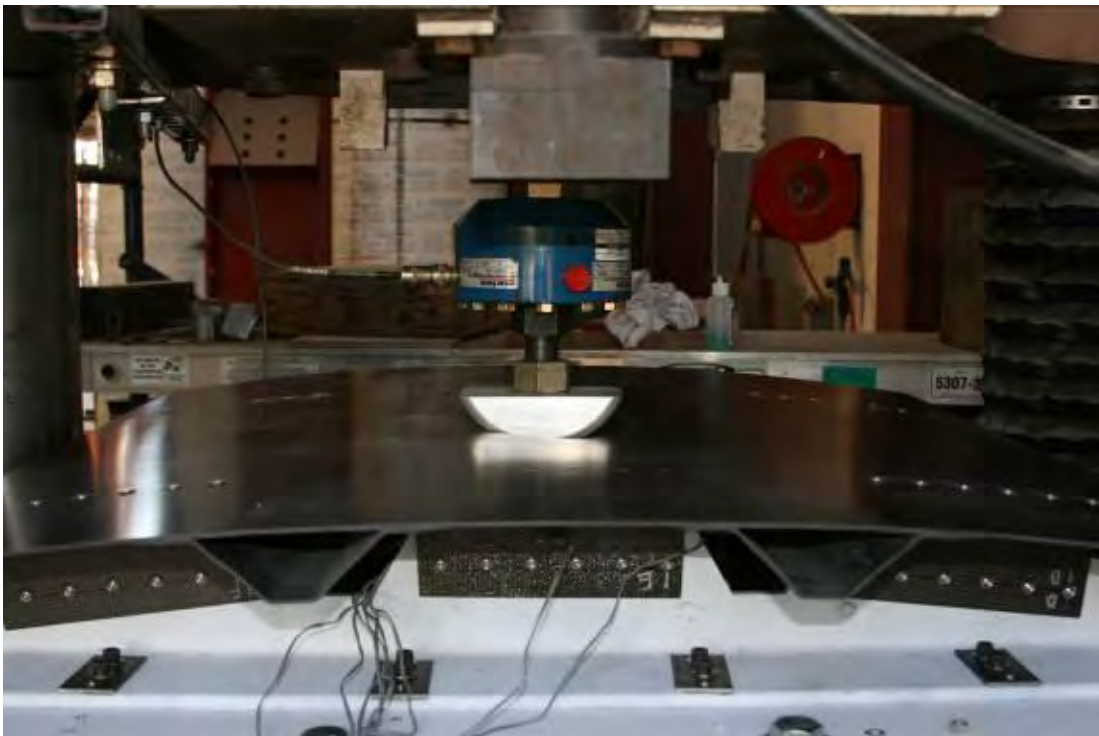
Figure 40: Panel Rebounded to Original Shape with Localized Damage

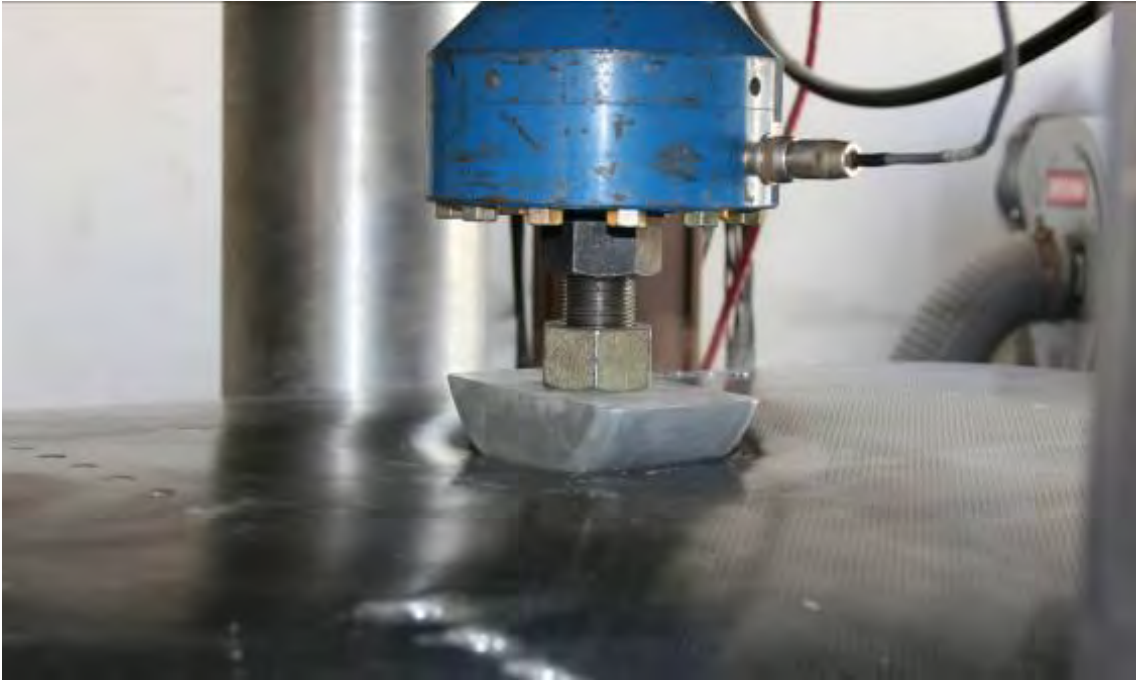
Figure 41: Close-Up View of Penetration of Impactor into Panel

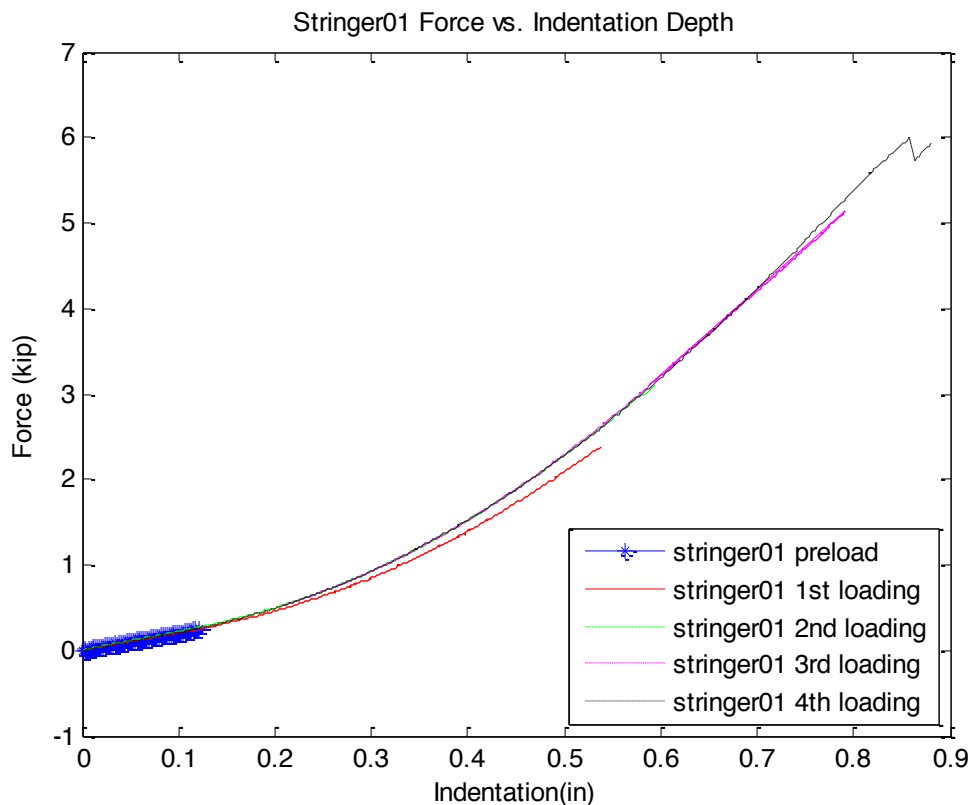
Figure 42: Stringer01 Force vs. Indentation Curves
