Impact Damage Formation on Composite Aircraft Structures

Hyonny Kim, Gabriela DeFrancisci, Zhi Ming Chen, Jennifer Rhymer, and
Jeff Tippmann

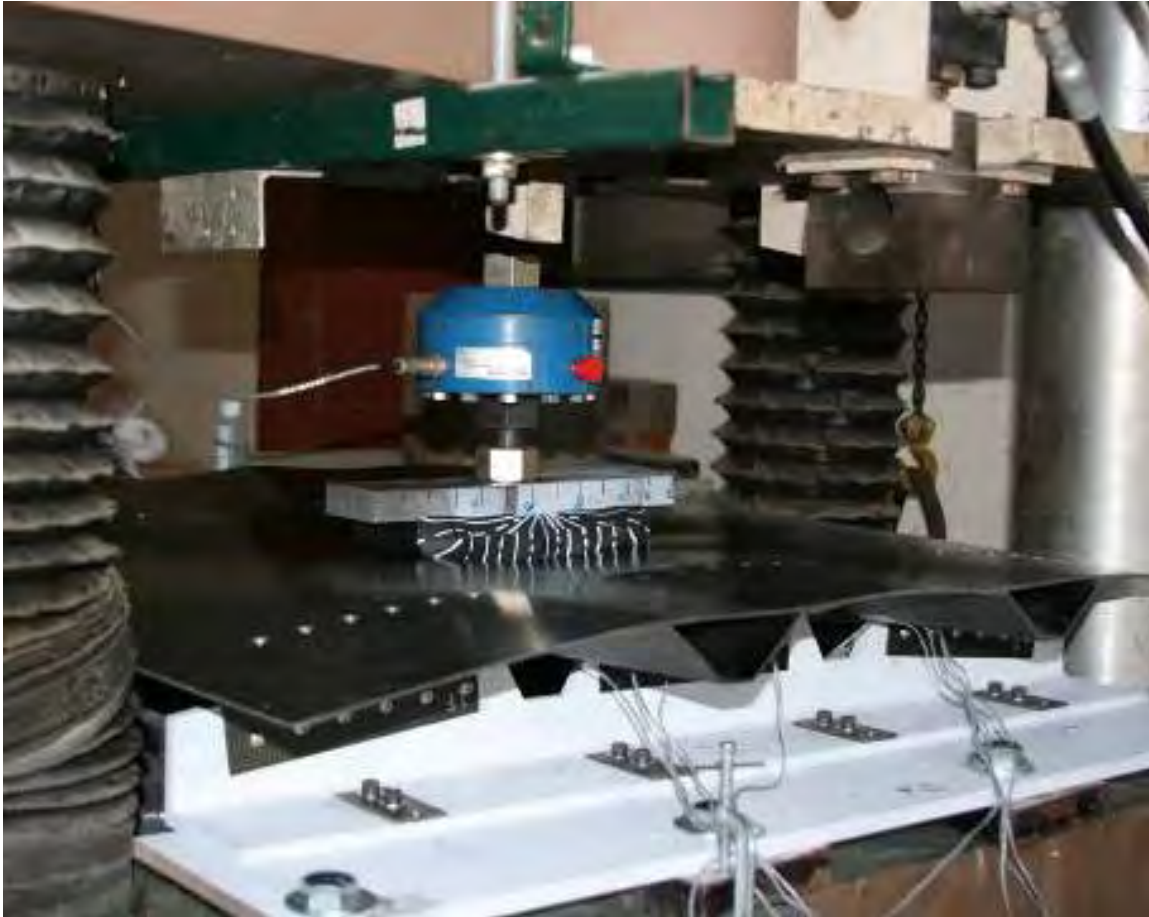
Figure 46: Large Deformation of Bumper and Panel Stringer02

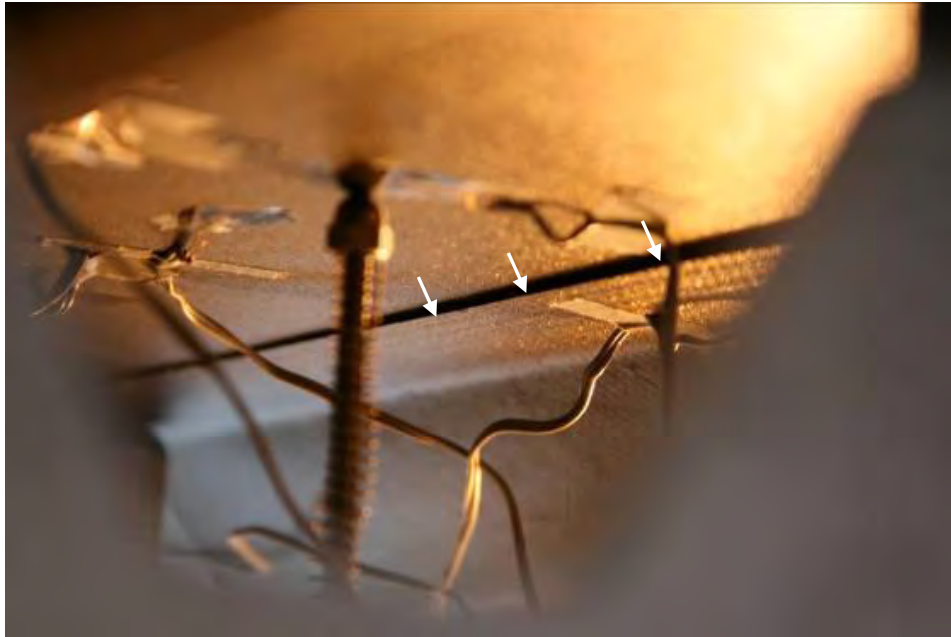
Figure 47: Stringer02 Delamination between the Skin and Stringer Following 4th Loading

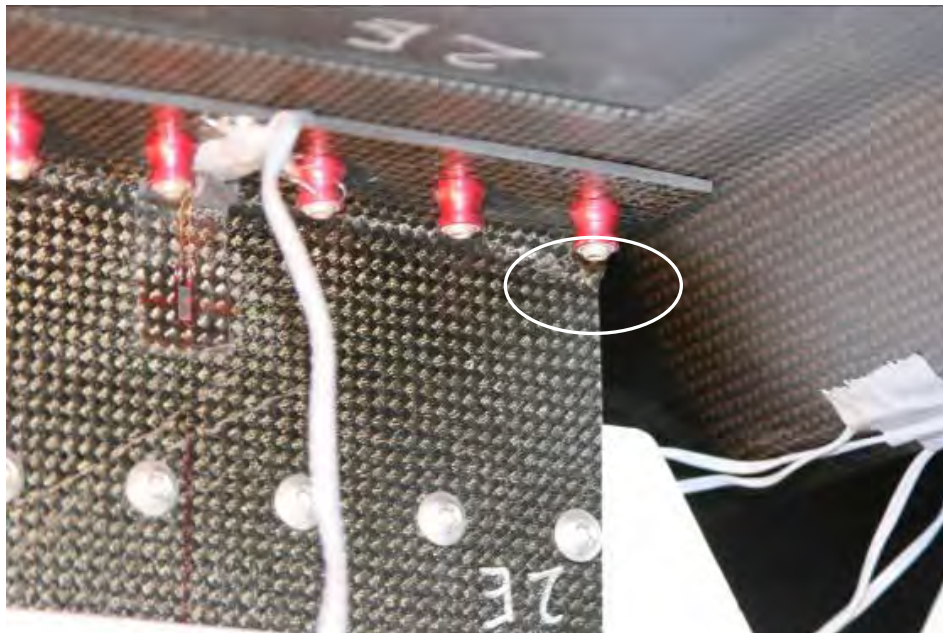
Figure 48: Stringer02 Radial Delamination of Shear Tie and Bending Failure at Corner Locations Following 4th Loading

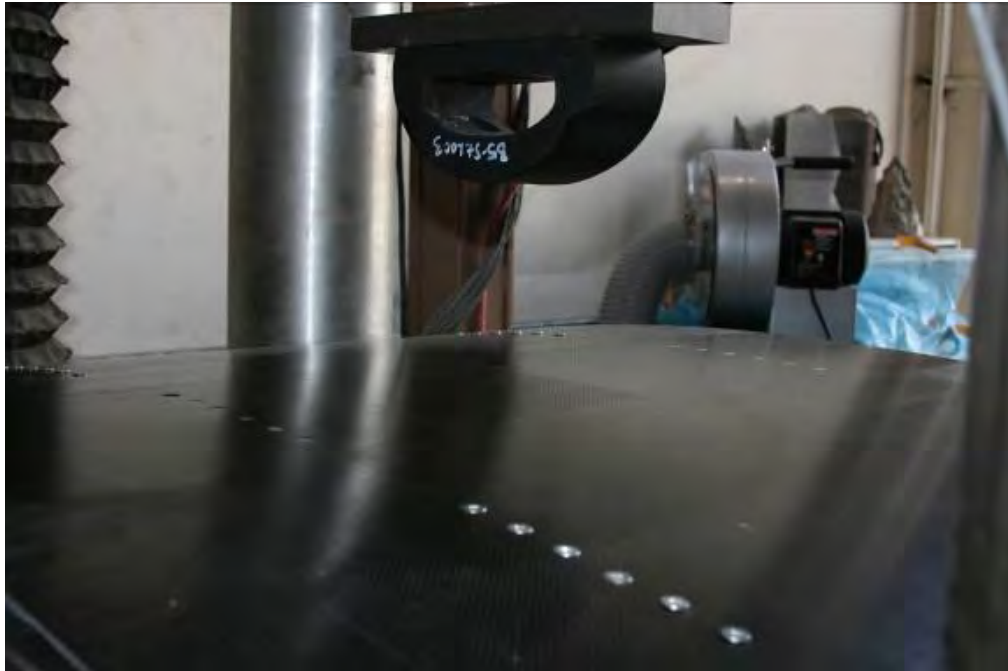
Figure 49: Exterior View of Stringer02 After First Stringer Delamination Following 4th Loading

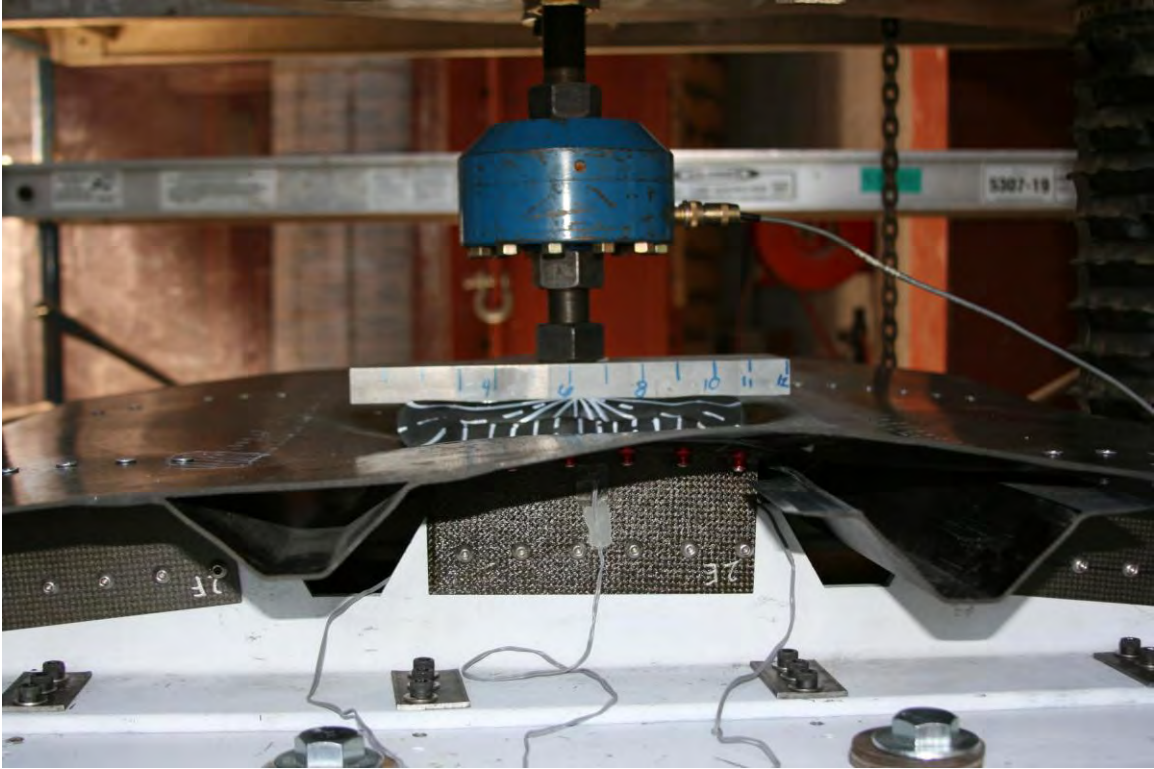
Figure 51: Stringer02 Following 5th Loading. Complete Delamination of the Right-Side Stringer (S2) Out to the Free Edge is Observed

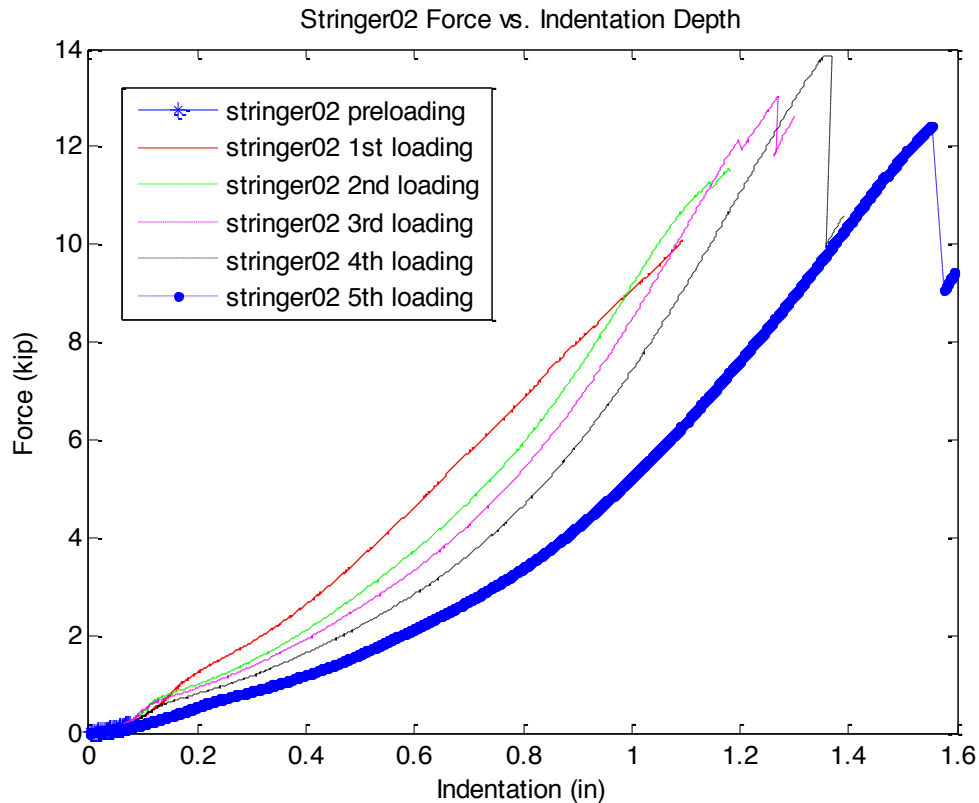
Figure 52: Stringer02 Force vs. Indentation Curves

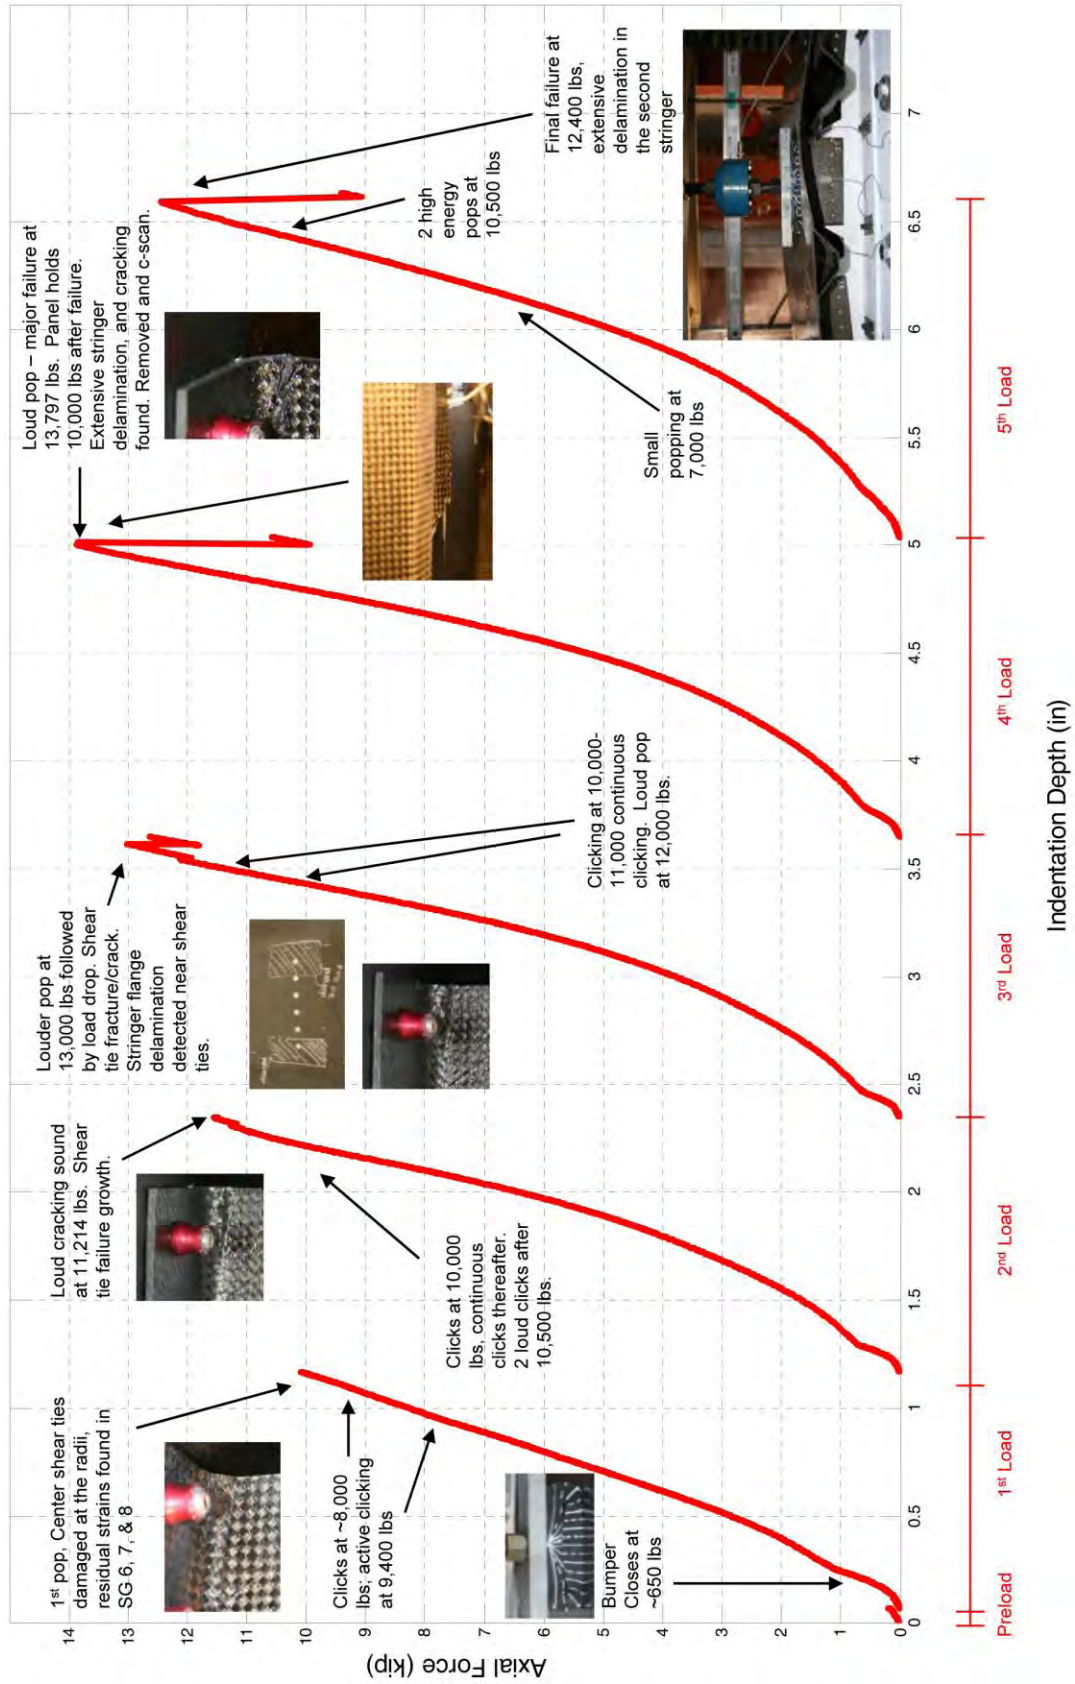
Figure 53. Stringer02 Time Event Plot

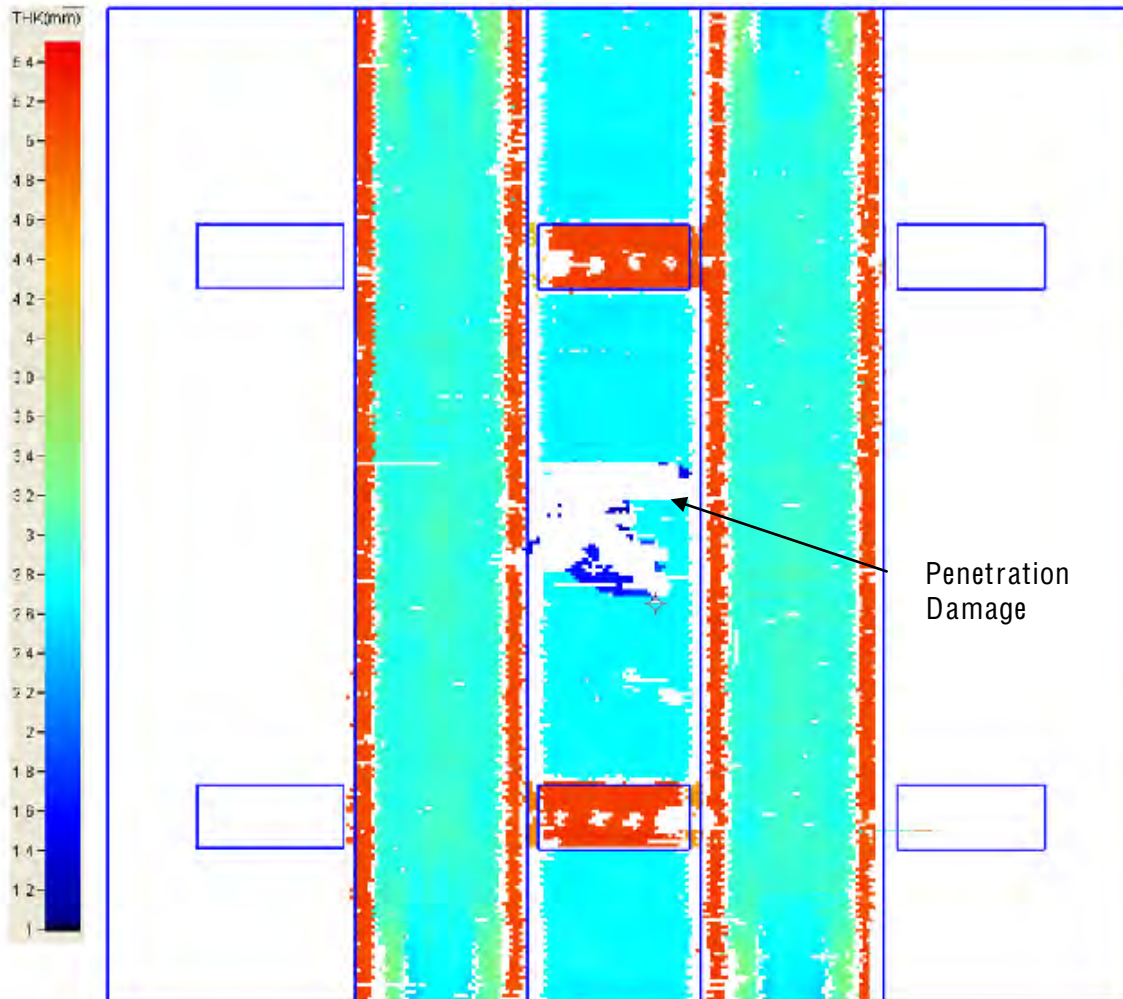
Figure 54. Post Test C-Scan Image of Stringer01 Indented by 3 in. Radius Aluminum Impactor (Resolution: 0.1x0.1 in). No Delamination of Stringer Flanges was Observed.

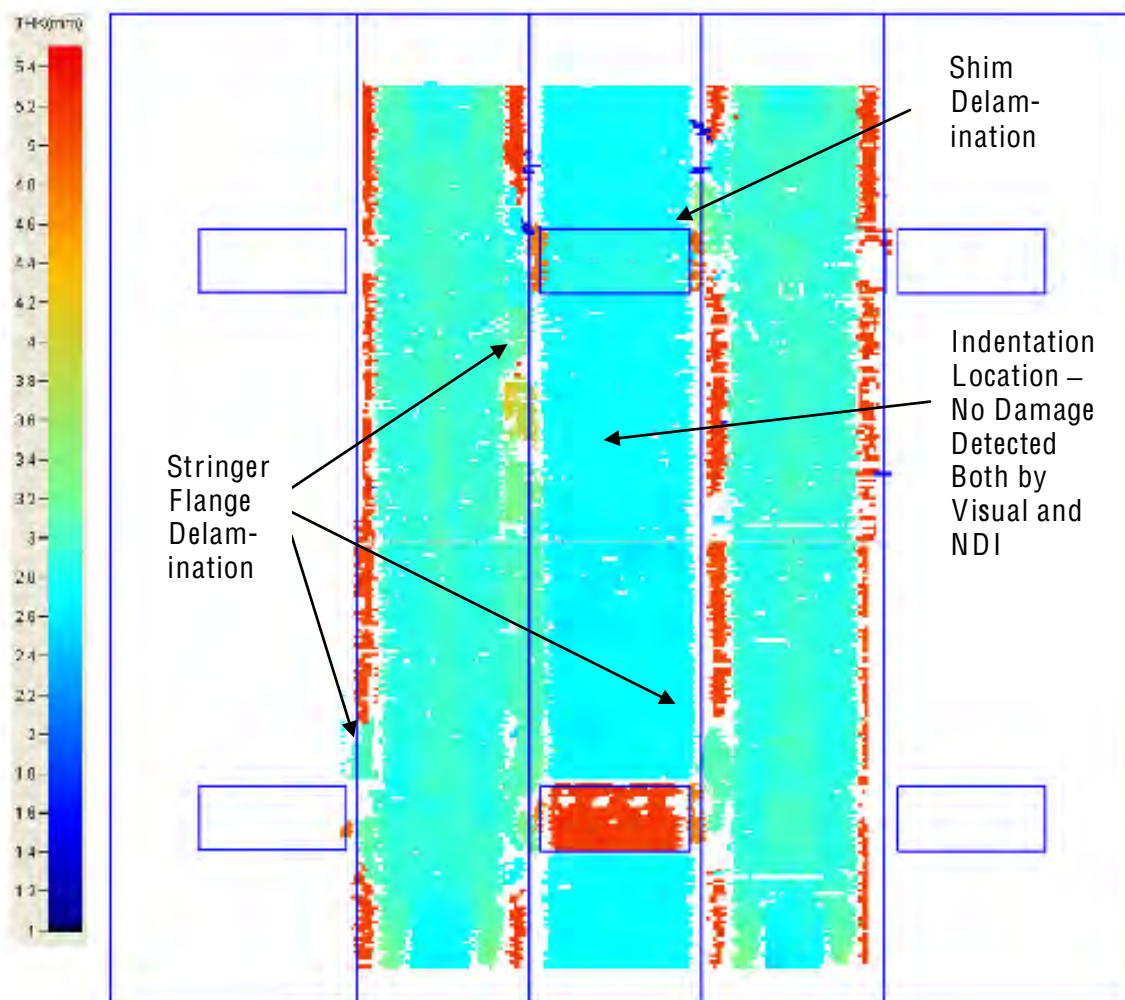
Figure 55. Post Test C-Scan Image of Stringer02 after the 4th Loading Indented by the Rubber Bumper (resolution: 0.1x0.1 in). Extensive Delamination of Stringer Flanges and Shim.

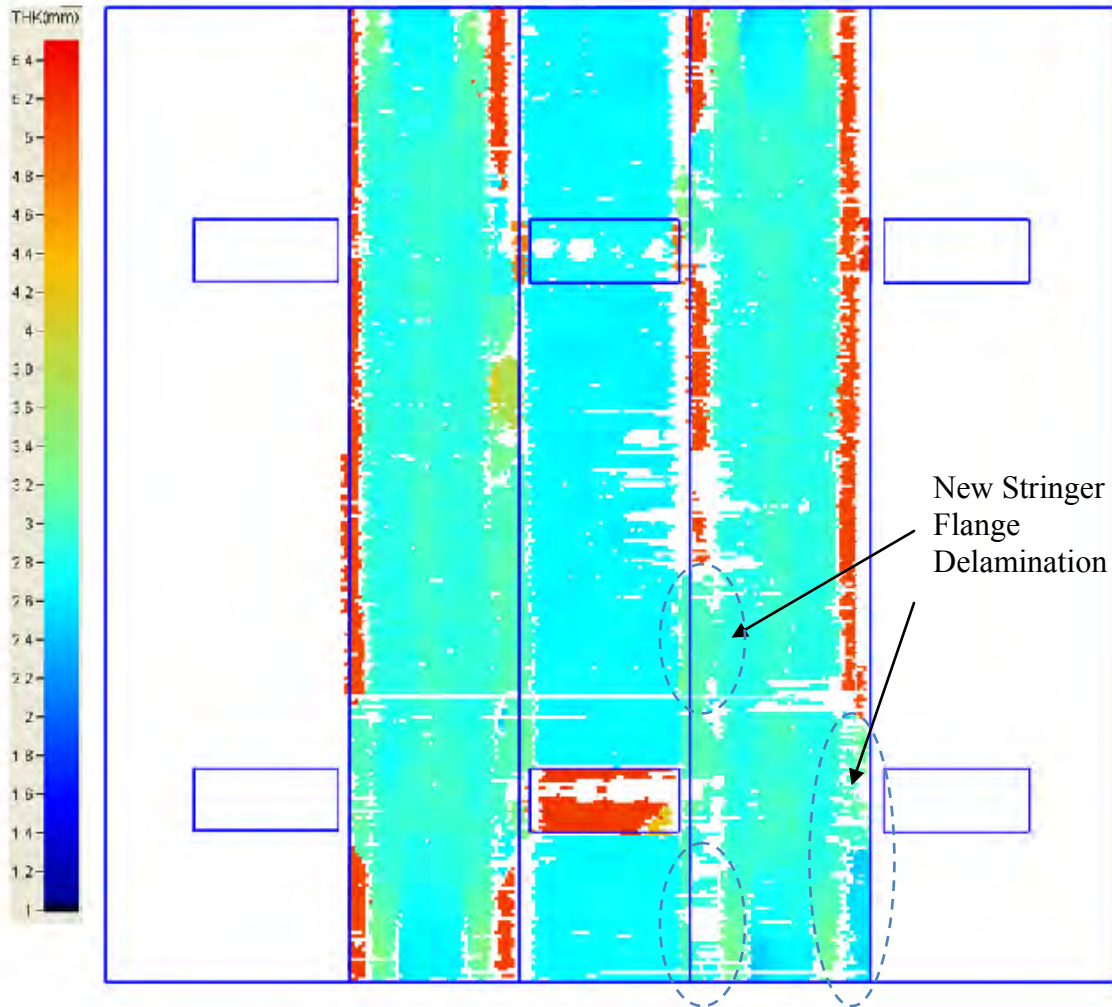
Figure 56. Post Test c-scan Image of Stringer02 after the 5th Loading Indented by Rubber Bumper (Resolution: 0.1x0.1 in). Delamination Growth Primarily in the Right Stringer (S2); Damage State Remained Unchanged Elsewhere in the Panel.

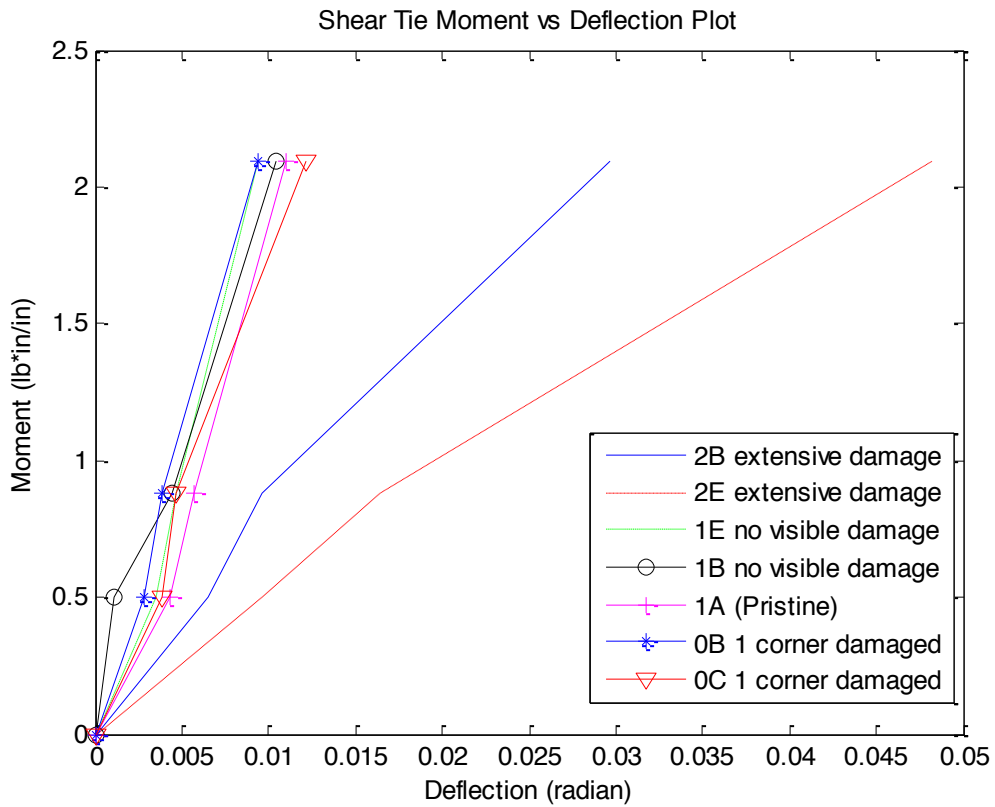
Figure 57. Moment vs. Rotation Plots for the Shear Ties.

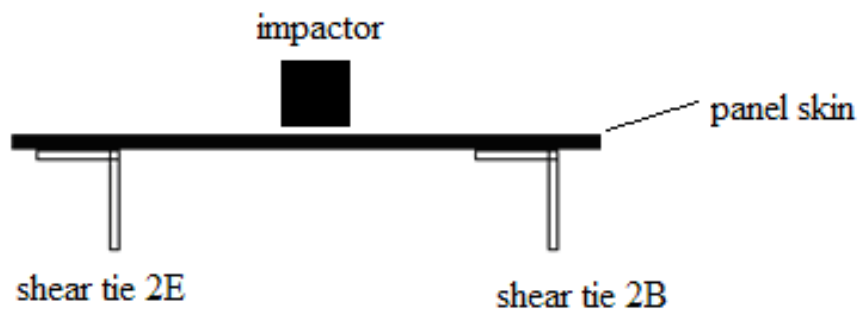
Figure 58. Locations of Shear tie 2E and 2B Relative to the Impactor.

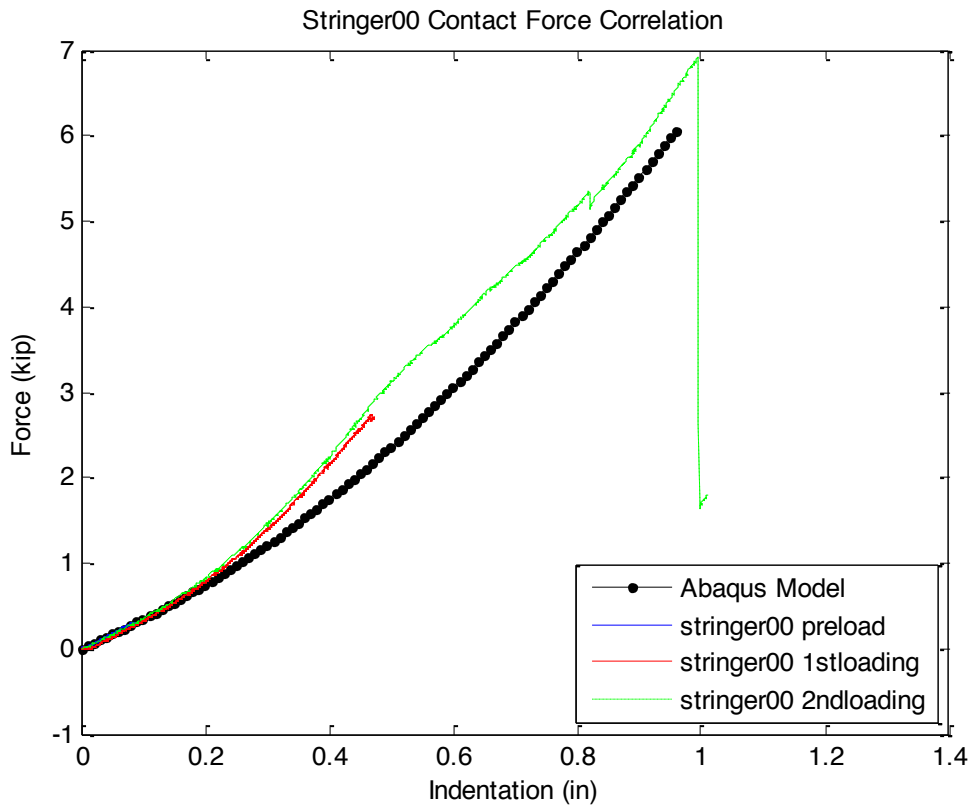
Figure 59. Contact Force of Stringer00 Model Plotted vs. Test Data.

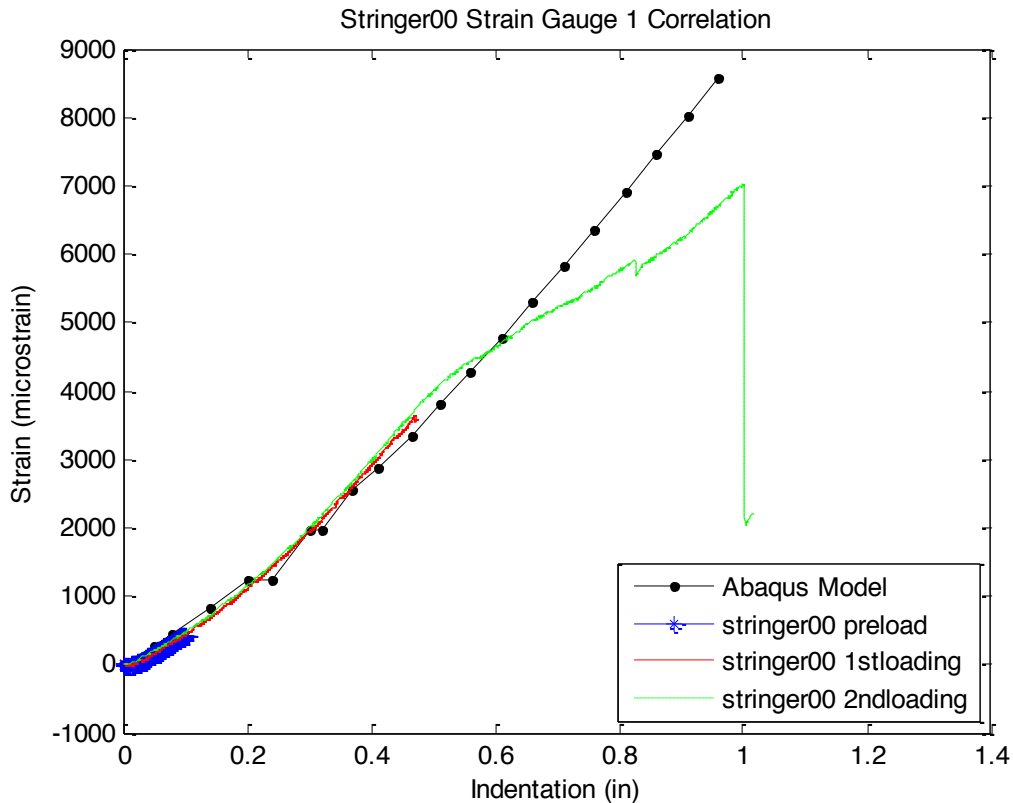
Figure 60. Surface Strain of the Stringer at Location Directly Beneath the Indenter for Stringer00; Model Data are Plotted with the Test Data.

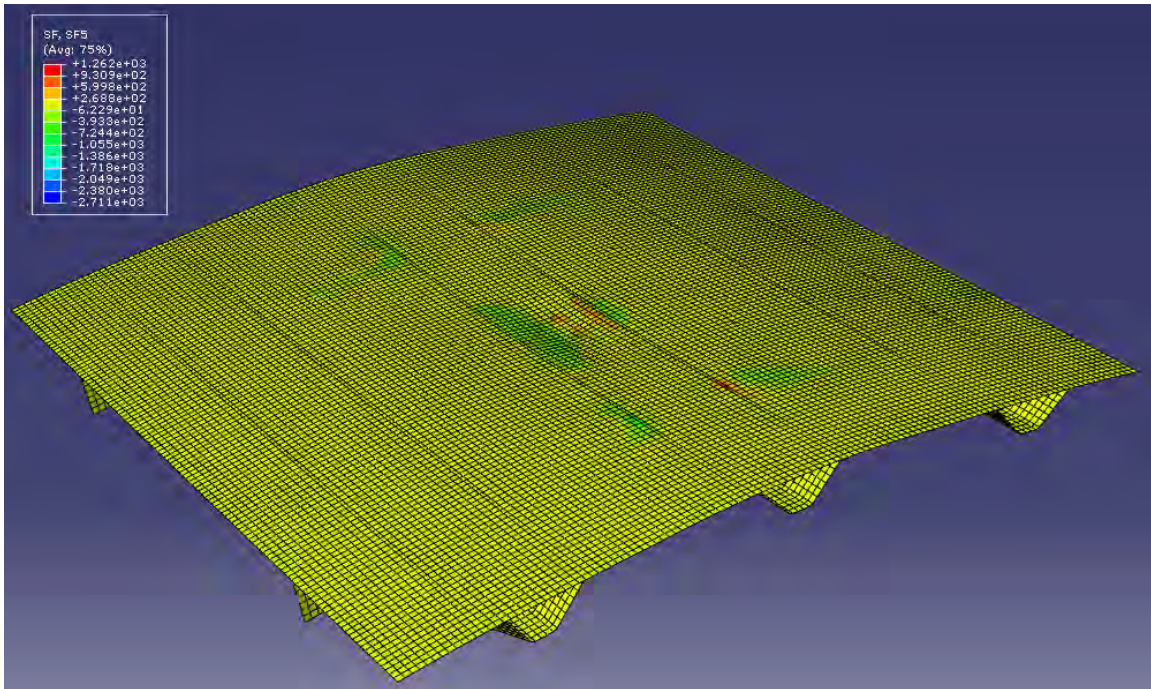
Figure 61. Interlaminar Shear Stress Resultants (Perpendicular to the Stringer Direction) in Stringer00

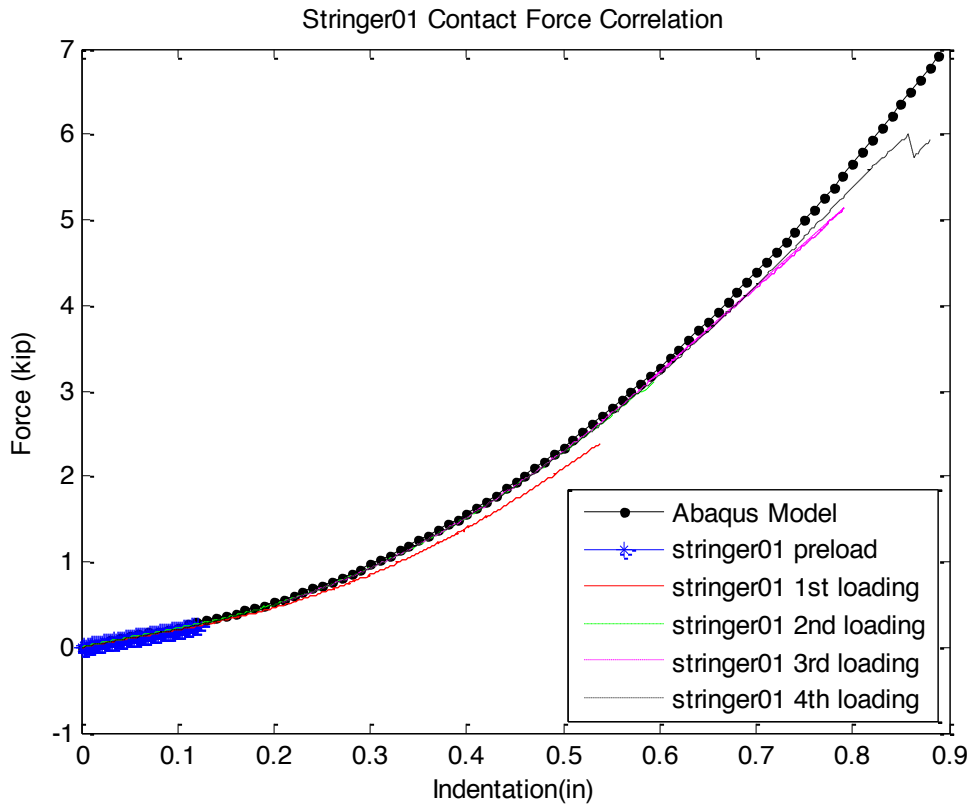
Figure 63. Contact Force of Stringer01 Model Plotted vs. Test Data

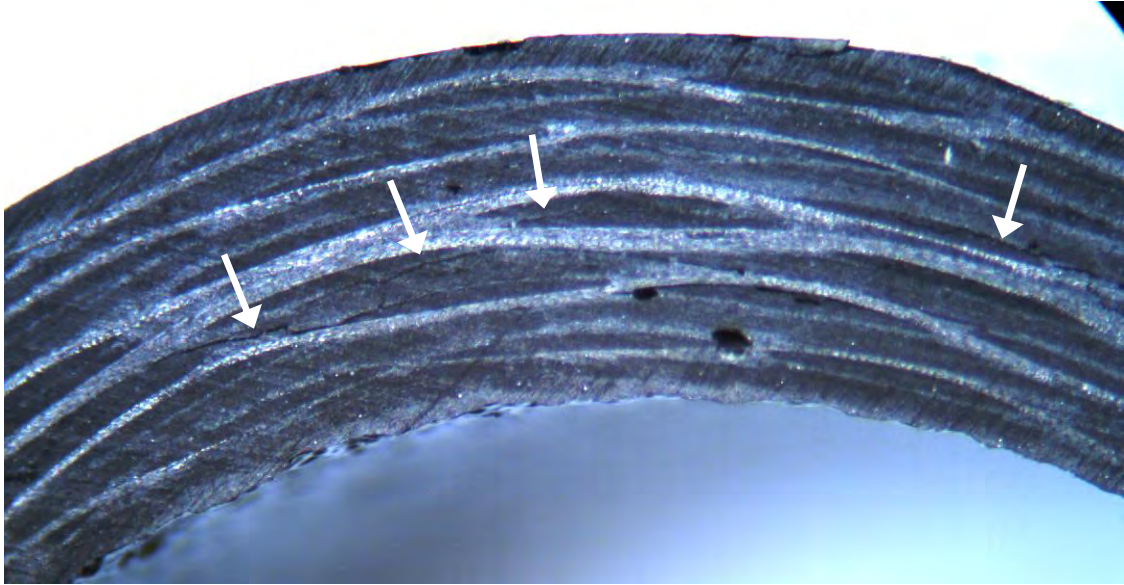
Figure 68. Photomicrograph of Shear Tie Coupons Showing Radial Delamination

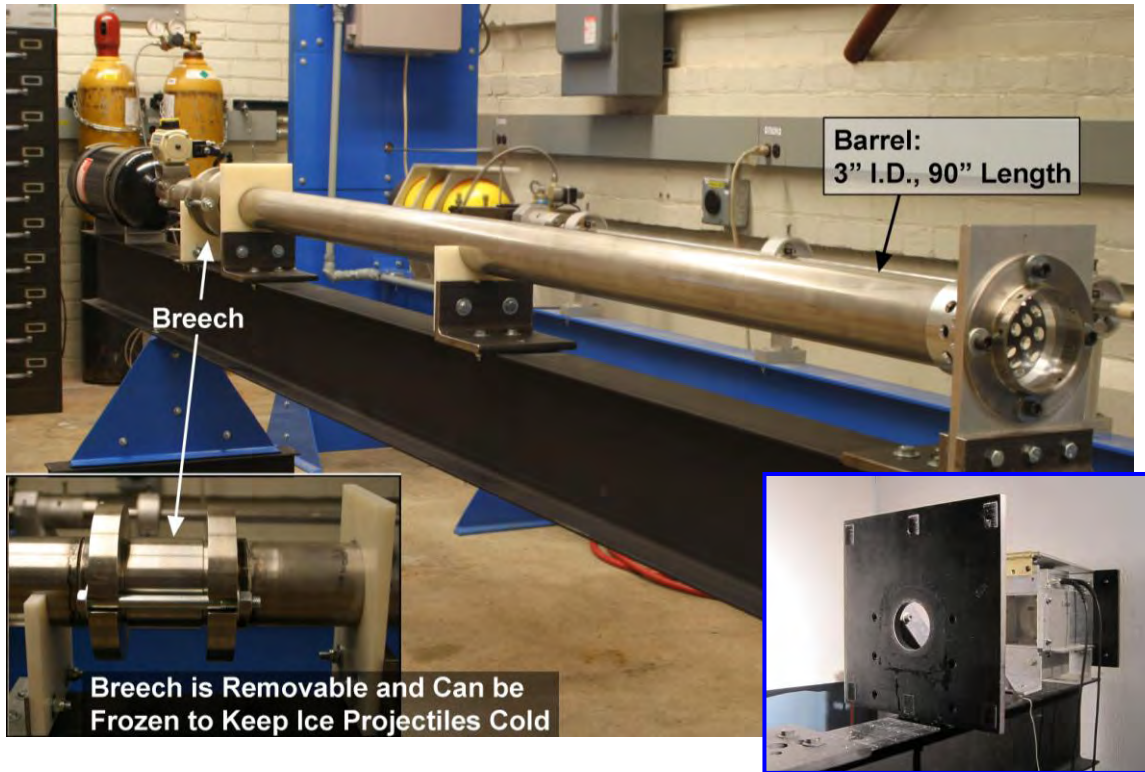
Figure 69. High Velocity Gas Gun System; Sabot Stop and Laser Photogate in Inset

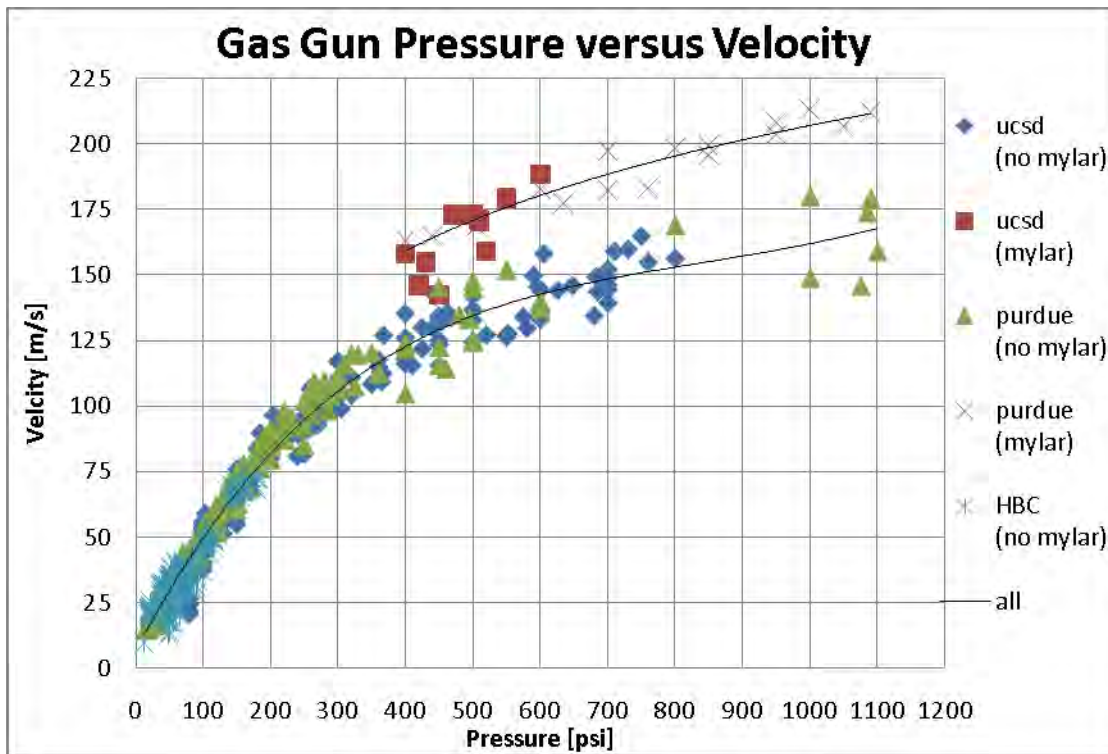
Figure 70: Gas Gun Pressure Versus Velocity

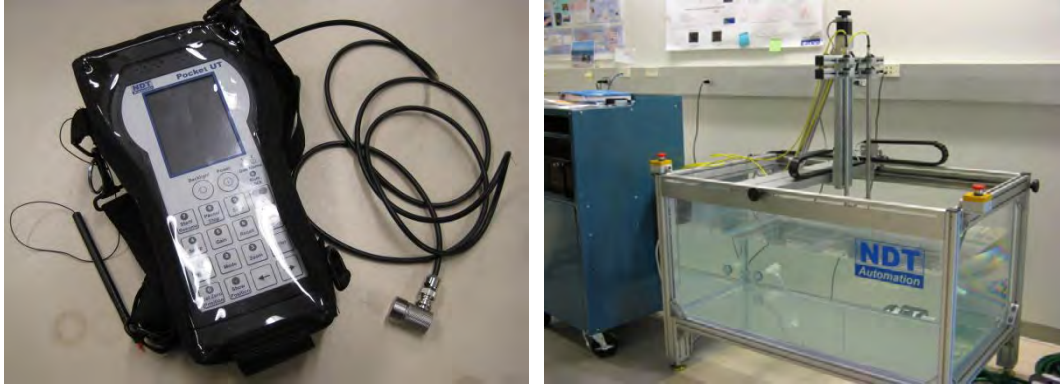
Figure 71: NDE Equipment; Pocket UT (Left) and C-Scan Immersion Tank (Right)

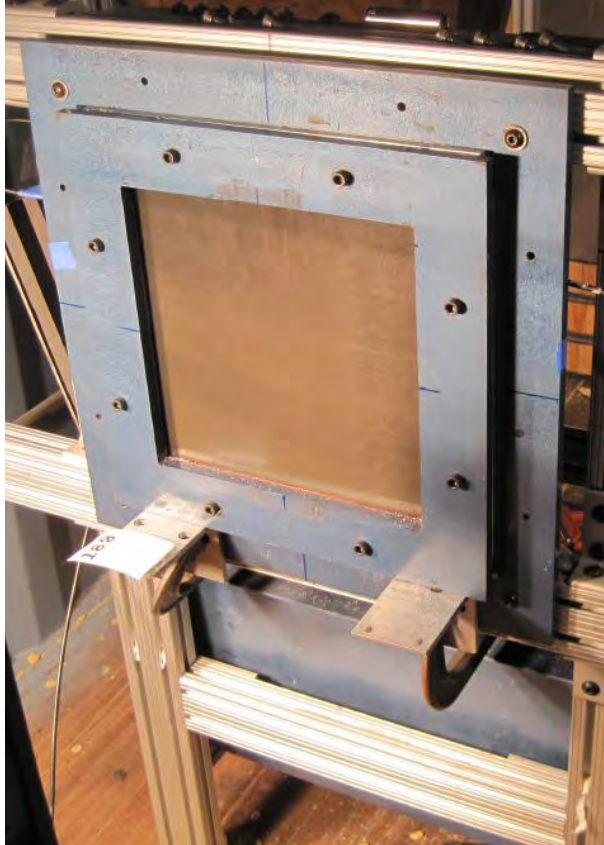
Figure 72: Composite Panel Mounted in “Picture Frame” Fixture

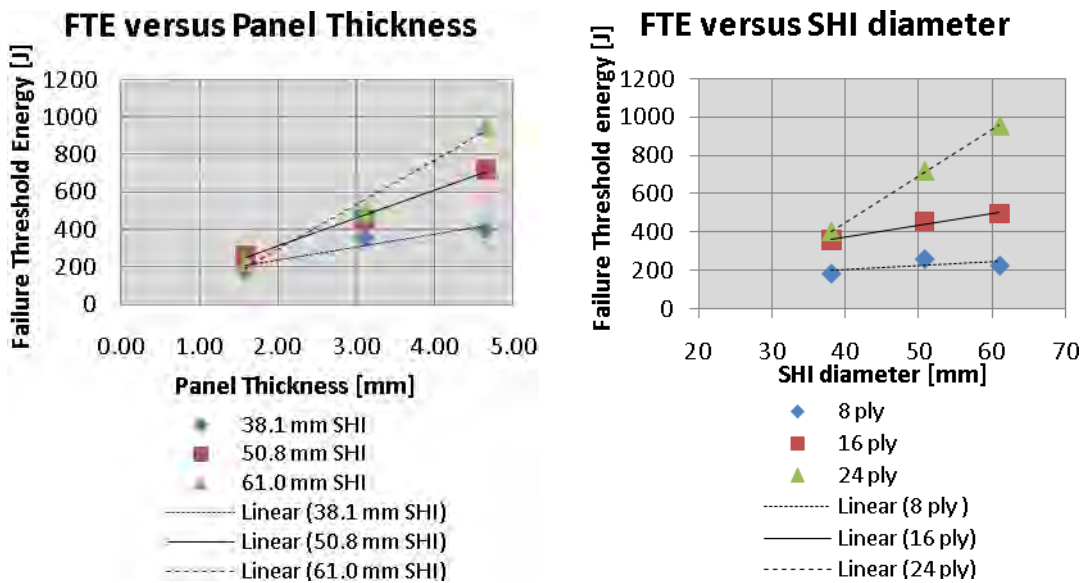
Figure 73: FTE Versus Panel Thickness and SHI Diameter

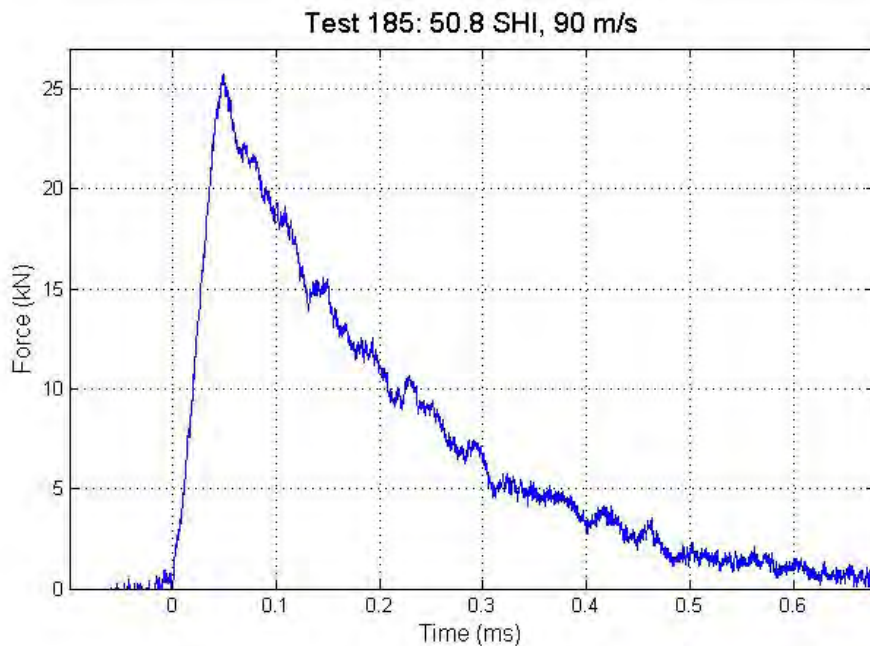
Figure 77: “Typical” Force History; 50.8 mm Ice at 90 m/s

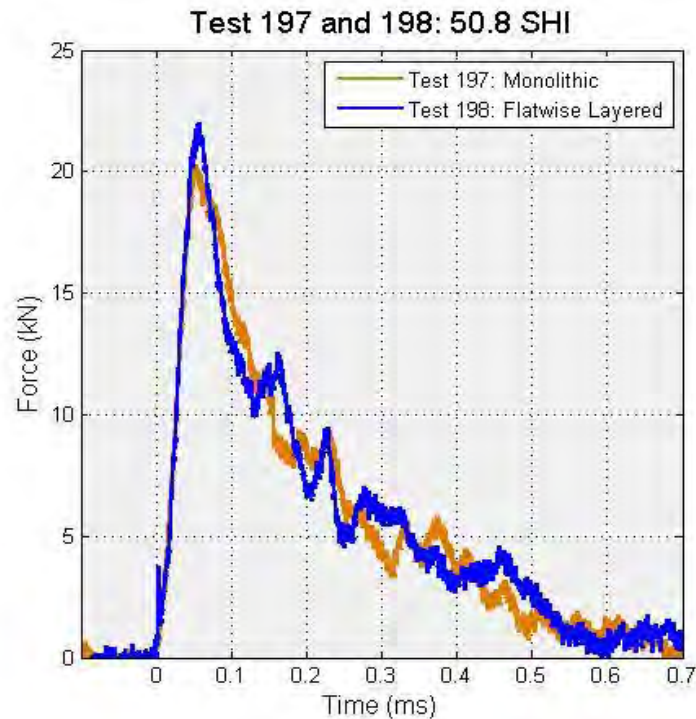
Figure 81: Comparison of Force History for Monolithic and Flatwise Layered SHI; 50.8 mm SHI at 80 m/s

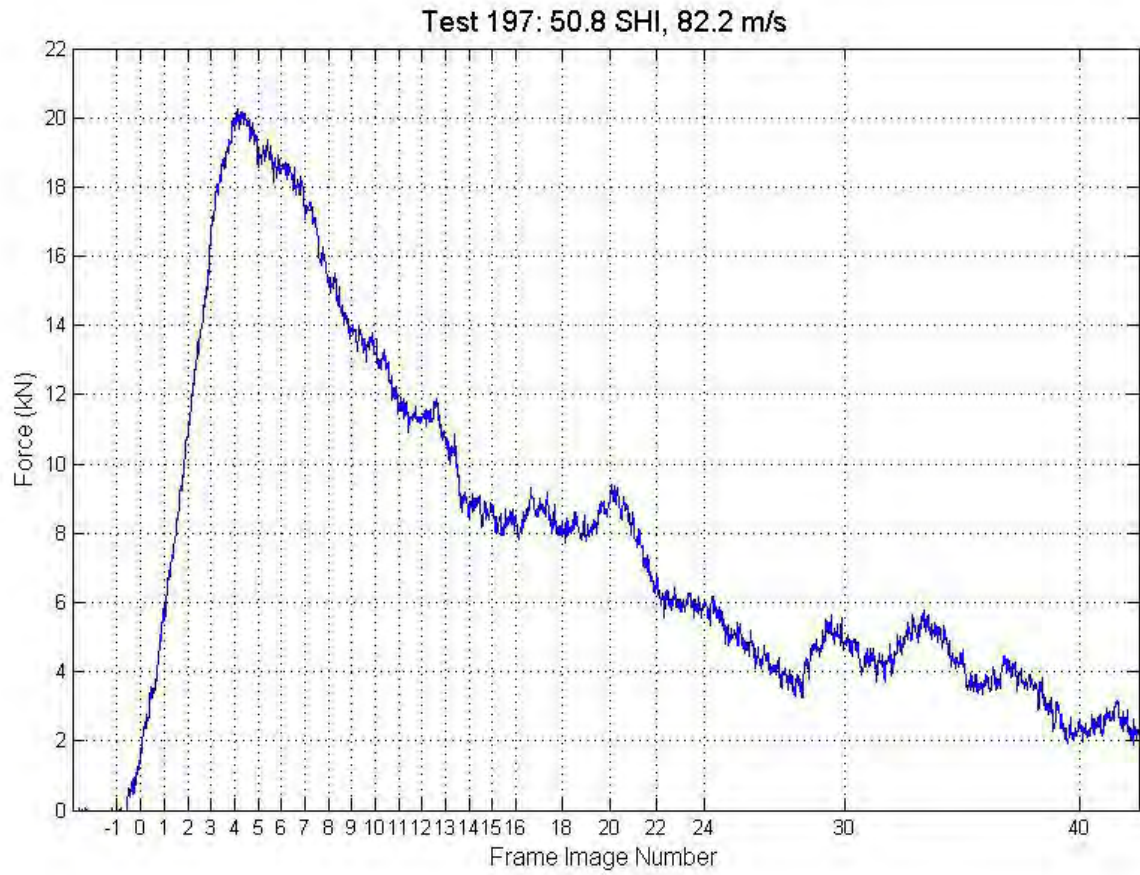
Figure 82: Frame Image Numbers on Force History; 50.8 mm Ice at 82.2 m/s

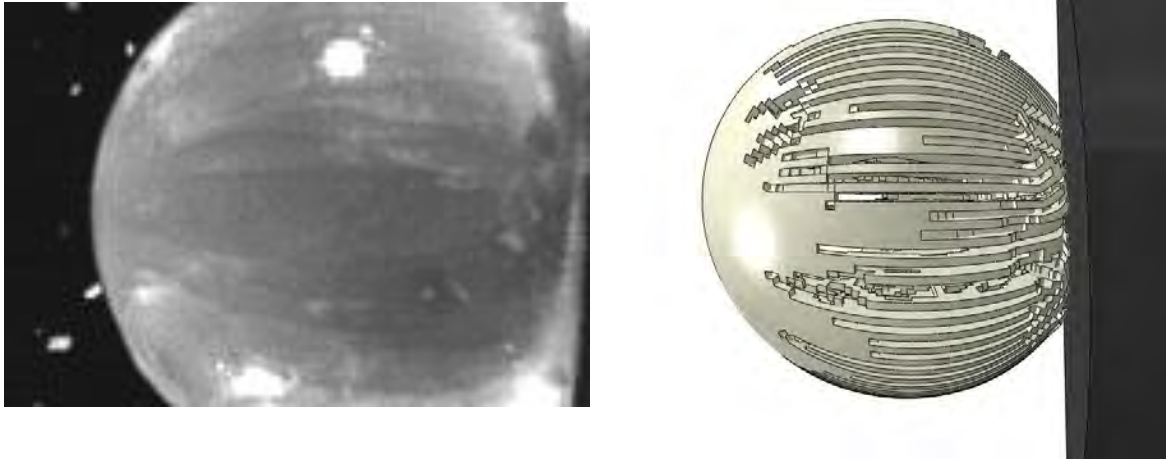
Figure 84. Comparison of Test 195 (61 mm Dia. at 61 m/s) Video (Left) and ABAQUS Simulation (Right) with Failed Elements Removed From View at 75 μ s After Initial Contact.
