Evaluation of Peel-Ply Materials on Composite Bond Quality

Molly K.M. Phariss*, Brian D. Flinn*,
Bjorn Ballien*, William Grace# and Peter J.
VanVoast#

* University of Washington, Seattle WA

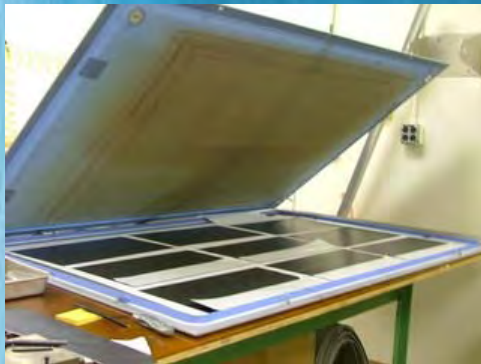
Autoclave Cure

Unidirectional 10 Ply
Toray Carbon Fiber
Prepreg Laminates

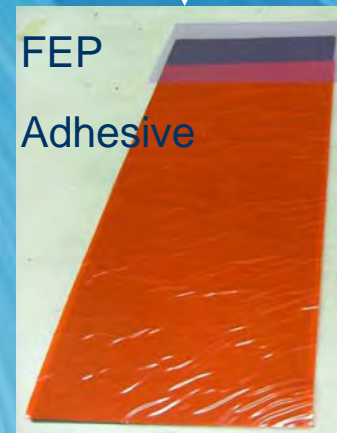
Bonded with film
adhesive A or B

Autoclave Cure

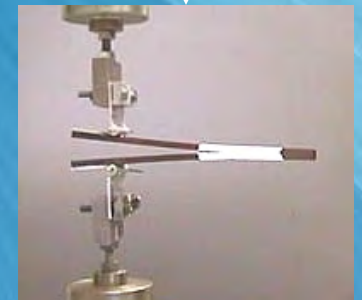
ASTM D-5528
To find G_{IC}

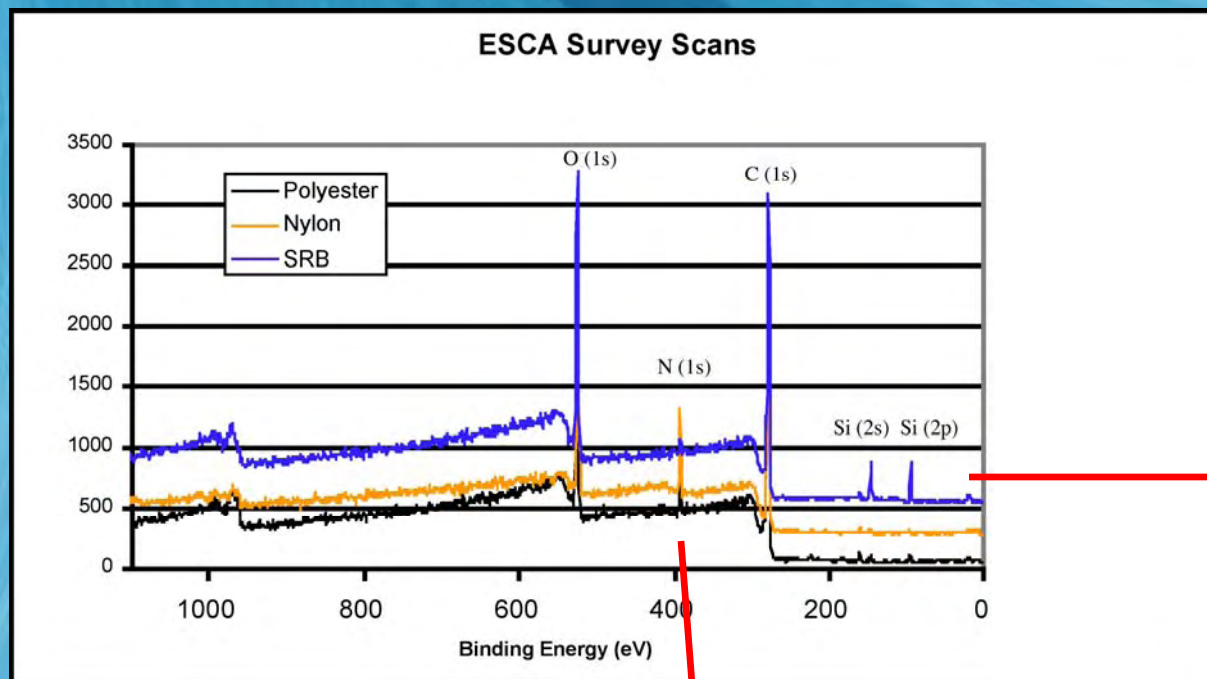
XPS survey scans found contamination on SRB and 52006 prepared surfaces.

- ♦ Amount of N, especially in nylon prepared, unexpected
 - ♦ Further suggests material transfer

- ♦ Si explains SRB low bond quality
 - ♦ Siloxane coating transfers
