UAS for Rockfall Site Monitoring

UAS in Transportation Workshop, Corvallis, OR

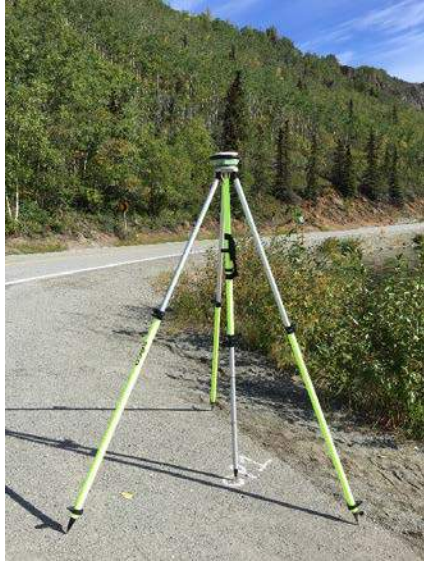
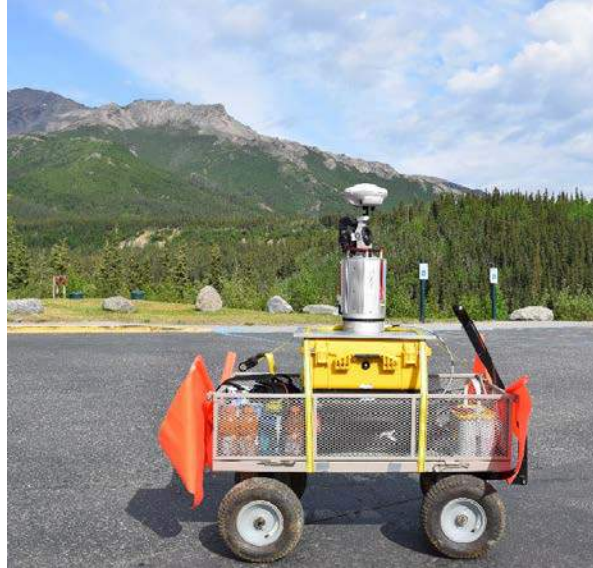
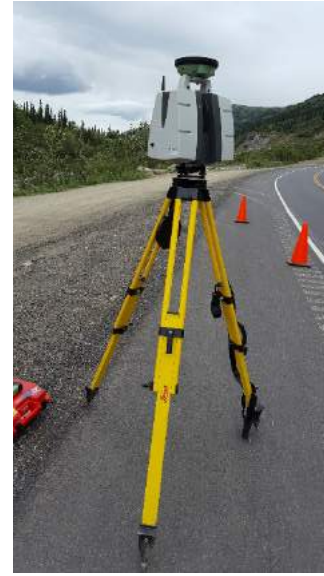
Leica GS14 GNSS Receiver Riegl VZ-400 Laser Scanner

Leica P40

Leica TS15 Total Station

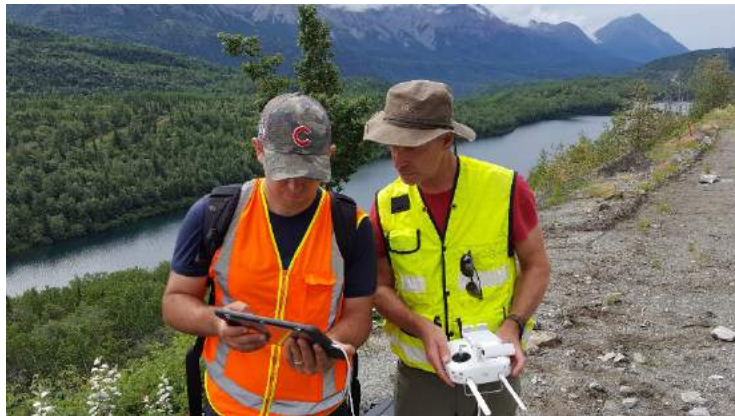
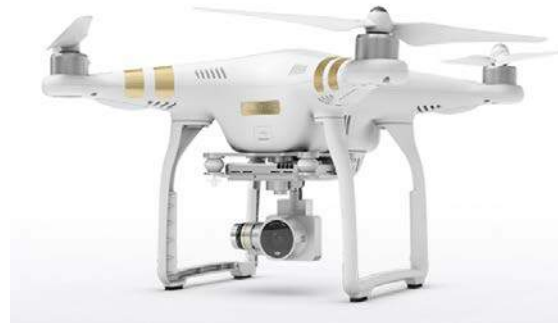
DJI Phantom Professional 3

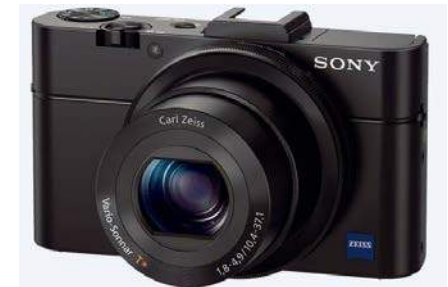
Sony DSC-RXM2 Camera

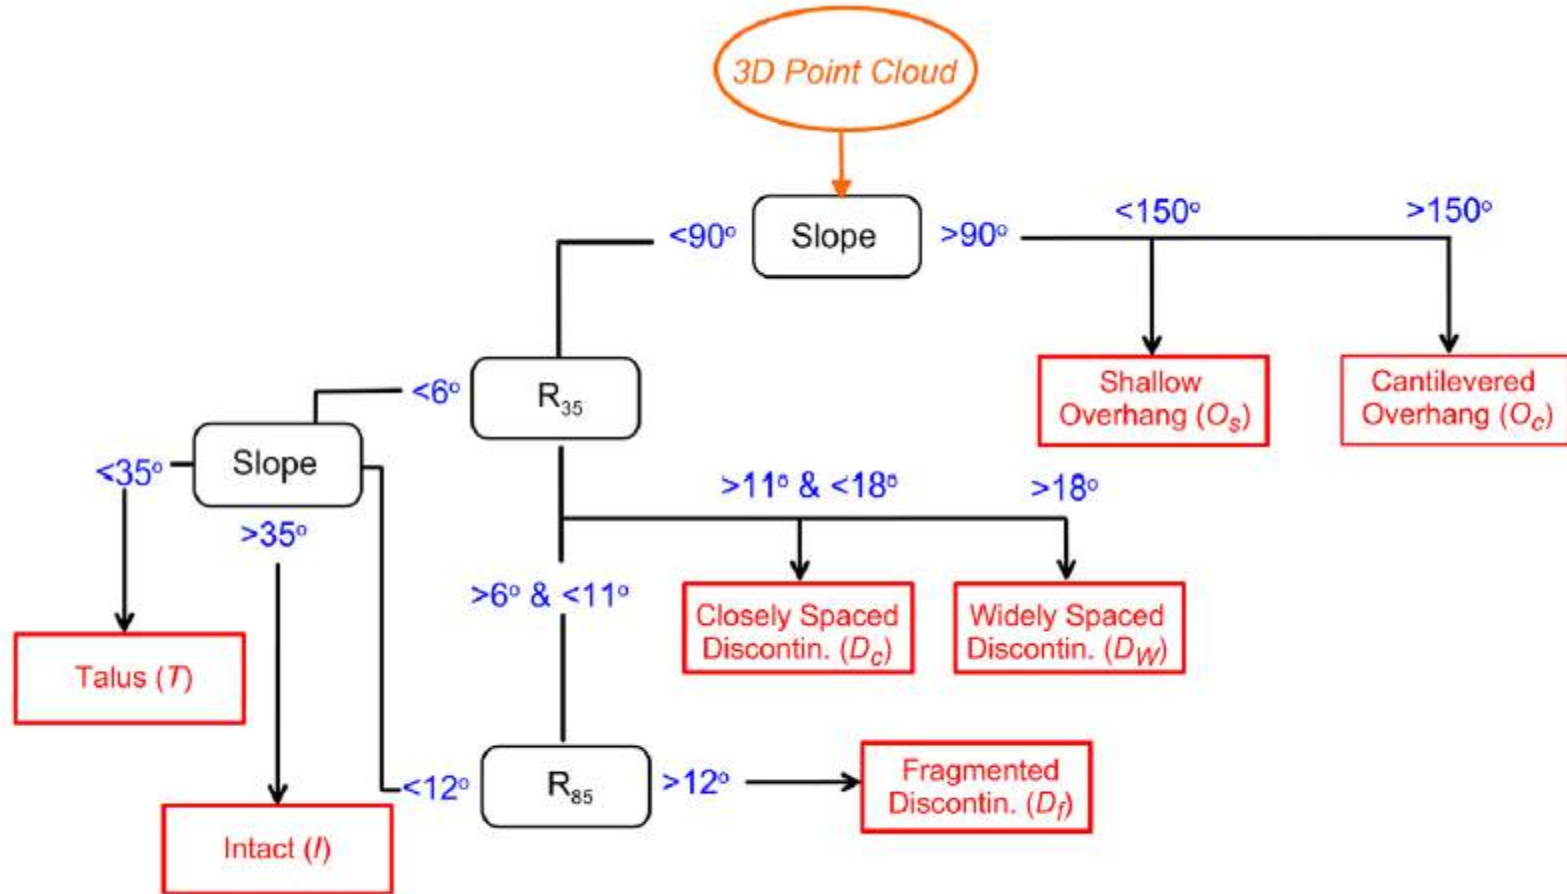
Rockfall Activity Index (RAI)

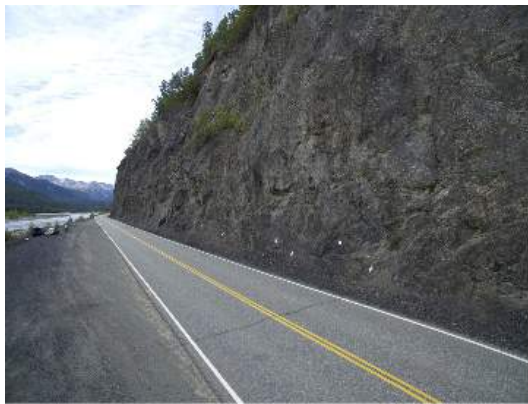
RS1
~9,300 m²

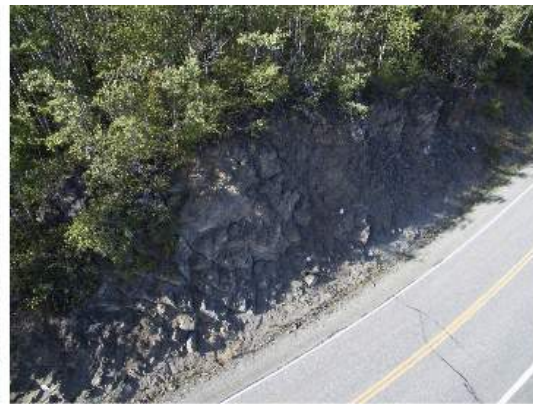
RS2
~450 m²

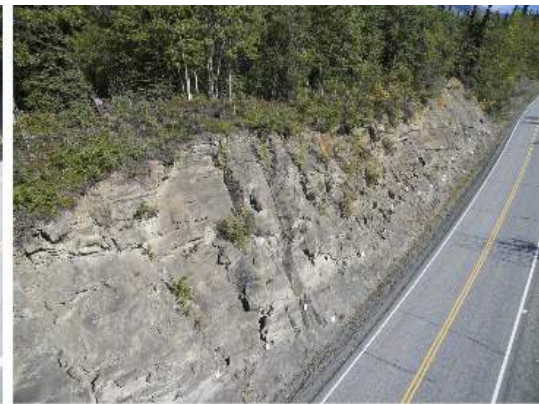
RS3
~1,680 m²

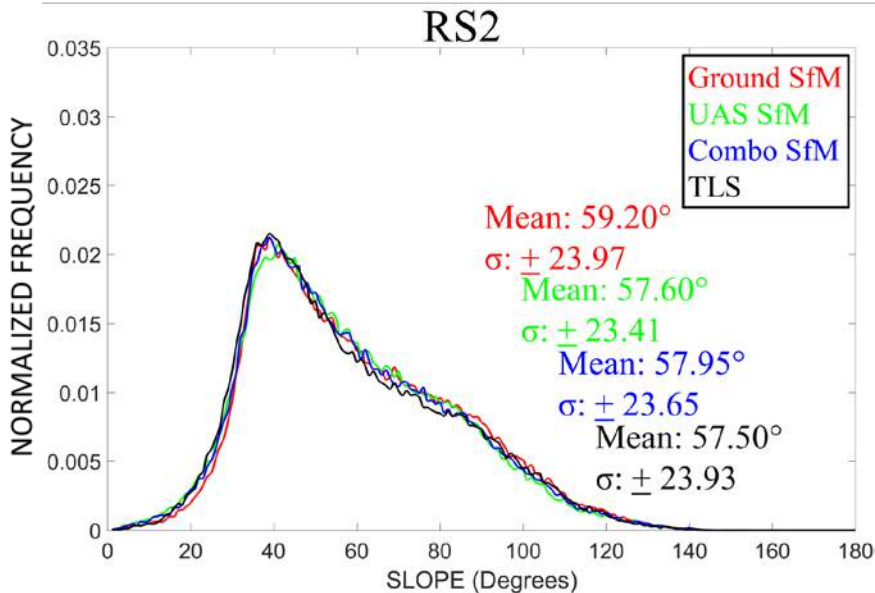
Surface Morphology – Slope

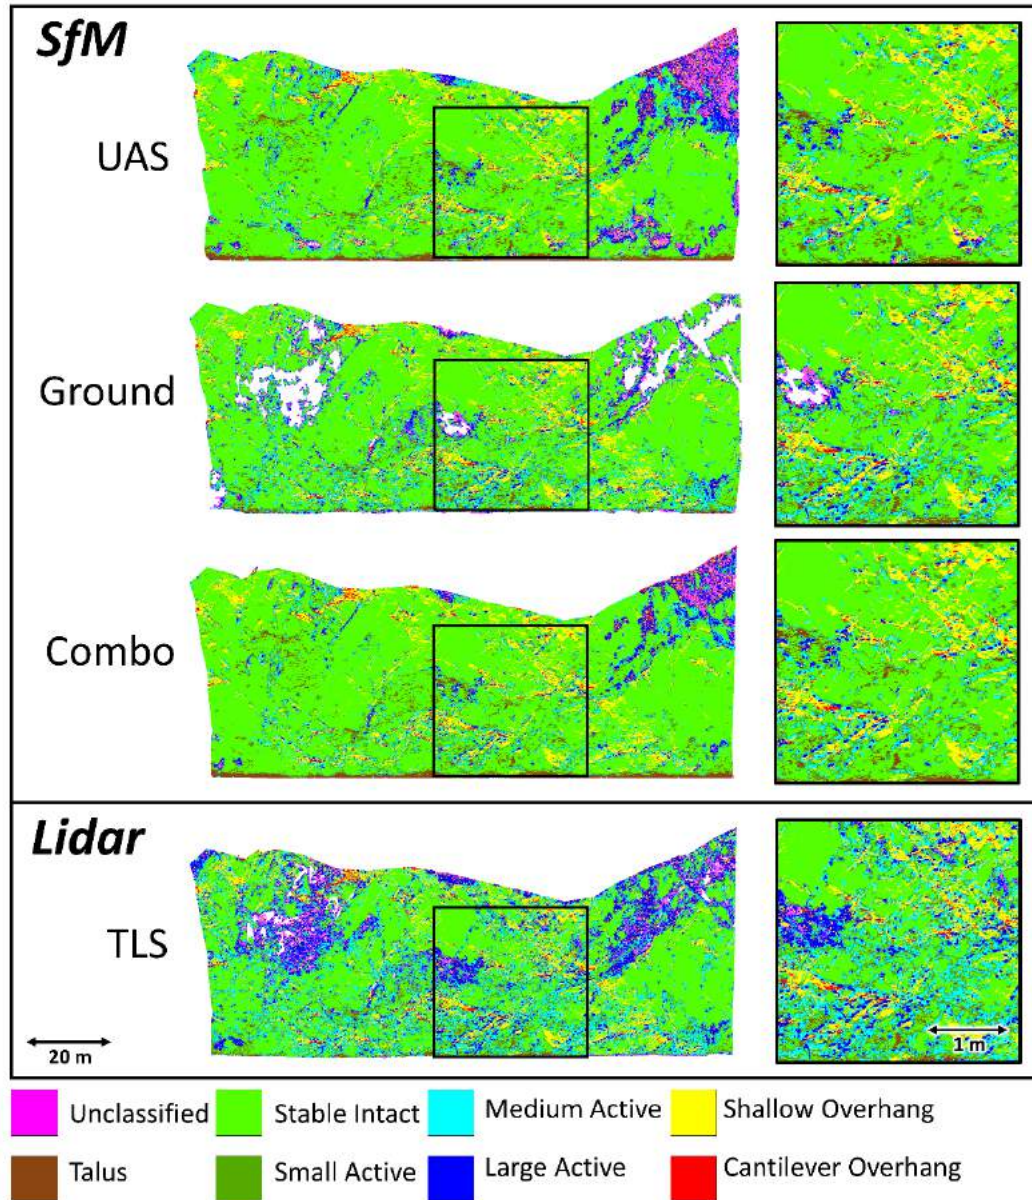
Rock-Slope Morphology Classification

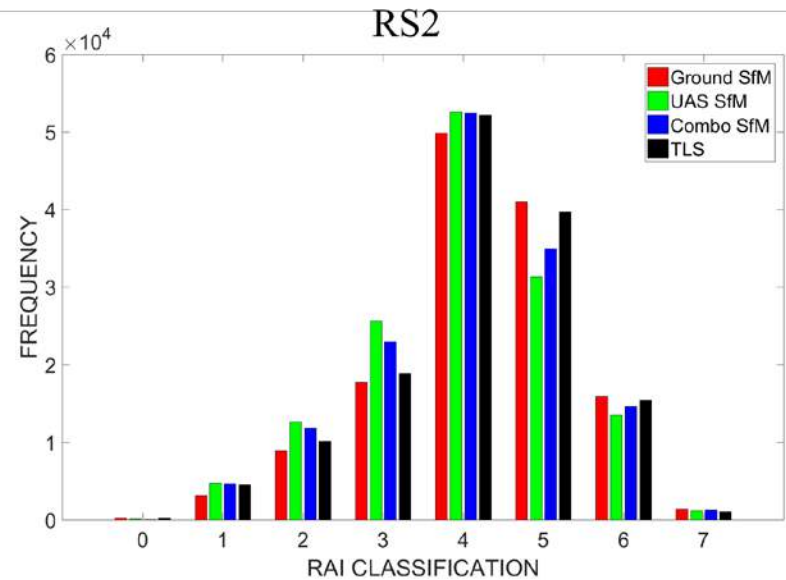
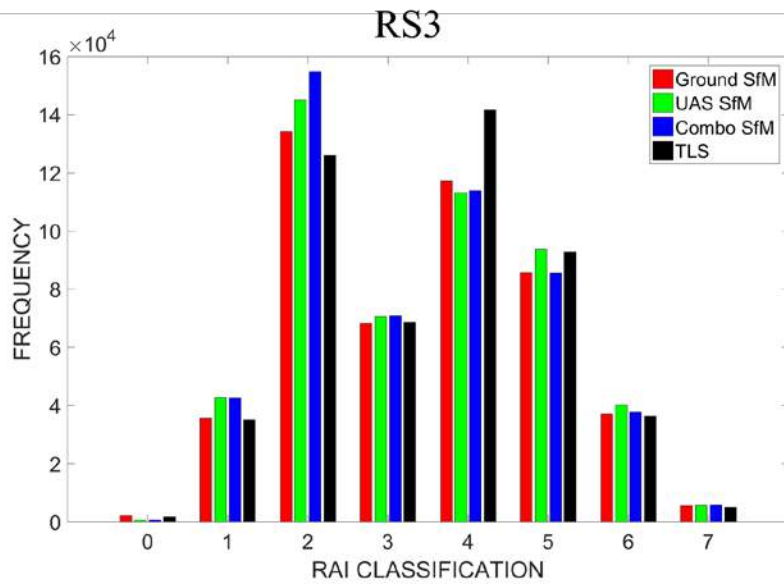
Rock-Slope Morphology Classification

Rock Activity Index (RAI) Classifications

0: Unclassified

1: Talus

2: Stable Intact Rock

3: Small Active Discontinuities

4: Medium Active Discontinuities

5: Large Active Discontinuities

6: Shallow Overhang

7: Cantilever Overhang
