Lessons Learned from OSU PacTrans & ODOT UAS Projects

UAS in Transportation Workshop

3+ Years' of Research Projects

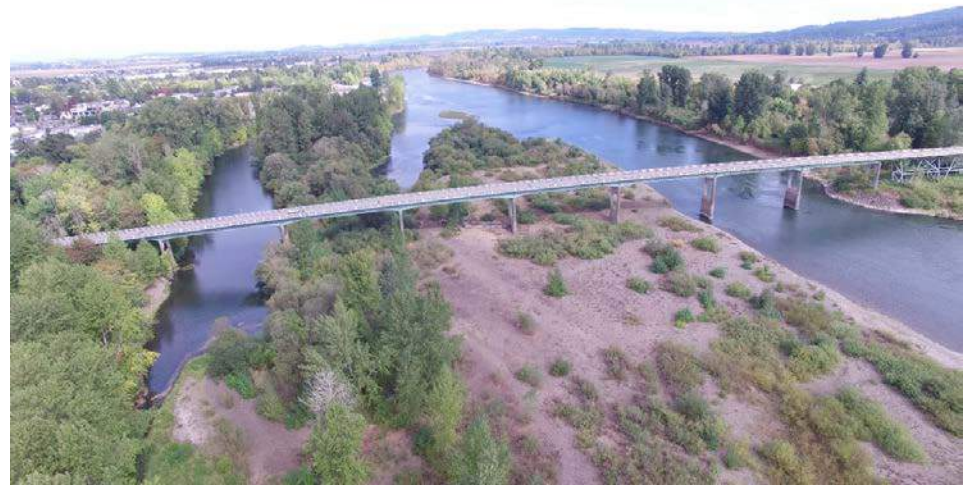
Independence Bridge: Sept 2015

- Large deck plate girder bridge
- 675.4 m long
 - Longest span: 46.3 m
- Classified as Fracture Critical

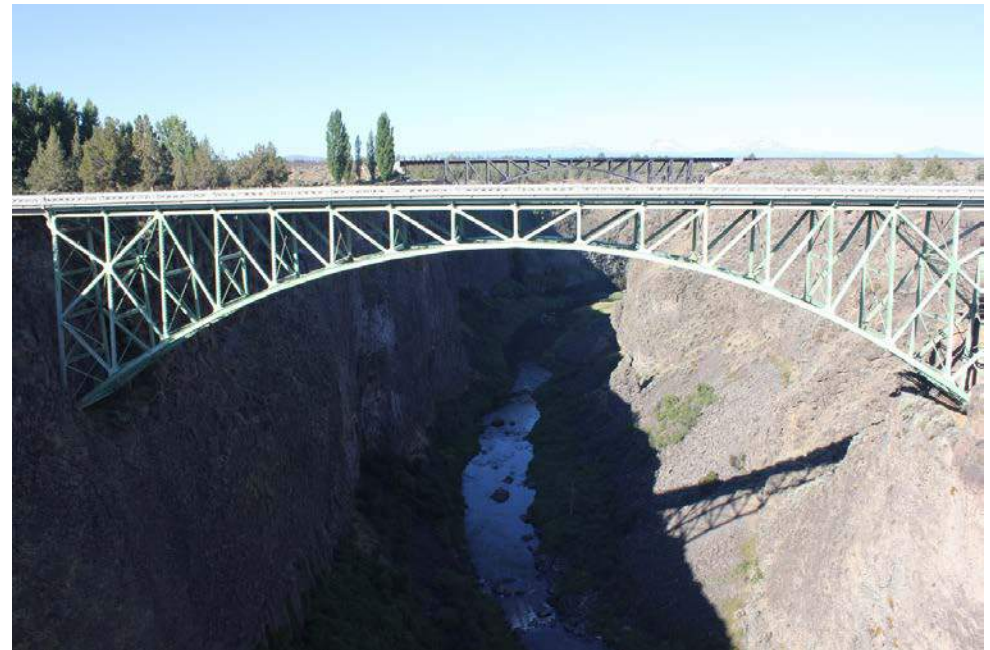
Crooked River Bridge: July 2016

- Steel Arch Bridge
- 141 m long
 - Longest span: 100 m
- Pedestrian Only

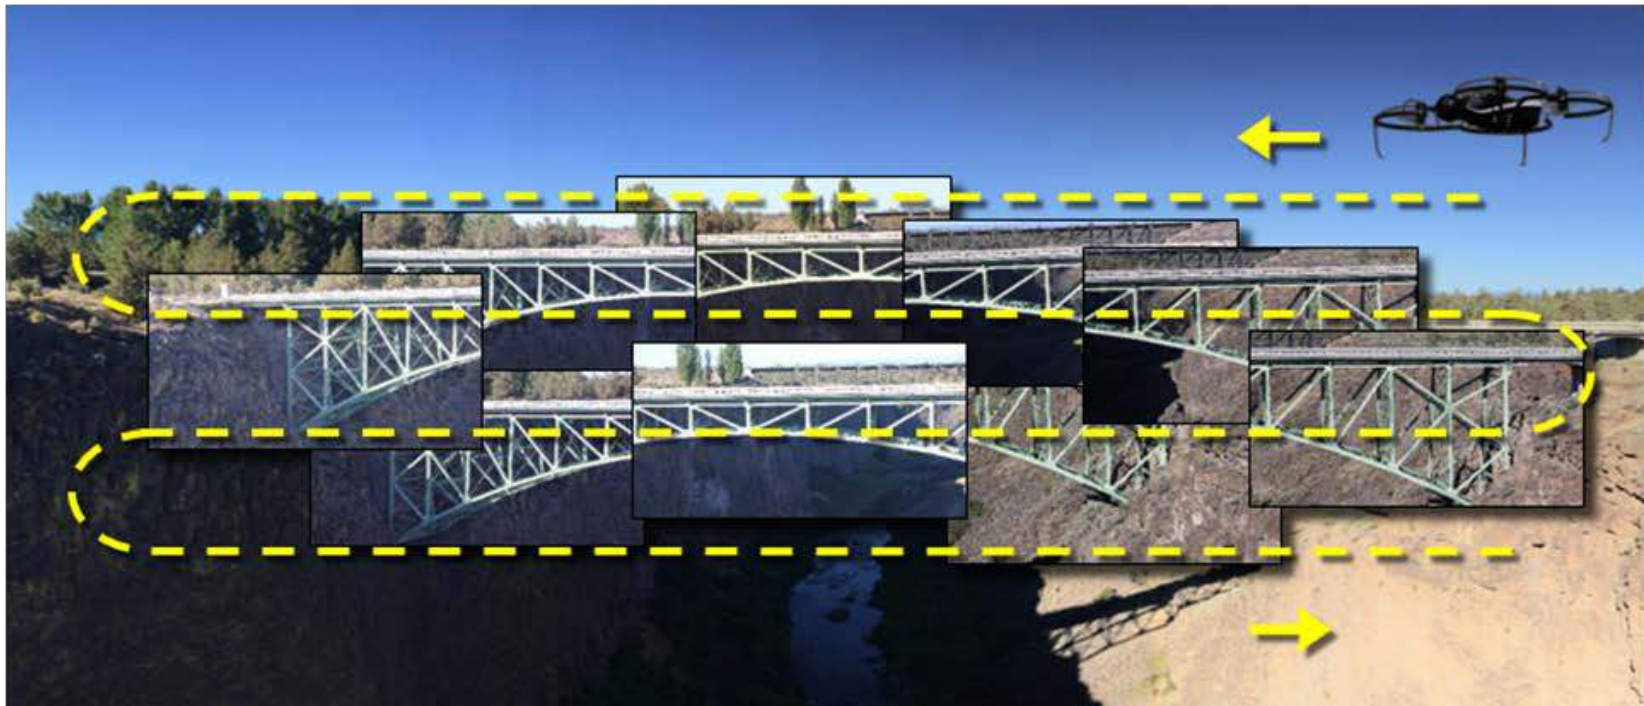
Flight Methods

Schematic representation of overlapping images taken from a UAS and the flight path using manual flight mode with sensor assistance (from Javadnejad et al. 2017, with permission)

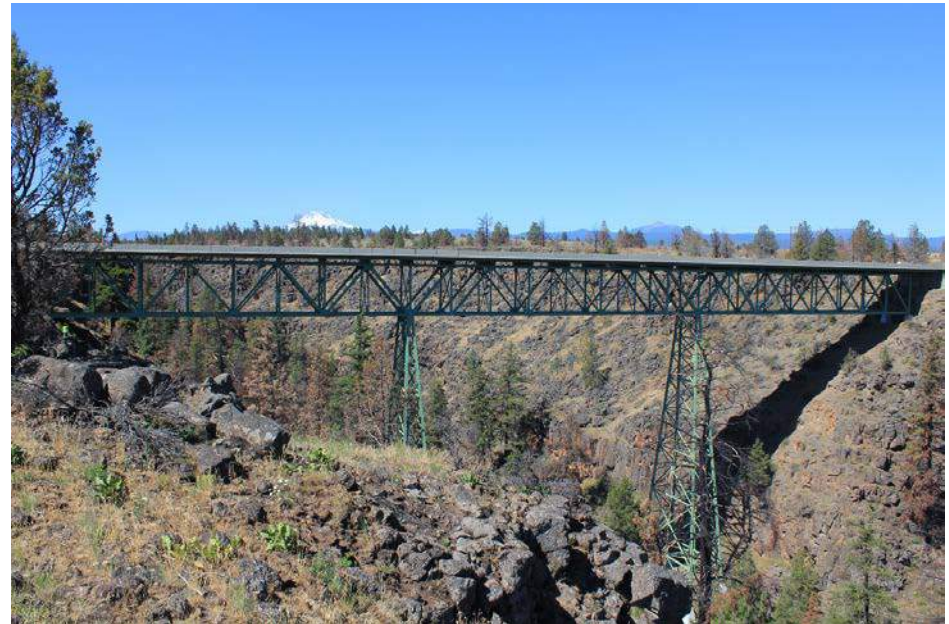
Mill Creek Bridge, July 2016

- Cantilevered Warren deck truss bridge
- 163 m long
 - Longest span: 50 m

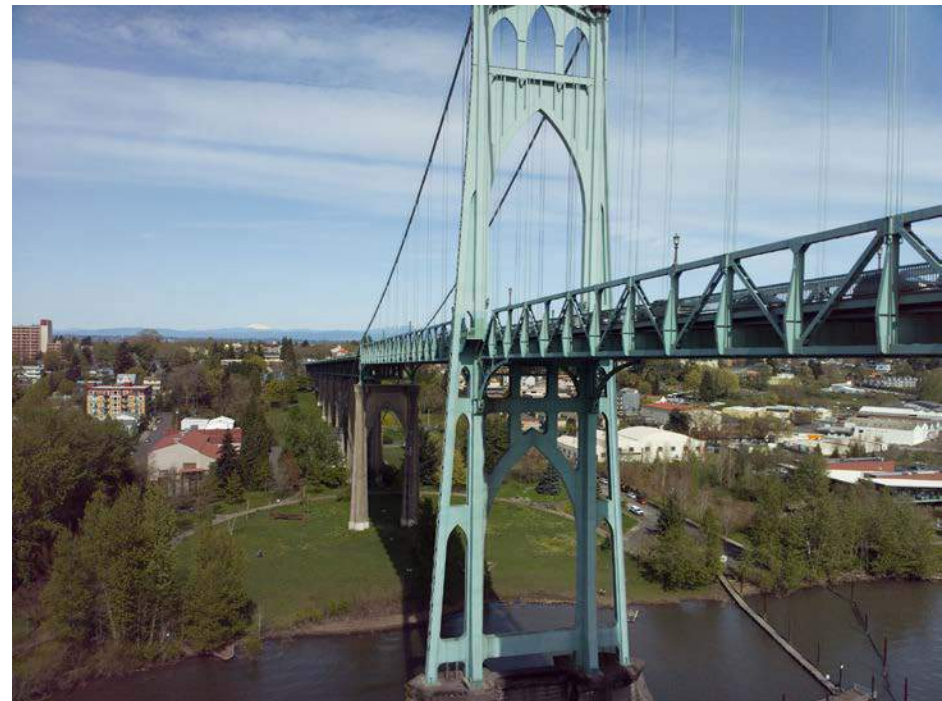
St. Johns Bridge (Prelim Test), Sept 2016

- Metal Riveted Warren deck truss
- Wire Cable Suspension
- 1100 m long
 - Longest span: 368 m

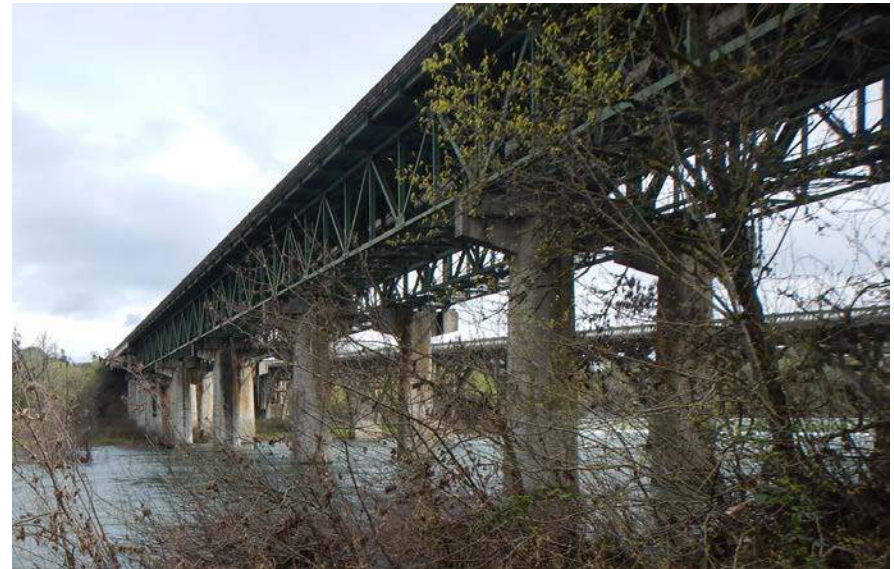
Winchester Bridge, March 2017

- Warren deck truss bridge
- Southbound bridge of I-5
- 500 m long
 - Longest span: 42 m

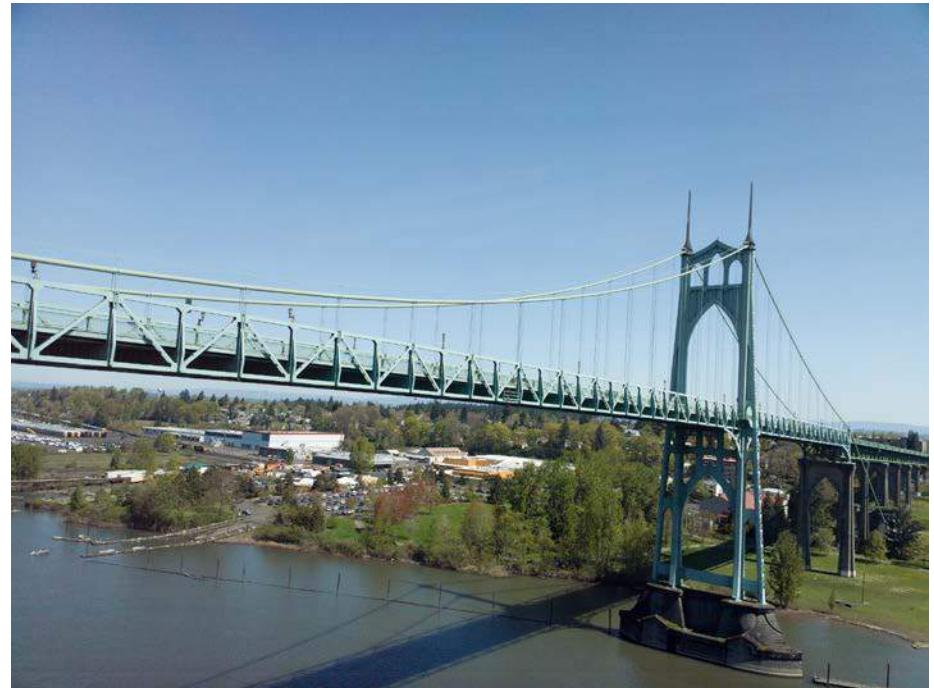
St. Johns Bridge (Detailed Test), April 2017

- Metal Riveted Warren deck truss
- Wire Cable Suspension
- 1100 m long
 - Longest span: 368 m
- Flight limited to eastern 550 m from center of main span

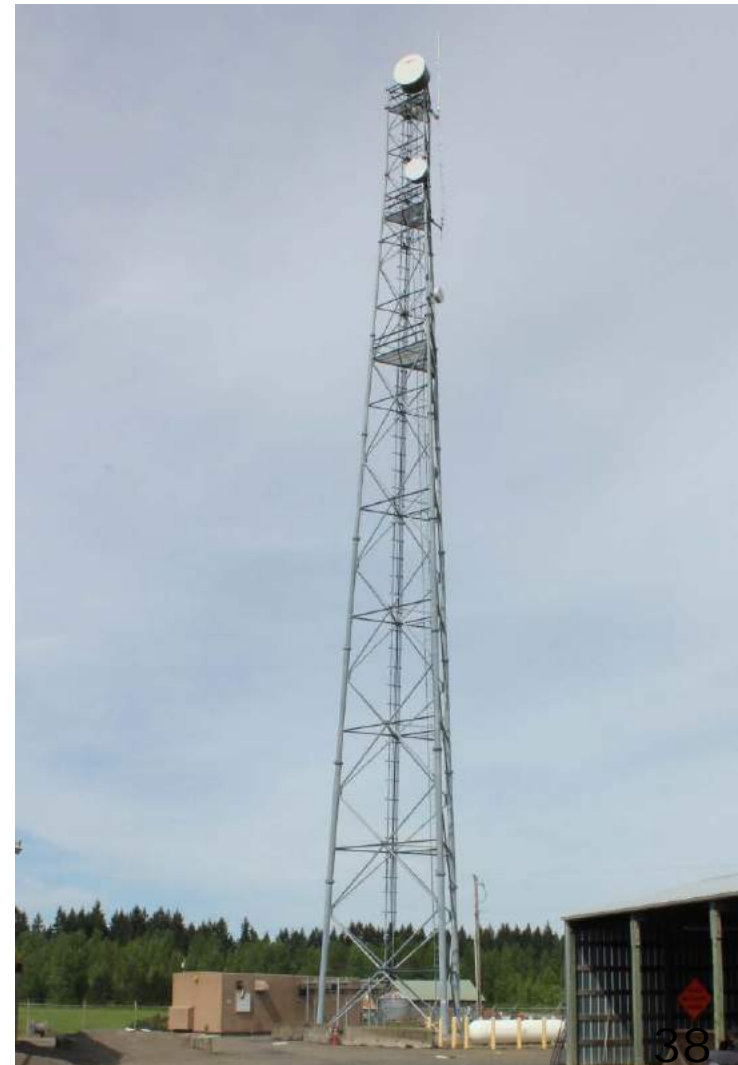
Woodburn Tower, April 2016

- Owned by Marion County
- A-Frame tower with triangle base
- 5 installed antennas
- 53 m tall

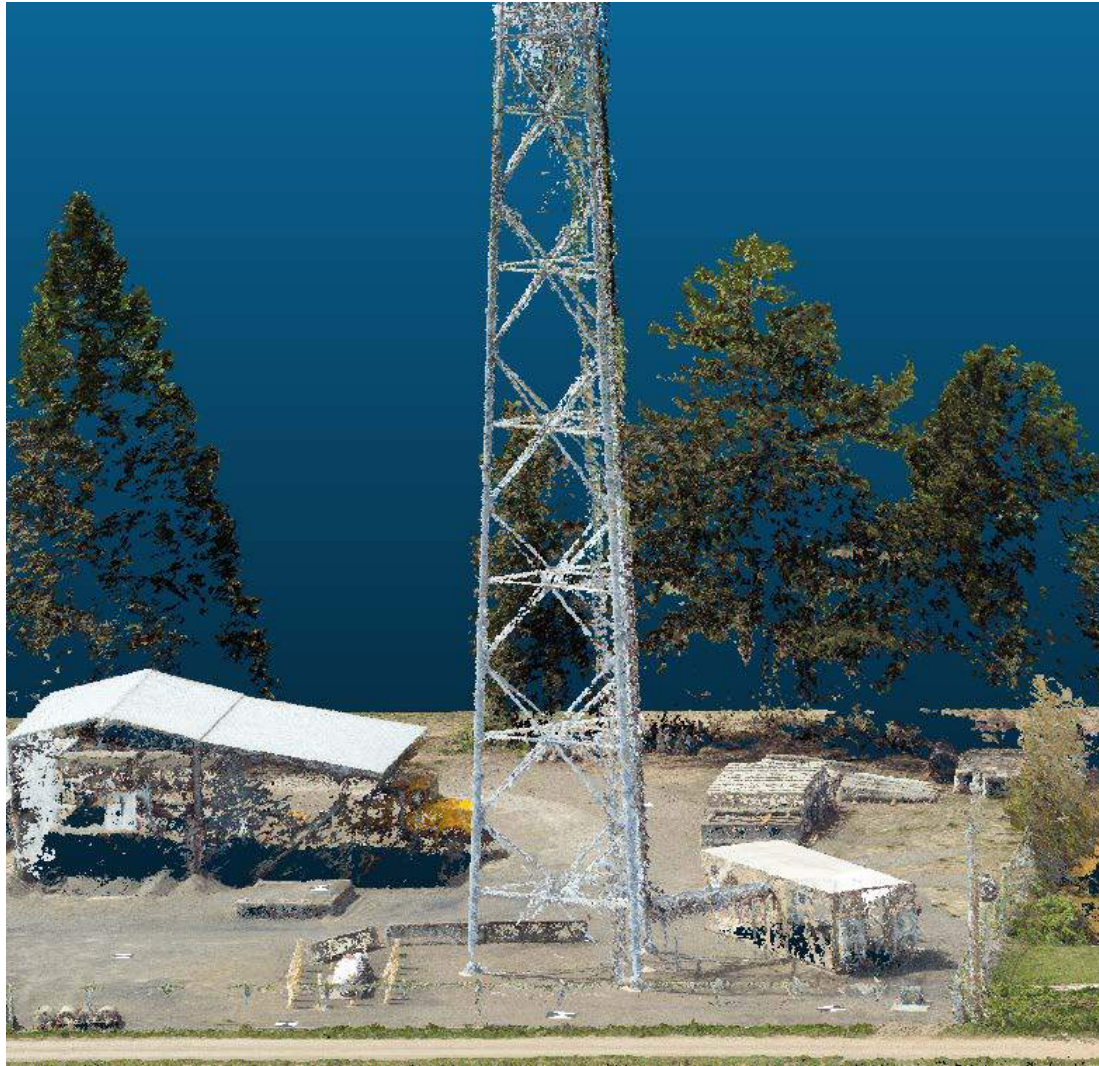
Woodburn Tower

Point cloud generated using PhotoScan

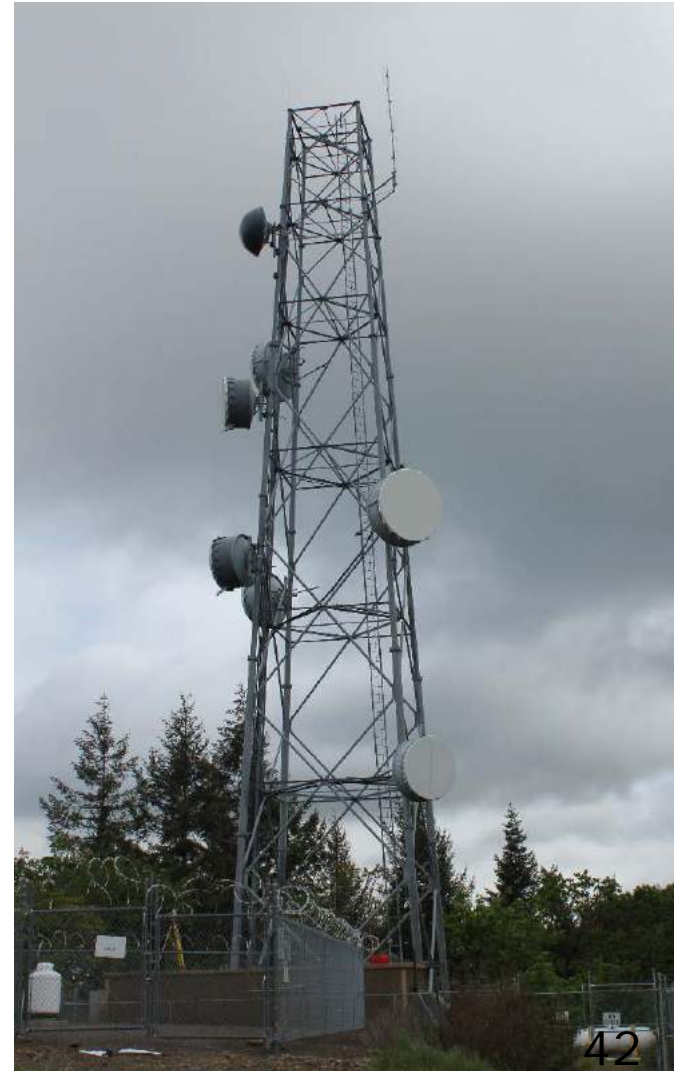
Washburn Butte Tower, April 2016

- A-Frame tower with square base
- 8 installed antennas
- 48.8 m tall

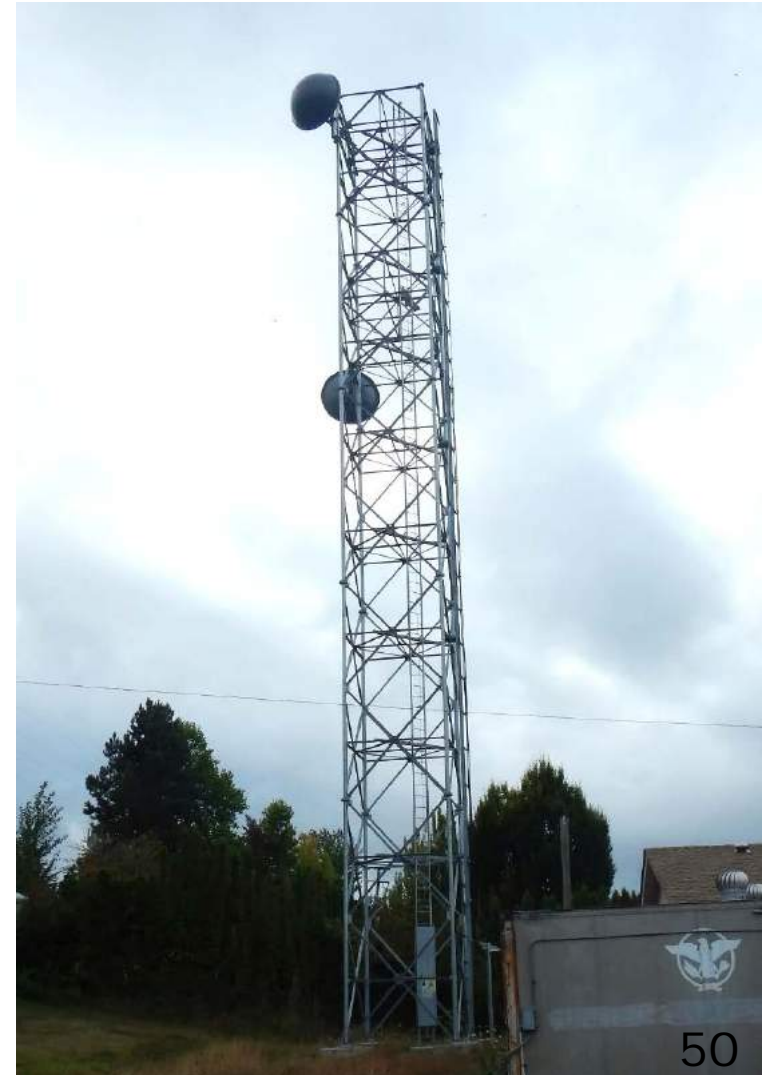
Corvallis Maintenance Site Tower, April 2016

- Rectangular tower with square base
- 2 installed antennas
- 27.4 m tall

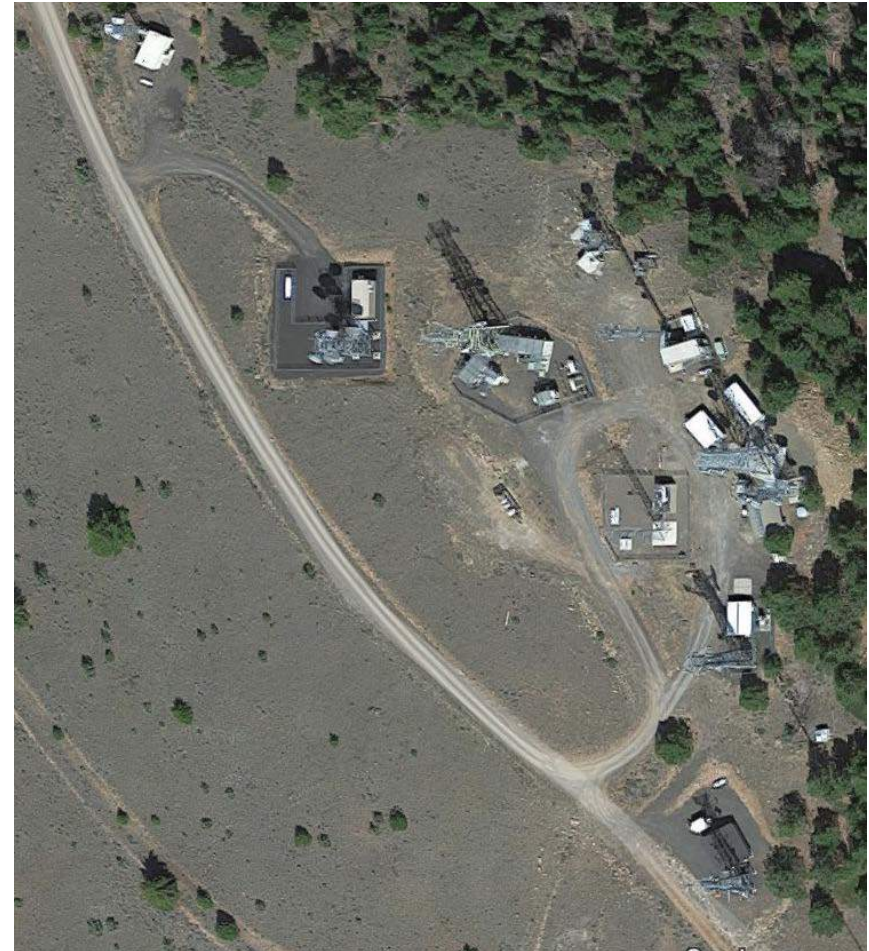
Grizzly Mountain Tower

- Over 10 towers near mountain summit
- Detected significant frequency interference using a spectrum analyzer
 - 2.4 and 5.0 GHz frequencies
- Interference from nearby Wireless Internet Service Provider (WISP) towers
- Unable to perform any flights
 - Tried all possible radio frequencies available
