# Mount Rainier National Park

## The Great Flood of November 2006

Updated April 27, 2007

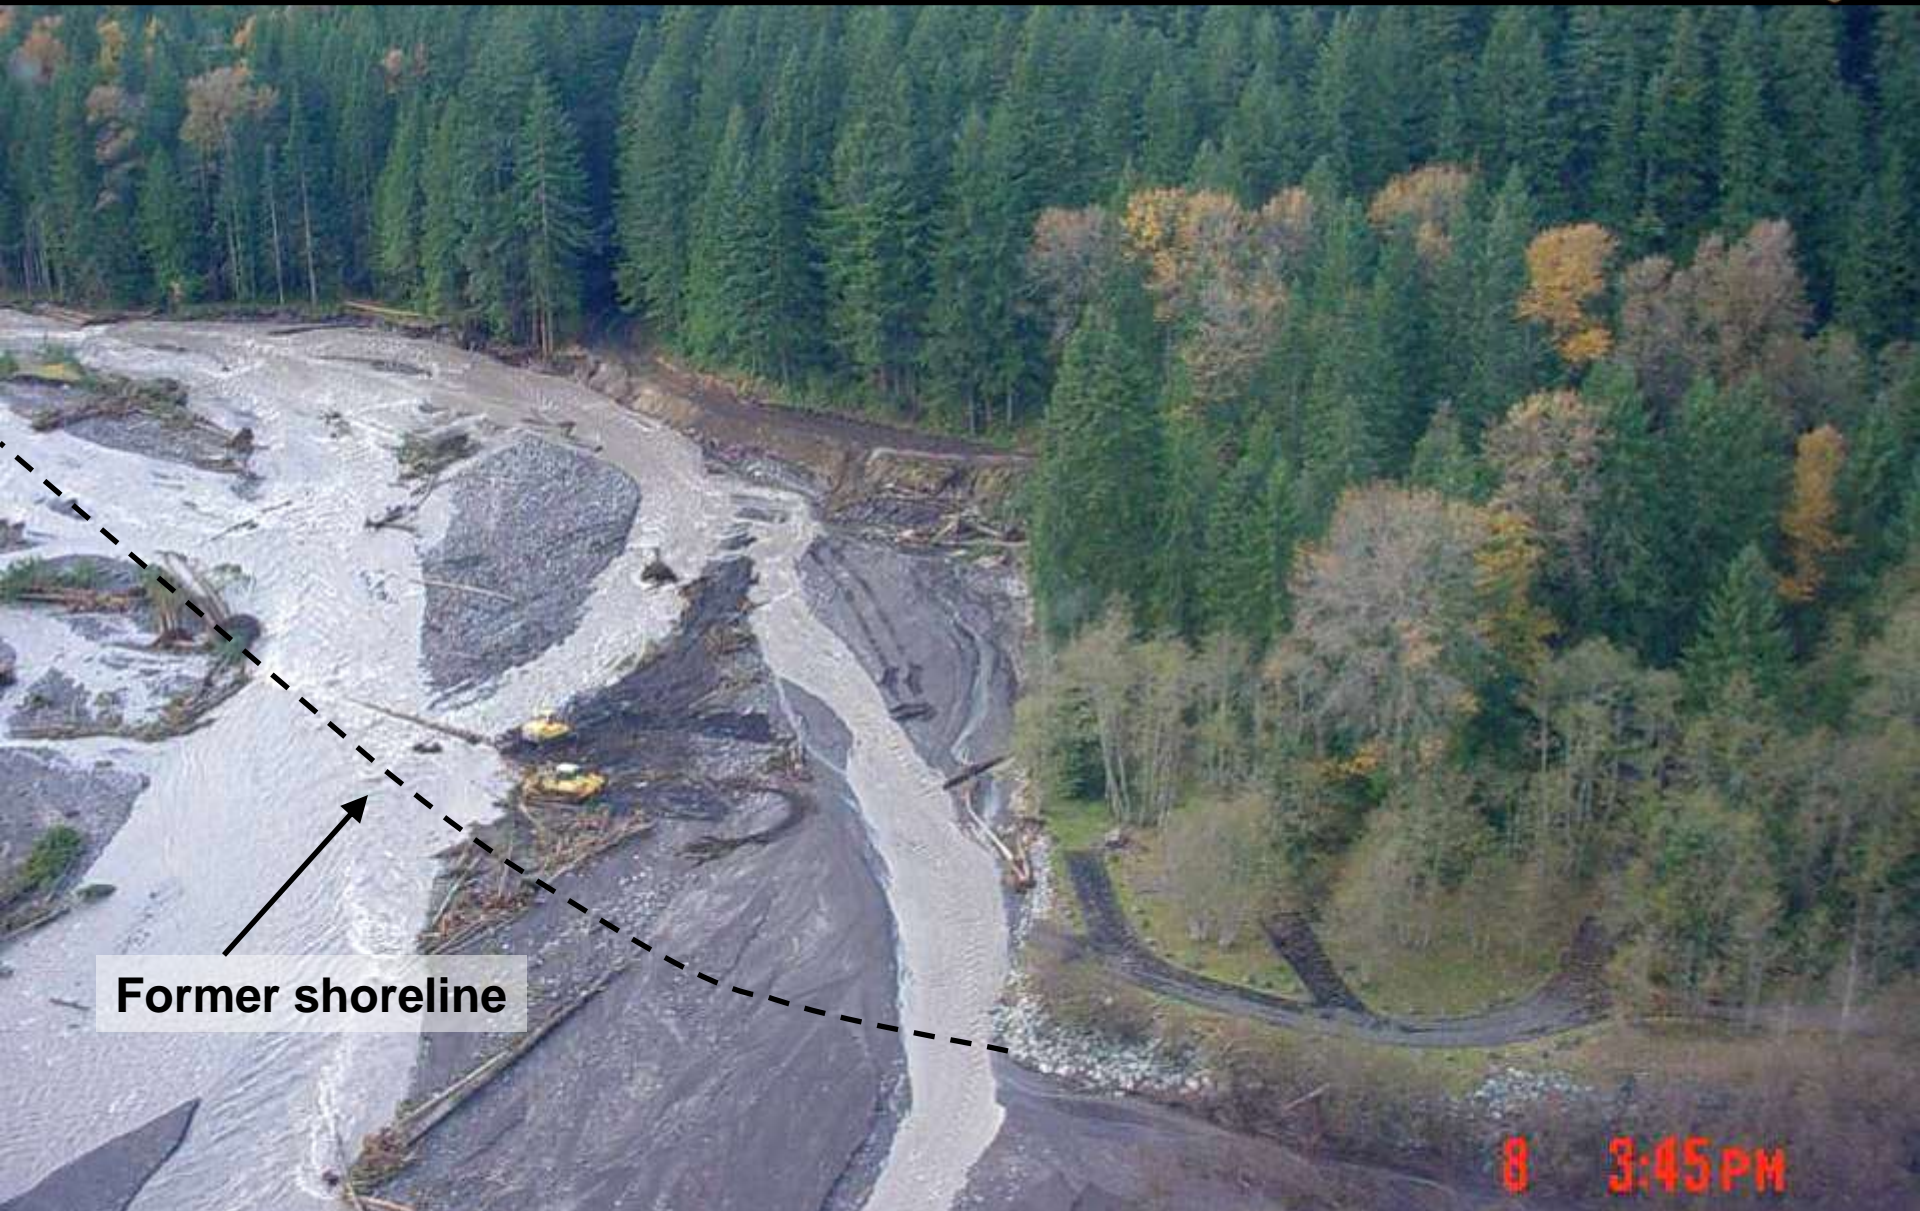
In all, more than 5 acres of land were washed away.

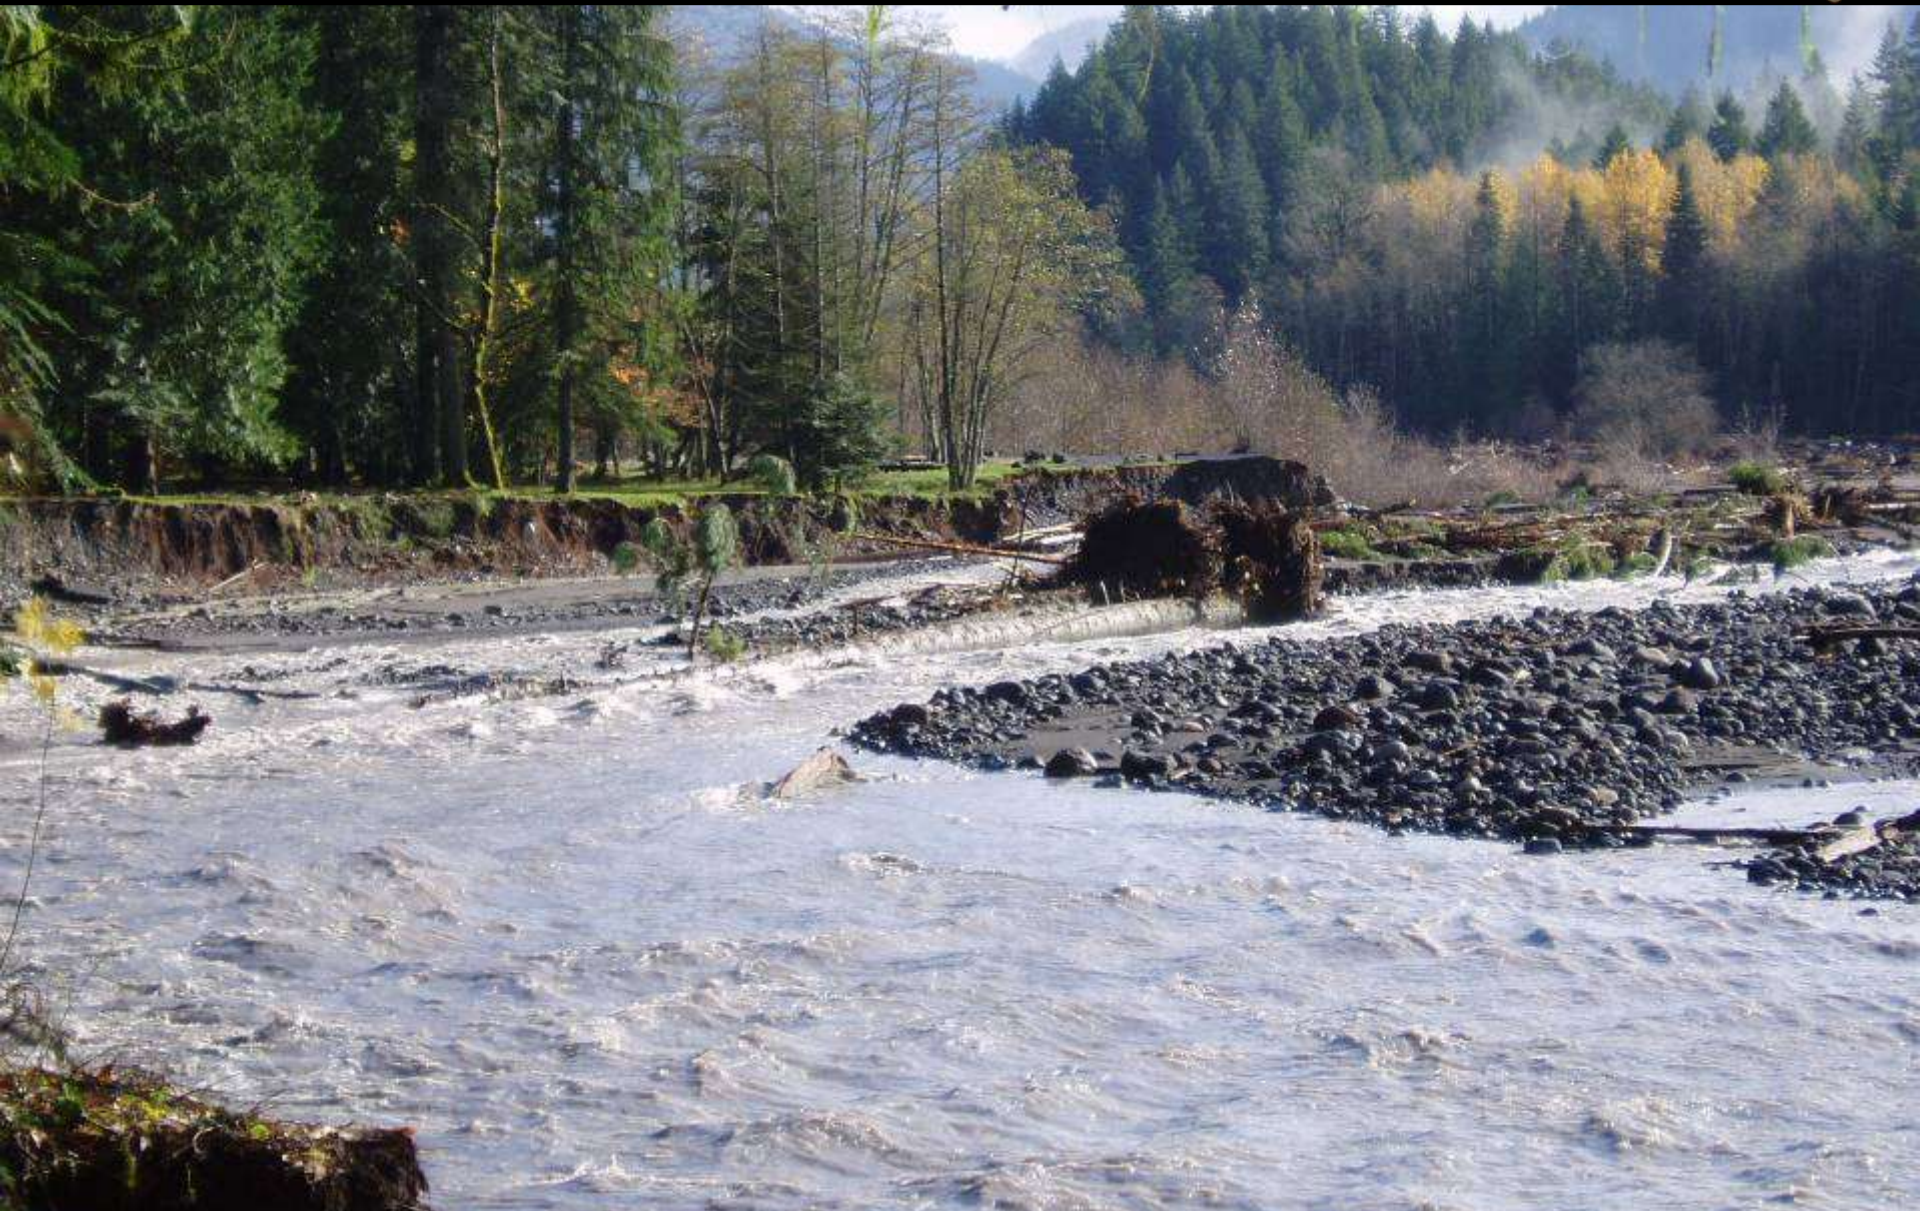
At Sunshine Point, the Nisqually River now flows where there once was a campground.

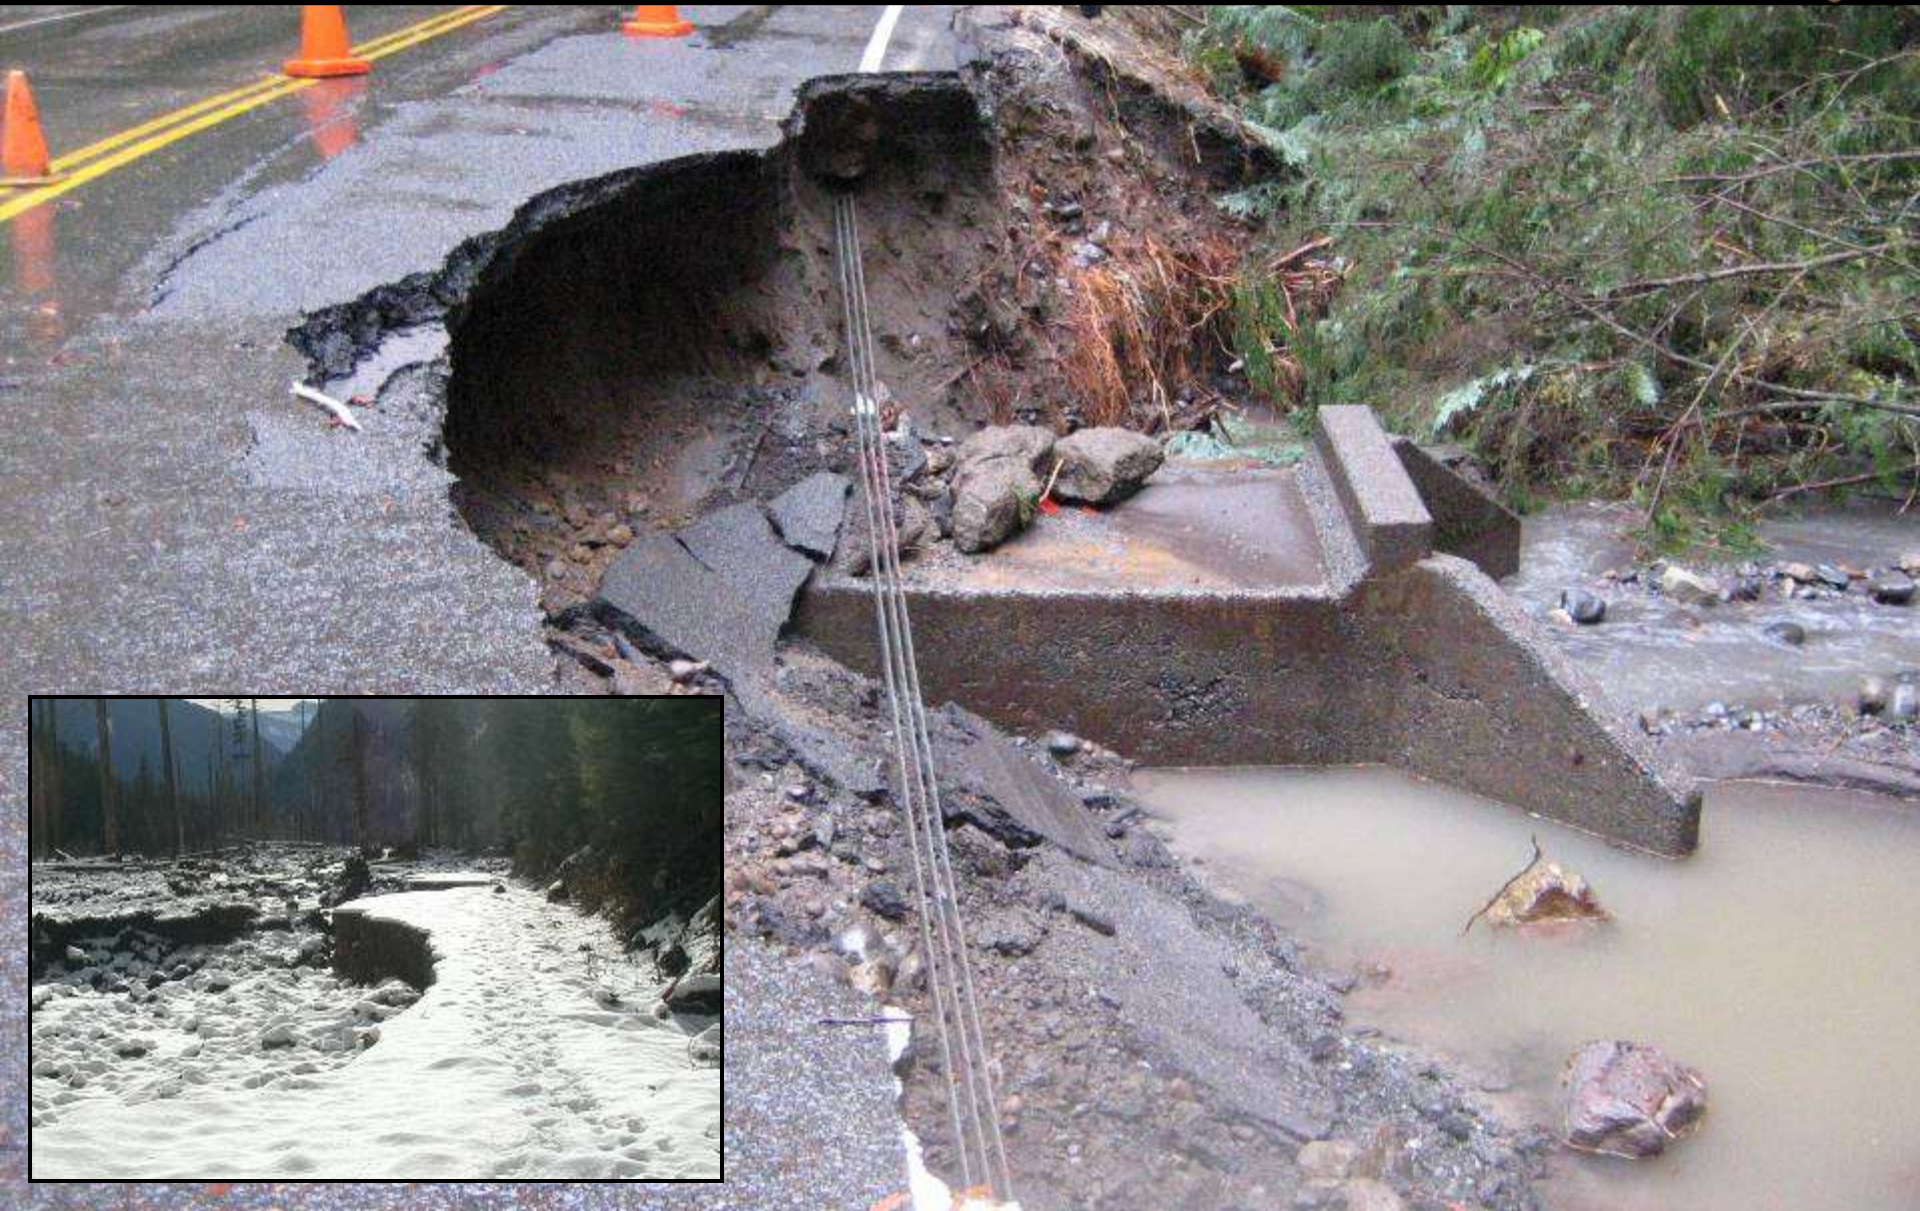
A mile up the road, Tahoma Creek caused extensive damage to the Westside and Nisqually Roads.

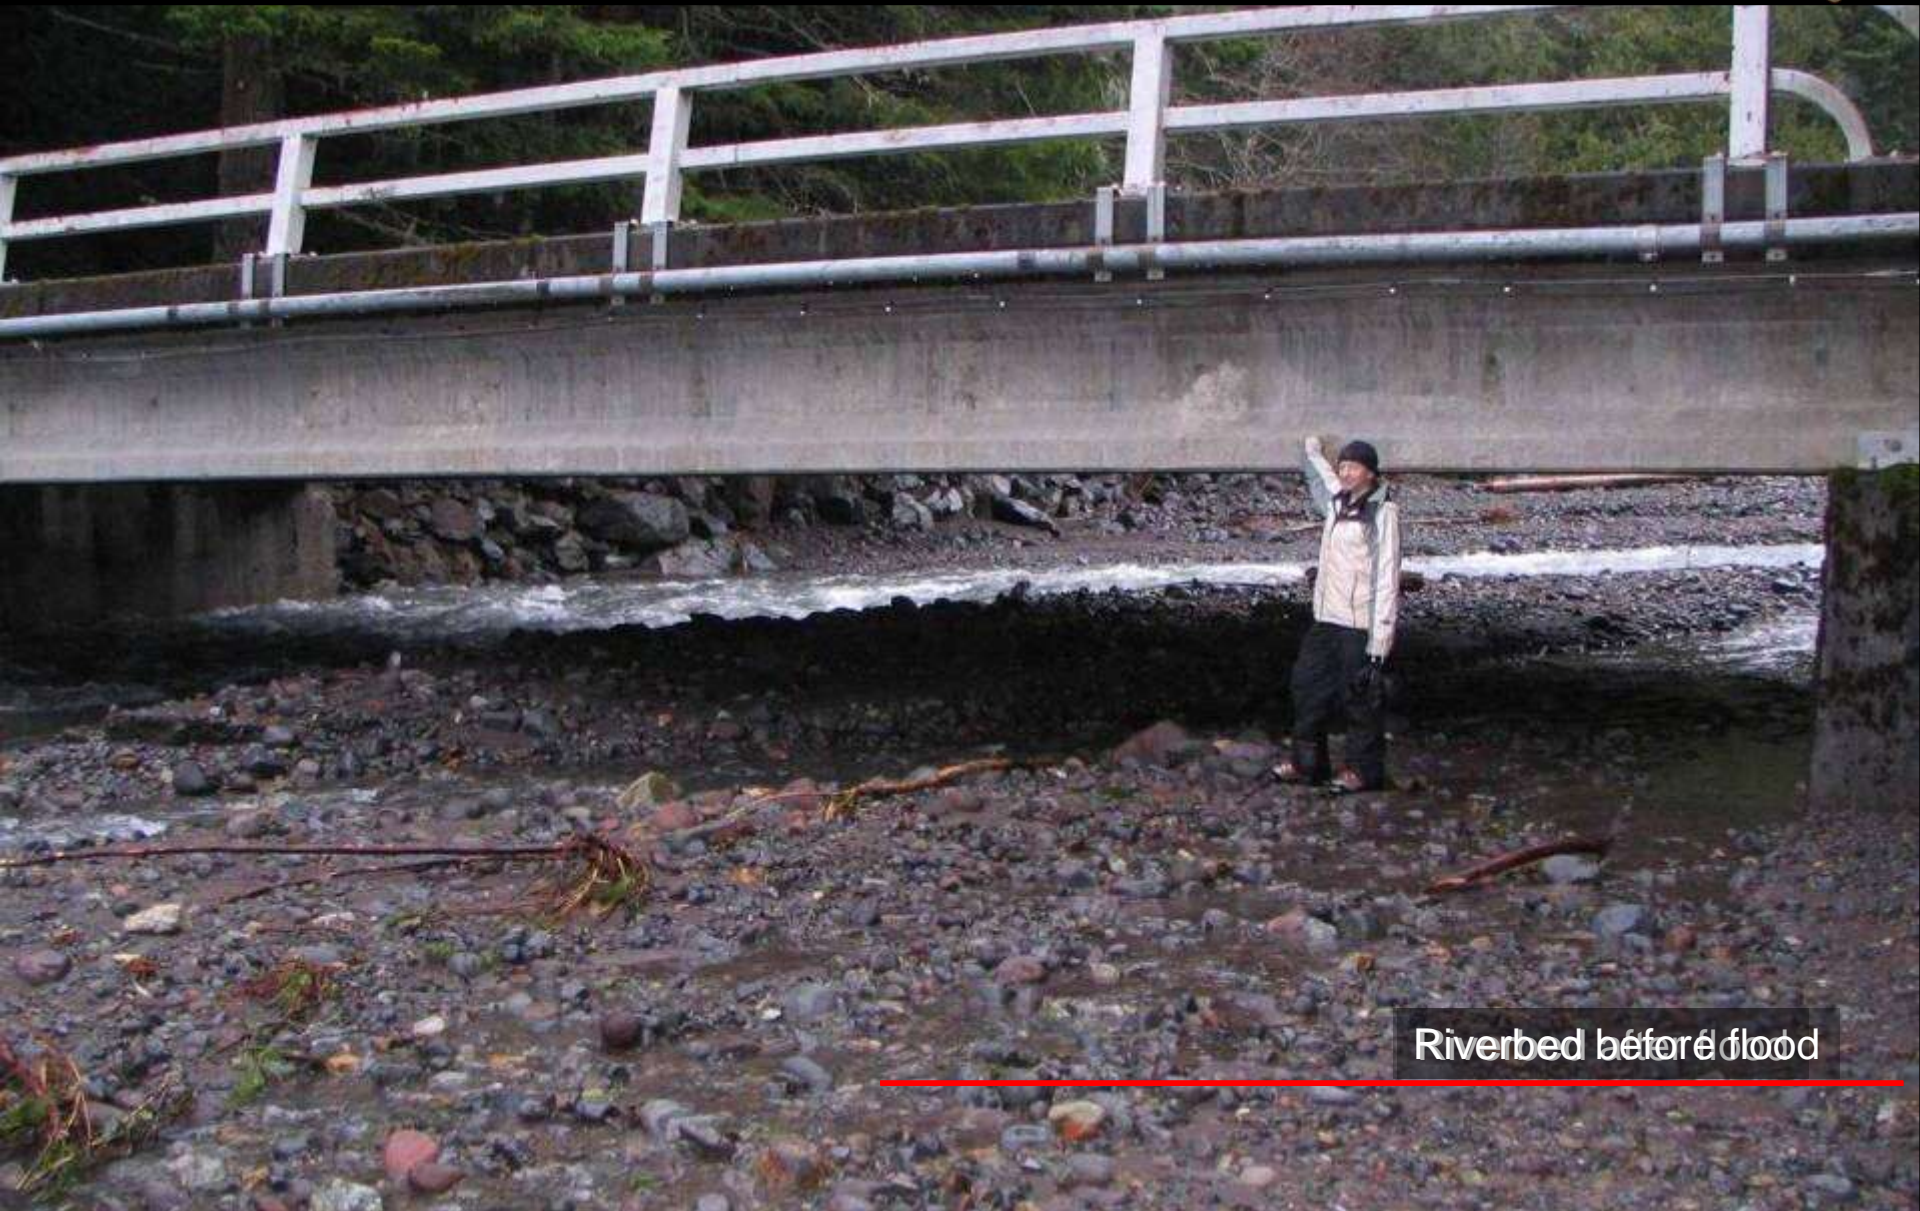
Riverbed before flood

The riverbed under the Tahoma Creek Bridge rose more than four feet during the November flood.

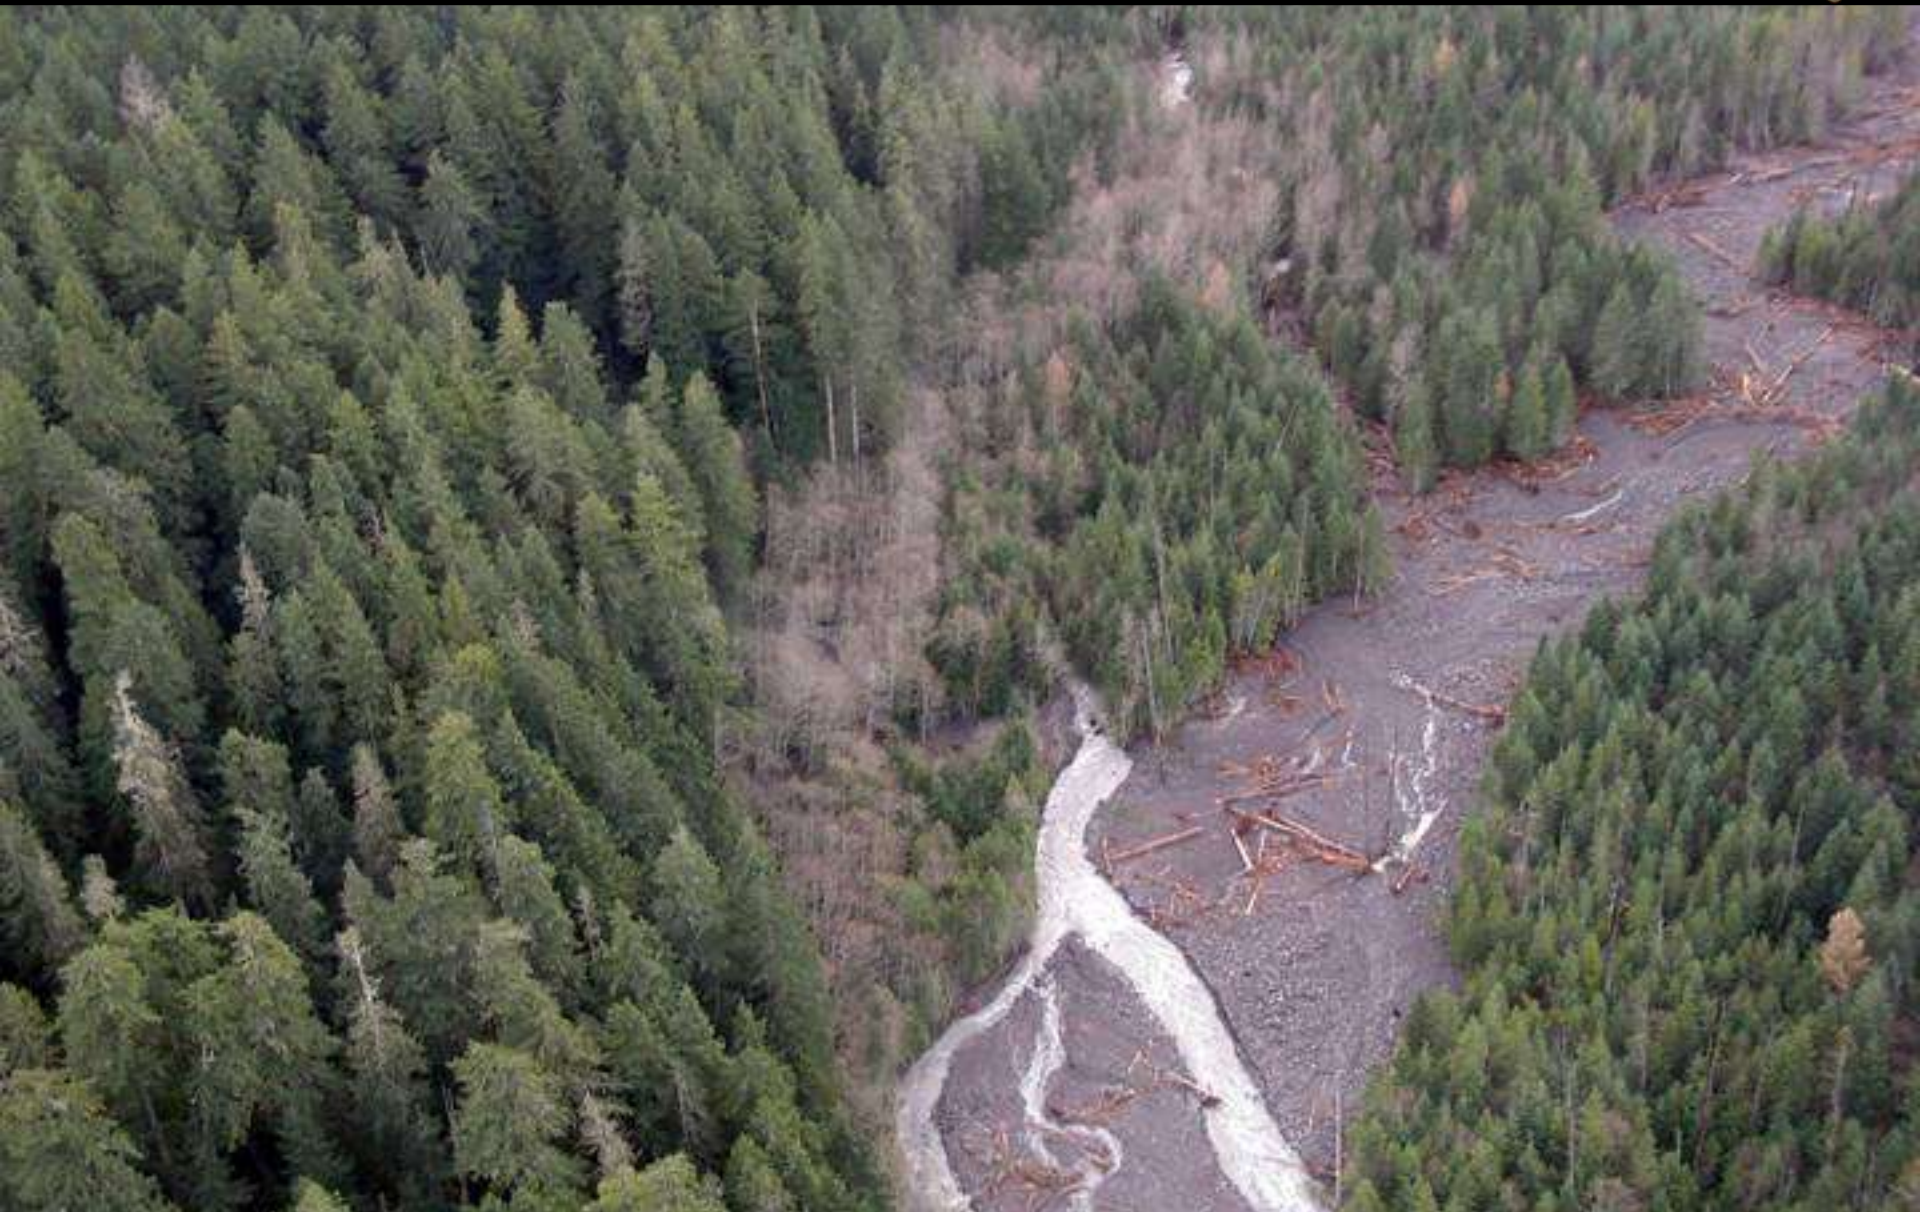
Aerial surveys showed that the creek had changed course more than a mile upstream from the road bridge.

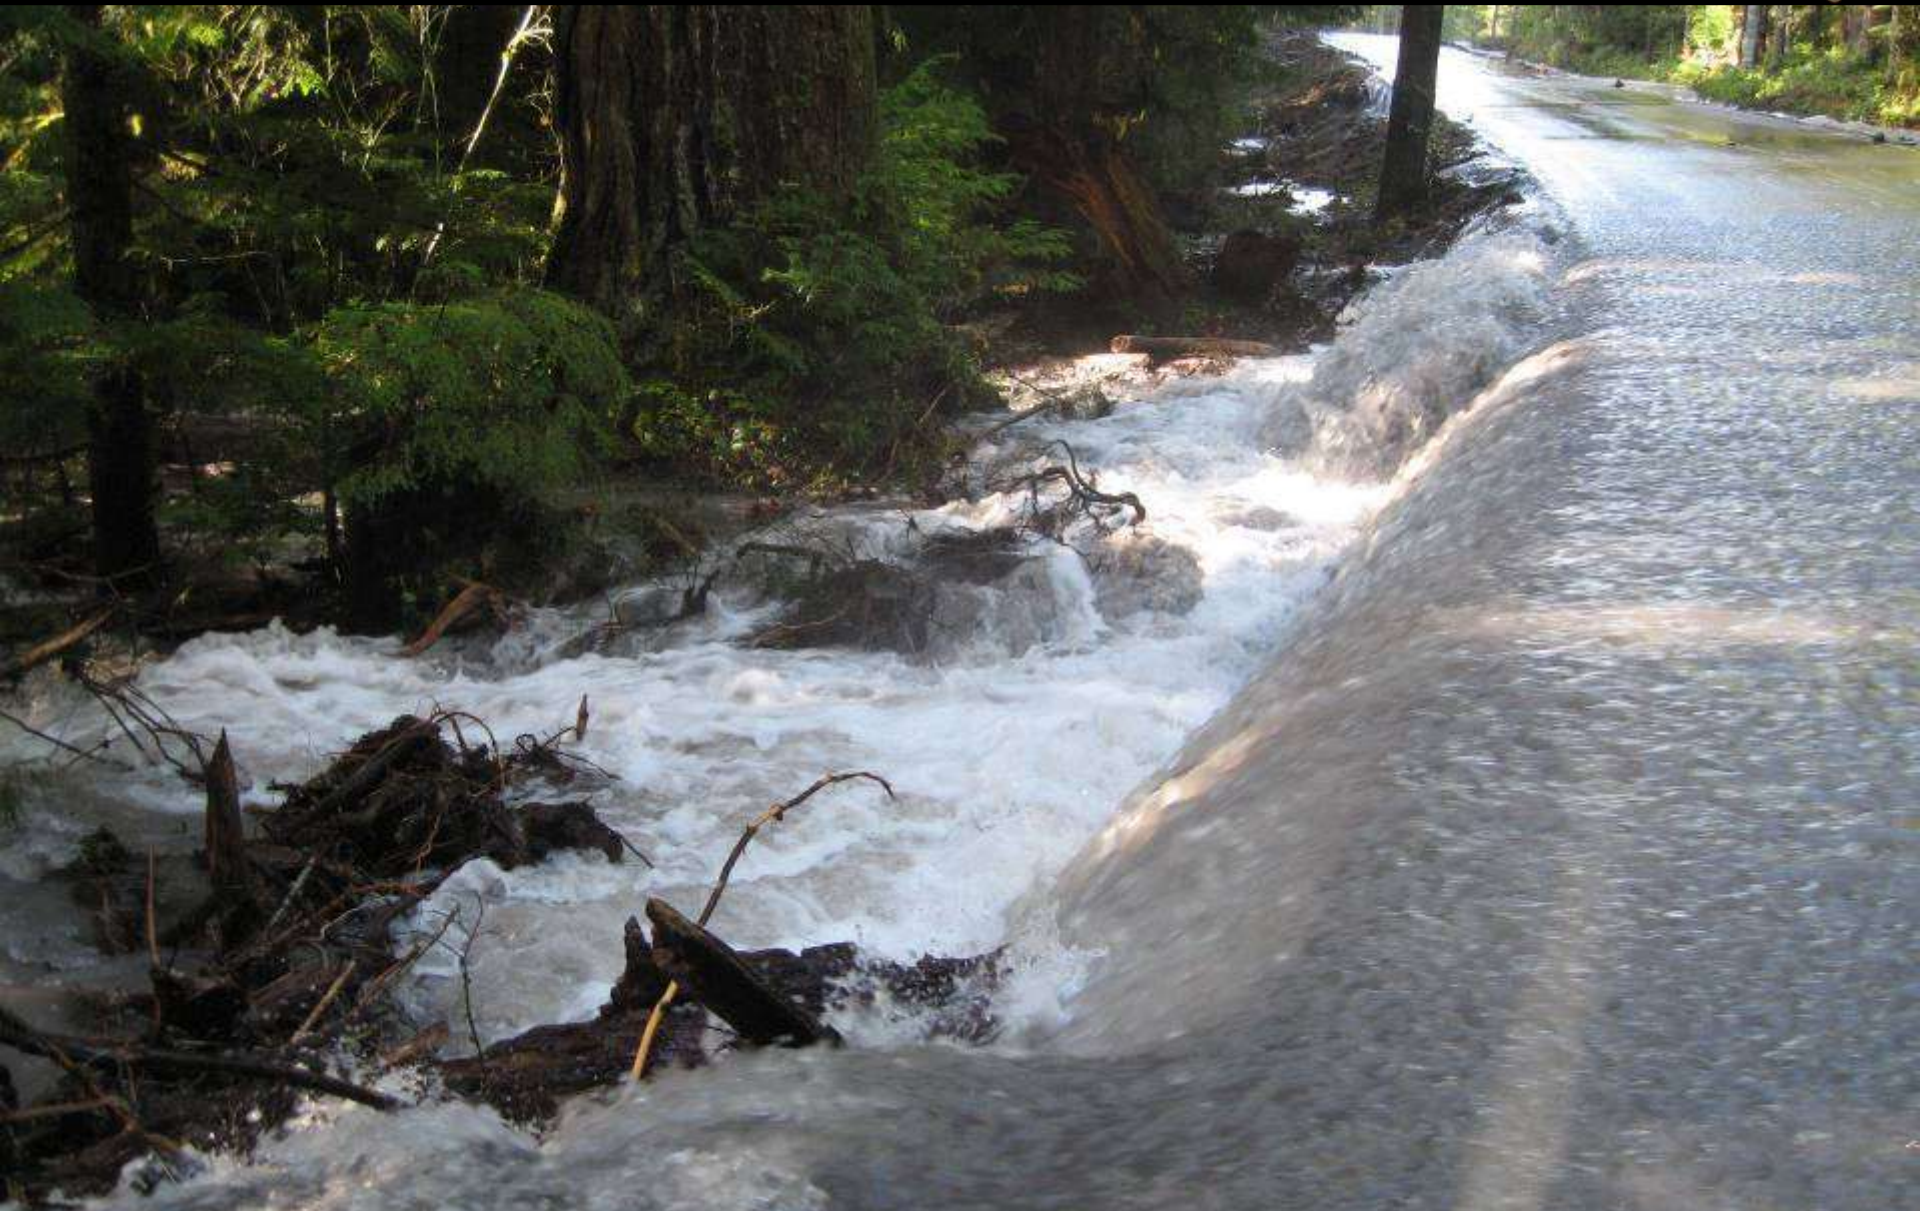
Instead, it crosses the park road a quarter mile east of the bridge.

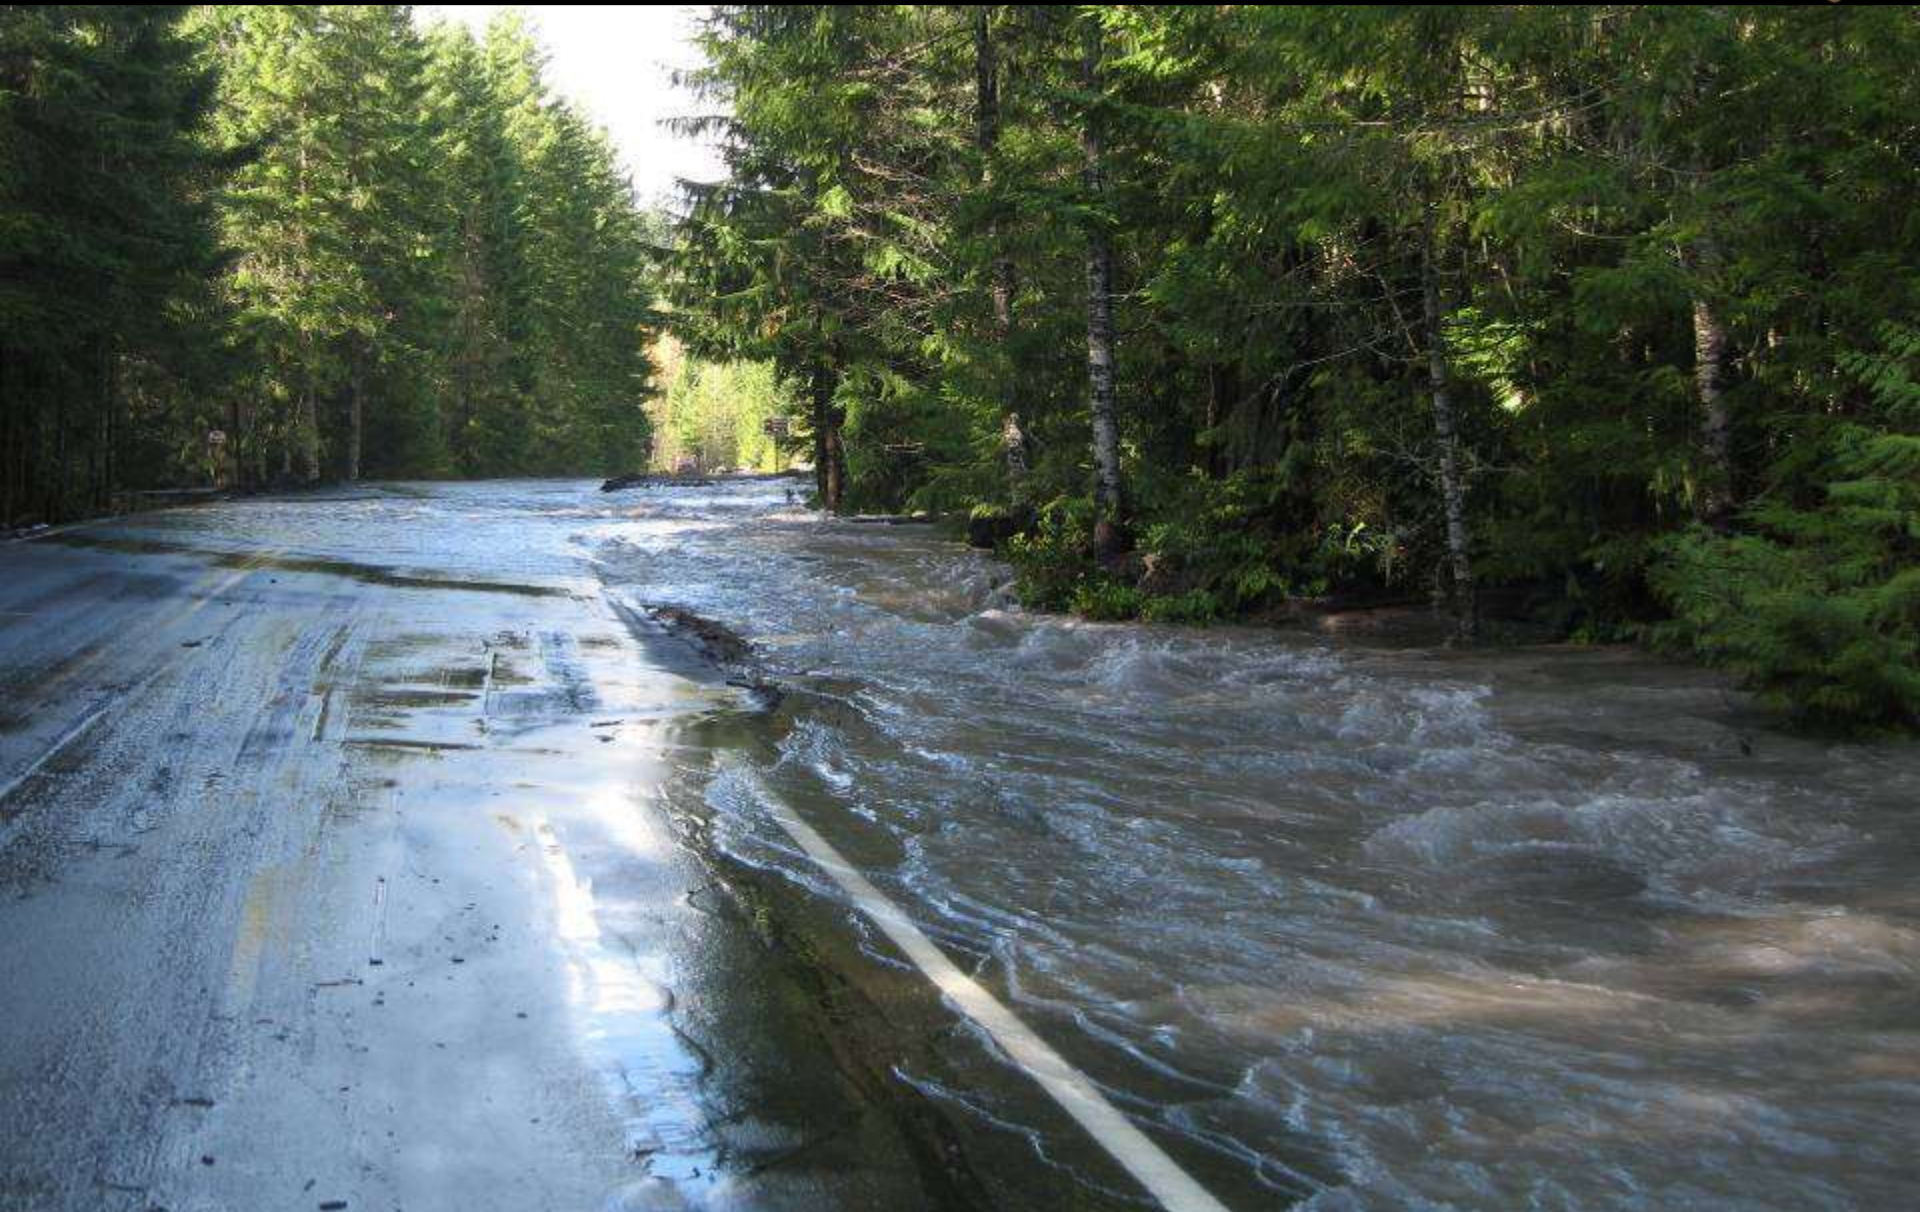
Two miles further, Kautz Creek no longer flows under the road bridge.

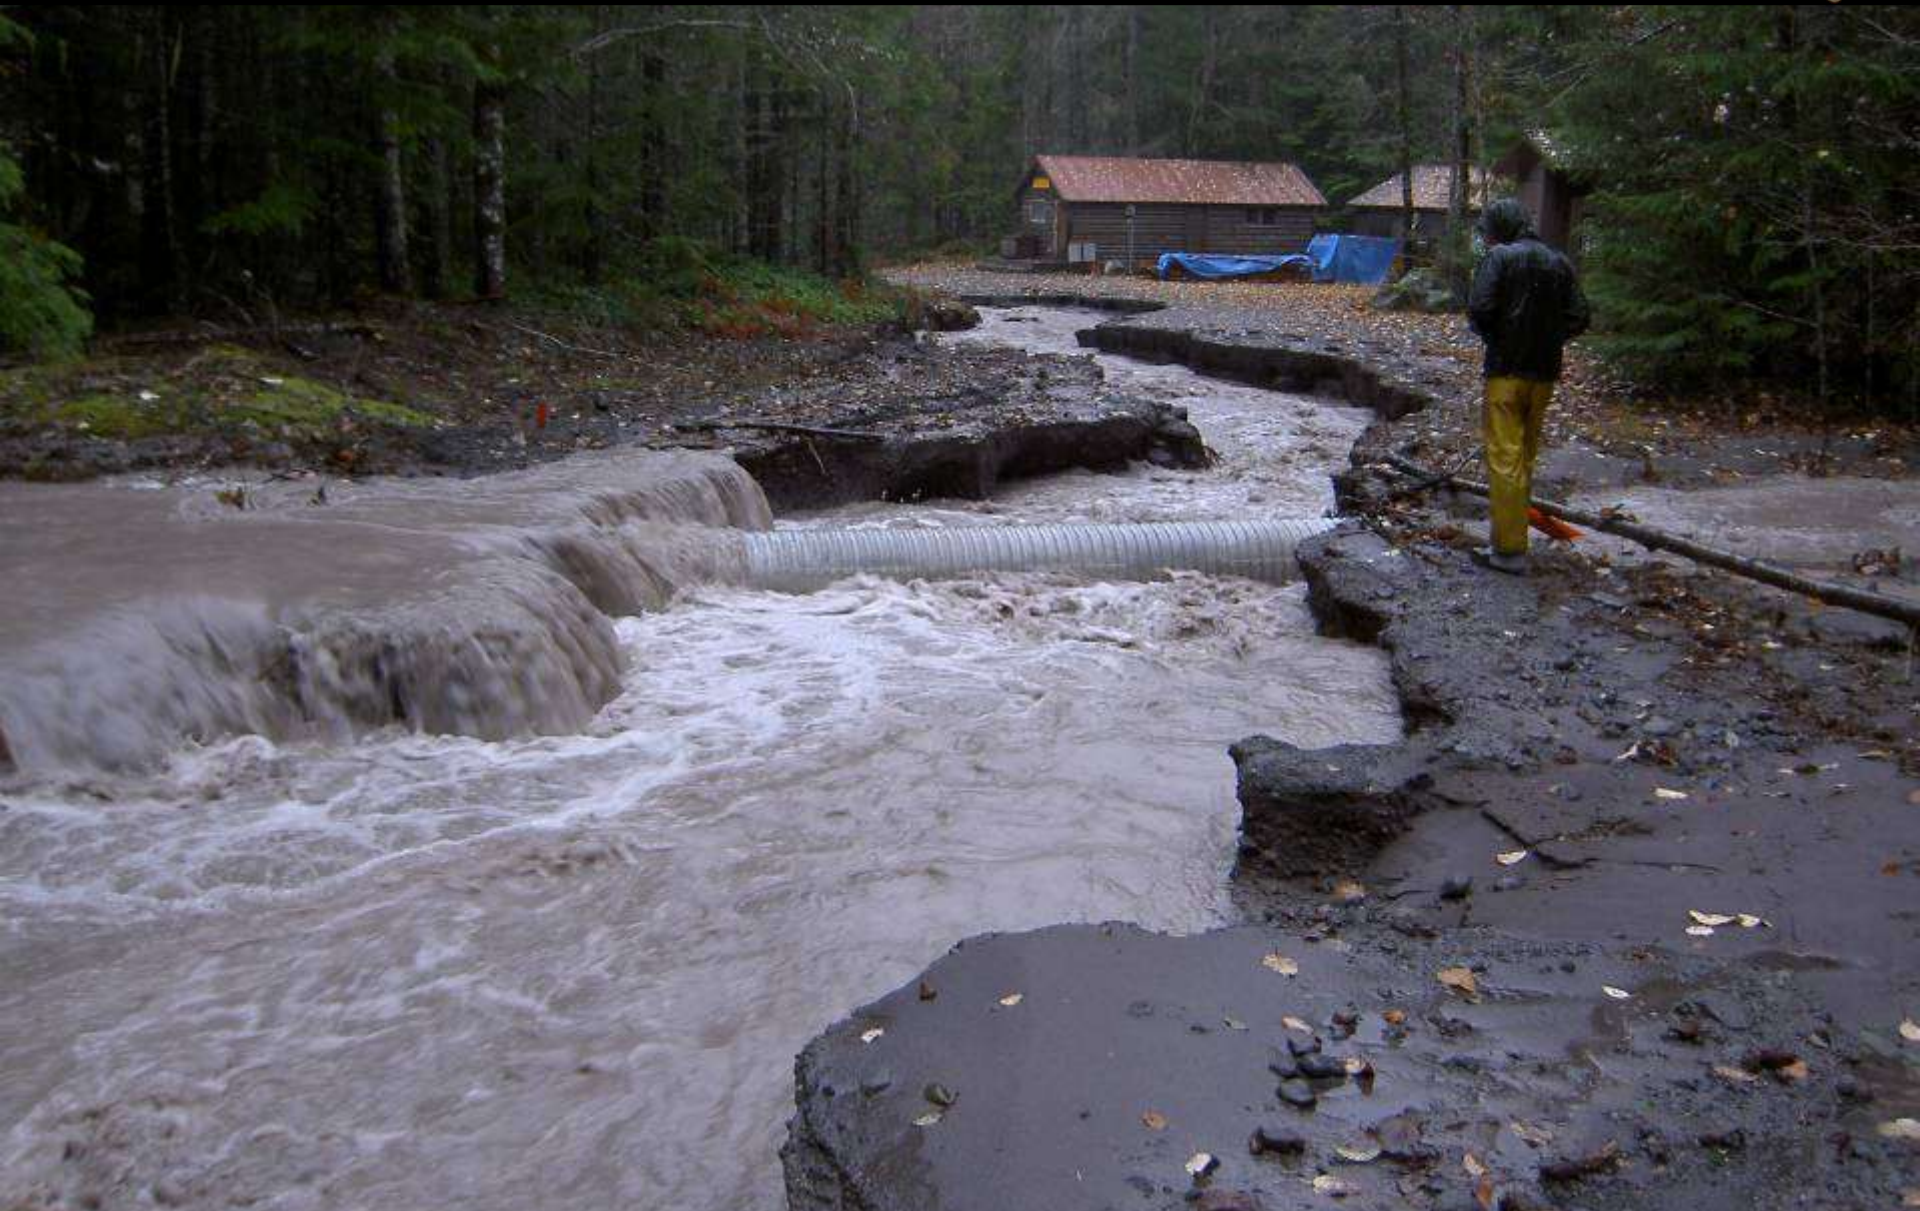
During the flood, it also flowed down a service road, carving a channel through the park's primary helibase.

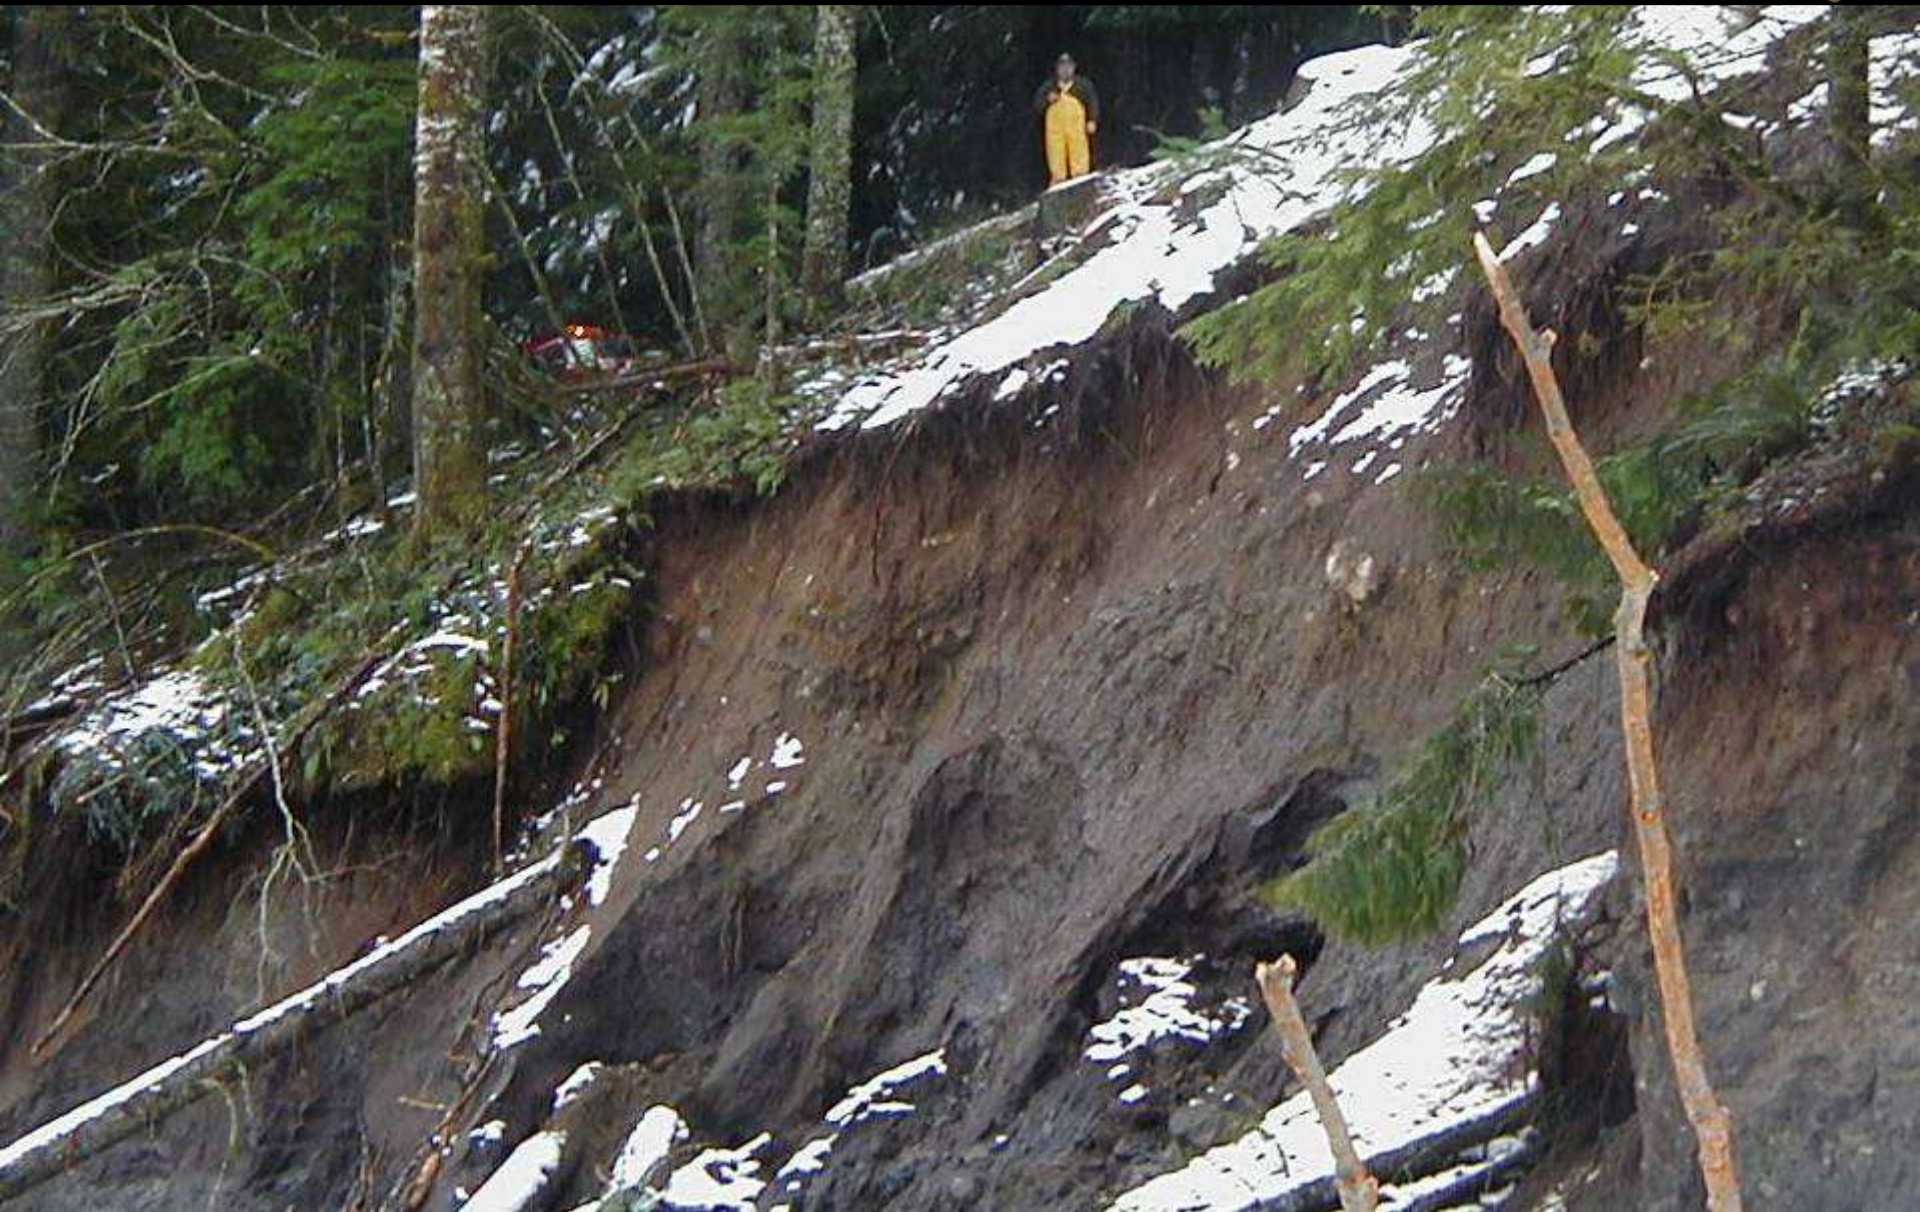
At Milepost 5.2—a mile below Longmire—the Nisqually River carved away the embankment to the edge of the park road.
