# Mount Rainier National Park

## The Great Flood of November 2006

Updated April 27, 2007

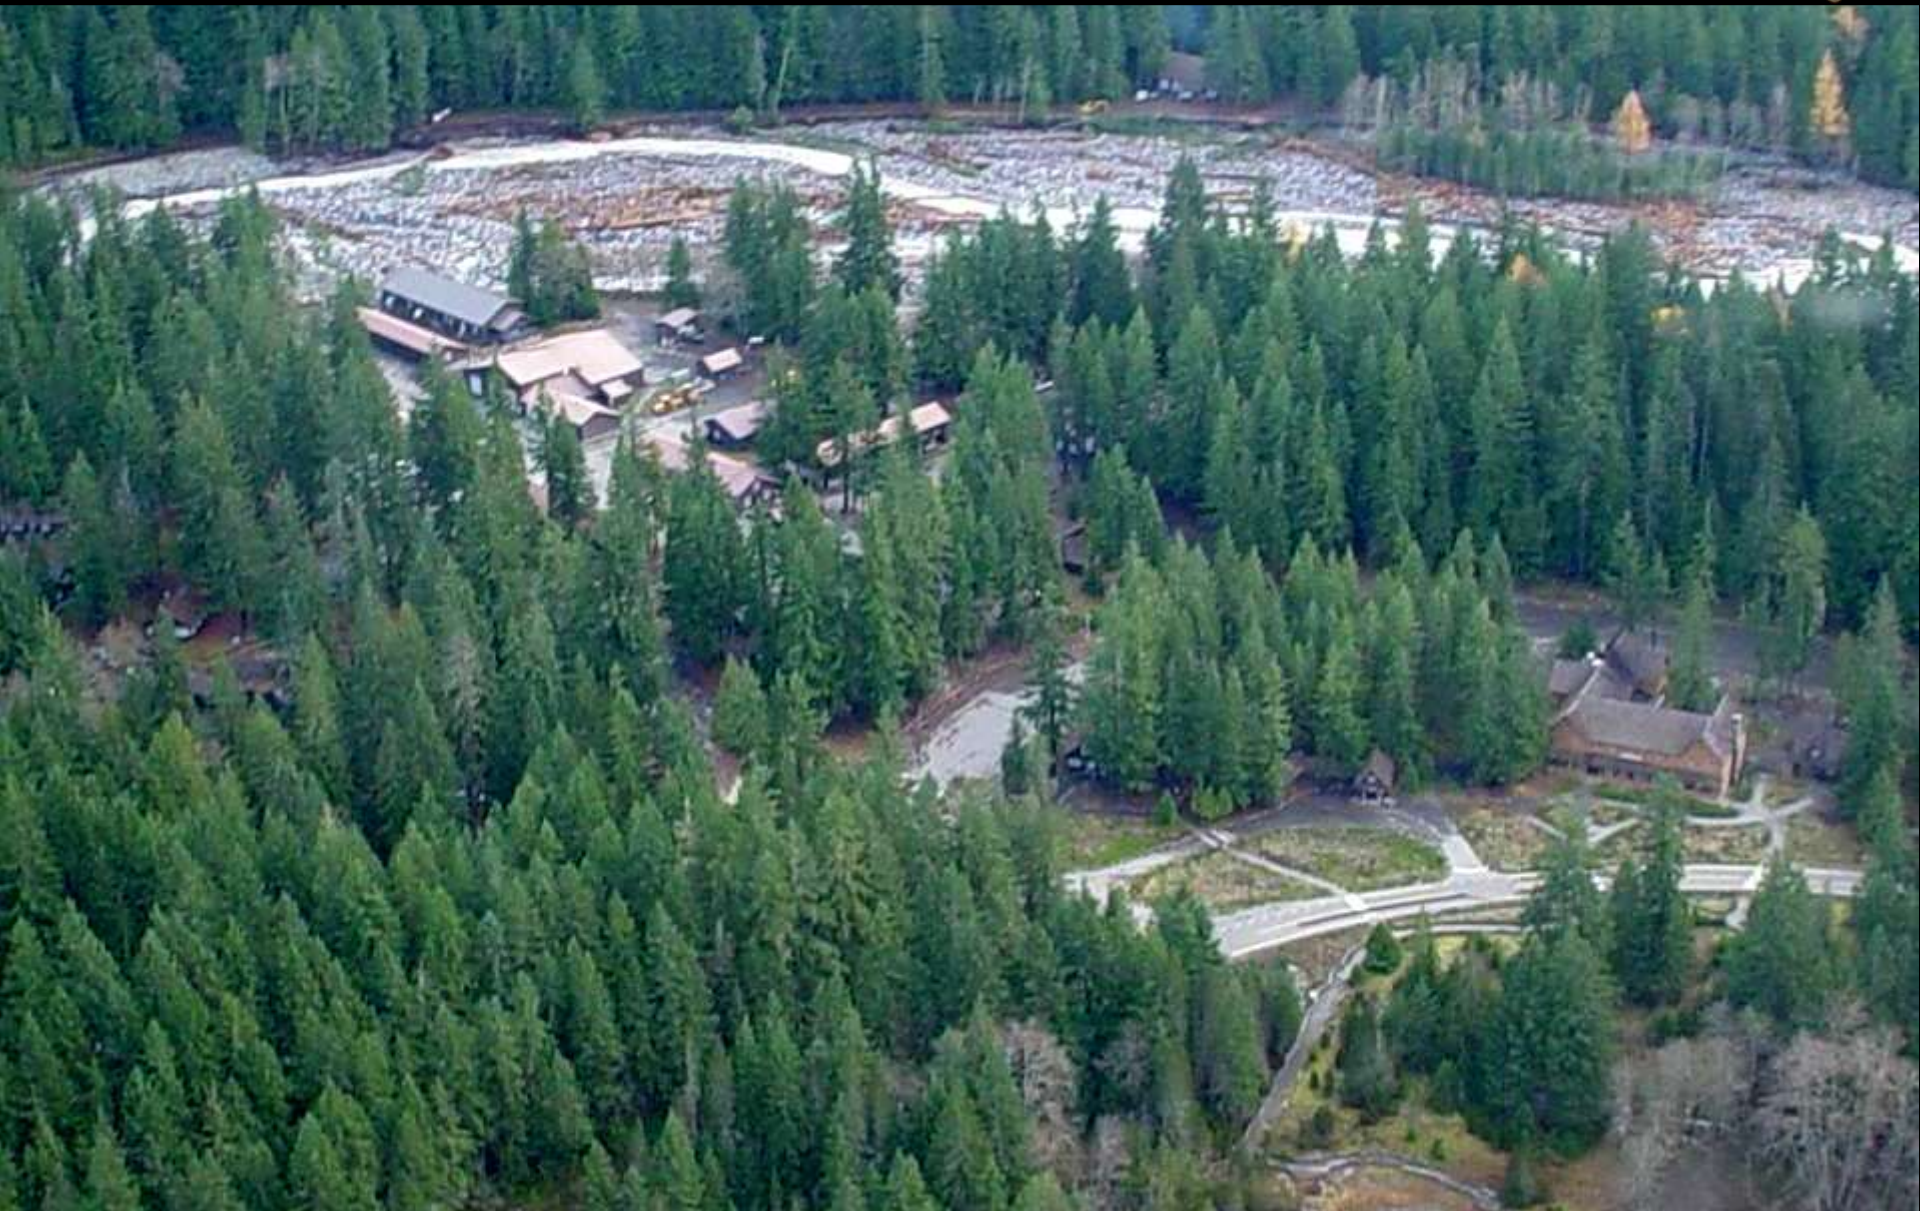
The Nisqually River flows higher than parts of Longmire.

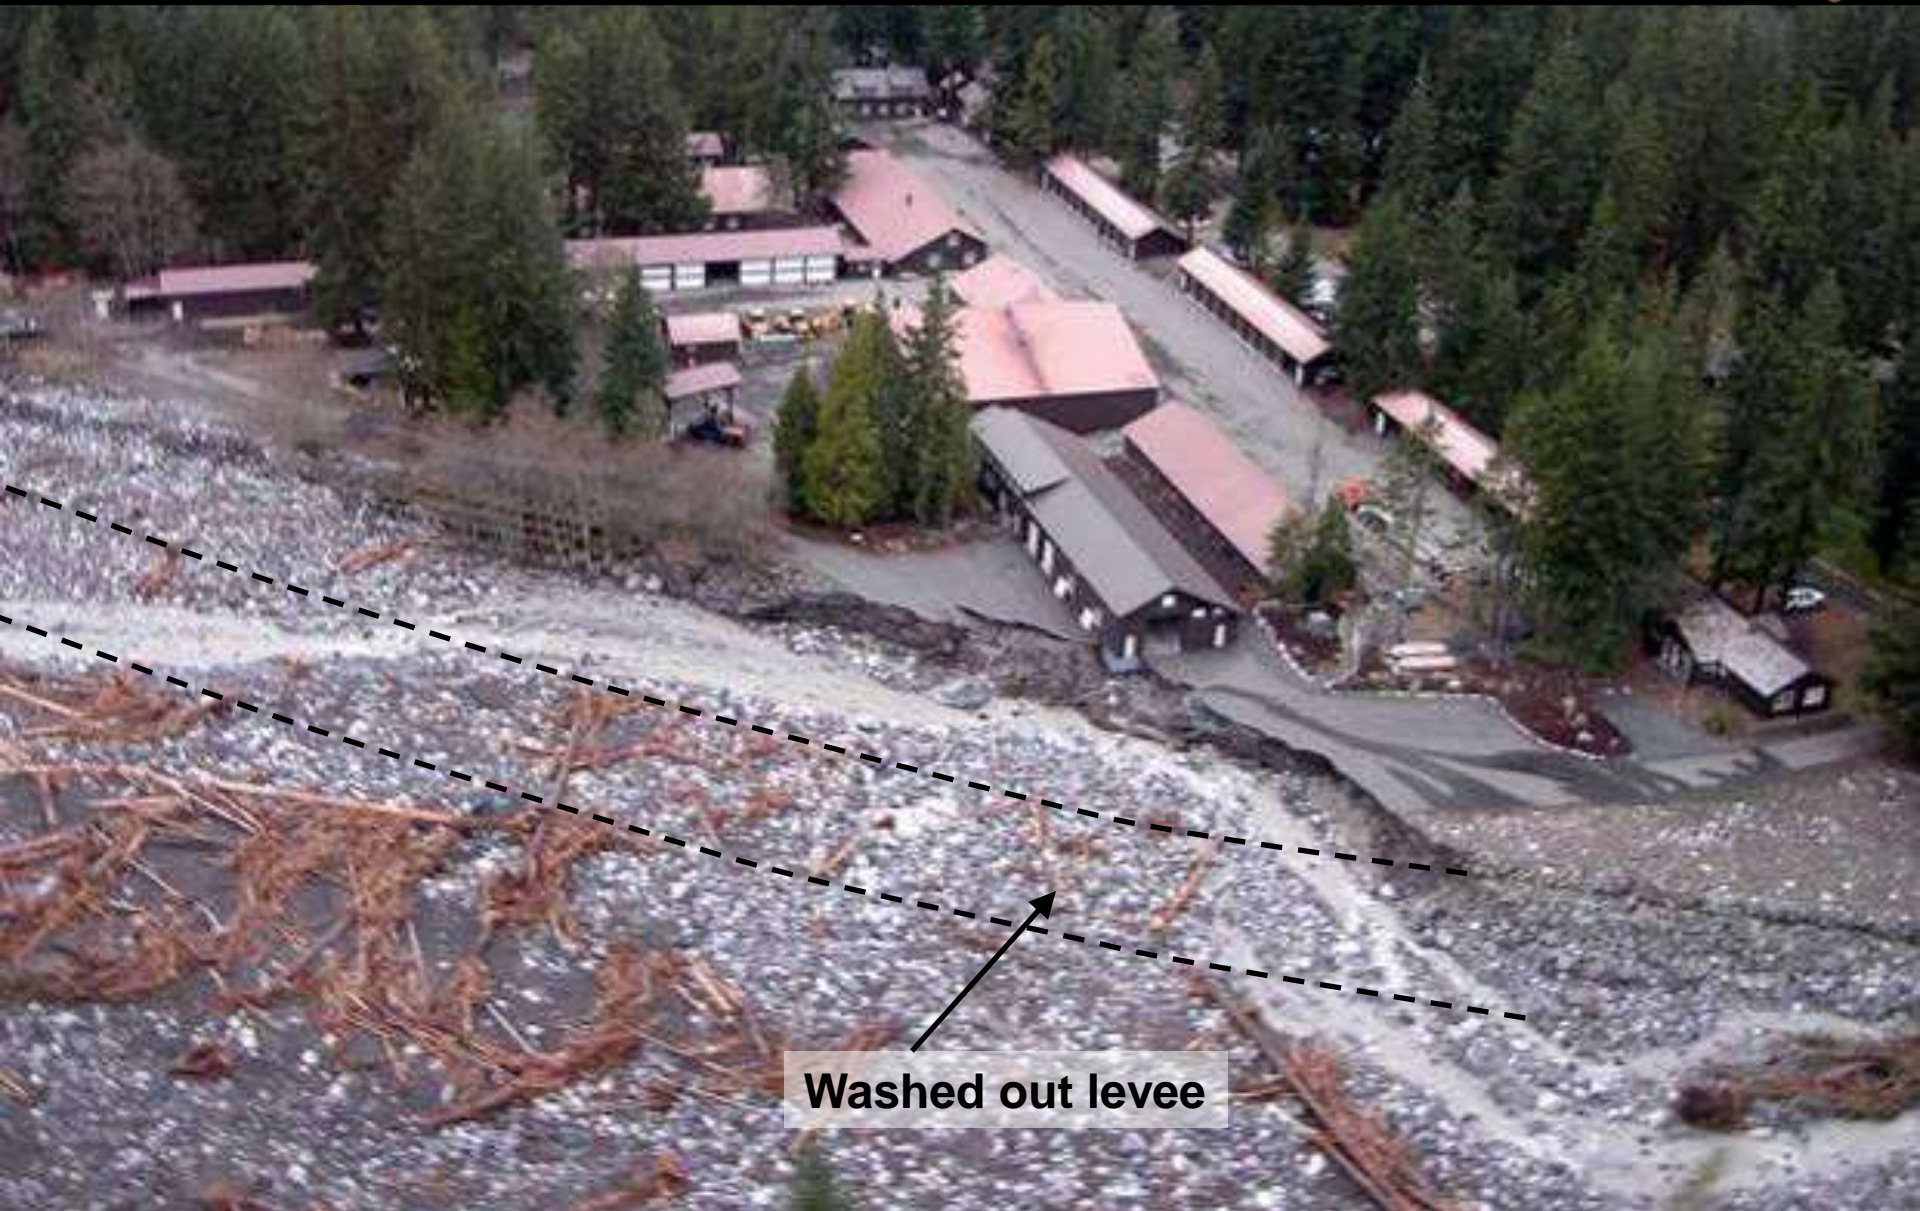
Washed out levee

At Longmire, most of the protective levee was washed away.

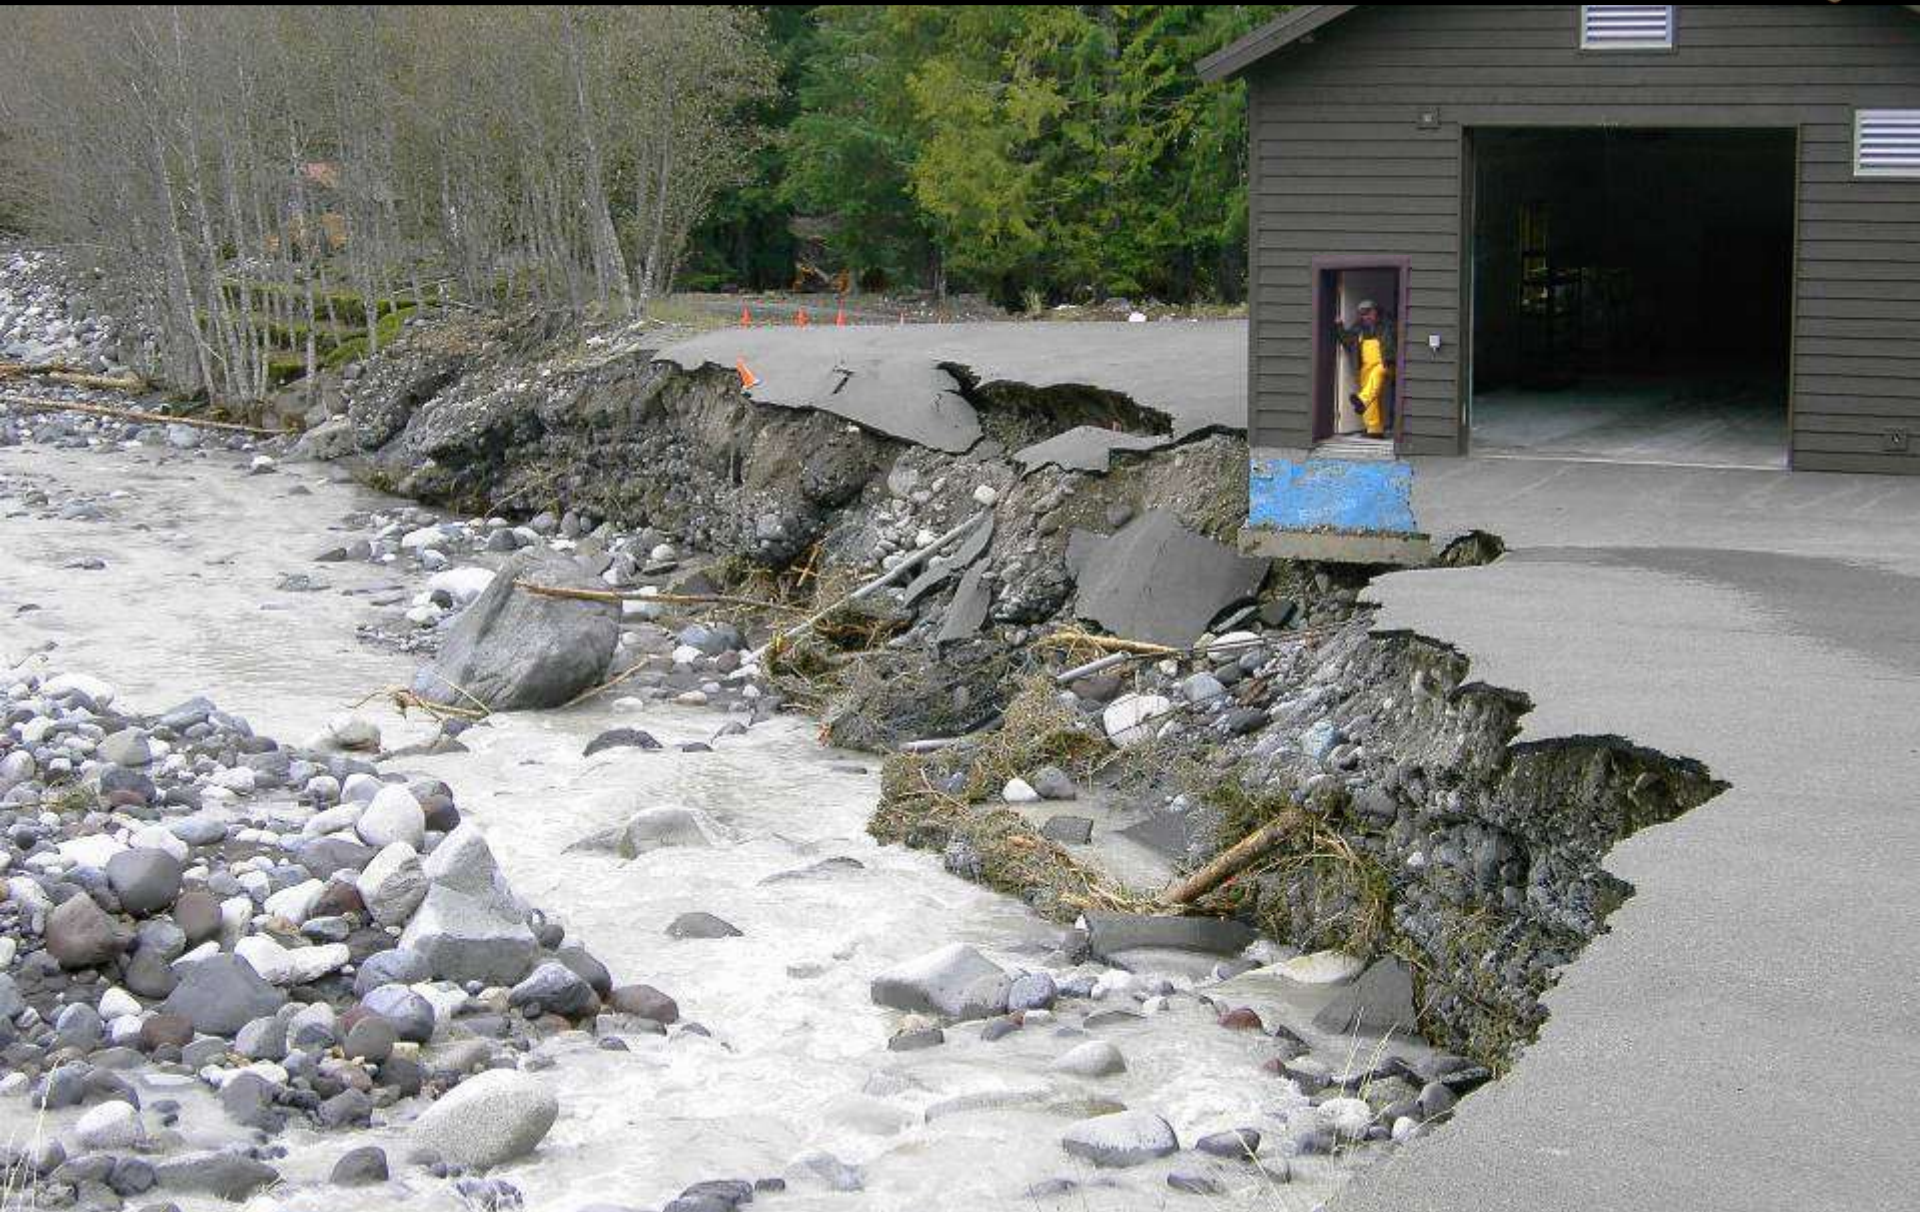
The park's Emergency Operations Center was undermined by the river.

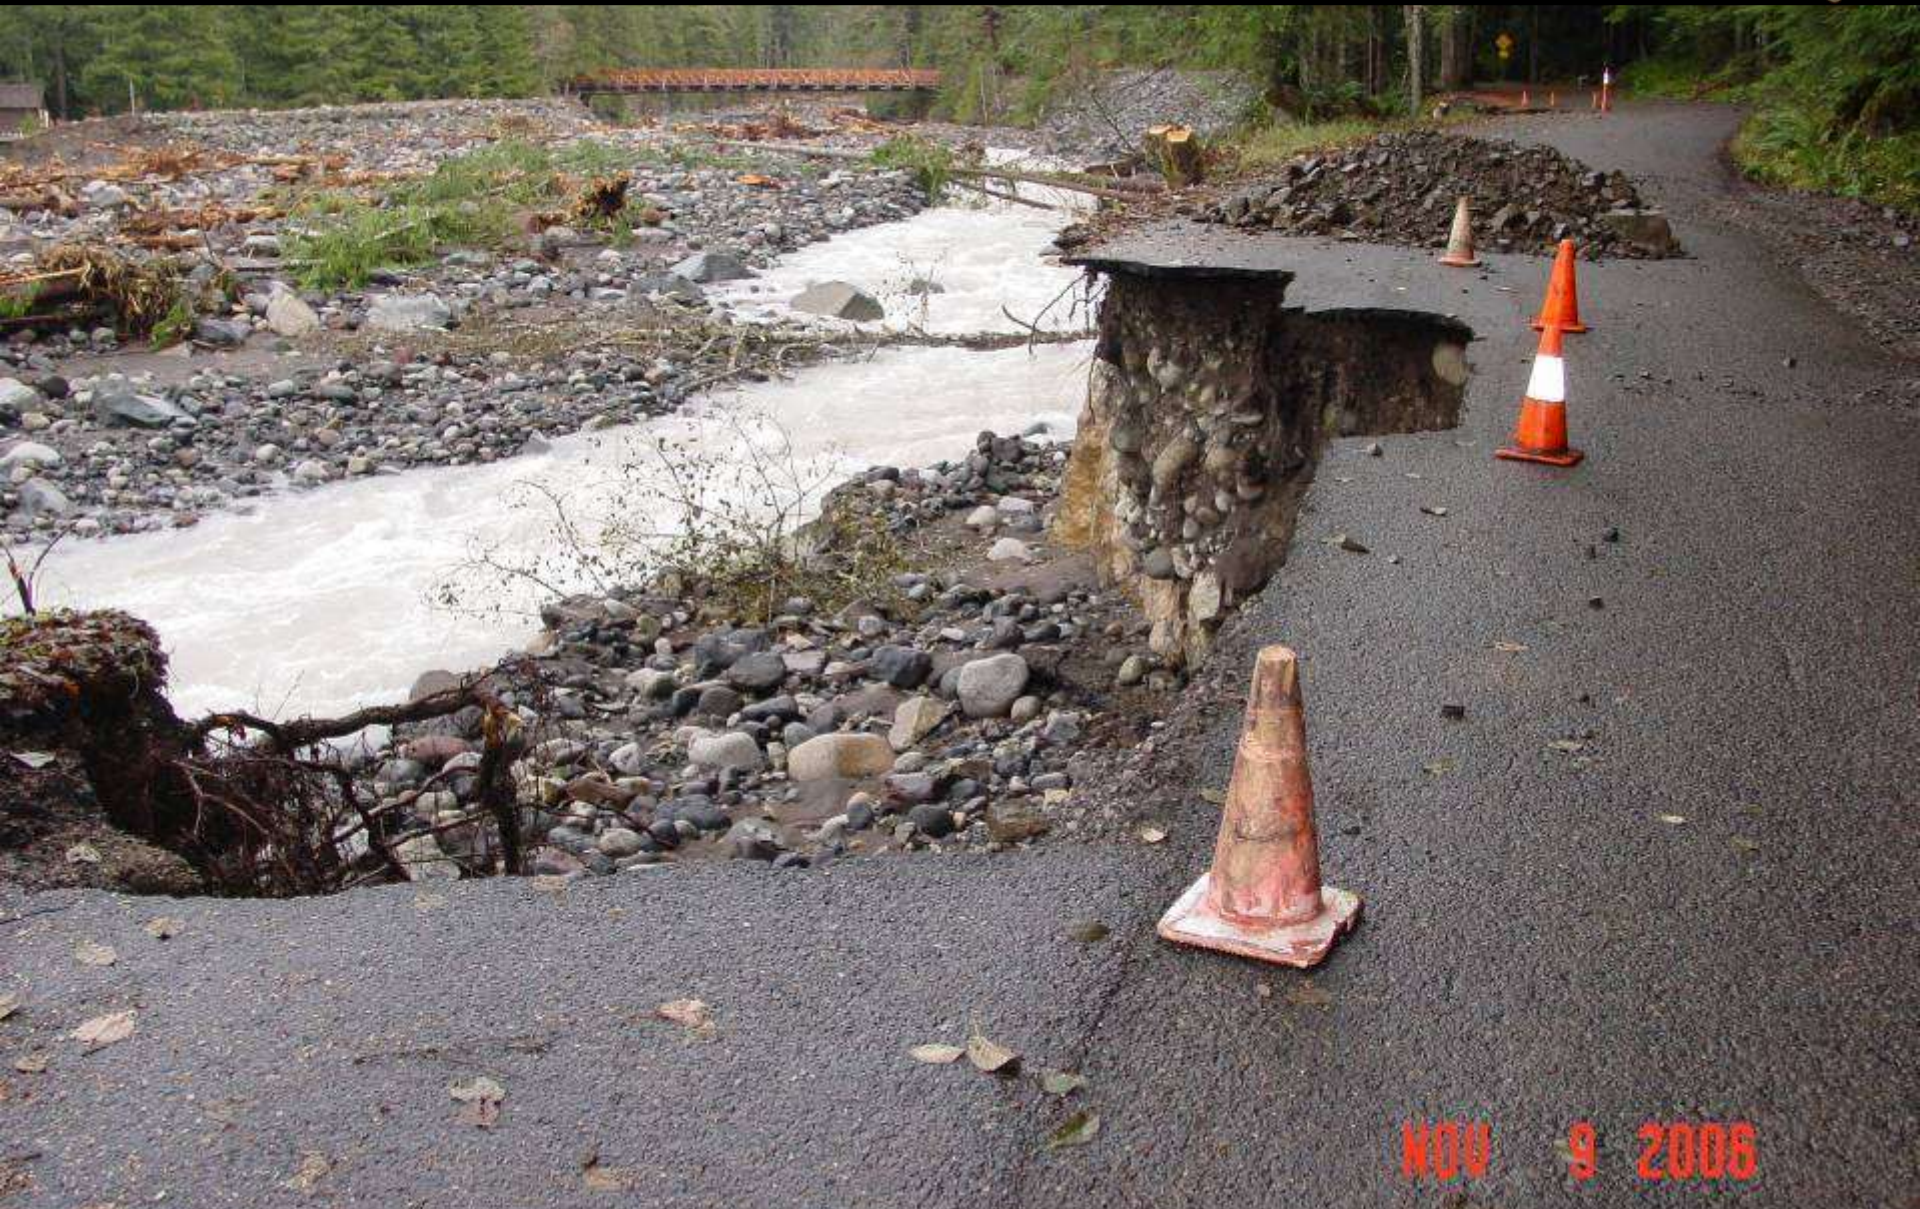
Across the river, a service road, which doubles as an emergency exit, was also undermined in several places.

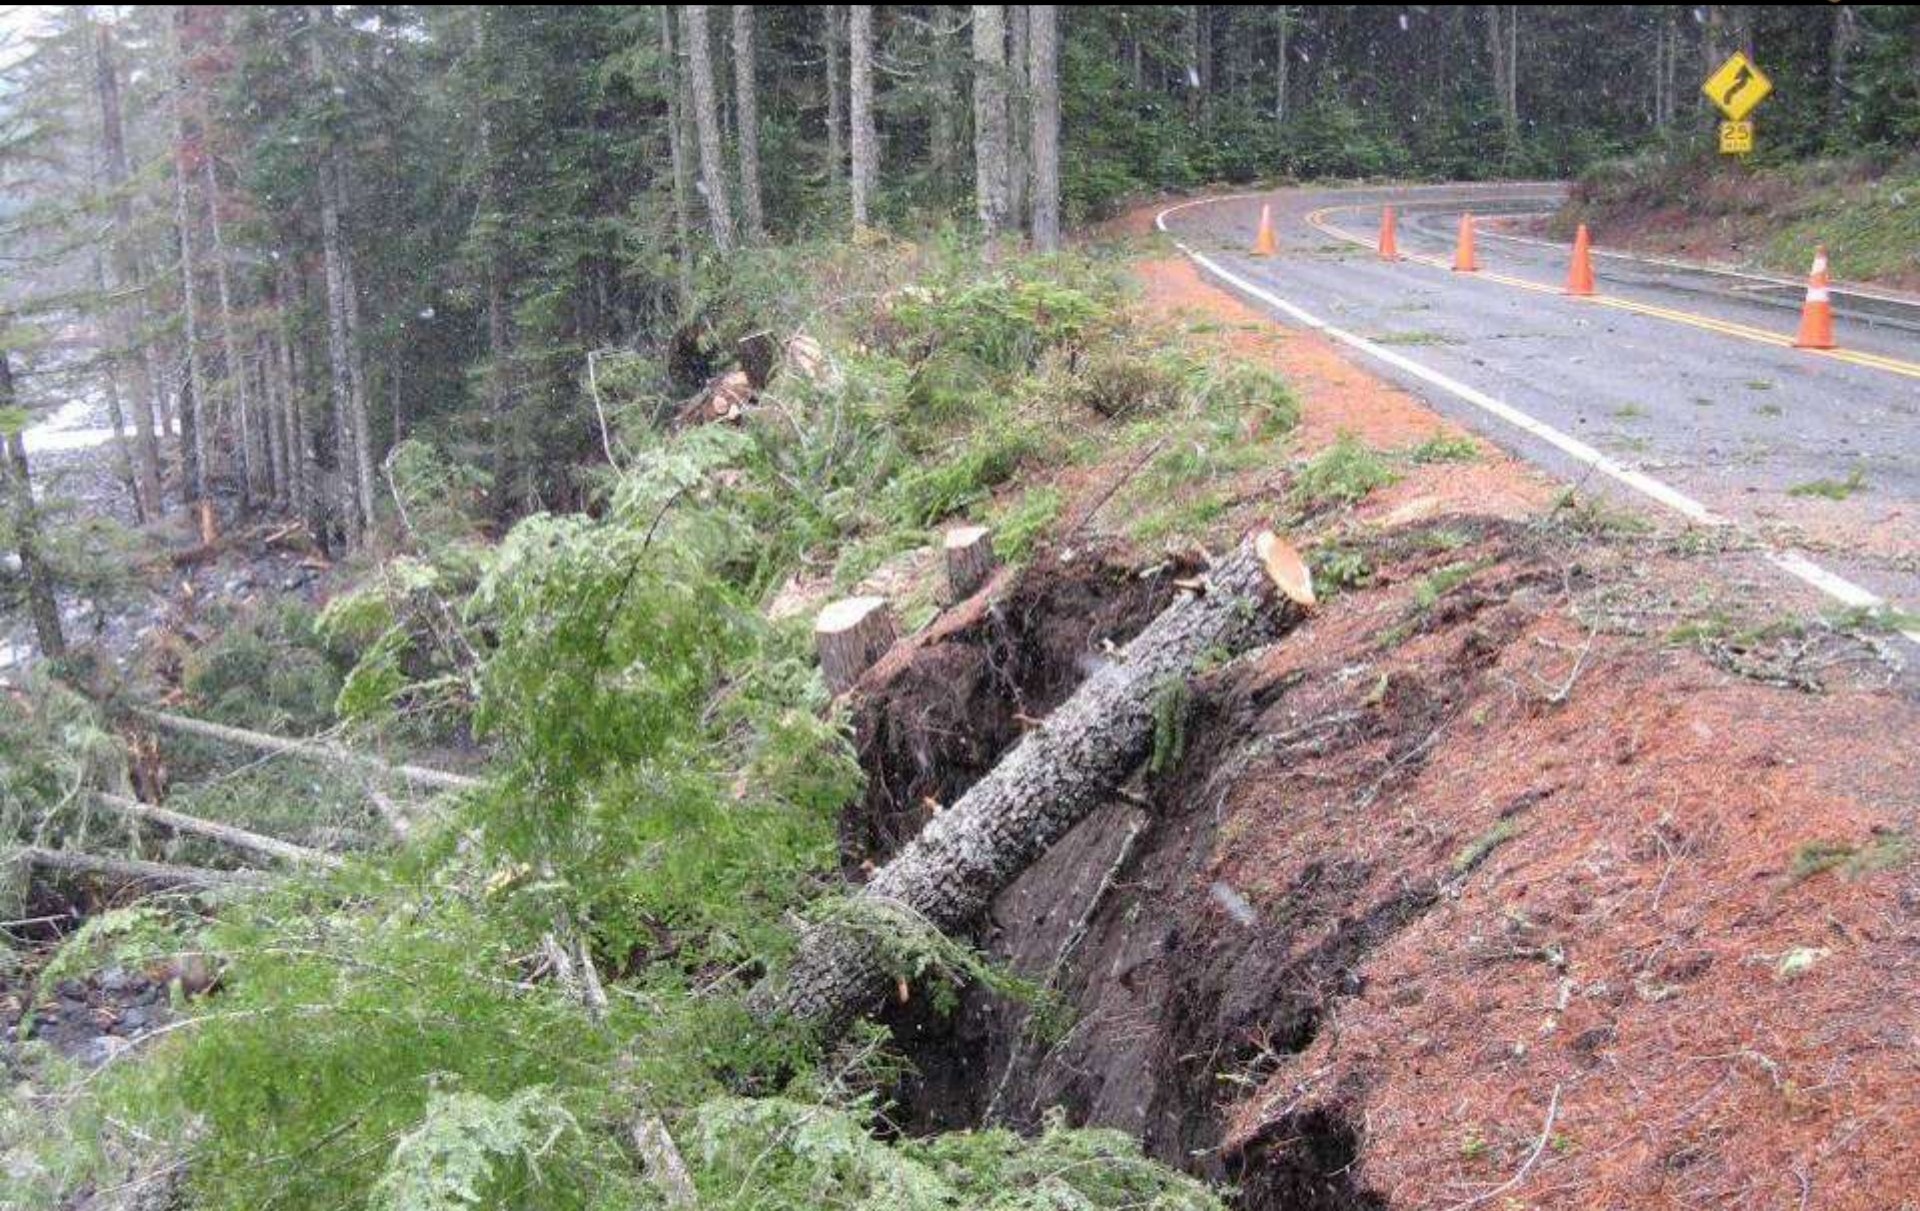
Similar damage occurred at Milepost 9.1, above Cougar Rock Campground.

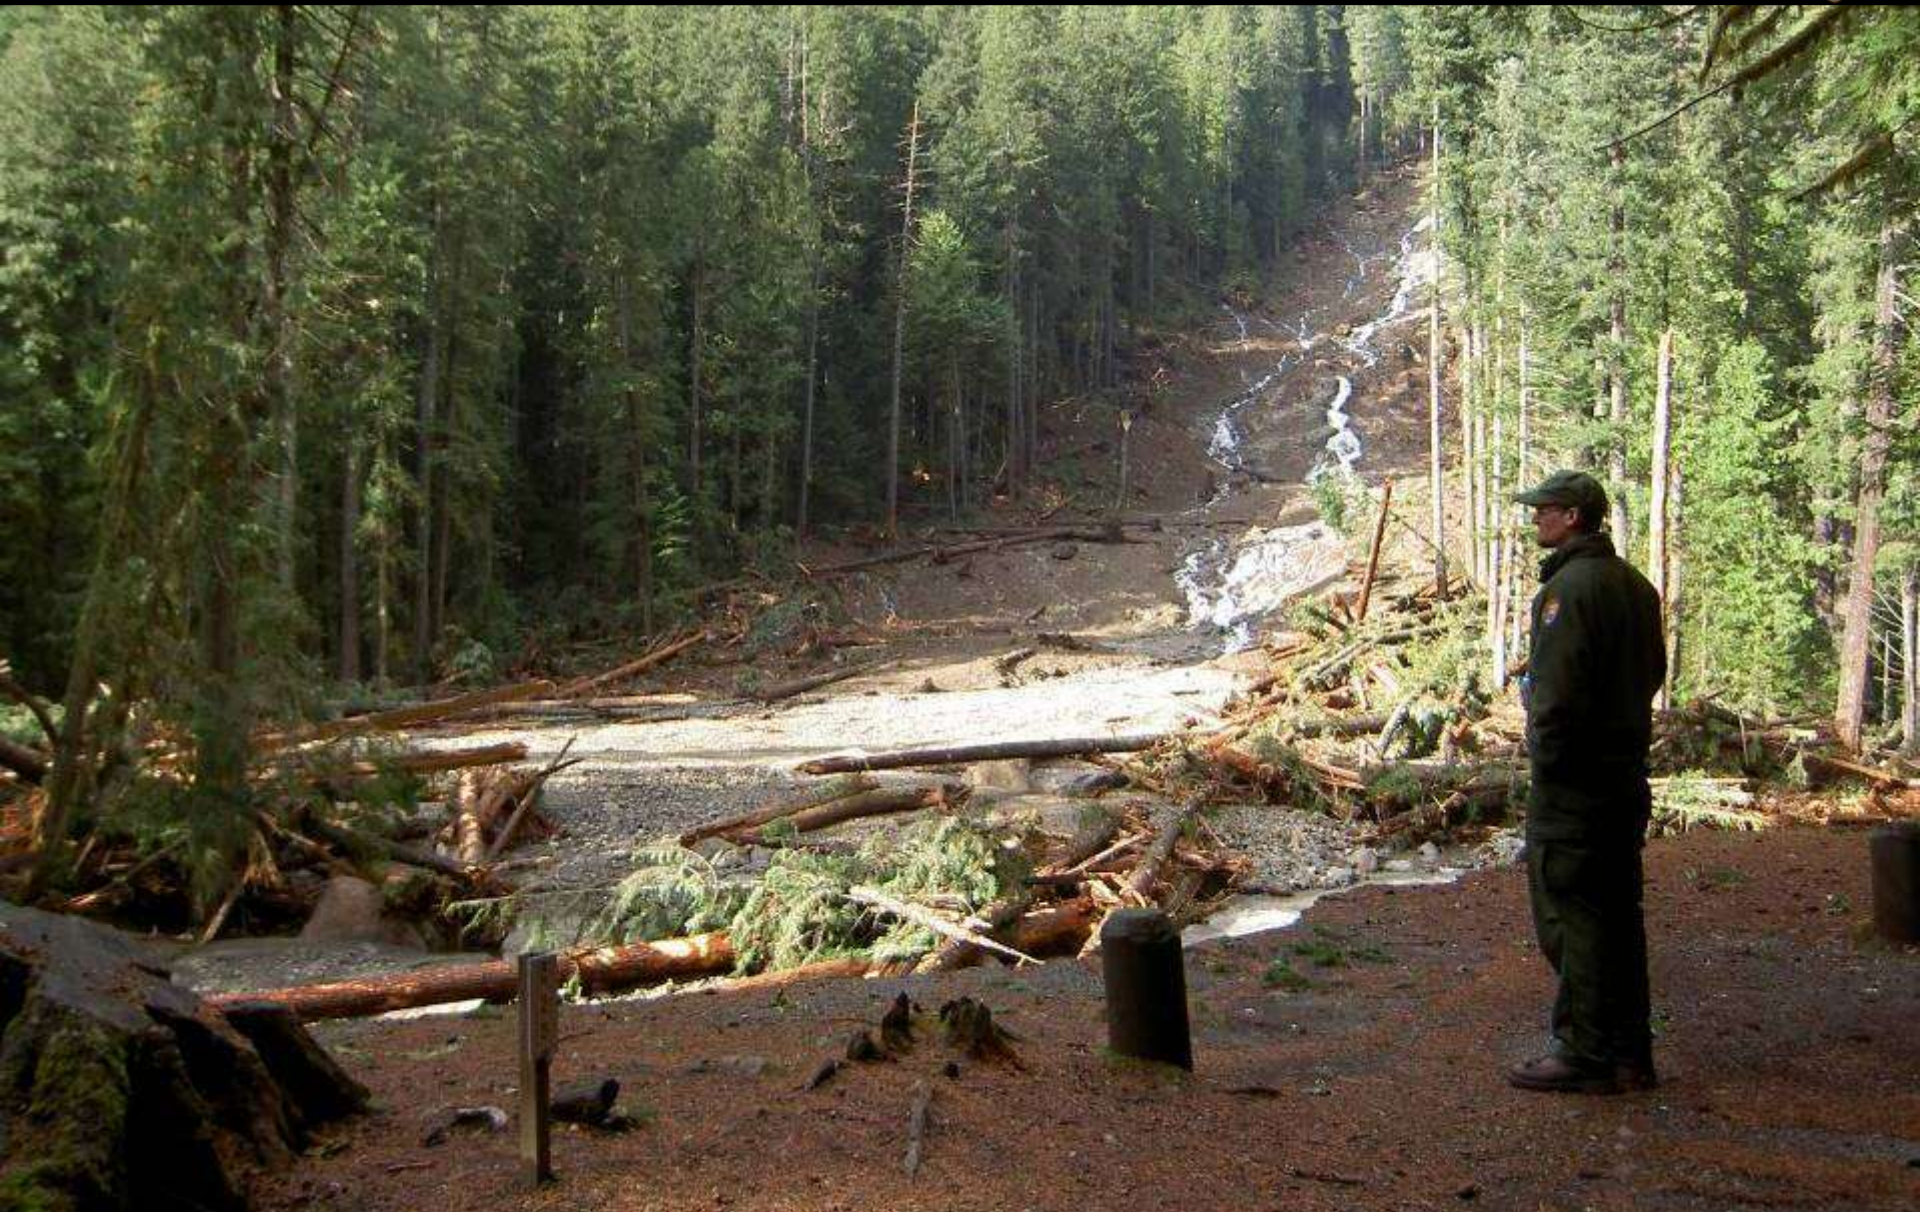
The bottom of the landslide is visible across the river from the Ohanapecosh Campground.

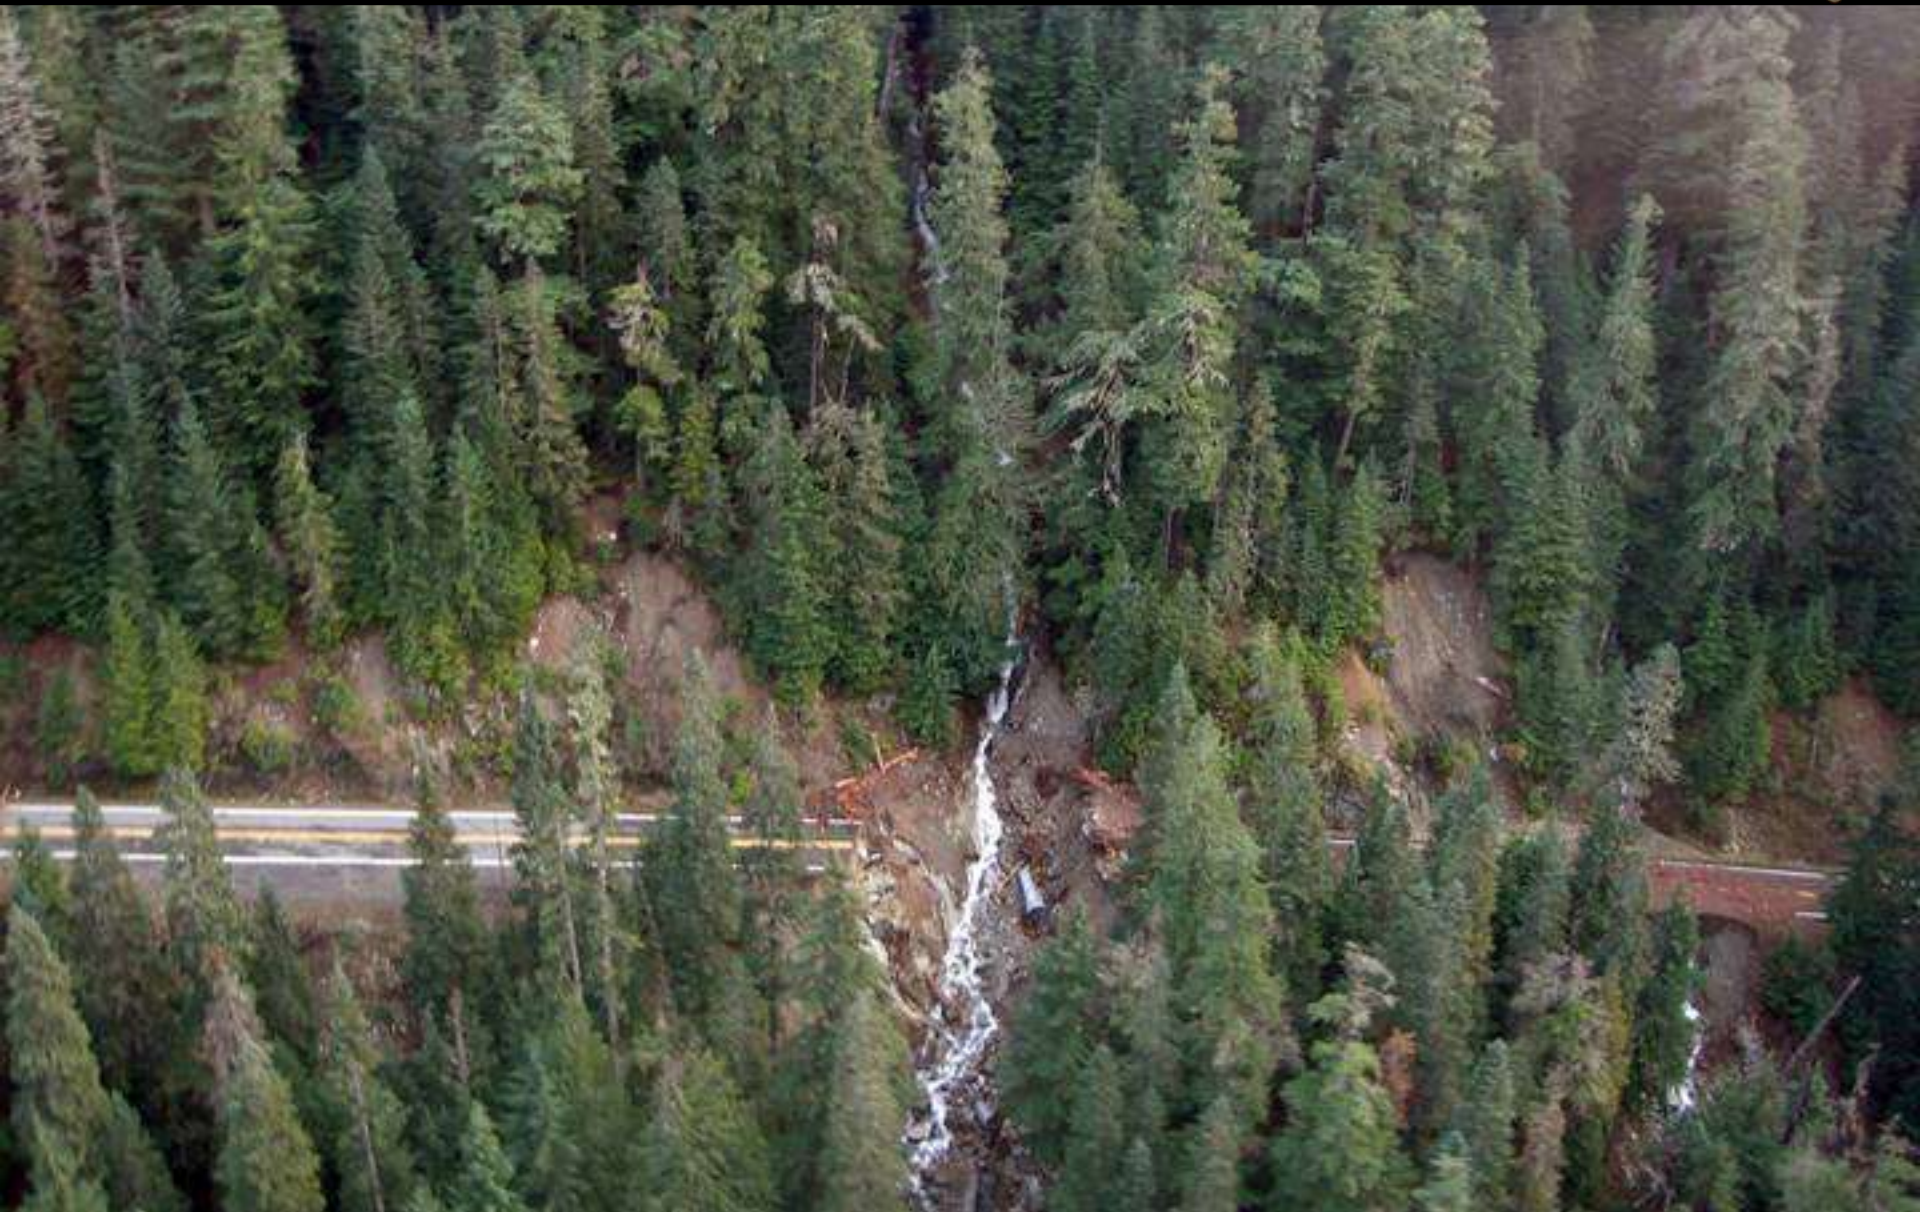
Highway 123 washed out in four places.

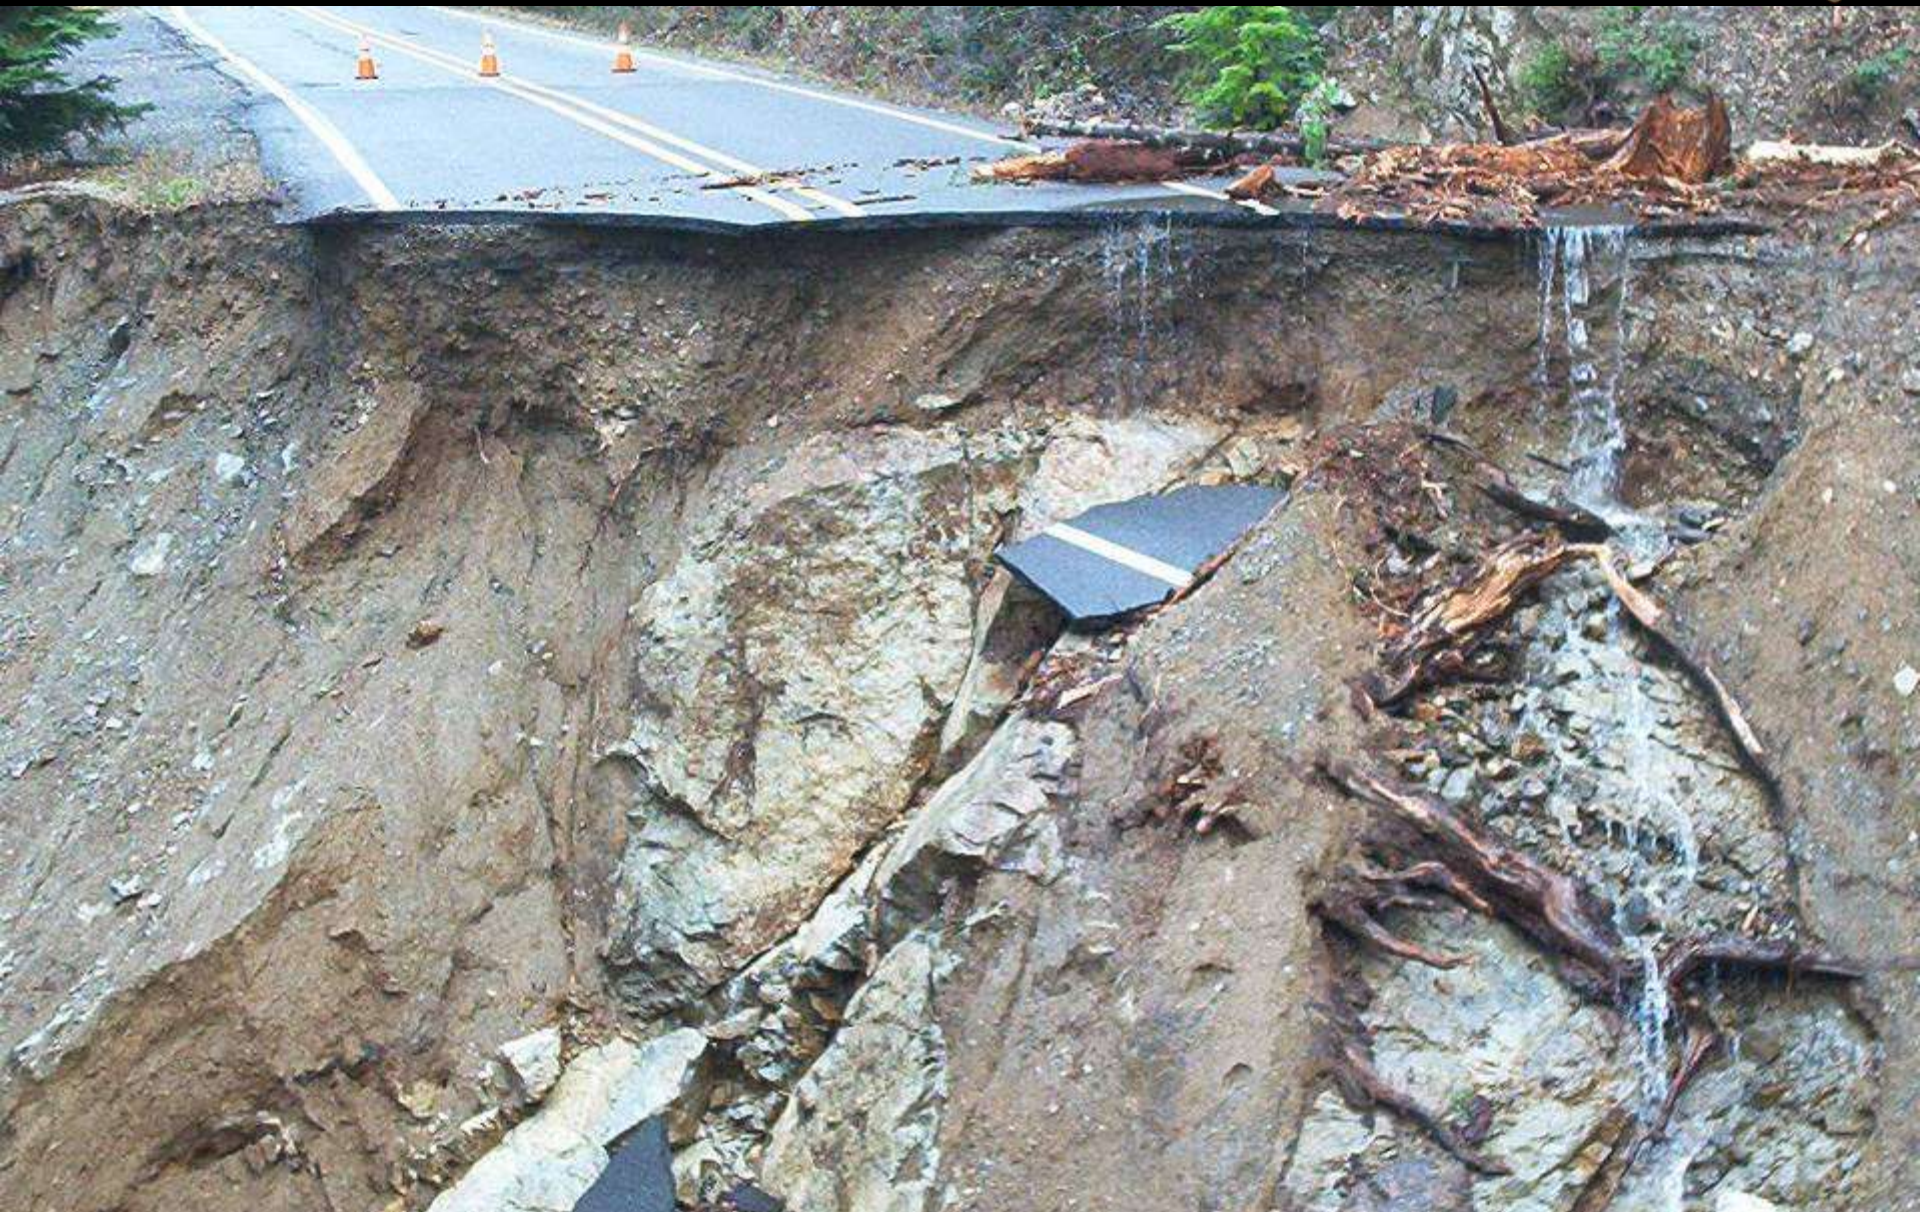
The worst washout, at Milepost 11, cuts across both lanes to a depth of 70 feet.

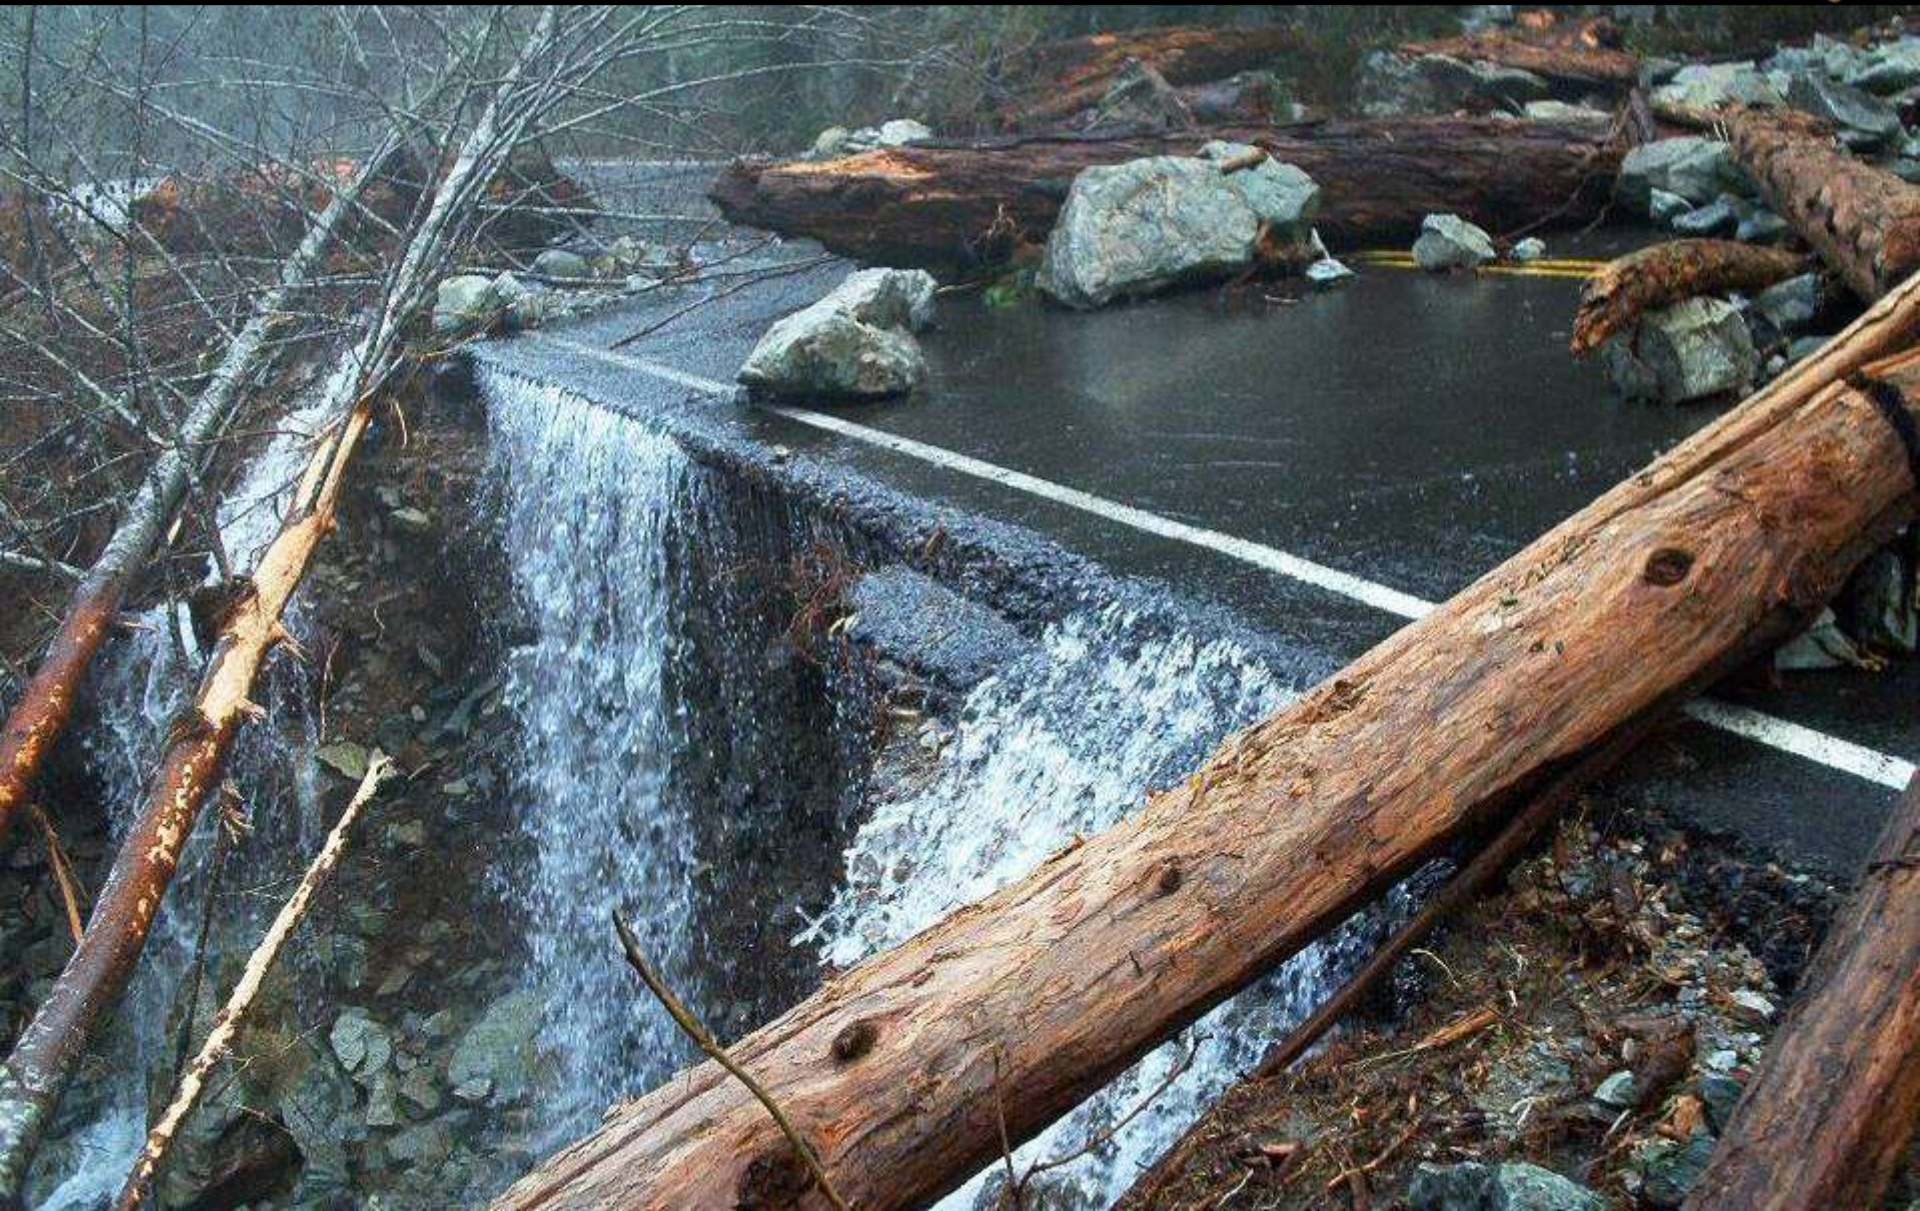
Debris covers the road in many places, and the edge is undermined.
