# Mount Rainier National Park

## The Great Flood of November 2006

Updated April 27, 2007

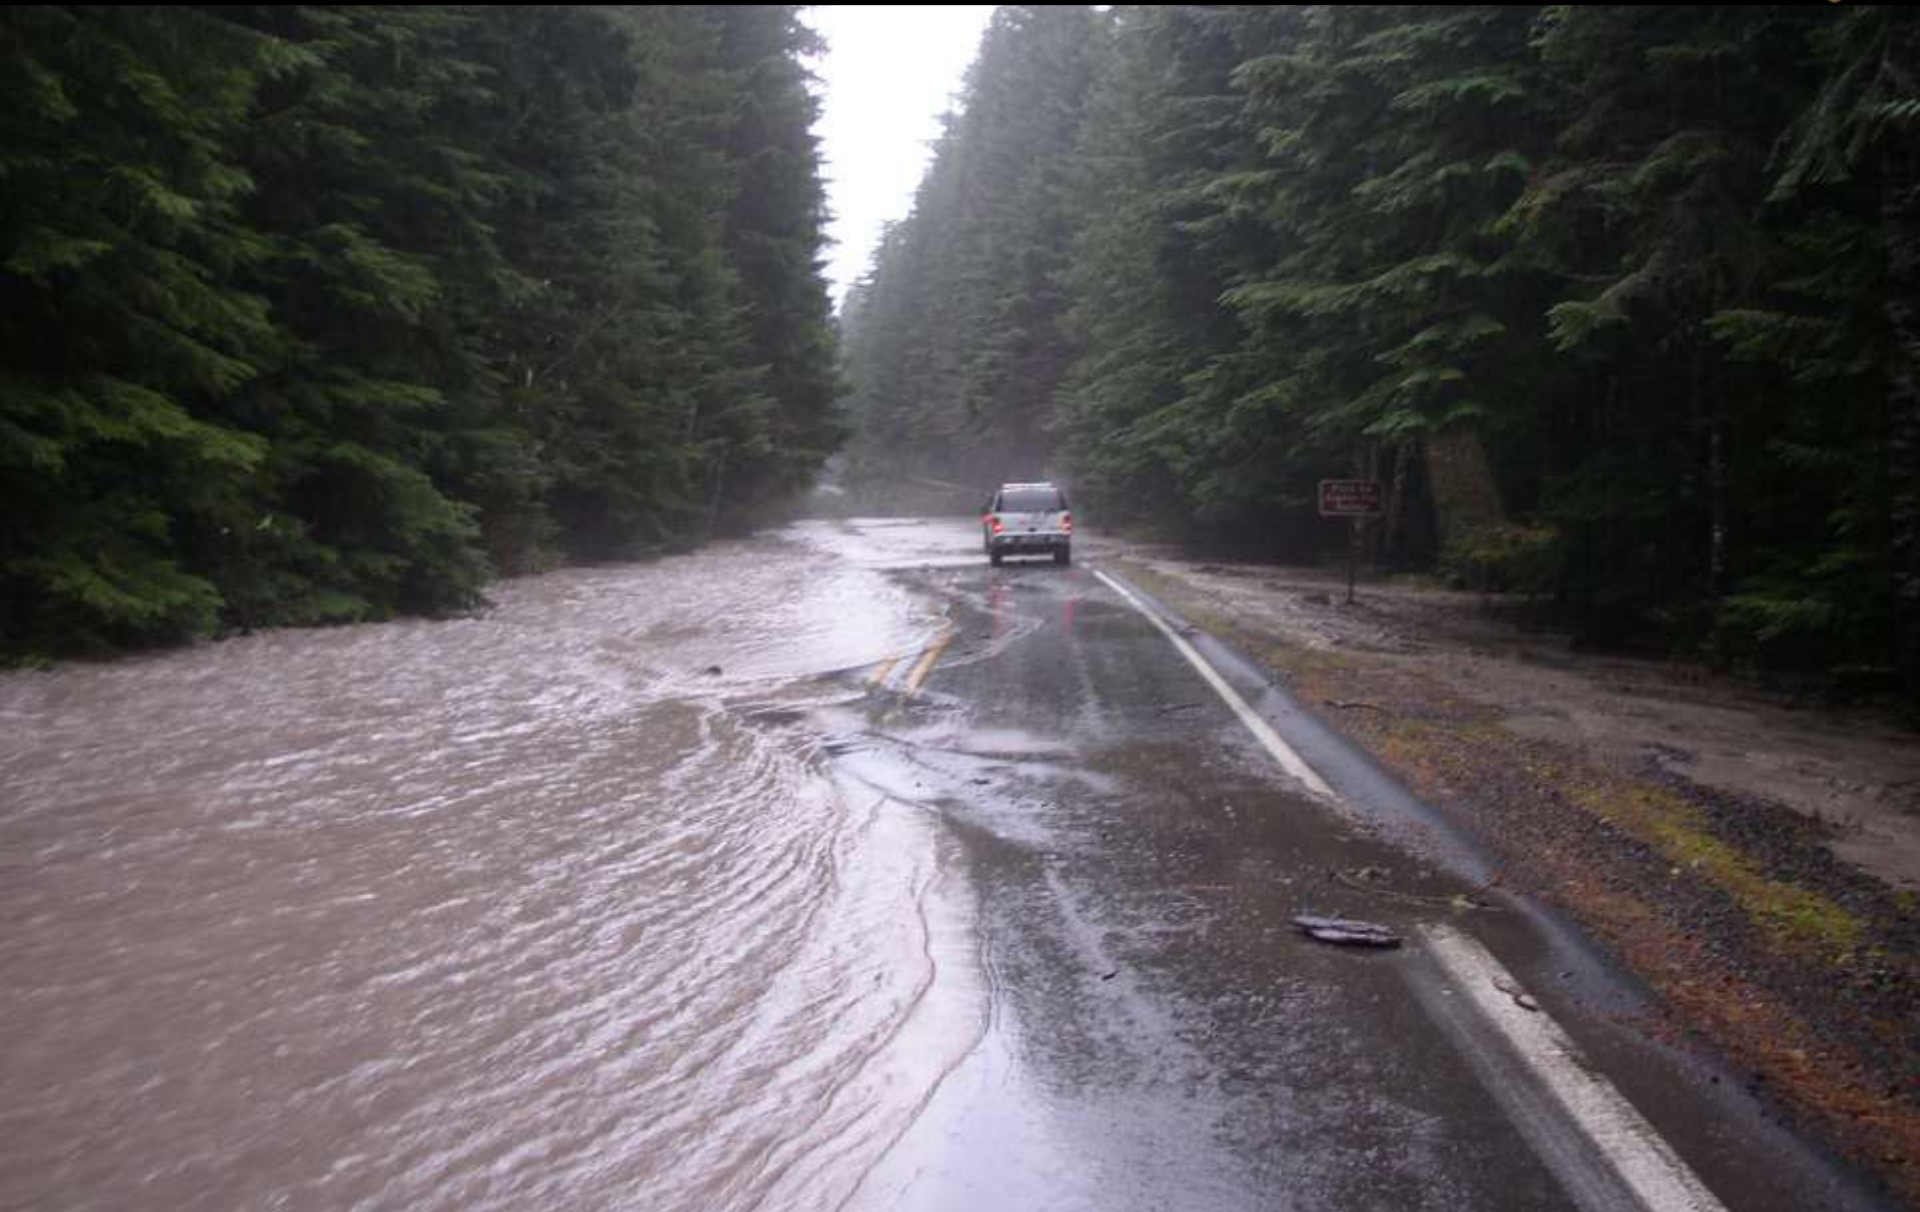
18 inches of rain fell in 36 hours, flooding roads like Highway 410 that usually stay dry.

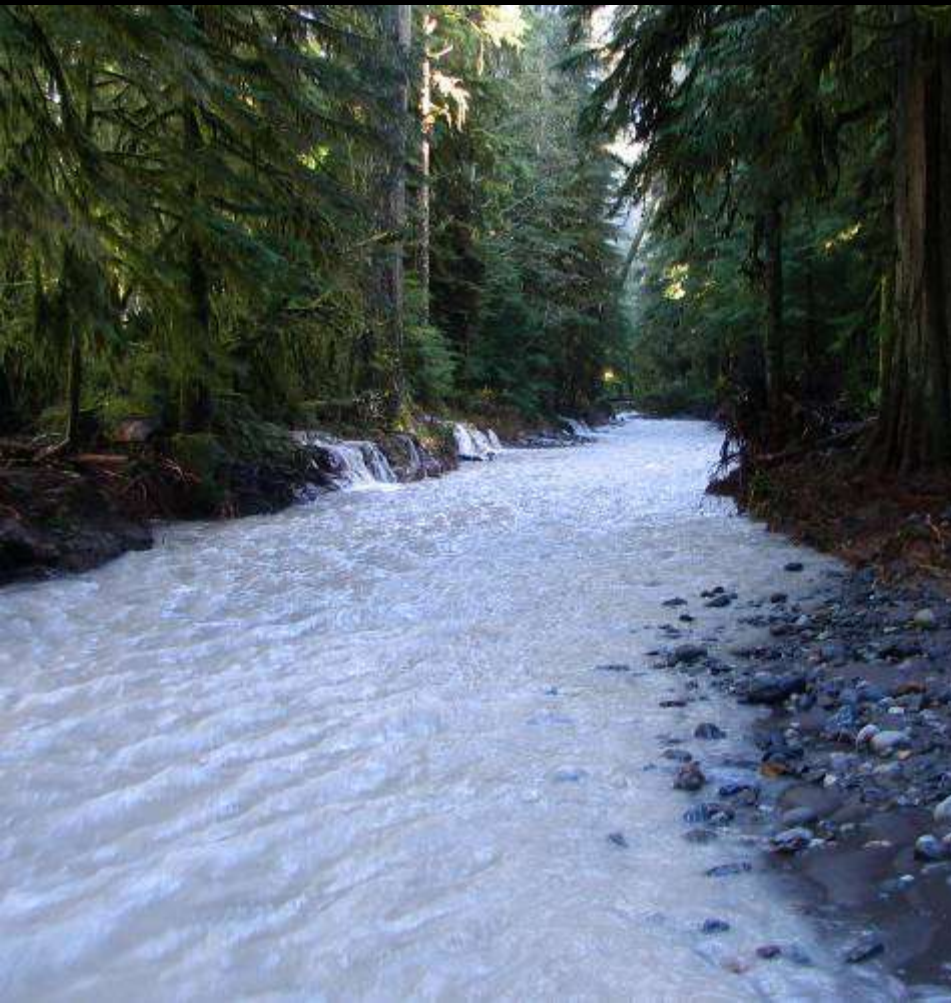
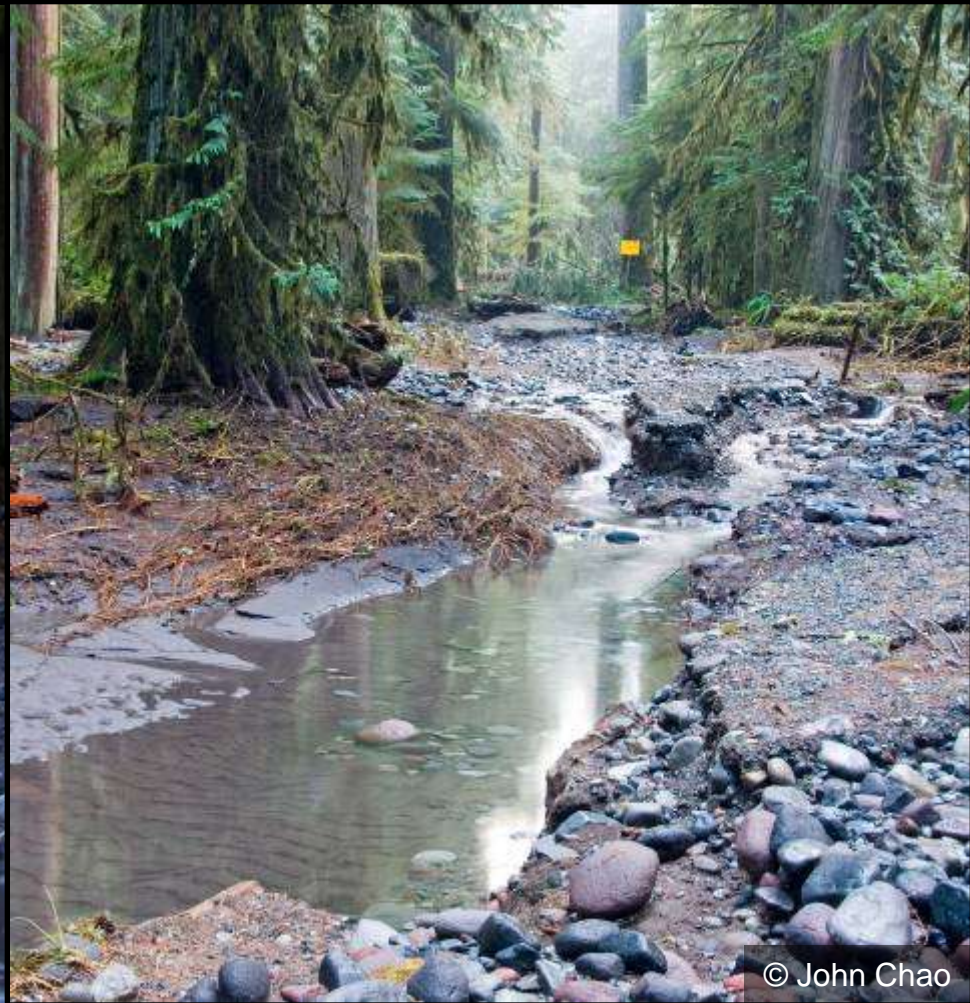
The Carbon River Road was damaged or destroyed in numerous places.

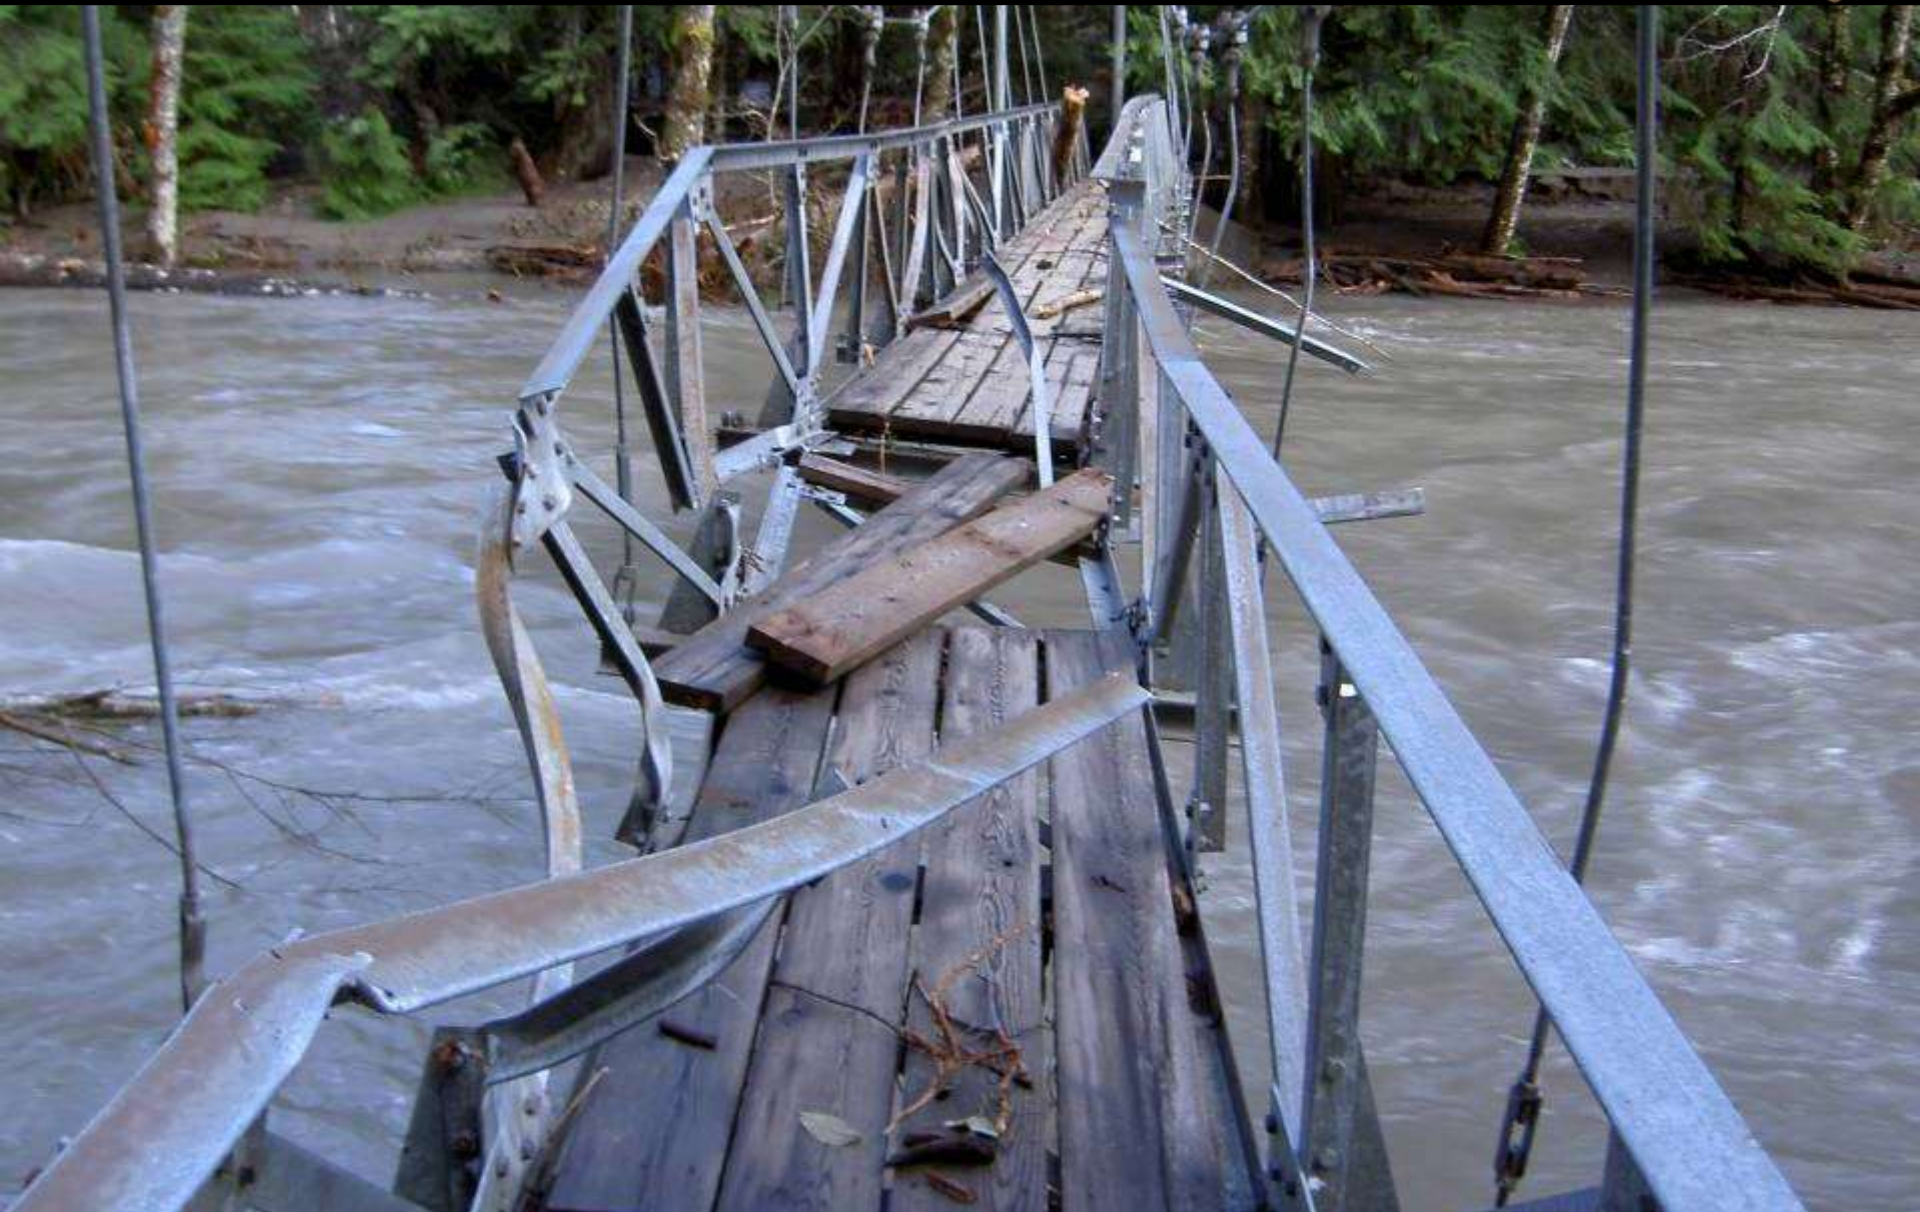
Trail bridges were damaged or destroyed all over the park, including the suspension bridge at the Grove of the Patriarchs.

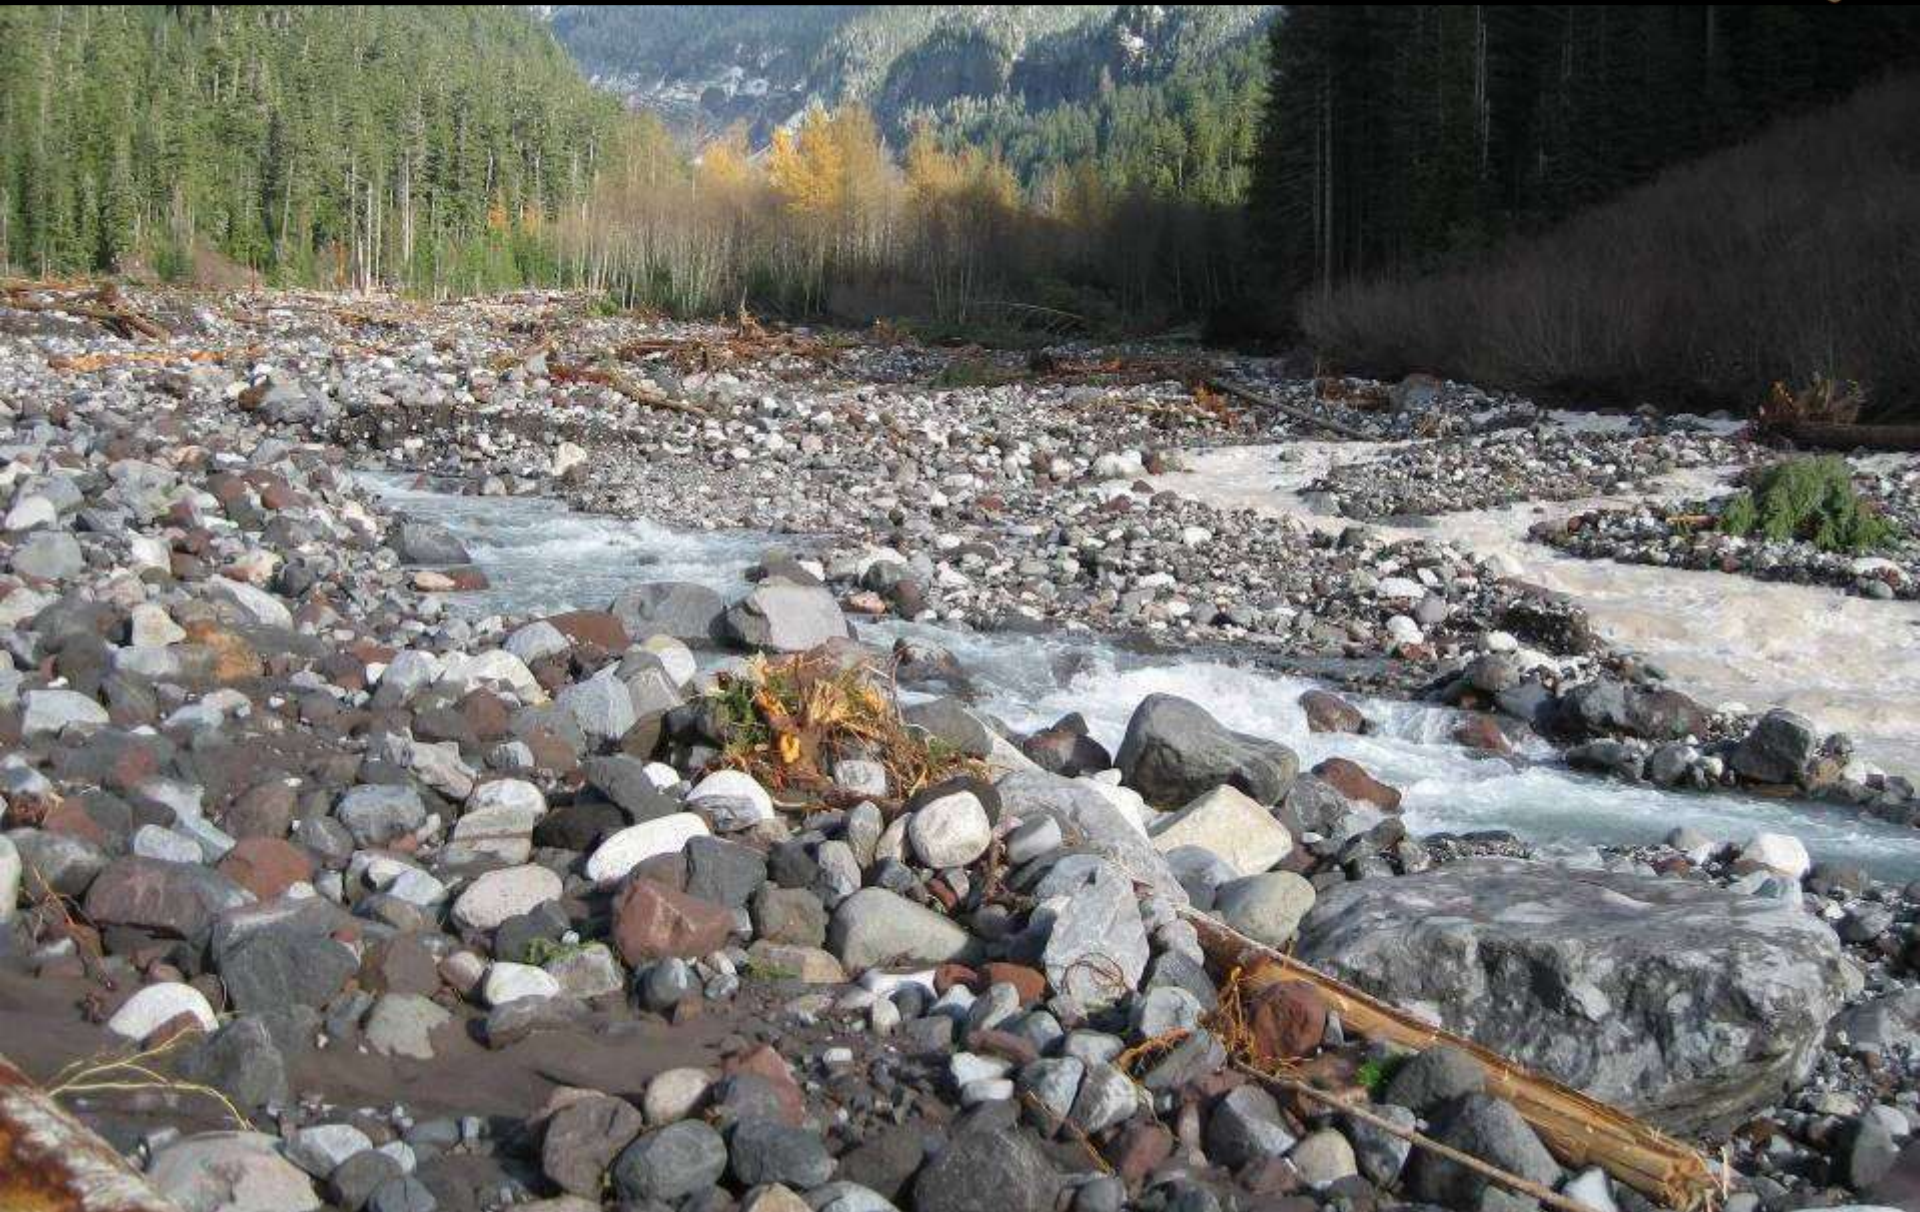
In some places, the process is much faster, causing riverbeds to rise tens of feet over the past century.
