# Trail, Road, and Access Management – North Cascades National Park Service Complex

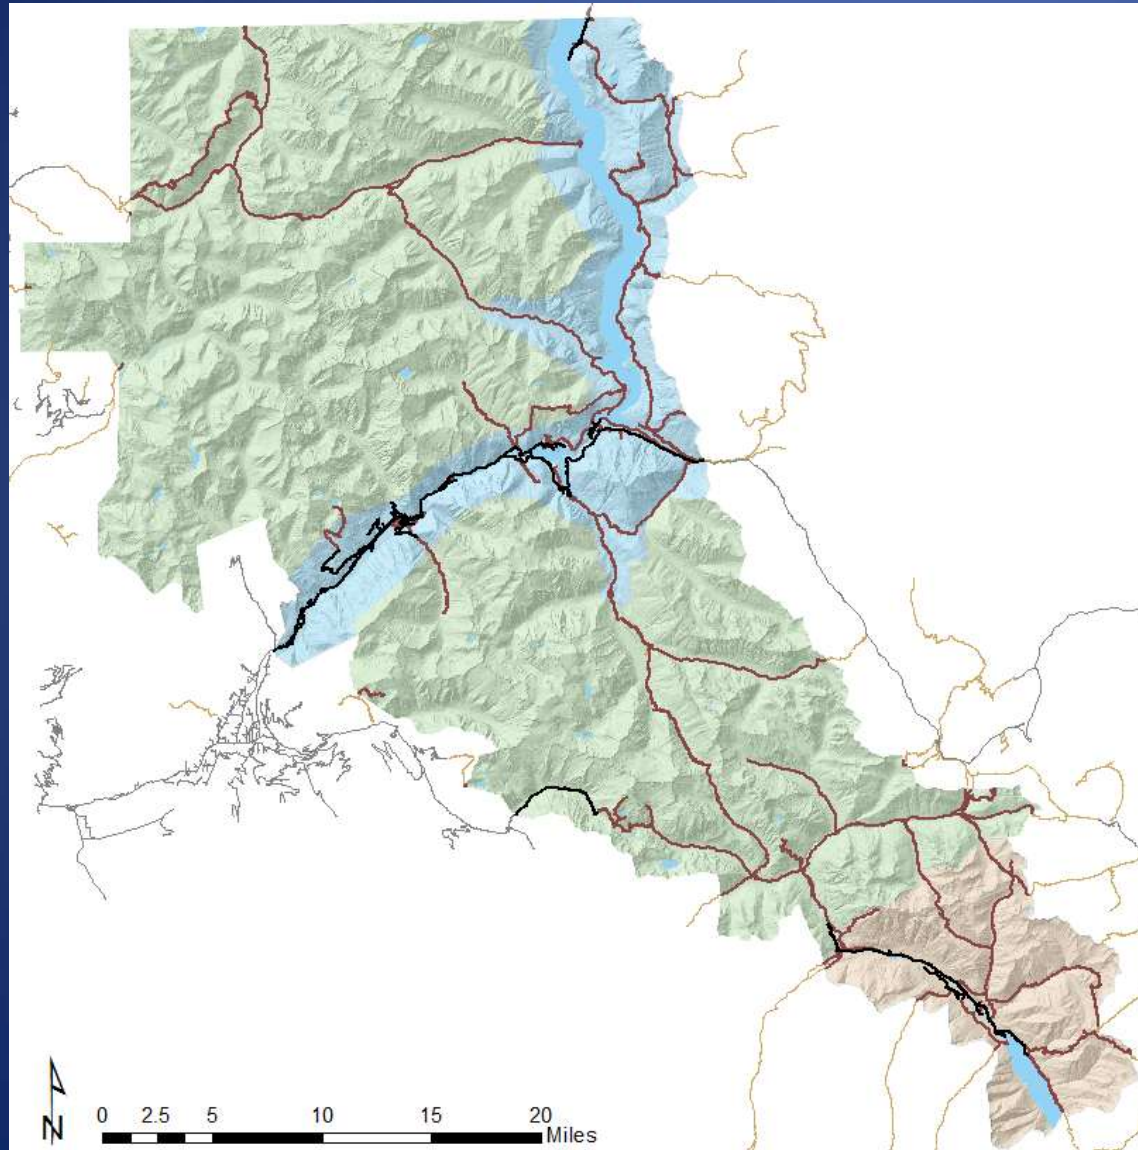
# Roads and trails network

## Roads

- NPS : 47 miles
- WSDOT (SR20): 28 miles

## Surface type

- Bituminous: 11 miles
- Gravel: 33 miles
- Soil: 1.3 miles

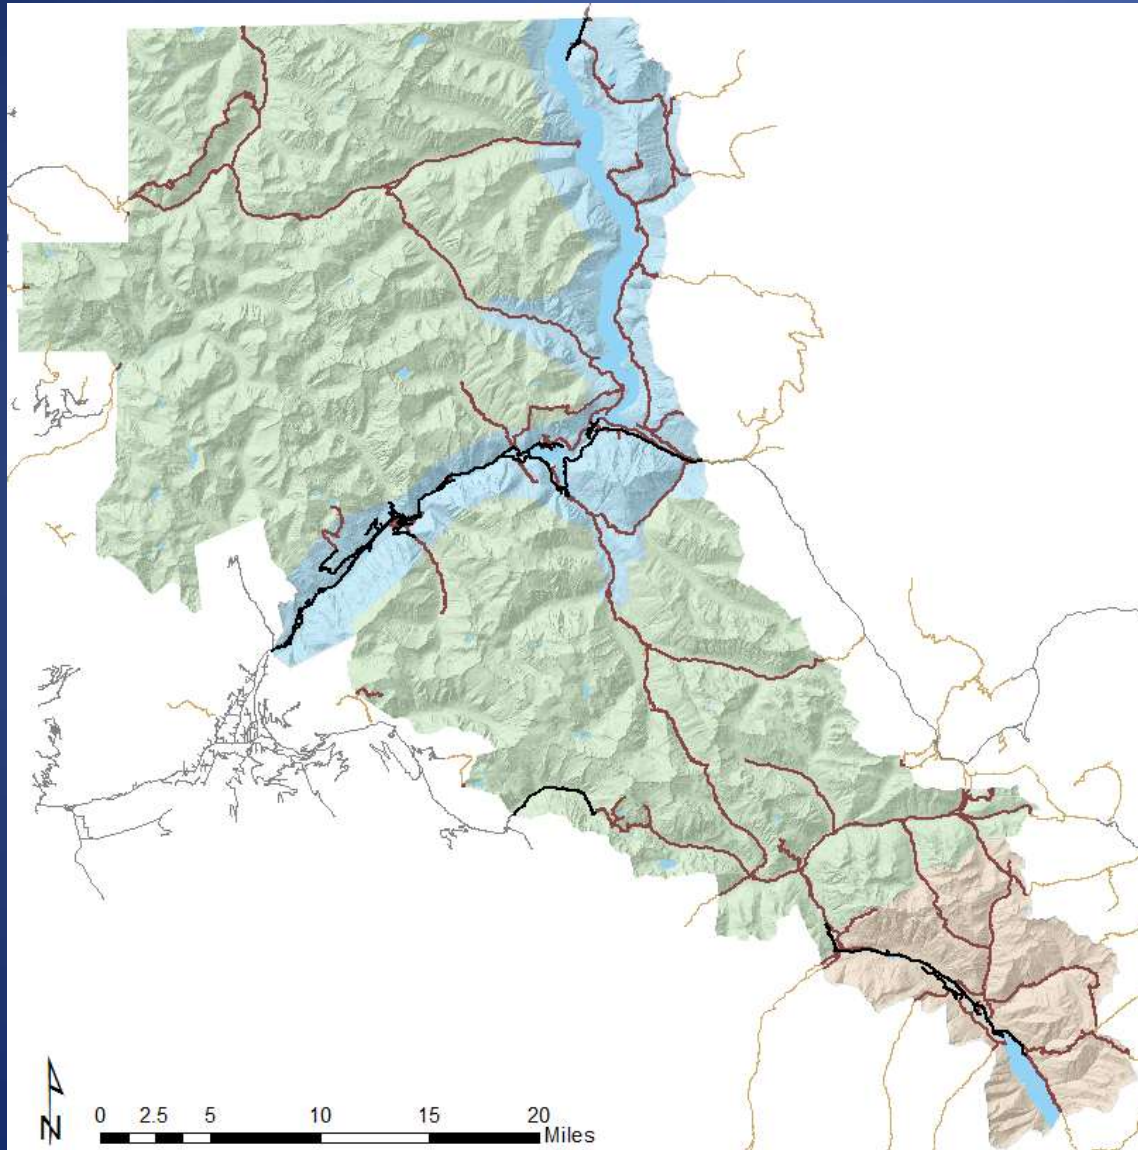
# Roads and trails network

## Bridges

- NPS: 11
- WSDOT (SR20): 14

## Culverts

- NPS: 194
- WSDOT (SR20): 268

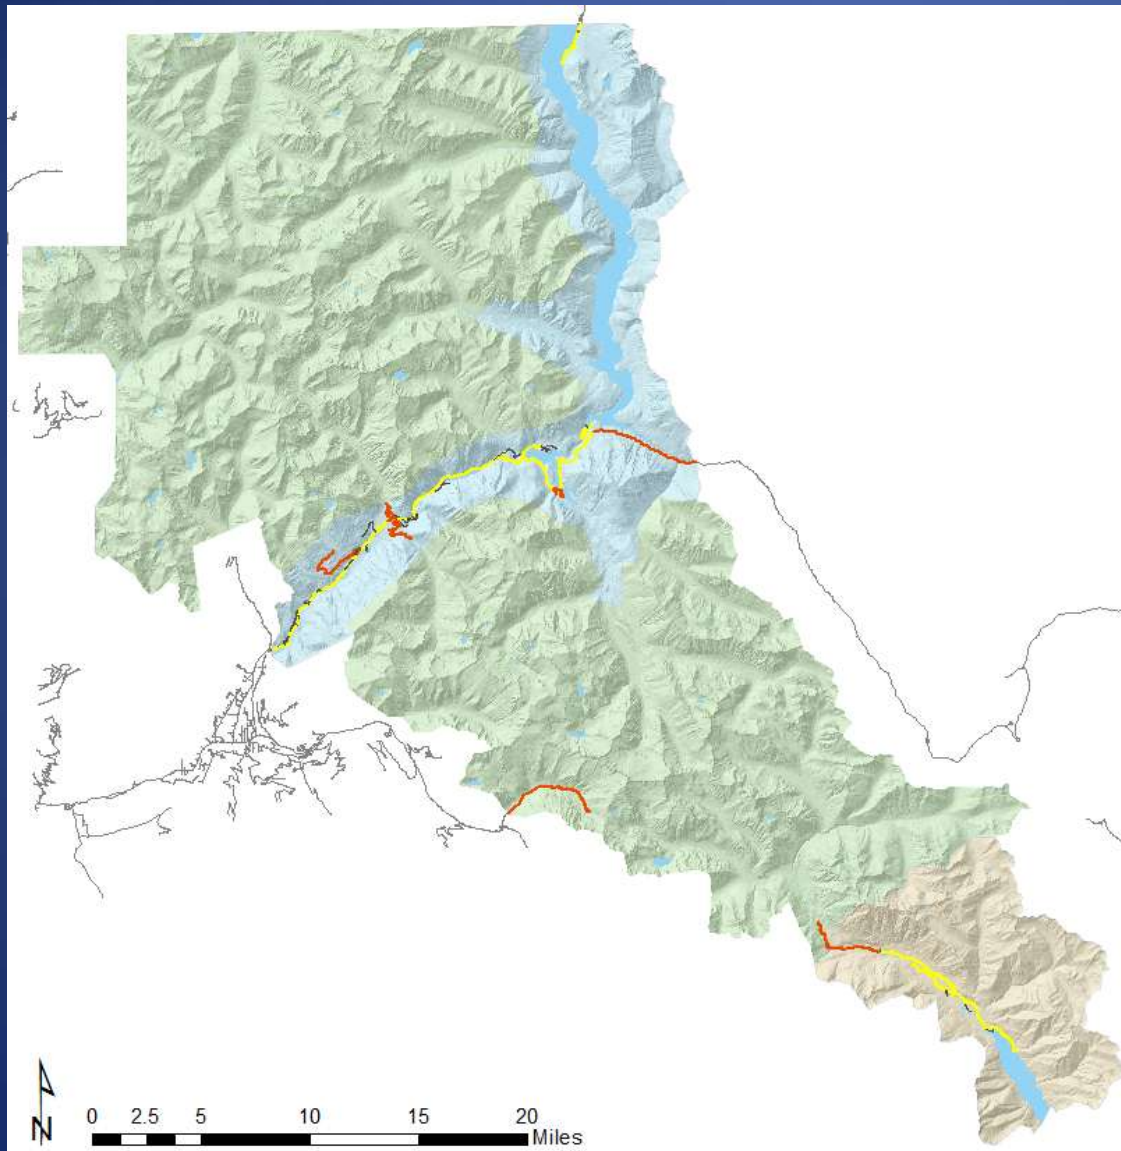
# Roads: Year-round vs. seasonal use

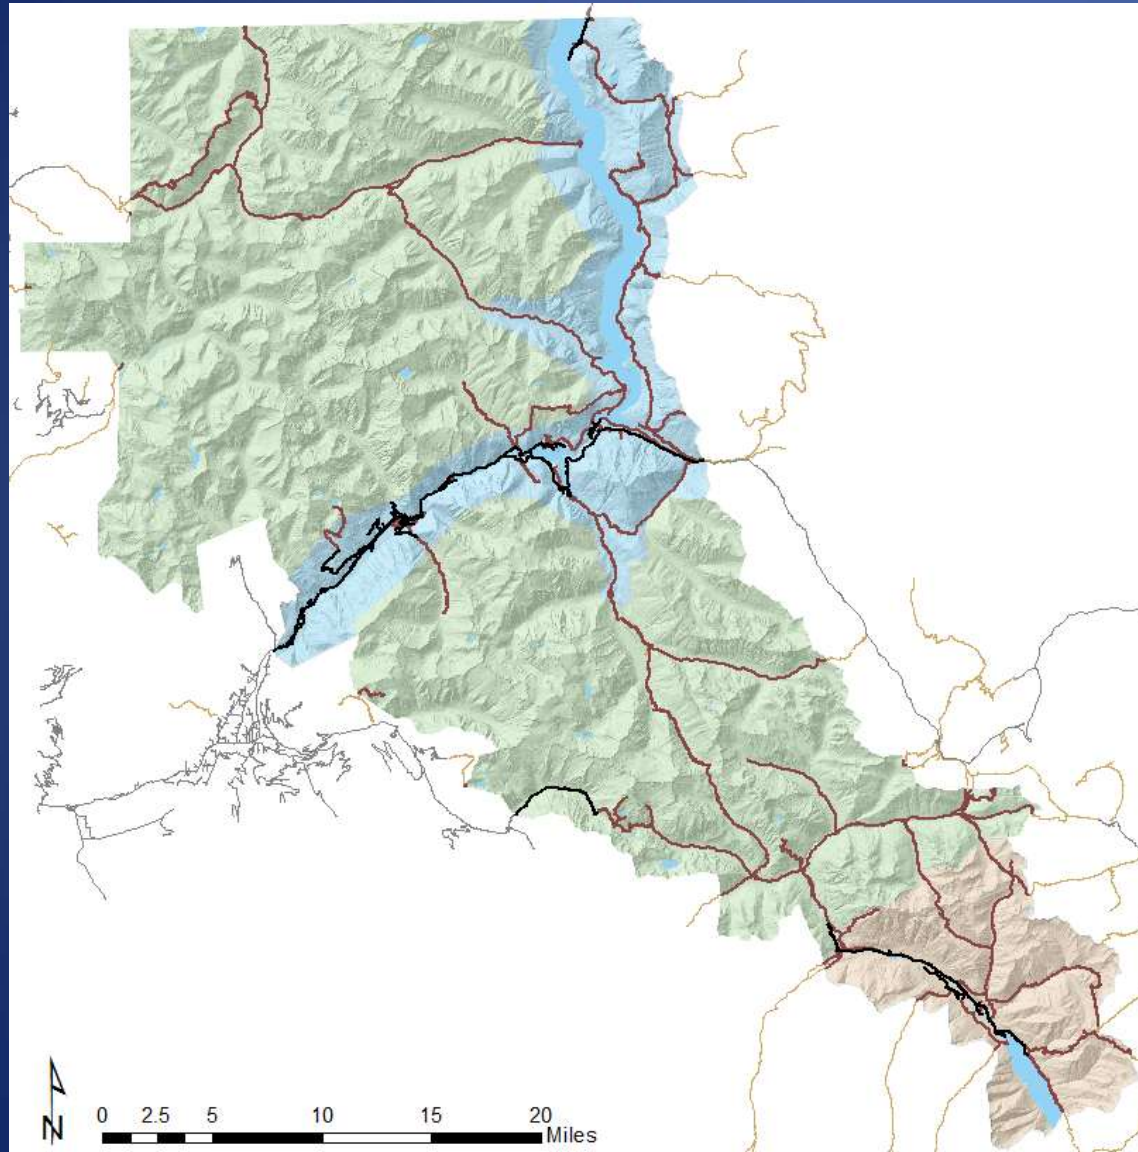
# Roads and **trails** network

## Trails:

- Hiker only: 133 miles
- Pack animal: 256 miles

Trail bridges (FHWA inspected): 11

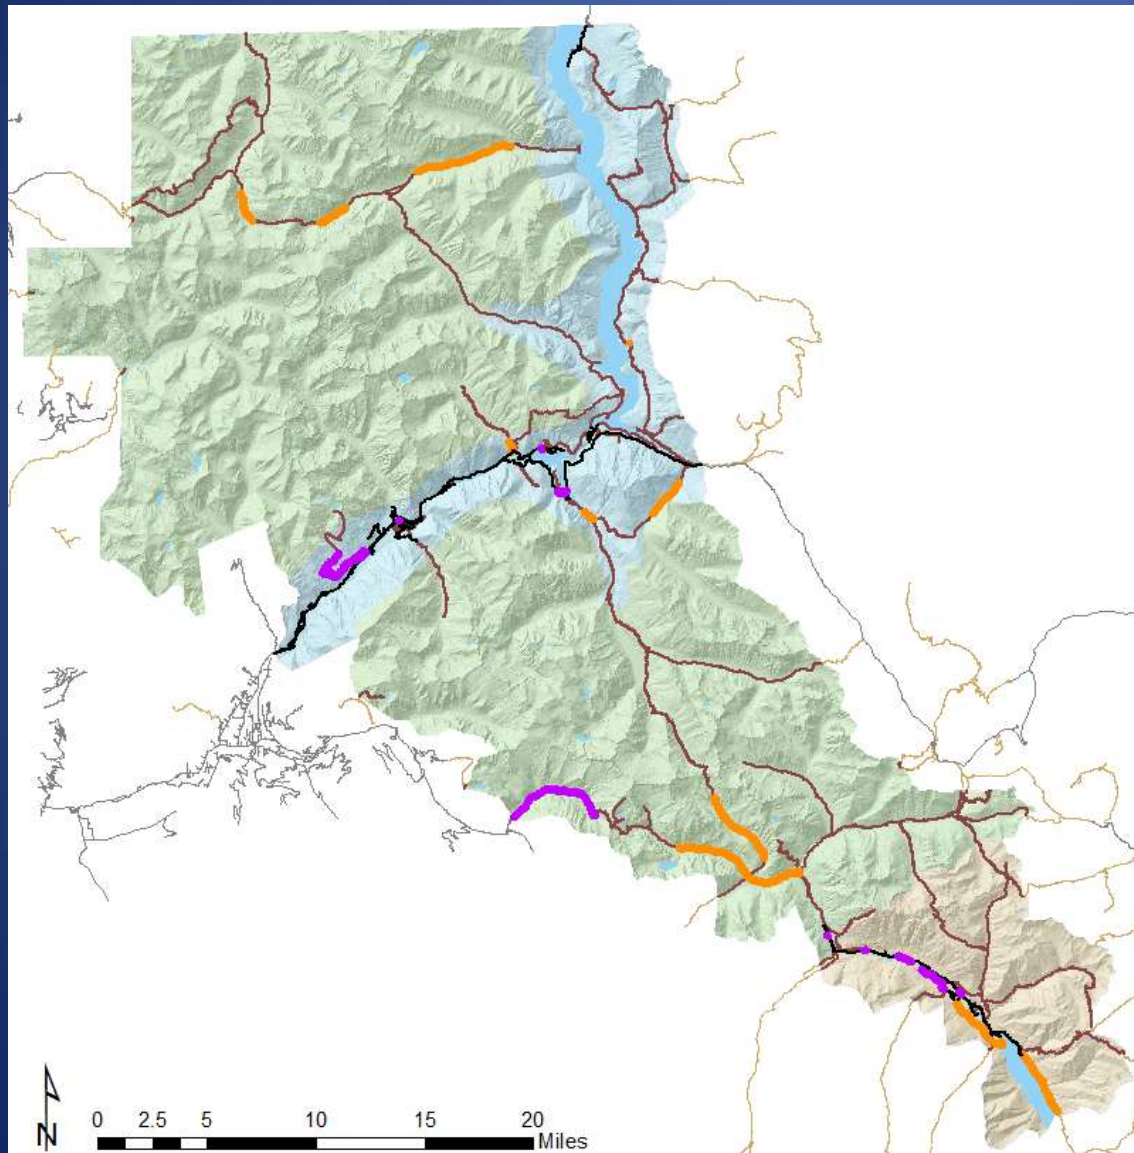
# Roads & trails w/ multiple damage events

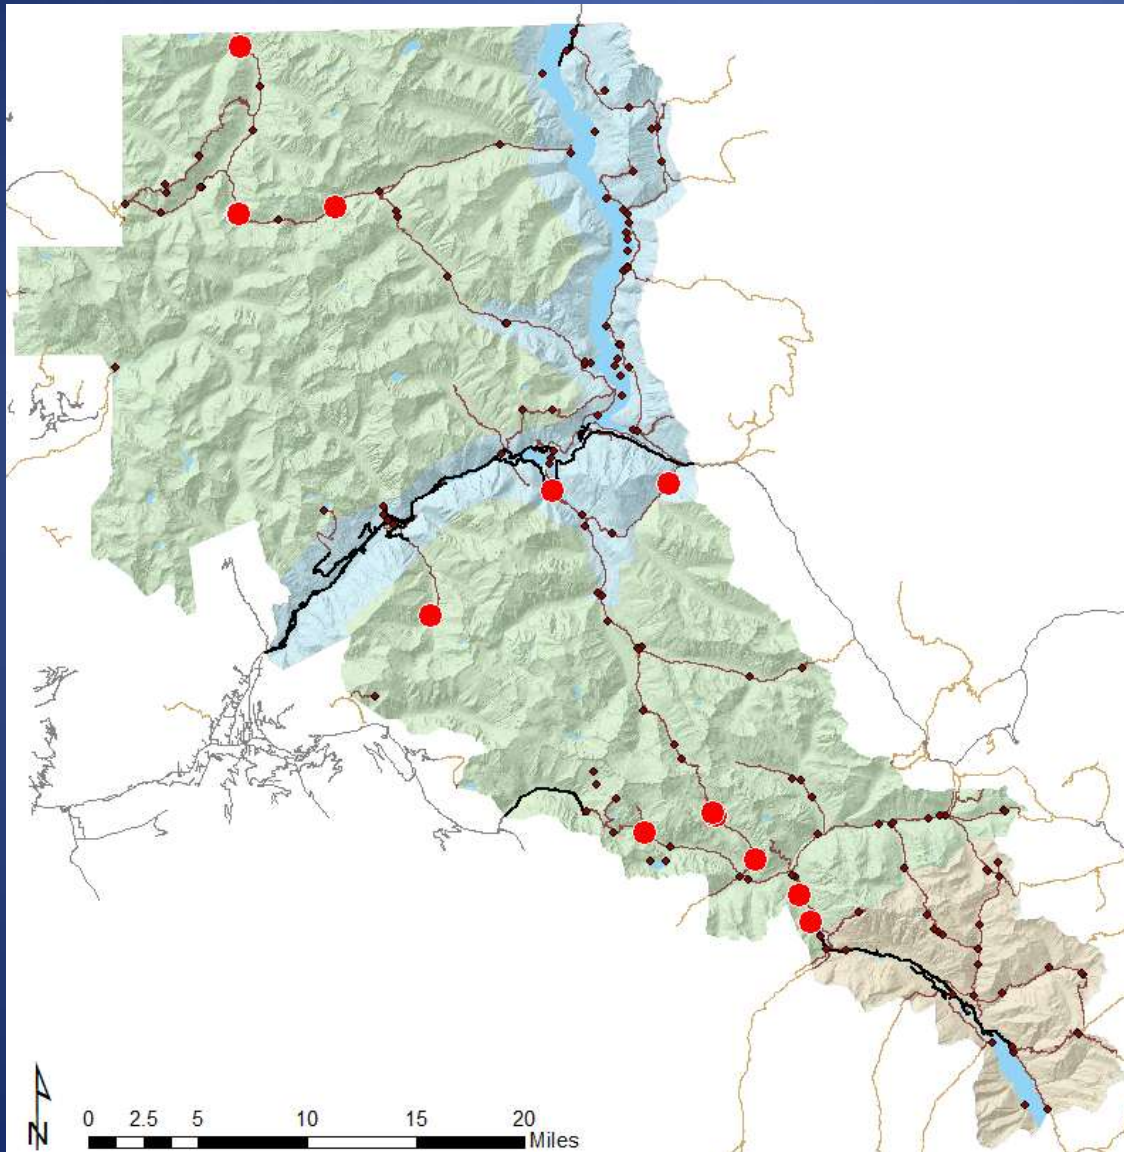
# Camps with multiple damage events

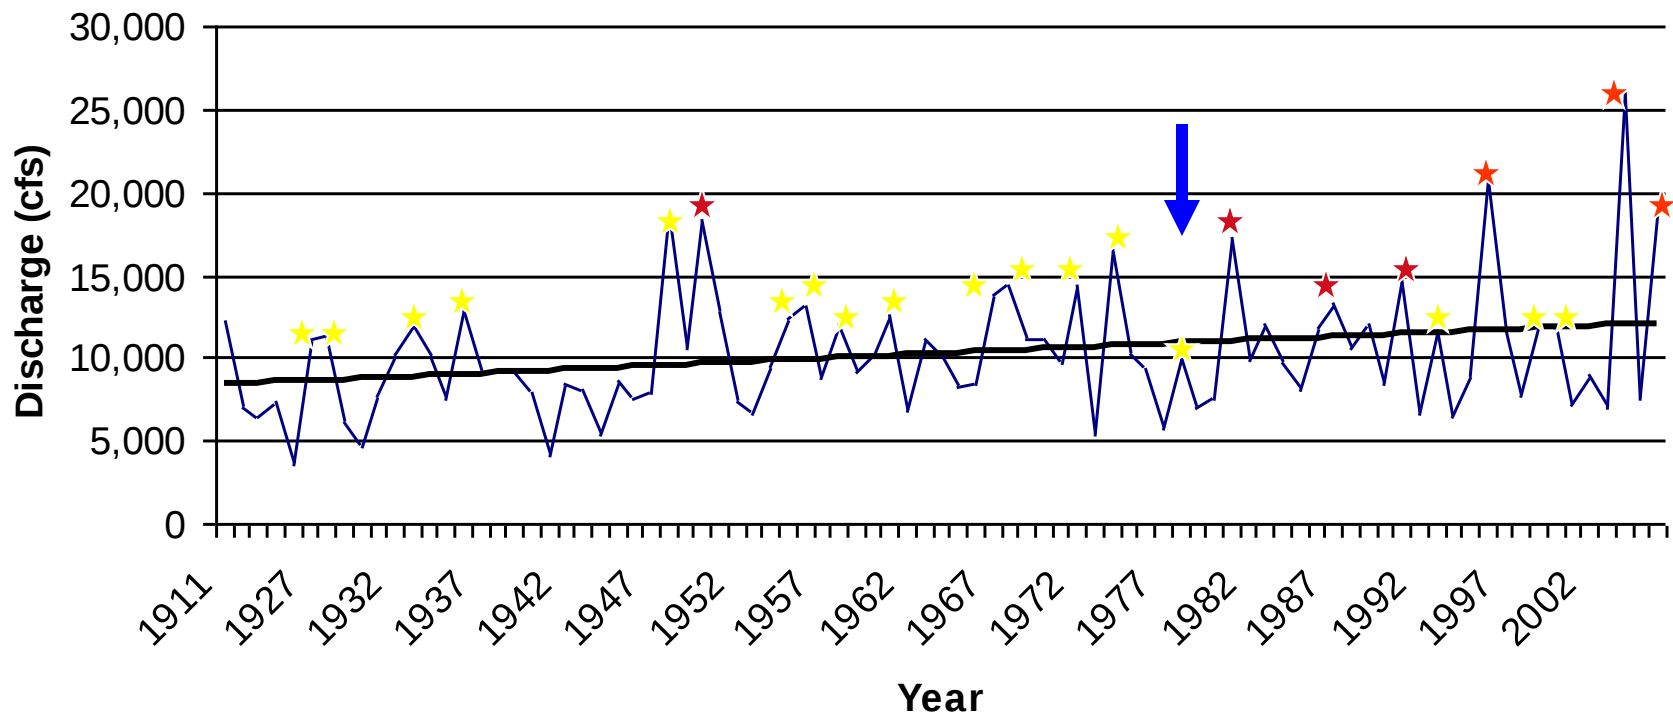
# Magnitude and Timing of the Annual Peak Flood on the Stehekin River

spring flood

fall flood

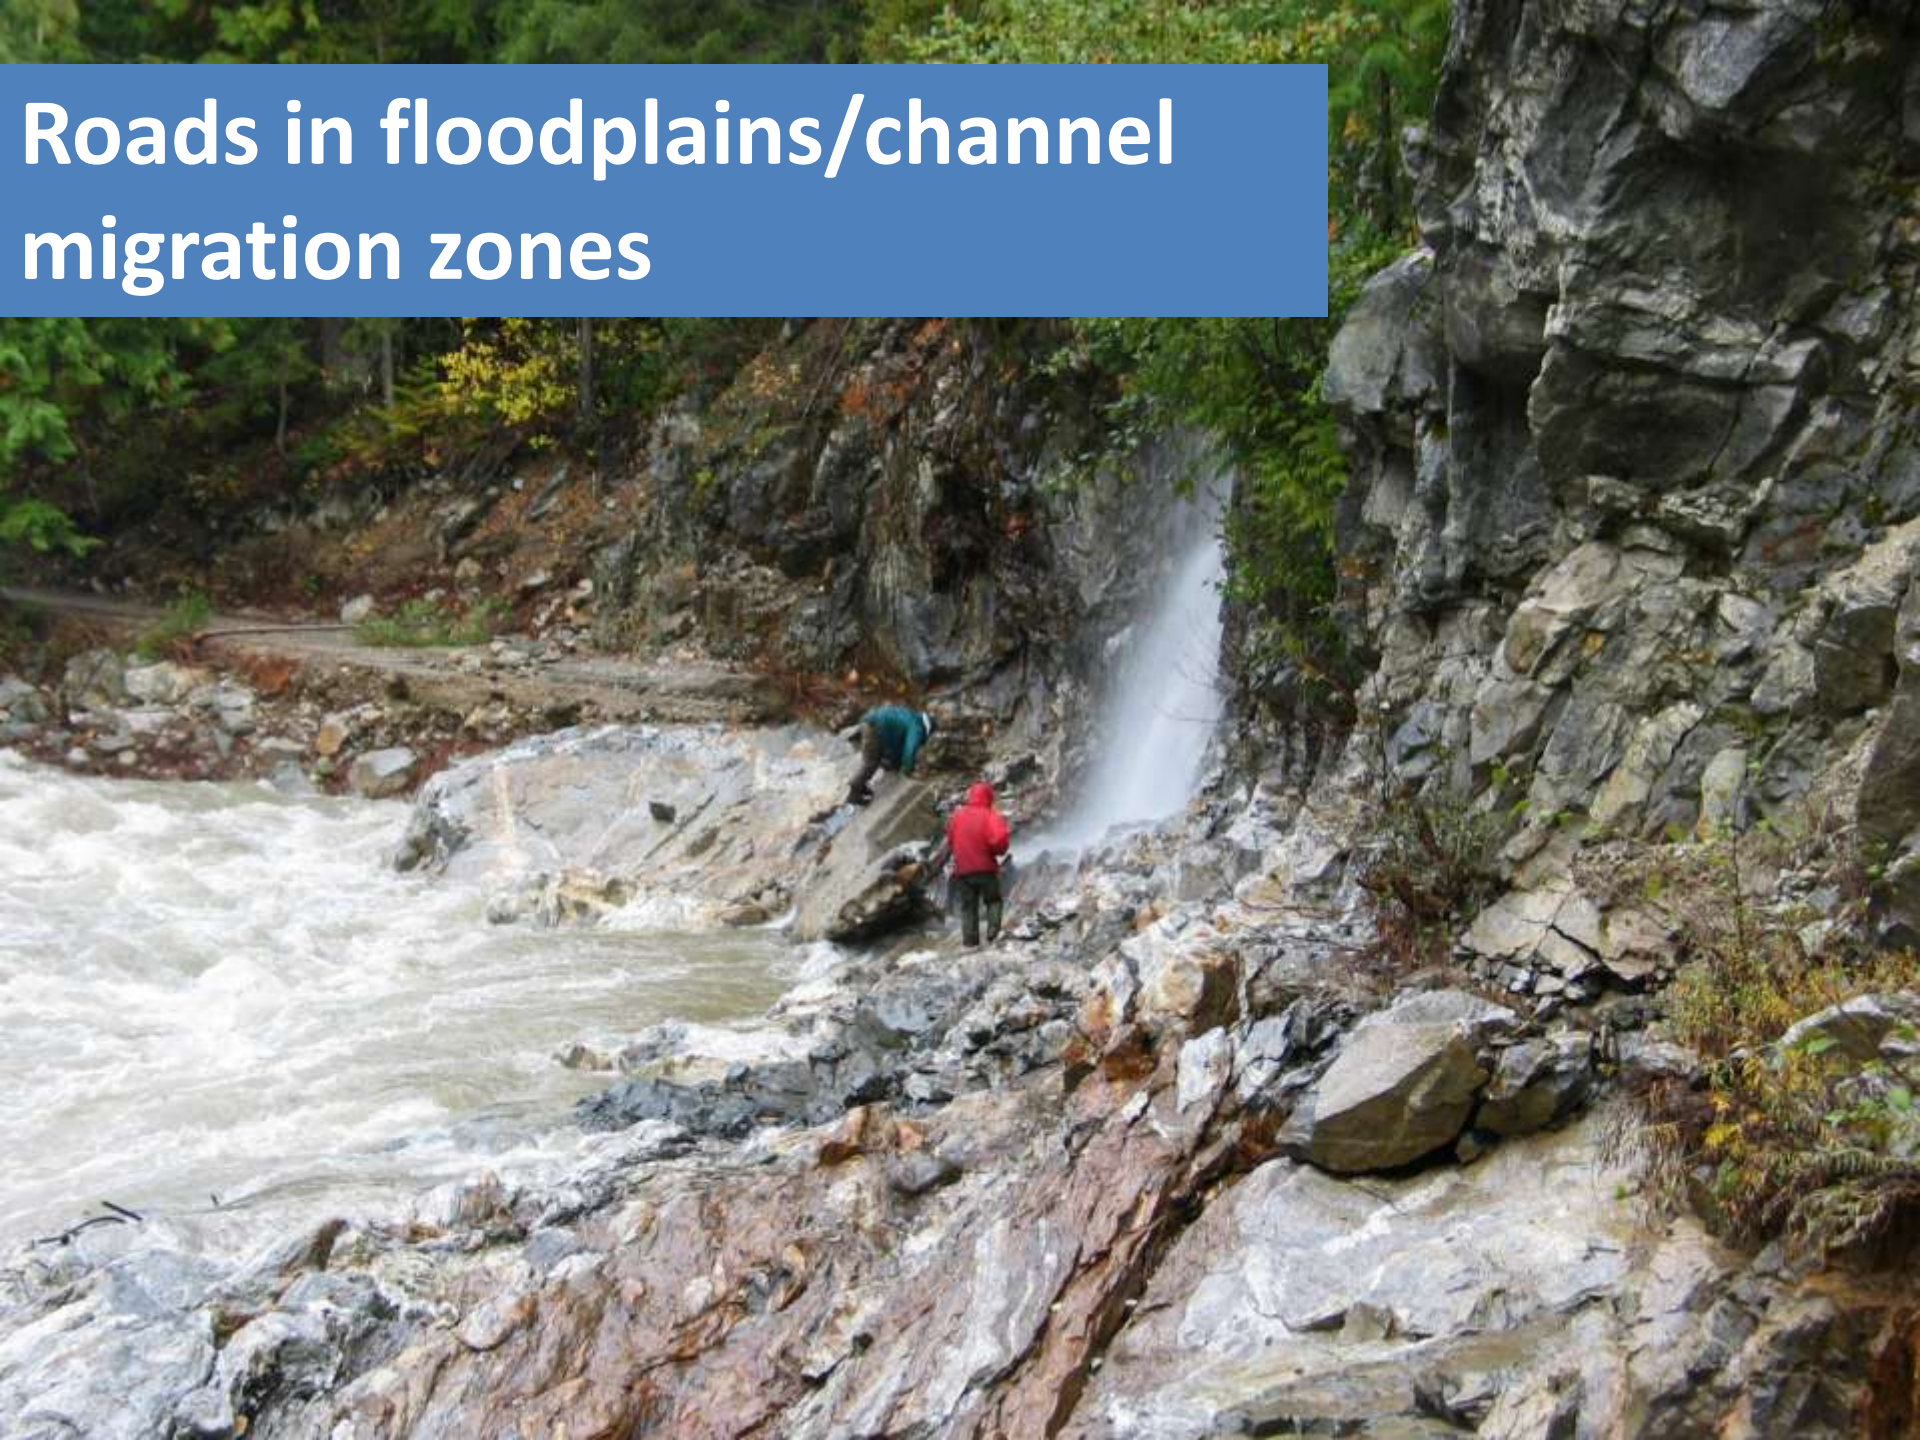
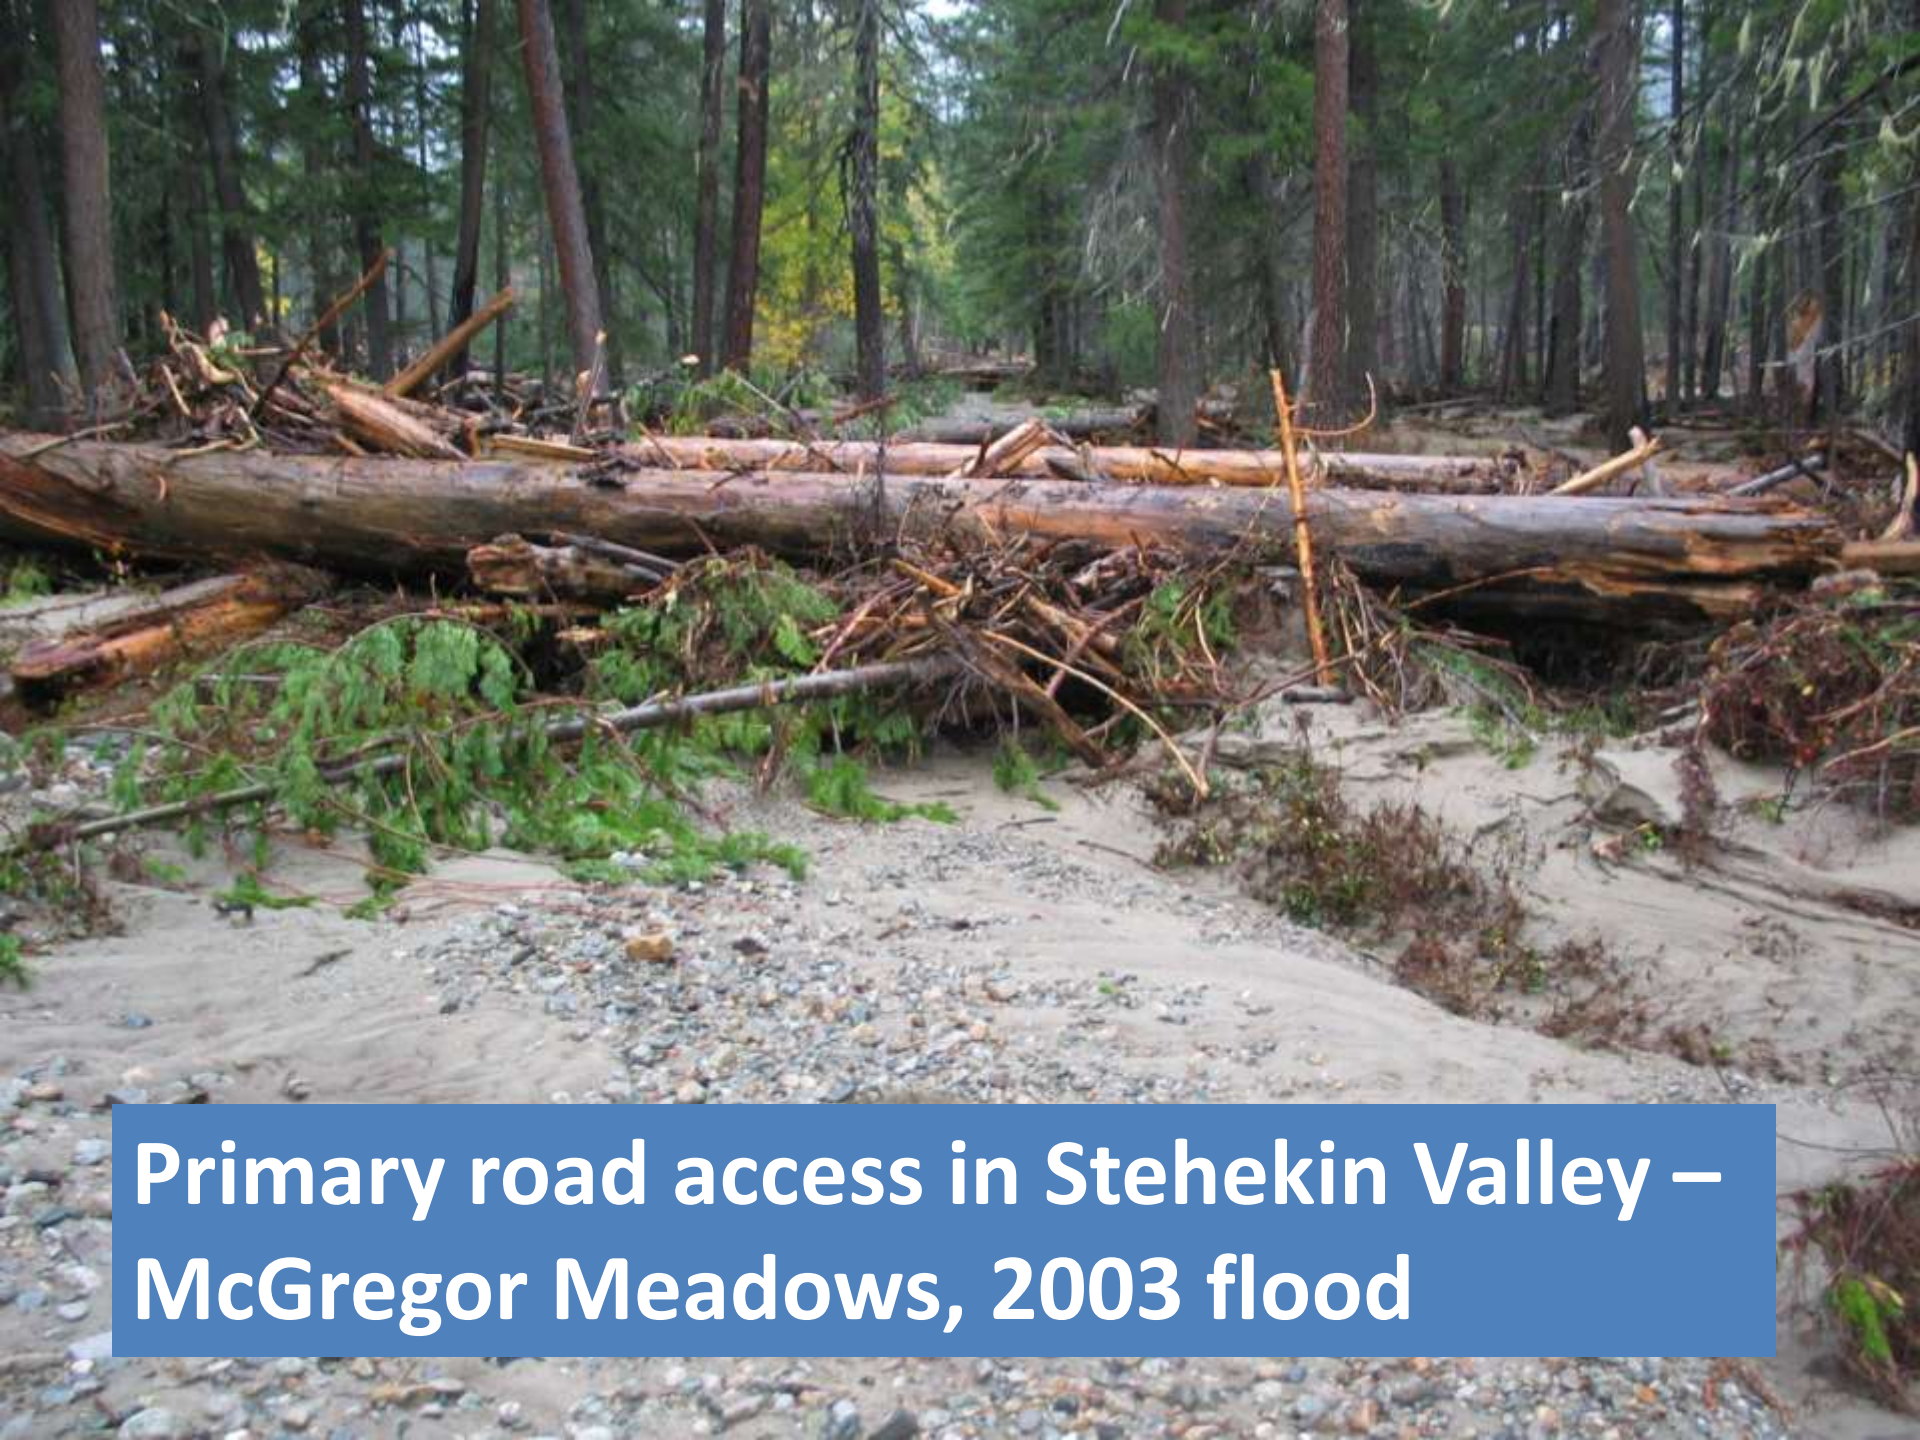
# Roads in floodplains/channel migration zones

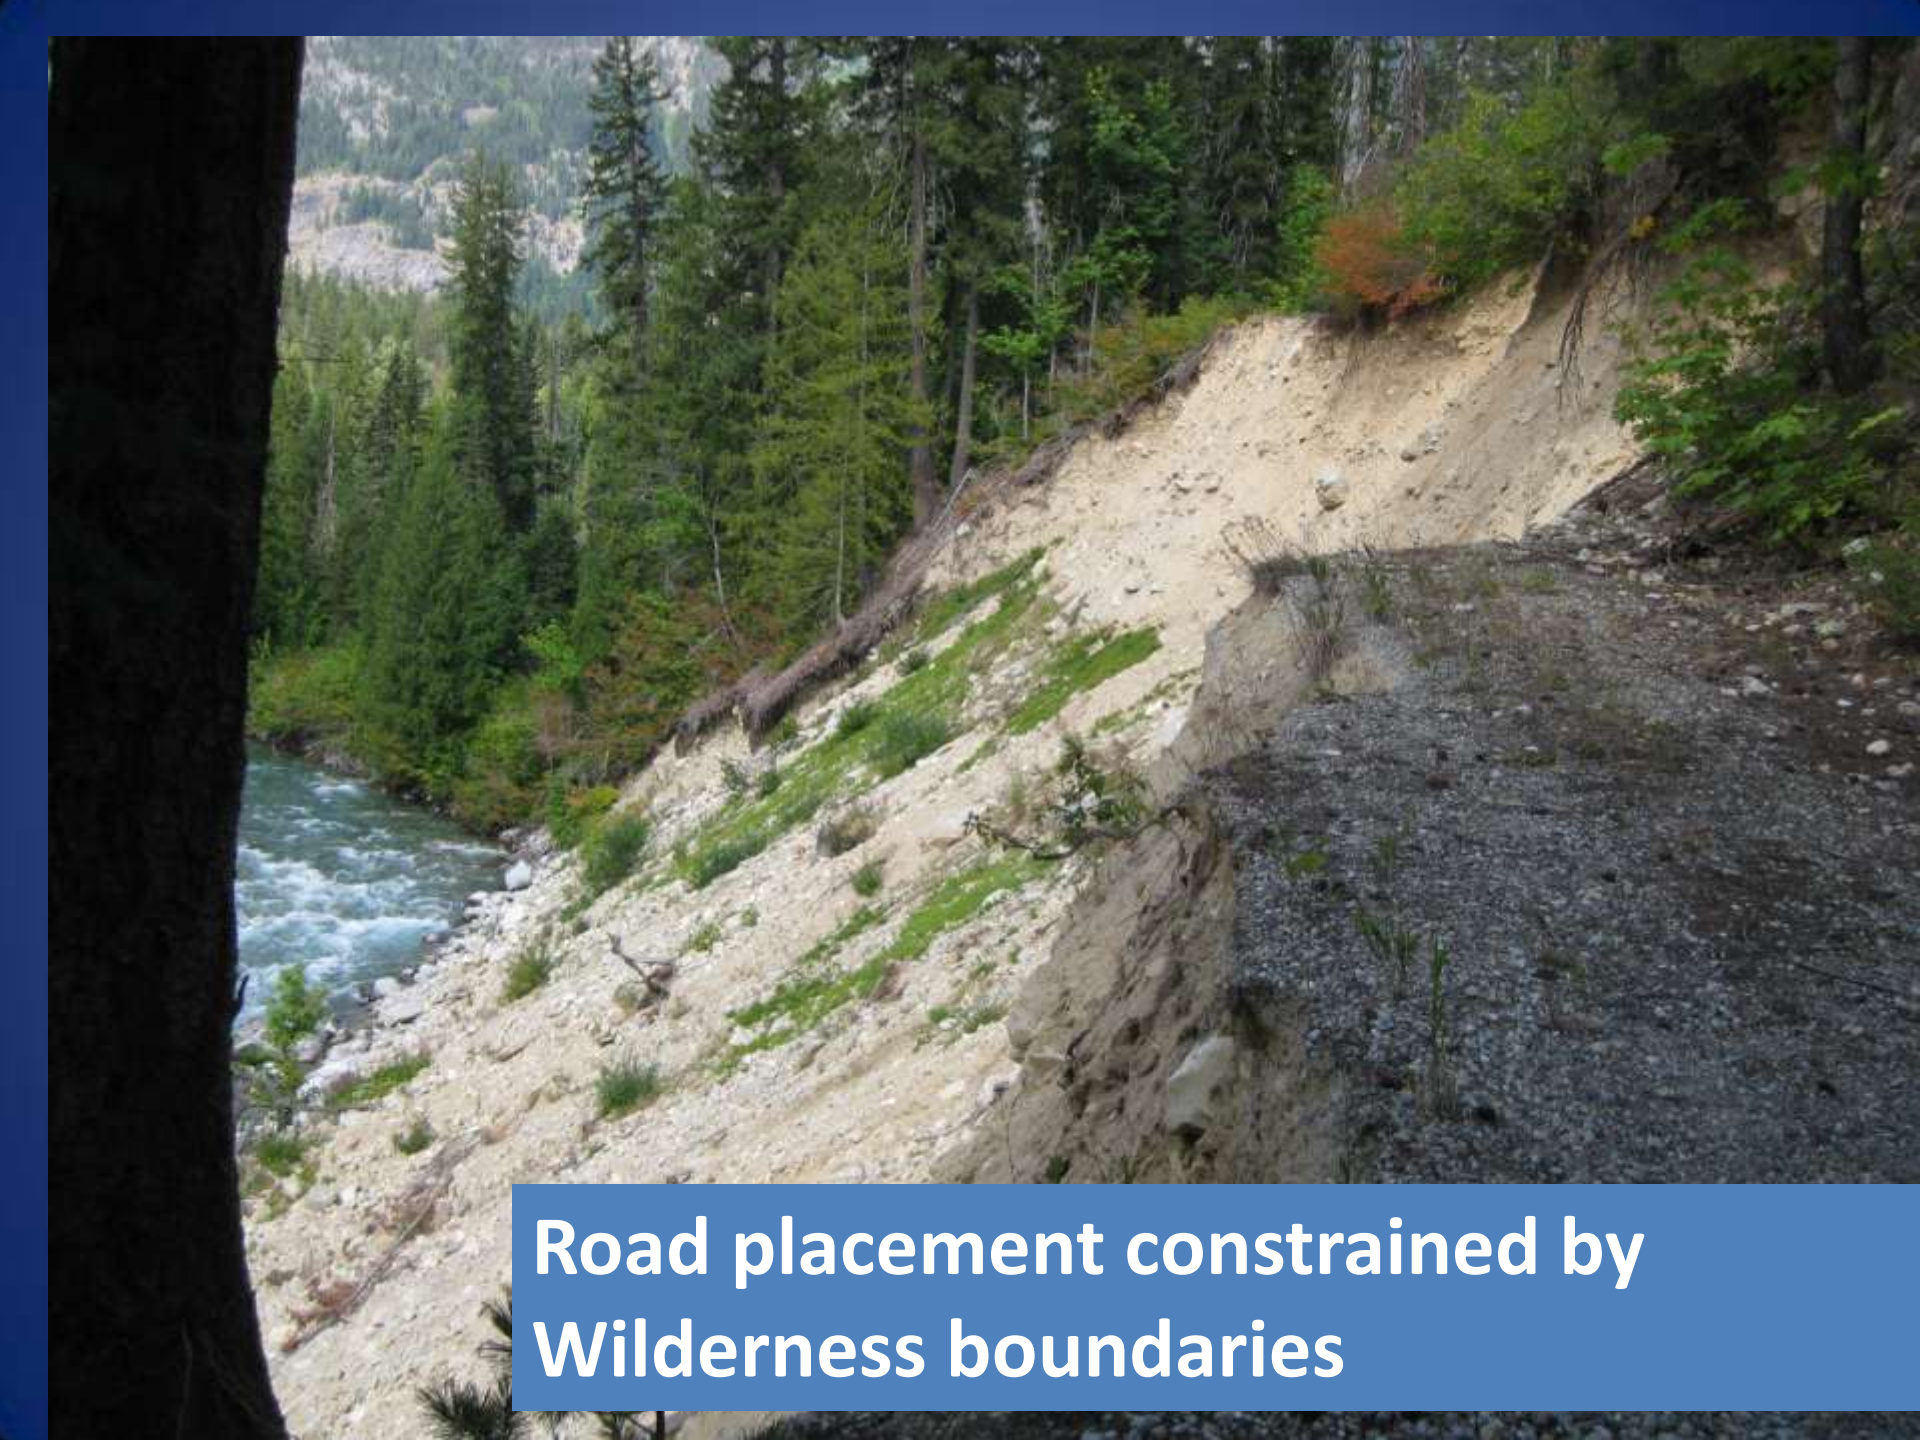
**Primary road access in Stehekin Valley –  
McGregor Meadows, 2003 flood**

A photograph showing a steep, eroded hillside next to a river. The hillside is composed of light-colored, sandy soil with patches of green vegetation. A large, dark tree trunk is visible on the left side of the frame. The river is turbulent and blue, flowing through a forested area. In the background, more forested hills and mountains are visible under a clear sky. A blue banner with white text is overlaid at the bottom of the image.

**Road placement constrained by  
Wilderness boundaries**

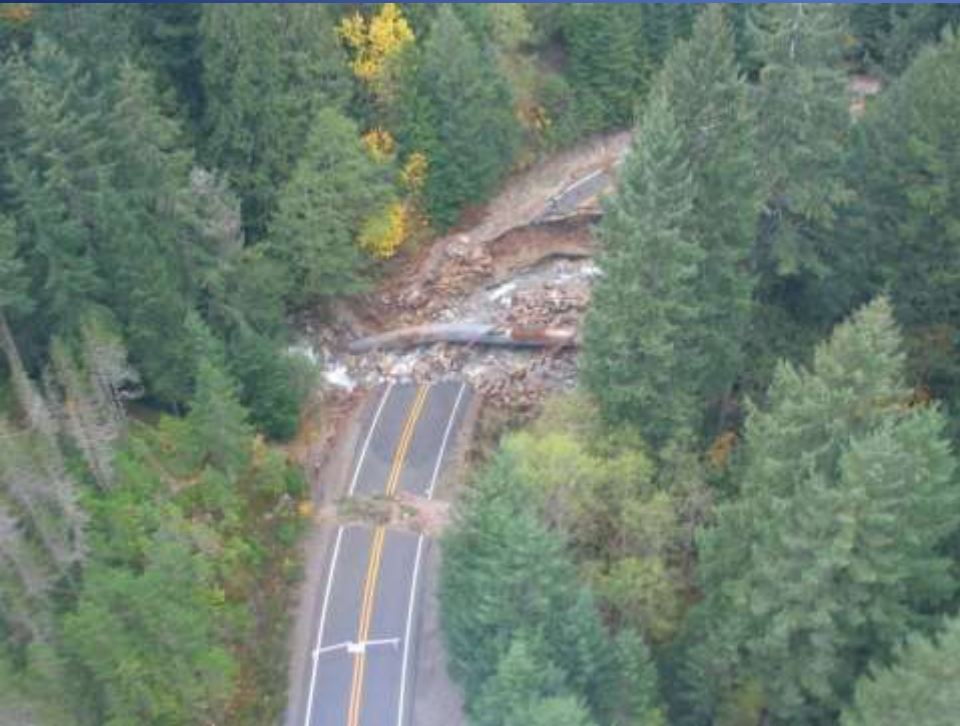
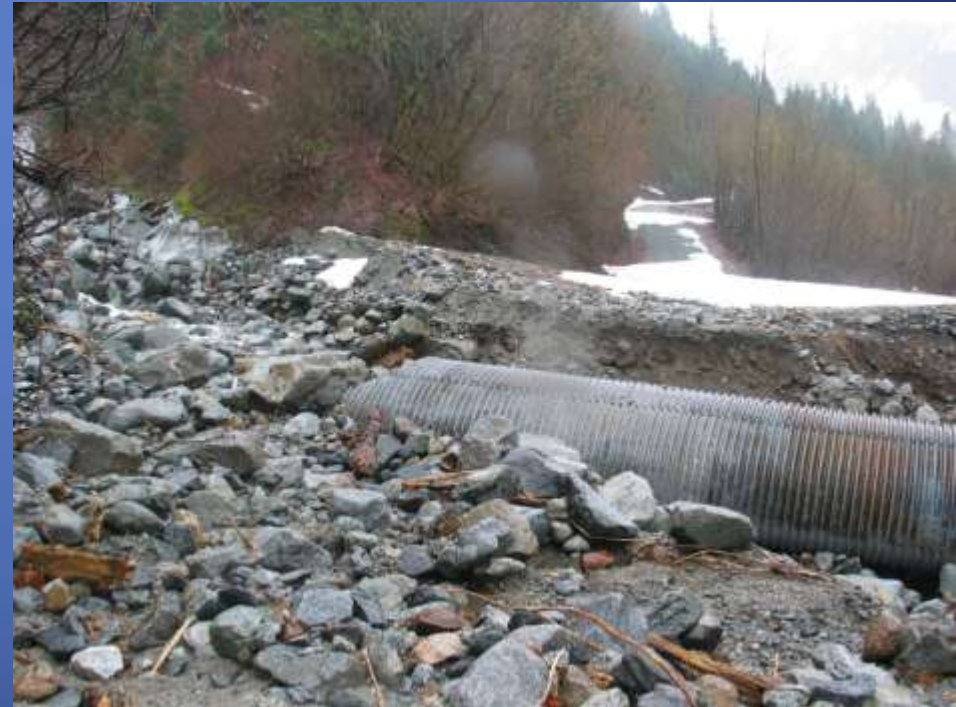
# West side road/flood issues

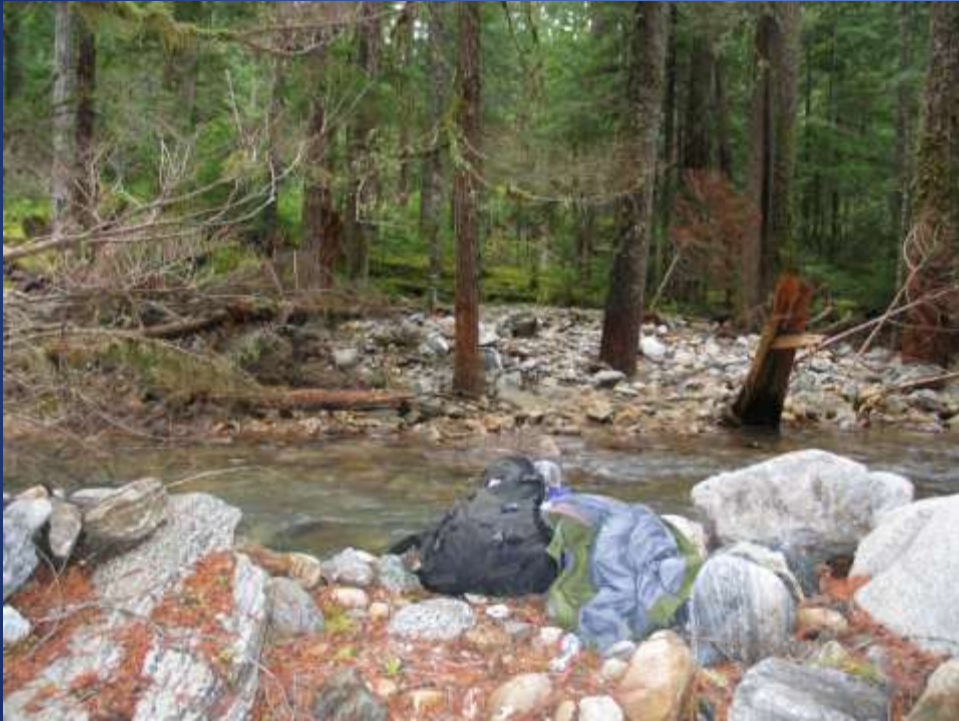
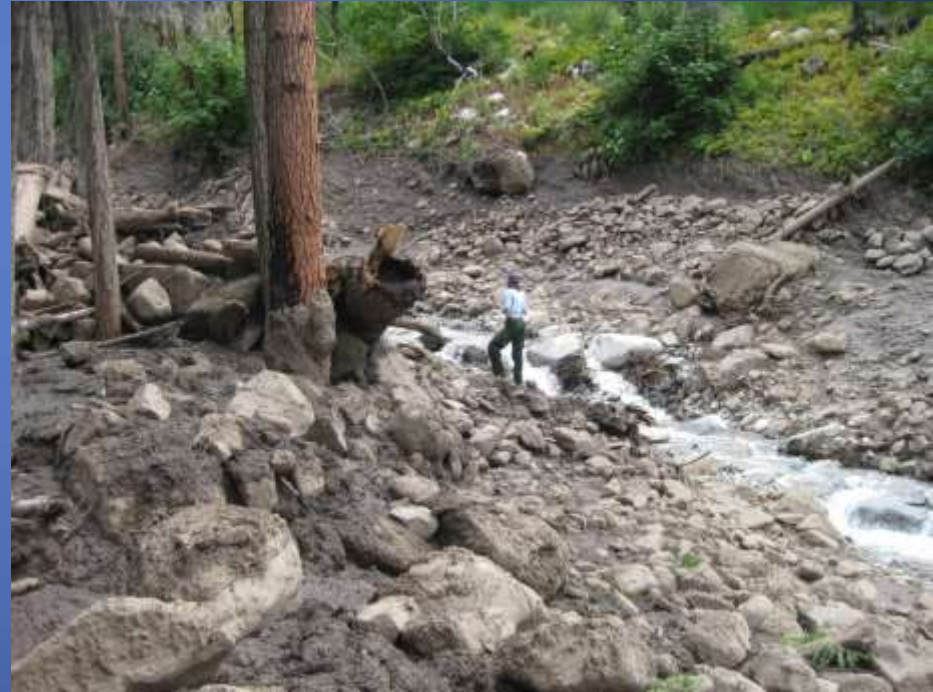
# Trail vulnerabilities

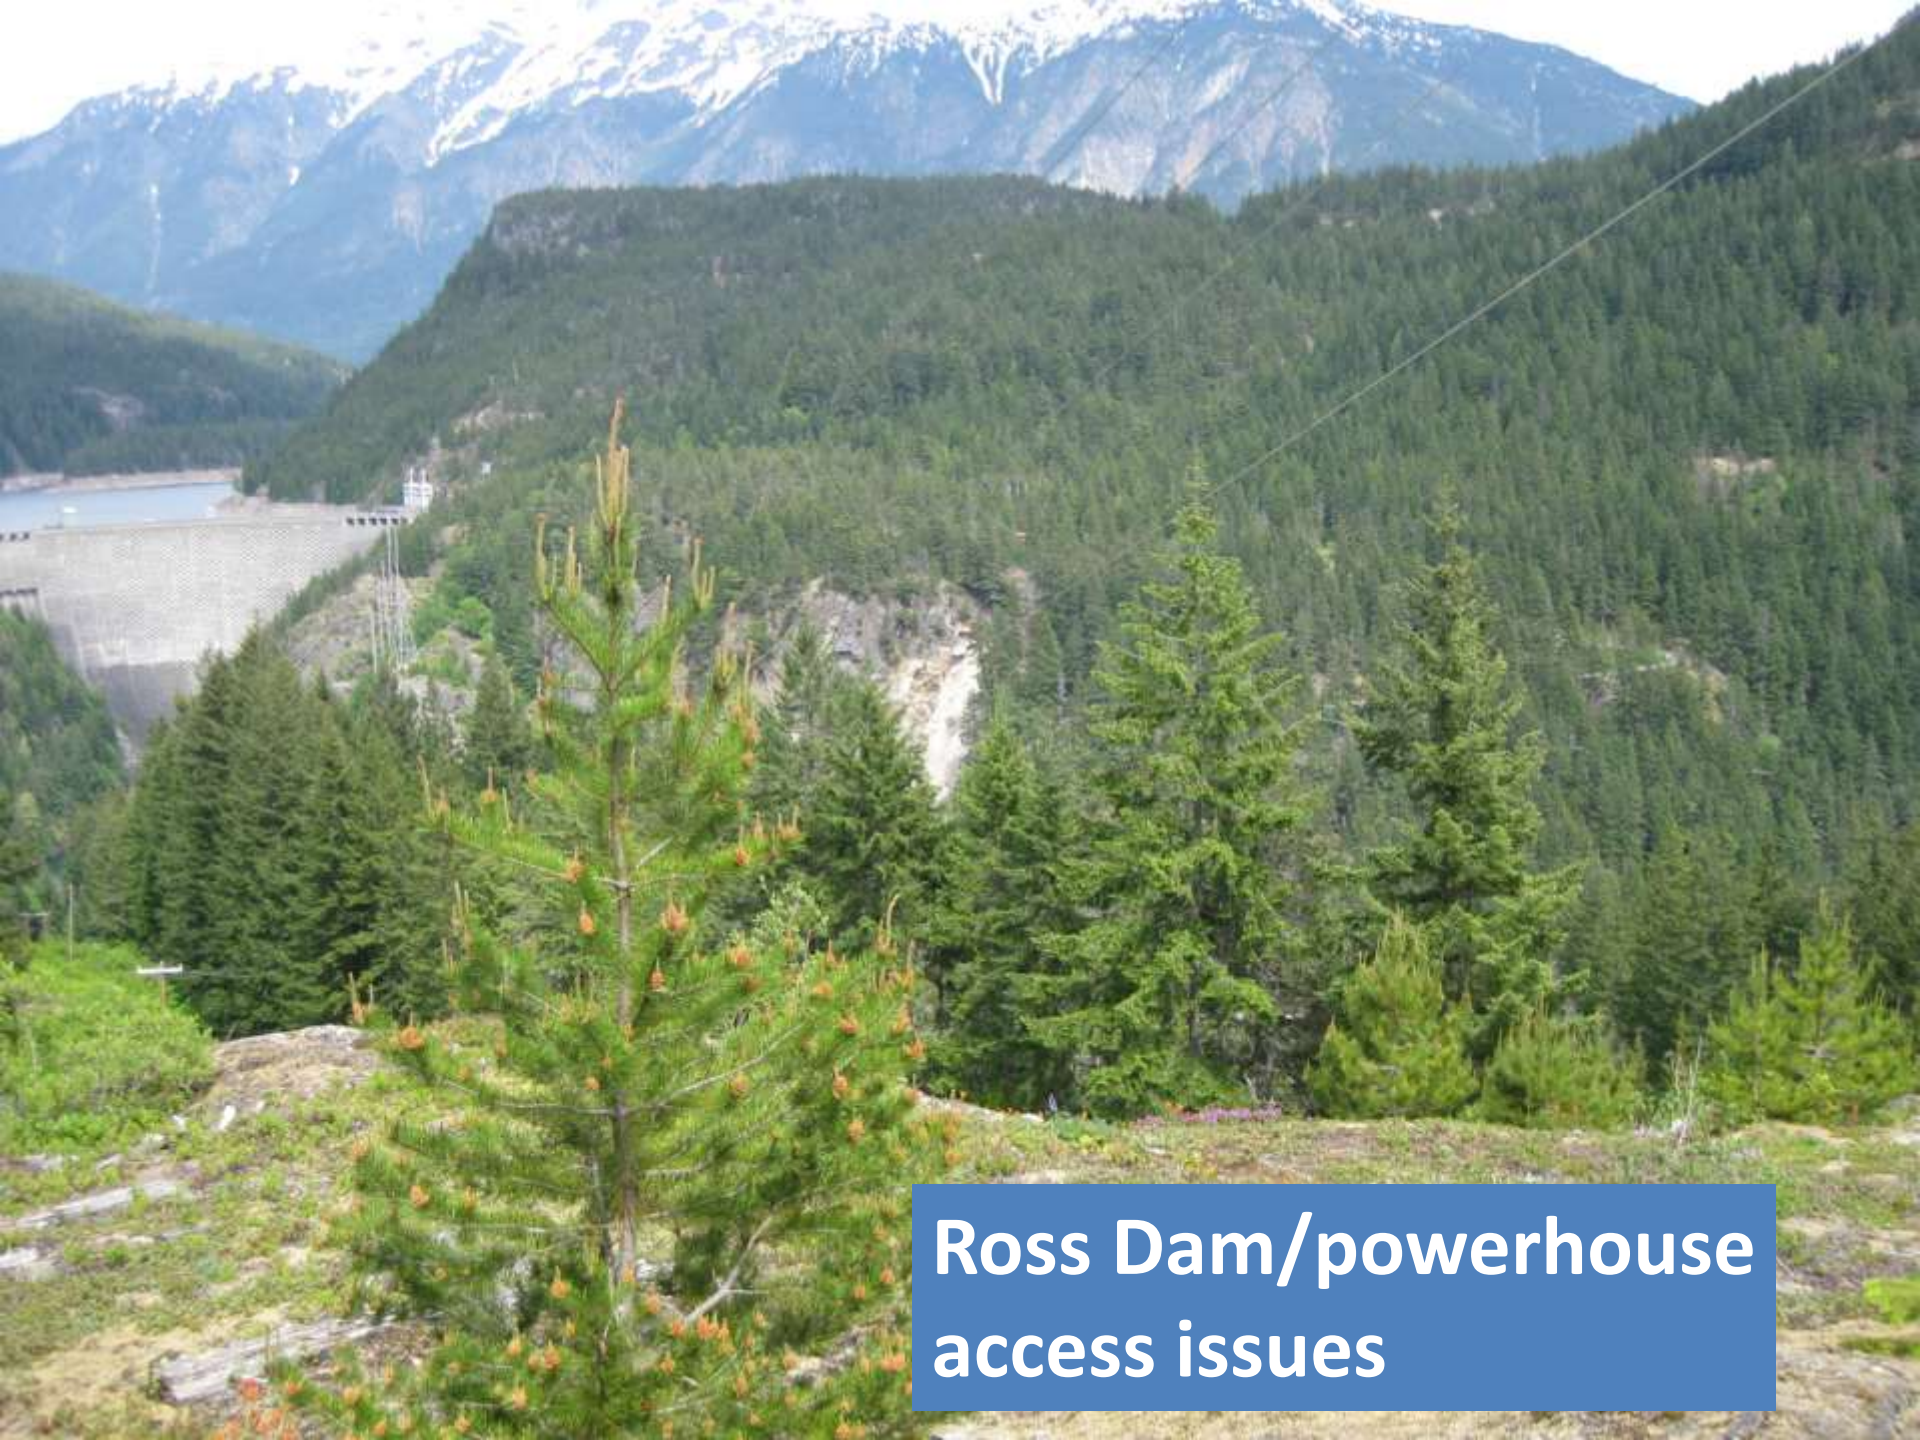
Colonial campground, 2003 flood

# NPS planning

- Ross Lake GMP:
  - “Abandon or rehab affected portions of Goodell Crk campground; alternative access...would be provided to the west of the existing access road”
  - “build replacement sites to the west of the Goodell Creek Lower Group campground, as necessary”
