# Trail, Road, and Access Management – North Cascades National Park Service Complex

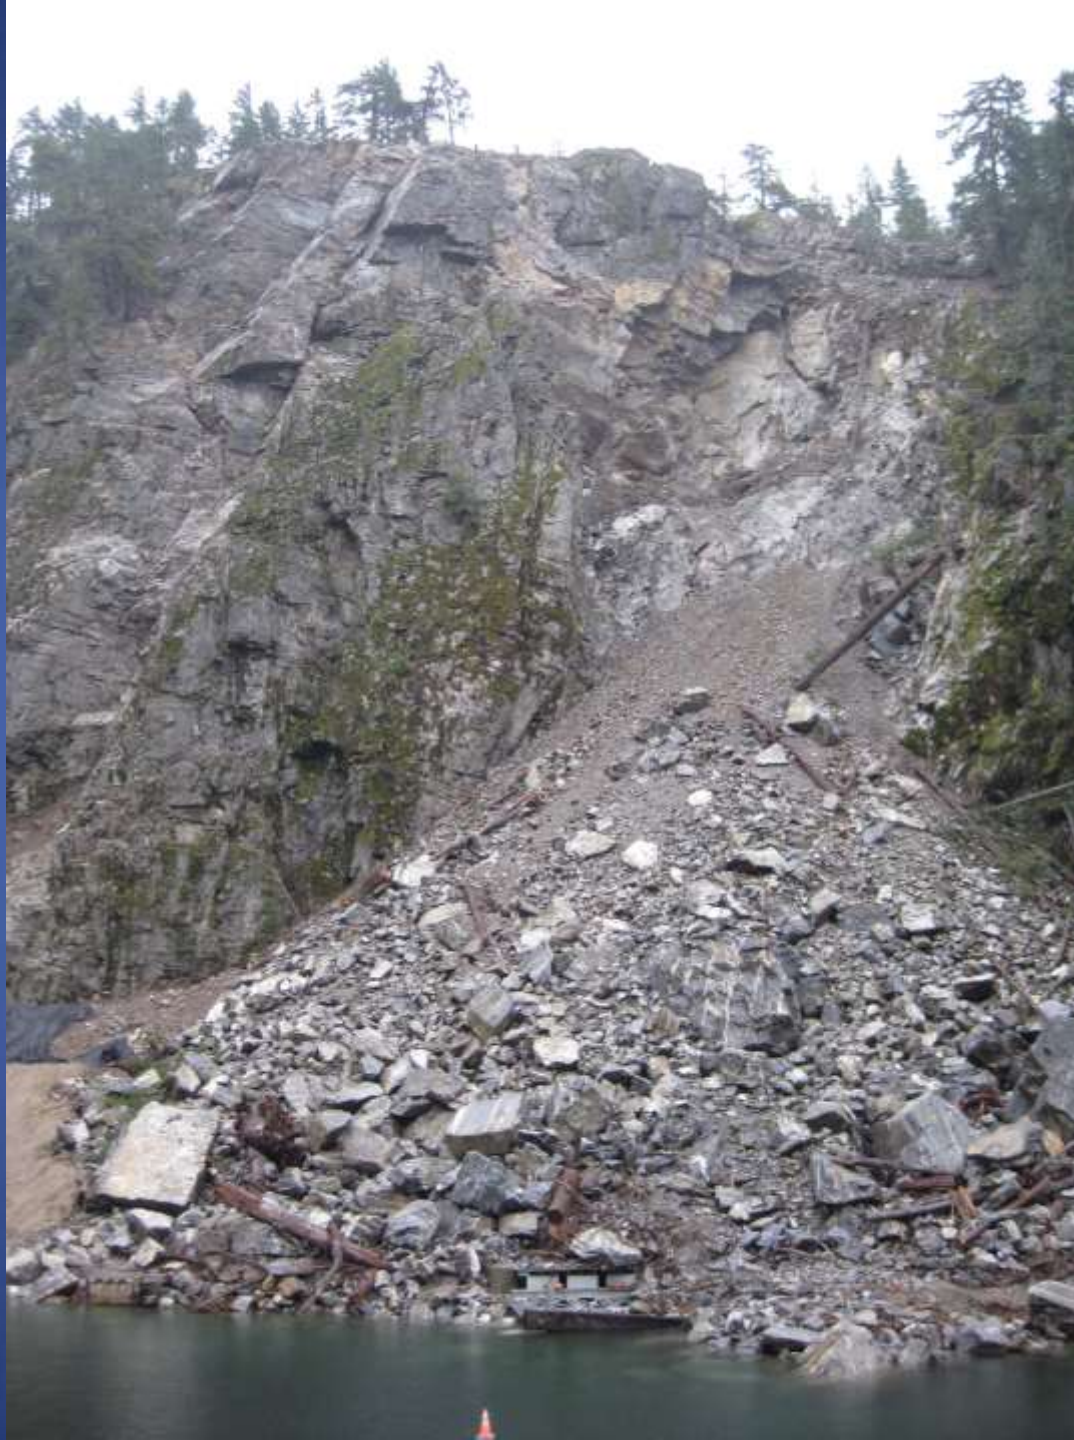
**Ross Dam/powerhouse  
access issues**

Powerhouse

Road to dam  
(and Ross Lk  
Resort)

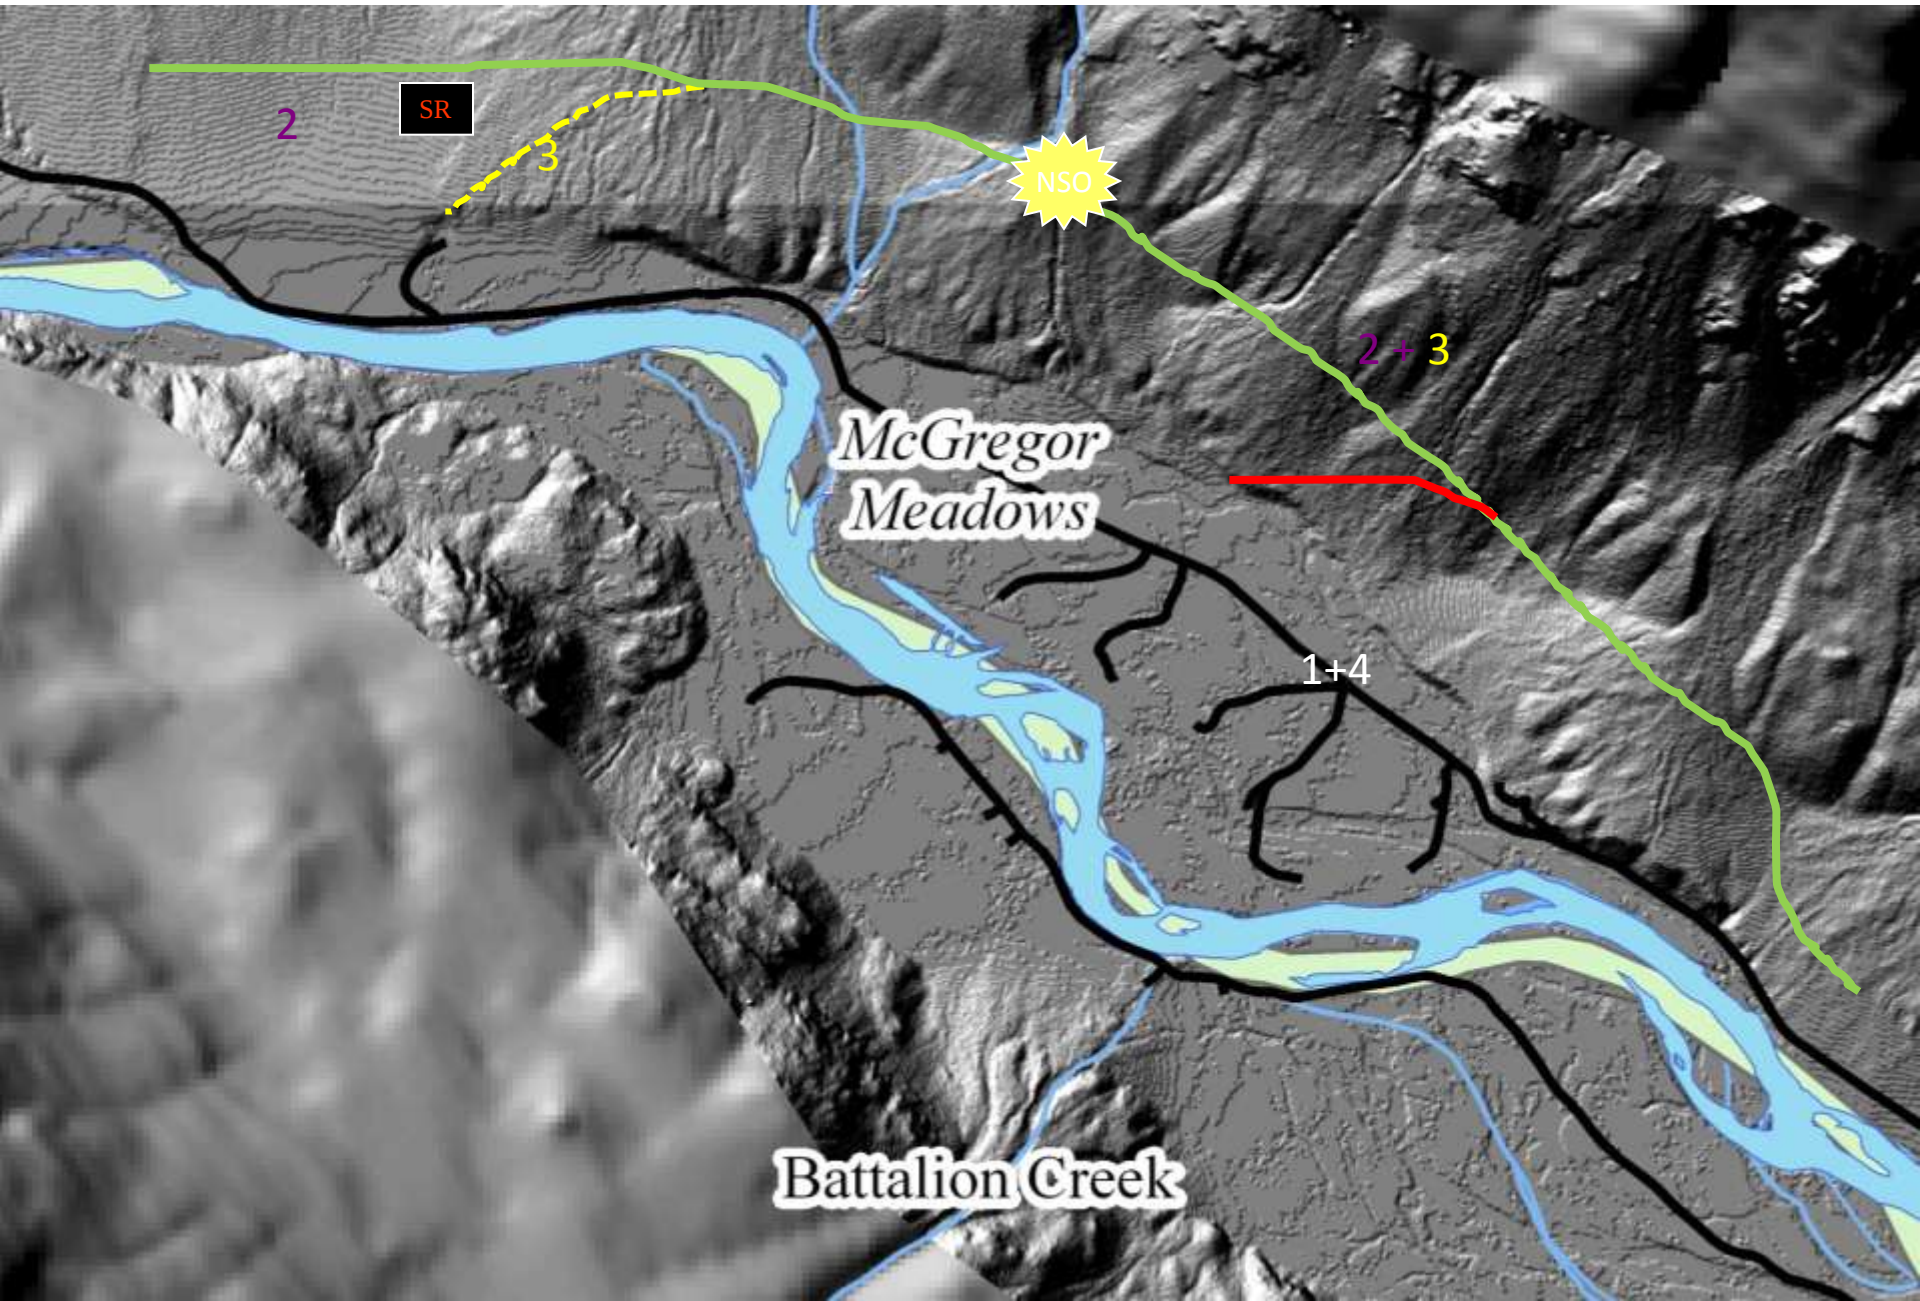
# NPS response? – move out of CMZ

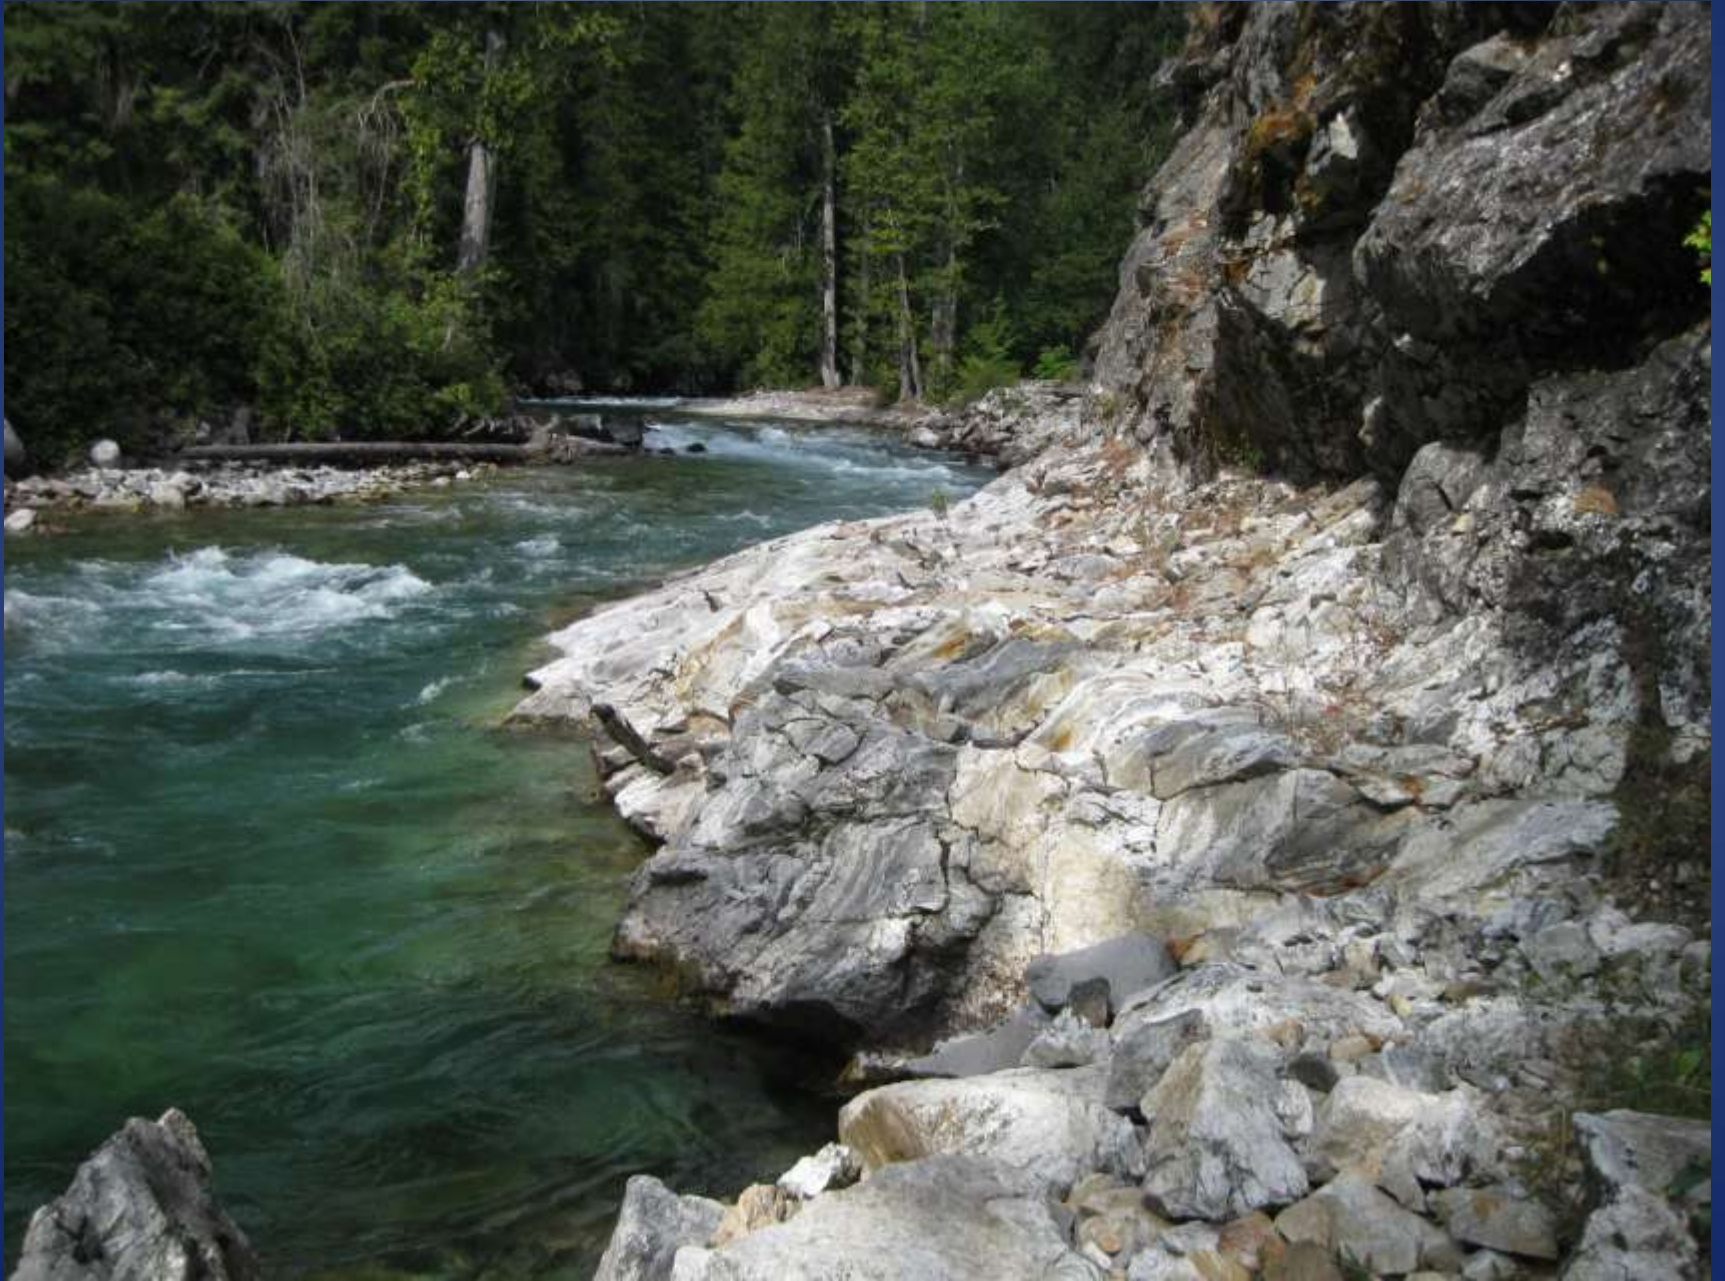
# Road abandonment – but at a cost

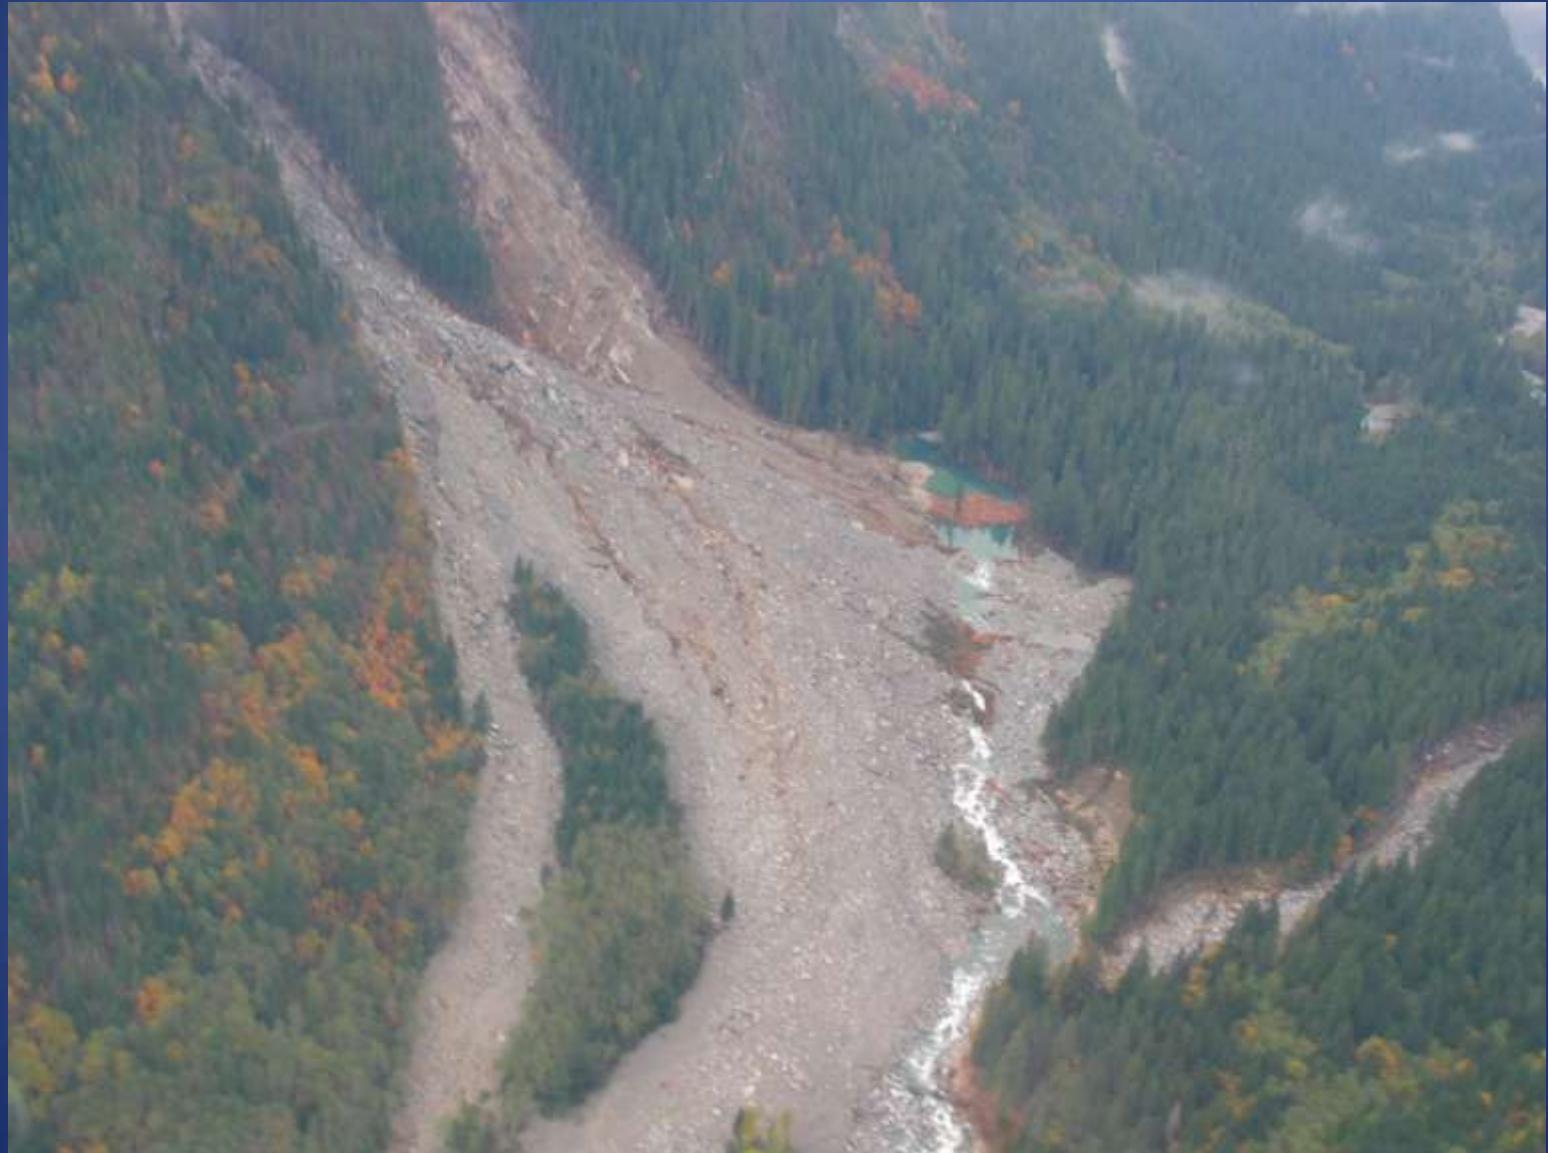
# Embrace it...? – interpretive trail
