Road and Bridge Project Case Studies on the Mt. Baker-Snoqualmie NF

Road Maintenance, Improvements,
and Decommissioning

Felix Nishida- Assistant Forest Engineer
Claribel Orellana- Project Engineer

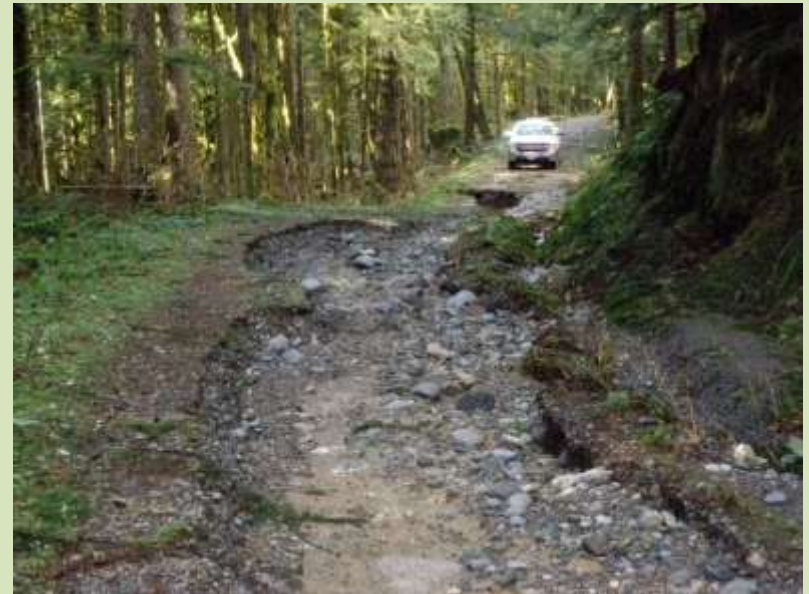
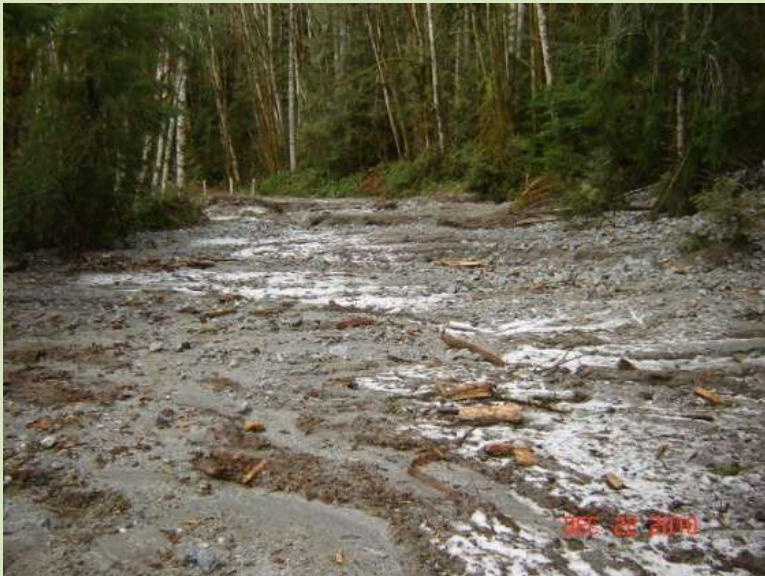
Storm Related Road Damages

- Transportation system being maintained beyond design life-aging infrastructure
- Major consecutive rain-on-snow events
- Limited funding
- NEPA analysis required

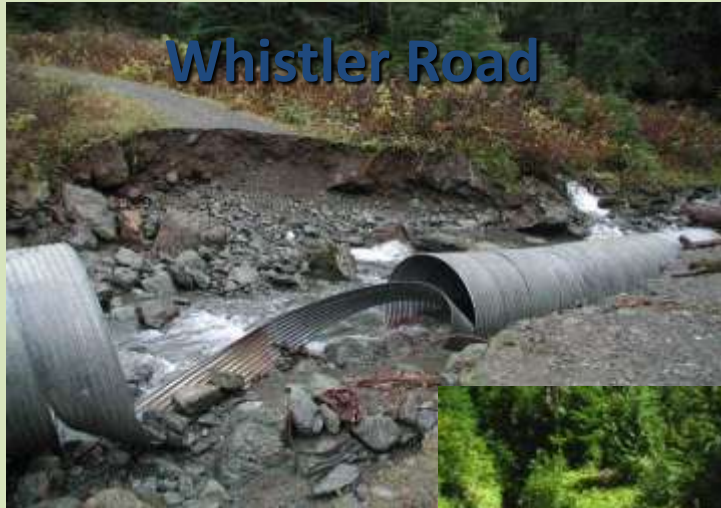
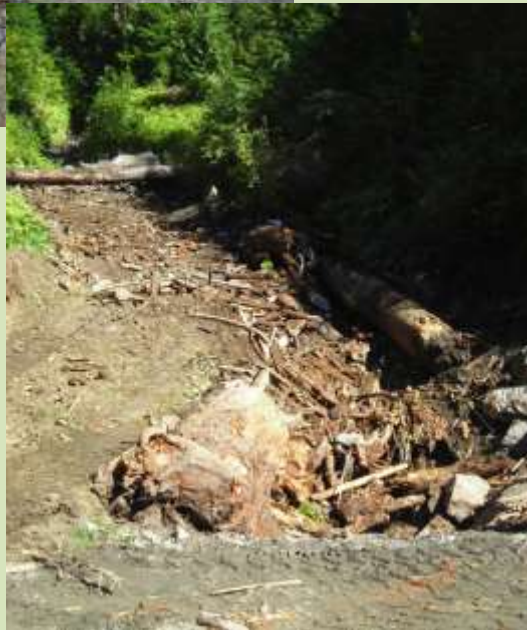
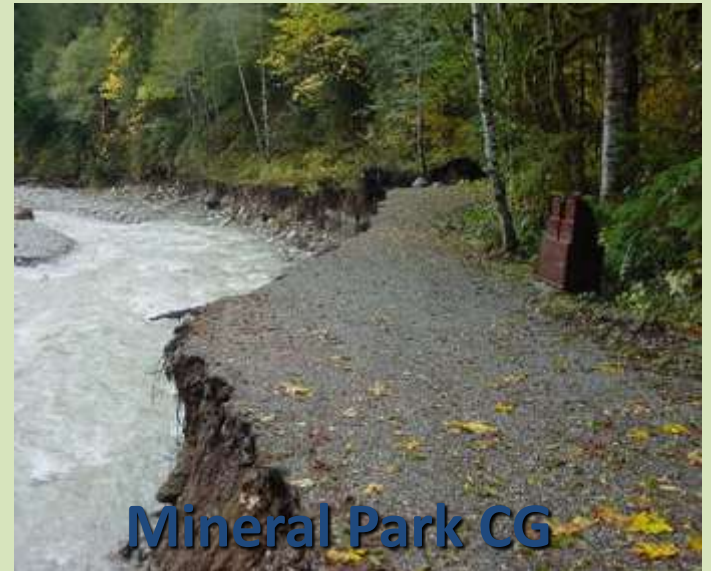
Excessive Water and Debris Flow Damages

- Under-sized culverts
- River bank erosion
- Major flood events
- Debris as a major factor

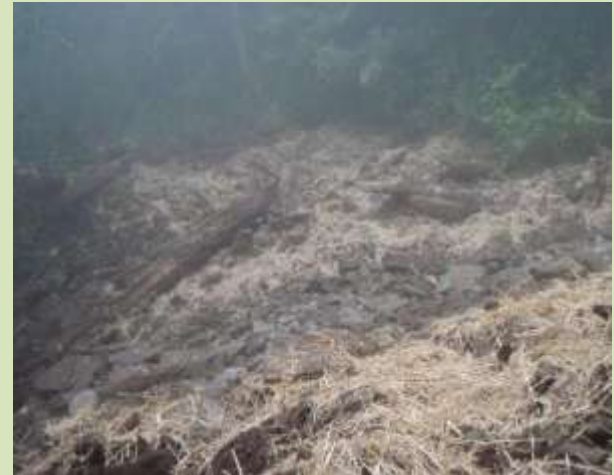
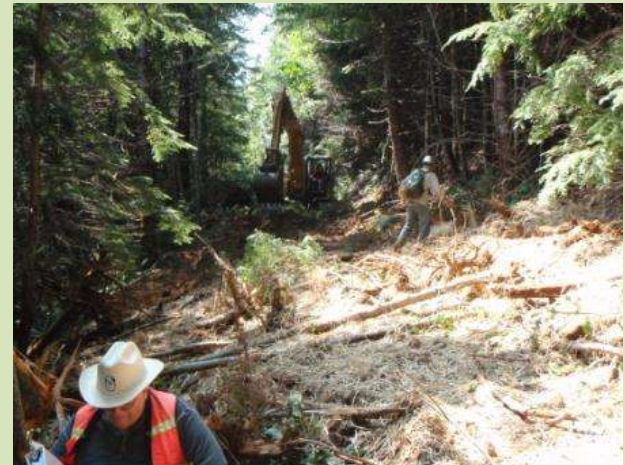
After decommissioning

Converted 13.7 miles into decommissioned road and 6 miles into trail contributing the Mountains to Sound trail system

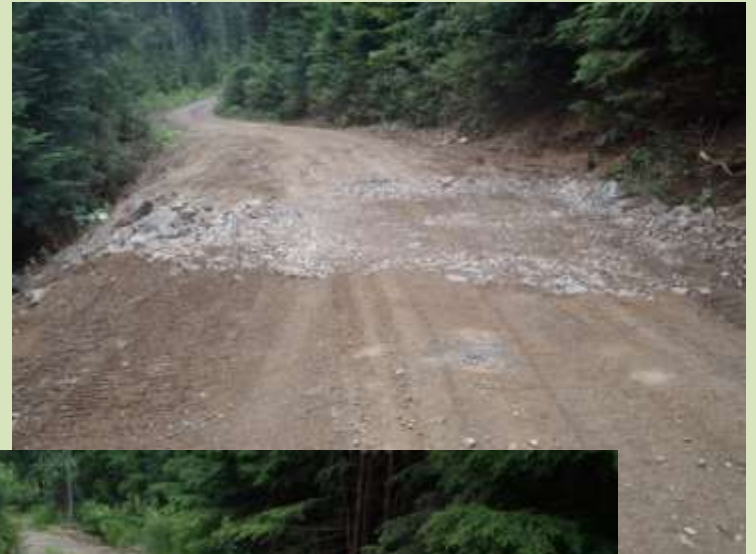
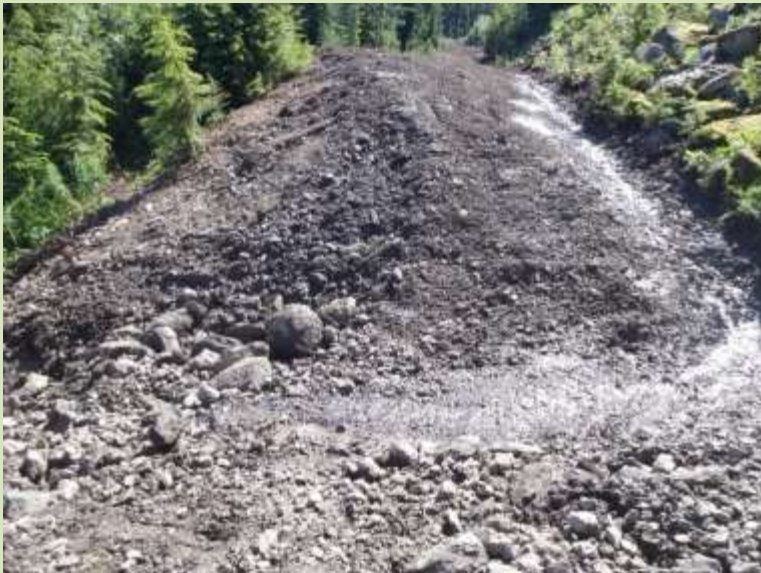
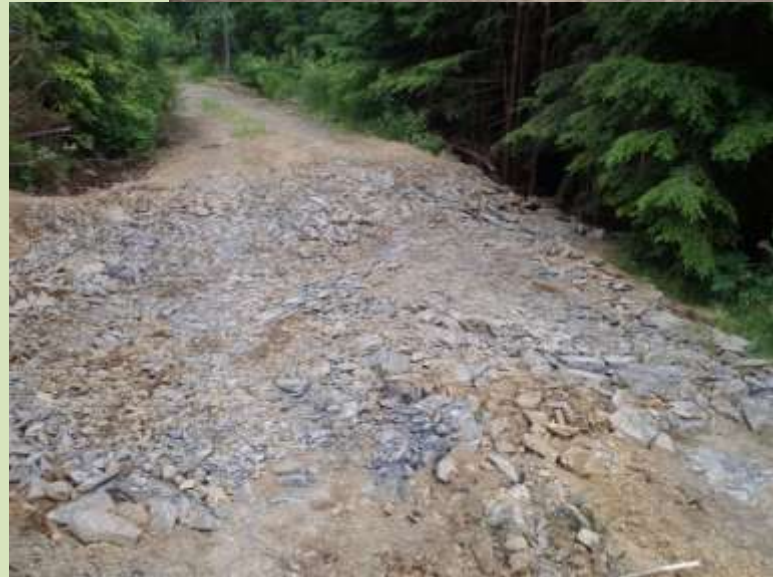
Storage of Roads

- Intended to future use
- Rock-lined drainage dips
- In-sloped roads-to ditch-to crossing

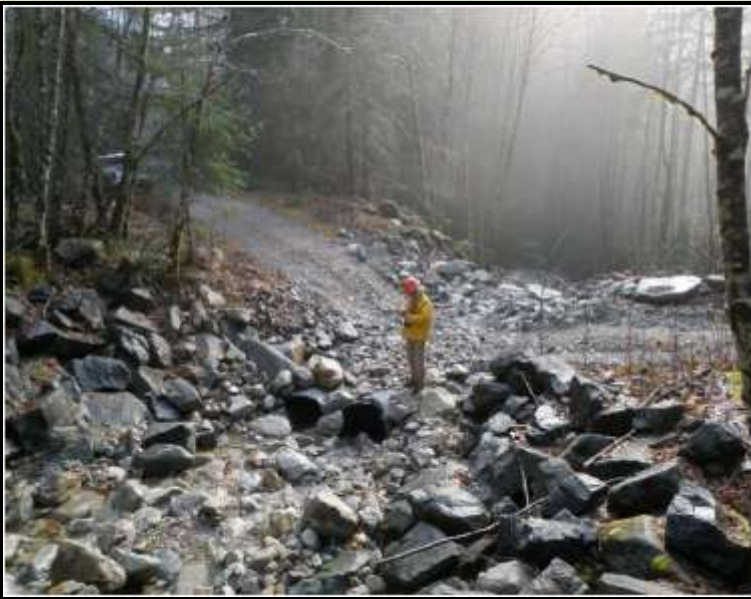
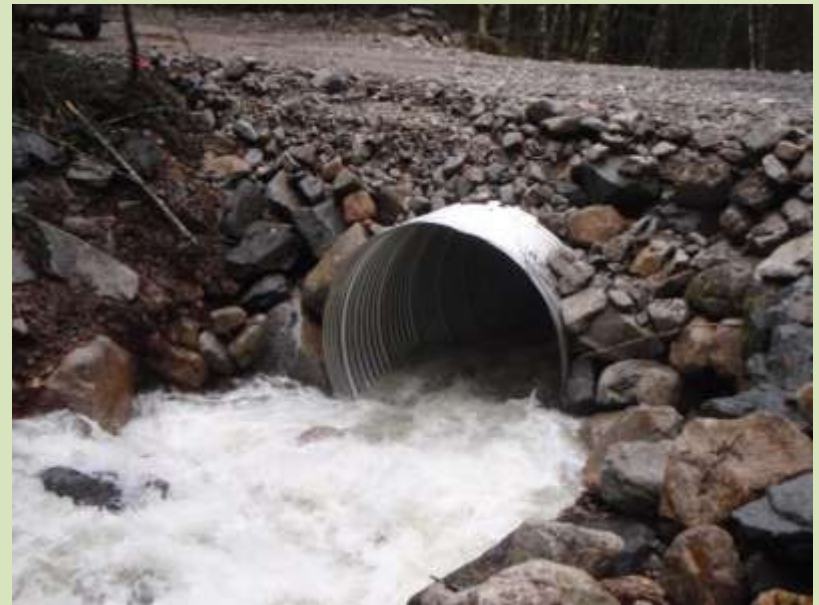
Culvert Upgrades

- From 2-24" culverts to 8' culvert
- Appropriate to flow volumes
- Less susceptible to debris blockage

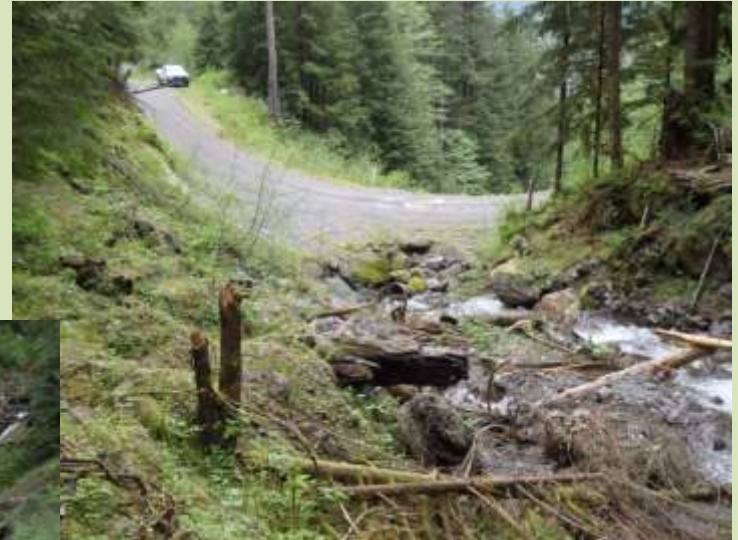
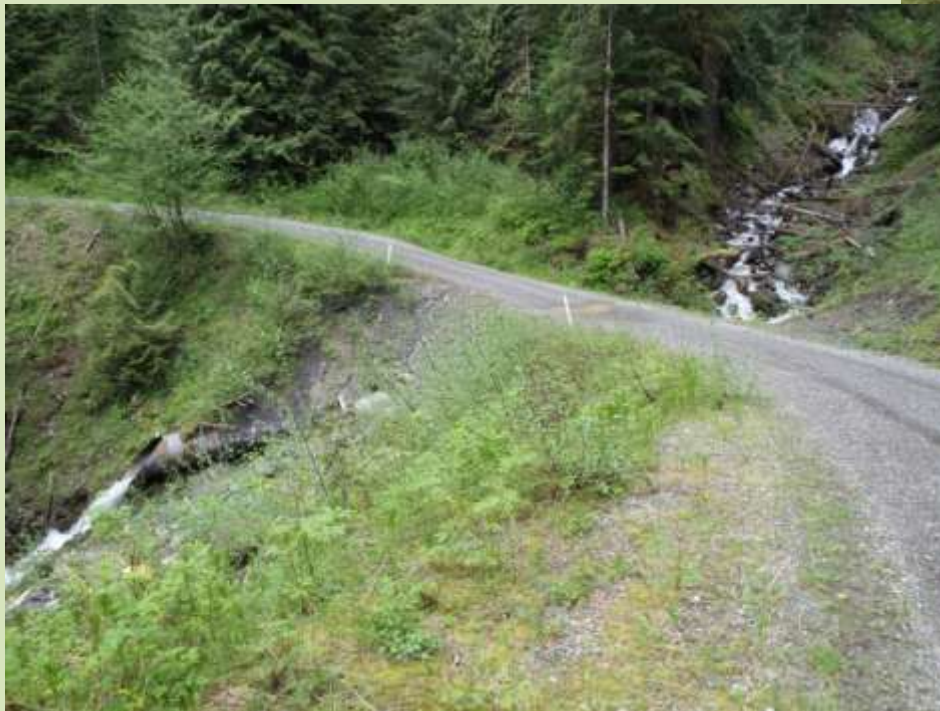
Culvert Upgrades

- FSR 41
- Debris/slide potential
- 60" diameter culvert

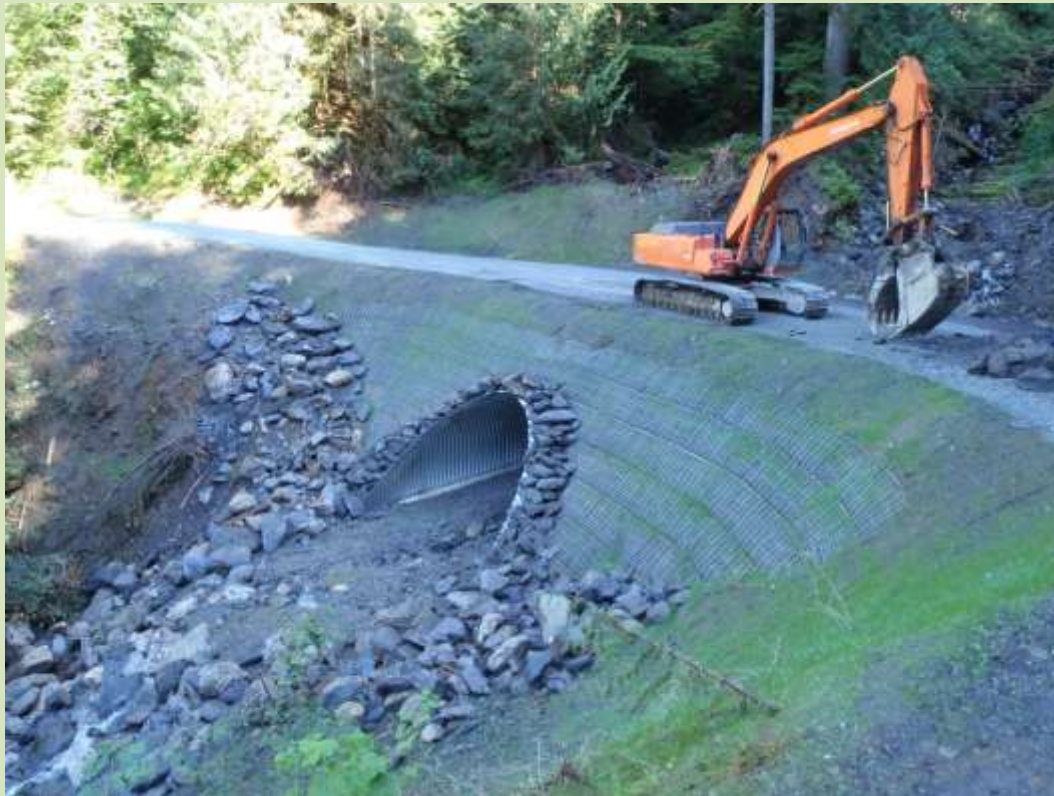
Slide prevention

- New Culvert: 24' span, 12' rise
- Additional erosion control measures

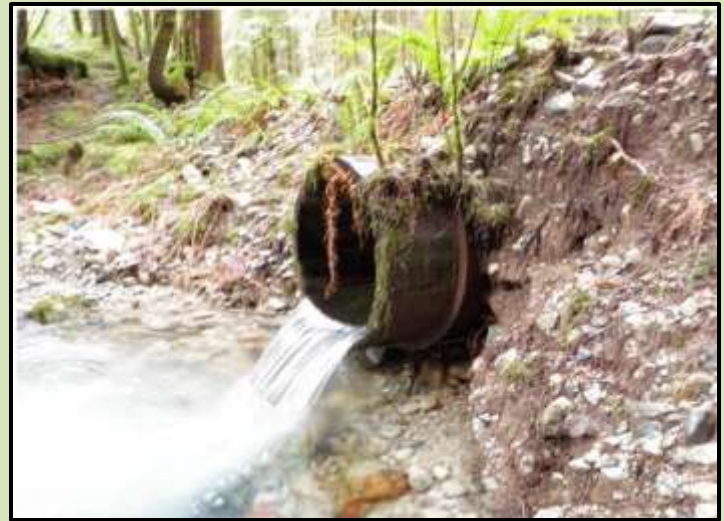
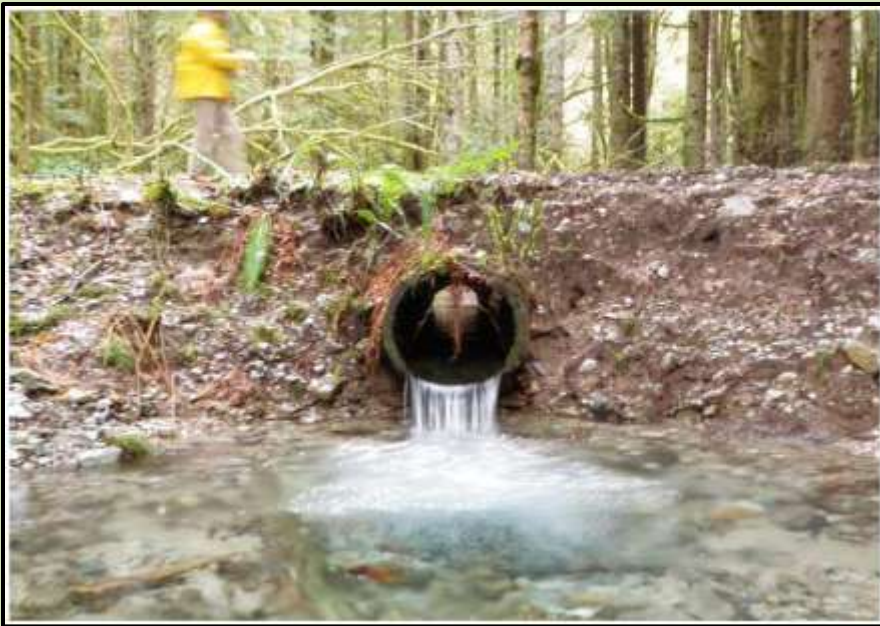
Aquatic Organism Passage Improvements

- Identified as a fish-bearing stream
- Under-sized for the natural width of the stream
- Functional 24" wood plank culvert (non-historical)

- Stream natural width (up and downstream): 14 feet
- Limited height of fill

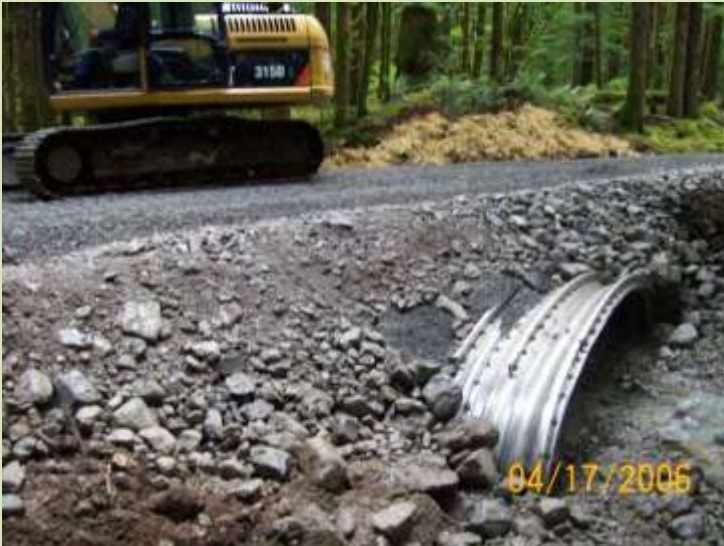
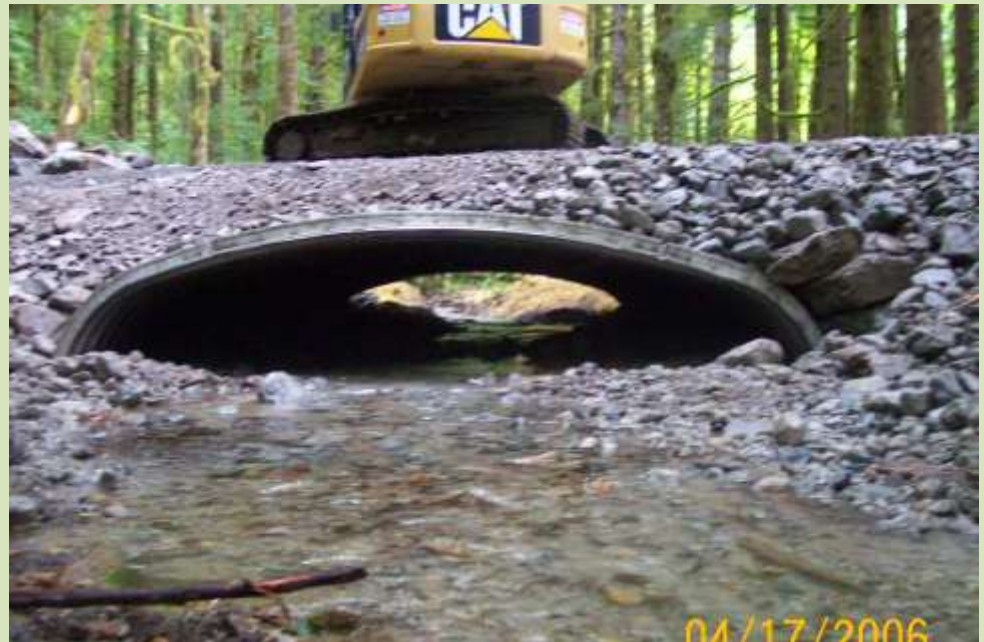
Aquatic Organism Passage Culvert Improvements

- Replaced with 18' span-4-8" high aluminum plate culvert
- Match natural stream width
- Allow natural flow

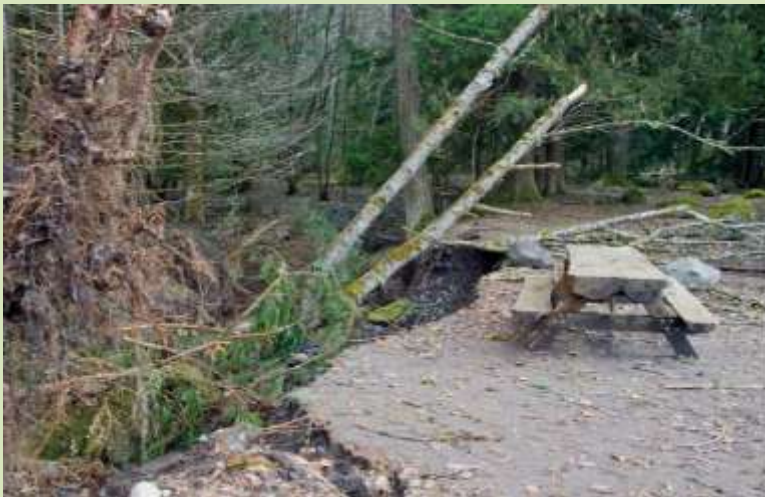
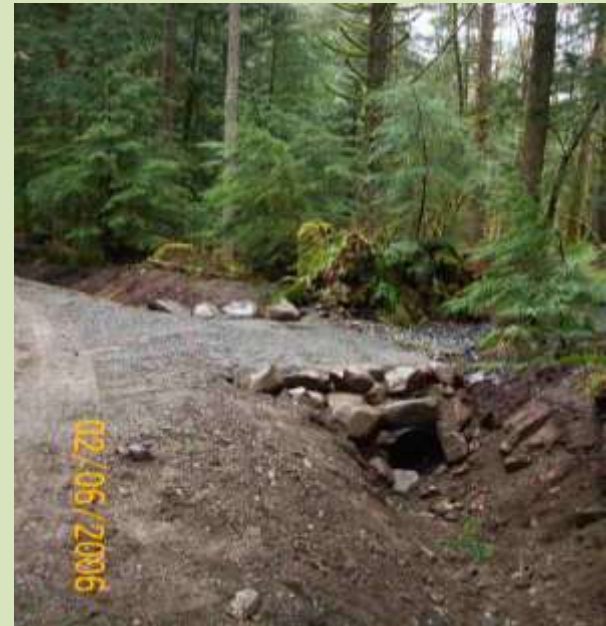
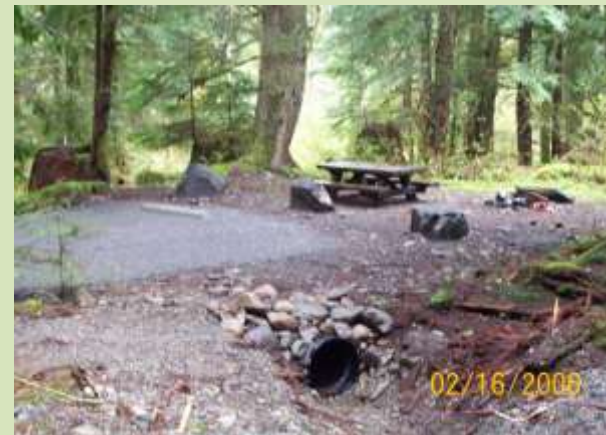
Campground Improvements

- Defining ditches to match capacity
- Securing camping spurs with additional drainage support through culverts

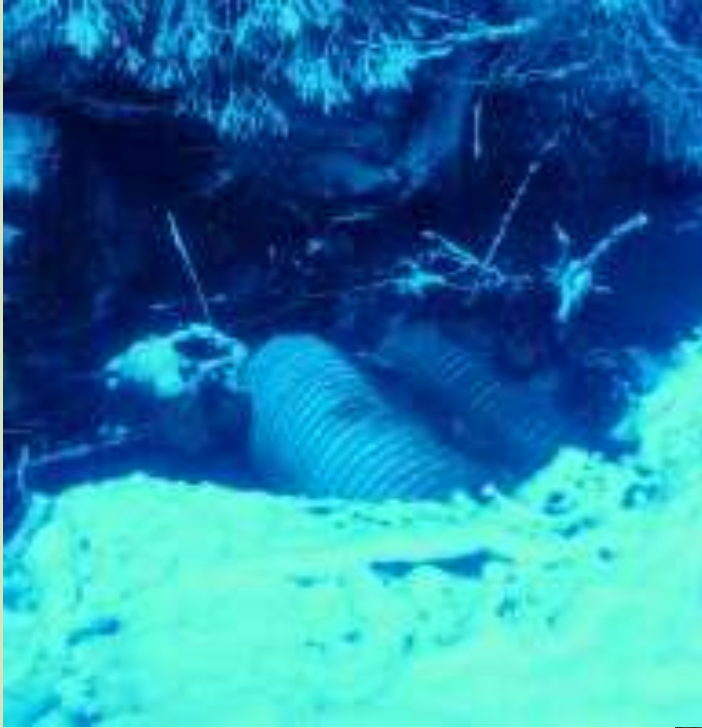
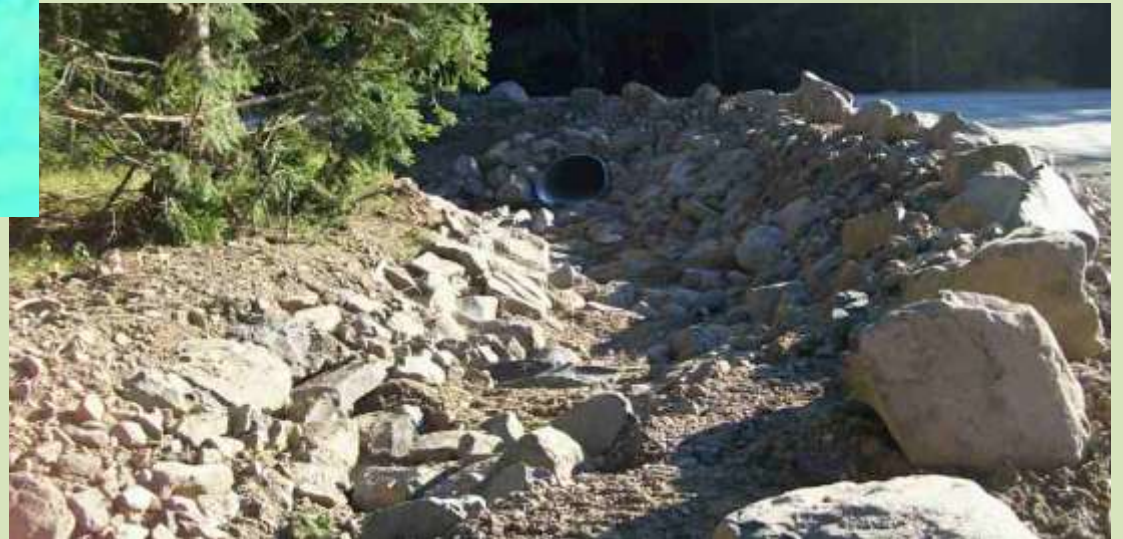
Ditch work

- Undersized culverts
- Debris
- Saturated roadways
- Re-defining ditches
- Rock-lined for shoulder/ditch reinforcement

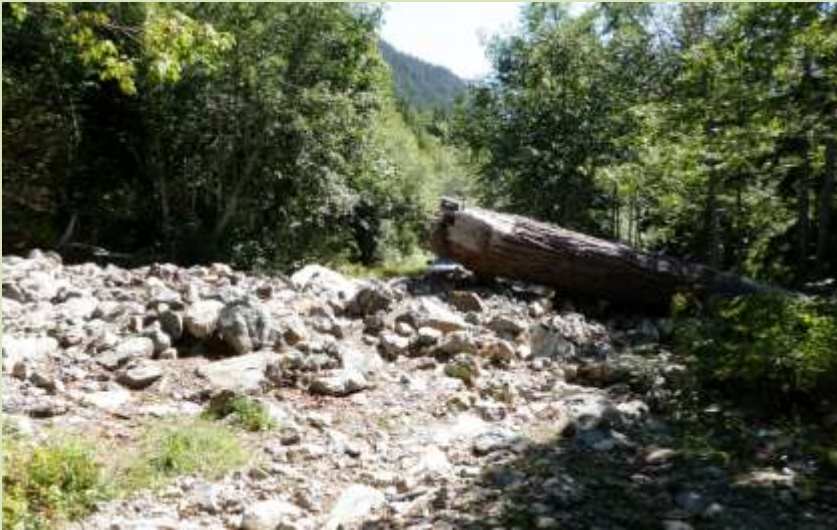
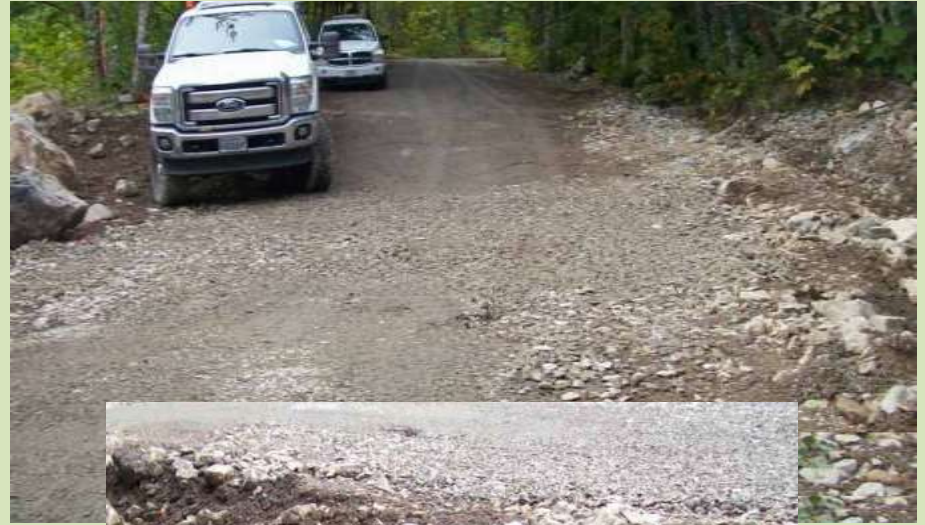
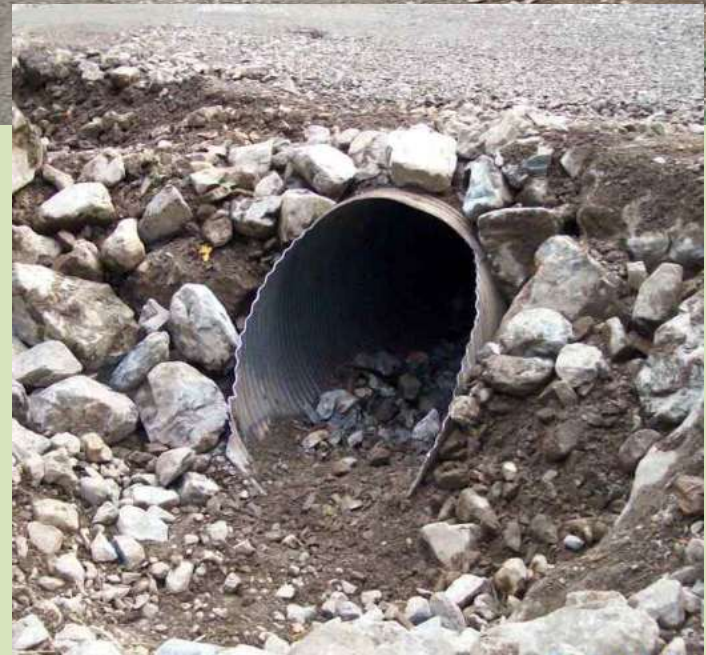
Drainage Dips

- With variable flows
- Debris shoots/channels
- Maintenance Level 2 Roads

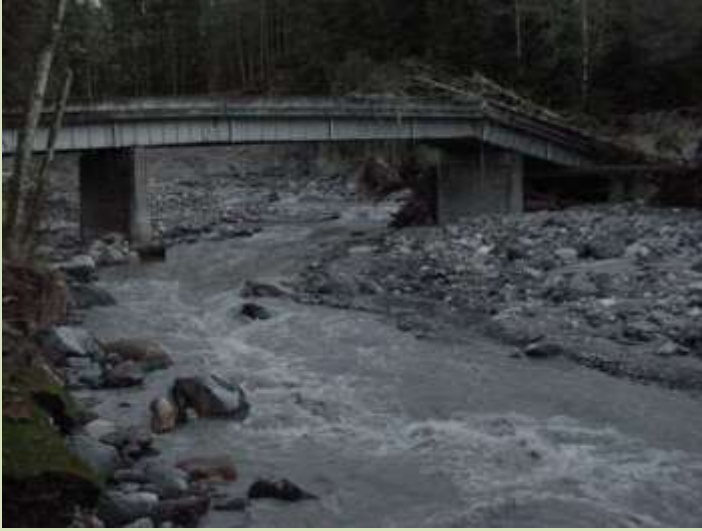
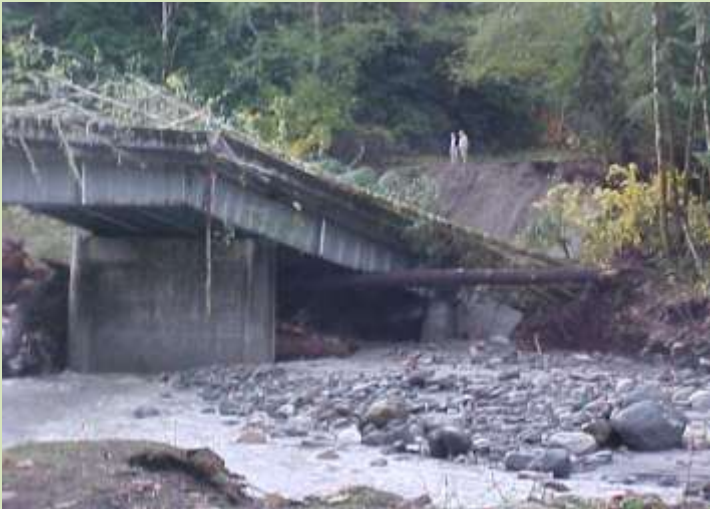
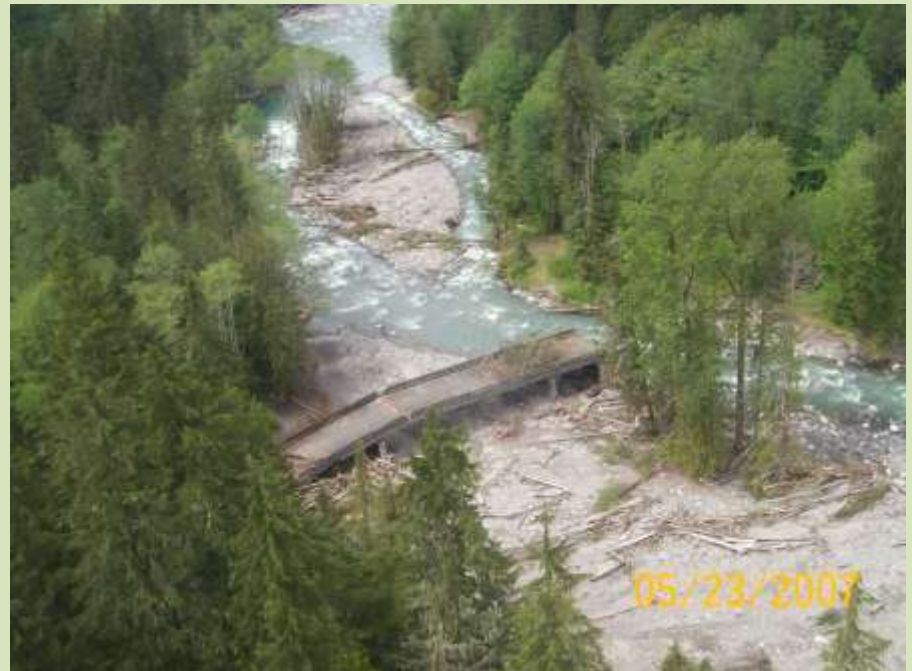
Bridges

- White Chuck Bridge collapsed 2003
- Erosion near abutments
- Stream changed course in 2006

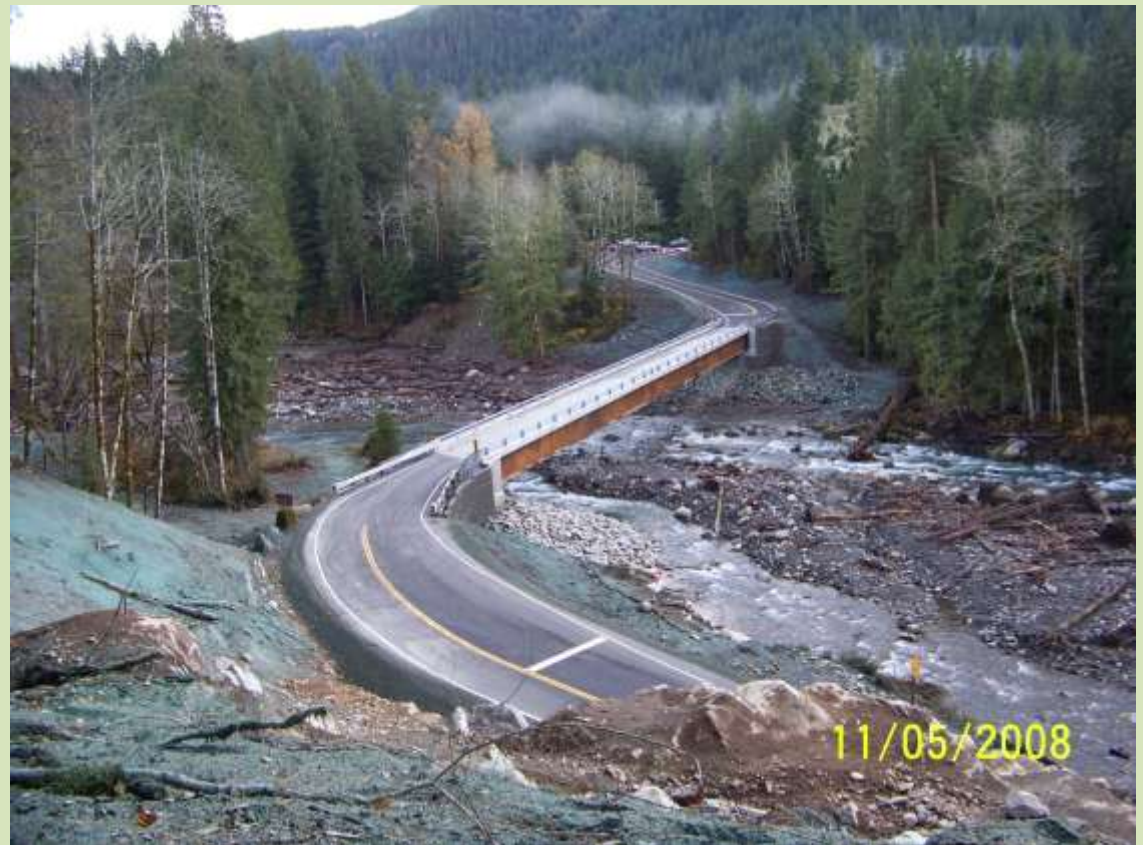
White Chuck Bridge

- Re-built in 2008
- Built downstream
- Approx. 3 million
- Administered by Federal Highways

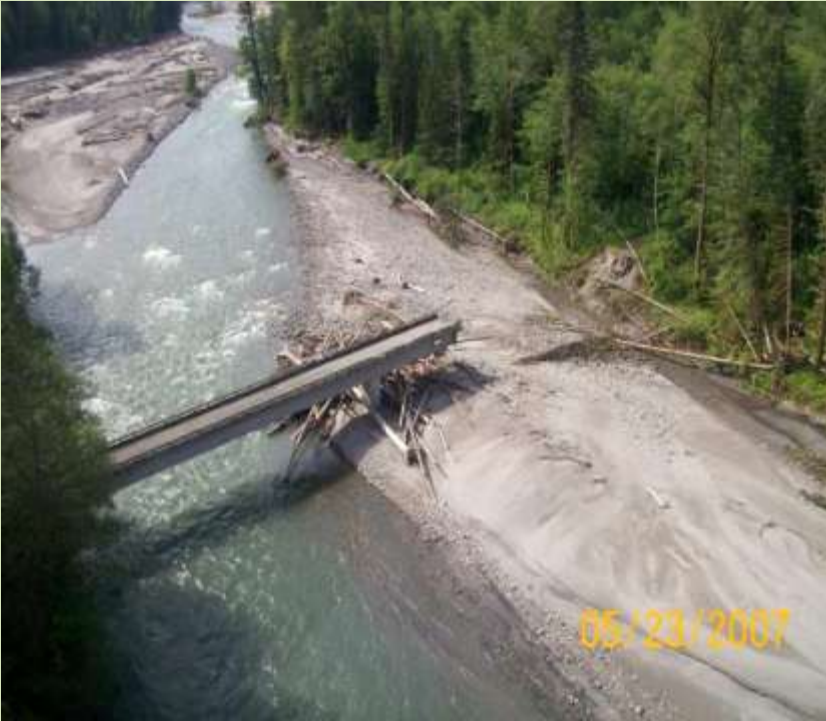
Boundary Bridge

- 240' long bridge
- Bridge washout- 2003 (Largest flood recorded for the drainages in this area)
- 2006 floods caused more erosion to the SW approach
- Fisheries and Wild and Scenic River concerns with the idea of adding another pier in the channel
- Intent is to span across the river without disturbing the SW side

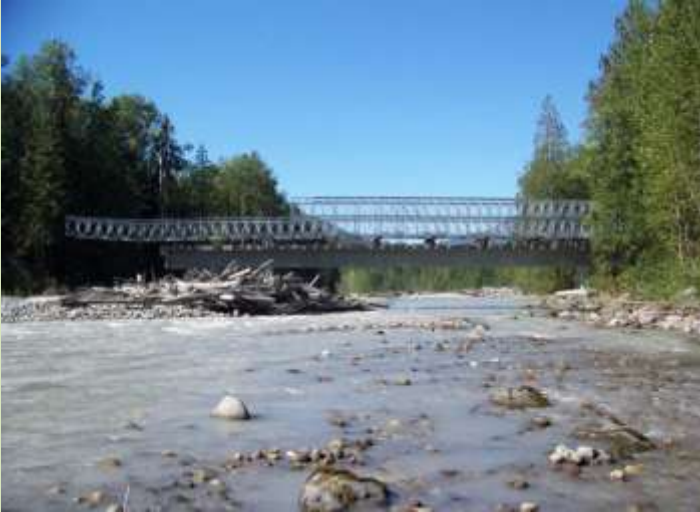
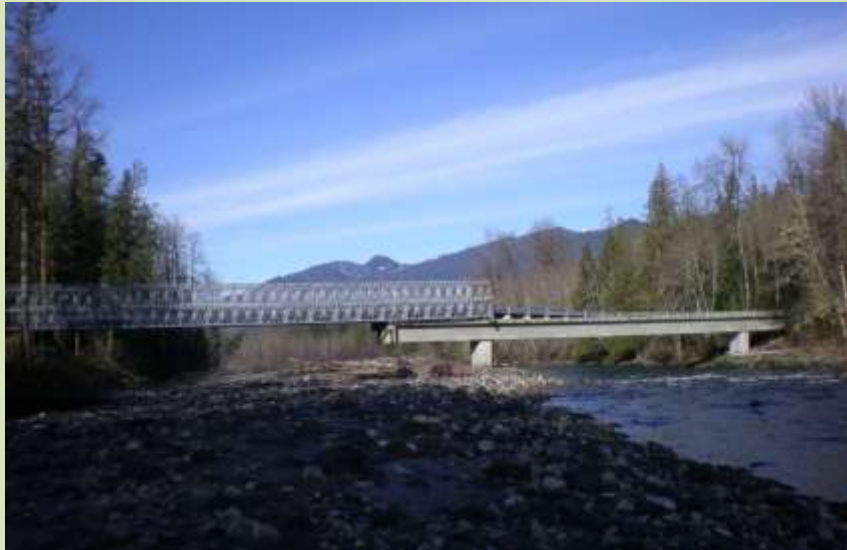
Boundary Bridge Repairs

- Solution: Built a 210 long panel truss bridge
- Total bridge span: 405 feet
- Supported by the 2nd piers, and piles driven on the SW approach with reinforcement
- Bridge launched to other side, with the possibility of bridge extension if ever needed, additional 100 feet

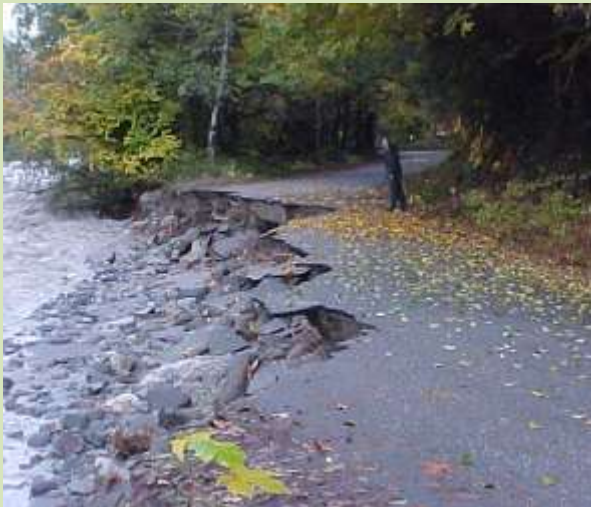
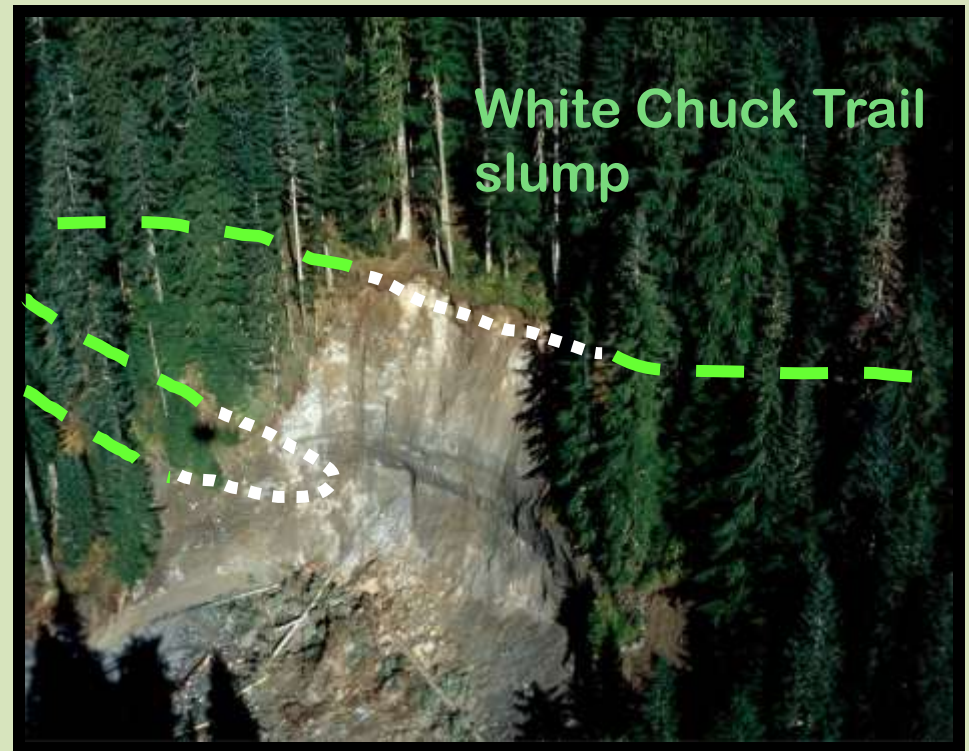
Road Failures

- Steep slopes
- Roads paralleling rivers
- Saturated ground due to storm events and maintenance needs
- Aging infrastructure

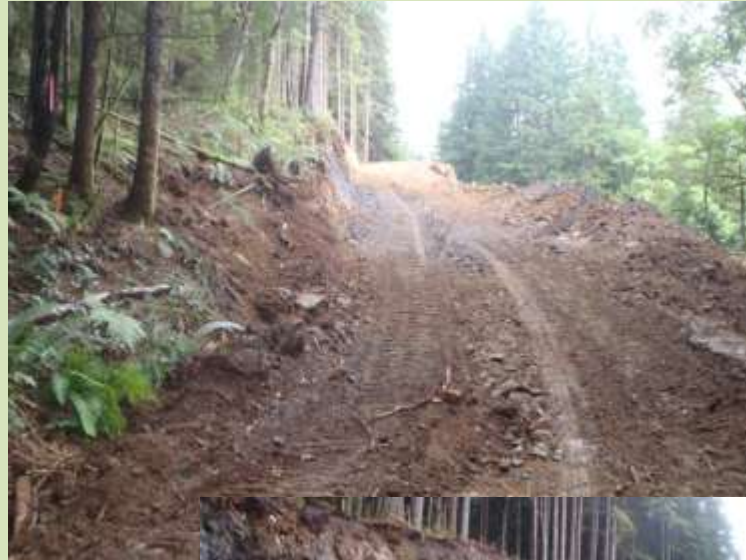
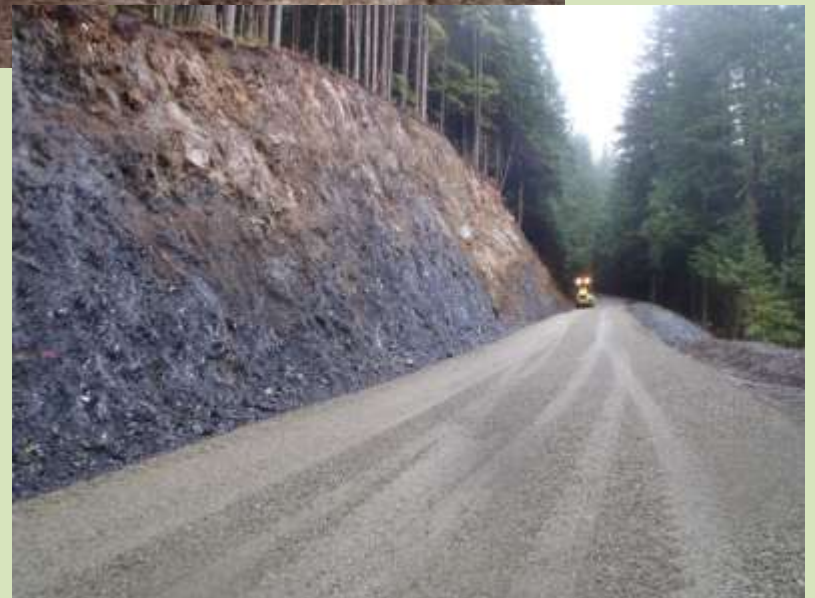
Road Improvements-new alignments

- Moving away from erosion potential areas
- Greater road width
- Moving farther away from streams/rivers
