Demonstration of Biofouling Mitigation Methods for Long-Term Deployments of Optical Cameras

James Joslin

Brian Polagye

Northwest National Marine
Renewable Energy Center,
University of Washington

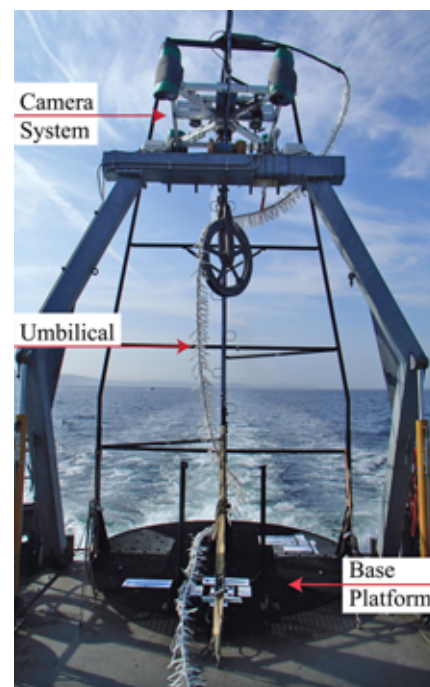
FIGURE 2

Five-meter-tall field test frame on the deck of the deployment vessel *R/V Jack Robertson*.

For the salt-water endurance trial, the camera system was mounted to the test frame shown in Figure 2. The Applied Physics Laboratory vessel *R/V Jack Robertson* lowered the test frame to the seabed in approximately 20 m of water at a point 100 m from shore. Mounted to this frame, the camera system was suspended 5 m above the seabed in a downward-looking orientation. The power and fiber umbilical was terminated on shore and connected to a data logging computer. Divers from the Applied Physics

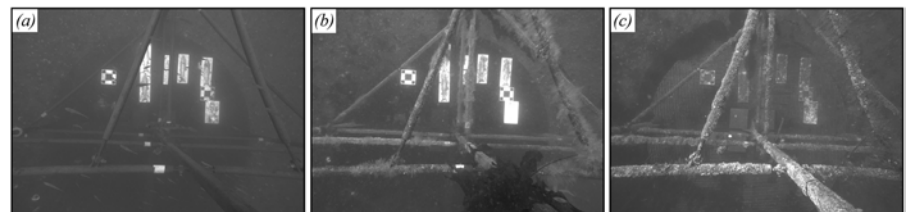
FIGURE 7

Camera 1 (Cu, Wi, and CS) images of biofouling on the field testing frame from (a) March 19, (b) May 15, and (c) July 2 prior to recovery.

Diving inspections confirmed increasing macrofouling on the test frame throughout the deployment (also observed in camera imagery), while the optical ports were observed to remain clear of fouling until the final (June 26) inspection. During this final inspection, the strobe optical ports (which were no longer being actively wiped) were observed to have varying degrees of macrofouling while the camera ports remained clear. Figure 7 shows the increasing level of biofouling on the test frame from camera images acquired over the course of the deployment.

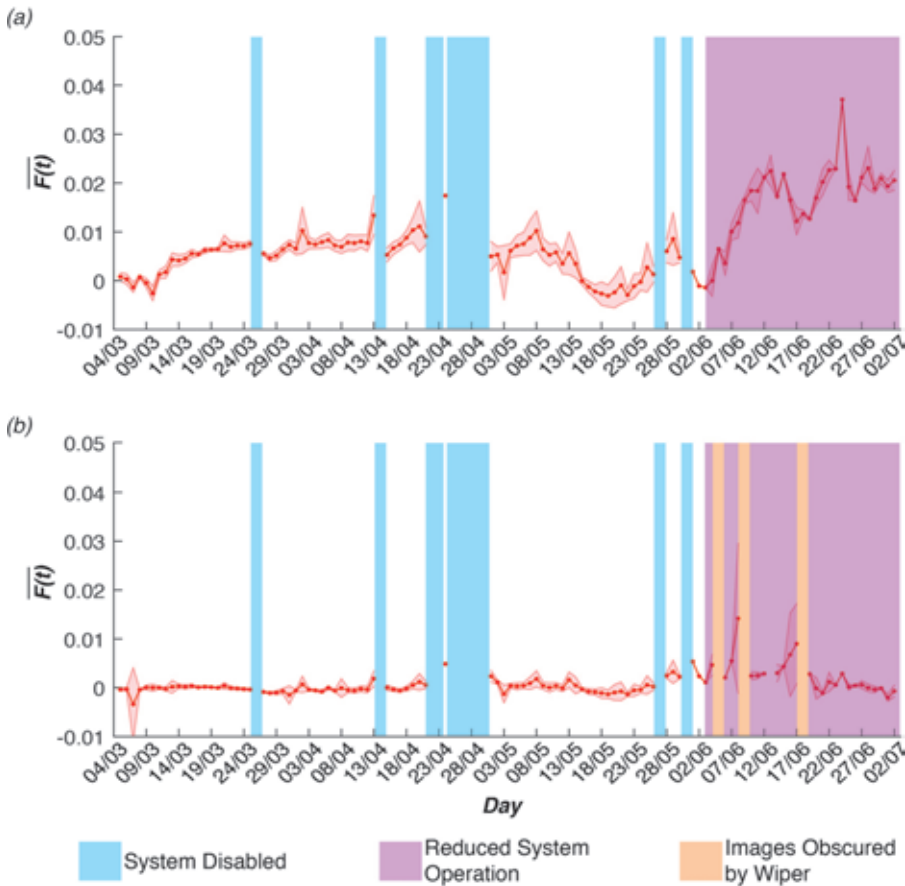
FIGURE 8

Averaged nightly biofouling metric values with shaded standard deviations on (a) Camera 1 (Cu, Wi, and CS) and (b) Camera 2 (Cu and Wi) optical ports throughout the endurance test.

Figure 8 shows the calculated daily mean biofouling metric for each camera from the images collected with 50-ms exposure times throughout the endurance trial. Qualitatively similar trends were observed with 10- and 25-ms exposure settings, suggesting an insensitivity to exposure time. Highlighted periods represent interruptions in system operation due to software errors, electrical interference with serial communications, and wiper malfunctions. As previously discussed, during the last month of the deployment, the system operation was reduced to a short period every night such that

The biofouling metric values shown in Figure 8 are consistently below 0.04, indicating that both camera optical ports remained clear throughout the deployment, consistent with diver observation and post-recovery inspection. Variation in the camera metrics is primarily attributed to changes in the water quality during the deployment because flocculent or turbidity in the water close to the optical ports is illuminated by the LED backlight and increases the value of F , without actually fouling the port. Days with F value variations during the first 3 months of the deployment also have increased standard deviations, indicating that the variation is within the uncertainty of the measurement. During the last month of the deployment, the F values for Camera 1 (Cu, Wi, and CS) increase without an increase in the standard deviation, indicating a true change in the signal. Camera 1 (Cu, Wi, and CS) images are consistently brighter than those from Camera 2 (Cu and Wi) and have a larger range of variation. It is hypothesized that the light diffraction

through the ClearSignal coating causes a “halo effect,” increasing the number of bright pixels and magnifying any variation in brightness. Images obtained with external strobe illumination from the coated camera port are not of markedly lesser quality than the uncoated port, so this does not suggest that the coating degrades operational effectiveness. Counterintuitively, with the wipers activated only once per day at the end of the deployment, the fouling metric increases for Camera 1 (Cu, Wi, and CS), even though one would expect that the ClearSignal coating would mitigate fouling more effectively than the bare acrylic.
