National Park Service
Cultural Landscapes Inventory
2014

Nuestra Señora Reina De La Paz
César E. Chávez National Monument

MANAGEMENT CATEGORY: **A: Must be preserved and maintained**

CONDITION ASSESSMENT: **Fair**

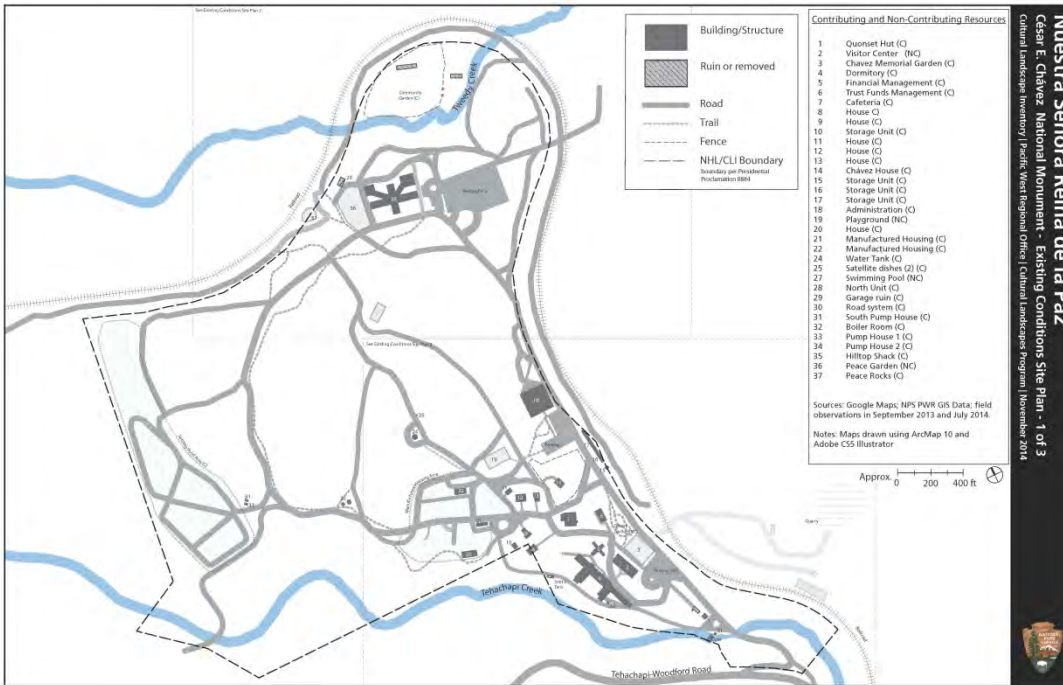
Site Plan

Site Plan: Nuestra Señora Reina De La Paz (PWR, CL Program, 2014). See the Supplemental Information section for an 11 x 17-inch version of site plan.

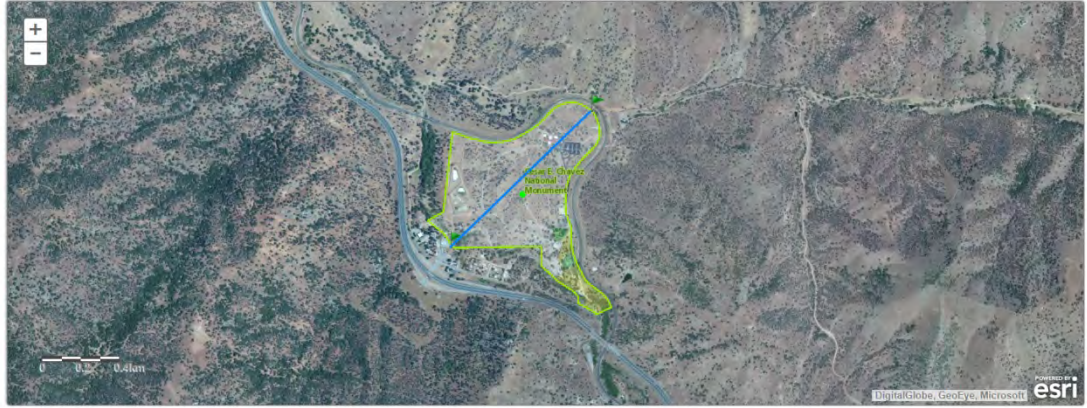
Natural Systems and Features: Elevation profile from southwest to northeast (see Appendix E for large format version of this profile sheet).

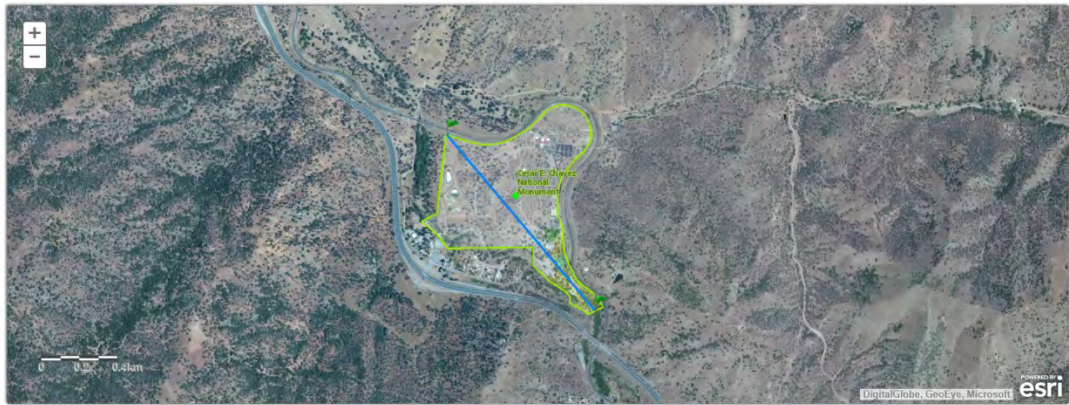
Natural Systems and Features: Elevation profile from southeast to northwest (see Appendix E for large format version of this profile sheet).

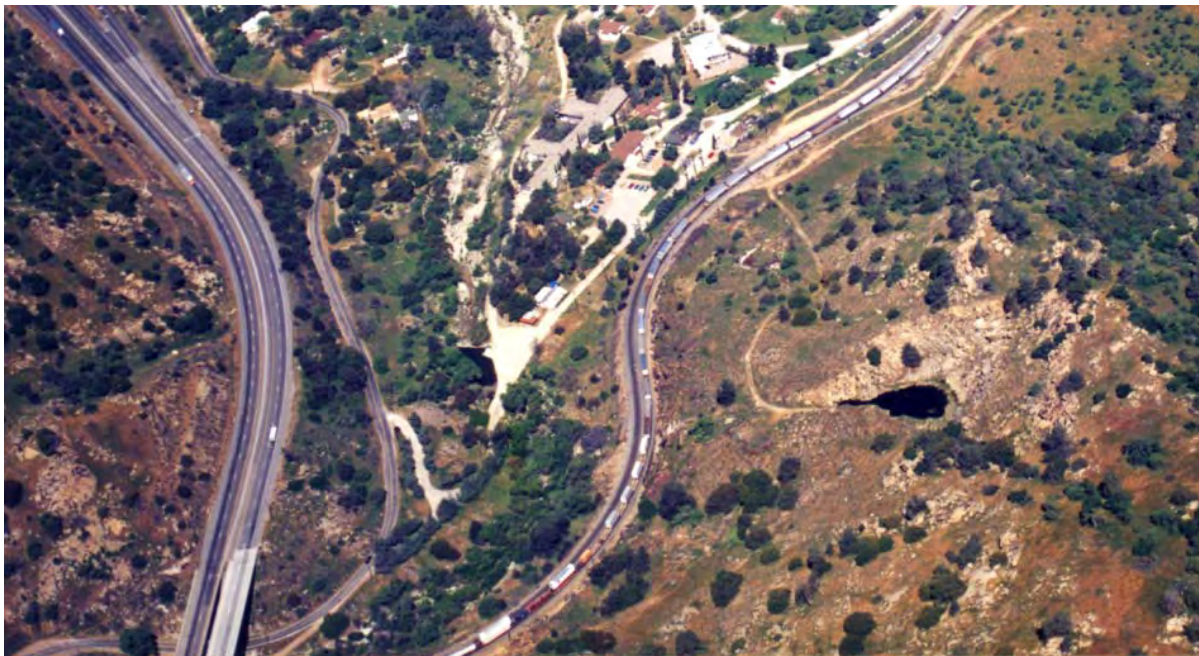
Cluster Arrangement: The entrance is located at the southeastern corner of the monument, compactly clustered between the railroad and the highway (PWR CL Program, 2014 based on a 1993 aerial).

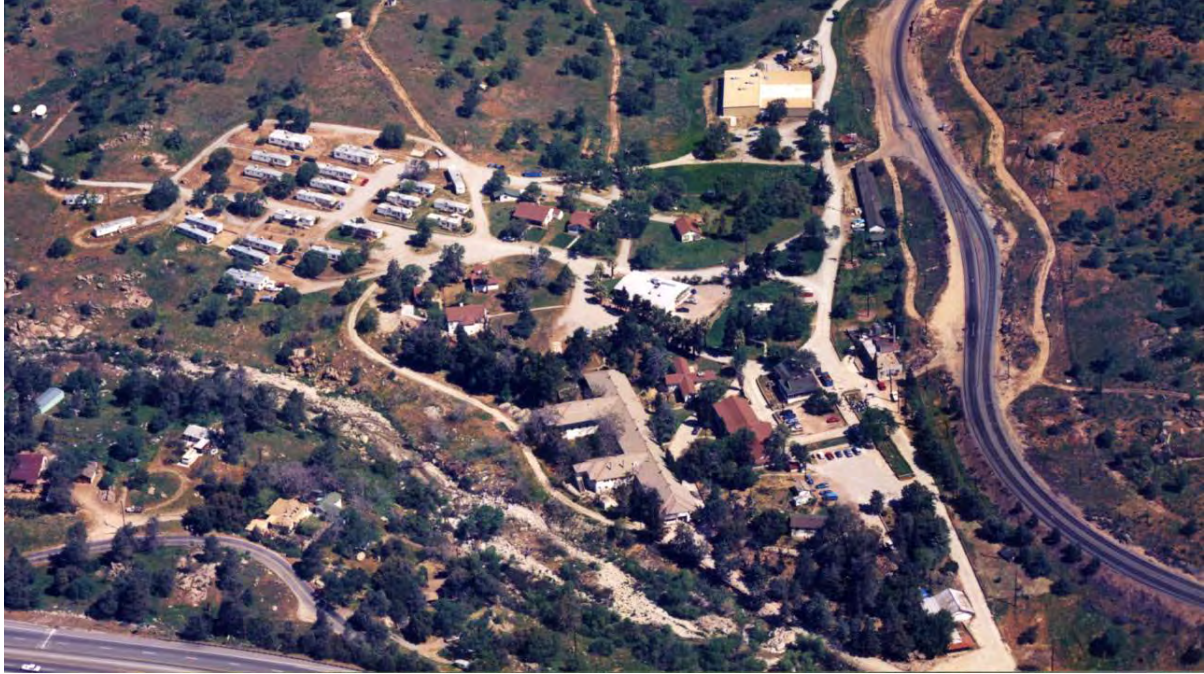
Cluster Arrangement: The residential area, is organized around a central formal drive, with the Cafeteria (building 7) building at its center (PWR CL Program, 2014 based on a 1993 aerial).

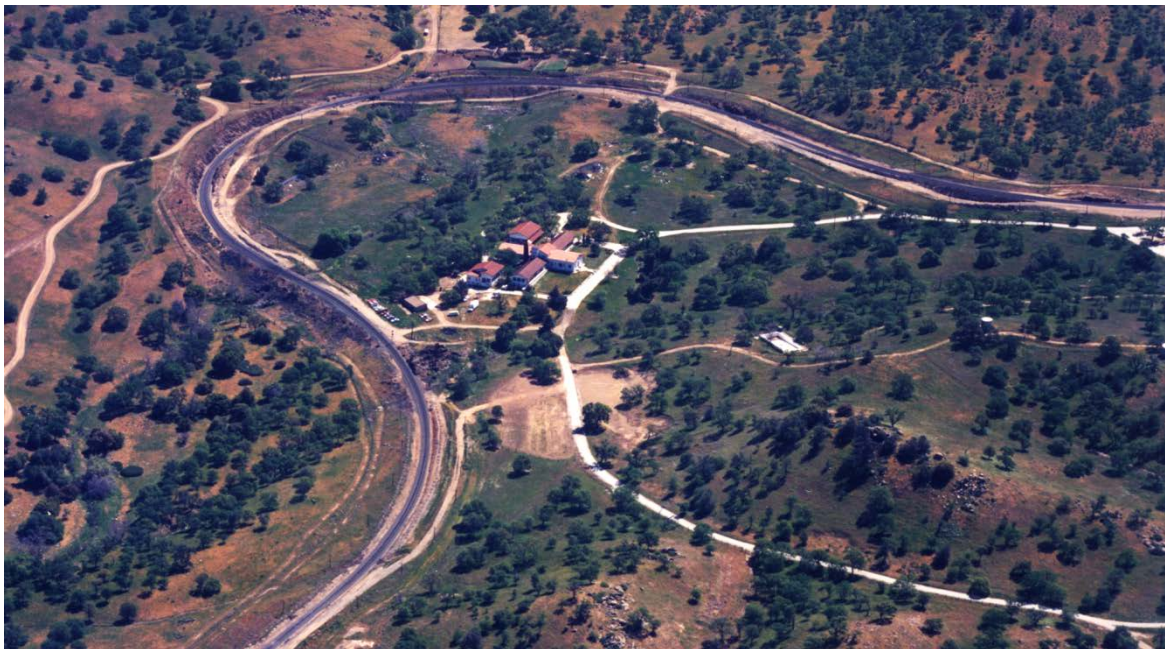
Cluster Arrangement: Villa La Paz is the central feature within the La Paz area, located at the northeast corner of the monument (PWR CL Program, 2014 based on a 1993 aerial).

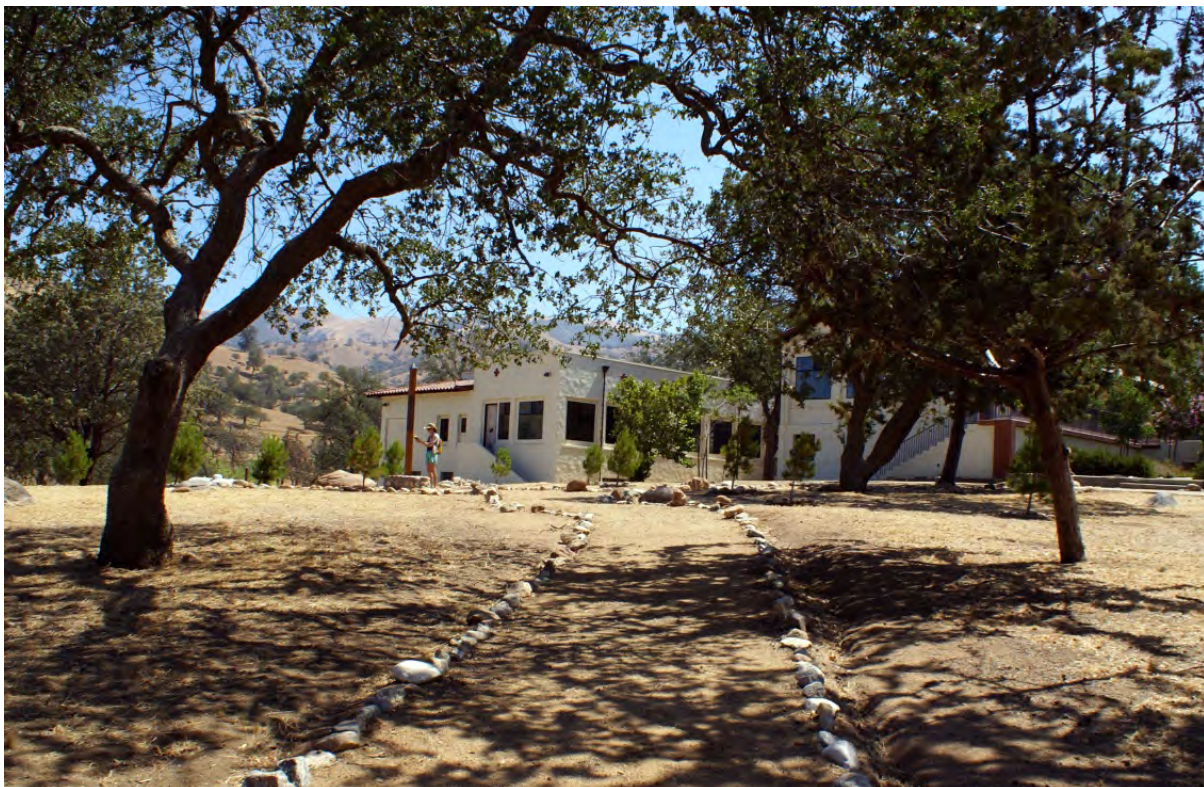
Vegetation: The Peace Garden (36), located directly west of Villa La Paz, incorporates stone-lined paths and an obelisk at the center. It was constructed after 1993 (PWR, CL Program, 2014).

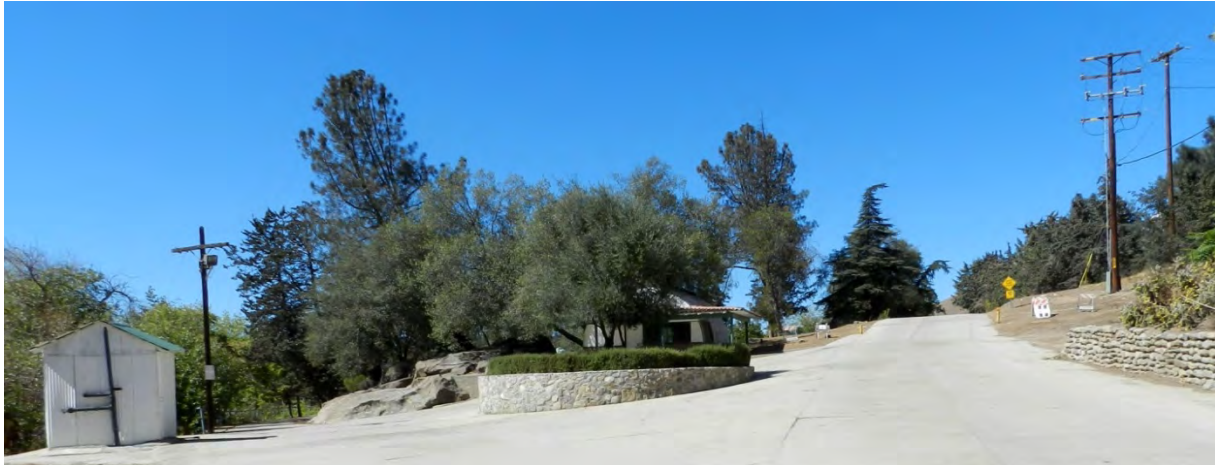
Vegetation: Looking north, the olive tree and the surrounding rosemary can be seen within the stone retaining wall roundabout in the center of the photo (PWR, CL Program, 2013).

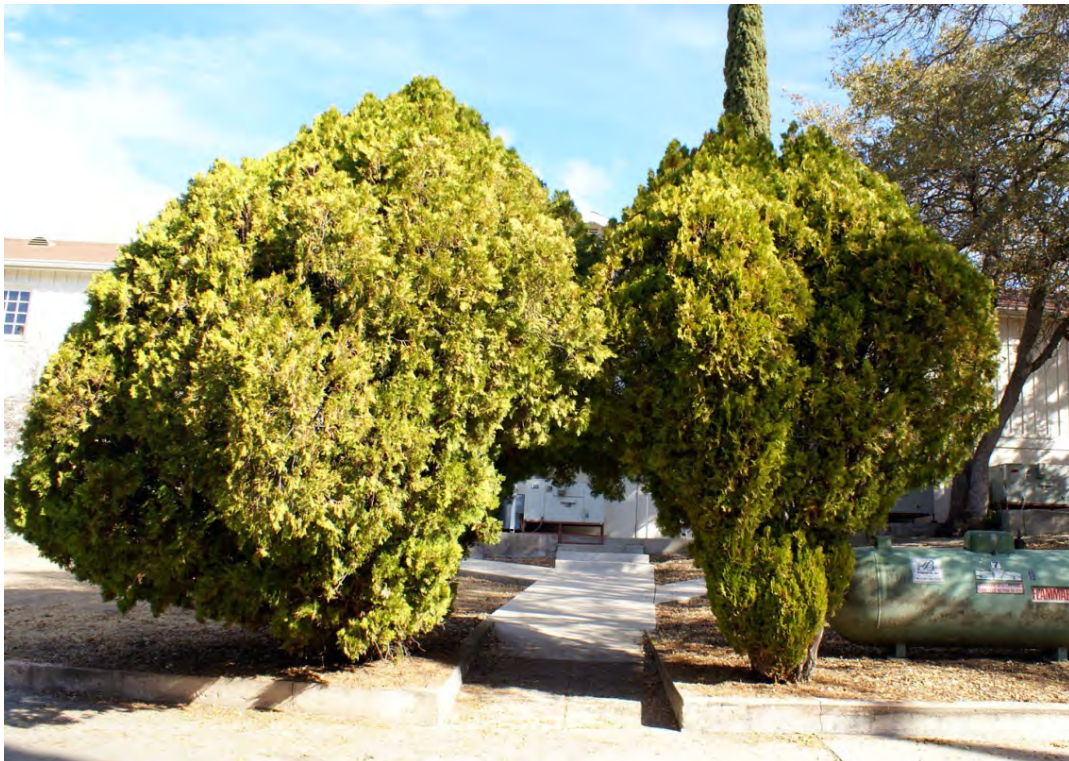
Vegetation: The rear of the Visitor Center (building 2) has two cypress planted on either side of the paved pedestrian path connecting the Visitor Center (building 2) with the Dormitory (building 4) building. The trees are overgrown, obstructing views and require pruning (PWR, CL Program, 2014).

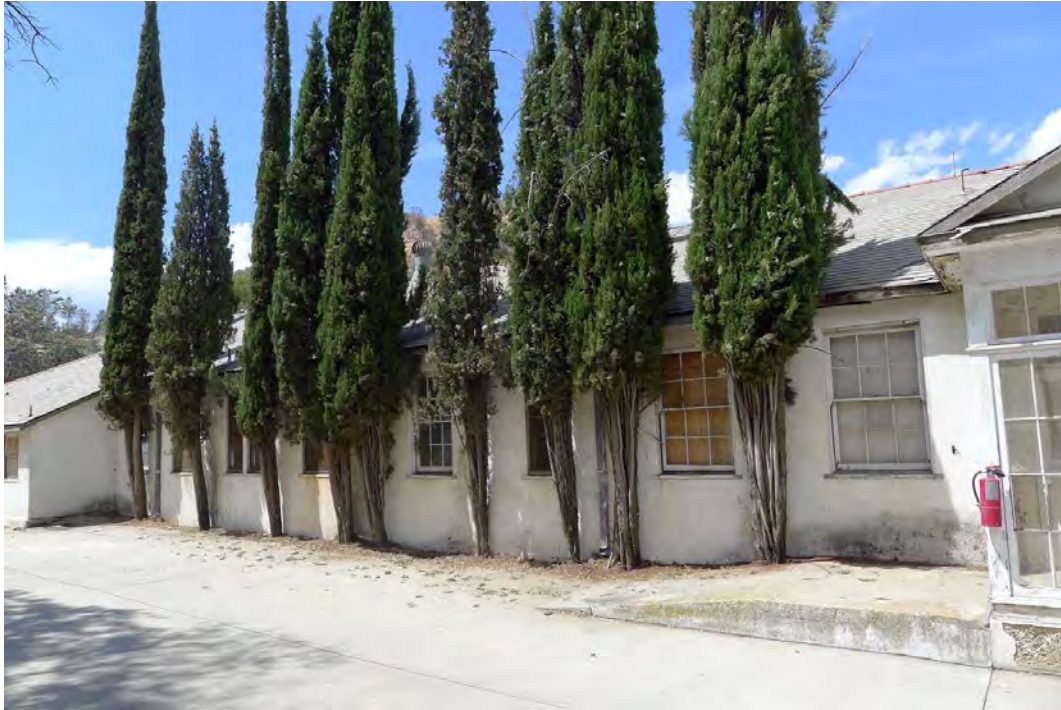
Vegetation: The Dormitory (building 4) building has a row of cypress on the northern side of the building that are encroaching upon the gutter and roof (PWR, CL Program, 2014).

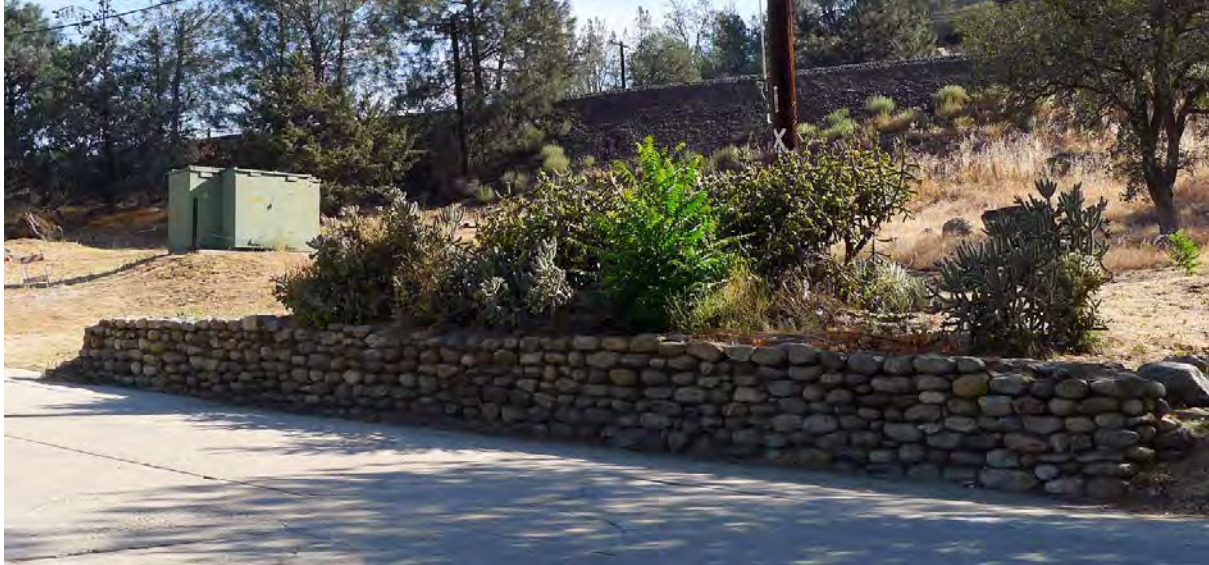
Vegetation: The cholla is located above the rock retaining wall, alongside the primary paved entry road (PWR, CL Program, 2014).

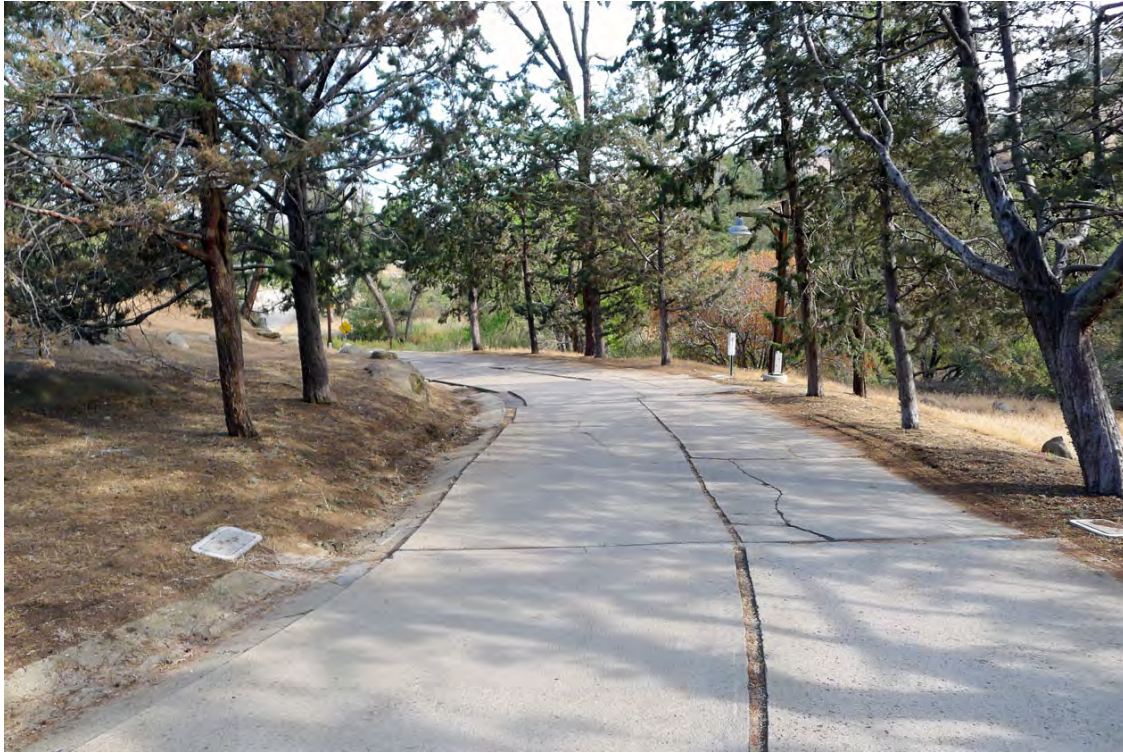
Circulation: The entrance road, looking north to Tehachapi Creek shows the Cypress allée and the road deterioration (PWR, CL Program, 2014).

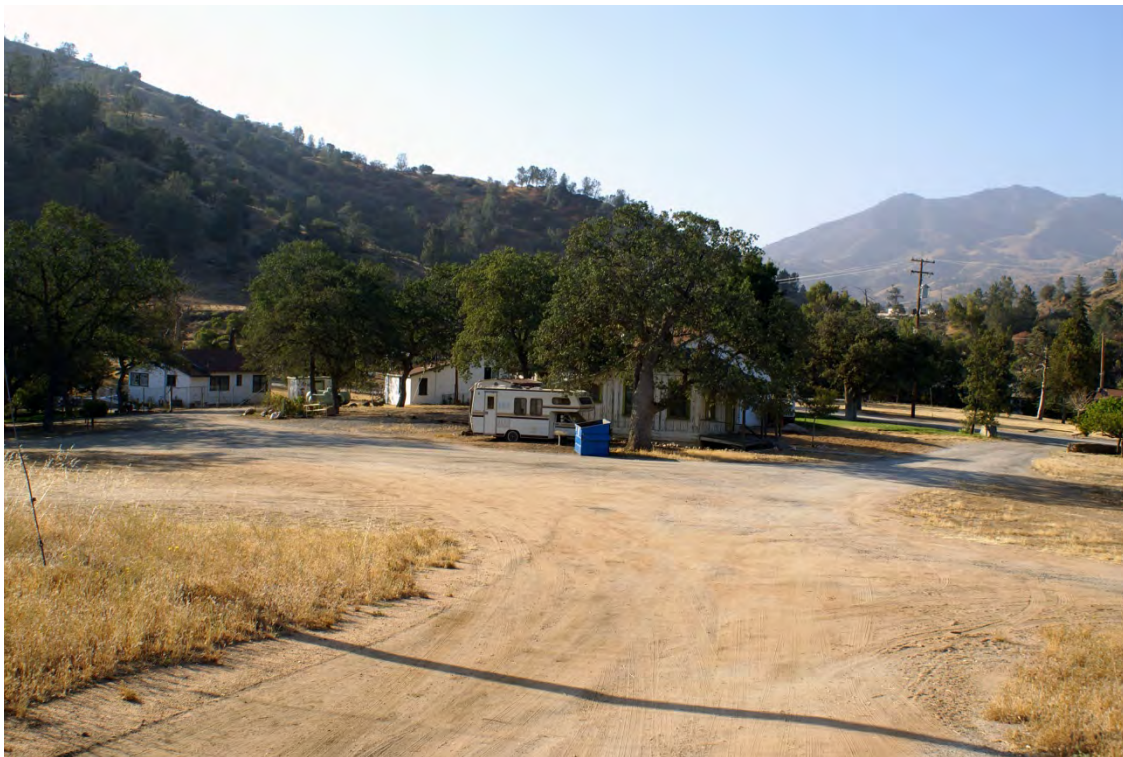
Circulation: A view of the typical unpaved roads in the Residential Area (PWR, CL Program, 2014).

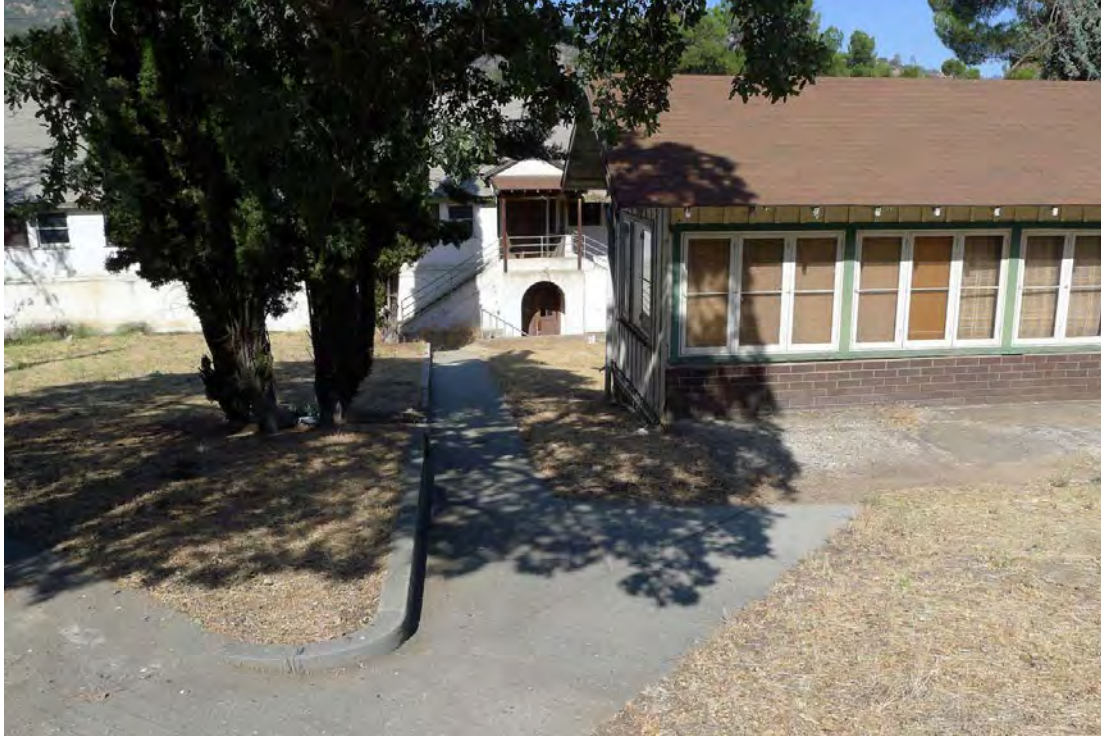
Circulation: Typical paved pedestrian paths, like this looking west towards the Dormitory (building 4) building, are located throughout the site. The path connects the road behind the Visitor Center (building 2) with the Financial building, in foreground, with the the Dormintory building, in background (PWR, CL Program, 2014).

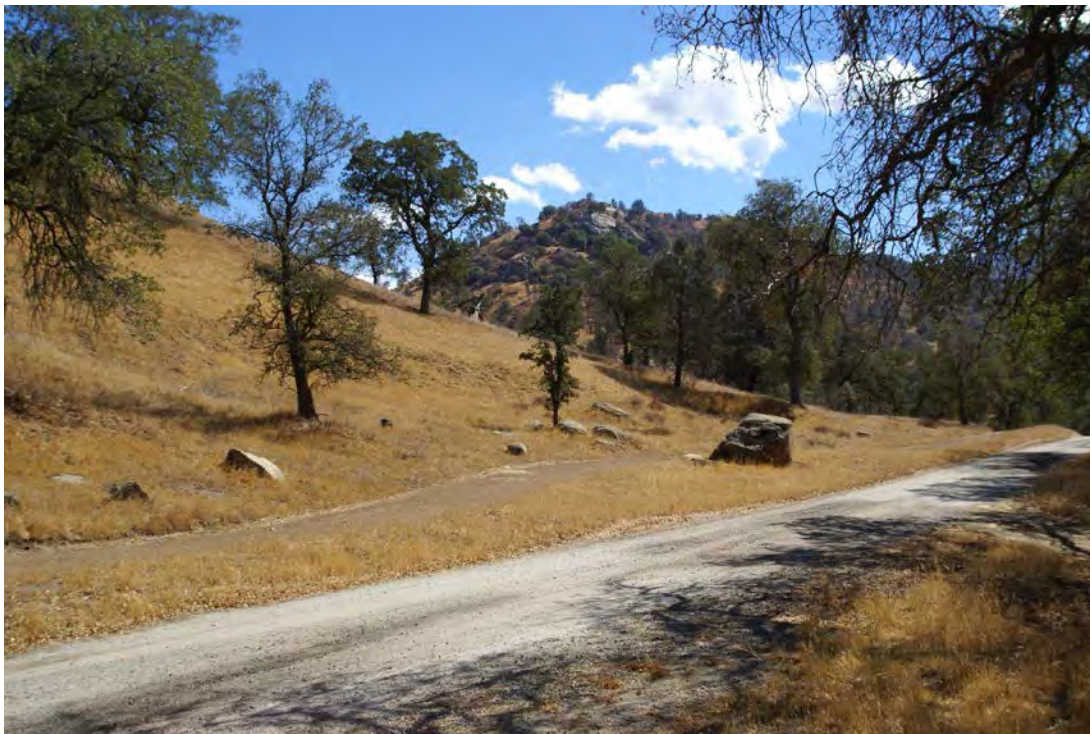
Circulation: A non-contributing trail system, as seen here to the left of the road, is located within the administration and facilities area (PWR, CL Program, 2013).

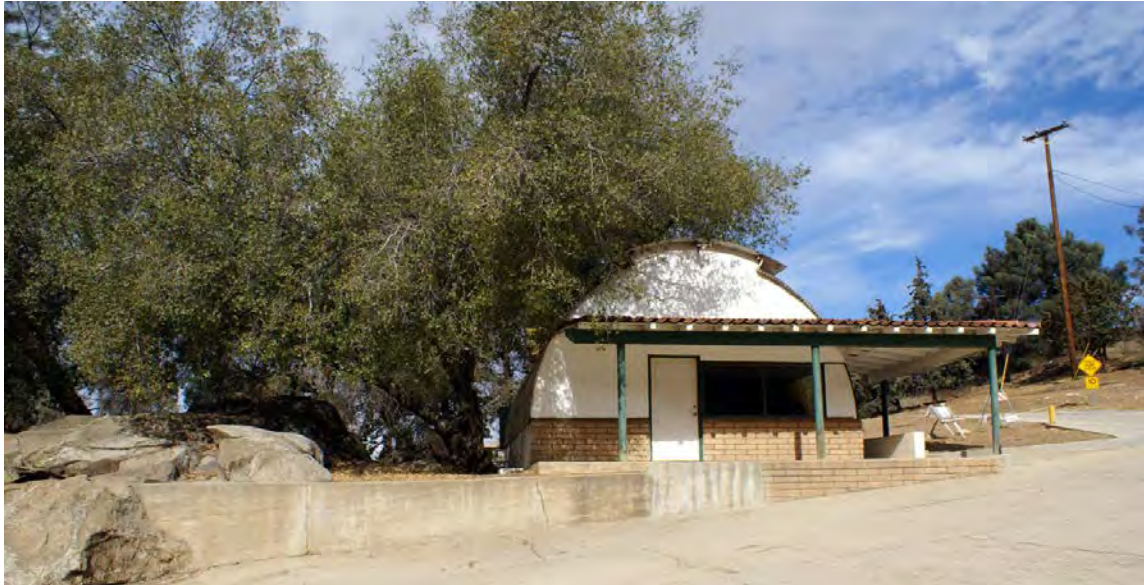
Buildings and Structures: The location of the Quonset Hut (building 1), looking north, is amongst the vegetation and the entry road (PWR, CL Program, 2014).

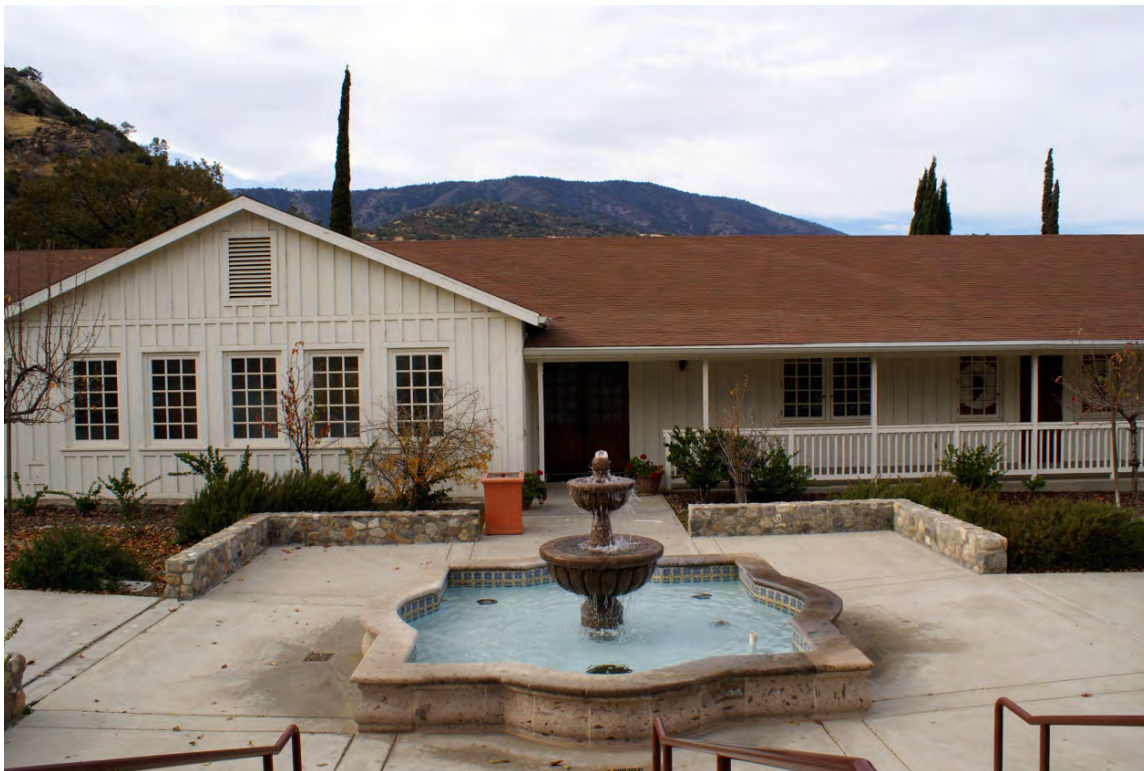
Buildings and Structures: The Visitor Center (building 2), looking west, was completed in 2004, but was built on top of the original building's 1914 foundation (PWR, CL Program, 2012).

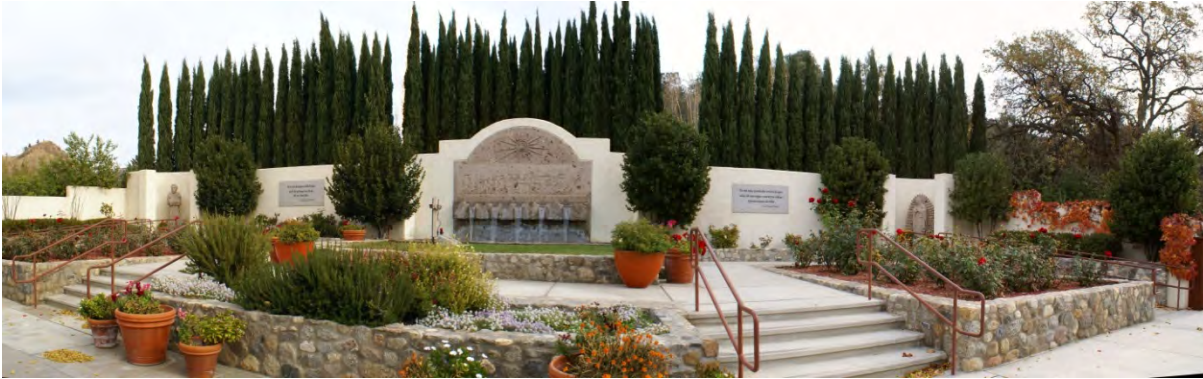
Buildings and Structures: The Chávez burial site, looking east, is directly east of the Visitor Center (building 2) and incorporates a water feature, lawn, and a variety of ornamental vegetation (PWR, CL Program, 2014).

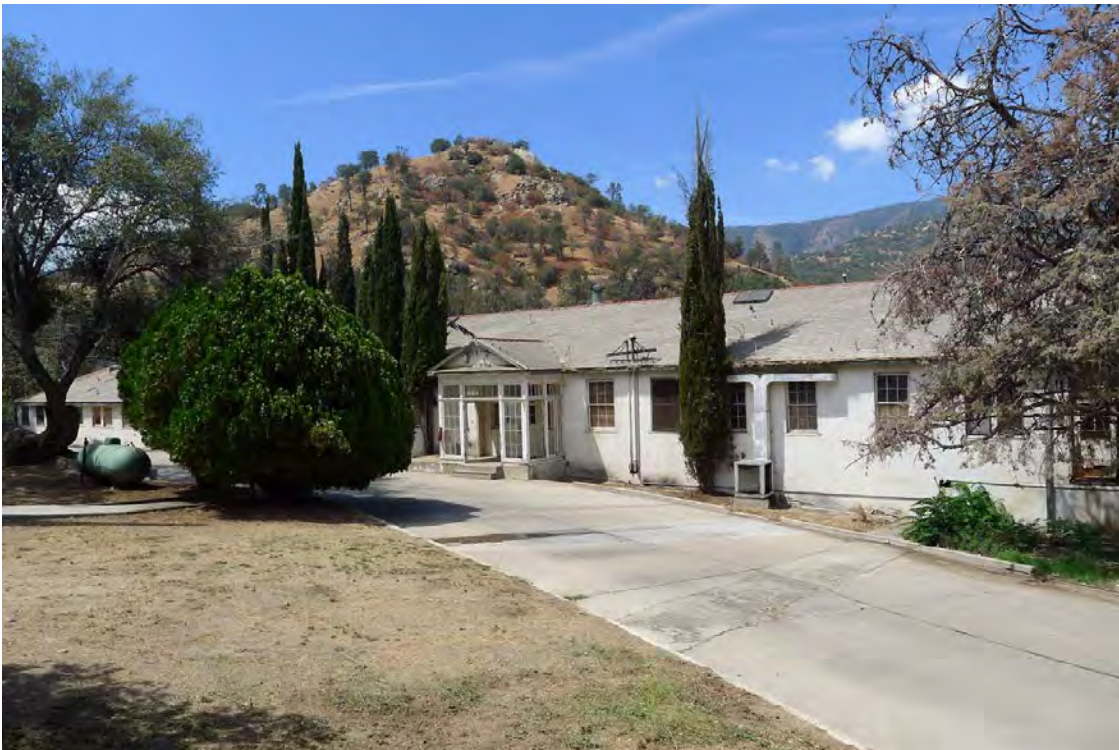
Buildings and Structures: The Dormitory (building 4) building, looking southwest, shows the formal entry and the adjacent, paved vehicular road (PWR, CL Program, 2014).

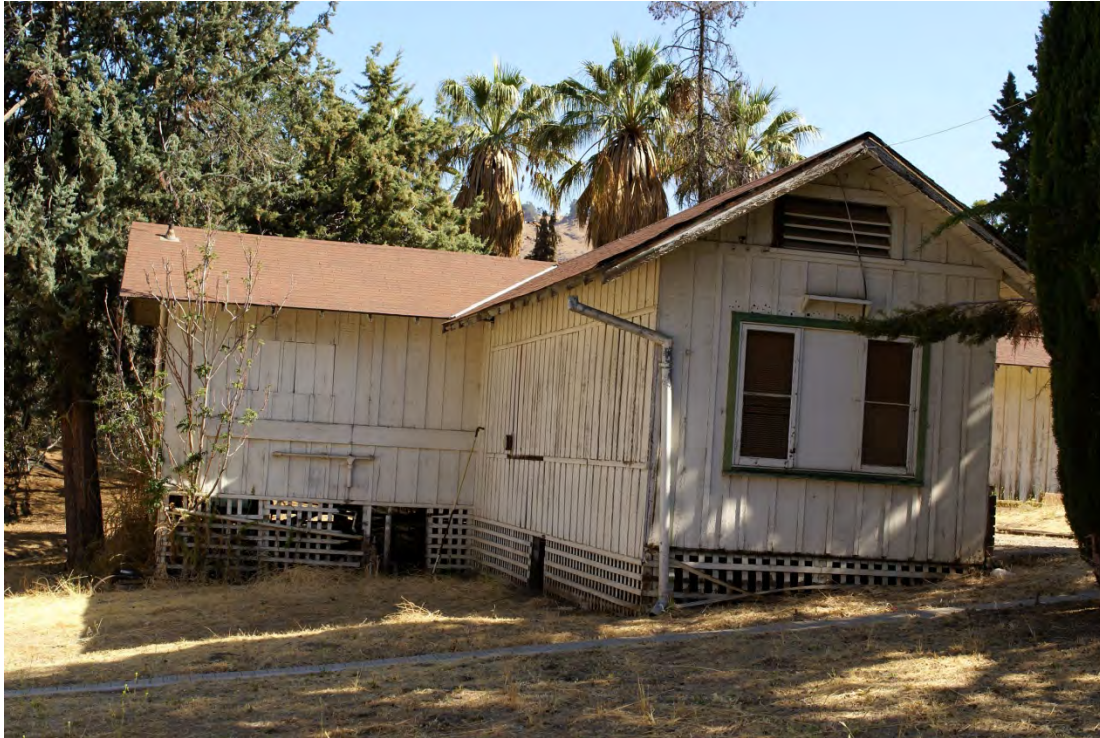
Buildings and Structures: The Financial Building, looking north, shows the building layout in the shape of a cross and its position on a slope (PWR, CL Program, 2014).

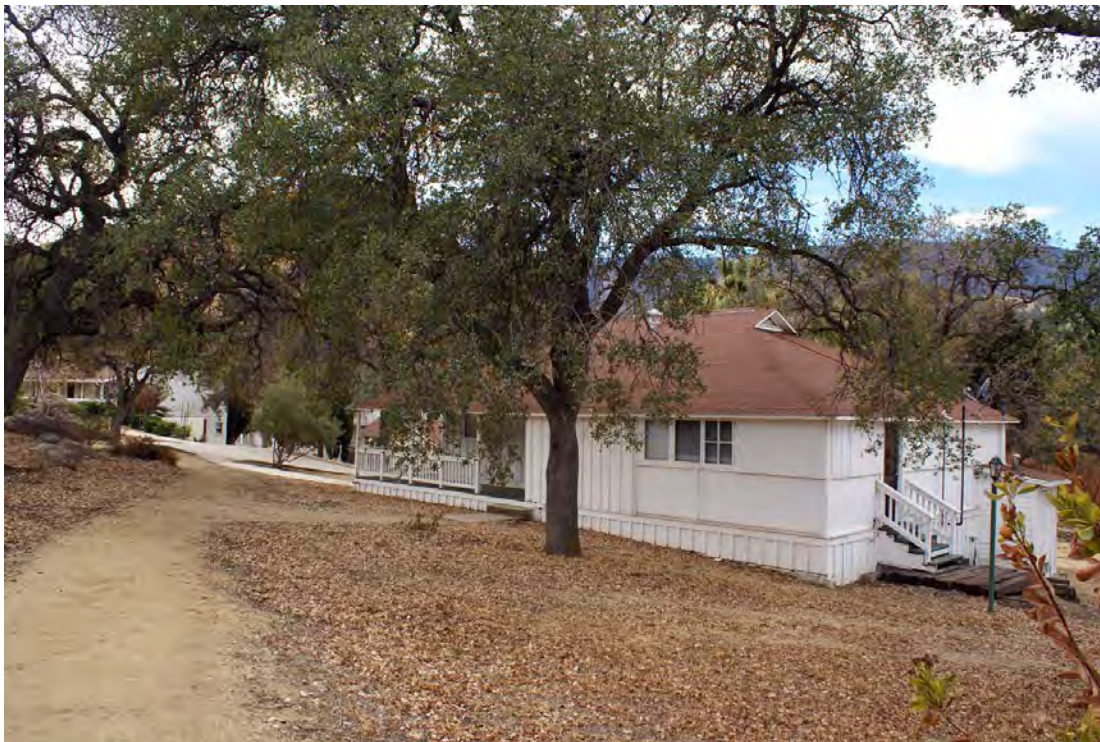
Buildings and Structures: Looking west, the Trust Funds Management Building (building 6) incorporates covered, wrap around porches on the south side. Originally it functioned as a residence, but then converted by the UFW in the 1970s (PWR, CL Program, 2012).

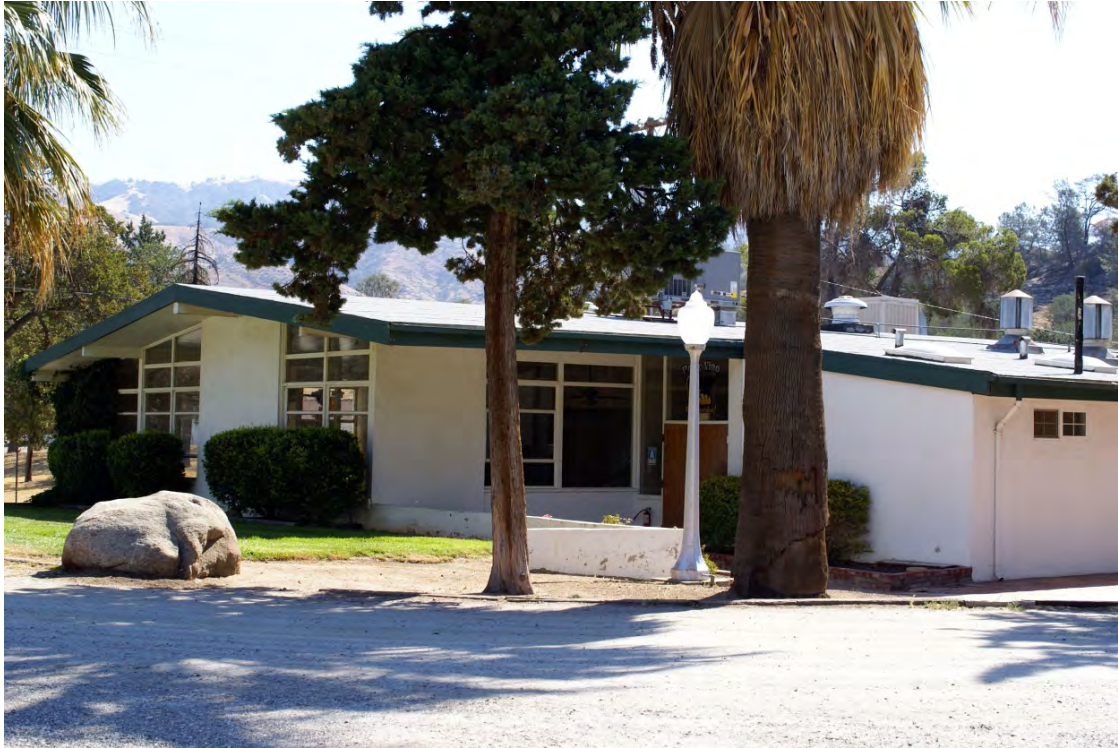
Buildings and Structures: The Cafeteria (building 7) Building, looking south, shows the 1950's architecture, the ornamental vegetation in the foreground and one of the original lamp posts (PWR, CL Program, 2014).

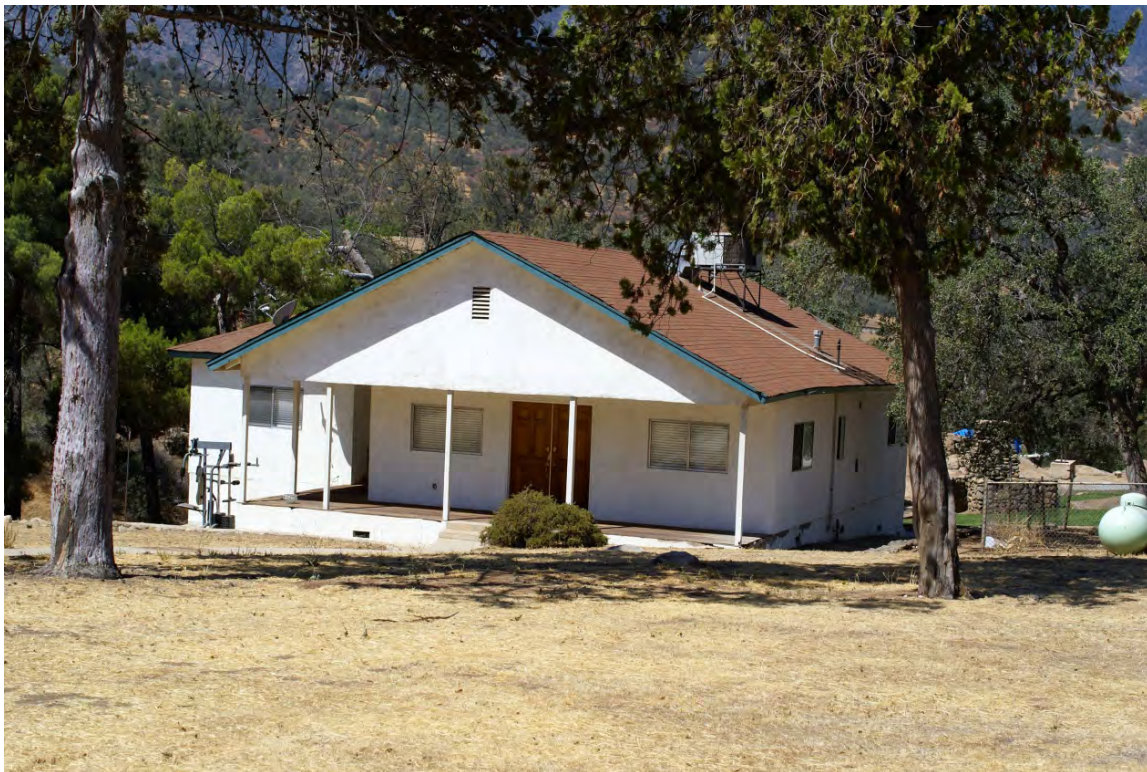
Buildings and Structures: Residence 8, looking west, shows the California bungalow influences with the low-pitched roof and wrap around porch (PWR, CL Program, 2014).

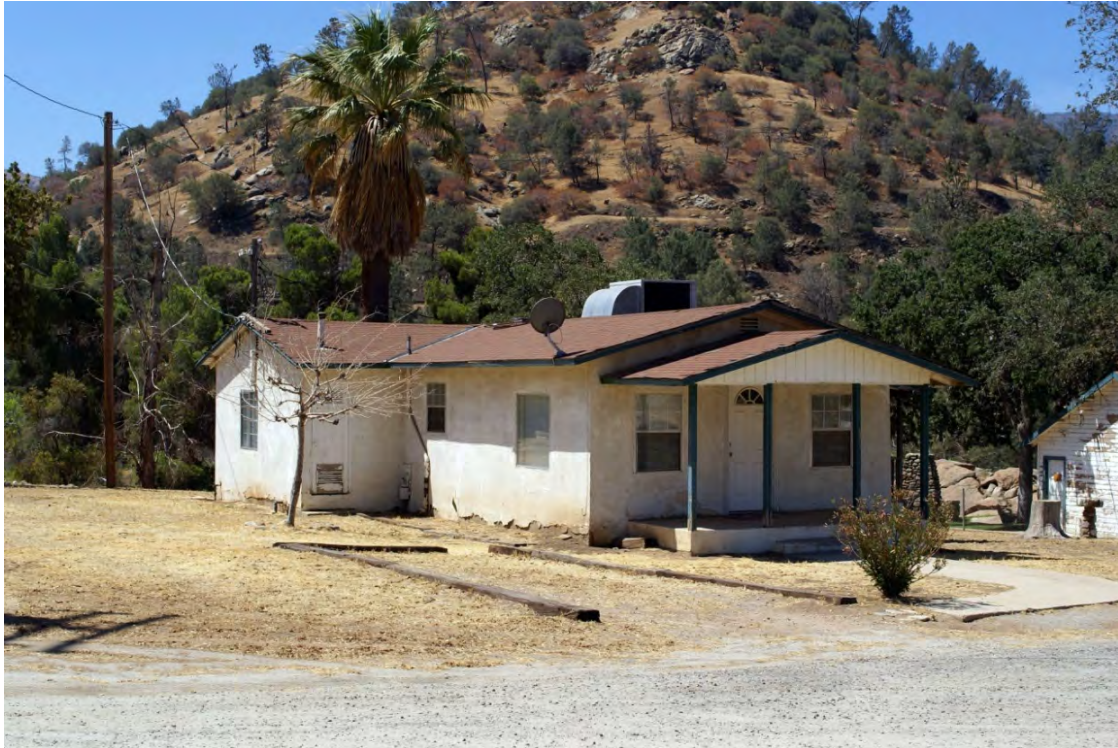
Buildings and Structures: Residence 9, looking southwest, shows the California bungalow influences, as well as the board-and-batten siding that was replaced with stucco in the 1950's (PWR, CL Program, 2014).

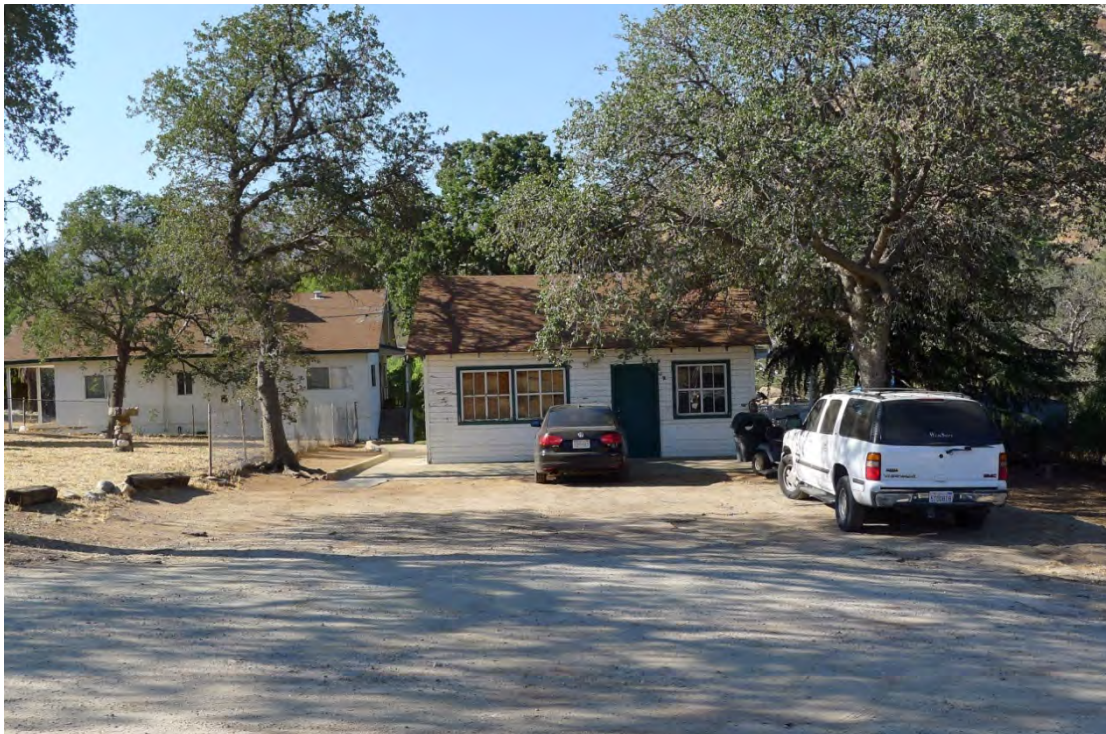
Buildings and Structures: Storage Unit Building 10, looking south, was built in the 1950's and shows its relationship with residence 9 in the background(PWR, CL Program, 2014).

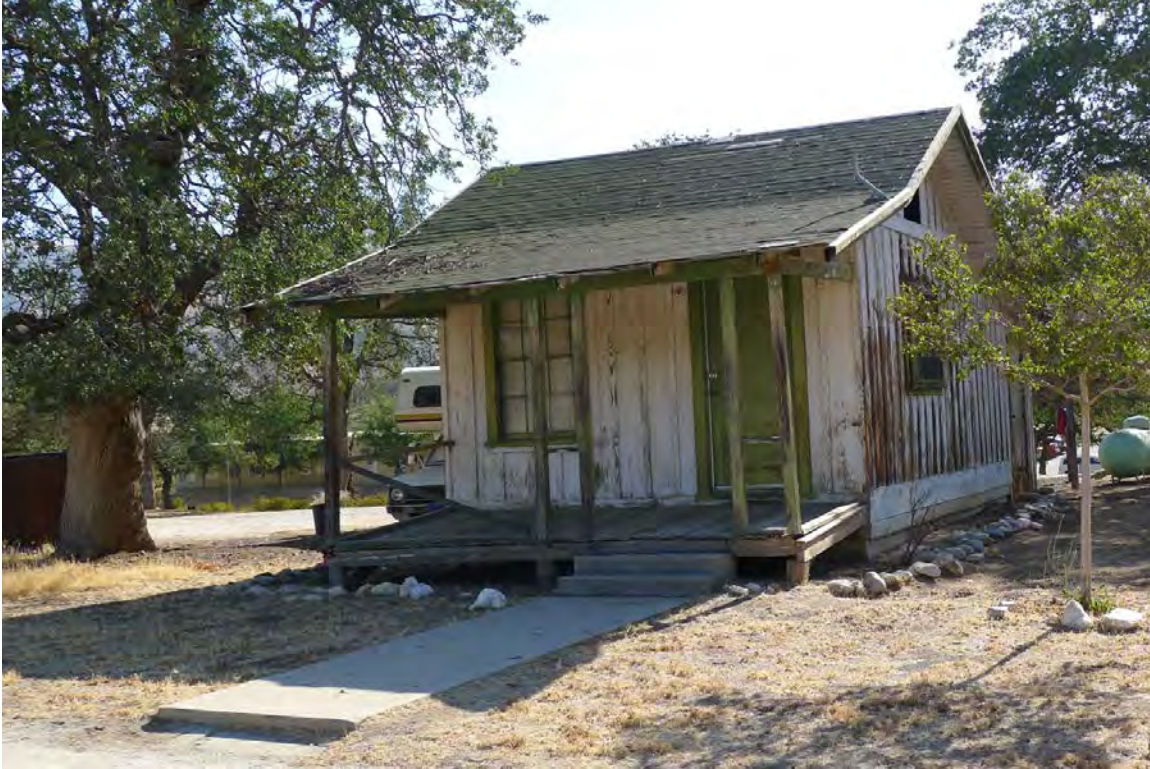
Buildings and Structures: Residence 11, looking east, shows the original board-and-batten siding (PWR, CL Program, 2014).

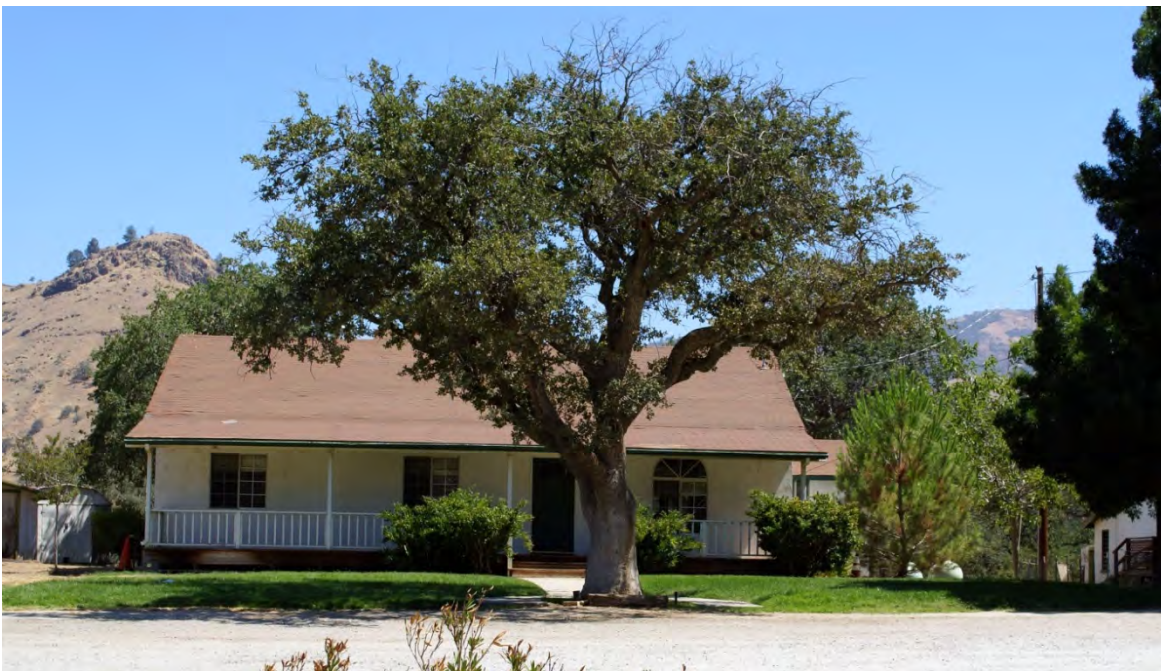
Buildings and Structures: Residence 12, looking north, shows formal vegetation in the foreground and the 1950's expanded front porch with Three Peaks in the background (PWR, CL Program, 2014).

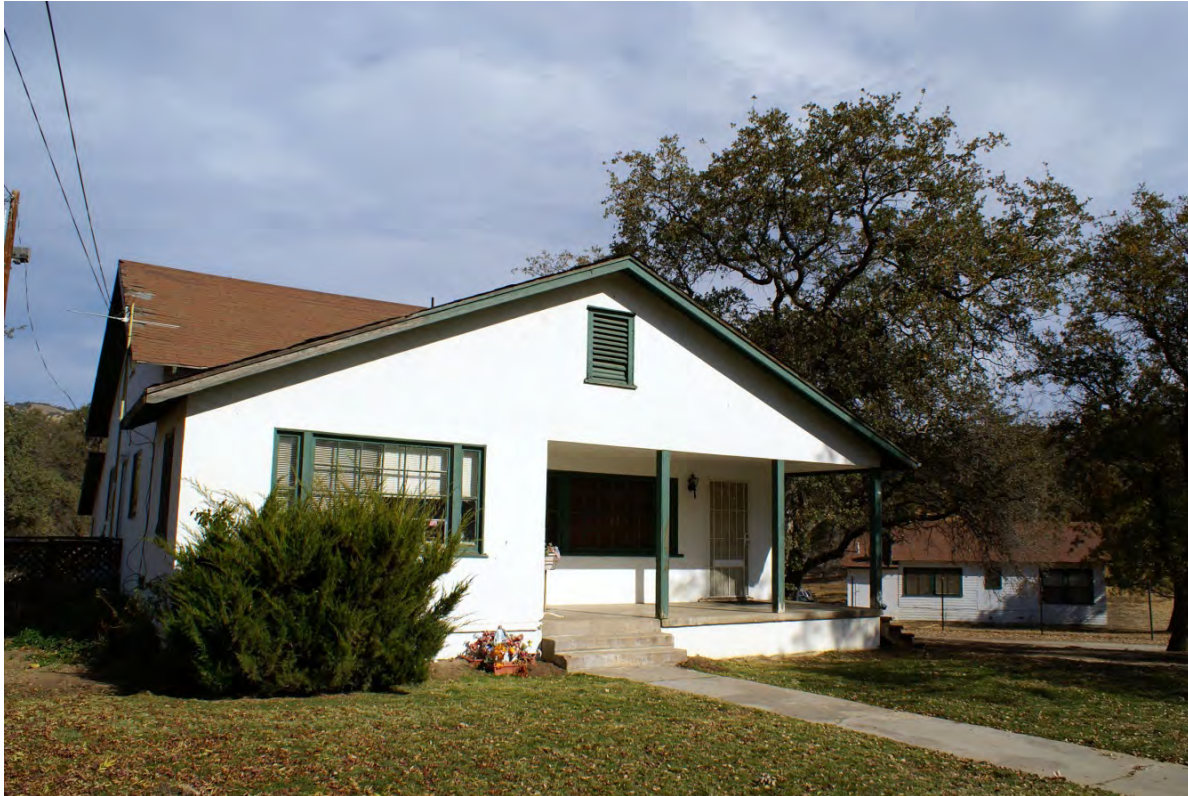
Buildings and Structures: Residence 13, looking east, was moved from its original location, near what is now the picnic area, to its present location in the 1950's (PWR, CL Program, 2012).
