National Park Service
Cultural Landscapes Inventory
2014

Nuestra Señora Reina De La Paz
César E. Chávez National Monument

MANAGEMENT CATEGORY: **A: Must be preserved and maintained**

CONDITION ASSESSMENT: **Fair**

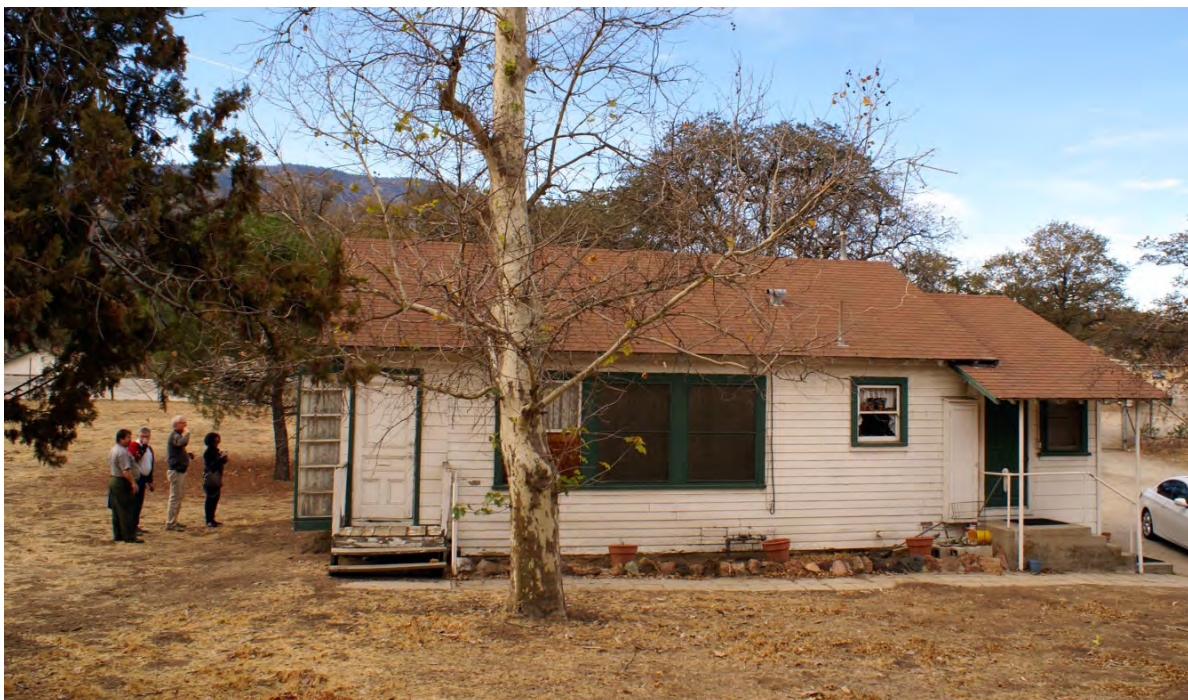
Buildings and Structures: The Chávez house, looking west, is a single story structure that was home to the Chávez family and where Helen Chávez still resides (PWR, CL Program, 2012).

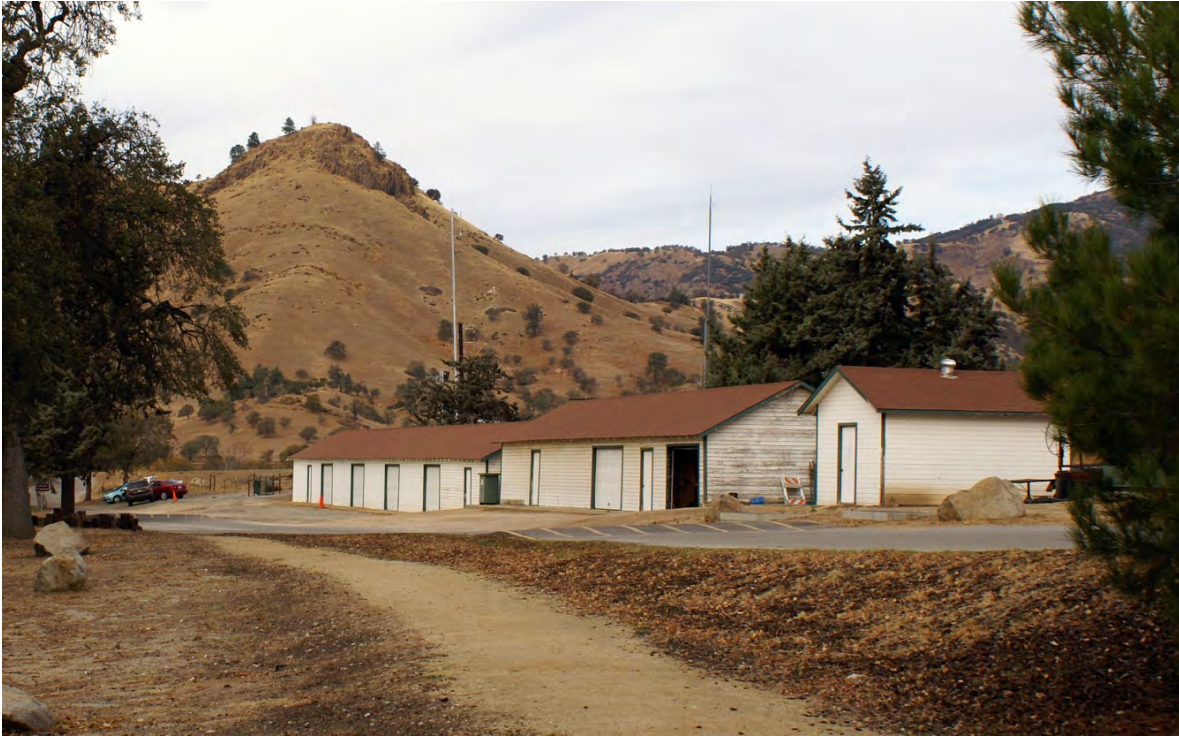
Buildings and Structures: Three garages, looking north, are located along the primary paved road that parallels the railroad. Three Peaks can be seen in the background (PWR, CL Program, 2012).

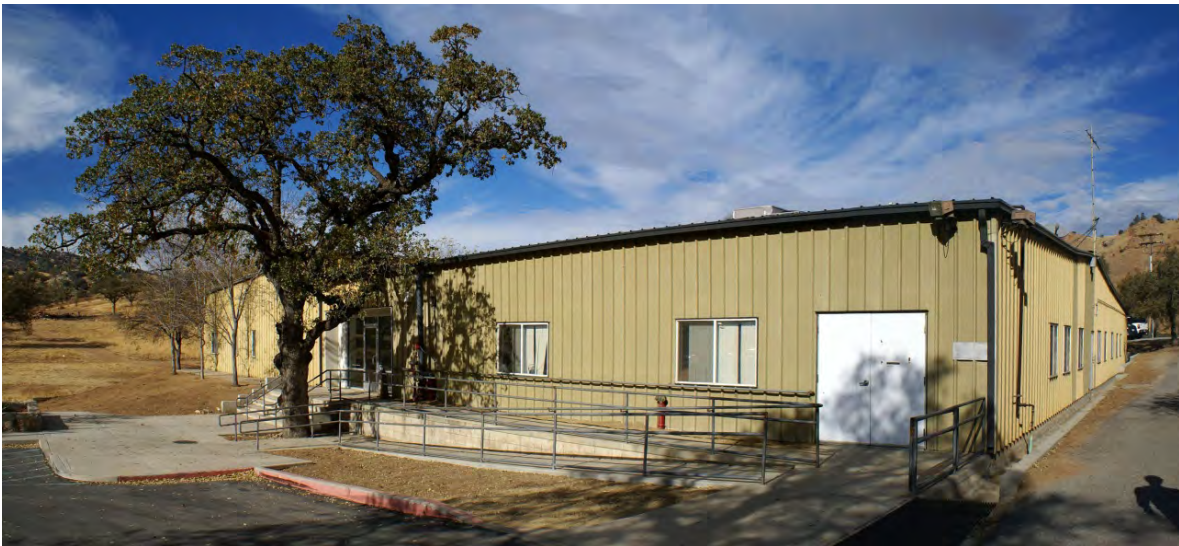
Buildings and Structures: The Administration building, looking northwest, shows the metal siding and the front entrance on the south side (PWR, CL Program, 2012).

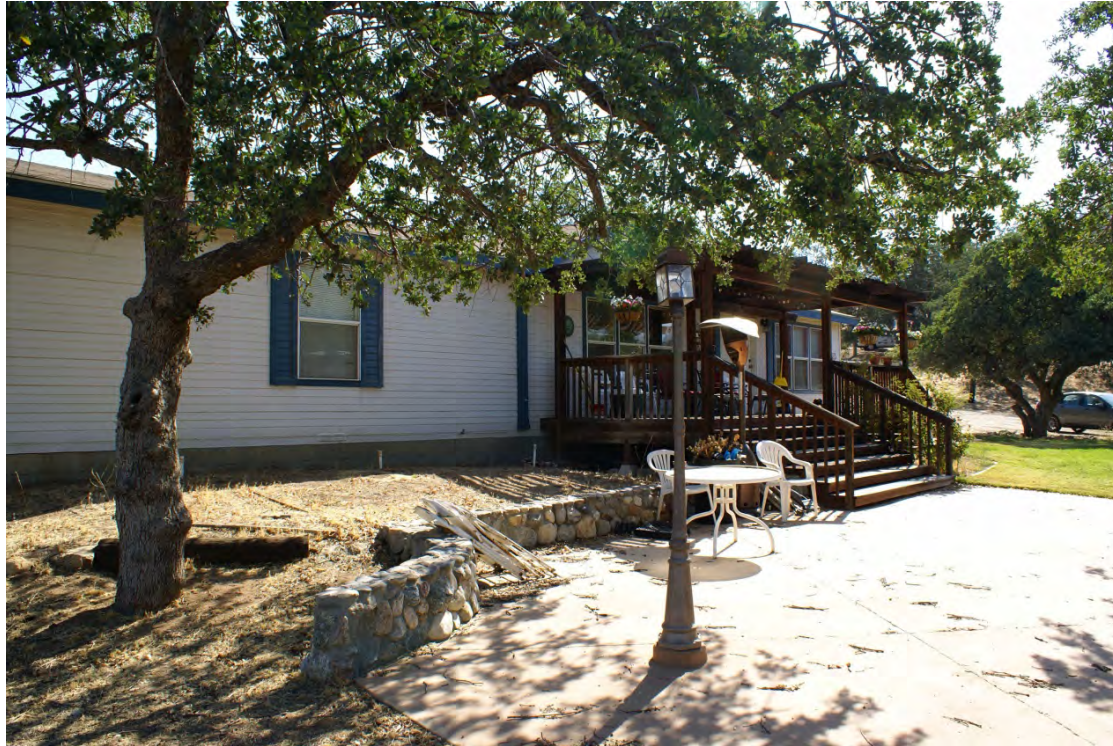
Buildings and Structures: House 20, looking east, is one of the last remaining structures within the manufactured housing area (PWR, CL Program, 2014).

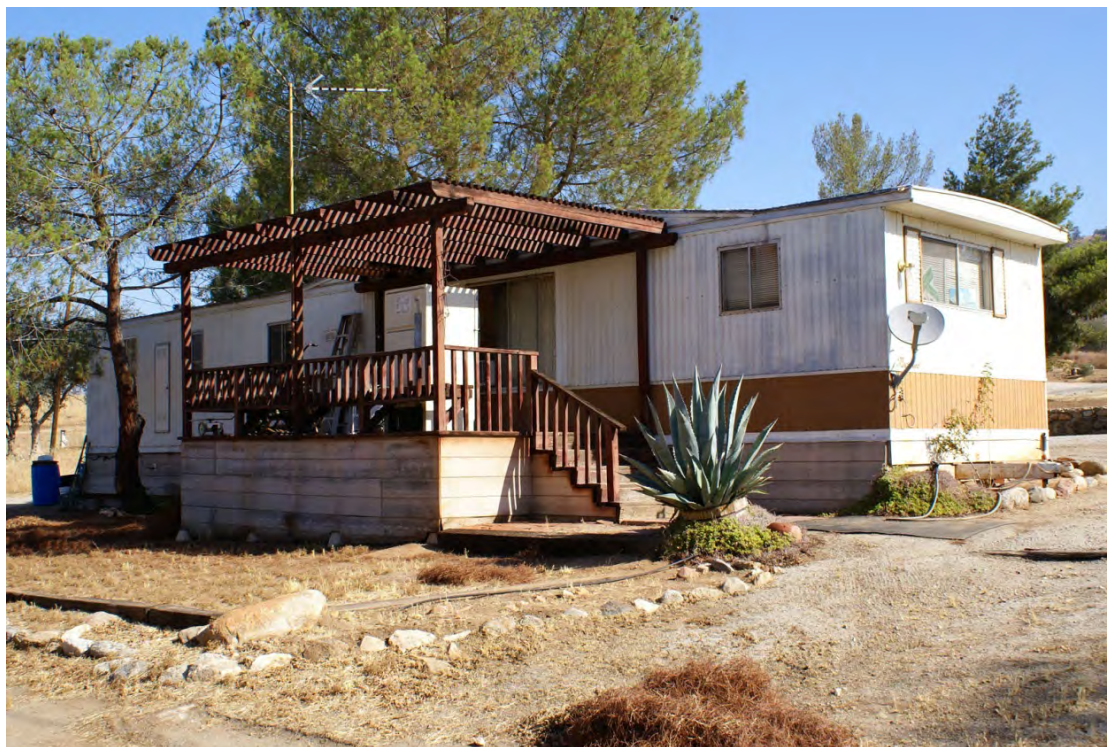
Buildings and Structures: This manufactured house (building 21), looking northeast, is the last remaining single-wide trailer of twenty that once resided in the manufactured housing area (PWR, CL Program, 2014).

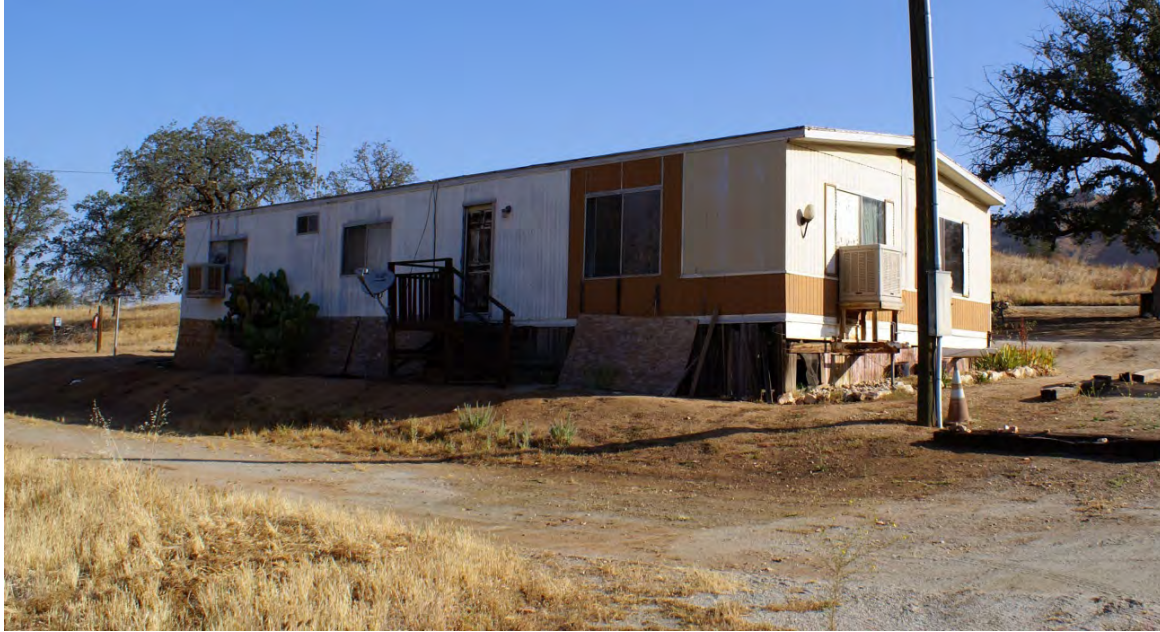
Buildings and Structures: This manufactured house (building 22), looking northeast, is one of two last remaining double-wide trailers within the monument (PWR, CL Program, 2014).

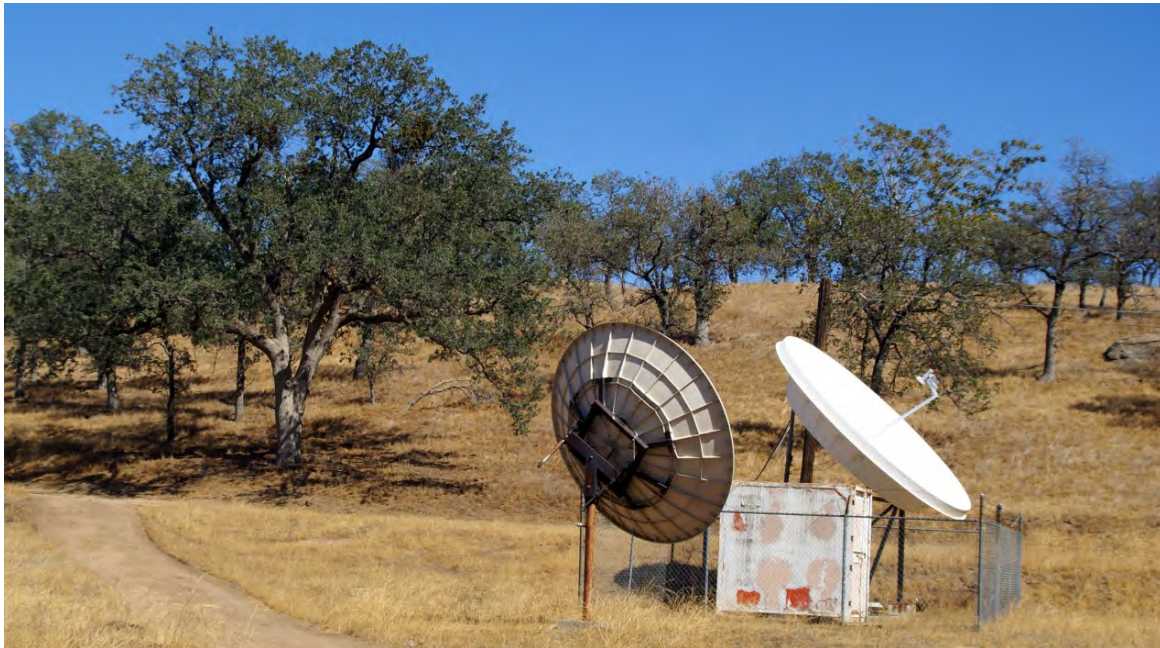
Buildings and Structures: The satellite dishes are located west of the manufactured housing area (PWR, CL Program, 2012).

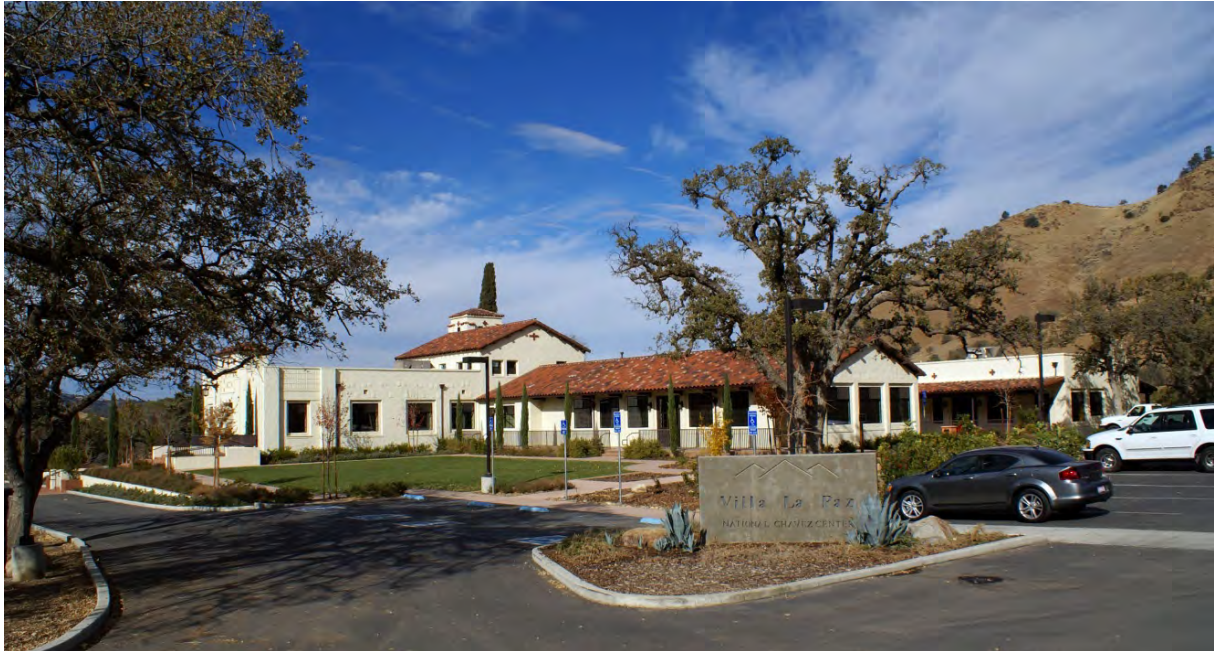
Buildings and Structures: The north unit, La Paz, is situated at the base of Three Peaks with its formal entry on the south end of the building (PWR, CL Program, 2012).

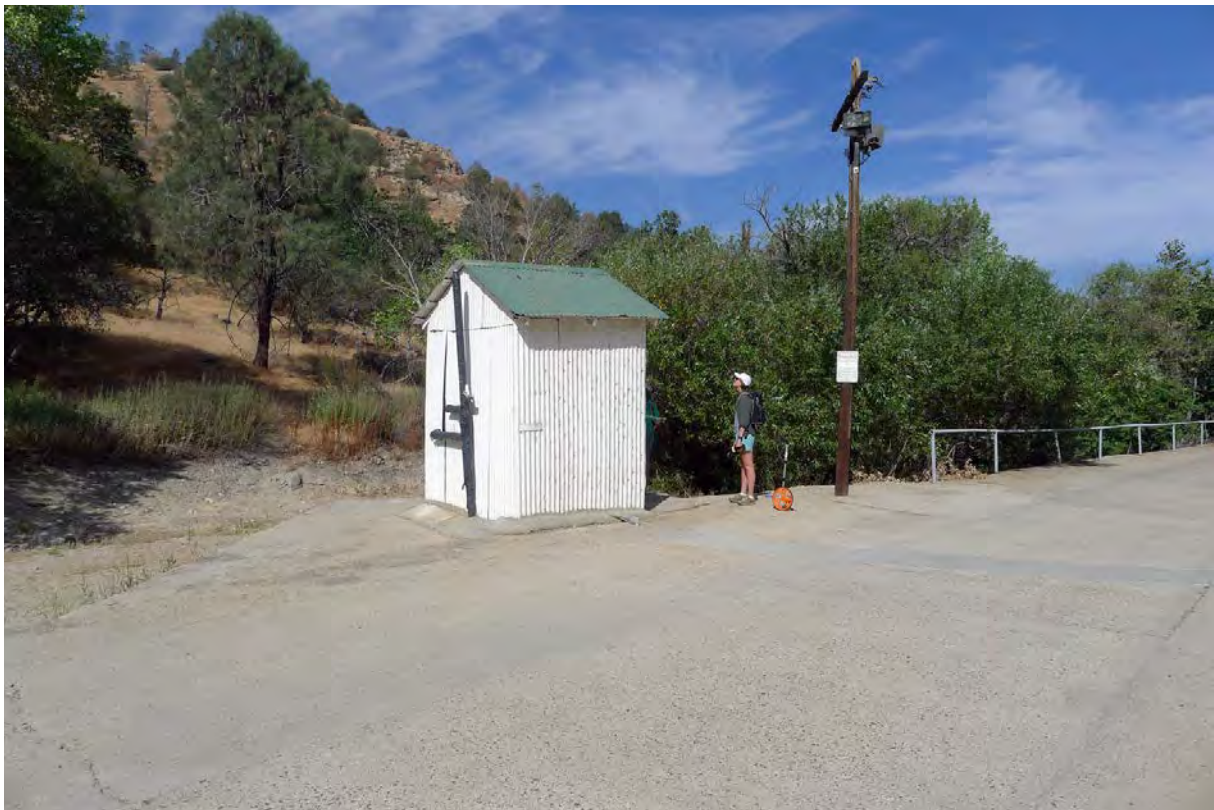
Buildings and Structures: The back side of the South Pump House (building 31), looking northwest, showing the location in relation to Tehachapi Creek (PWR, CL Program, 2014).

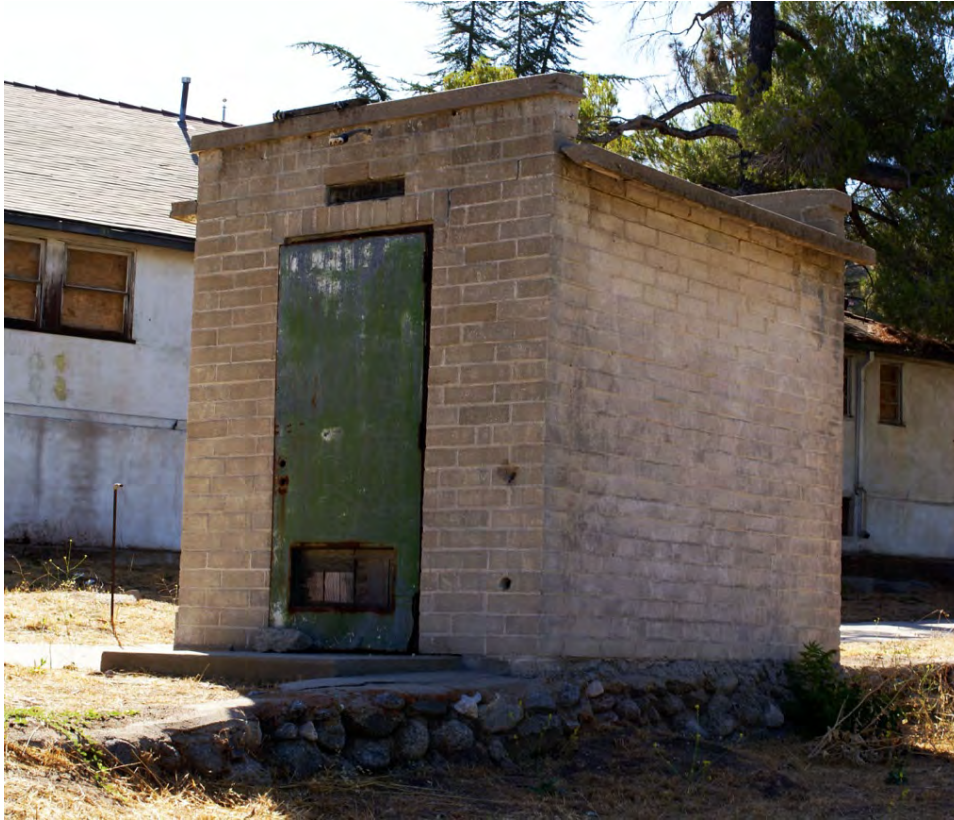
Buildings and Structures: The Boiler Room, located on the southwest side of the Dormitory (building 4), stands on a leveled surface formed by the existing stone retaining wall (PWR, CL Program, 2014).

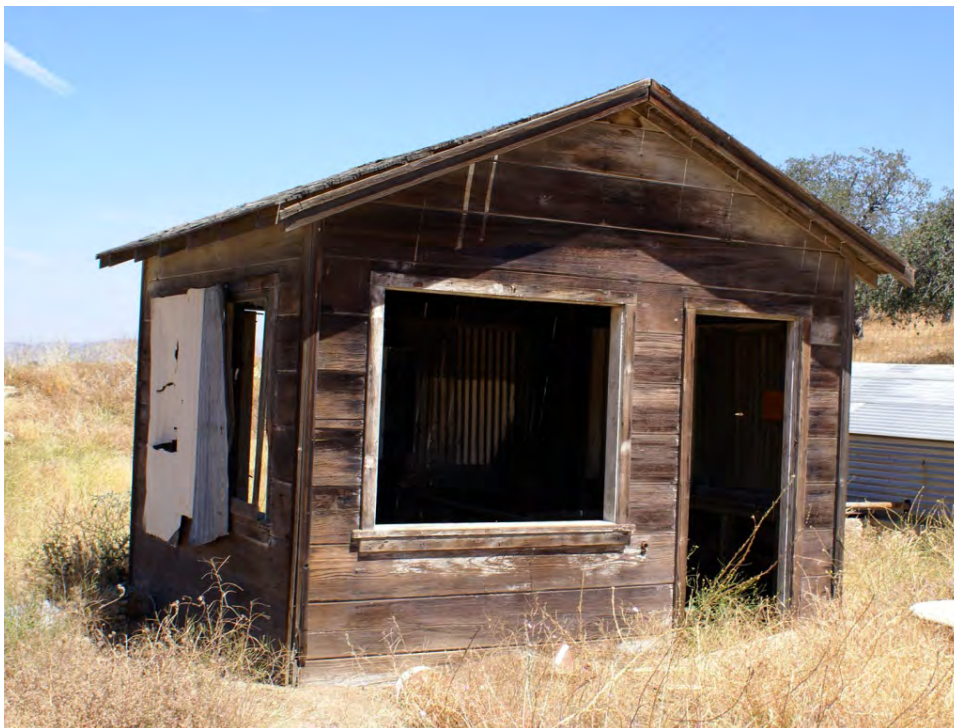
Buildings and Structures: The first settling ponds Pump House 1 (building 33), looking north, at the southern entrance of the pond area (PWR, CL Program, 2014).

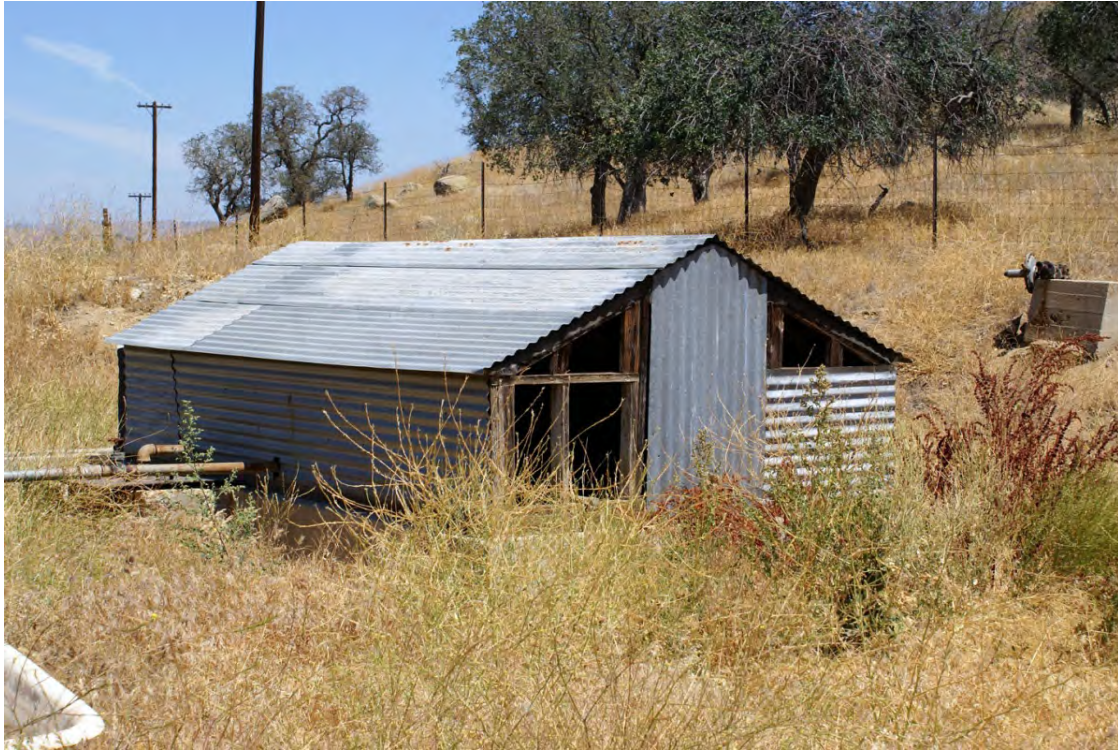
Buildings and Structures: The second settling ponds Pump House 2 (building 34), looking north, at the southern entrance of the pond area, north of Pump House 1 (PWR, CL Program, 2014).

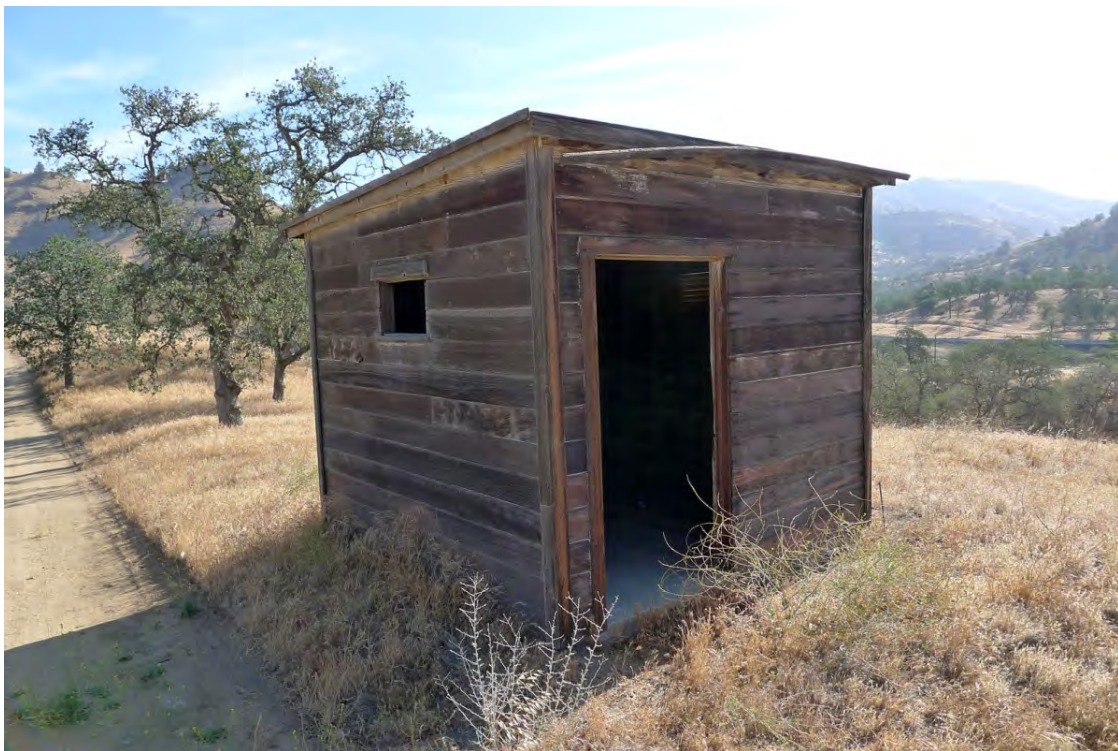
Buildings and Structures: The Hilltop Shack (building 35) located at the top of the hill, and adjacent to the water tower (PWR, CL Program, 2014).

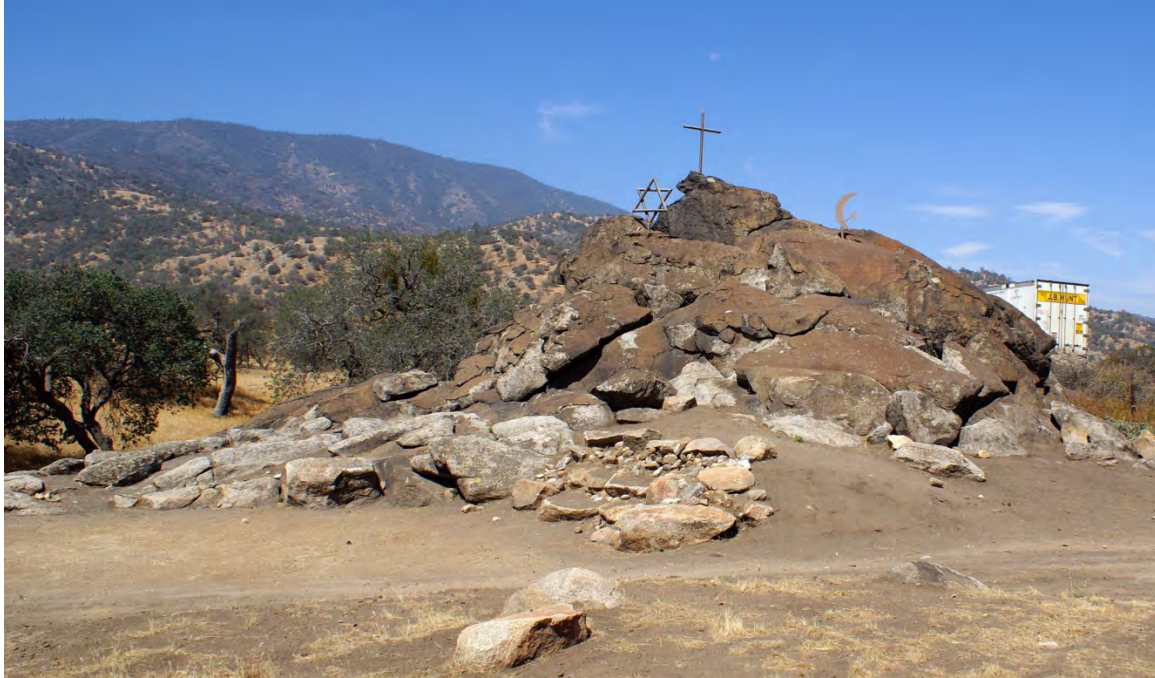
Small-Scale Features: The Peace Rocks (feature 37), looking northwest, are located to the west of La Paz and directly adjacent to the railroad tracks. The three religious signs can be seen at the top (PWR, CL Program, 2014).

Type of Impact:	Inappropriate Maintenance
Impact Description:	Removal of historic artifacts around the Peace Rocks (feature 37) and grading of unpaved roads is causing damage to historic features and diminishes the integrity of the features.
Type of Impact:	Neglect
Impact Description:	Contributing buildings need to be mothballed to prevent pest and weather damage. Foundation plantings around the dormitory (building 4) and the cafeteria (building 7) are in poor health. Trees along roads need to be assessed by an arborist and replaced as needed. Retaining walls need to be repaired to maintain their integrity.
Type of Impact:	Pruning Practices/Deferred Maintenance
Impact Description:	Pruning of the vegetation along the west side of the visitor center (building 2) should be done in a uniform way to maintain the integrity of the plantings along the sidewalk. The cypress along the east of the dormitory (building 4) need to be pruned back and/or removed to prevent further damage to the building.

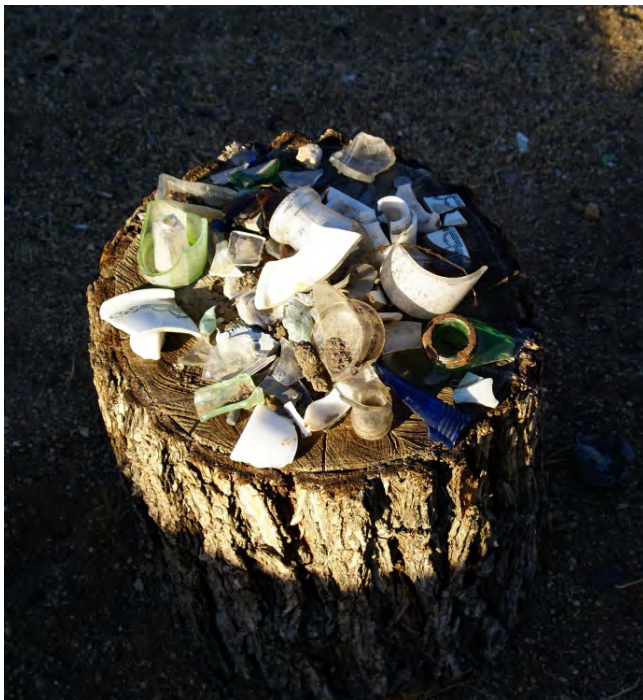
Small-Scale Feature: The broken glass and mementos from the sanitorium period there were scattered in front of the Peace Rocks (feature 37) were recently removed (PWR, CL Program, 2012).

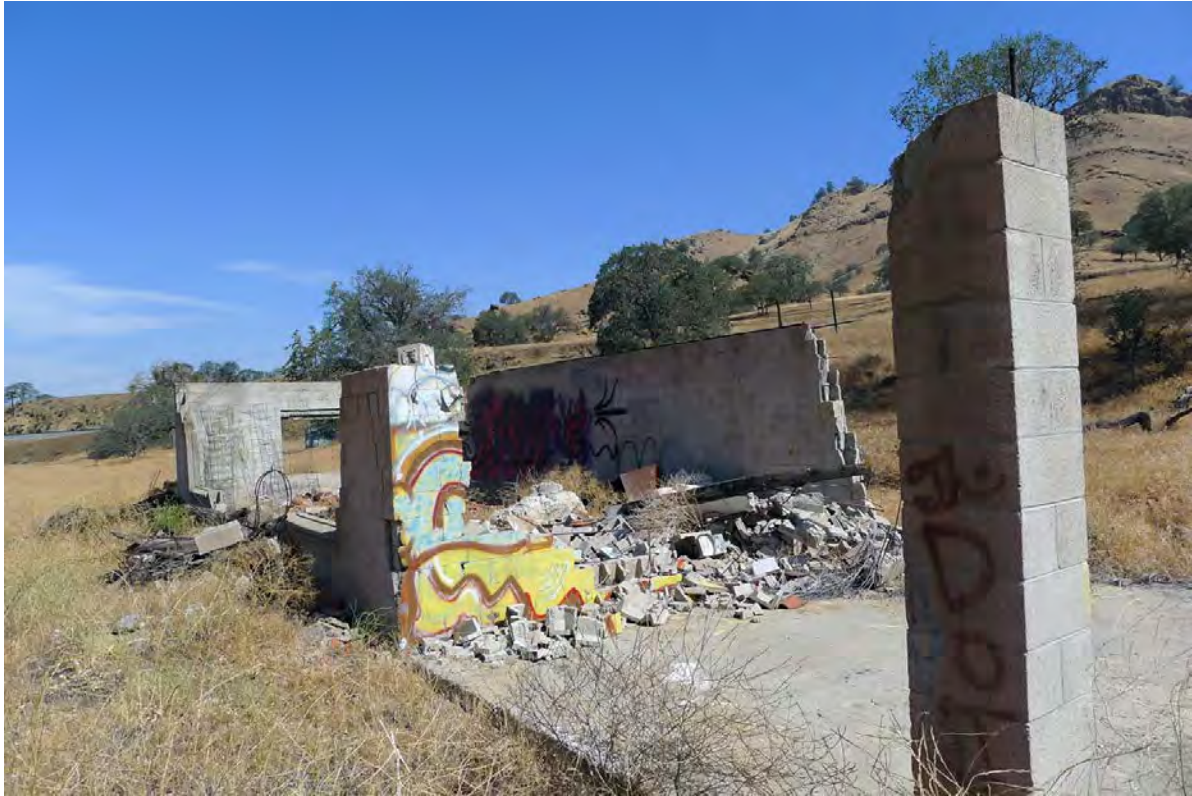
Small-Scale Features: Ruins, looking northwest, show the remaining pieces of the structures Within the community garden area (PWR, CL Program, 2014).

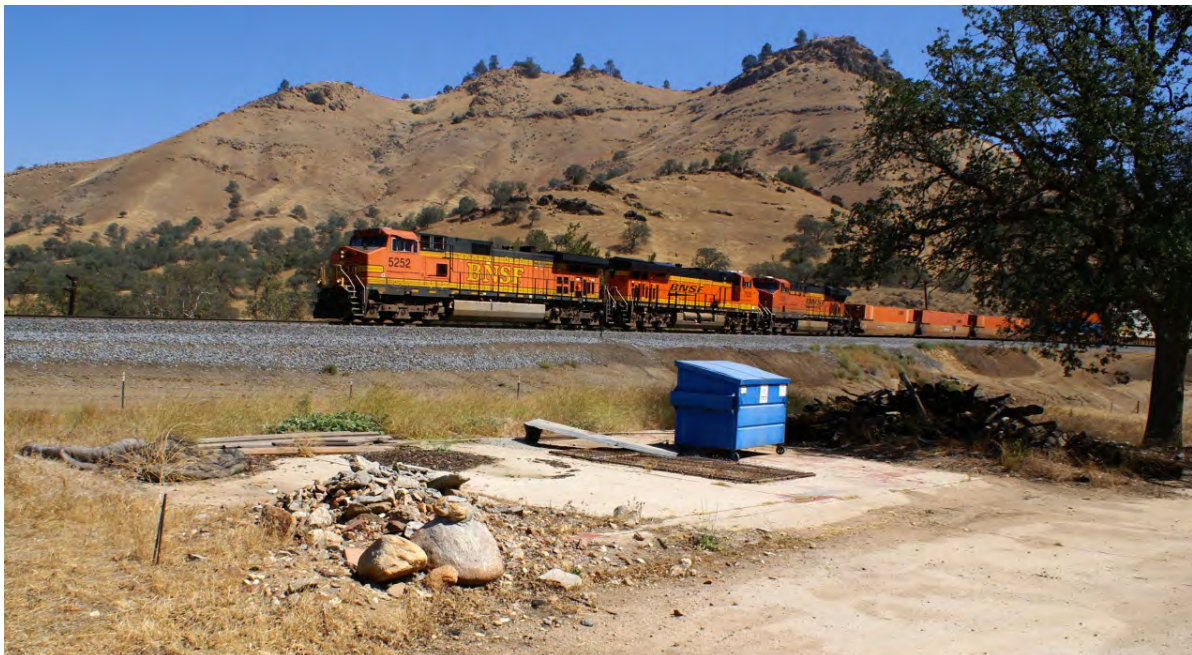
Small-Scale Features: A concrete pad is located to the north of Villa La Paz, where a vehicular garage once stood. It was constructed in the 1930's (PWR, CL Program, 2014).

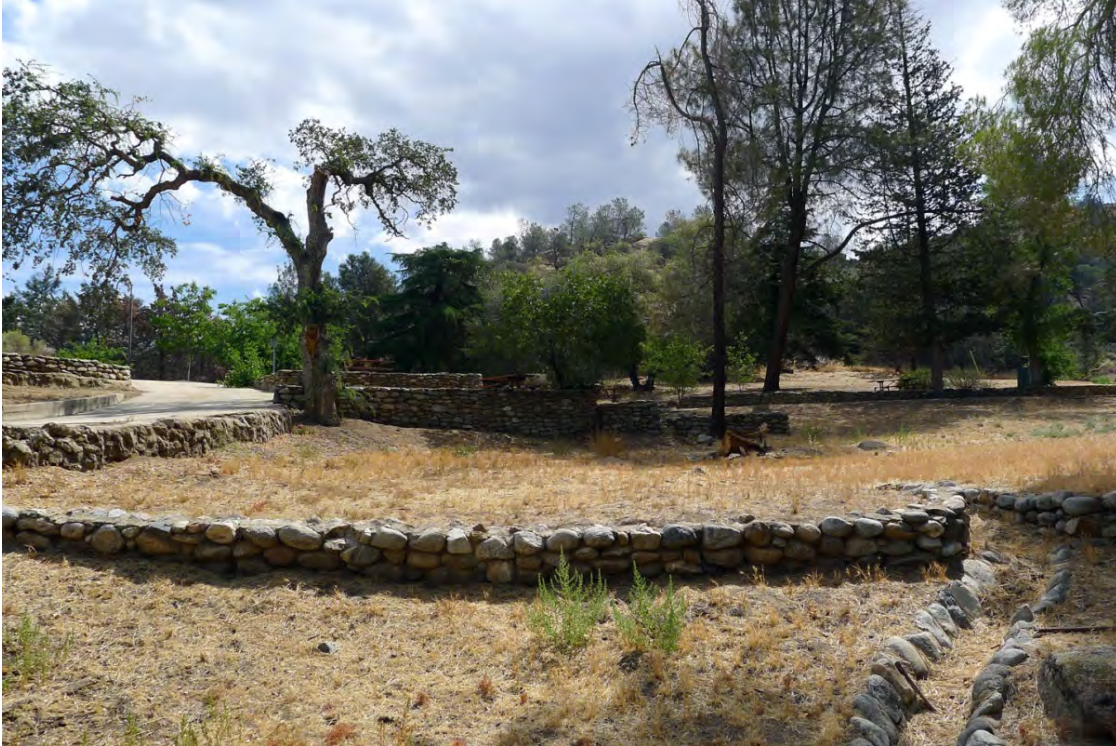
Small-Scale Features: The dry-stacked stone retaining walls define the picnic area just south of the Visitor Center (building 2) (PWR, CL Program, 2014).

Retaining walls: Repair damage to historic retaining walls by resetting existing stones with new mortar ensuring the appropriate color mortar is used in the repair. Reset stones in walls that are not mortared. Address pest and erosion to ensure walls stay in existing alignment.

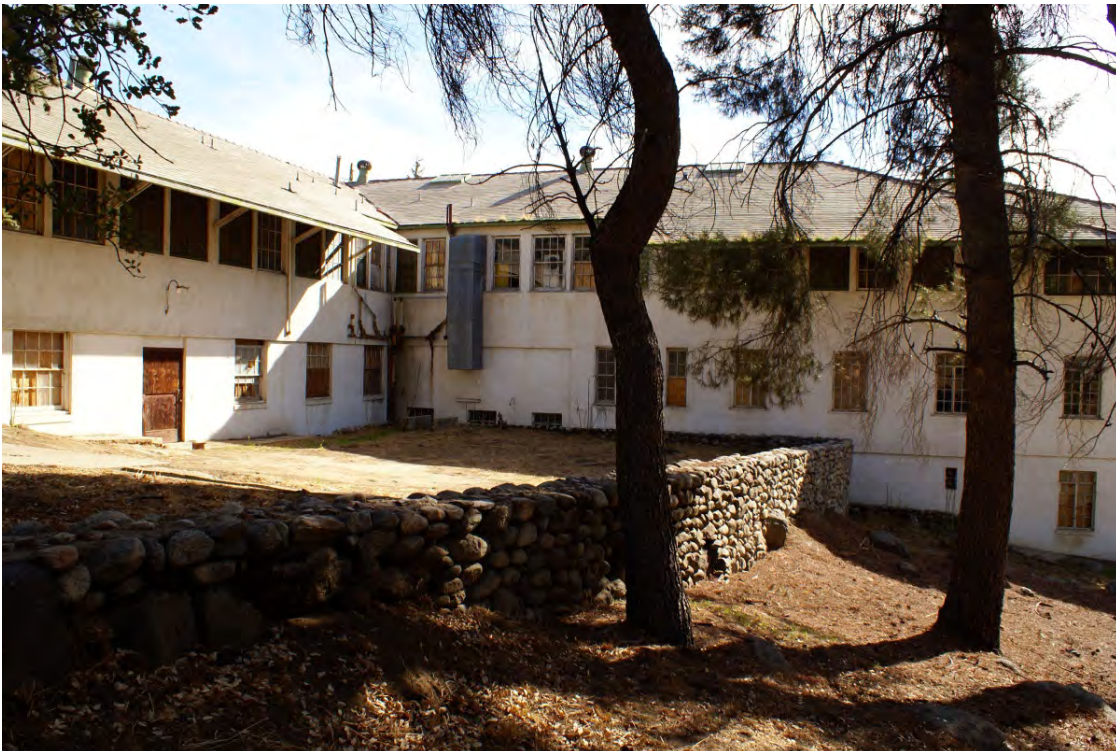
Small-Scale Feature: This stone retaining wall, looking south, is located on the north side of the Dormitory (building 4) building, and provides a leveled area at the terminus of the adjacent paved driveway (PWR, CL Program, 2012).

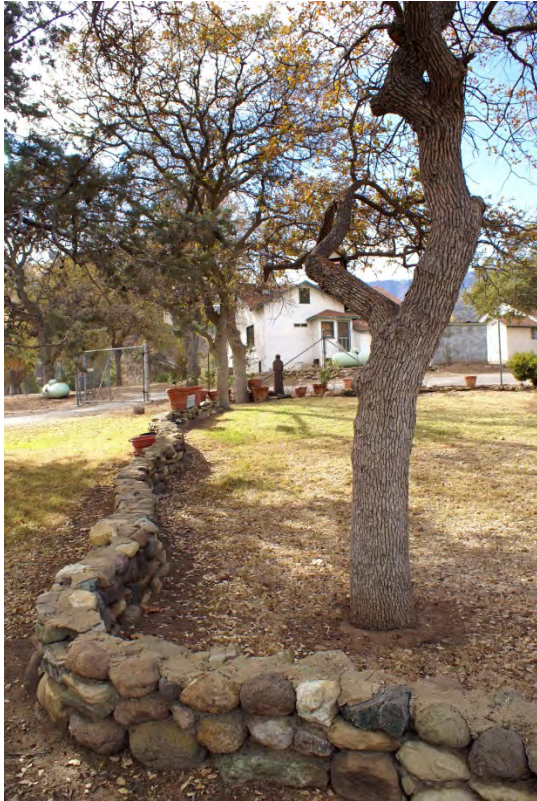
Small-Scale Feature: Looking west, the stone wall running the perimeter of the Chávez garden area is a combination of round river rock and concrete (PWR, CL Program, 2012).

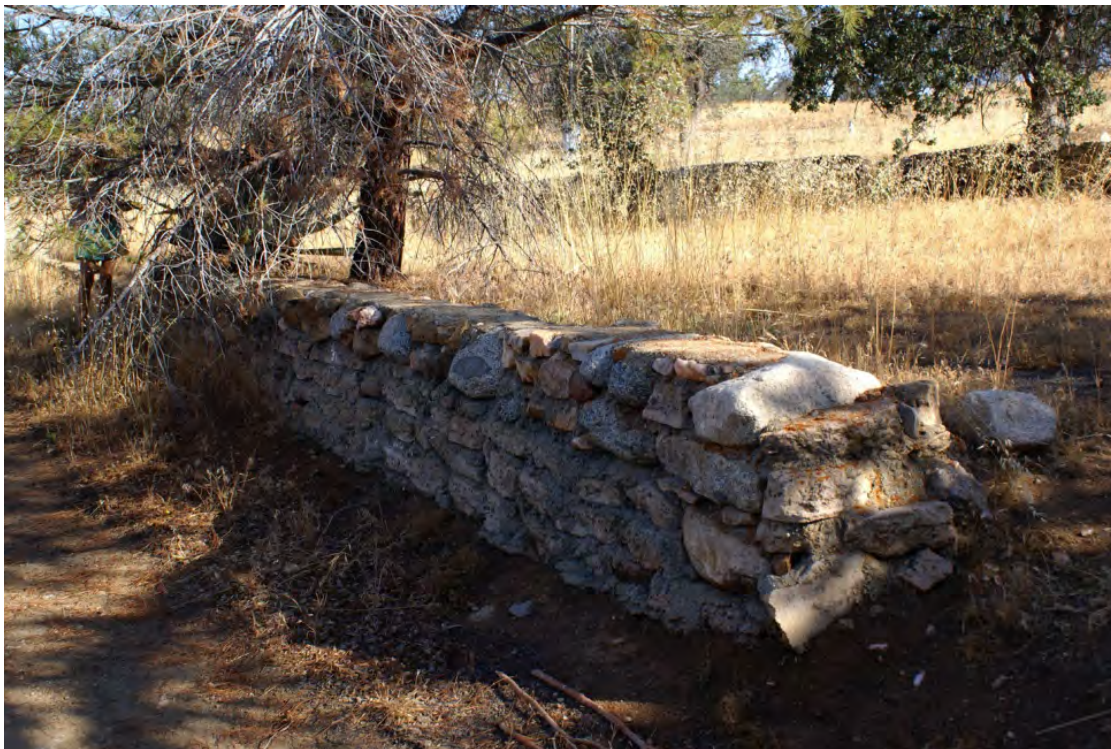
Small-Scale Features: Looking north, an example of a stone retaining wall within the manufactured housing area (PRW, CL Program, 2014).

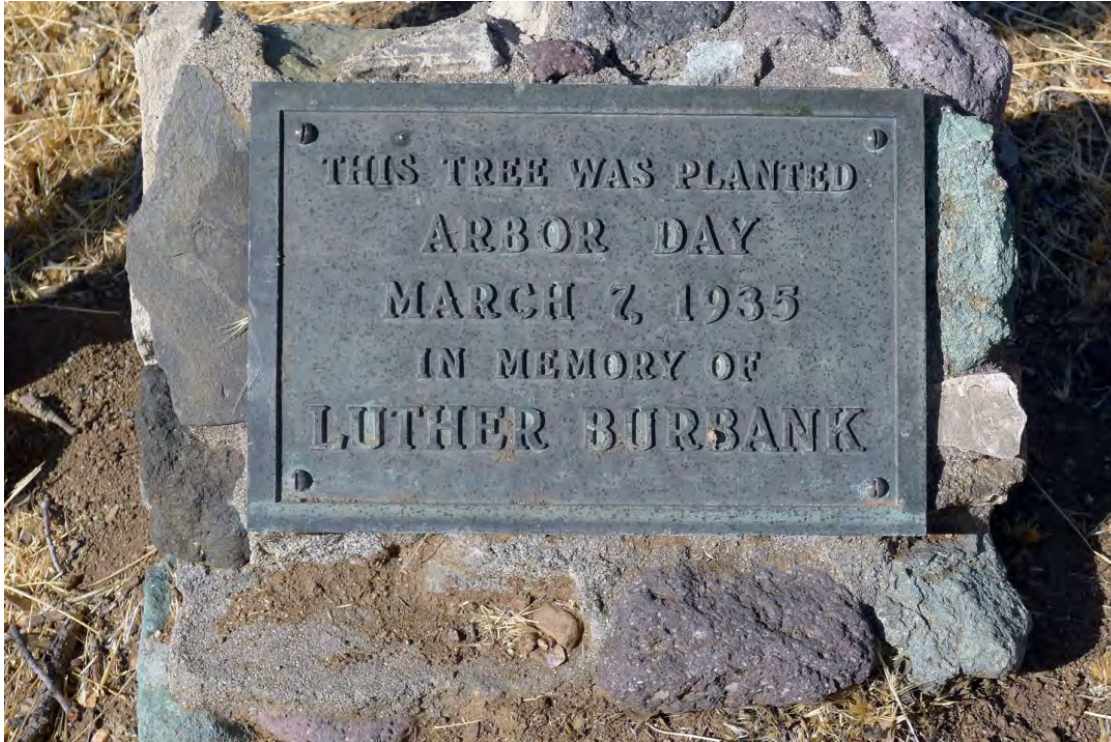
Small-Scale Features: The memorial plaque to Luther Burbank is located approximately 25 feet south of structure 21 (PWR, CL Program, 2014).

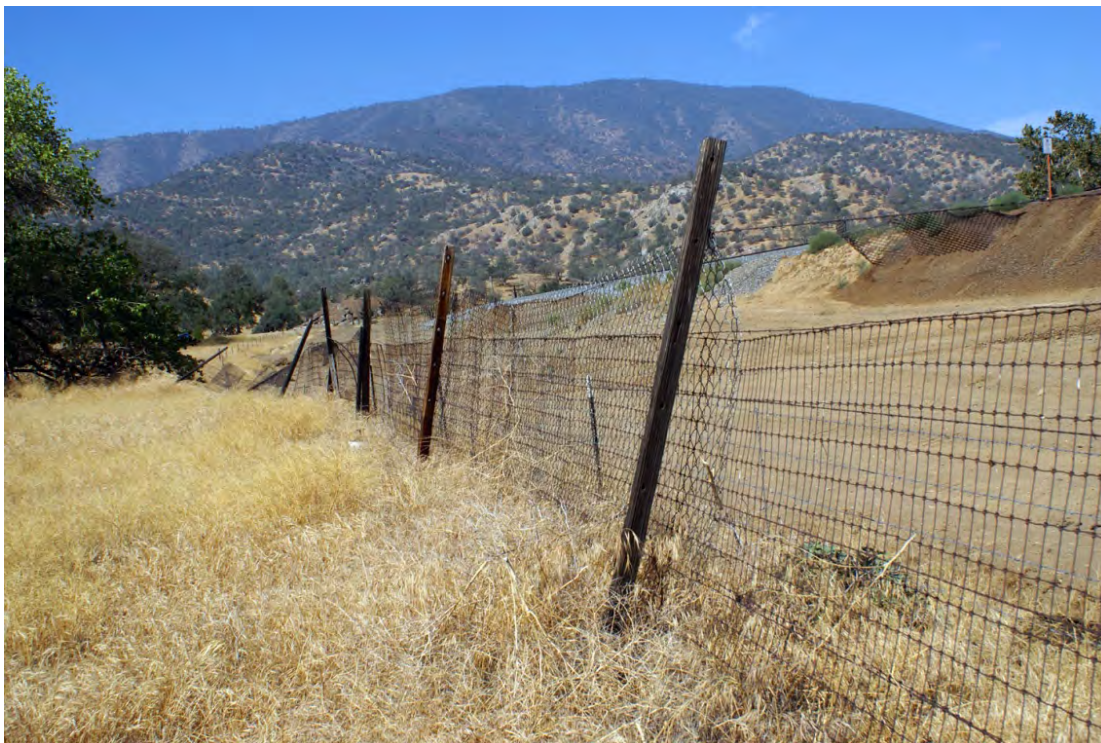
Small-Scale Features: Looking west at the fence that surrounds the community garden area (PWR, CL Program, 2014).

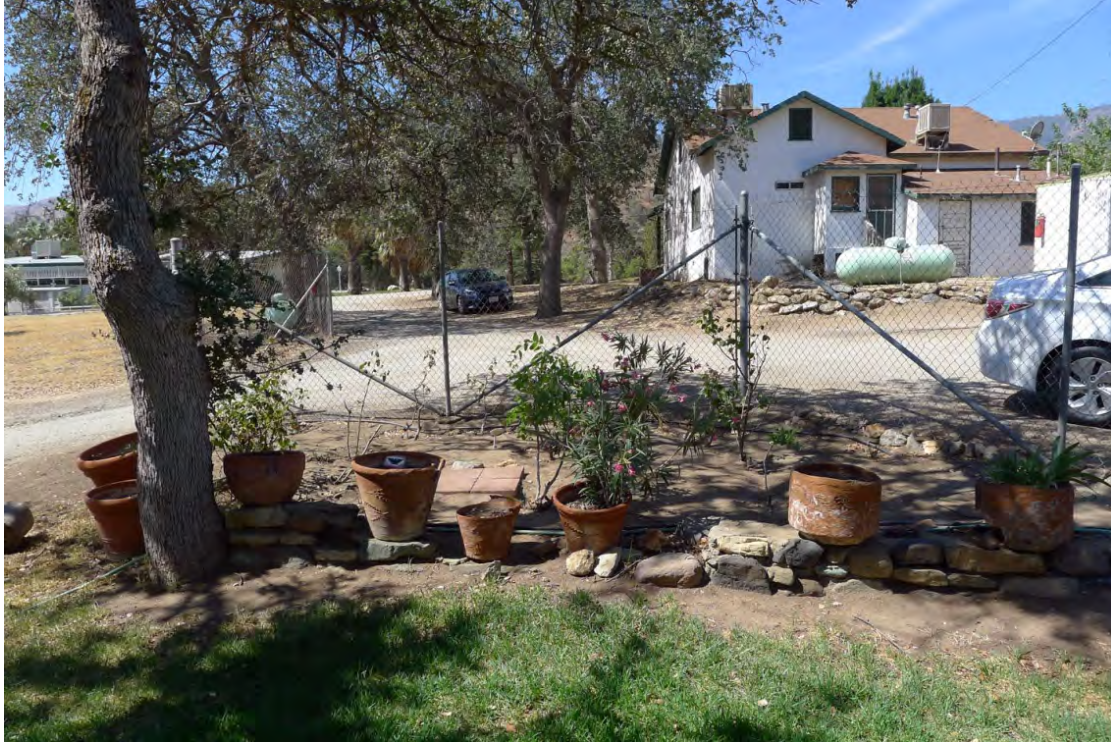
Small-Scale Features: Looking southwest, the chain-link fencing that surrounds the Chávez residential property can be seen just beyond the potted plants (PWR, CL Program, 2014).

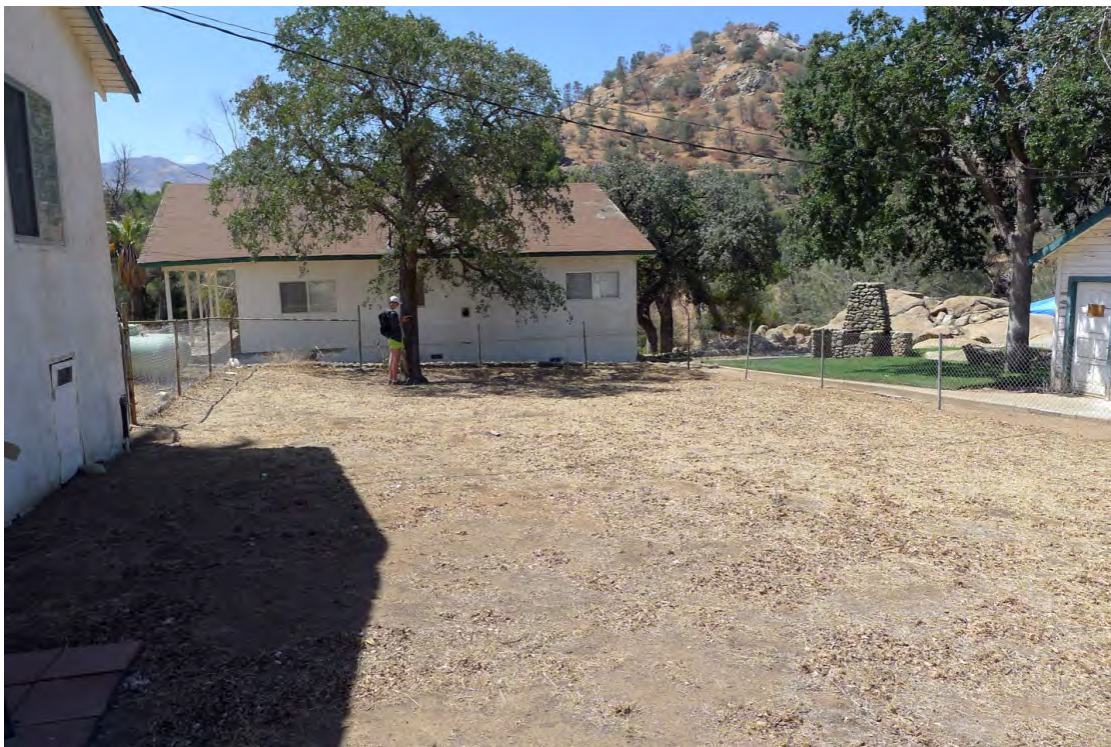
Small-Scale Features: Looking south, the chain-link fence that forms the backyard for residence number 9 can be seen in the background. The fence includes a metal gate on the east side (PWR, CL Program, 2014).

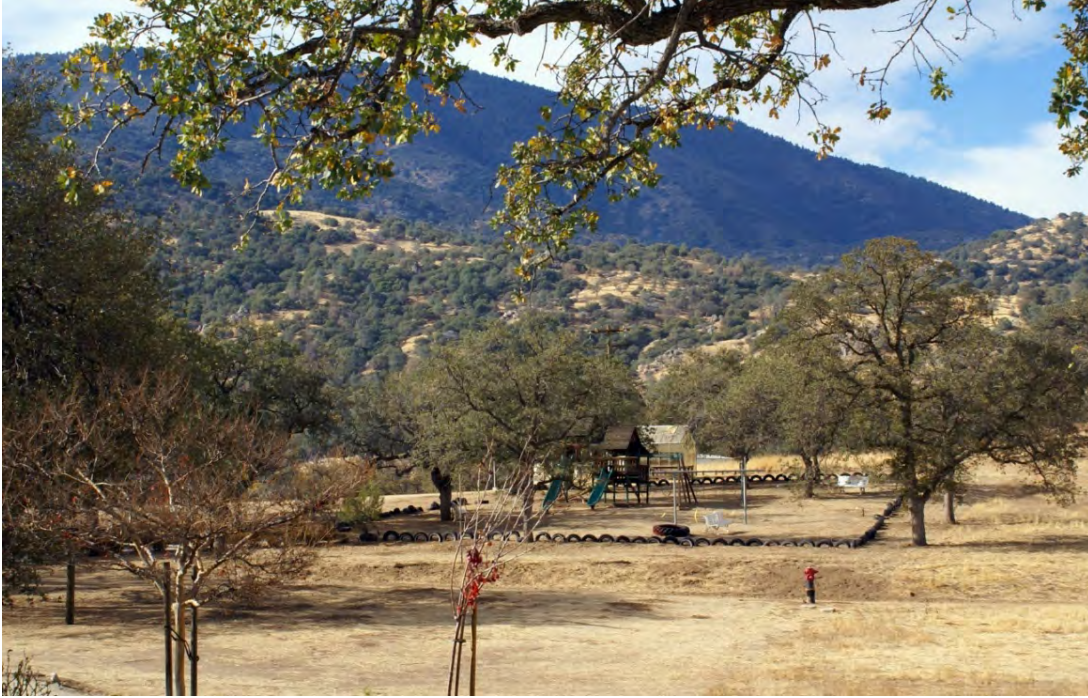
Small-Scale Features: The playground, looking west, is located within the residential area and was constructed in 2003 (PWR, CL Program, 2012).

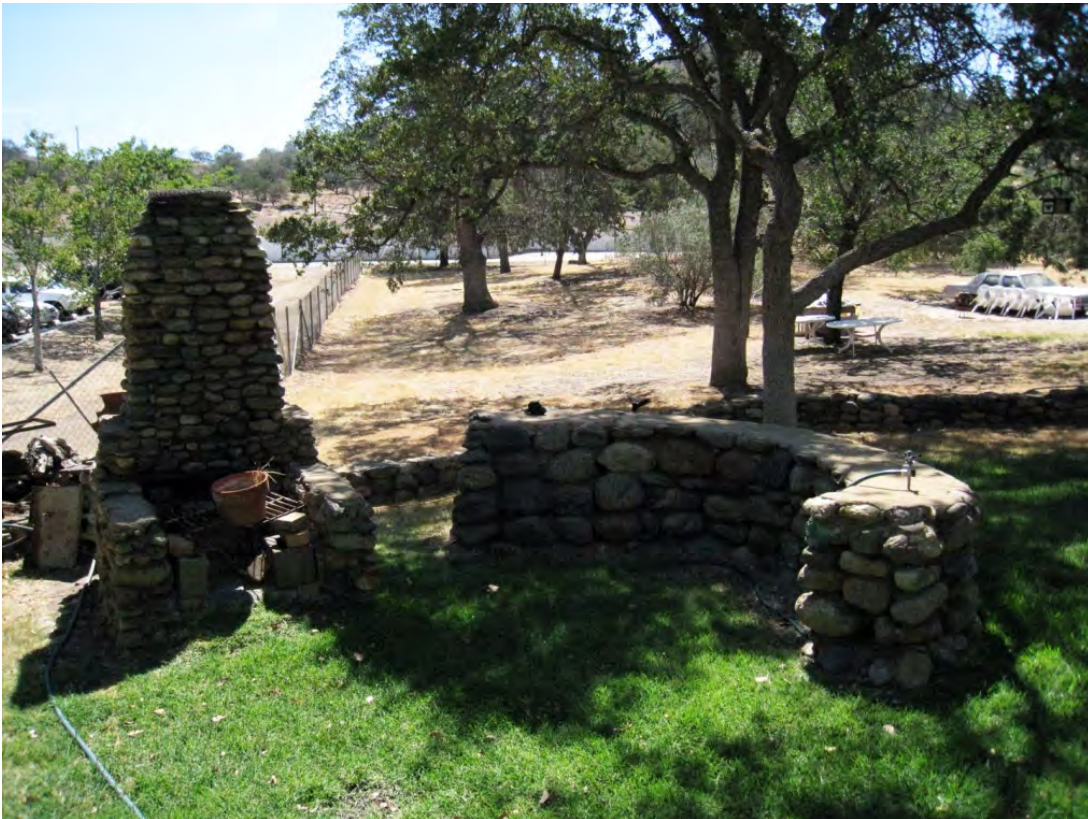
Small-Scale Features: Looking east, the stone fireplace and stone wall within the Chávez garden created a social gather area during the UFW (PWR, CL Program, 2014).
