National Park Service
Cultural Landscapes Inventory
2014

Nuestra Señora Reina De La Paz
César E. Chávez National Monument

MANAGEMENT CATEGORY: **A: Must be preserved and maintained**

CONDITION ASSESSMENT: **Fair**

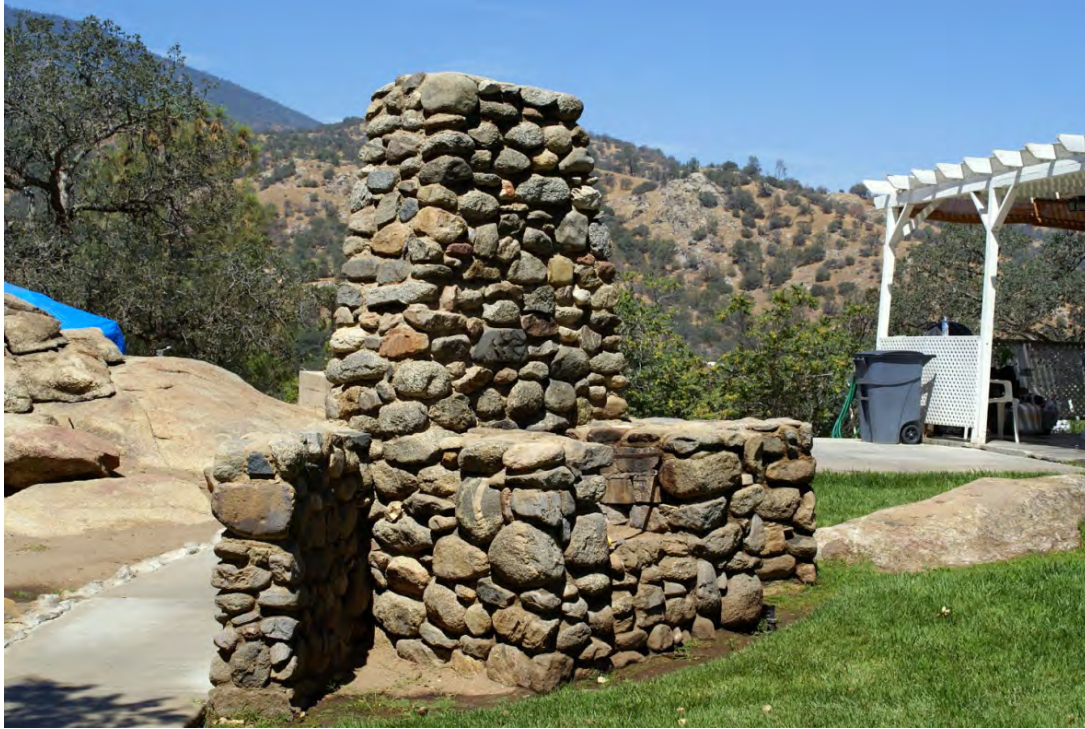
Small-Scale Features: Looking northwest residence 8 includes an outdoor stone fireplace within the backyard (PRW, CL Program, 2014).

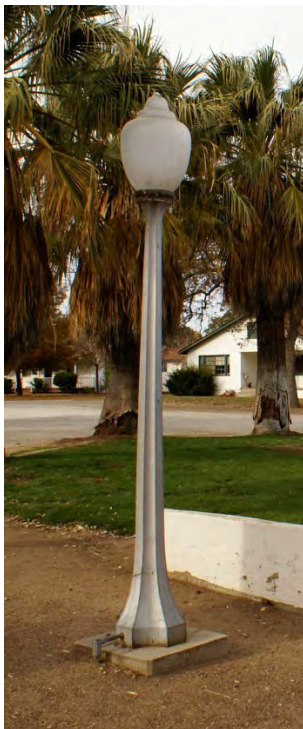
Small-scale Features: One of the light posts added during the period of significance, near Cafeteria (building 7) (PWR, CL Program, 2012).

Four light posts are located within the entrance. They are cast-iron post topped with glass lampshade. Some are missing their lampshade and may not be operable. These lamps were used during the period of significance.

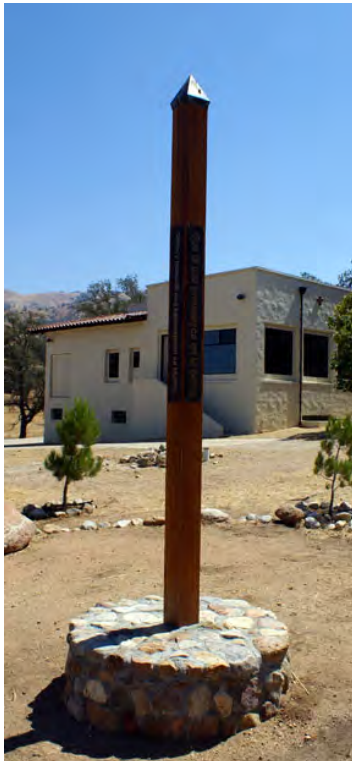
Small-Scale Features: The obelisk at the center of the Peace Garden (feature 36) (PWR, CL Program, 2014).

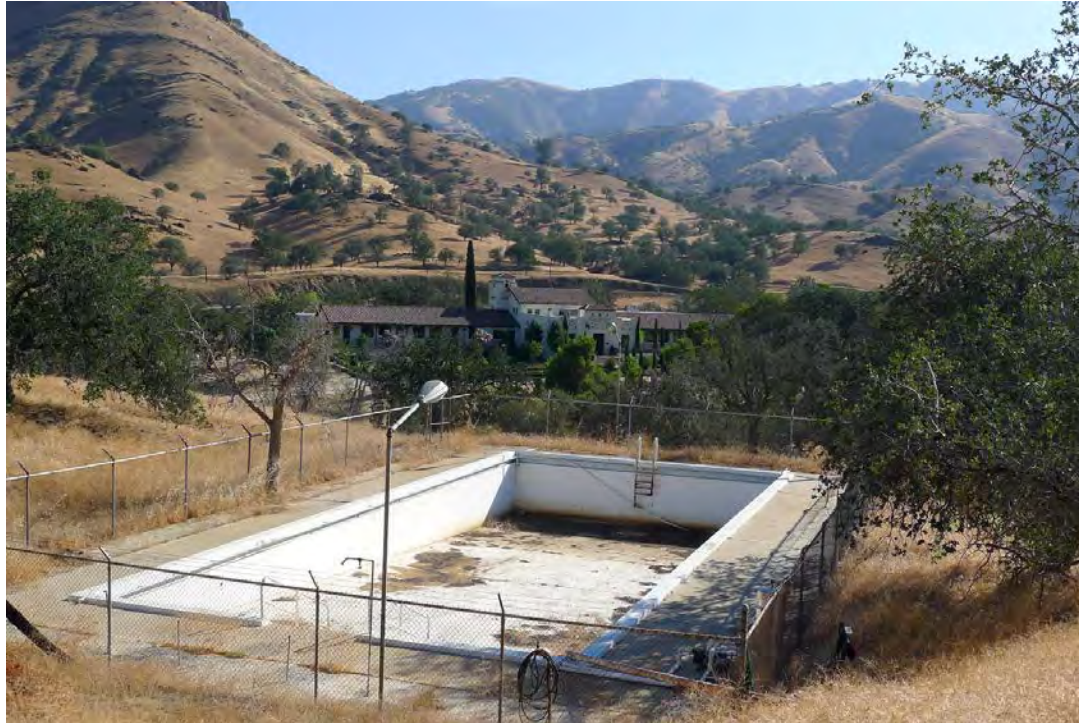
Constructed Water Feature: The swimming pool, looking northwest, was constructed during the 1950s (PWR, CL Program, 2014).

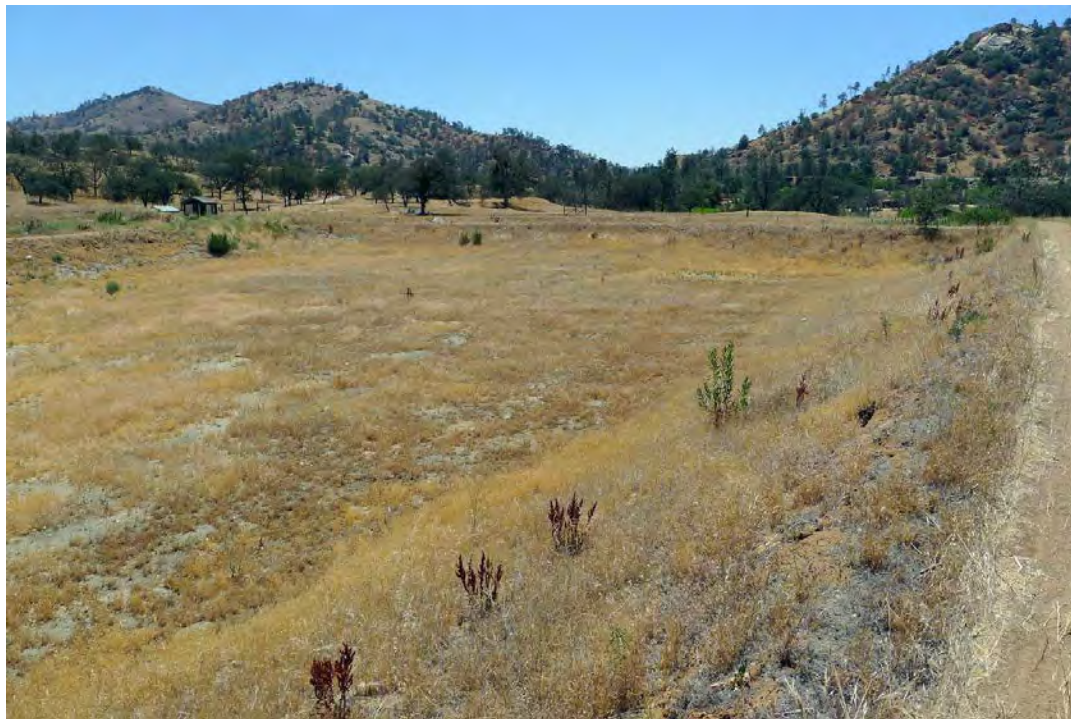
Constructed Water Features: The settling ponds, looking south, are located in the western half of the monument and were functional during the Sanatorium period and continue to be used today (PWR, CL Program, 2014).

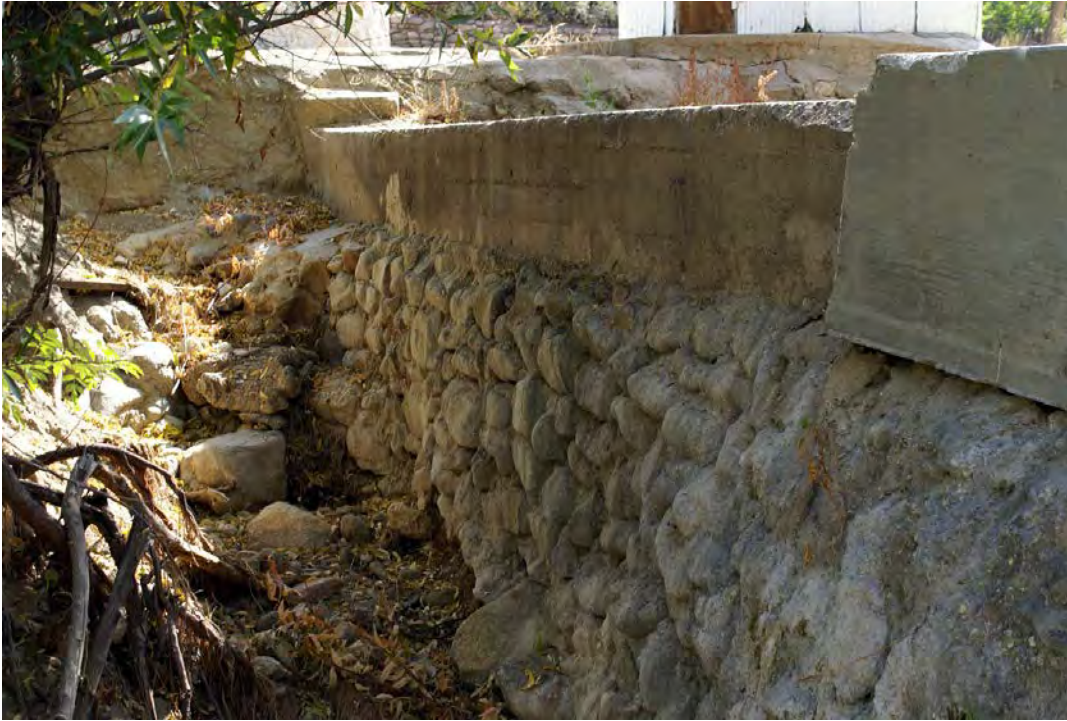
Constructed Water Features: The Tehachapi creek dam, looking east, is located directly adjacent to the South Pump House (building 31) is constructed of concrete and lined with stone on the northern side (PWR, CL Program, 2014).

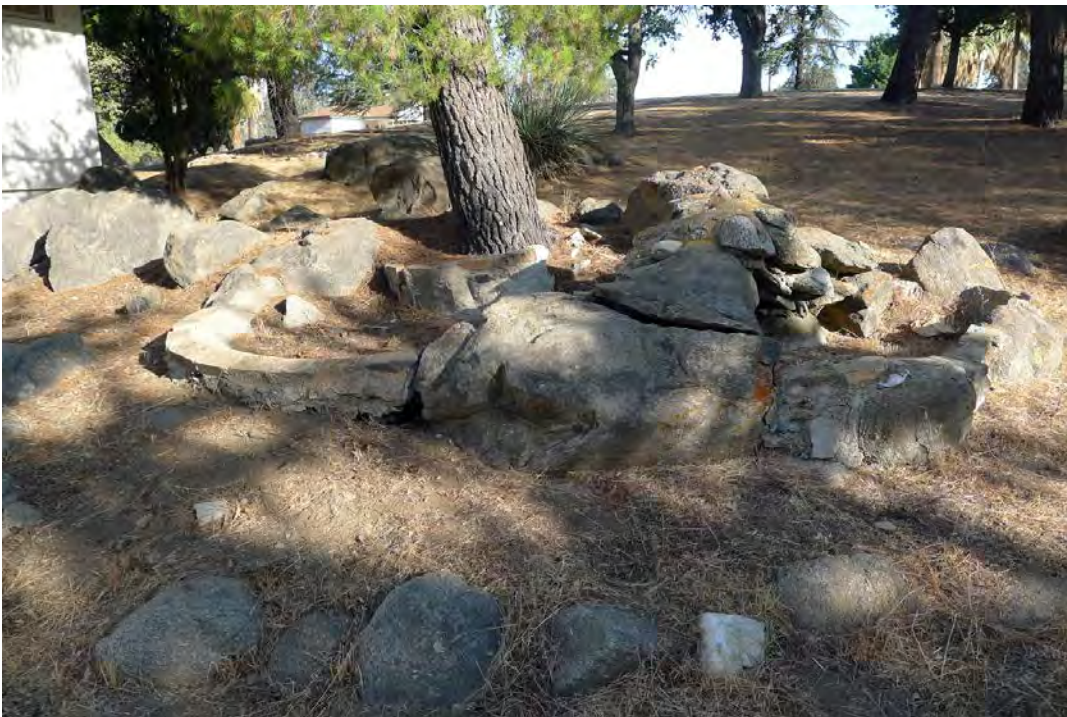
Constructed Water Features: Looking north, what remains of the fish ponds includes three tiers of stone and concrete walls and metal water pipes (PWR, CL Program, 2014).
