THE ROLE OF BIOFILMS AND LICHENS IN THE PRESERVATION OF ARCHAEOLOGICAL FEATURES IN THE BANDELIER TUFF, BANDELIER NATIONAL MONUMENT

THE SCHOOL OF ENGINEERING, UNIVERSITY OF VERMONT

Bandelier National Monument

Task Agreement #P13AC01151 Cooperative Agreement #H8W07110001 Term of agreement- 08/05/2013 - 06/30/2014 The Role of Biofilms and Lichens in the Preservation of Archaeological Features in the Bandelier Tuff, Bandelier National Monument

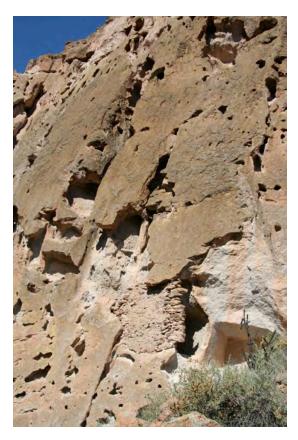
Figure 3. Cavate B002 with its surviving masonry wall (bottom center). Note the broad range of case hardened surfaces of the surrounding tuff, and the "swiss-cheese" texture that develops where the durable case hardened surface is breached, exposing the soft underlying tuffs to erosion. The extensively altered surfaces (upper half) are Types 6 and 7 (see Table 1); on the far right a more recently exposed surface, slightly recessed and having a smoother texture, has developed another rind. Areas of recent erosion appear as white or grey patches (Type 1); erosion at the lower right edge of the cavate threatens to undermine the prehistoric wall. Some of the freshly exposed tuff has begun to acquire silt-clay coatings (Type 2) that constitute one of the initial stages of case hardening. At bottom left, moderately well indurated surfaces have silt-clay layers colonized by lichens and other microflora (which appear yellow, green and black in the photo). Note the partially detached boulder above the wall, the column of cantilevered stones at the east end of the surviving wall, and the erosion of the tuff just below this column.

One challenge of conserving the cavates is how to preserve their physical integrity despite constant landscape-level change and erosion of the cliffs (Fig. 3). Deterioration processes affecting cavate condition include mass wasting of the cliff face through losses of fracture-bound boulders, mechanical damage of outcrop surfaces, the interaction of the tuff with wind and water, and the presence (or not) of a weather rind or case hardened surface on the tuff outcrops. Case hardening appears to protect the glassy ash of the Qbt1g unit (the cooling unit in which most of the cavates are carved) from erosion and loss, at least partially as the result of secondary minerals deposited in near-surface pore spaces. Weather rind formation begins with the deposition of dissolved solutes and suspended particulates on rock surfaces by surface water flowing over canyon walls, followed by the colonization of the rock surface by surface-stabilizing biota that include cyanobacteria and lichens. The growth of lichens and other biotic crust constituents on exposed surfaces is especially important for promoting development of case hardening by catalyzing bio-geochemical reactions that lead to dissolution of the volcanic glass and precipitation of secondary minerals in the near-surface zone.

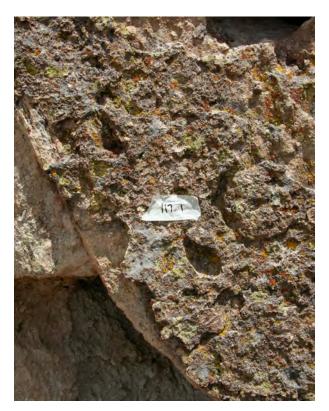
Figure 5. Edge of an erosional remnant of a Type 7 case hardened surface showing a more recently exposed adjacent surface (left) that is less altered.

Canyon walls with Type 6 and 7 surfaces (Table 1 and Fig. 5) are strongly indurated and form the most erosion-resistant cliff faces in unit Qbt 1g. These surfaces are extremely rough and support extensive biocommunities. Case hardened surfaces form crusts that are generally 1 to 1.3 cm thick, but pockets of alteration extend as much as 2.5 cm from the canyon wall. The case hardened zone is commonly made up of two parallel bands of alteration (Fig. 14). The outer alteration band, next to the canyon wall, is 3.5-6.7 mm thick and is mostly white in color. The inner alteration band ranges 5 to 8.5 mm thick and is medium to dark brown in color. The transition between the two zones is abrupt, occurring over a distance of 0.1 mm or less. The outer band is extensively

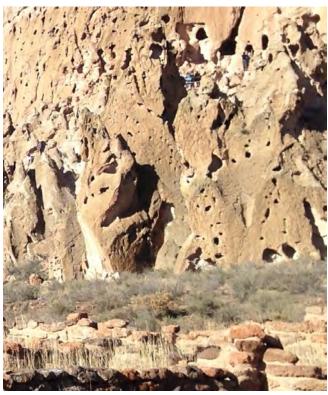
Figure 6. Case hardened surfaces in unit Qbt 1g of the Tshirege Member of the Bandelier Tuff. 'Swiss-cheese' texture is characteristic where holes develop in the durable case hardened surface, exposing the soft underlying tuff to preferential erosion by wind and water.

Many Qbt 1 canyon wall exposures are covered by pale-orange case hardened surfaces that are 0.25 to 1.3 cm thick. These surfaces are resistant to erosion and form a protective layer over the underlying softer tuffs (Fig. 5). Some of the anthropogenic features, like petroglyphs and hand-and-toe-hold trails carved into the outcrops 500-1000 years ago, have case hardened surfaces. The case hardened surfaces commonly have a distinctive "swiss cheese" appearance where round to elliptical cavernous hollows penetrate the hard surface layer, exposing underlying softer tuffs to selective erosion by wind and water (Fig. 6; cf. Fig. 3). The degree of case hardening

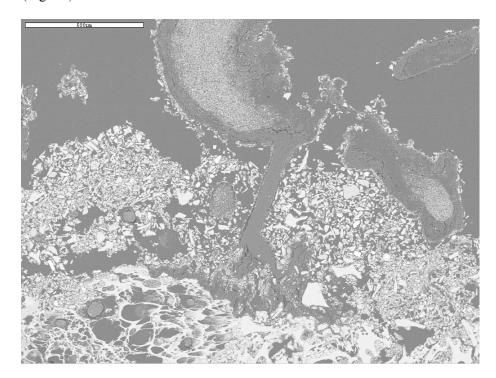
Figure 8. SEM backscatter image showing a lichen thallus on sedimented volcanic ash adhering to the canyon wall. The lichen is the dark mass at the top. The sedimented layer (middle zone) is over $500~\mu m$ thick and includes shards, ash, and crystal fragments embedded in a clay matrix. Lichen rhizines / hyphae (microfilaments) pervade the sedimented layer and help stabilize it. The canyon wall bedrock is the area with the large pumice at the bottom.

Lichens are found on most tuff surfaces³ and their abundance and diversity appear to increase along with the degree of case hardening. SEM images show that lichens grow on top of the sedimented layers (Fig. 8) as well as on bare bedrock surfaces (Fig. 9). In the Qbt 1g subunit, lichens and other biotic crust constituents help stabilize canyon walls by acting as a protective buffer between the tuffs and wind and surface water erosion and they trap wind-blown and water-transported silt particles within their overlapping lobes. Secretions of sticky polysaccharides enhance cementation of the friable materials found at the substrate surface⁴. Lichen rhizines form a dense network of filaments that invade, reinforce, and stabilize the sedimented layers and the open intergranular pores and pumice vesicles of the bedrock tuff (Figure 10); in the samples examined for this study, microfungal filaments were found to extend up to 1 mm into the tuff bedrock. Oxalic acid excreted by biotic constituents plays a role in the dissolution of volcanic glass. The role of lichens as a source of oxalic acid is demonstrated by dense accumulations of 1 to 3 µm oxalate crystals in lichen thalli. These crystals are identified

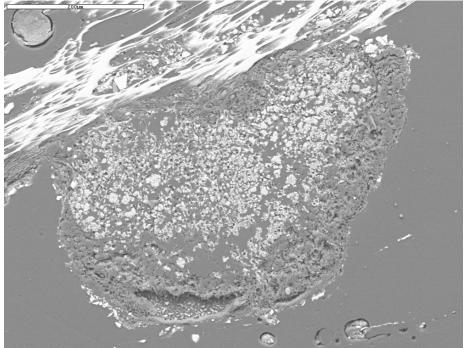
Figure 9. SEM backscatter image showing a lichen thallus growing directly on tuff on the canyon wall. The lichen is the dark mass with the cellular structure. Light gray crystals of weddellite (calcium oxalate) fill the thallus. Microfilaments invade the long-tube pumice vesicles of the bedrock tuff at the top of the photo.

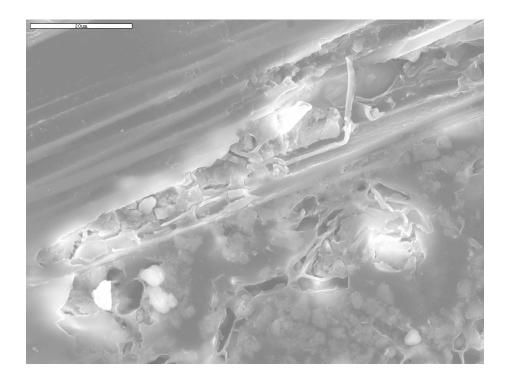
Figure 10. SEM secondary electron image showing dissolution of pumice vesicle walls in contact with lichen hyphae. The tubular pumice (extending from lower left to upper right) has scalloped edges. Lichen (lower right) is in contact with the pumice and hyphal filaments invade the large open vesicle (upper right).

as weddellite ($CaC_2O_4 \cdot 2H_2O$) based on their tabular form and SEM EDS analyses. Glass dissolution at the thallus-substrate interface is manifested as scalloped and embayed edges on glass shards and pumice lapilli (Fig. 10).

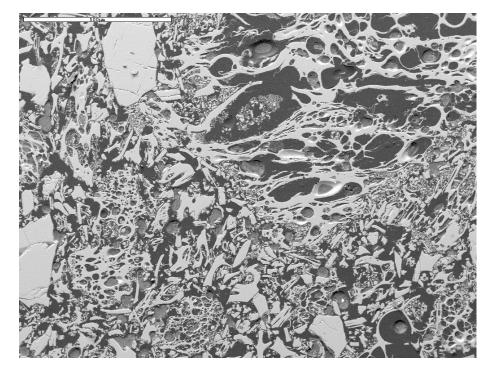
Figure 11. SEM backscatter image of canyon wall tuff bedrock with Type 1 to 2 alteration. The tuff has undergone minimal alteration and lacks cementation by secondary minerals. The tuff contains abundant vitric ash in the groundmass, and delicate shard and pumice lapilli structures are well preserved. The porosity of the tuff is 40 to 50%.

Canyon walls with Type 1 and 2 surfaces (Table 1) are the least altered and least durable. Pyroclasts in these tuffs show little or no evidence for glass dissolution and secondary minerals cementing the soft tuff matrix are rare to absent (Fig. 11). In one sample, small amounts of intergrown opal ($SiO_2 \cdot nH_2O$) and smectite group minerals (Na, $Ca)_{0.33}(Al,Mg)_2(Si_4O_{10})(OH)_2 \cdot 4H_2O$) are deposited in pores near the outer wall surface, but most

of the sample is free of alteration. Important characteristics of Type 1 and 2 surfaces are: 1) fine glassy ash in the tuff matrix is abundant and unaltered; 2) the matrix porosity is high (40-50%); 3) secondary minerals are absent to rare; and 4) exposed tuff surfaces are soft and friable because of the lack of cementation.

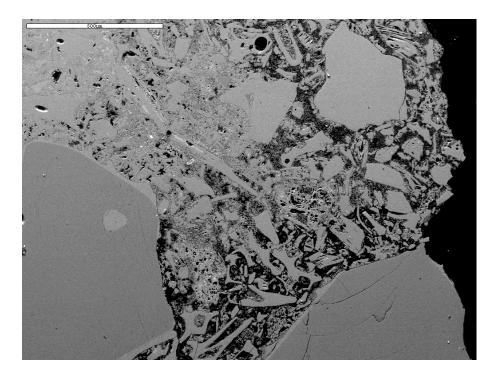
Figure 12. SEM backscatter image of case hardened tuff with alteration typical of Types 3 to 5. At the sample surface (right), the larger glass shards are moderately scalloped and unfilled pore spaces still account for 30-40% of the sample volume. Moving left, there is more dissolution and replacement of the original material and pore space is reduced to < 20%. Opal is the dominant filling material; other filling materials include sepiolite and intergrown calcite and opal. At the far left, open pore space is less than 5% at a depth of approximately 1.30mm.

Canyon walls with Type 3 through 5 surfaces (Table 1) are moderately indurated and resistant to erosion. Lichens and other biota are abundant on these surfaces and their root systems extend up to 1 mm into the tuff. Dissolution of volcanic glass and deposition of secondary minerals generally occurs in a zone 0.1 to 0.5 cm thick adjacent to the canyon wall. Beyond this zone, secondary minerals are absent and the tuffs show little evidence of alteration. Thin sections examined by optical microscope and SEM show that alteration of the tuff is not uniformly distributed throughout the case hardened zone, and there is significant heterogeneity in the distribution of secondary minerals. This results in enclaves of tuff with few or no secondary minerals interspersed with areas that are thoroughly mineralized. Alteration is largely concentrated in the fine ashy matrix of the tuff where glassy pyroclasts in contact with pore water underwent hydrolysis. Pore water in this near surface environment is recharged by infiltrated surface water, and near-saturation conditions occurred in some pore spaces for at least short periods of time. Organic acids released by the lichens are almost certainly an important catalyst for hydrolysis reactions by reducing the pH of pore water. Following dissolution, secondary minerals were deposited in open pores, cementing the tuff matrix. Secondary minerals are largely concentrated in the fine-grain groundmass of the tuff and largely replaced fine ash particles (Fig. 12). Larger pyroclasts such as shards and pumice lapilli remain abundant in the alteration zone, but many show moderate to severe dissolution along their margins. Except for oxidation halos around magnetite, crystalline components of the tuff such as phenocrysts and lithic fragments show no apparent alteration. Optical petrography and analyses by microprobe and SEM EDS identify the primary secondary minerals as opal (SiO₂ nH₂O) and sepiolite $(Mg_4(Si_6O_1)(OH)_2 \cdot GH_2O)$. Calcite $(CaCO_3)$ and smectite-group minerals are subordinate secondary minerals and barite (BaSO₄) is relatively rare. Texturally, the secondary minerals are intergrown and were apparently coprecipitated. Opal not only co-precipitated with other secondary minerals, it also formed thick, optically continuous deposits in pores as a late stage mineral. Botryoidal and rhythmically layered opal lining open vugs suggest that mineralization occurred under saturated conditions. In some samples, lichen thalli adhering to the tuff surface are silicified to opal, preserving delicate structures as pseudomorphs (Fig. 13). Similarly, lichen rhizines / rhyzoids that penetrate the tuff are sometimes replaced by opal, preserving their delicate structures. The porosity of Type 3 through 5 surfaces decreases as the abundance of secondary mineral cements increases. Porosity remains high where the tuff is little altered, but in heavily mineralized areas the porosity is reduced to

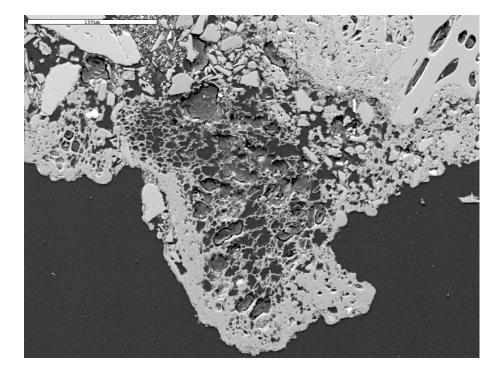
Figure 13. SEM backscatter image showing psuedomorph of lichen thallus replaced by opal in a case hardened surface; delicate cellular structure of the lichen is preserved by the mineralization. The lichen is attached to tuff bedrock where most of the fine ash in the matrix is replaced by intergrown opal and clay. Small bright white areas are trace barite.

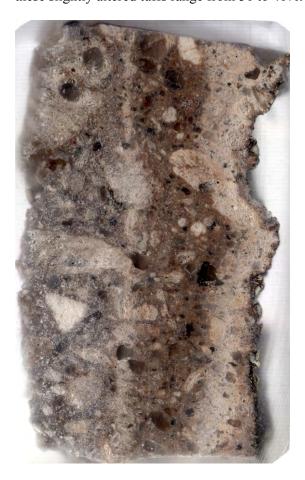
Figure 14. Canyon-wall tuff with Type 7 alteration. The image is a thin section butt 2.5 cm wide cut perpendicular to the canyon wall. The canyon wall is on the right side of the image. The case hardened zone is made up of two parallel bands of alteration. The outer alteration band, next to the canyon wall, is mostly white in color. The inner alteration band ranges is medium to dark brown in color. Both bands are extensively altered, but the inner band is more highly mineralized. The tuff left of the inner band of alteration is slightly altered and contains abundant volcanic glass. Porosity is 20 to 30% in the outer band, 1 to 15% in the inner band, and 30 to 40% in the slightly altered tuff.

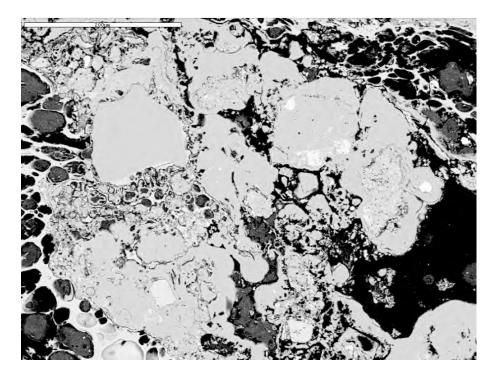
Figure 15. SEM backscatter image for the outer band of alteration in Type 7 case hardened tuff. Volcanic ash in the tuff matrix is replaced by thick, massive bands of opal (medium gray) and finely intergrown opal and clays (mottled appearance). Some larger glassy pyroclasts (vesicular pumice and 100-μm-wide equant clast in the upper left quadrant) survived alteration, but show moderate to severe effects of dissolution at their margins. There are thin rinds of opal pseudomorphs replacing pumice vesicles in the center left part of the image.

altered, and is characterized by replacement of the ashy tuff matrix by opal that envelops glass shards and pumice lapilli (Fig. 15). The edges of shards and pumice lapilli show moderate to severe dissolution effects. Some of the opal shows rhythmic growth layering. Subordinate to trace amounts of aluminum-rich clay minerals and calcite are intergrown with opal. These secondary minerals form a durable cement that fills a significant amount of the available pore space. Porosity estimates for the outer band of alteration ranges from 20 to 30%. The inner band of alteration is more strongly mineralized than the outer band. Secondary minerals in the inner band of alteration consist of massive opal with intergrown calcite ± sepiolite. Locally, sepiolite and calcite are the dominant secondary minerals. All of the fine ash in the tuff matrix is replaced by massive deposits of secondary minerals that envelop the surviving glass shards and pumice lapilli (Fig. 16). Many of the surviving shards and pumice lapilli are extensively modified by dissolution, but some delicate cuspate shards are surprisingly well preserved. Porosity for the inner alteration band was estimated by image analysis of SEM backscatter images, and ranges from 1 to 15% and was commonly <5%. The transition from the inner alteration band to deeper tuffs (i.e. more than about 1.3 cm from the canyon wall) is marked by a gradual decline in mineralization. As the alteration diminishes, glassy ash in the tuff matrix becomes more prevalent. Porosities in these slightly altered tuffs range from 30 to 40%.

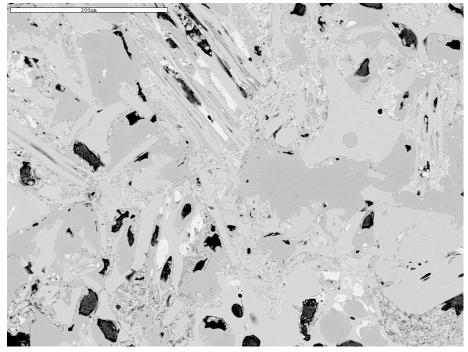
Figure 16. SEM backscatter image for the inner band of alteration in Type 7 case hardened tuff. Large glassy shards (light gray) show few delicate cuspate structures due to dissolution. The shards are thoroughly cemented by massive opal (medium gray), calcite (white), and sepiolite (small mottled dark gray areas). All of the fine matrix ash and most of the original pore space have been replaced by mineralization. The few remaining pores are shown in black. Image analysis yields the following proportions: 49.2% glass shards, 43% opal, 4.3% calcite, trace sepiolite, and 3.5% porosity.

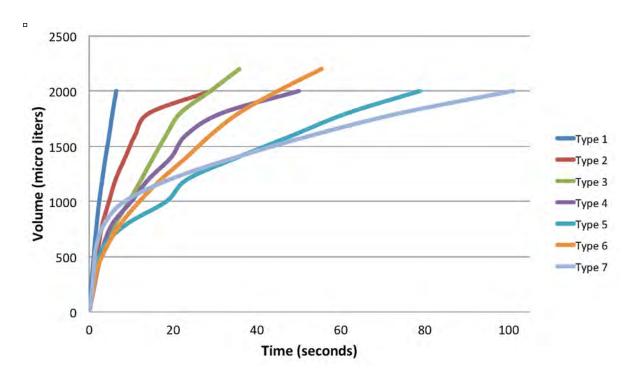
Table 2. Absorption values for each surface type are plotted against time. For Type 1 surfaces the average rate is essentially linear, while for Types 2-7 rates slowed significantly as the experiment progressed. Table prepared by R. Domingue

To test the hypothesis that pore filling minerals and mucilaginous cyanobacteria in crusts that develop on the rock surface reduce the water uptake of the porous rock, investigators collected measurements using a prototype device developed by the Institute for Theoretical and Applied Mechanics (Czech Republic) that quantifies the volume of water absorbed by the rock *in situ* through time. Among the advantages associated with the device is that water is applied only to the surface (this is important because case hardening is a surface / near surface phenomenon), and the instrument is graduated specifically for imbibition rates typical of porous rocks⁵. In trial runs of this test, absorption rates of recently exposed tuff surfaces were greater than for samples having more highly developed crusts. Rates for unaltered surfaces (Type 1) were essentially linear. For altered surfaces, absorption rates slowed as the experiment progressed; this suggests that the swelling of clays or mucilaginous films may play a role in reducing absorption for crusts in initial stages of development (Types 2-4), while for well developed crusts with occluded pores, there appears to be initial filling of the available porosity followed by leveling off of the absorption rate (Table 2).

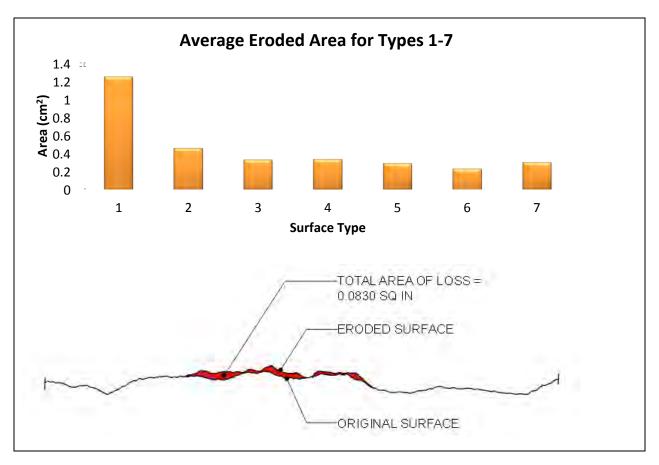
Table 3. Erosion was measured as the area between surface profiles collected before and after each test (see sample profile), and average erosion areas were plotted for each surface type. A substantial proportion of the losses recorded for Type 6 and 7 surfaces was due to erosion of sedimented / biological material accumulated on the sample surfaces, rather than to losses in the near-surface zone of the bedrock. Table prepared by R. Domingue

To evaluate comparative erosion resistance, investigators developed an in situ erosion test adapted from ASTM G76: Standard Test Method for Conducting Erosion Tests by Solid Particle Impingement Using Gas Jets. The method was adapted to the poorly consolidated tuff in terms of gas delivery pressures and blast media selected. The ASTM standard quantifies erosion in terms of mass loss, and measurements are made by weighing samples before and after each test run. Because tests at Bandelier were conducted *in situ*, the adapted test protocol includes a technique for collecting surface profiles before and after the test and calculating the areas between the profiles. Pilot test results indicate that sedimented silt / clay coatings and the presence of even intermittent lichen cover enhance the erosion resistance of the tuff. There was frequently no measurable erosion of surfaces with highly developed case hardened crusts (Types 6 and 7) apart from the loss of surface sediments and biological material (Table 3). Since tests were run once at each test site, results document changes in surface profile regardless of the type of material (tuff vs. sedimented coatings/surface biota) lost. Running additional tests at

each test site would tend to highlight the role of sedimented surface materials in the erosion resistance of the surface. For crusts in initial stages of development, it is expected that the rate of erosion would increase abruptly following the loss of the surface material; for well developed crusts, erosion resistance is largely a function of hard secondary minerals precipitated in the near-surface zone, and it is expected that losses would tend toward 0 once sedimented and biotic surface crusts were removed.

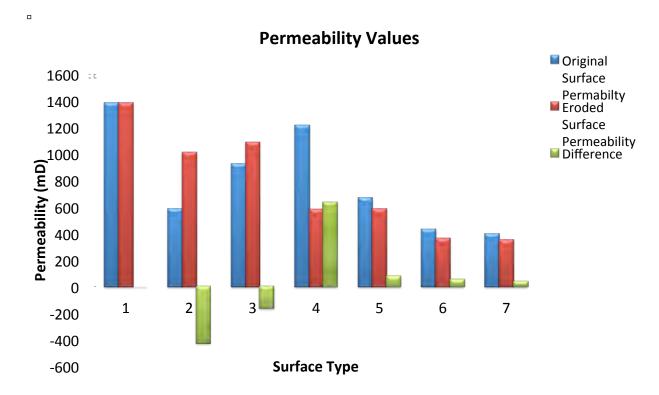
Table 4. Surface permeability values were collected for each sample with the sample surface intact. A second set of values was collected after eroding sample surfaces to remove sediments and biological material. Table prepared by R. Domingue

of these samples had little impact on the measured values. The performance of surface Type 4 seemed clearly to mark a transition between the two groups, where removal of surface coatings resulted in a substantial reduction in surface permeability (Table 4).
