# **The Flood Damage Mitigation Works of the Miami Conservancy District, Ohio, 1922 -**

**Stephen J. (Steve) Burges**

CEE 500 Seminar – April 13, 2023

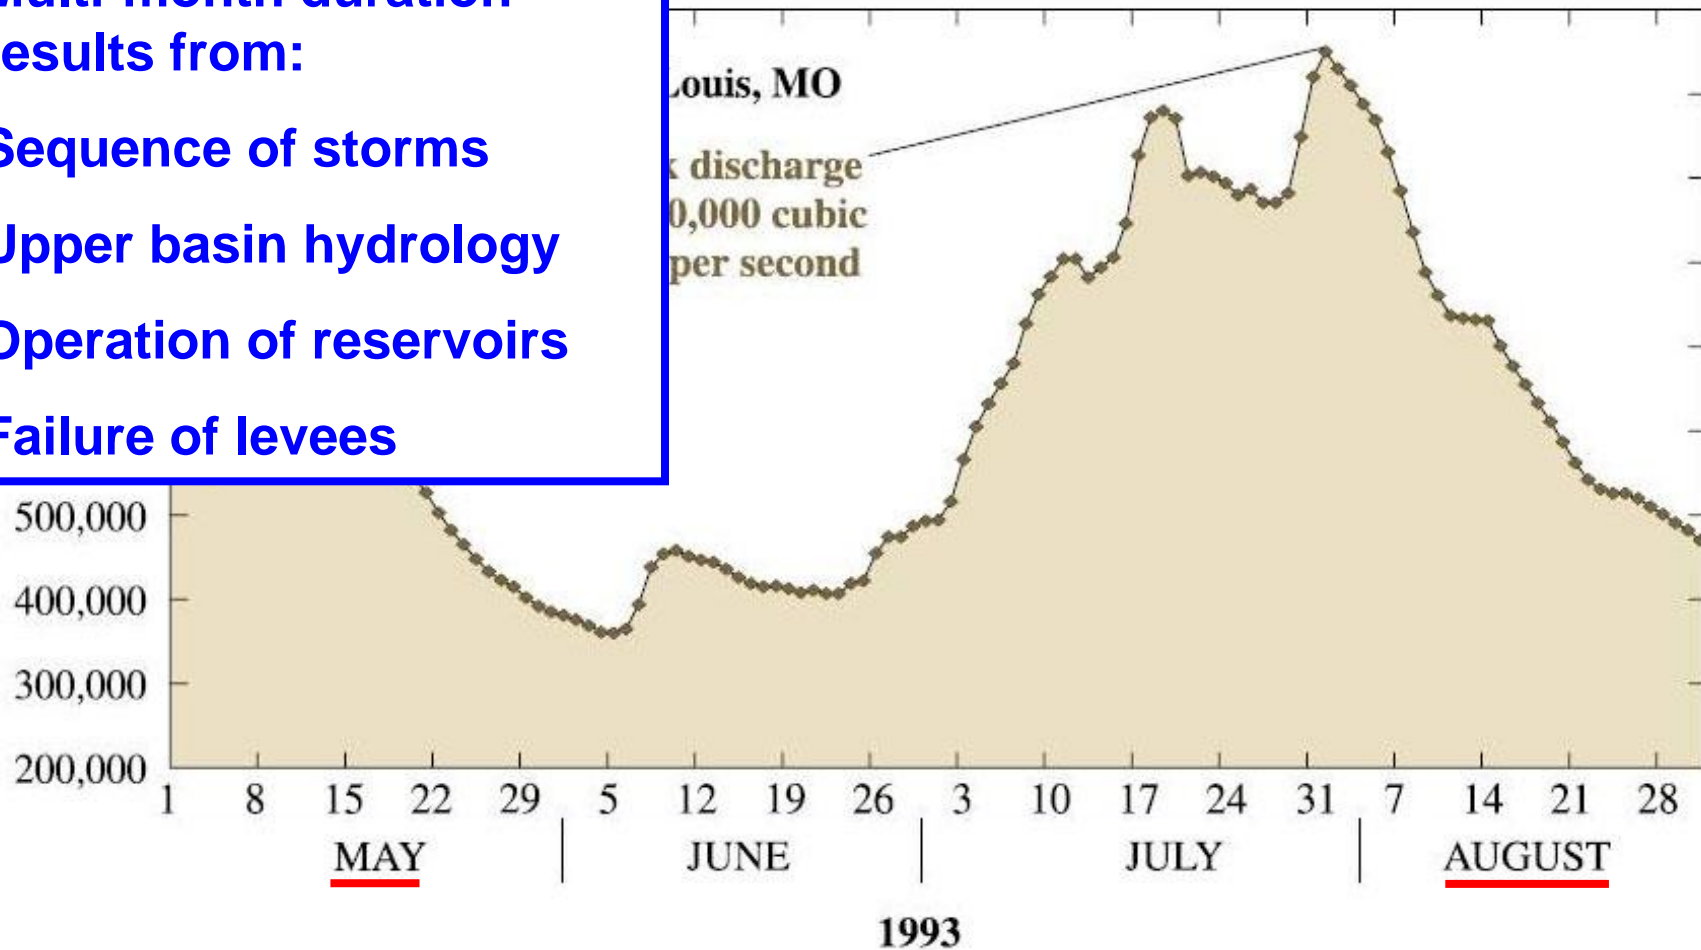
Multi-month duration  
results from:

Sequence of storms

Upper basin hydrology

Operation of reservoirs

Failure of levees

**Figure 3.** Hydrograph of Mississippi River at St. Louis, Missouri, from May to August 1993.

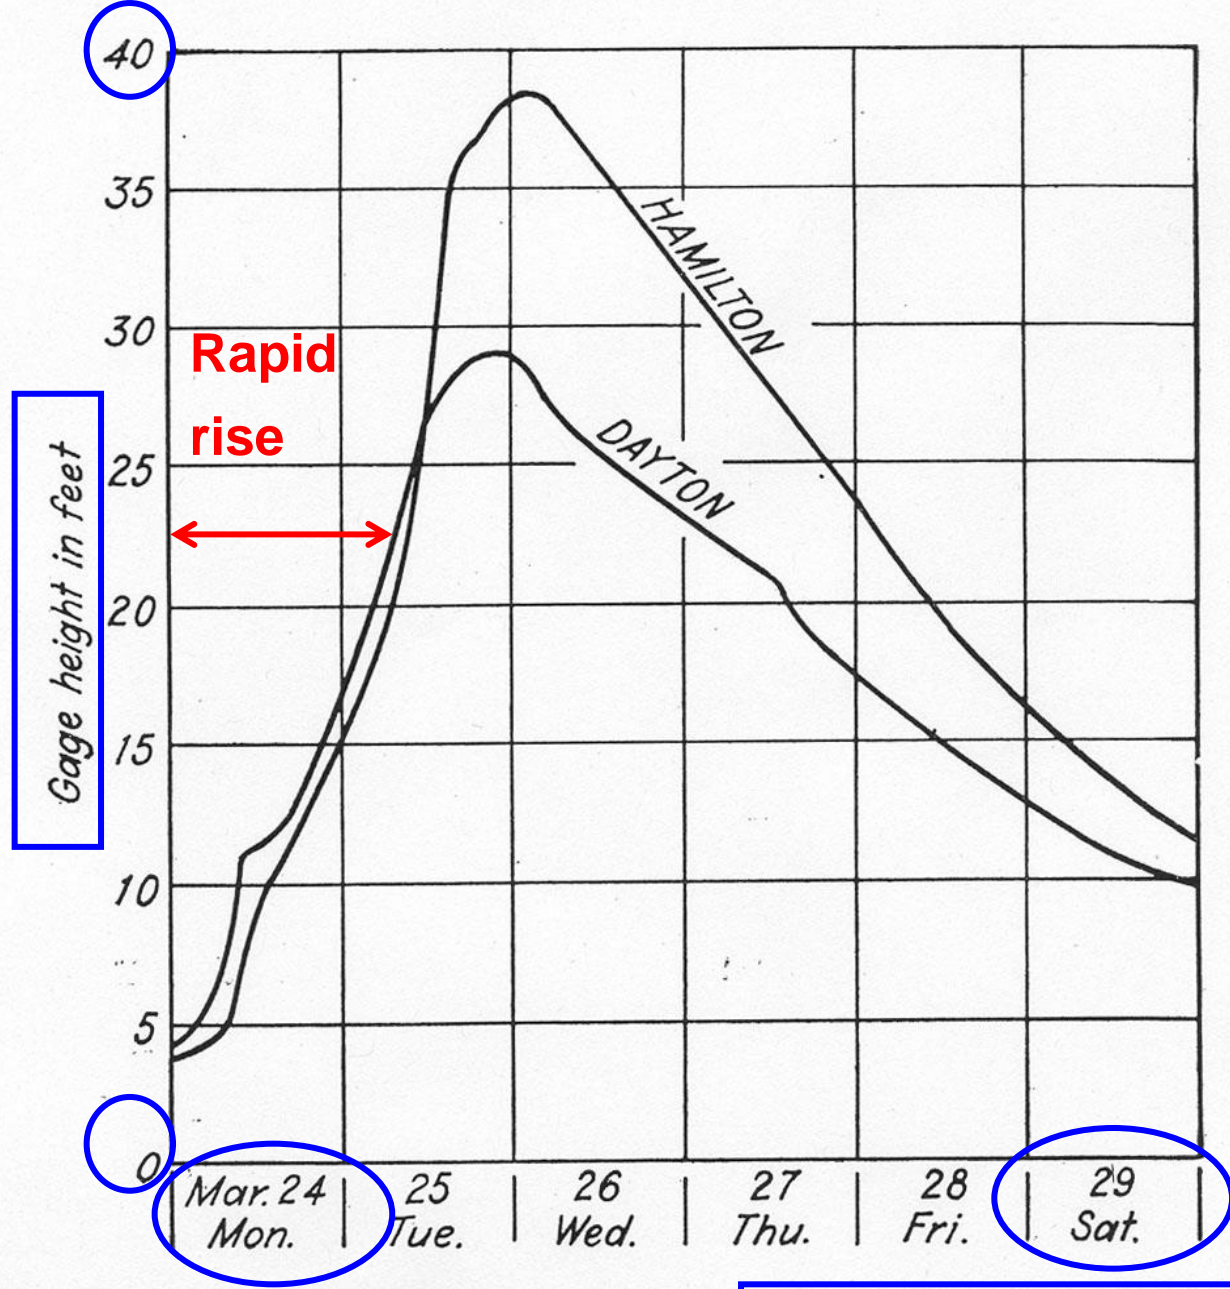
Diagram showing the rise and fall of the Miami River at Dayton and at Hamilton during the flood of March, 1913.

Rain fell on saturated ground – approximately 90% runoff

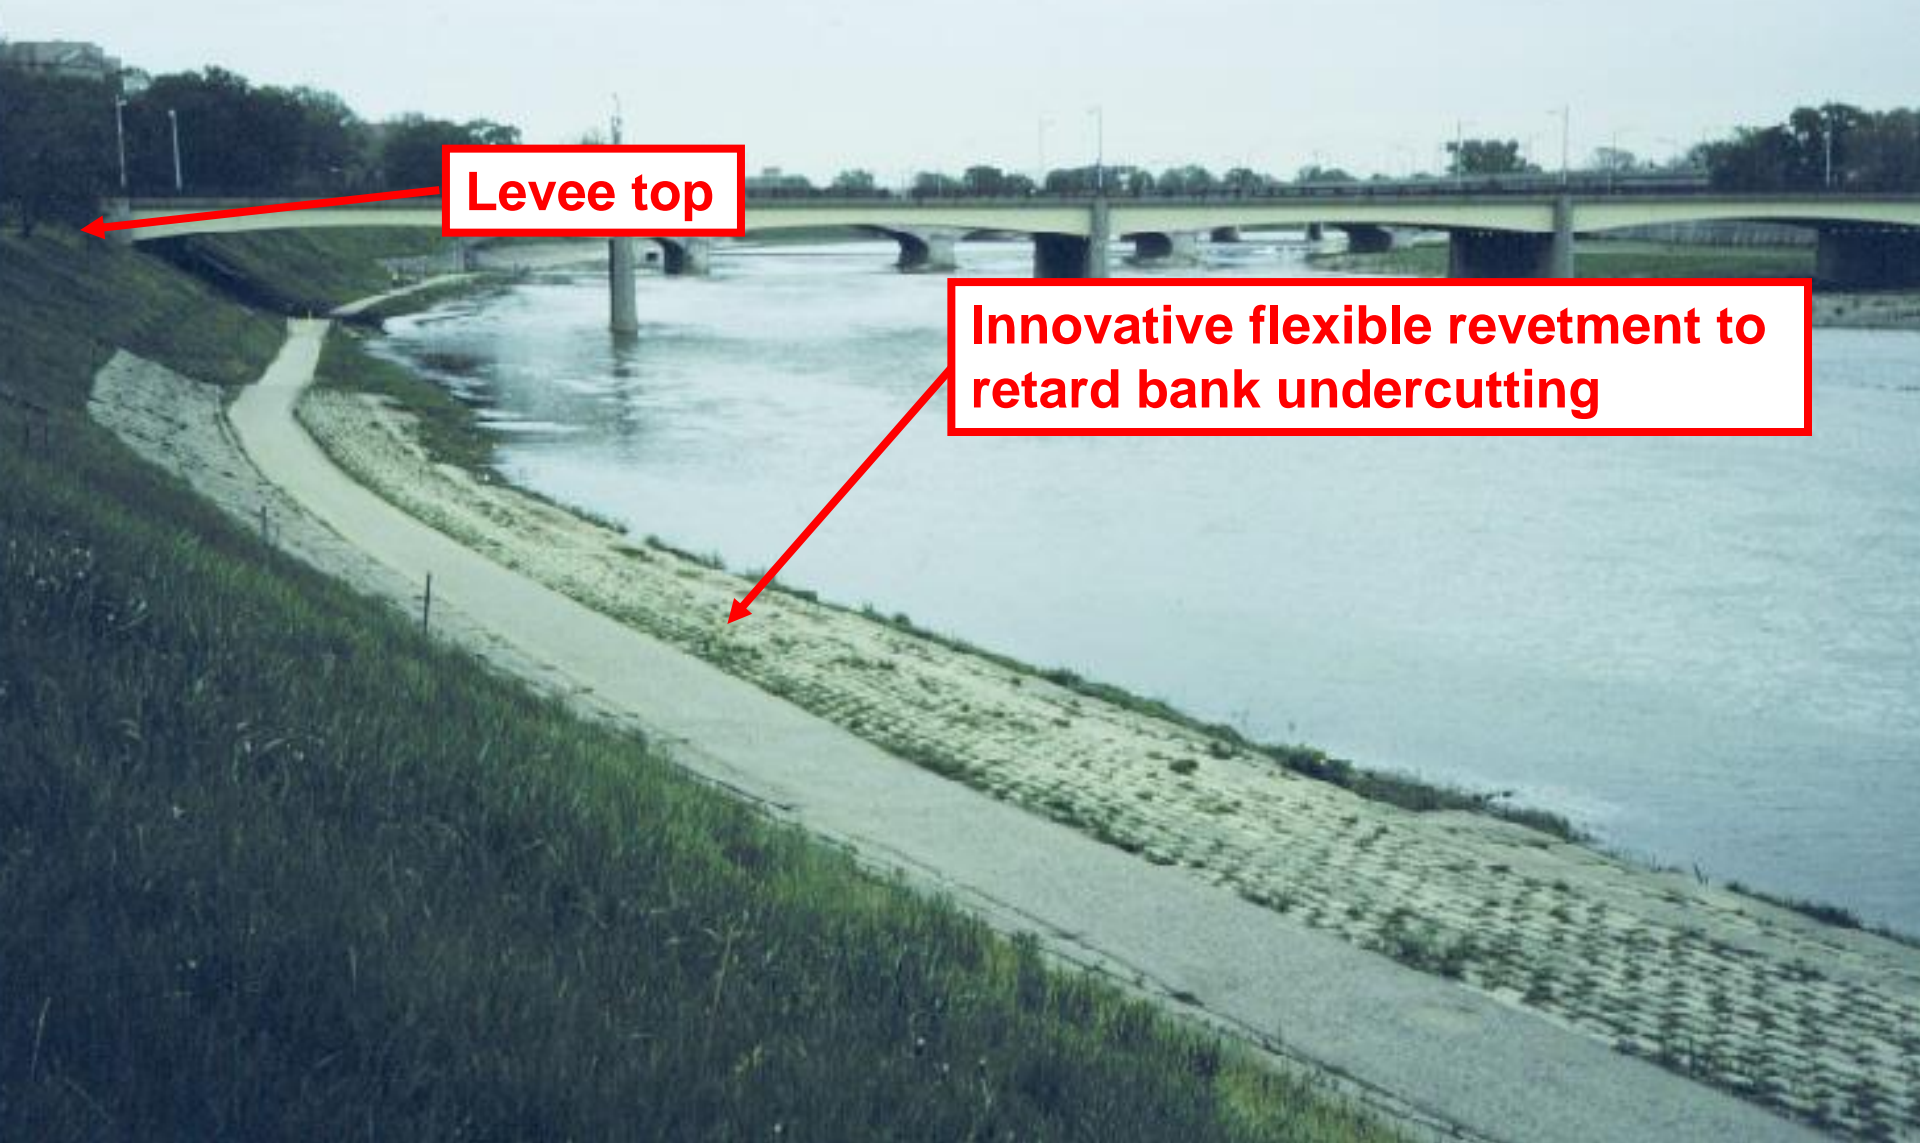
Levee top

Innovative flexible revetment to retard bank undercutting

Levee and hydraulically efficient channel liner near Dayton –  
**original materials** - photograph (Steve Burges)

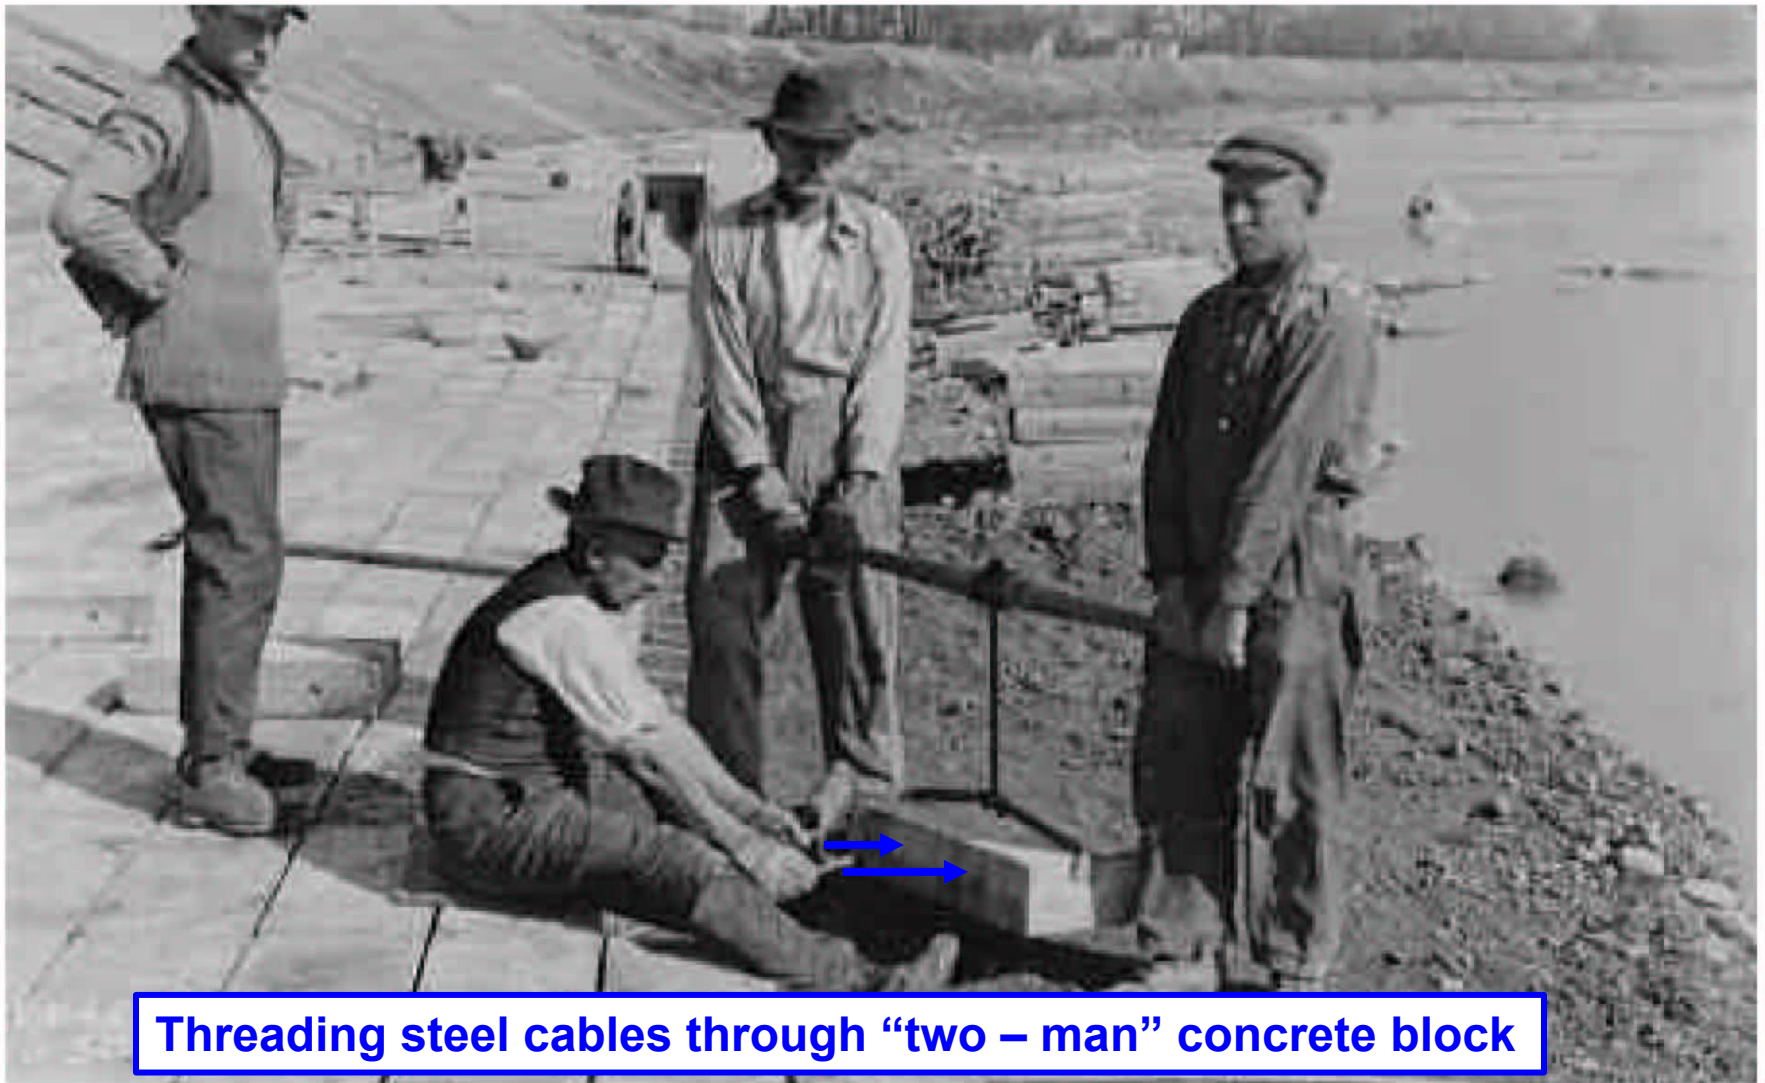
**Threading steel cables through “two – man” concrete block**

Figure 71 Dayton Feature - Laying blocks for flexible revetment. Looking upstream of Great Miami River. McKinley Park sewer outlet in slope

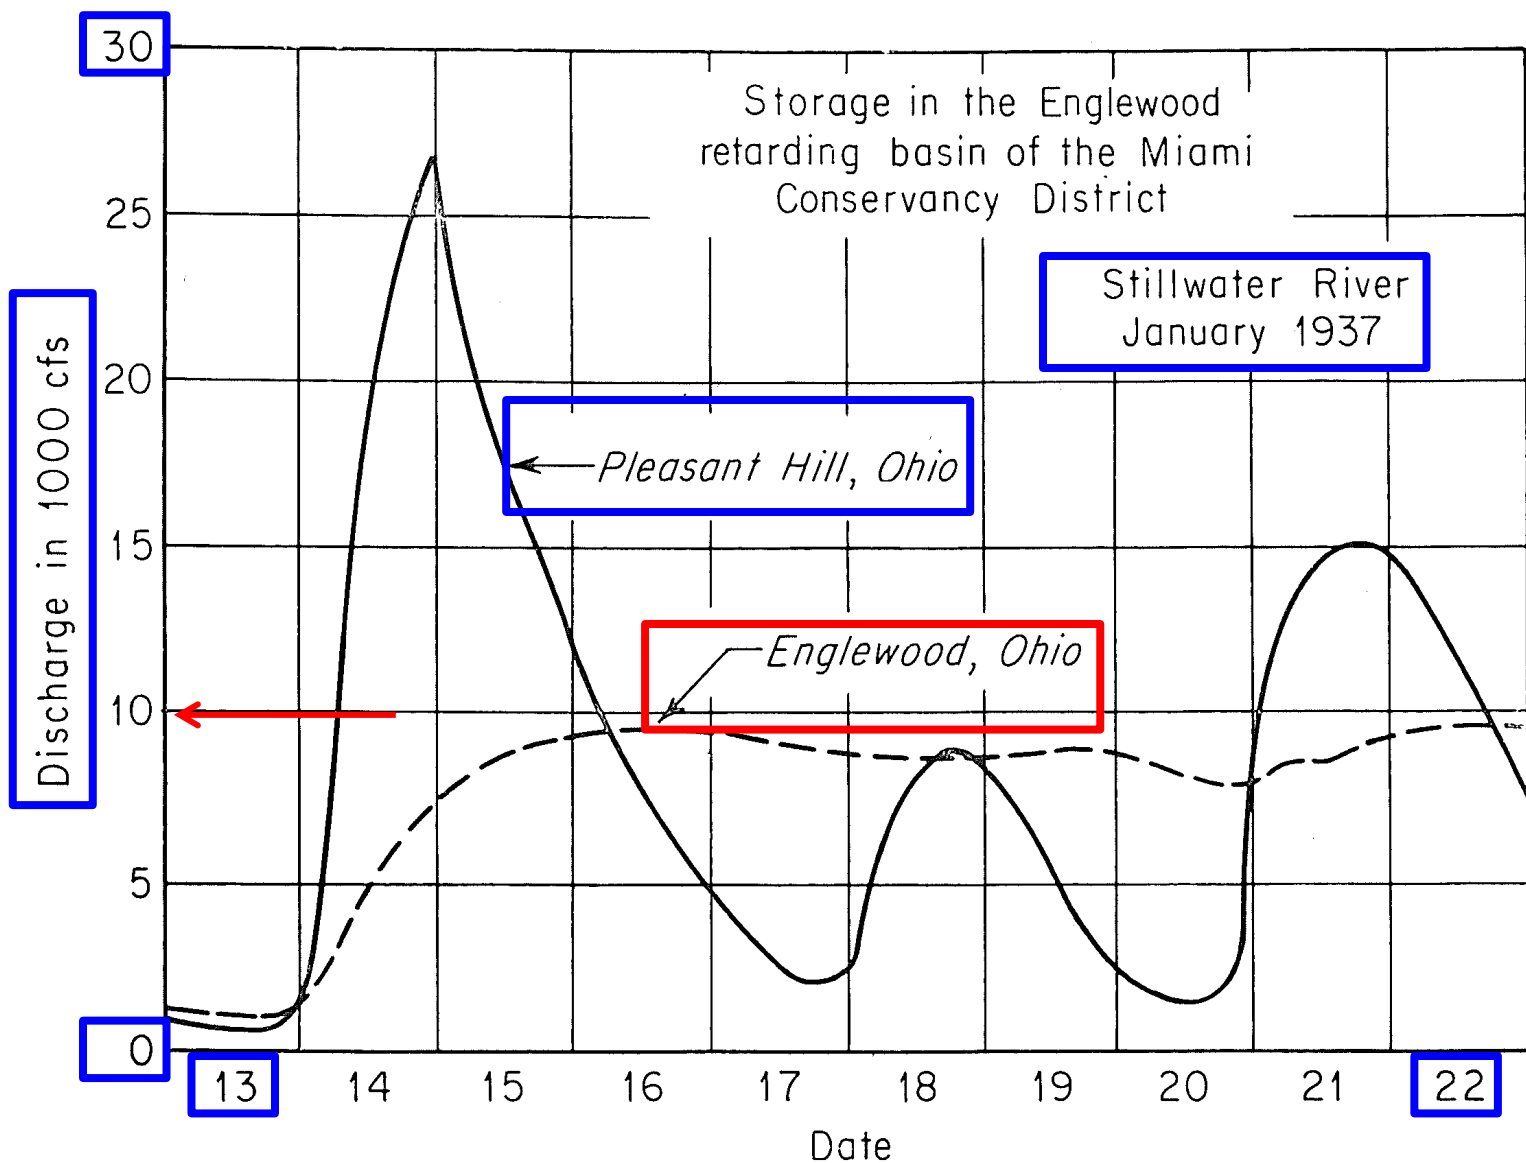
**Flood peak flow reduction – Englewood Dam**

FIG. 10-5. Reduction of discharge through reservoir action, Stillwater River, Ohio.

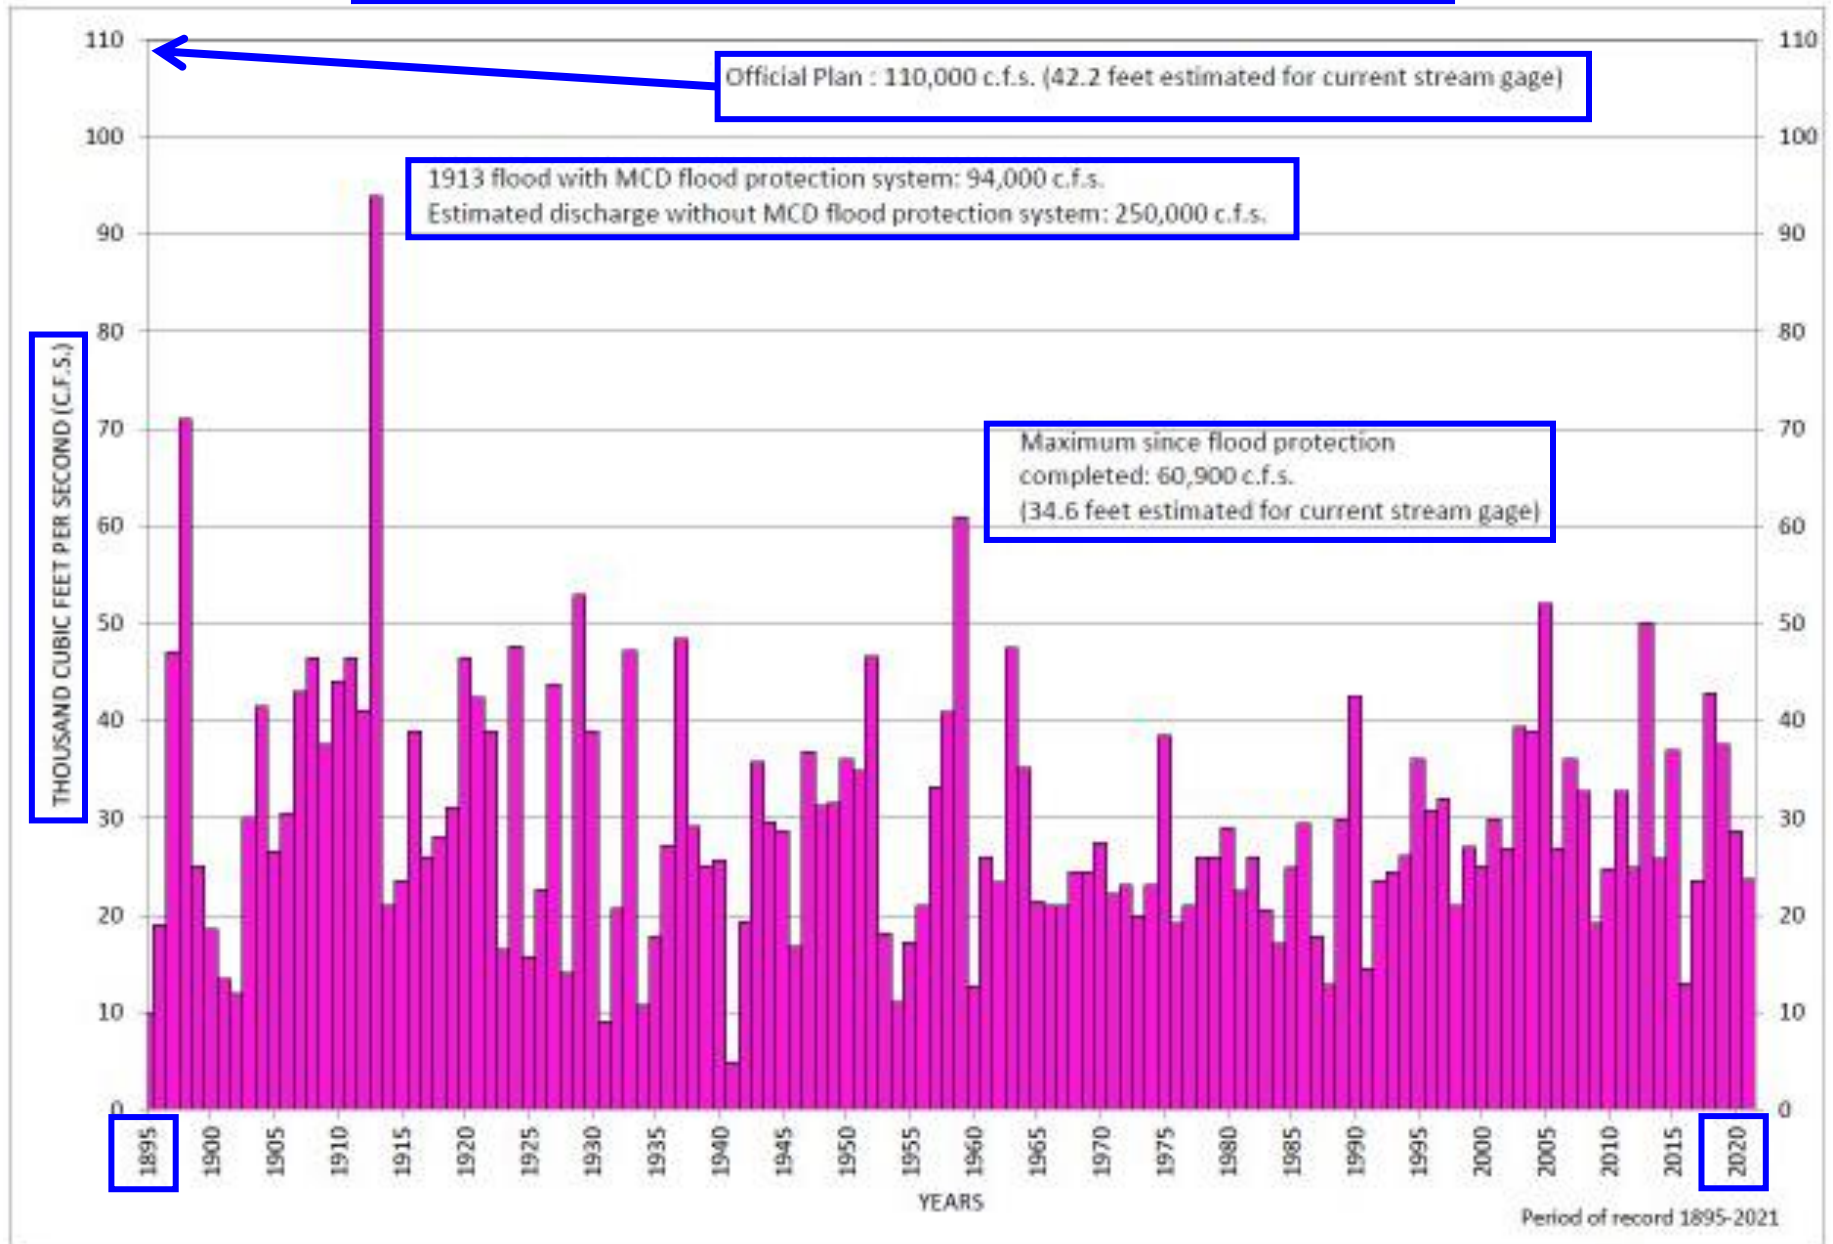
Figure 12—Annual Peak Discharges of the Great Miami River at Dayton, Ohio

**The 1913 flood was the “flood of record”.**

**The facilities (levees, dams, and hydraulically efficient channels) were designed for the 1913 flood peak plus 40% additional runoff.**
