# Tunneling and Bridging to Success: Innovative Forest Road Design and Construction in Rugged Terrain on British Columbia's West Coast

**ABSTRACT** - The CW300 road at Phillips Arm, on British Columbia's rugged west coast, is an example of a challenging new road that was built using thinking and methods that try to live up to the high standards of forest road design and construction demanded by today's regulatory and environmentally-conscious climate. To successfully complete this project, an experienced team, able to identify all issues and work together to find solutions, was first assembled. A considerable amount of time was spent on location surveys and terrain stability field assessments so that the best possible road alignment could be defined. Once the optimum route was established, detailed site surveys, a geometric road design, and a metre-by-metre geotechnical prescription was used to produce road construction plans. Finally, very specific plans and innovative solutions were developed for two special sites where a major bridge was needed to cross a precipitous, ice-avalanche-prone creek channel, and an adit was excavated to allow the road to be turned through a narrow sw

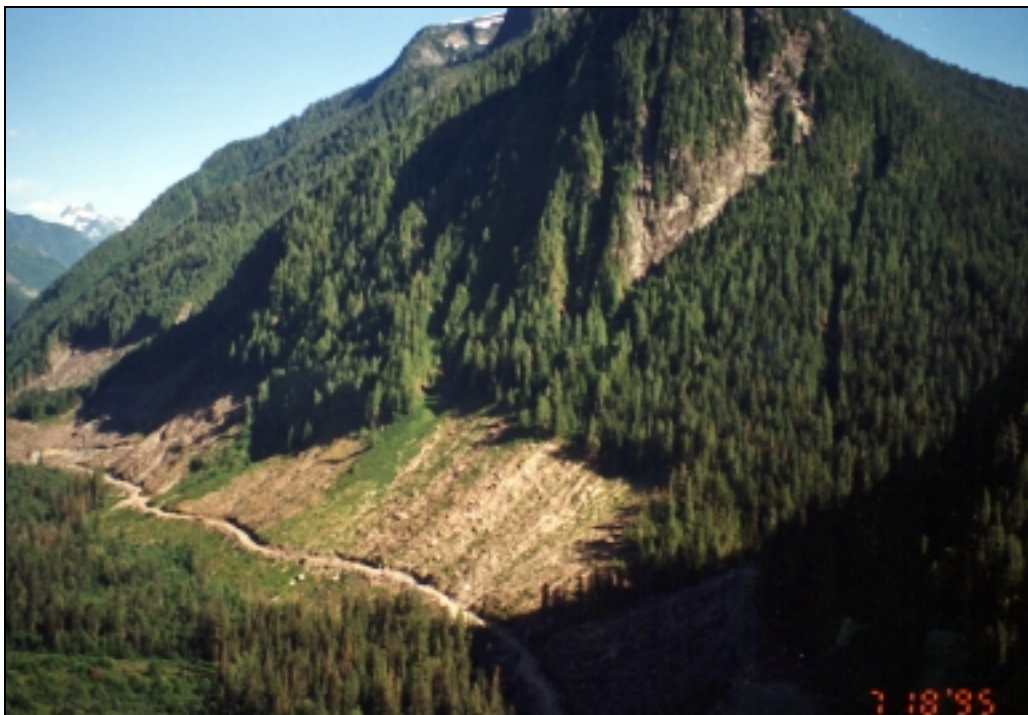
Figure 2: overview of the main Clearwater River valley and the Shore Creek side valley on the far right. The initial road heading is visible in the left center of the picture.

The first attempt to build a road up into the Shore Creek valley was made in 1994 using a direct route that angled up the steep sidehill from the Clearwater Valley. But this heading ended in failure because the road had to be fully benched into the hillside to provide bearing support for heavy equipment, which left steep surficial material resting on bedrock above the road unsupported. When this upper material became saturated with water during a period of wet weather, a slide involving several thousand cubic metres of material abruptly cascaded down, burying the road heading. Fortunately, the road construction supervisor was aware of the potential problem and had pulled out the equipment when heavy rains started falling just prior to the slide releasing. But the slide proved that the road could not be safely built at this location, and so this heading was abandoned.

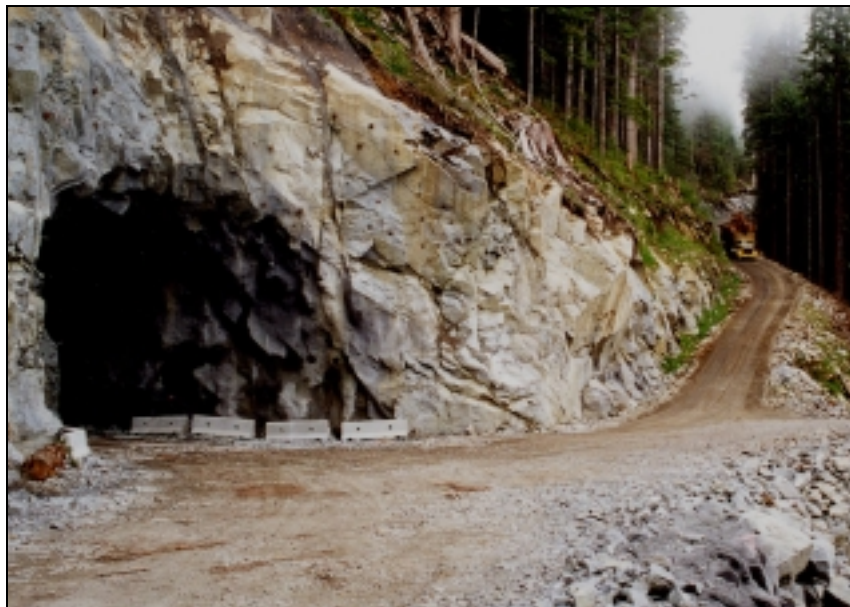
Figure. 3: adit and the railroad-style switchback at the CW 300 road at Phillips Arm. Trucks come down the upper road, back into the adit, and then turn sharply and continue down the lower road at far right. The adit is fully grouted and bolted to minimize rockfall.

These problems and costs justified another assessment- and so for the third time, another attempt was made to find another route. Now the earlier location surveys really paid off because they allowed all the knowledge already gained of the area to be applied to new situations. A third route was found, but also required building a switchback on a steep sidehill- although this time there was no convenient slot to provide enough room for even a railroad-type switchback. Instead, a hole, or adit, had to be blasted into the rock face to provide the necessary gallery to allow a fully loaded logging truck to back up and turn down the hill.

Table 1: adit statistics

Length	Width	Volume	4 m Bolts	Shotcrete	Cost
17.5 m	8.0 m	3520 m <sup>3</sup>	>200	60 m <sup>3</sup>	\$490,200

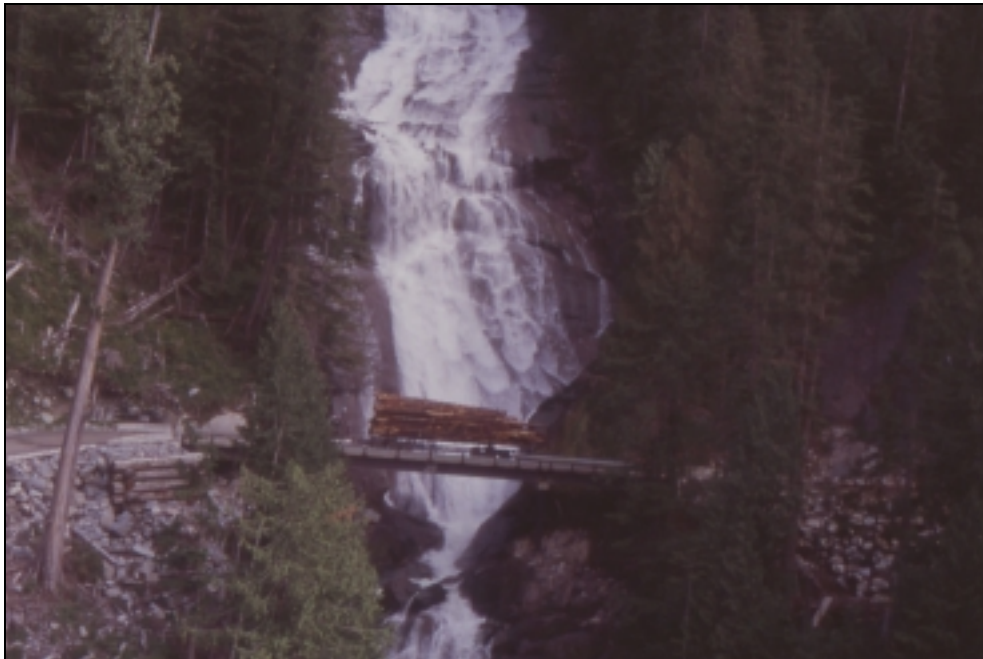
Figure 4: overview of the Shore Creek bridge at the base of the waterfall. In winter, ice avalanches are a major problem at this location and the bridge needed to be designed to avoid being damaged by both high water flows and cascading ice.

The only feasible location for a bridge was at the base of a major waterfall which has high flood flows and periodically freezes over in winter. When the ice melts, large masses of ice cascade off the rock slabs, and there was a concern that this could damage the bridge. In order to find the specific best location for the bridge and so minimize the ice avalanche problems, a careful assessment of how the ice cascades down the channel was done using the evidence provided by damaged tree trunks on both sides of the channel. When this assessment was completed, the pattern of ice movement down the face could be defined, and the bridge could then be located in one of the troughs where cascading ice was least likely to be a problem. Then, in order to provide an additional assurance of safety, the bridge was located as far out and up from the water as possible, and a steel barrier plate was placed in between the bridge columns to help ensure that cascading ice would not score a direct blow on any one support column.
