Stability Analysis of Timber Cribbed Road Fill on a Steep Slope

ABSTRACT - In an effort to minimize the hazard that results from traditional cut/sidecast road construction on steep slopes, forestry companies operating under the BC Forest Practices Code Act have been forced to utilize the more expensive full bench, end haul technique. Historically, roads have been successfully constructed using timber cribs braced against stumps to support the fill, but the stability of such construction has never been measured. This technique potentially offers a lower cost, environmentally less disruptive alternative to full bench endhaul construction.

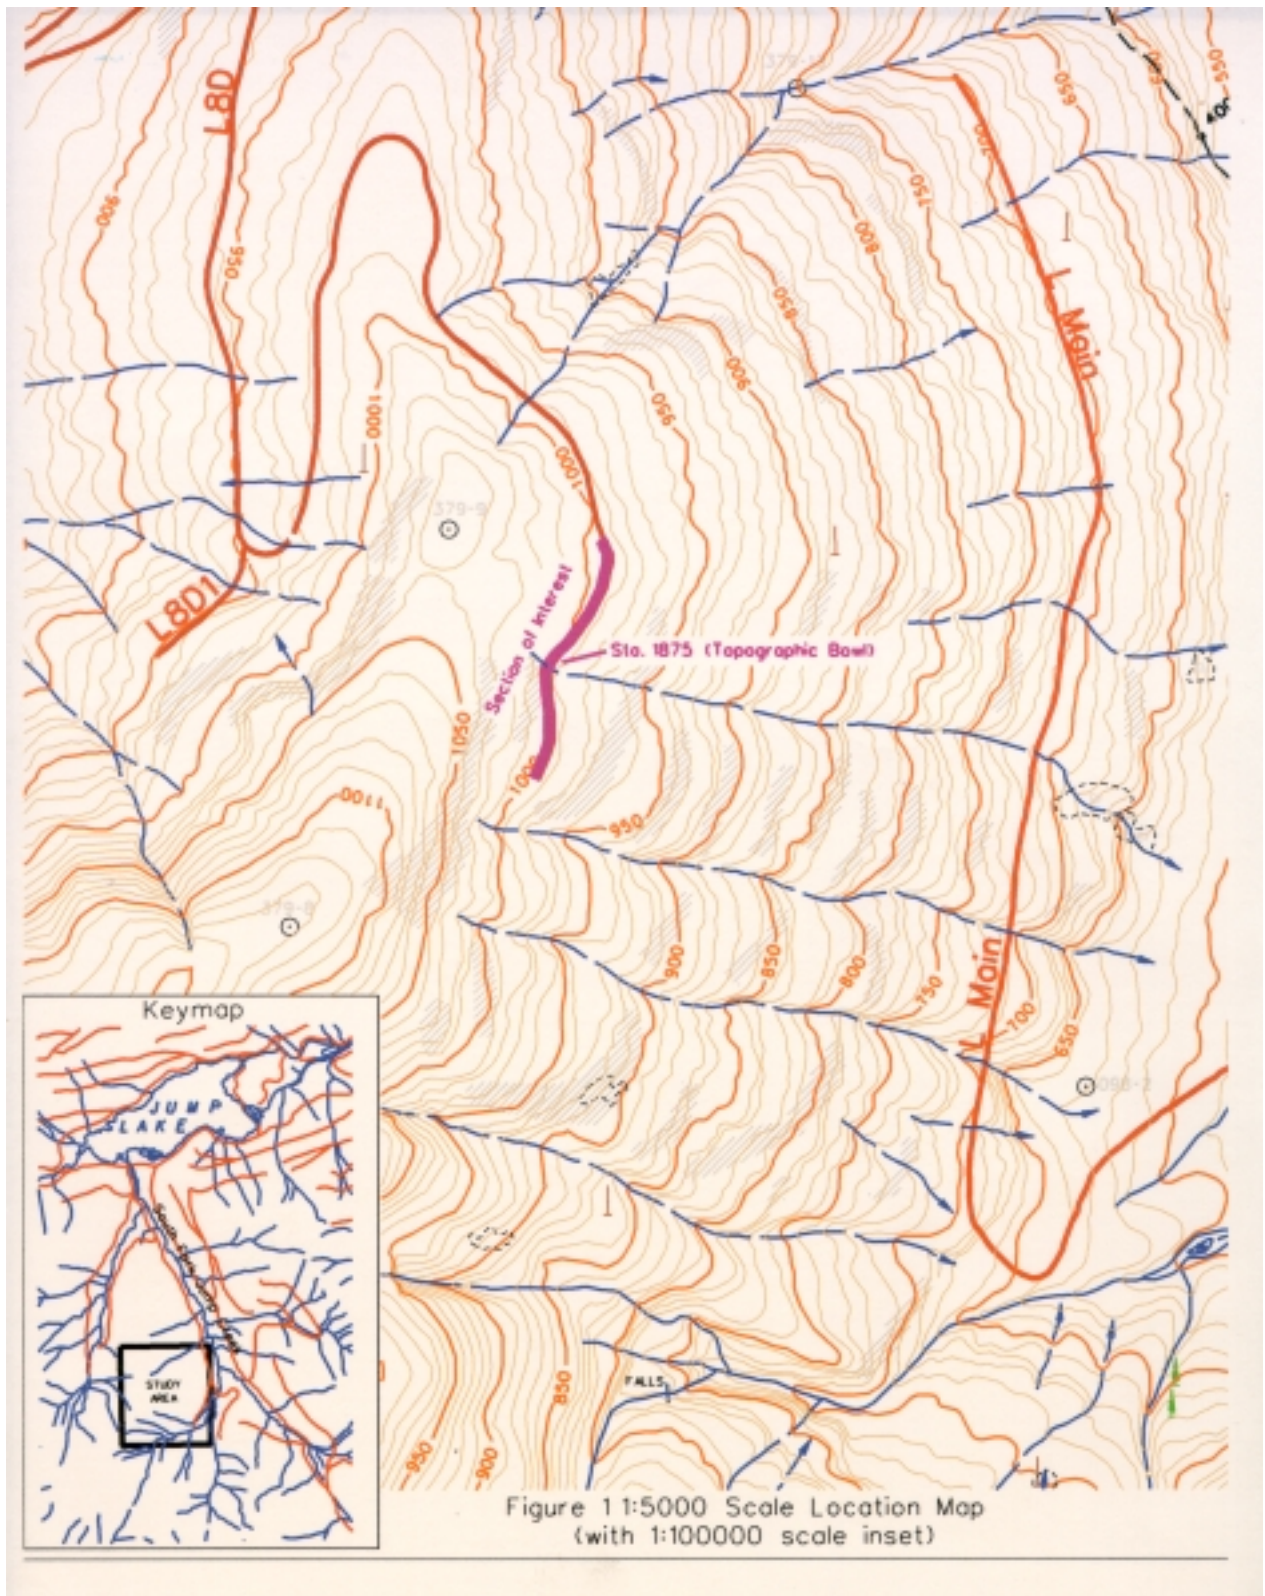
The site is located along spur Road L8D which is located in east Vancouver Island, BC. A location plan is attached as Figure 1. It is approximately 30 km west of Ladysmith, just south of Jump Lake. The road is situated near the top of an east facing slope approximately 400 m in elevation above South Fork Jump Creek, which flows to the north into Jump Lake.

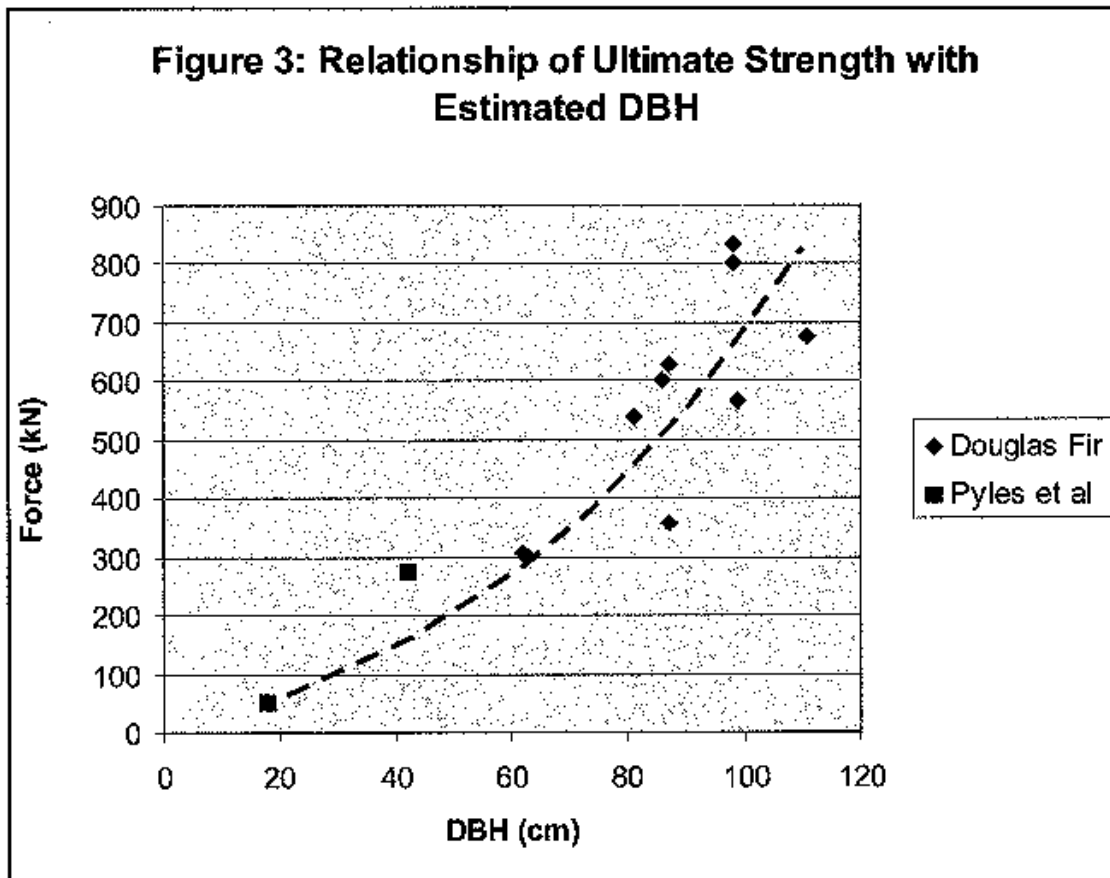
Eight Douglas-fir stumps ranging in diameter from 280 mm to 810 mm were tested. Displacement of the stumps was measured using an extensometer connected to a data logger. Figure 3 shows the results of the testing. The ultimate strength is plotted against stump diameter. When the ultimate strength was recorded, the stumps had undergone significant deformation, 300+ mm in some instances.

The results of the stump pull testing agree reasonably well with the results published by M.R. Pyles, J.W. Anderson and S.G. Stafford. As can be seen in Figure 3, which is a plot of both sets of results, there is a definite trend to more ultimate resistance for larger diameter stumps.

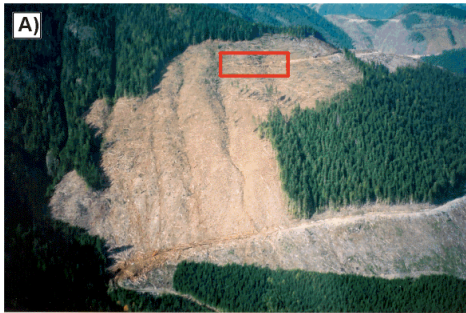
A) Area of stump crib construction on spur Road L8D is shown by the red box.

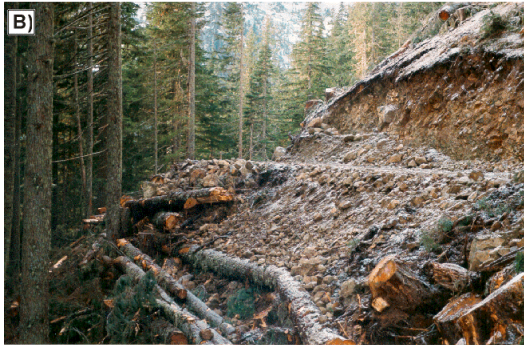
B) View south showing the log crib structure shortly after construction in Fall 1999.

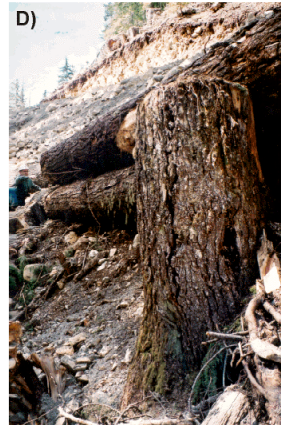
D) View of the stump on which the tiltmeter was ultimately installed.

A stump, located immediately downslope of the grapple yarder during the testing and part of the stump crib structure, was equipped with an X, Y axis tiltmeter (RST Model #IC6505) to determine if the loading from the operation translated to the crib stump (Figure 6). The tiltmeter was fastened to the top of the stump such that it measured tilt in the downslope (Y axis) and cross-slope (X axis) movement. The output was recorded by the data logger.

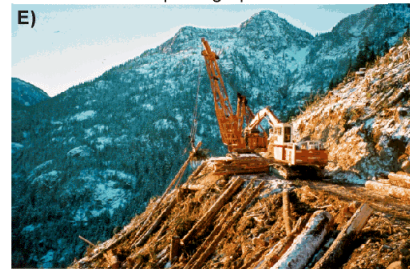
E) View south showing the grapple yarder and loader yarding logs to the stump crib constructed section of road. This is the same section of road shown in (B) and (C).

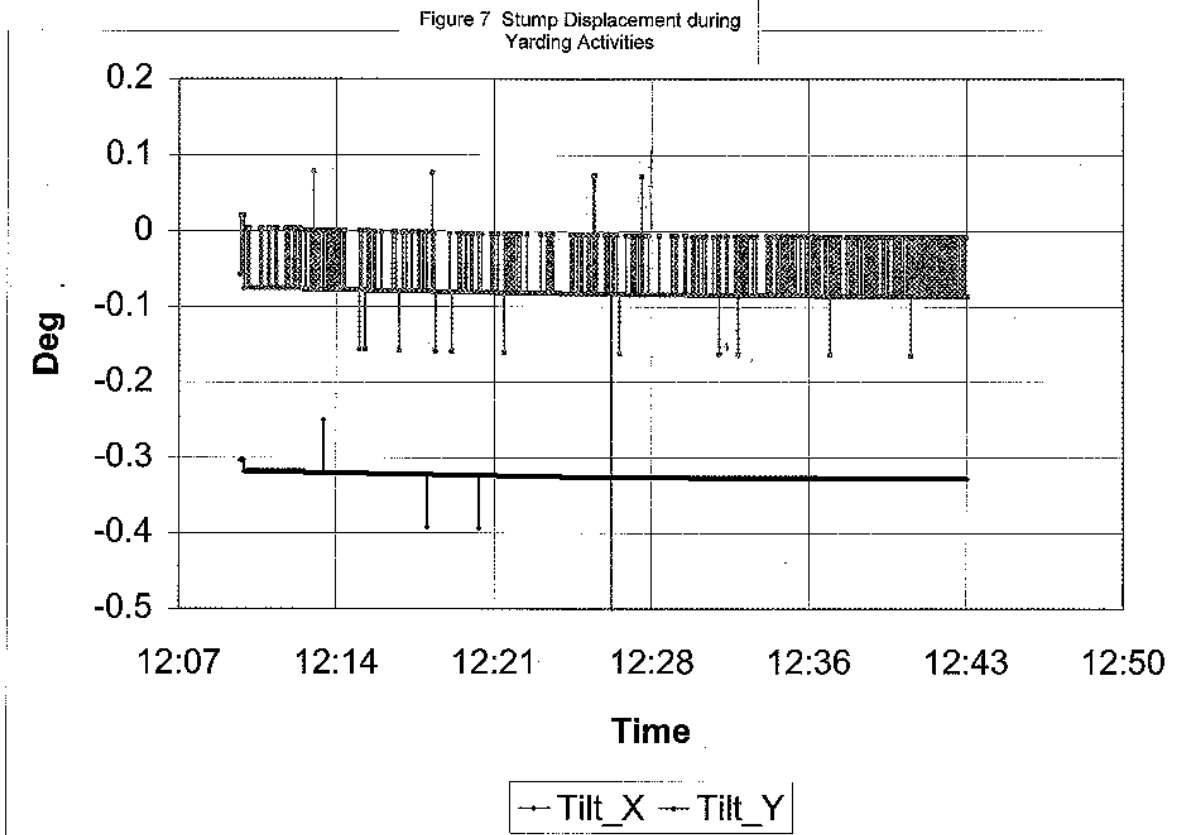
Very little movement, refer to Figure 7, 0.68° tilt in the Y direction (downslope) was recorded at one point during the yarding. Typical movements were much less than this, in the range of 0.1° . Although it was difficult to correlate the downslope movement at the stump with the timing of the loads applied by the grapple yarder, there was definitely some deformation in this axis. In order to correlate the loads imparted on the stump with those measured in the stump pull, the tilt can be used to predict the movement of the stump. For a 1.5 m high stump, this would be a downslope movement of less than 1 mm at a height of 300 mm.
