WASHINGTON STATE HIGHWAY DEPARTMENT RESEARCH PROGRAM  
REPORT

**NORTH CASCADES HIGHWAY  
SR - 20 AVALANCHE ATLAS**

JUNE 1971

E.R. LACHAPPELLE  
C.B. BROWN R. J. EVANS  
GEOPHYSICS PROGRAM AND  
DEPARTMENT OF CIVIL ENGINEERING  
UNIVERSITY OF WASHINGTON

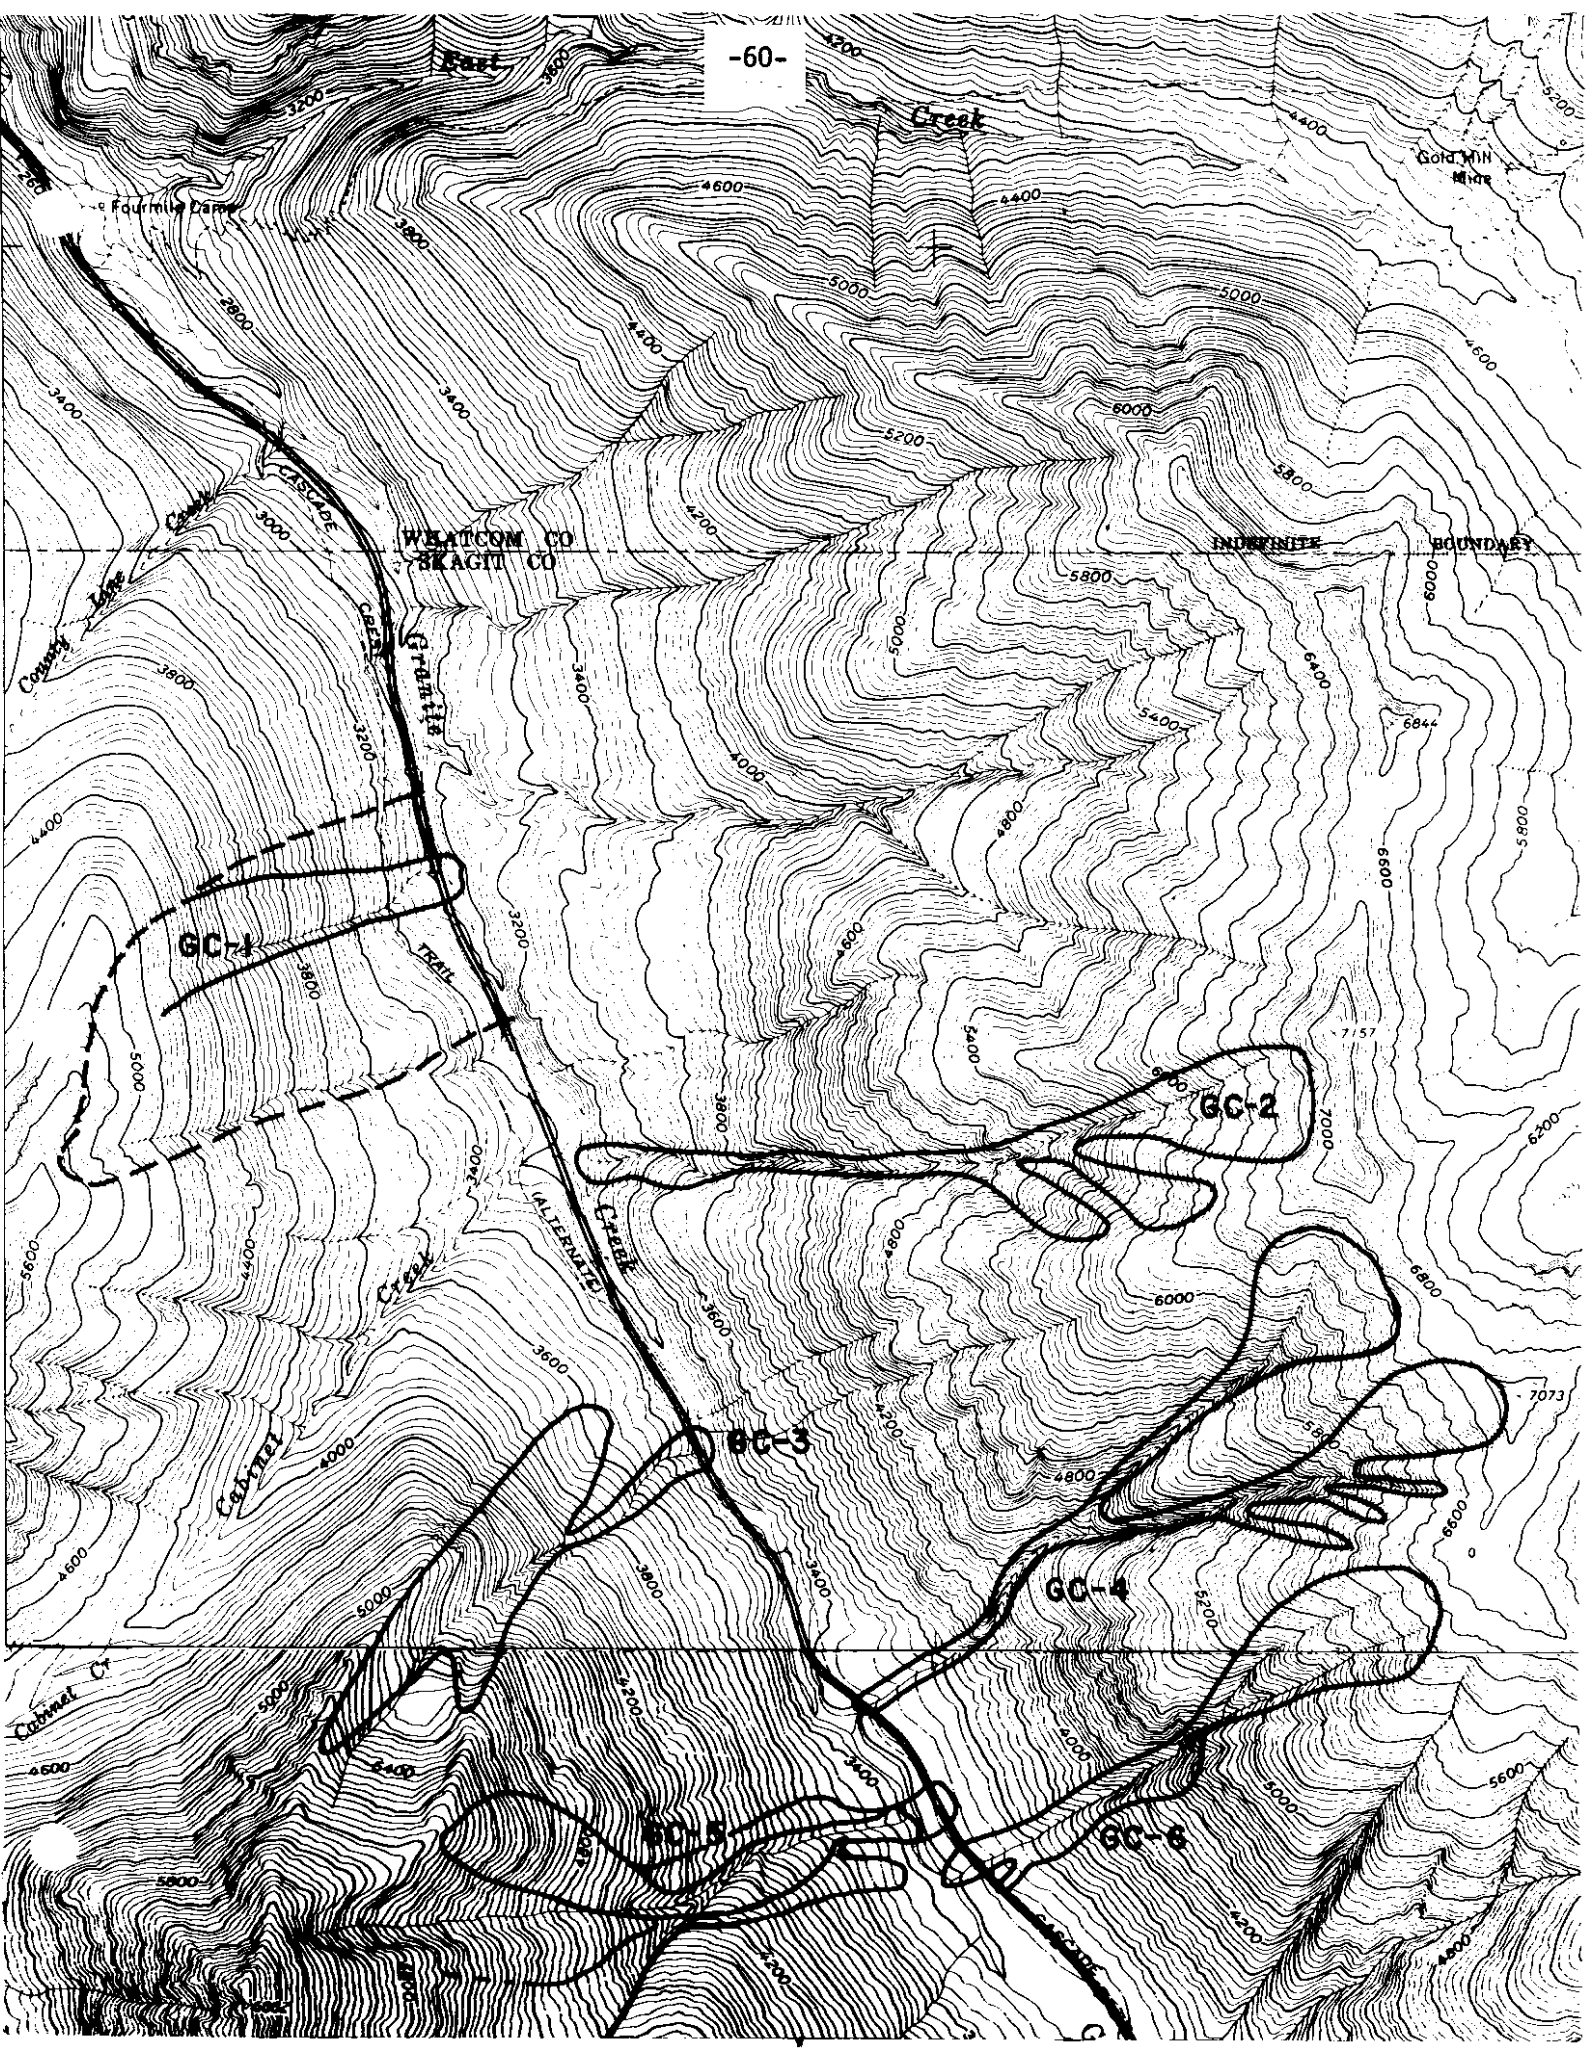
Granite Creek No. 1, No. 2, No. 4 and No. 6 (GC-1, 2, 4 and 6)

About 50 to 75 years ago a large avalanche along the stream channel (solid line on map) reached Granite Creek and deposited a large amount of timber debris on the far bank. The effects of forest fire and avalanche are not easy to distinguish on other parts of the path. A more accurate history can be constructed only after a careful investigation of vegetation patterns throughout the path.

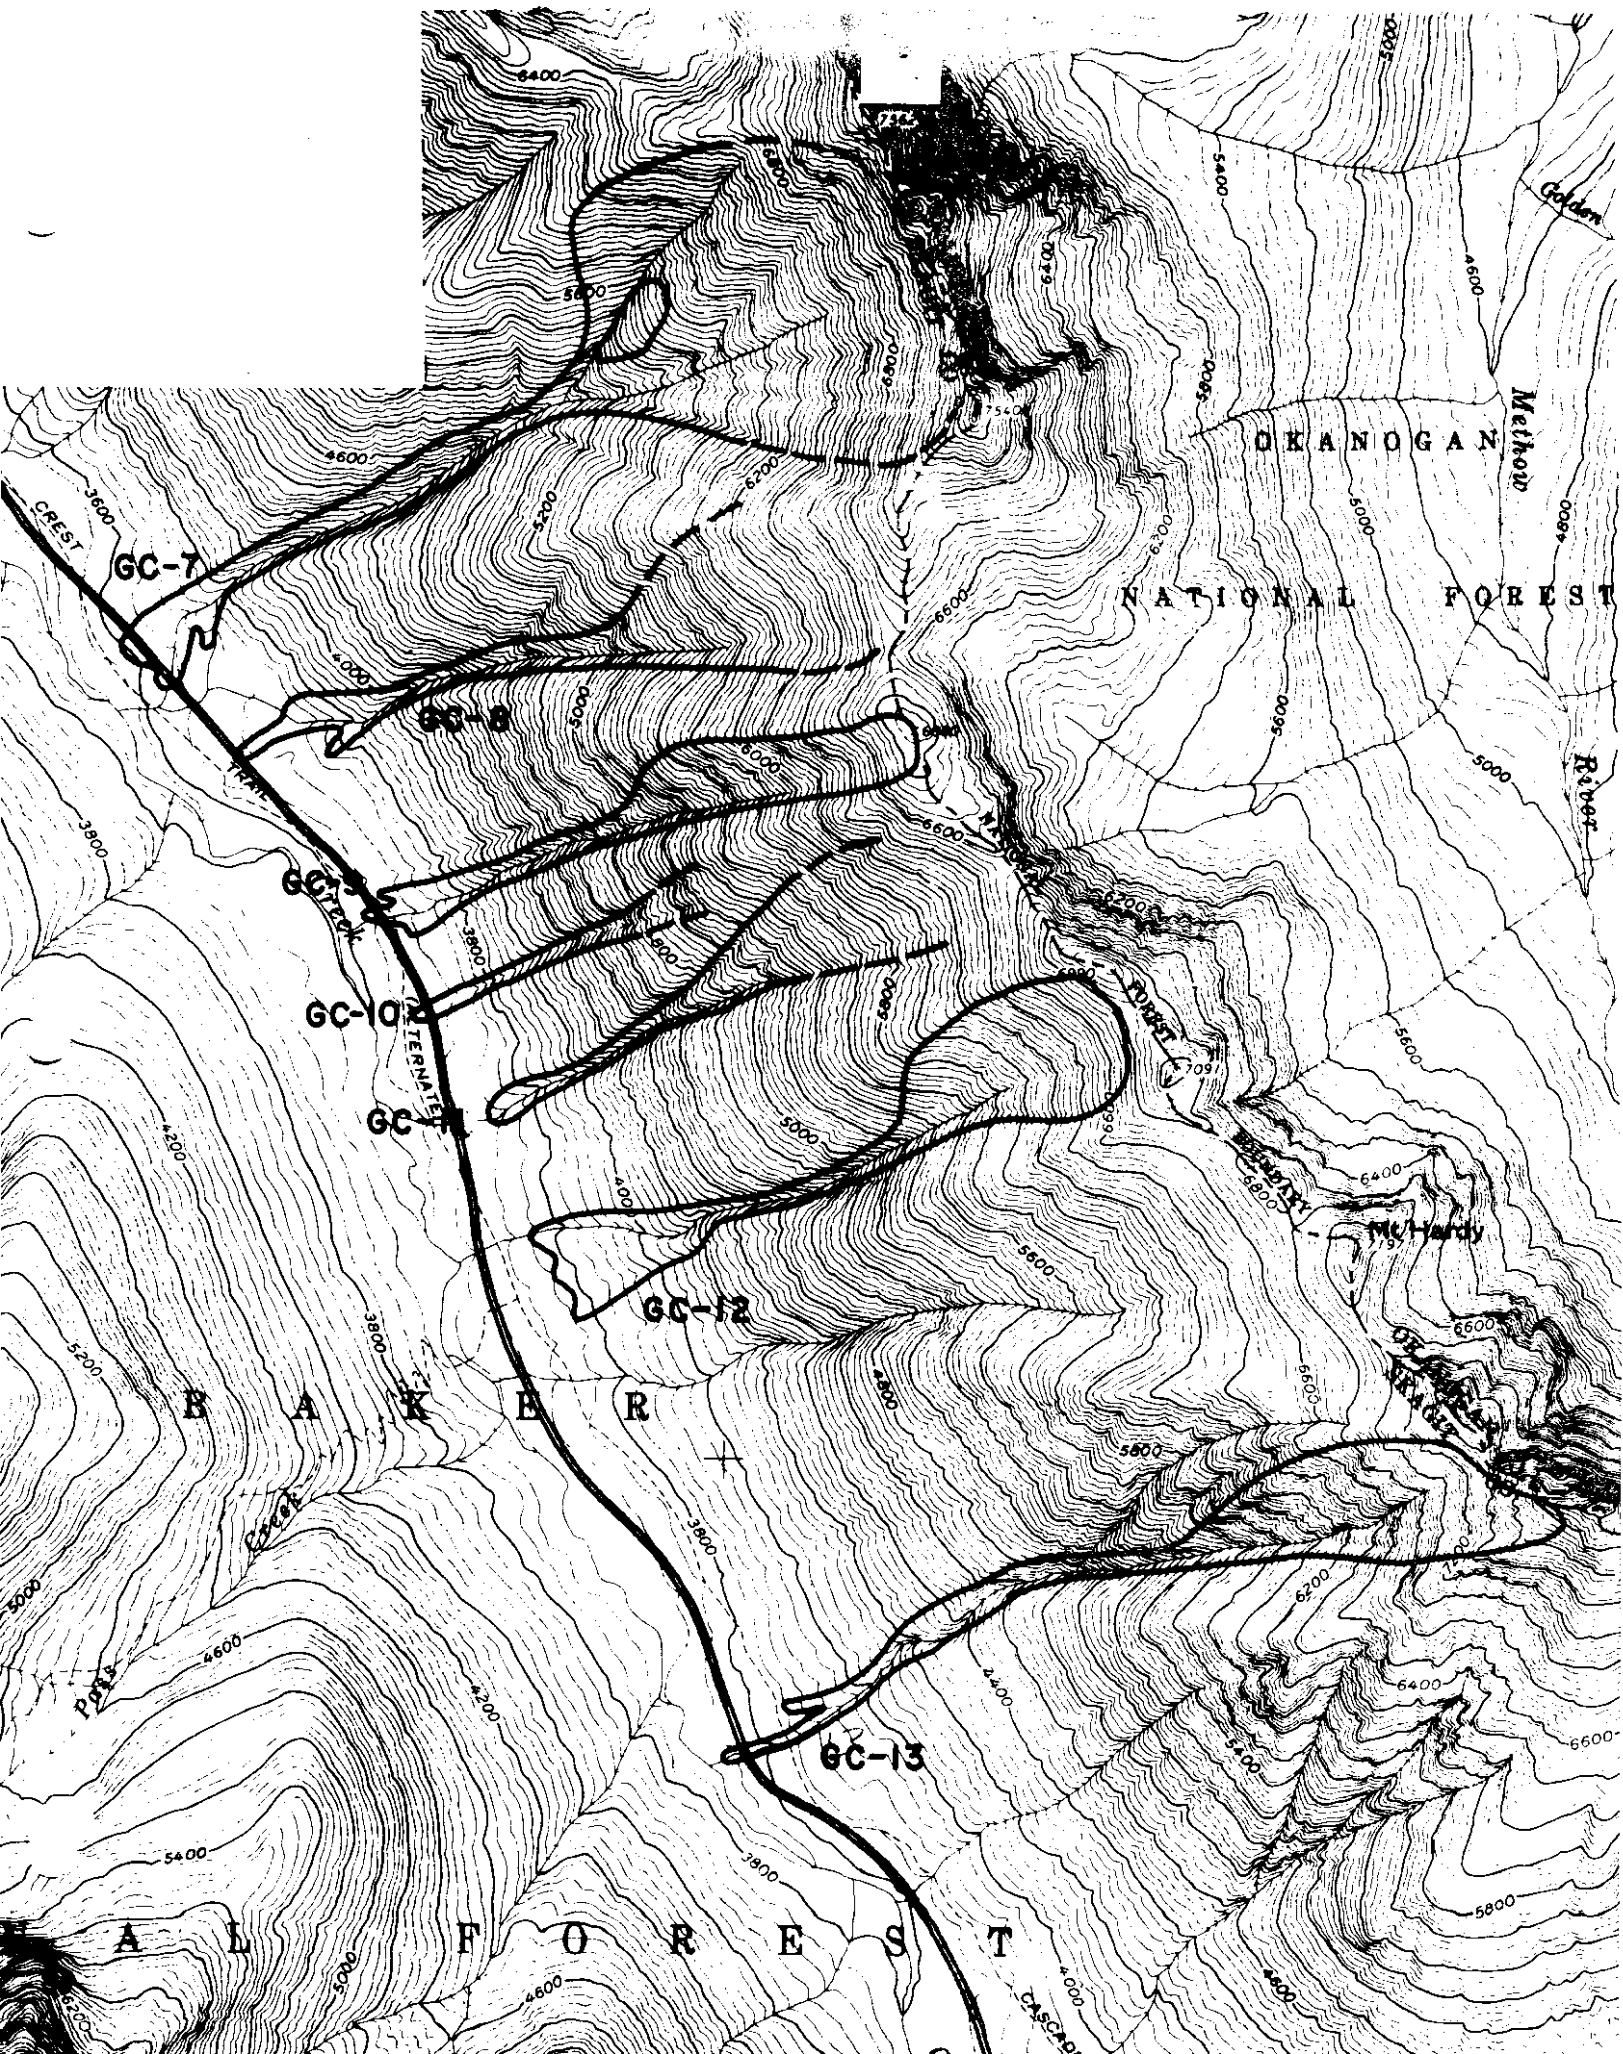
Granite Creek No. 7 through No. 13 (GC-7 through 13)

One small avalanche was reported reaching the highway from GC-10, but no snow debris remained from this in mid-April.
