**CASCADE PASSES****AVALANCHE  
ATLAS****Part 1****Chinook, Cayuse, White and  
Snoqualmie Passes**

August 1974

## Cascade Passes Avalanche Atlas

#### Chinook, Cayuse, White and Snoqualmie Passes

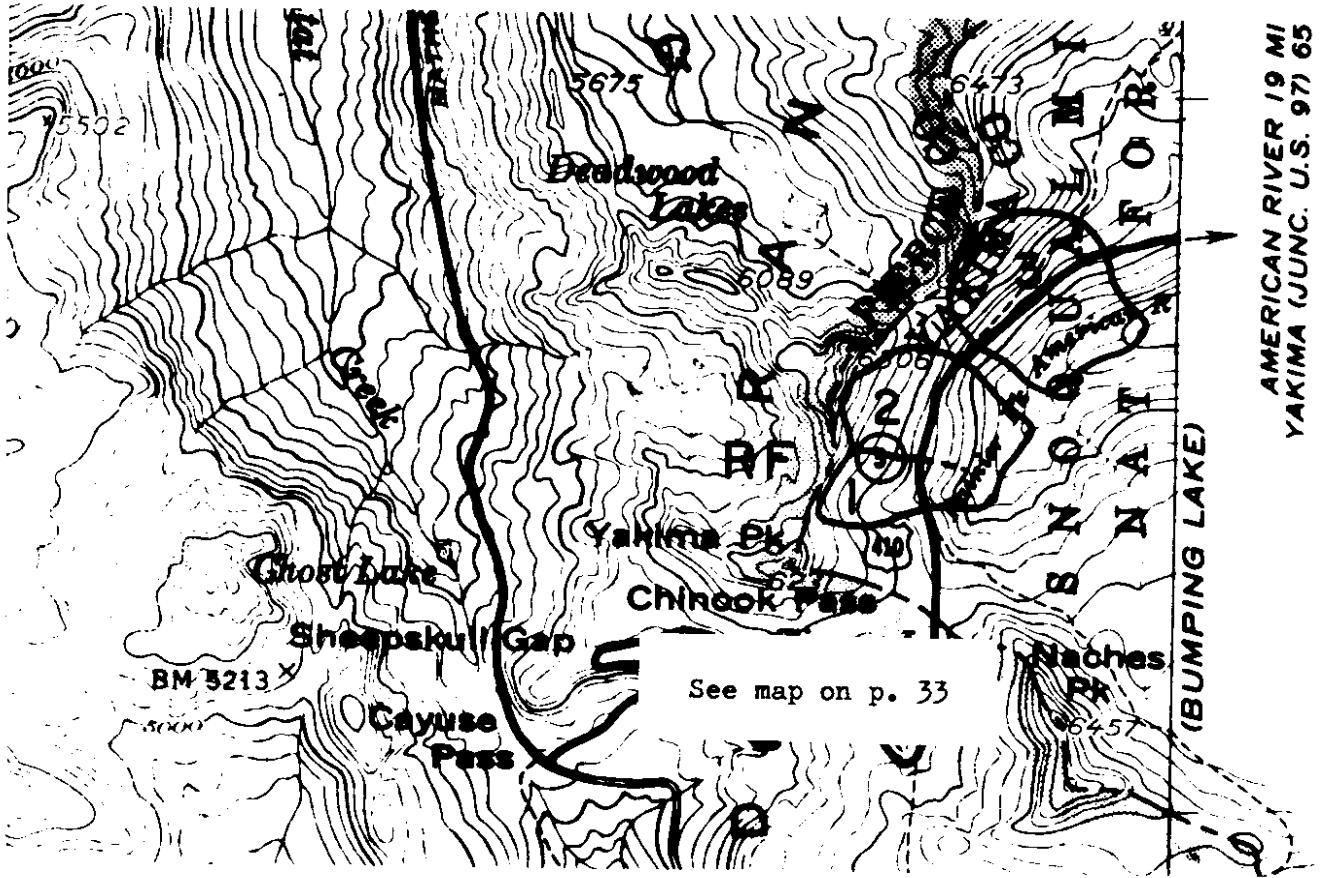
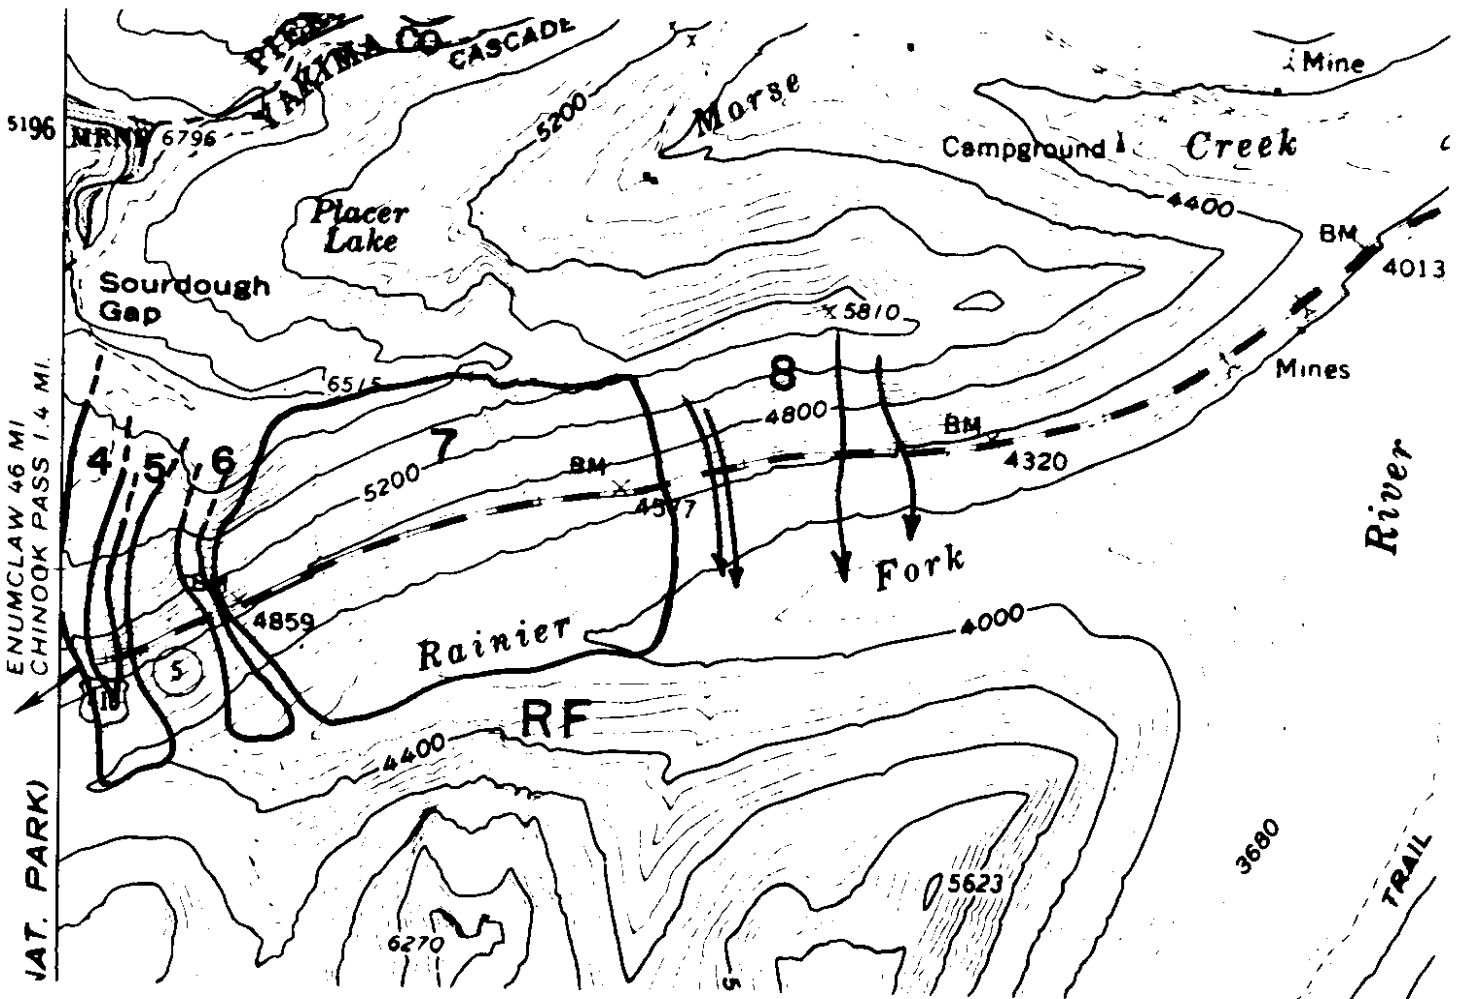
Name of Path: Windy Point East (WE)

Normal run is into the lower switchback of U.S. 410 and beyond. Maximum run is into the trees below this lower switchback. At the extreme S.W. end a finger occasionally reaches across S.R. 123. Highly active, no timber debris, and a frequent hazard to the highway. Rocks can come down with spring wet slides.

No mid-winter observations. Spring plowing indicates frequent heavy avalanching each winter to U.S. 410 and occasionally to S.R. 123.

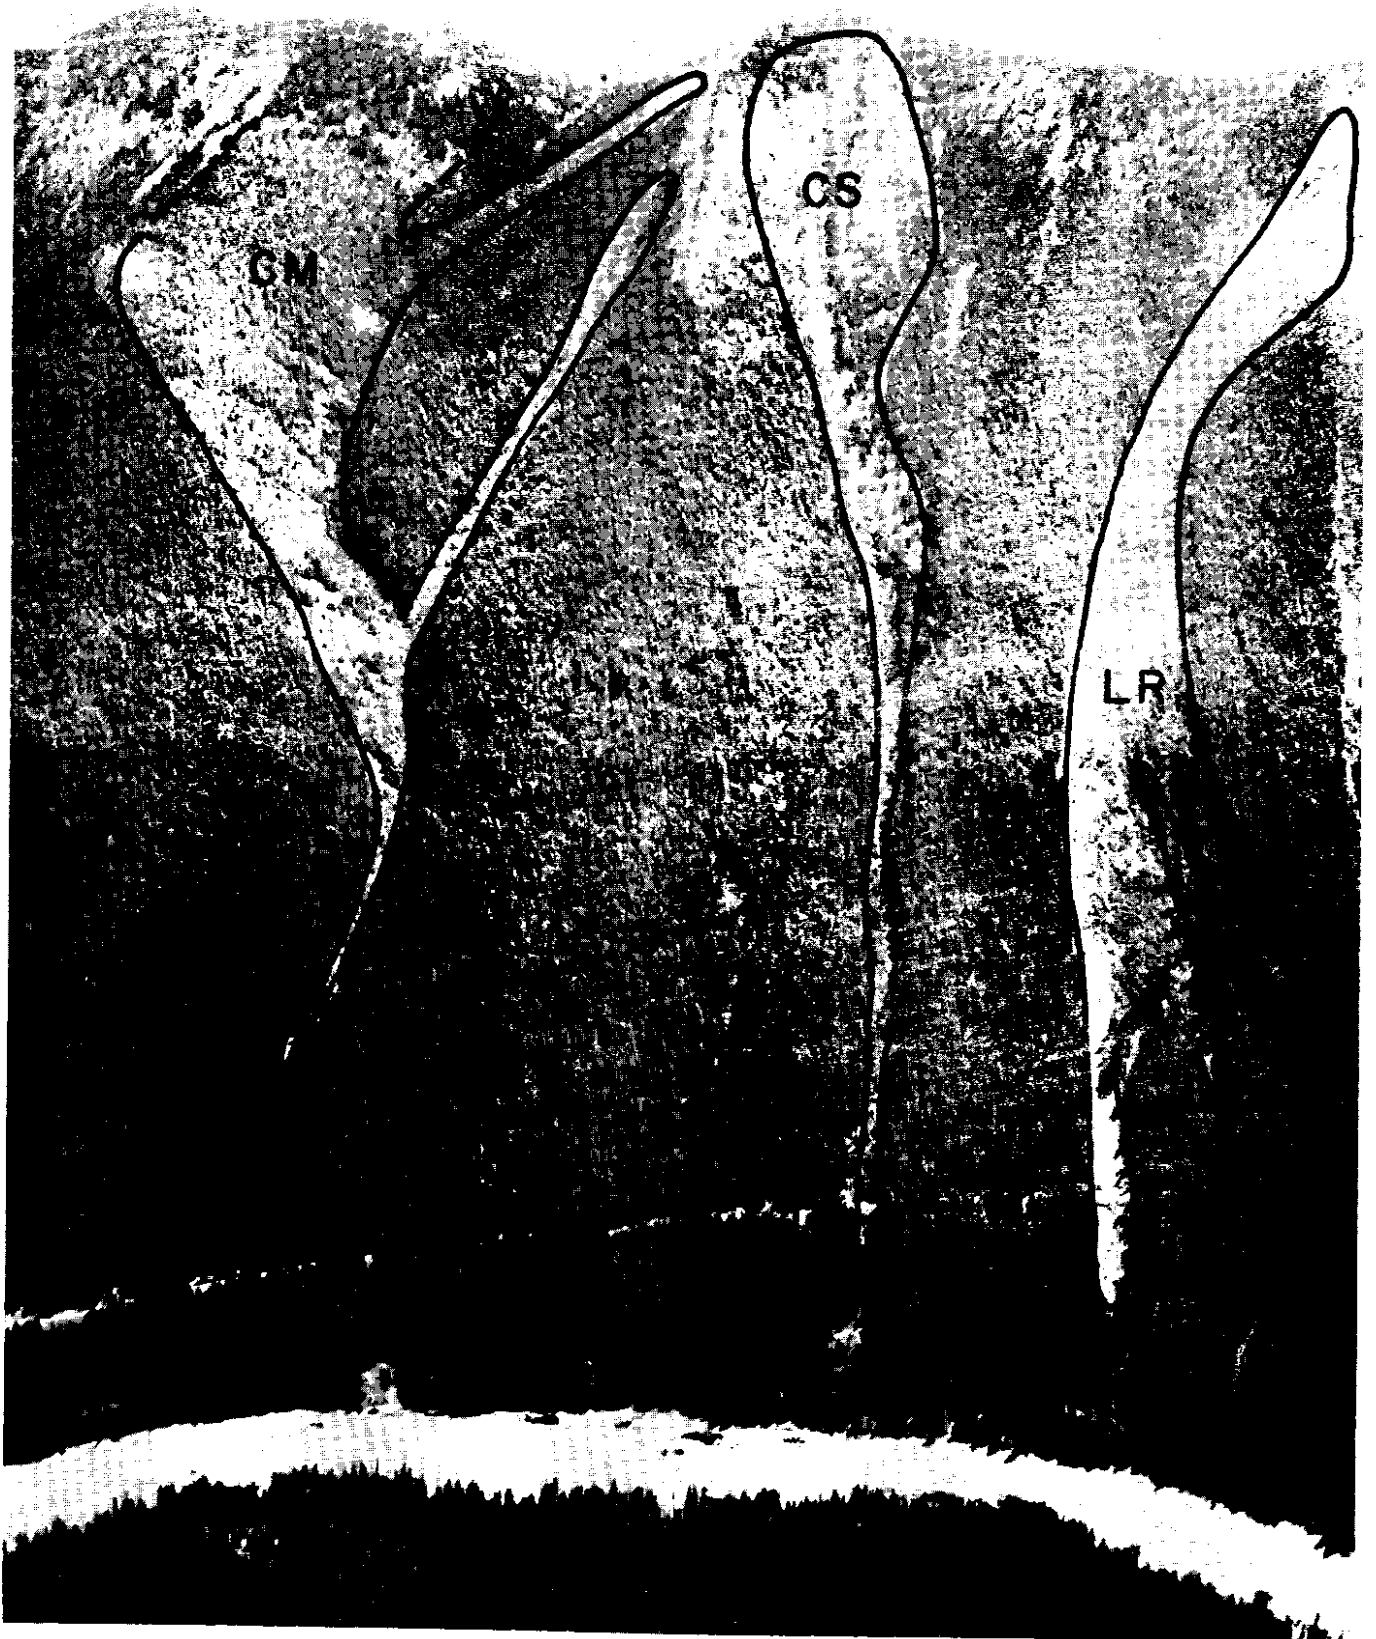
Just to the south of LR is another avalanche path with three similar fingers reaching to 3800' level. It is possible that an exceptional avalanche on this path might one day cause one of these fingers to break through to the highway.

Infrequent large avalanches, usually laden with timber, can cross the highway and leave a deep debris deposit. There is a possibility that the second finger of LR could also break through the highway under exceptional avalanche conditions.

Highway Department personnel report that this path has not slid "in some time". The National Park Service reports that a major avalanche with timber destruction fell here on 20 Jan. 1972. Timber destruction along the trimlines at highway level confirms that a sizeable avalanche has fallen recently. This path has long been known as an active, if infrequent, generator of large avalanches. Slides are known to have fallen in 1948 and 1957; others may have occurred but are not recorded.

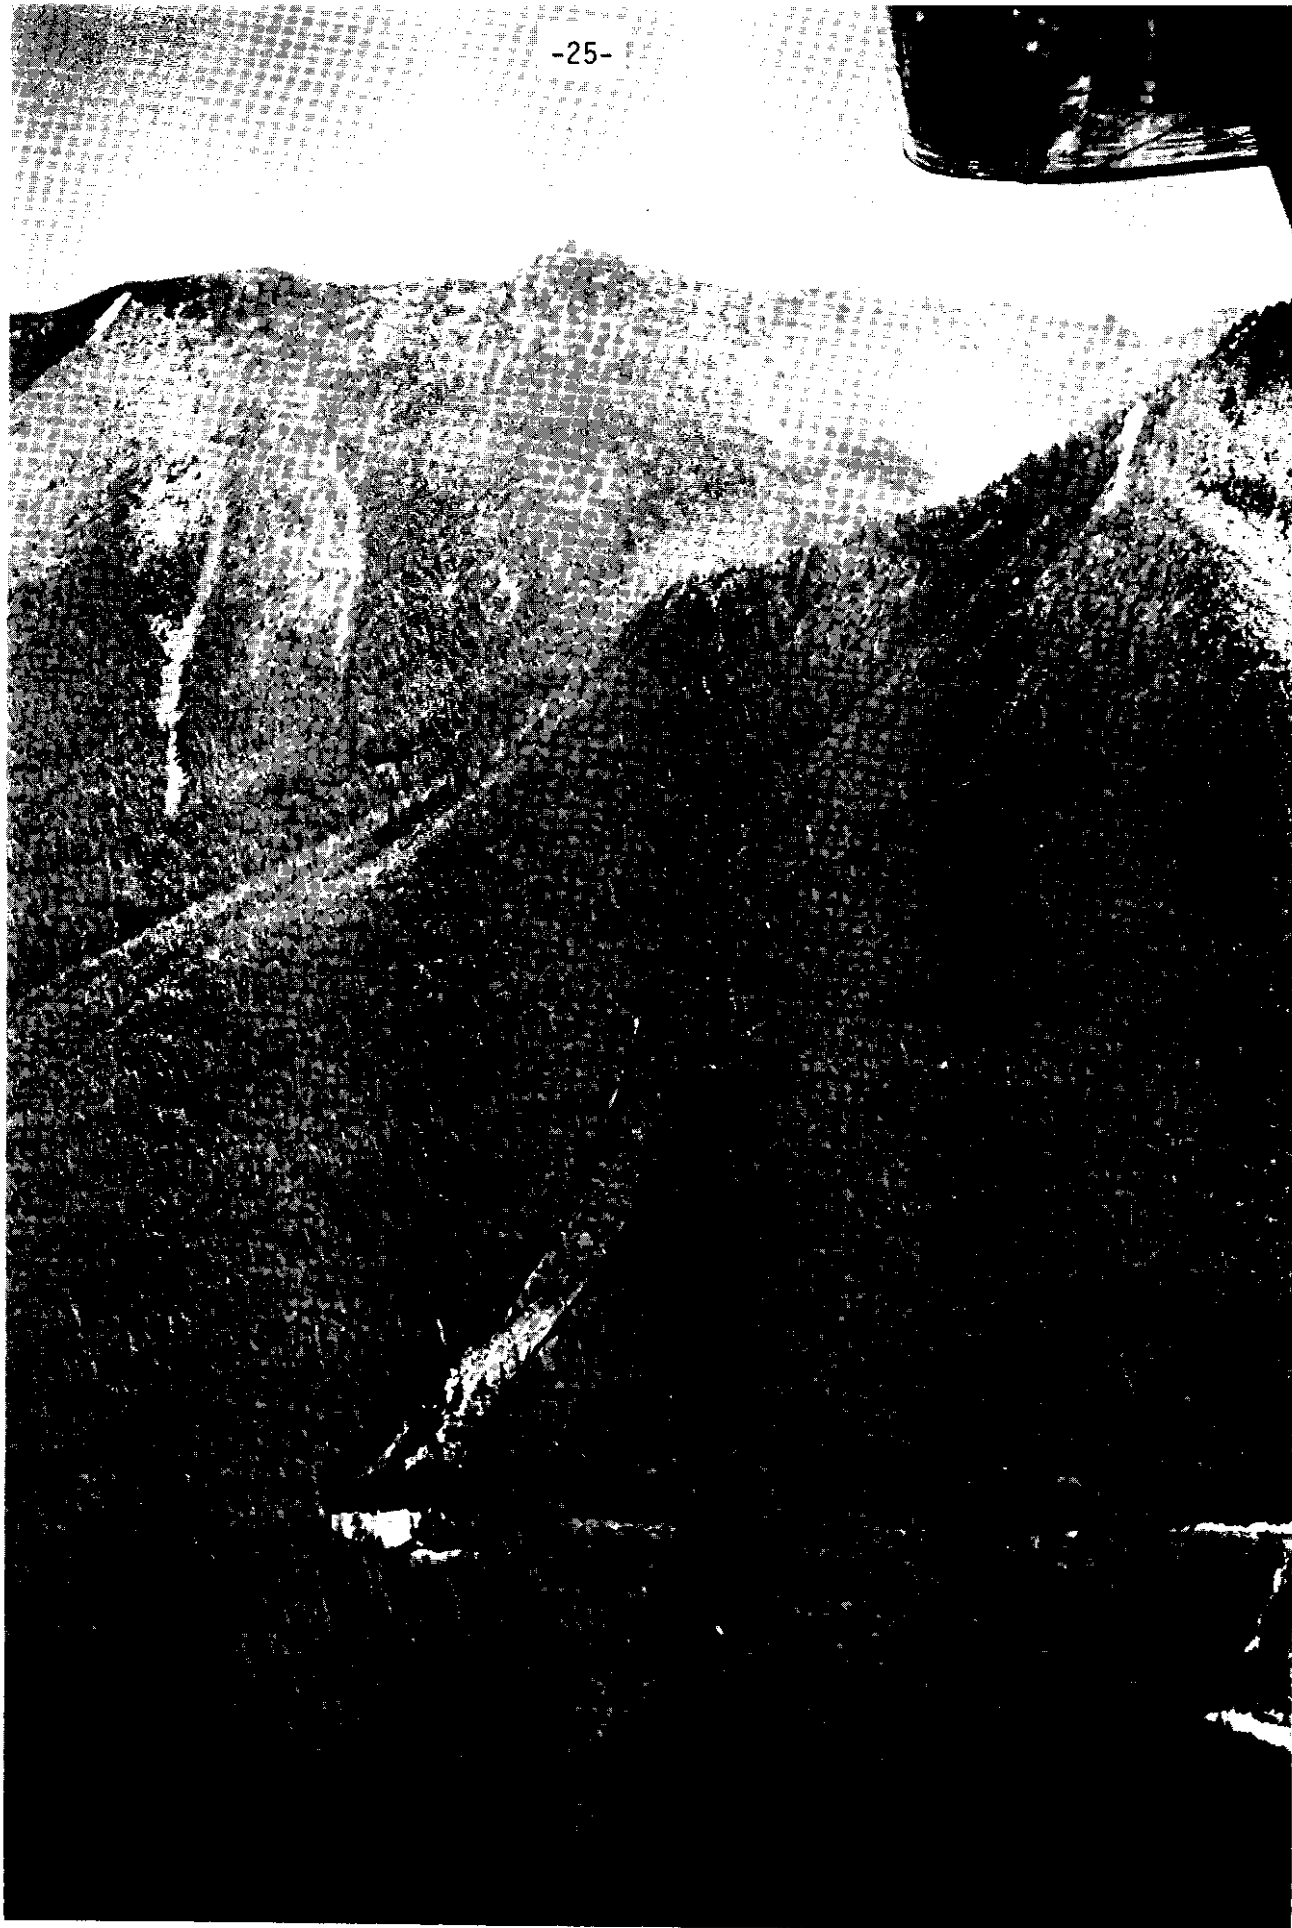
The smooth release zone has a broad arrow shape bordered by trees. There are many young trees in the slide path. The path is quite wide and pronounced at the road, 500 ft. There are few signs of timber damage below the "Y".

Will probably reach the road annually. Maximum run would be to ~200 ft. below the lower leg of the "Y".

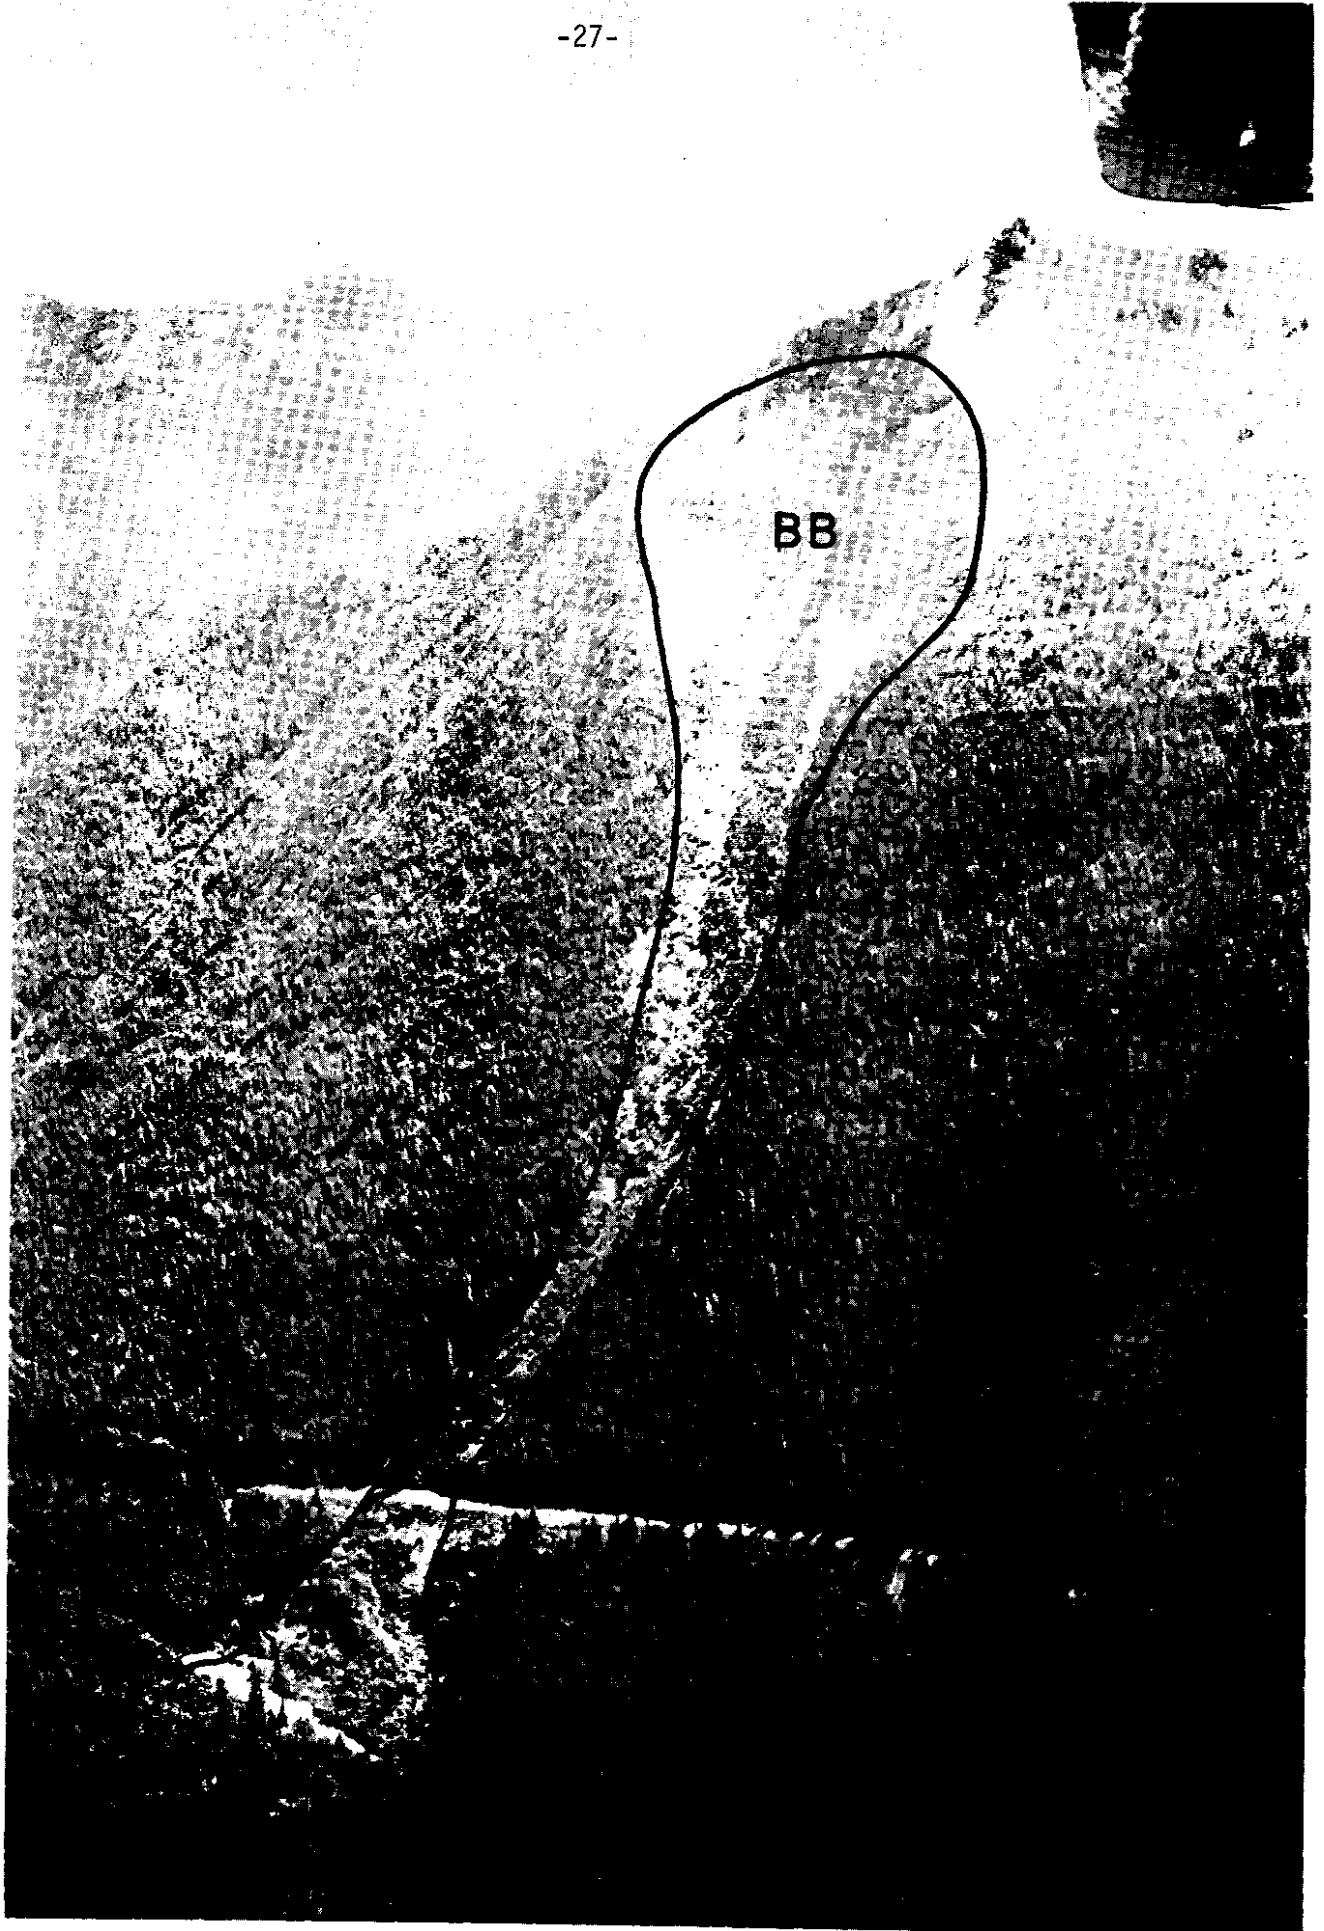
Highway Department personnel report that this path crosses the upper road at least once each year. On Feb. 22, 1956, this path slid twice, depositing debris 13' deep and 1000' wide on the Sunrise Road. A slide crossed both U. S. 410 and the Sunrise road on Feb. 22, 1967. Three elk were found in the debris. Other major avalanches were recorded on Mar. 23, 1967, Jan. 15, 1970 and Dec. 31, 1970.

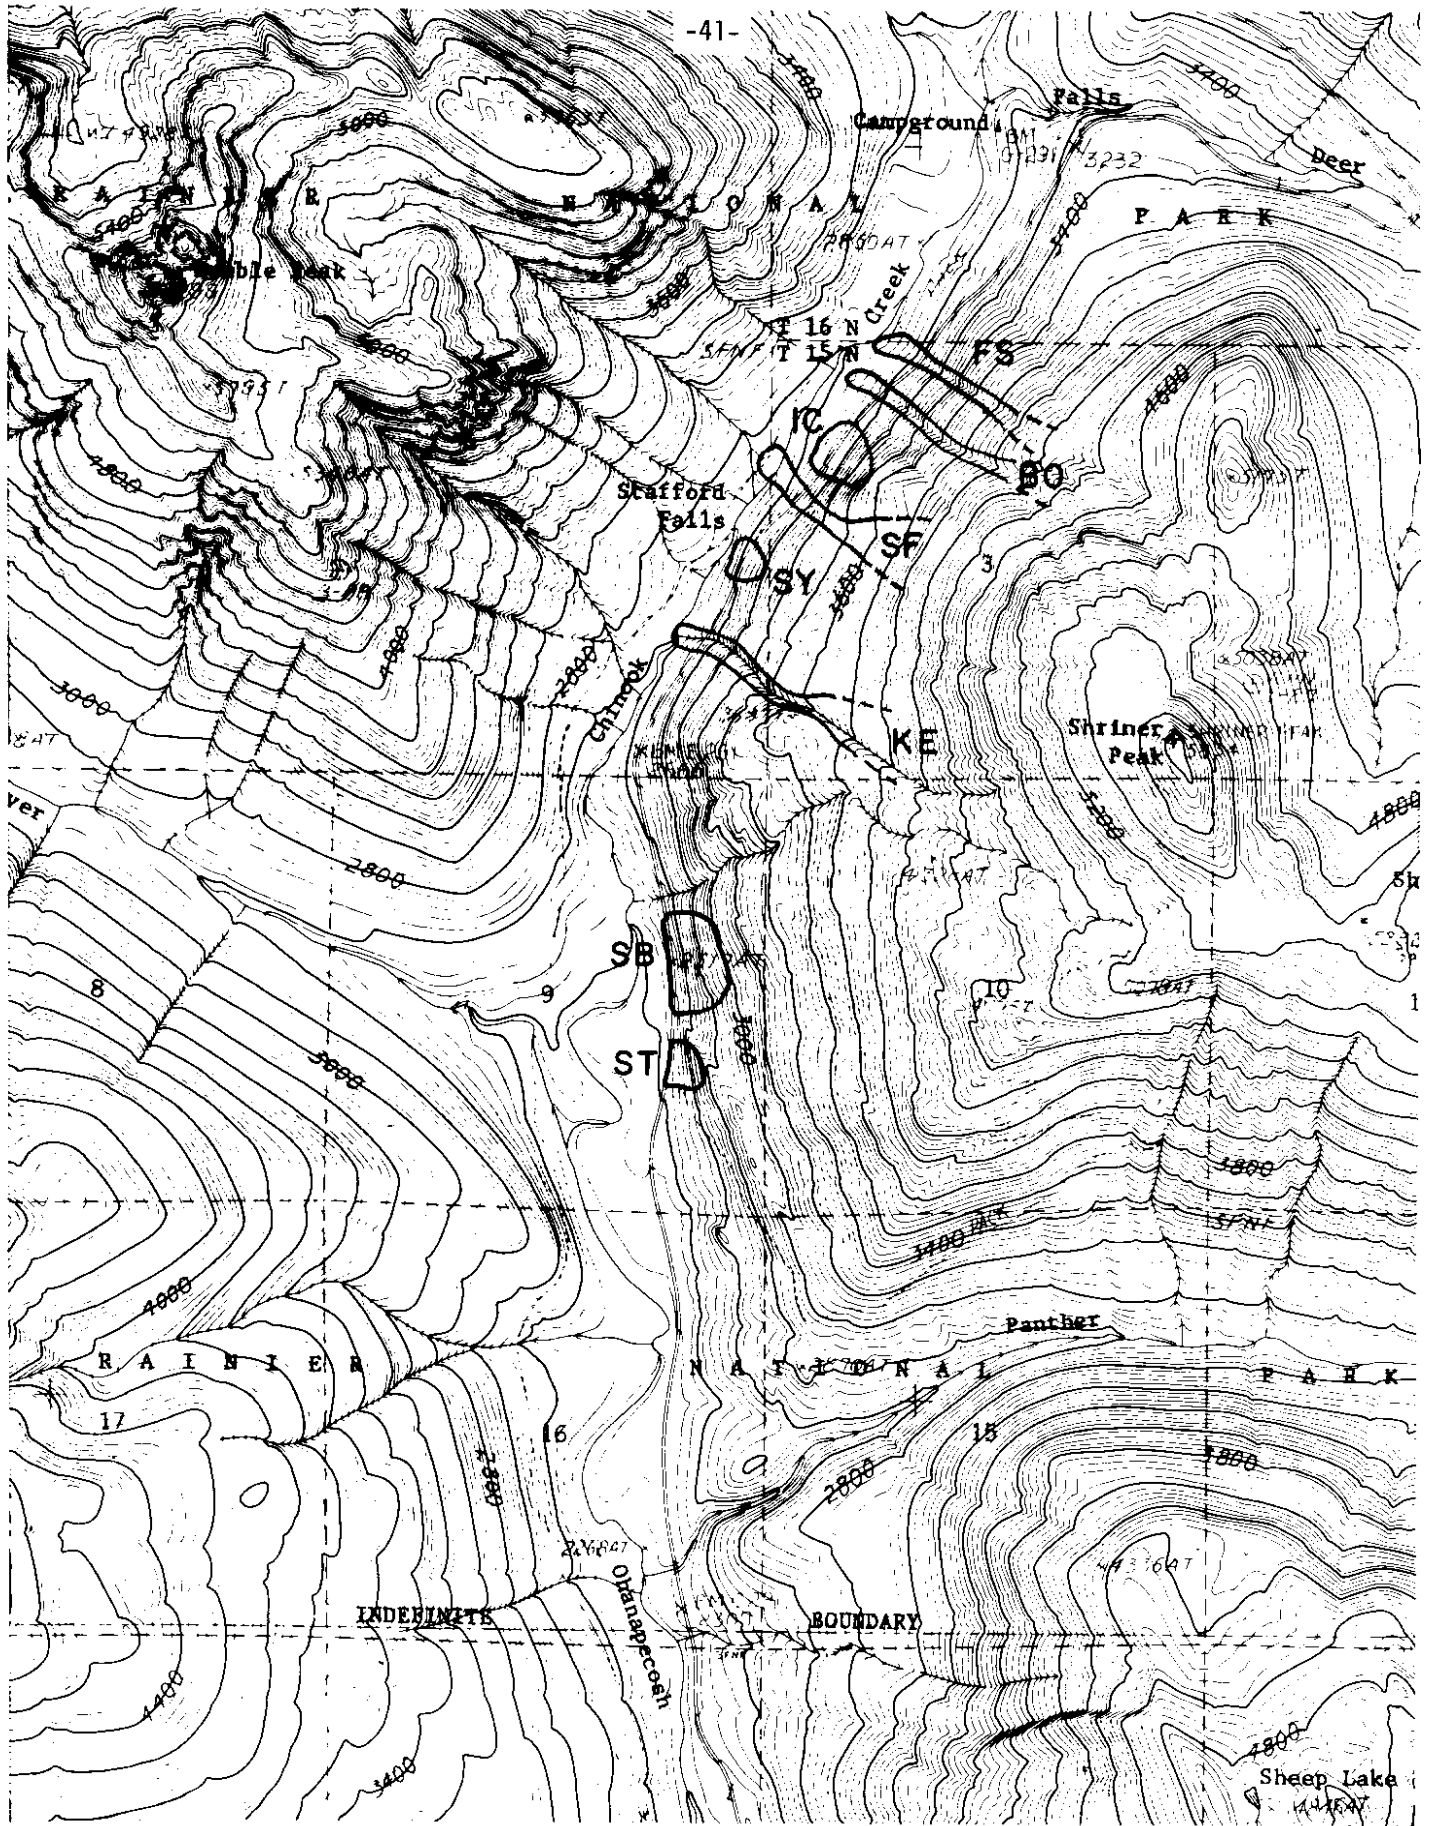
Slides every year with only an average snowfall. Always sluffs off  
tunnel at both ends.

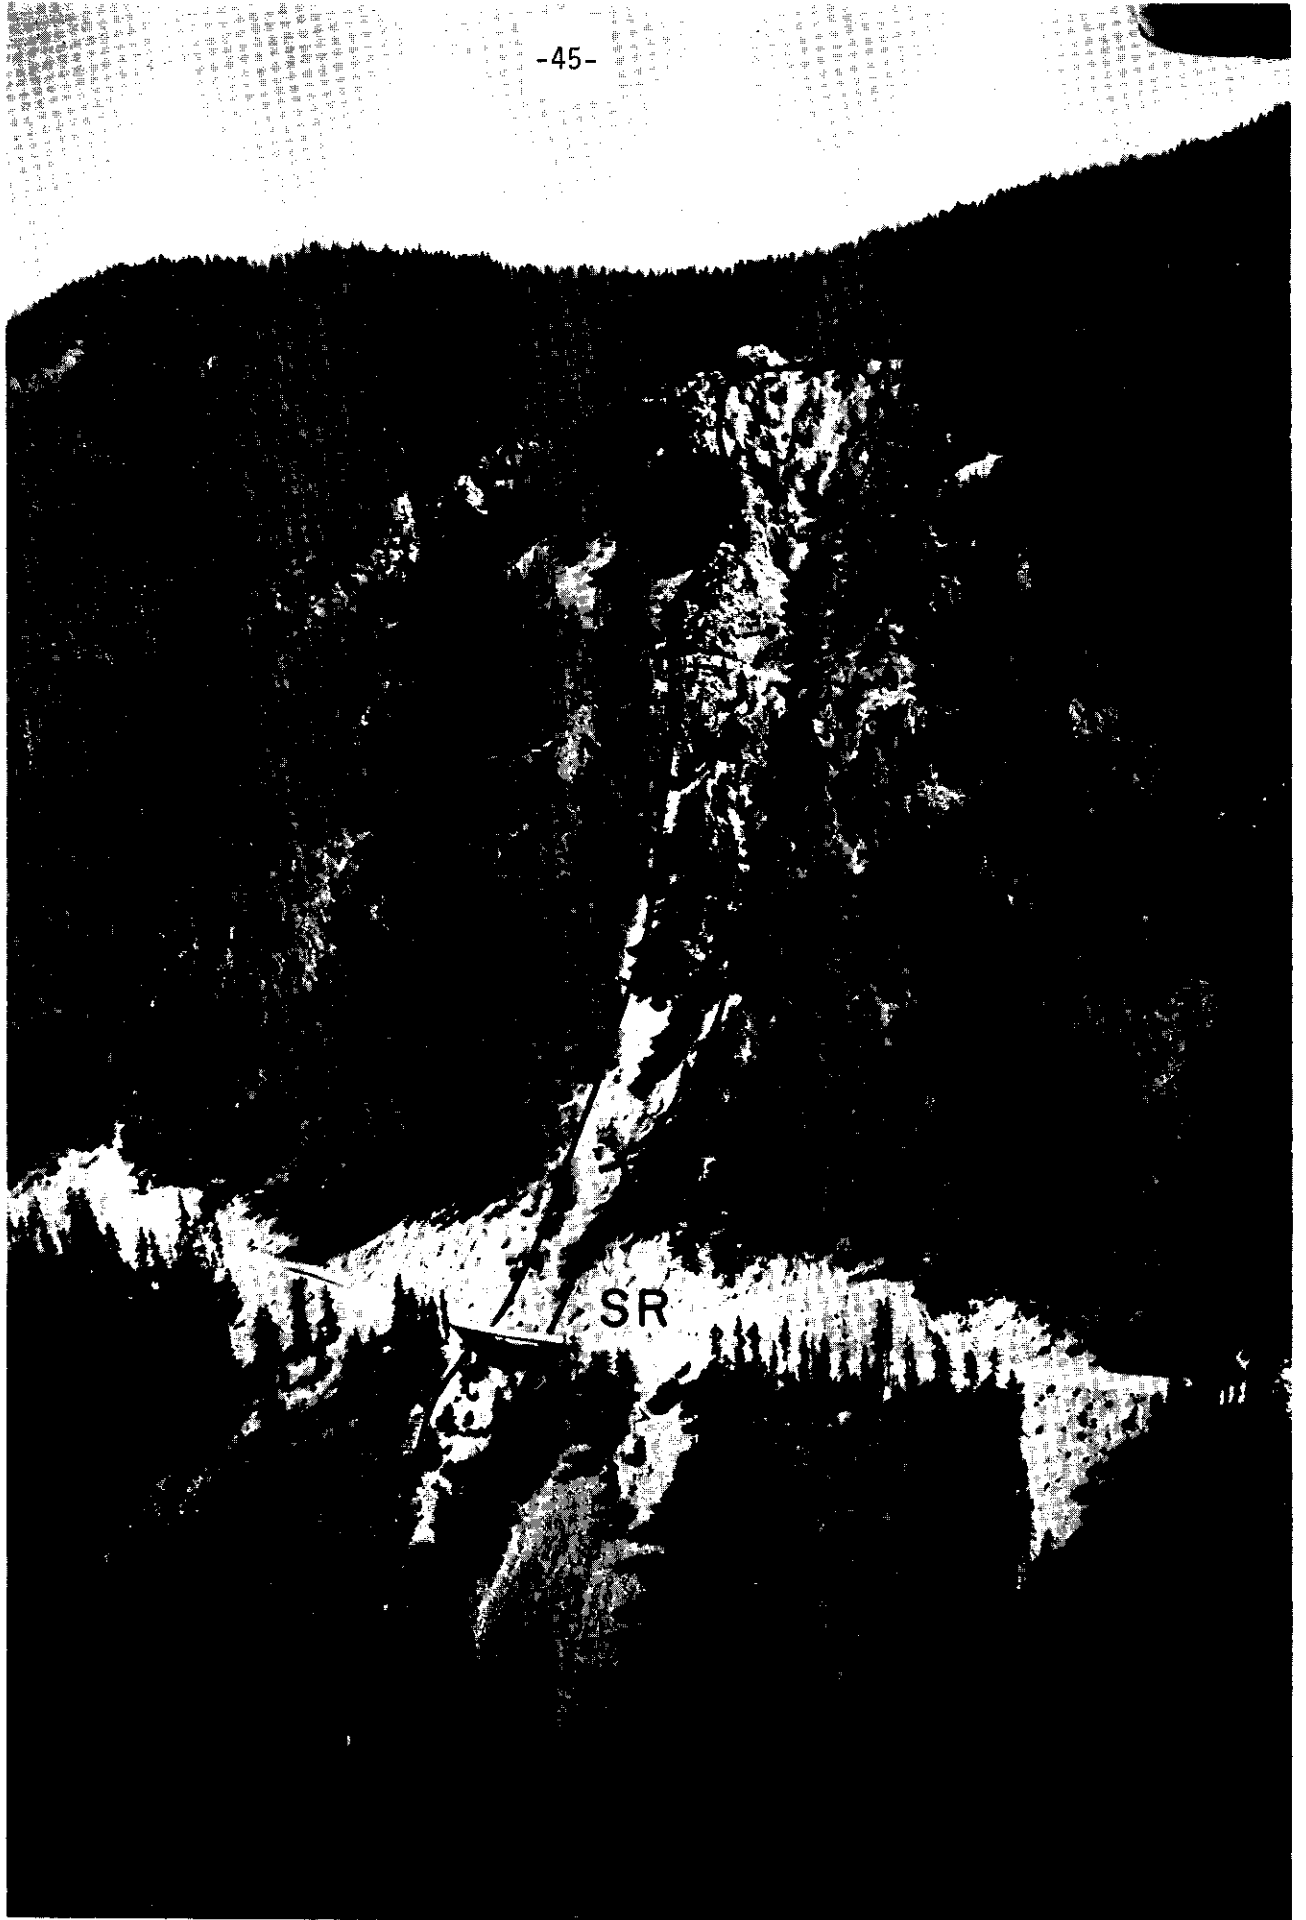
Breadth at road - 200'. (There is a broad bank slide on either side of the bridge.)  
The channelled avalanche path runs under the bridge from a release zone at the ridge top. Terrain is rocky, broken and lightly timbered.

Normal run and maximum run will be beneath bridge to timber below. This is primarily a wet snow slide area. In the event of unusual dry snow avalanche conditions, wind blast could damage the bridge and endanger traffic.

Has never hit road.  
The adjacent bank slides are a significant hazard. They fill up road to a considerable depth.

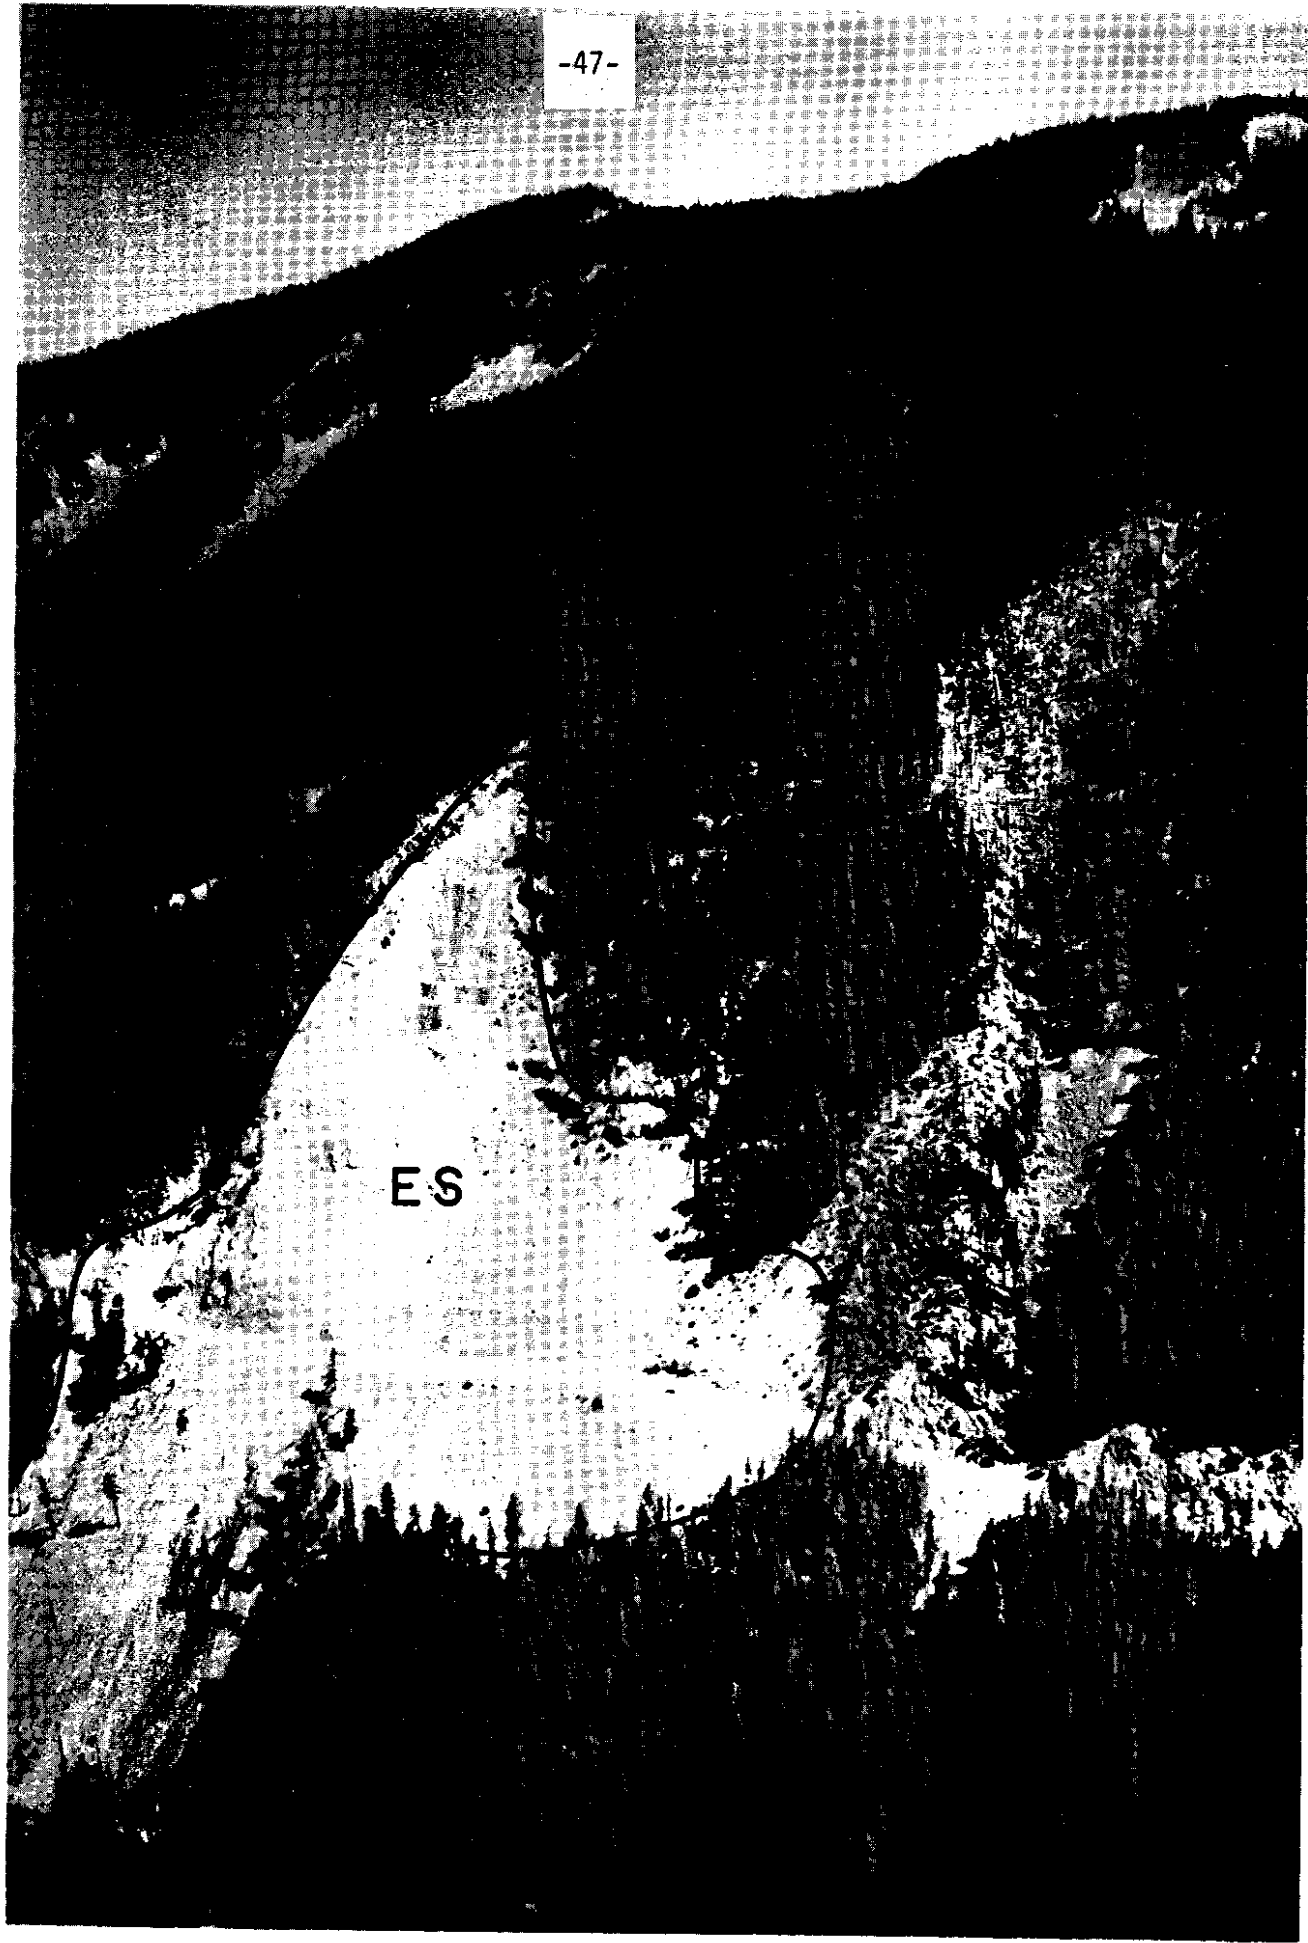
This is a large and apparently man-created avalanche. It is a frequent performer running annually or oftener. The terrain is a smooth, very high cutbank with open, loose, sandy soil and no vegetation.

There is an old burn just to the E of this path which is a potential avalanche path, but has no history of sliding to the highway.

This slide is named for a highway maintenance man who was once buried by it. The benches in the slope used to reduce slide frequency, but erosion has wiped them away. Usually puts 5-6' snow in the highway but can deposit snow up to 20' deep in a bad year.

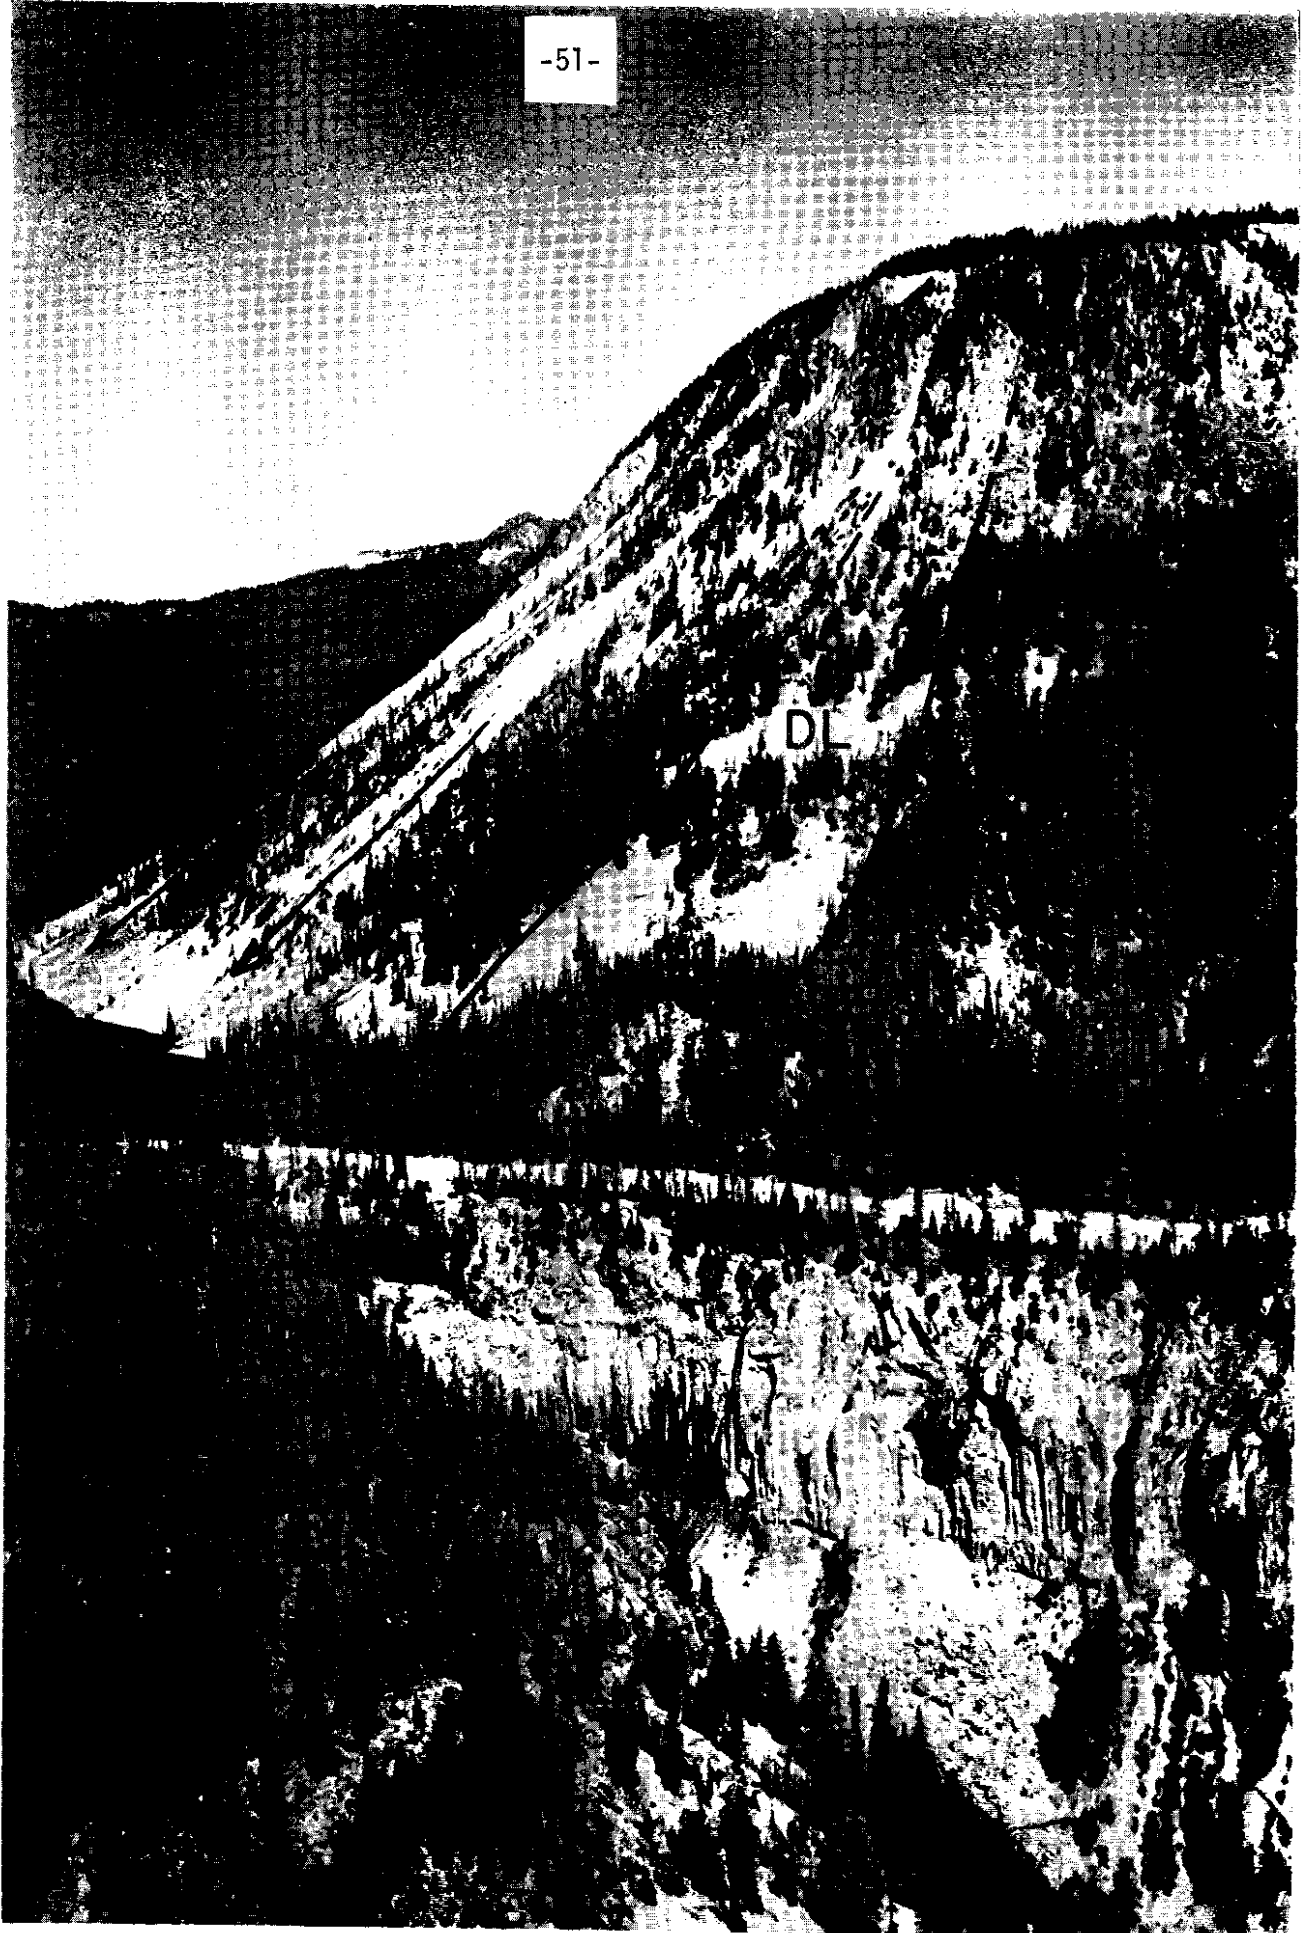
Effects on vegetation indicate this path has run to within 100' of the highway within the past 3-4 years.
