**CASCADE PASSES****AVALANCHE  
ATLAS****Part 1****Chinook, Cayuse, White and  
Snoqualmie Passes**

August 1974

## Cascade Passes Avalanche Atlas

#### Chinook, Cayuse, White and Snoqualmie Passes

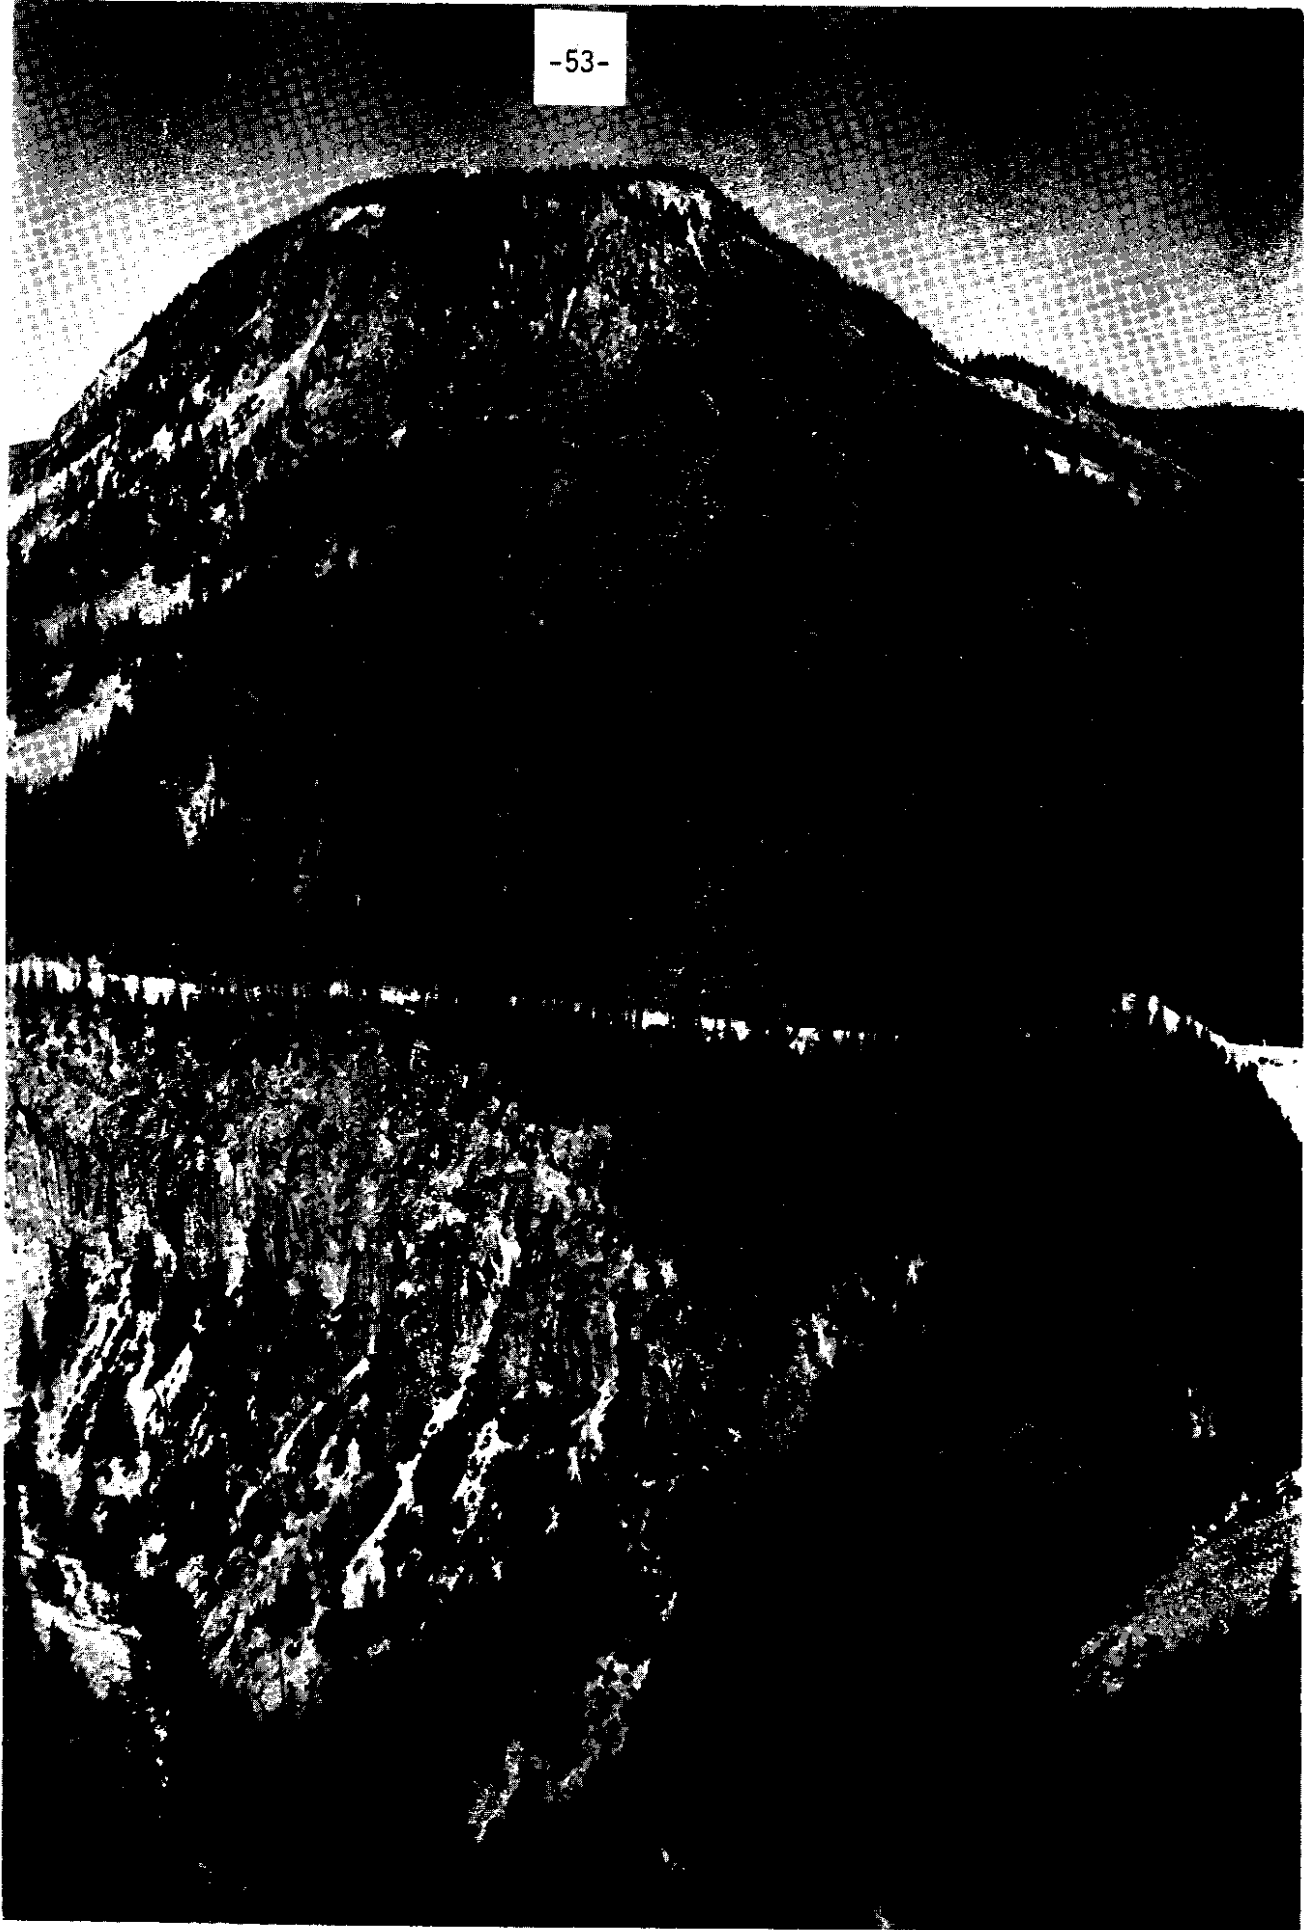
Some avalanche snow reaches the highway here every year. There have been two major avalanches with a large amount of timber debris in the 21 years prior to 1973/74. In 1973/74 a third such avalanche occurred when the eastern part of the path broke through mature timber to the highway.

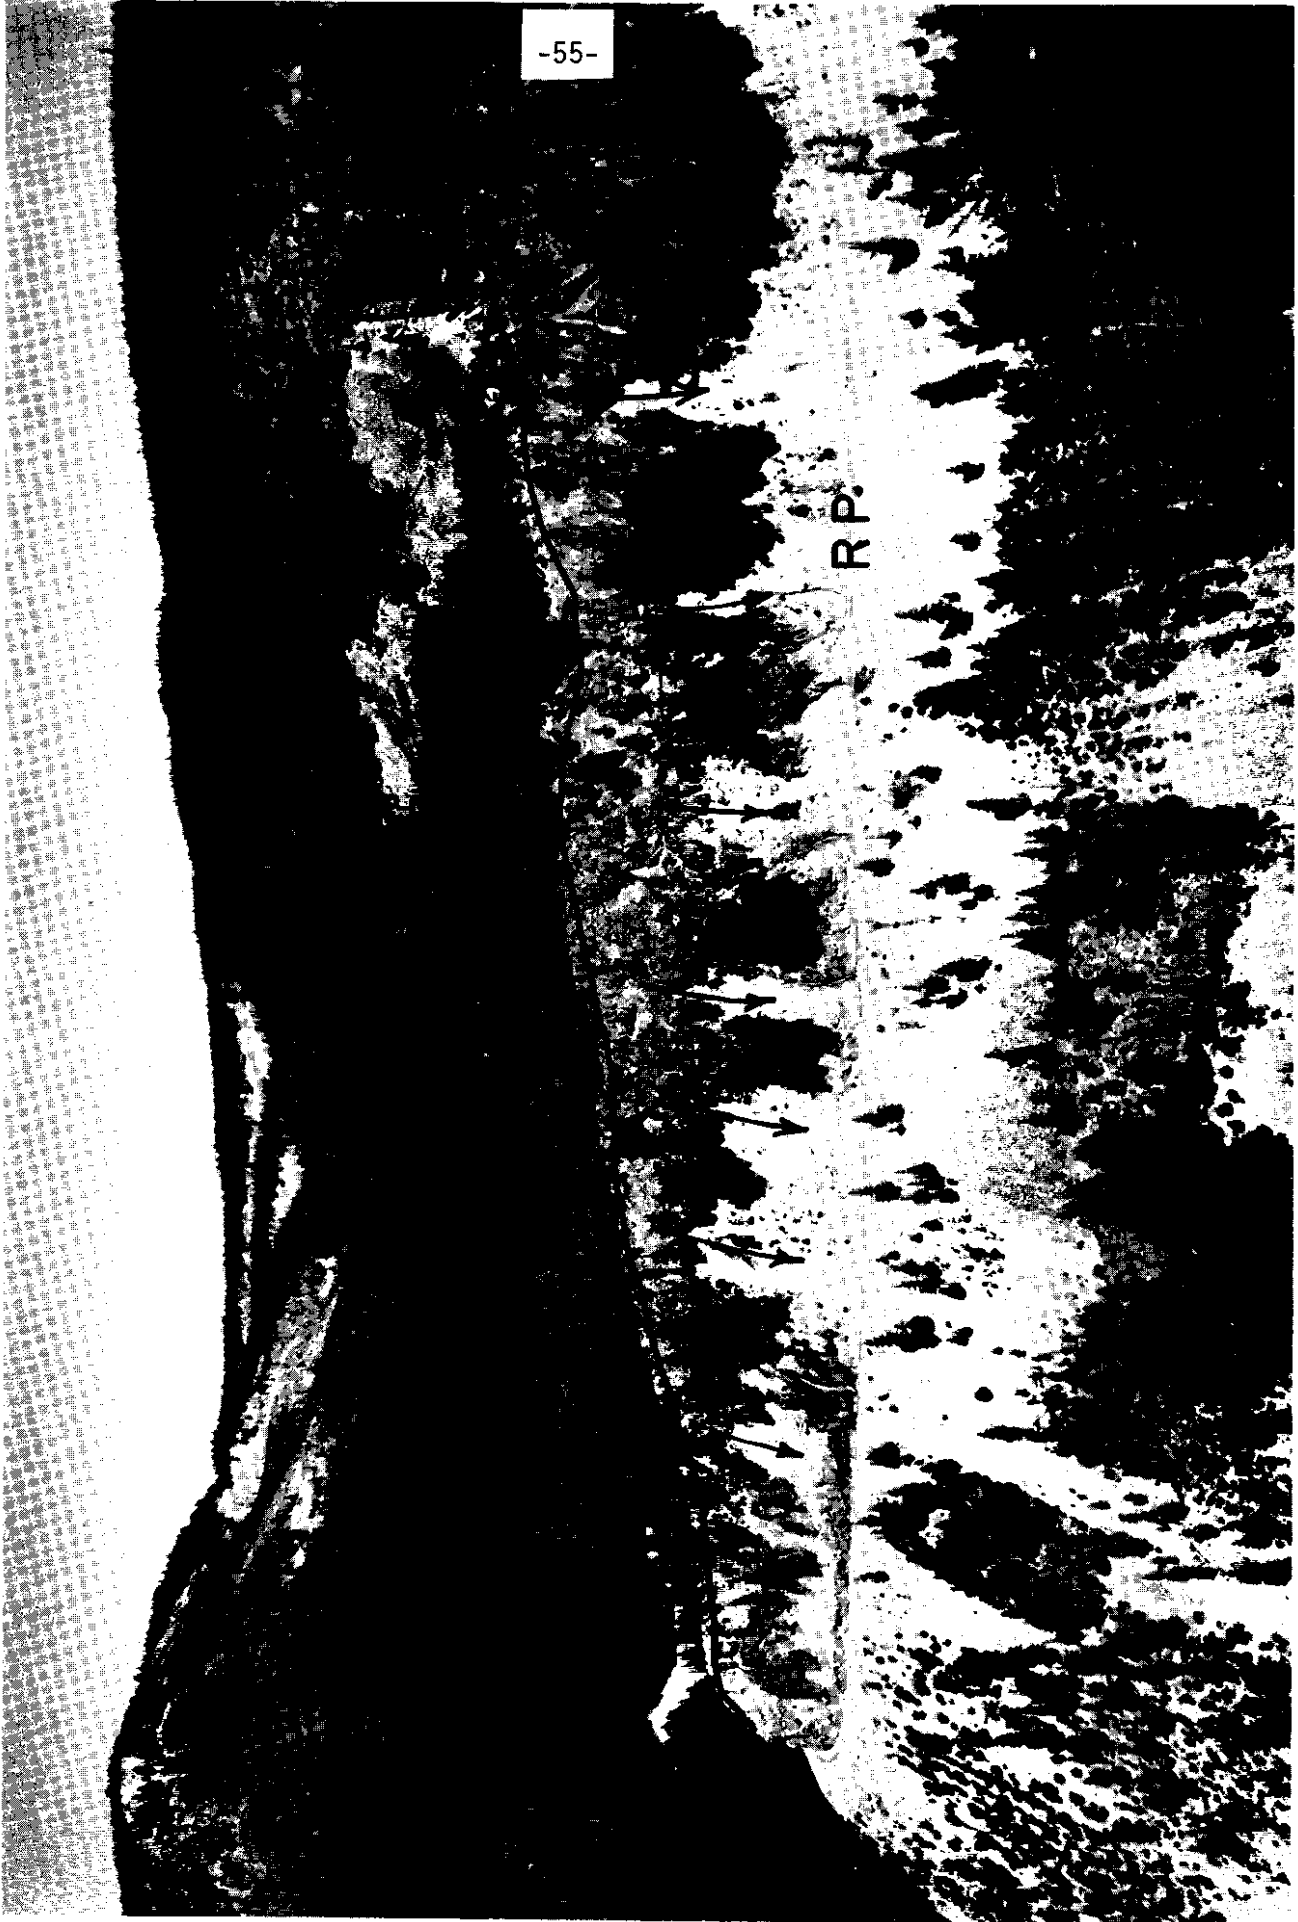
RP.

This area slides "all the time" (Highway Department). A man was buried by a slide in the Rocky Point area in 1971.

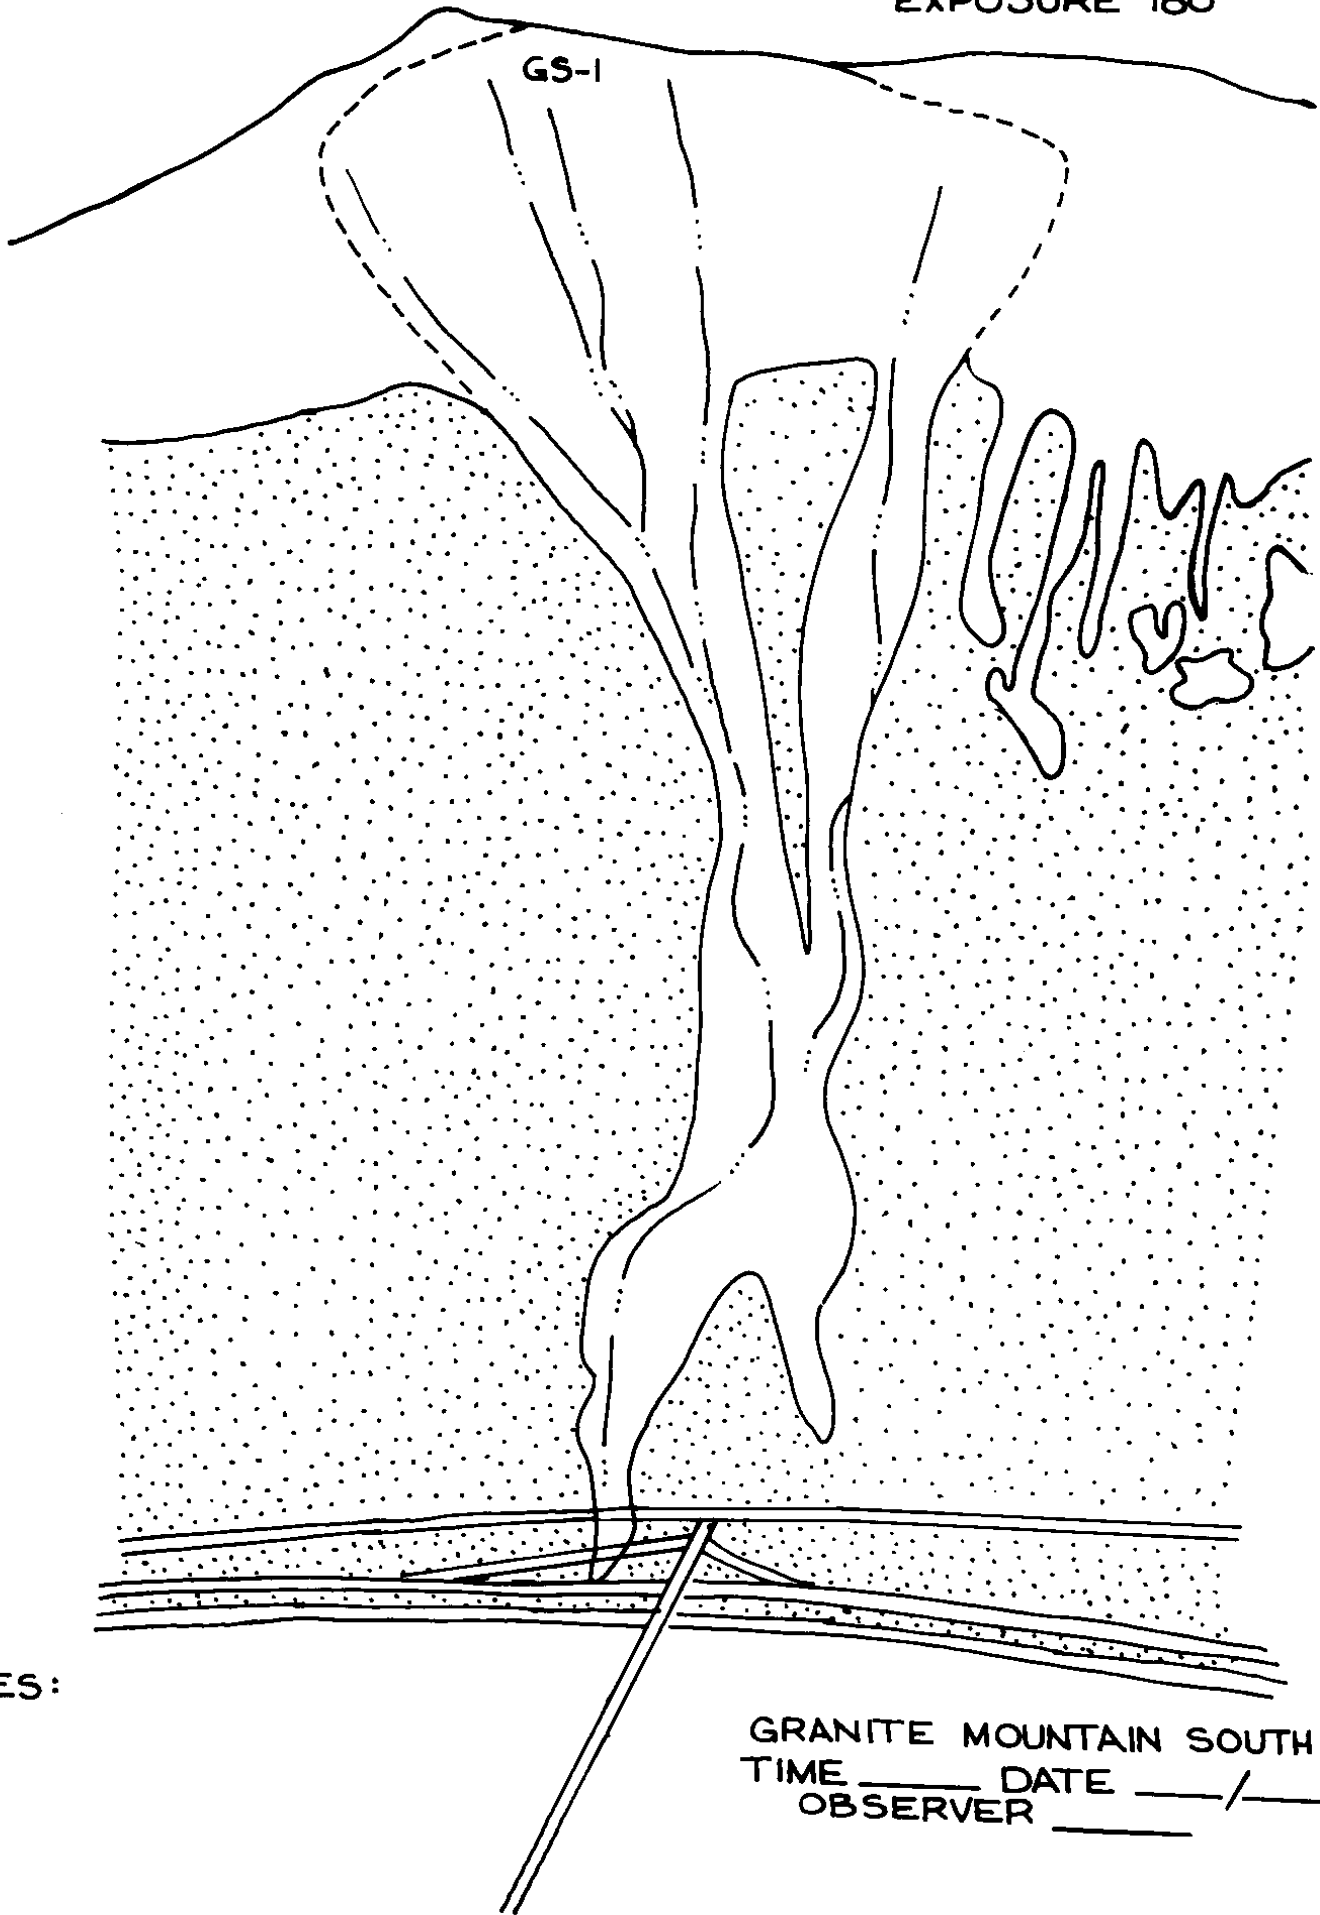
GRANITE MOUNTAIN SOUTH GS-1  
TIME \_\_\_\_\_ DATE \_\_\_\_/\_\_\_\_/\_\_\_\_  
OBSERVER \_\_\_\_\_

Description: Path GS-1 lies on the southern flank of Granite Mountain. The starting zone is a very large old burn. Only a sparse cover of conifers and huckleberry cover this area. There are several bare rock outcrops. Three distinct gullies from near the summit merge near timber line. Another chute further east joins this path near the runout zone. Midtrack below timberline is a broad old slide path with watercourses thru the center. Vegetation consist of vine maple, huckleberry and a few scattered conifers. Although a tree barrier separates the path from the highway, vegetation indicates that this slide has reached the highway vicinity in past years.

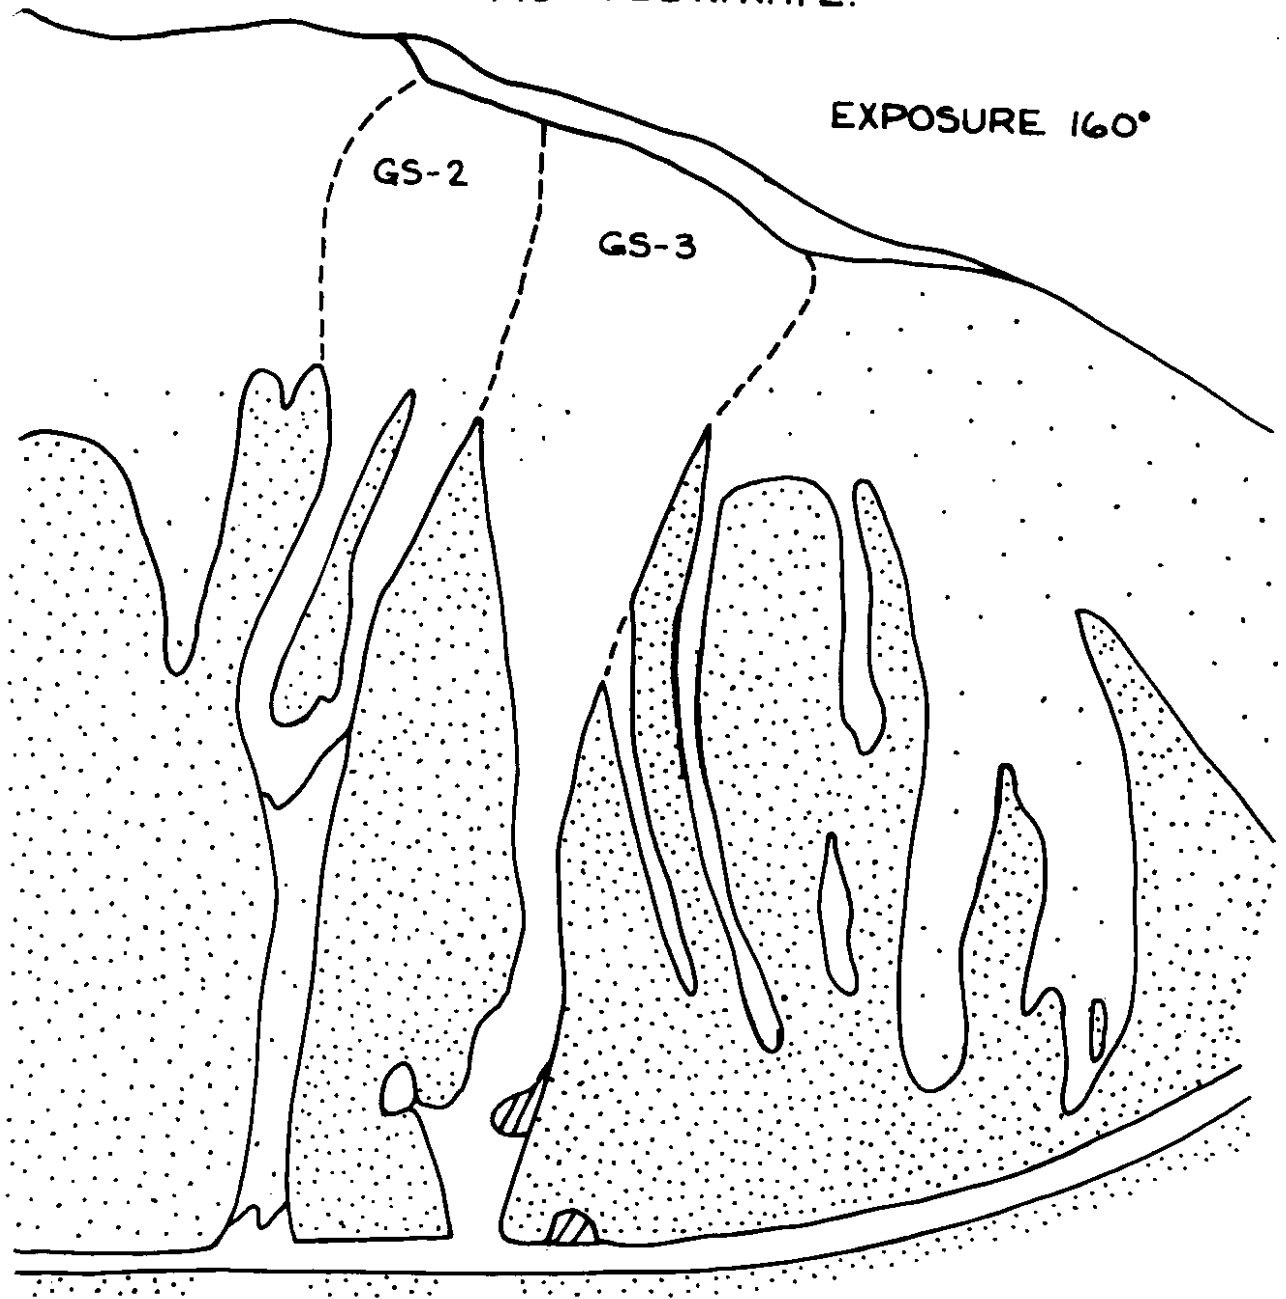
GRANITE MOUNTAIN SOUTH GS 2 & 3

Description: The starting zone of GS-2 begins above timberline in an old burn area. Very little vegetation has established itself in this area. Lower in the track is a wide area filled with vine maple and an open stand of conifers. Below this in the lower half of the track is a denser stand of timber. Evidence from aerial photography indicates that avalanches have passed thru the trees in this area.

Description: Beginning in the same high barren ridge as GS-1 and GS-2, Path GS-3 has the same burned over sparsely vegetated starting zone. However, the midtrack and deposition zones are more confined and contain far less brush. Vine maple grows to a height of 4 to 8 feet, but a growth of conifers is eliminated by constant avalanche activity. Above the proposed westbound lanes of SR90, a rock promontory deflects the snow into the treeline and impedes any avalanches which occur.

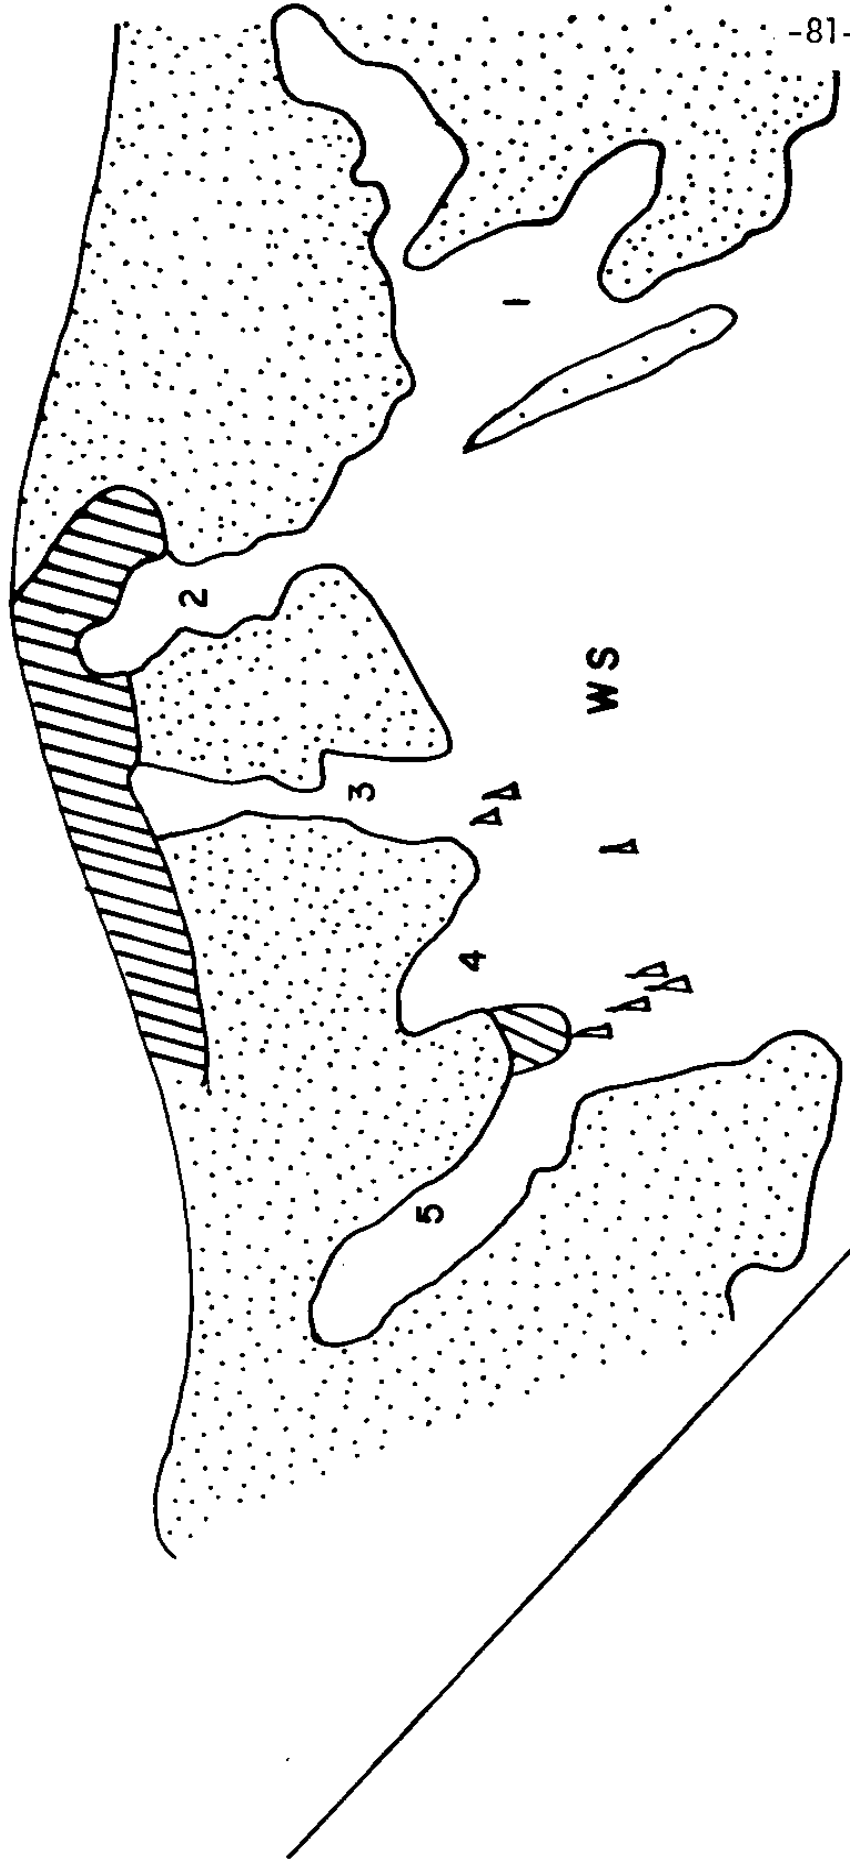
AIRPLANE CURVE/WEST SNOWSHED

Effect on Highway: Continuous clearing of sluffs and occasional large slides. Cars can be trapped between slides in this area exposing them to slide danger.

History: Over the years, this area has been a continual maintenance problem area. Continual sluffs plague the area between AC-1 and AC-3. Occasional large releases block all four lanes during each winter. Many vehicles have been caught and several including a rotary snowplow have been buried. The most severe slides occurred at Path A-1. Very heavy sluffing occurs in all the Airplane Curve Paths with each new snowfall.

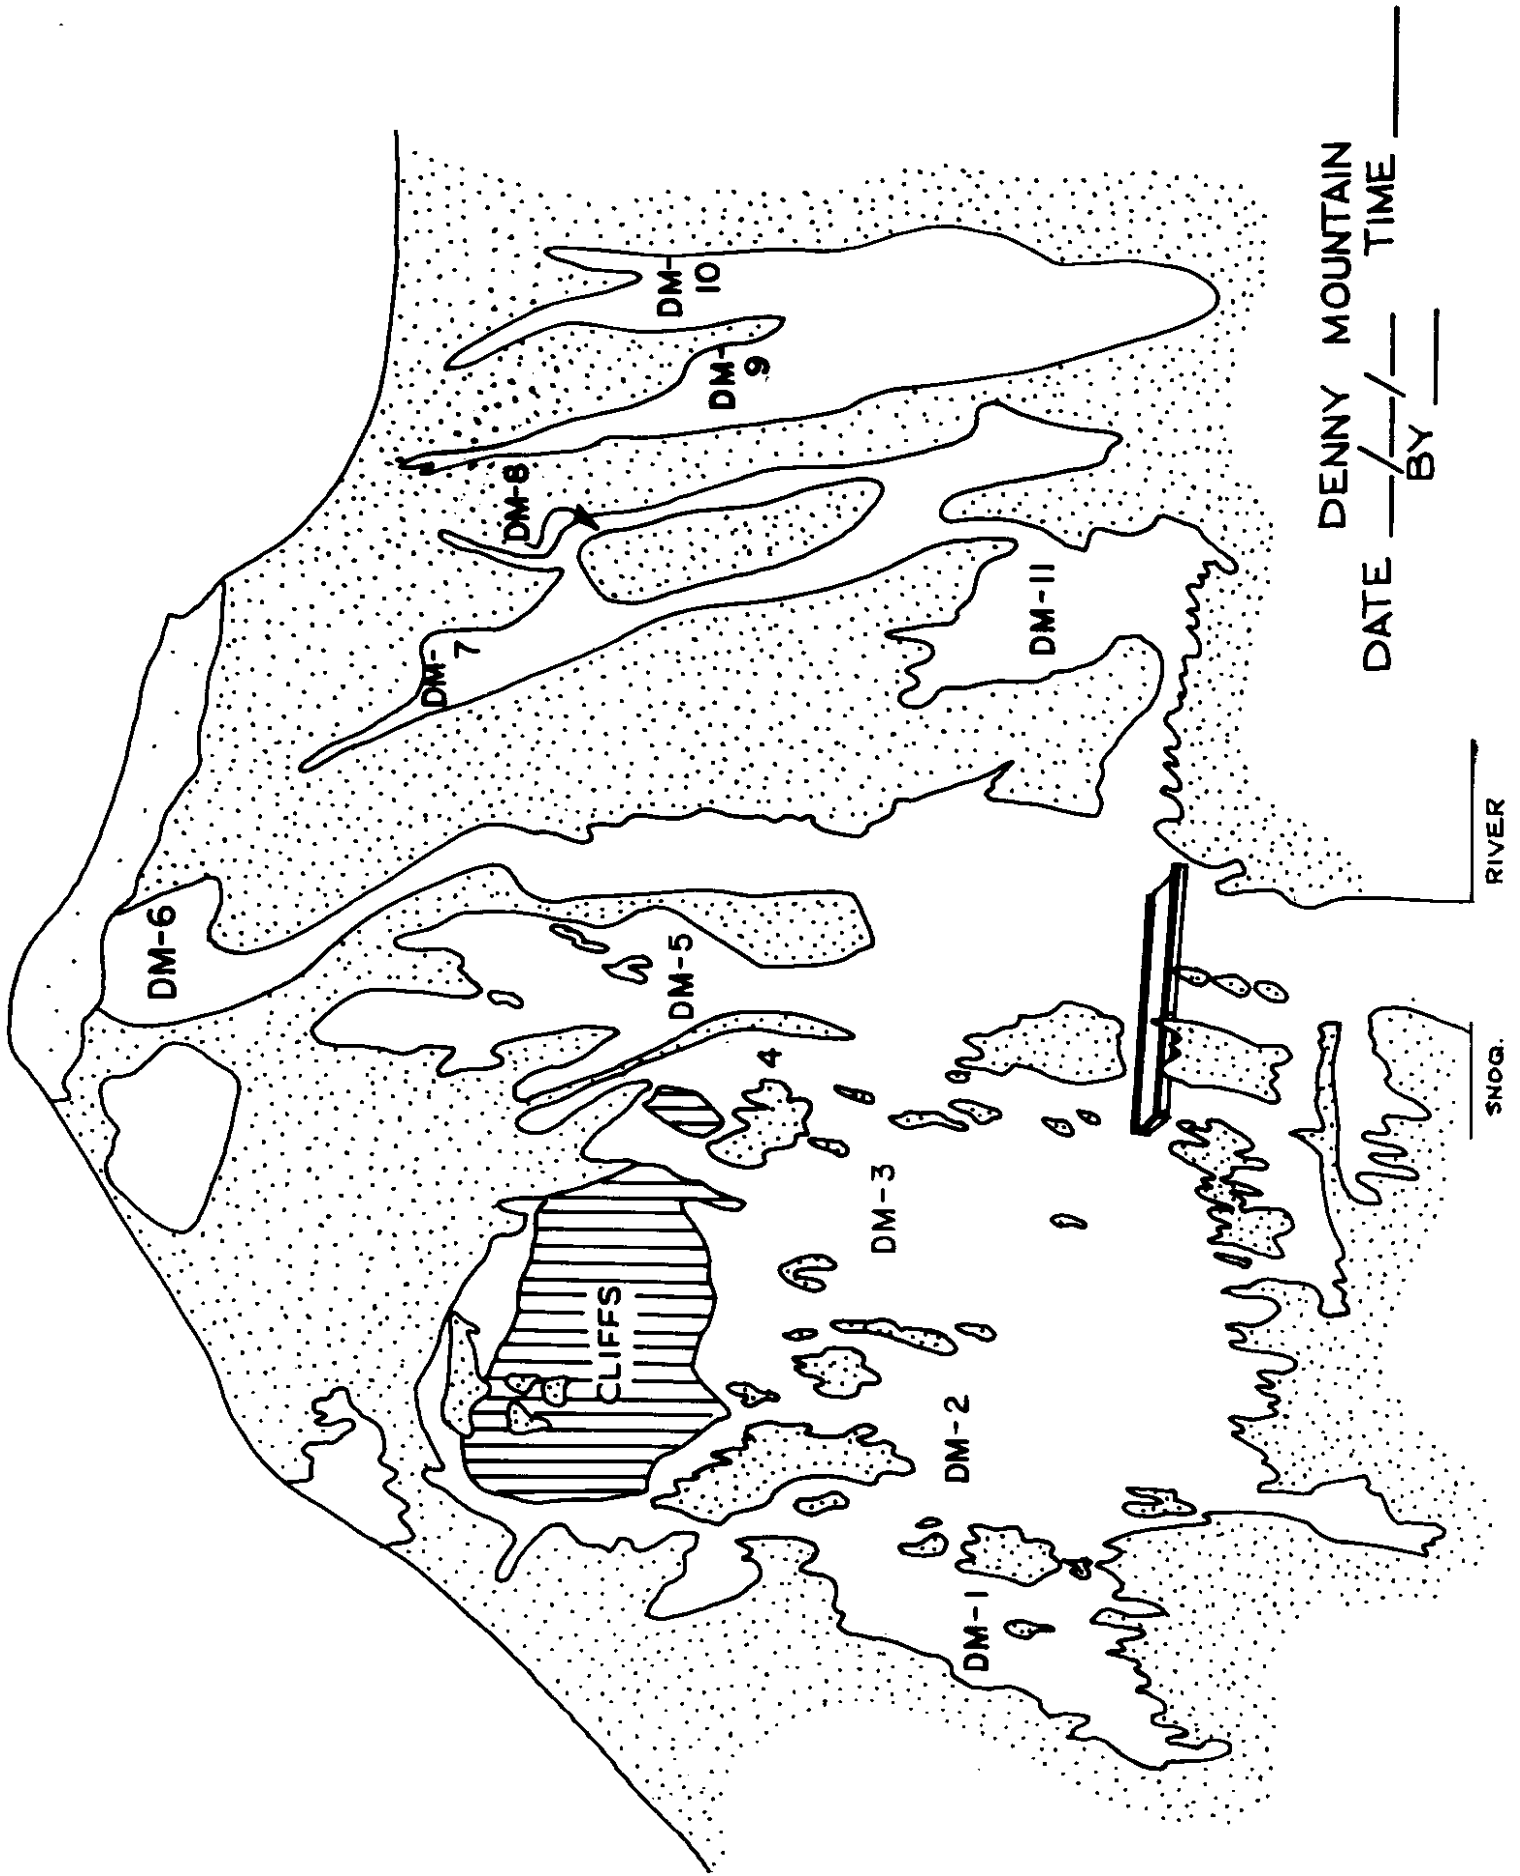
Effect on Highway: Sluffs can be expected to reach the roadway with each significant new snowfall or continuously with a warming trend. Slides in path D-2 might fill the roadway prism with large amounts of snow with each snowfall. Infrequent large slides could cover the roadway for a distance of 1,000 feet.

History: Observations in the winter 1973-74 indicate that these paths run frequently, although not with every storm. Path D-1 normally generates sluffs. Path D-2, on the other hand, deposits a great deal of snow at the bottom of the runout zone and into the trees. Paths D-3 and D-4 produce frequent sluffs and infrequently, large deep slides. Path D-4 deposits snow against and under the west end of Franklin Falls Bridge. Nearly all slides observed have reached the proposed westbound alignment of Interstate 90.
