PAVEMENT RESEARCH  
at the  
WASHINGTON STATE UNIVERSITY  
TEST TRACK

EXPERIMENTAL RING NO. 4: A STUDY OF UNTREATED,  
SAND ASPHALT, AND ASPHALT CONCRETE BASES

Report to the Washington Department of Highways  
on Research Project Y-993

Highway Research Section  
College of Engineering Research Division  
Washington State University  
Pullman, Washington  
August 1970

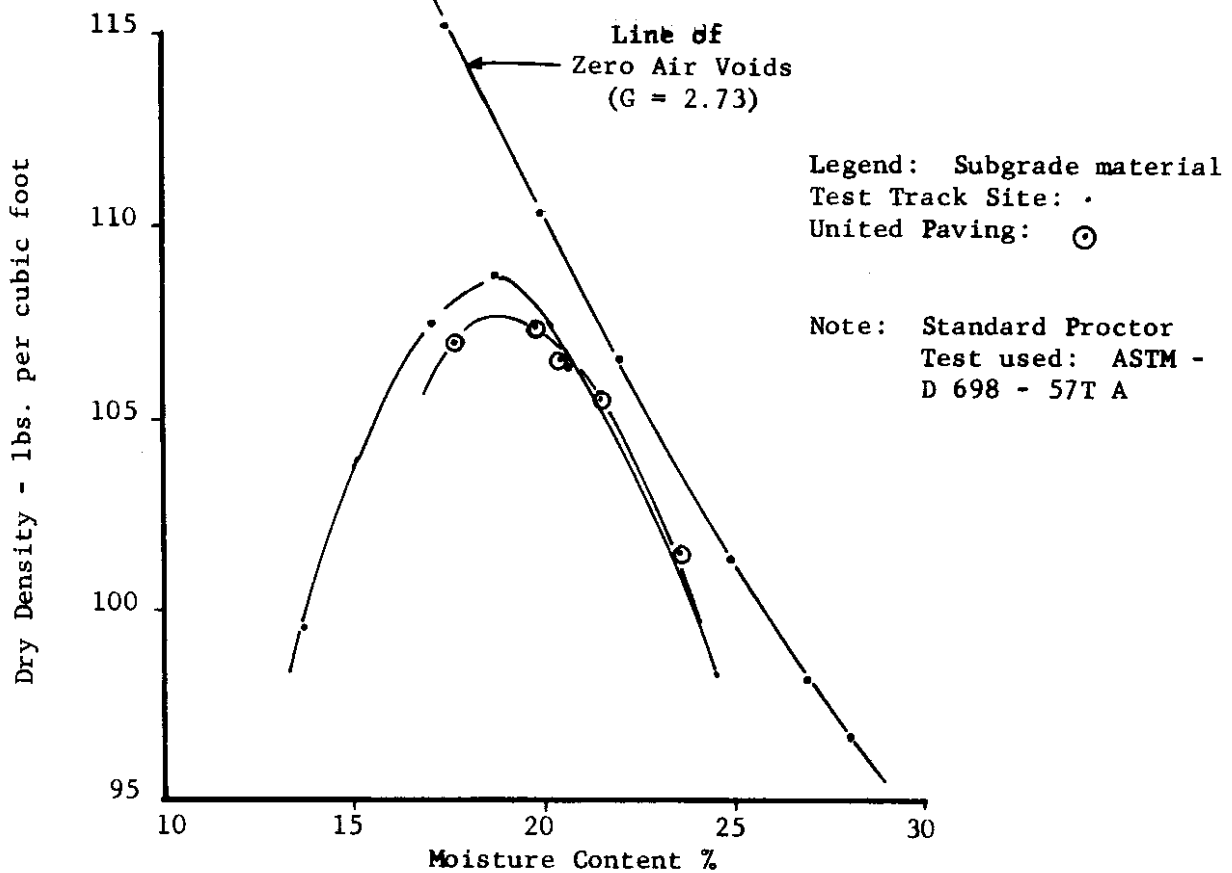
FIGURE 4. DENSITY - MOISTURE CURVES  
(Subgrade Soil Characteristics)

soil moisture-density relationship curves are shown in Figure 4 and Table 2. Characteristics and classifications are shown in Table 3. Table 4 shows the results obtained from a series of tests run by the Asphalt Institute on the Palouse silt subgrade samples (5). The results are similar to other work done at Washington State University. Some of the soil came from the contractor's local pit and the curve is also shown in Figure 4. The slight difference in density may be attributed to a difference in the clay contents of the two silts or to testing variance.

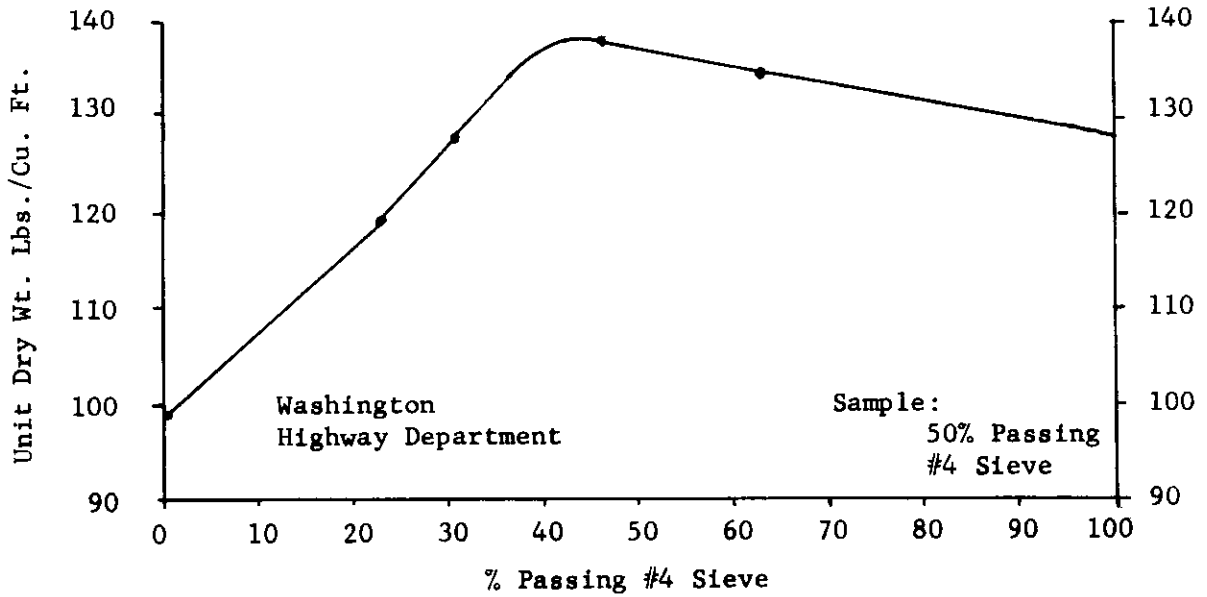
FIGURE 6. MAXIMUM DENSITY CURVE  
CRUSHED SURFACING TOP COURSE

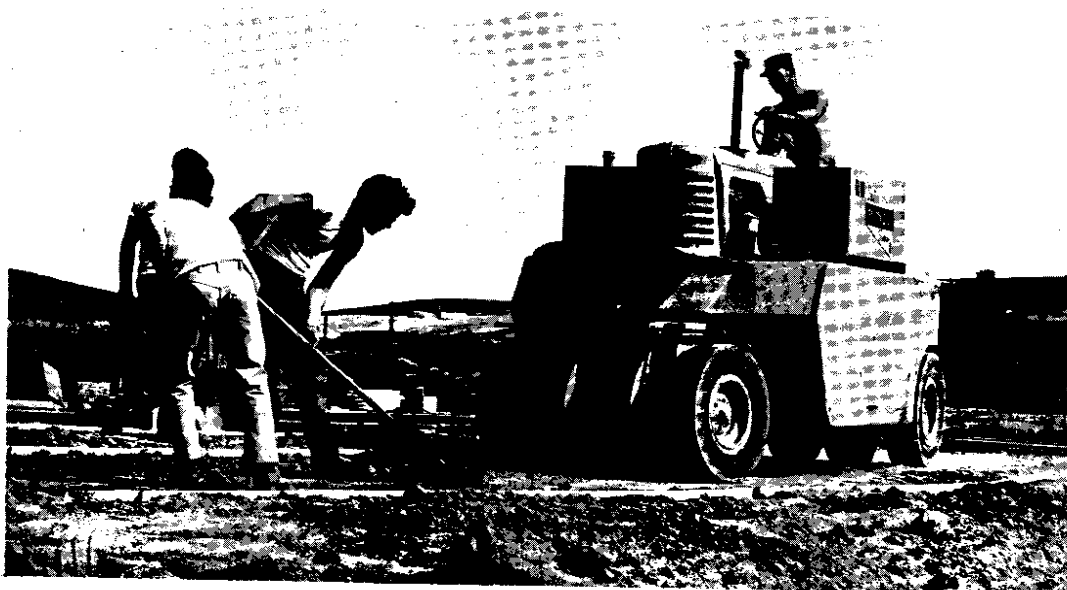
FIGURE 12. SPREADING THE SILT BY HAND AND COMPACTING WITH A  
PNEUMATIC RUBBER-TIRED ROLLER.

The subgrade was brought up in 6-inch lifts, spread by a Huber blade dozer, and compacted by a pneumatic rubber-tired, smooth steel wheel, and steel vibratory rollers (Figures 11 and 12). Density was checked by nuclear methods. It was noticed that as construction progressed, the lifts became progressively dryer. This was due to the favorable warm weather which lasted for about two weeks, long enough to prepare the subgrade.

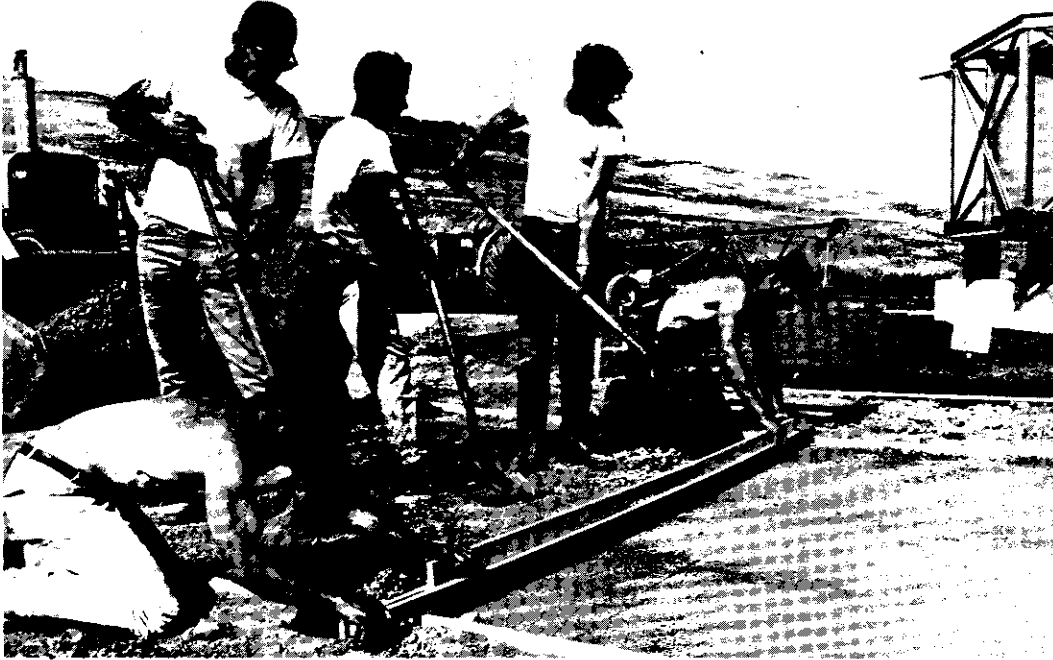
FIGURE 13. HAND WORKING AND SCREEDING OF THE SUBGRADE TO FINAL ELEVATION BY THE CONTRACTOR'S CREW. THE FORMS WERE SET TO CORRECT GRADE PRIOR TO FINAL GRADING.

The subgrade was brought up to the final rough grade; that is, each group of sections 1-4, 5-8 and 9-12. Then each section was cut to a final grade elevation. The contractor tried to speed up this grading by setting up 1" x 4" forms, 14 feet apart and then working the area by means of hand shoveling and screeding to the exact elevation as shown in Figure 13. Then the forms were removed and the whole area was compacted. Table 5 shows the final densities and moisture contents; the final column shows how well 95% of specified density was achieved. This method of working the subgrade seems to have required as much time and labor as did the hand-labor final grade construction procedure used for Ring #3.

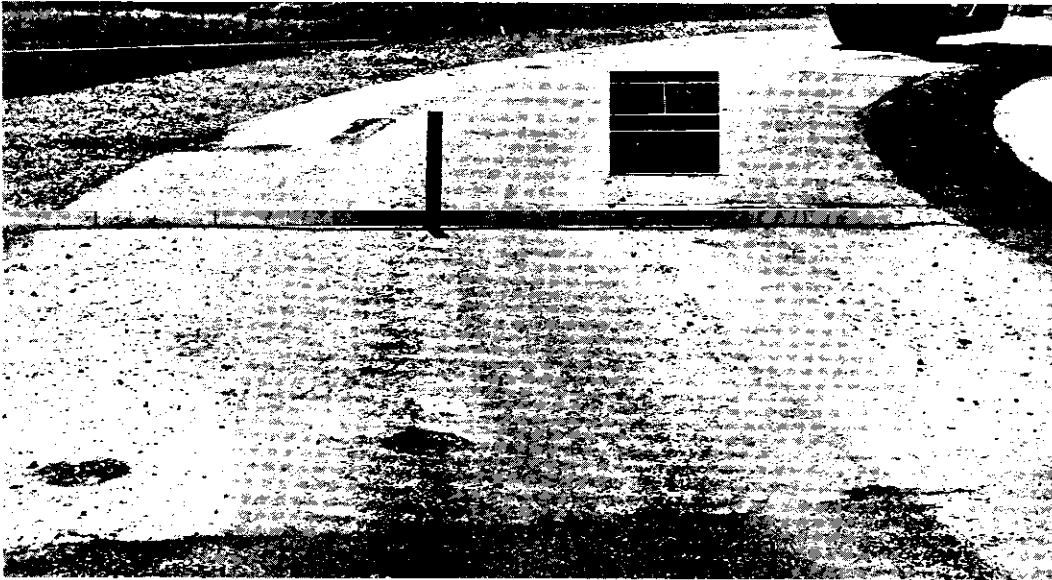
FIGURE 51. APPEARANCE OF SECTION 6 AFTER 157,473 WHEEL LOADS ON MAY 22, 1969. NOTE DEPTH OF PERMANENT DEFORMATION.

Initial distress next appeared in section 6 and followed a similar pattern. Figures 50 to 55 show the progressive failures history of this section. Figure 53 (p. 67) shows that rutting was localized in the path of the dual tires and increased with longitudinal tension surface cracks appearing along the dual tire edge path. This eventually sheared causing a collapse of the

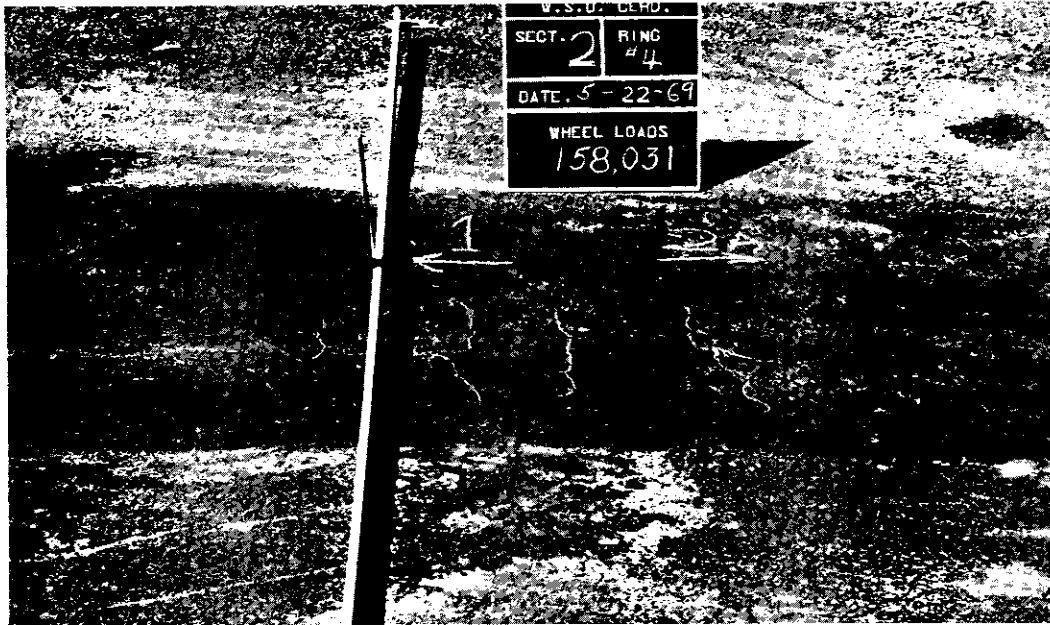
FIGURE 57. FAILURE IN THE TRANSITION ZONE BETWEEN SECTIONS 1 AND 2 AT 158,031 WHEEL LOADS--MAY 22, 1969.

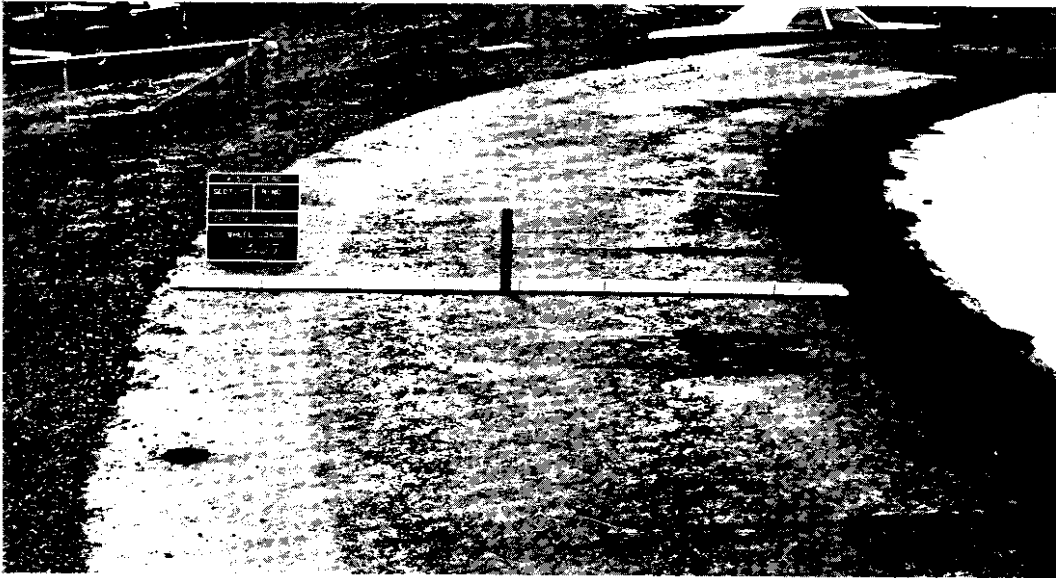
FIGURE 65. APPEARANCE OF SECTION 7, 3.5 INCHES OF ACB, AT 143,370 WHEEL LOADS PRIOR TO RESUMPTION OF TESTING IN THE SPRING.

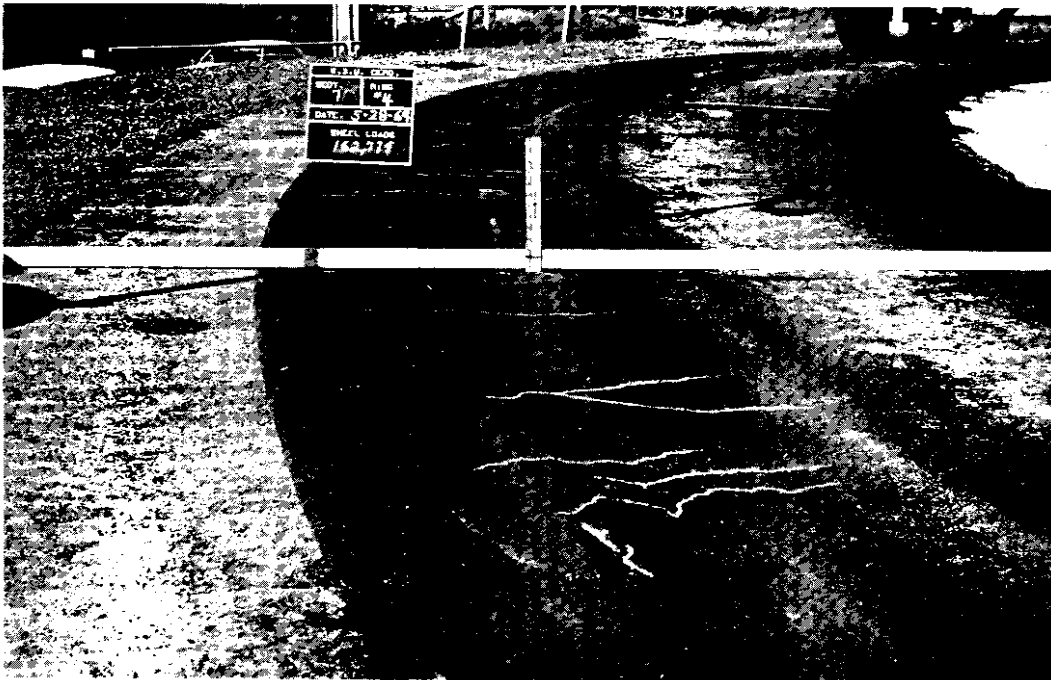
FIGURE 66. APPEARANCE OF SECTION 7 AFTER 162,774 WHEEL LOADS ON MAY 28, 1969. NOTE THE TRANSVERSE CRACKS AND THE DEPTH OF DEFORMATION.

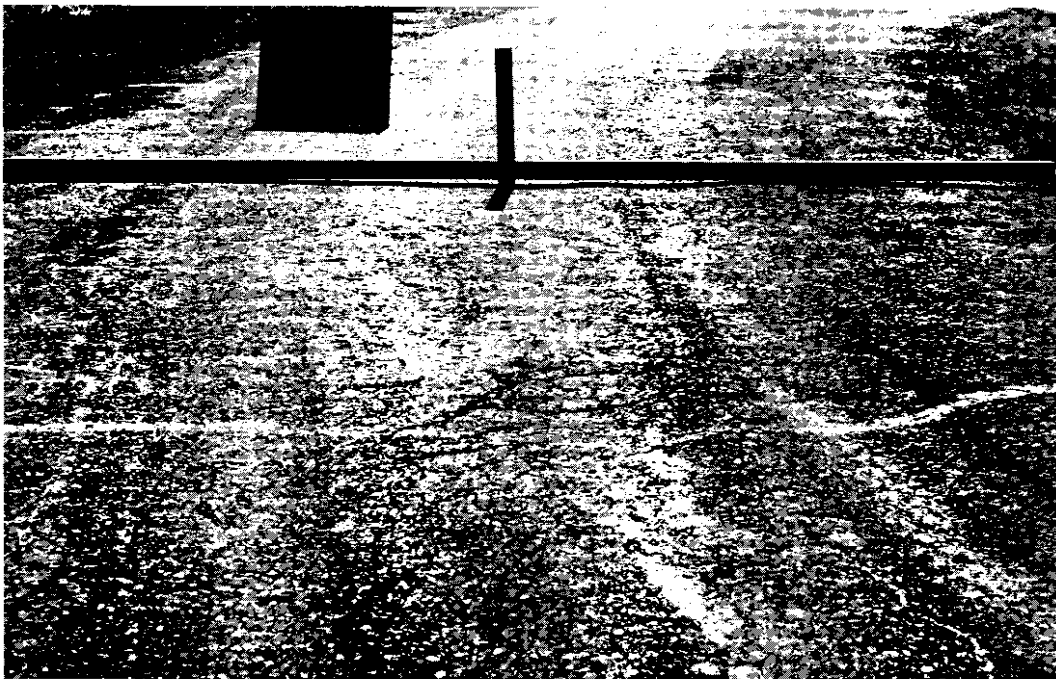
FIGURE 72. DEFORMATION OF SECTION 3 AFTER 162,774 WHEEL LOADS--MAY 28, 1969. NOTE THE EXTENT OF DEFORMATION. CRACKS IN THE TRANSITION ZONE BETWEEN SECTIONS 2 AND 3 ARE VISIBLE IN THE FOREGROUND.

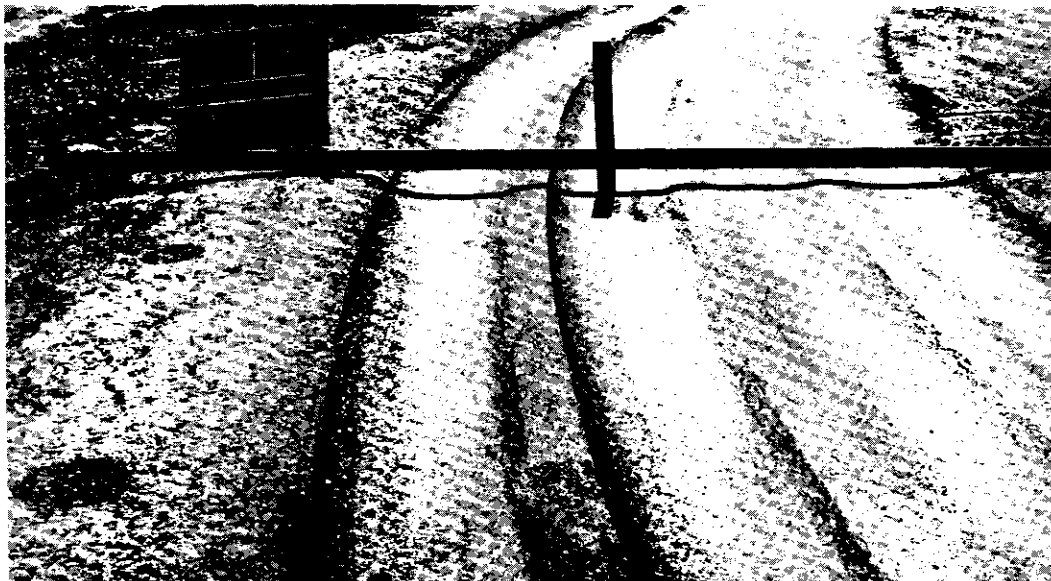
FIGURE 74. CONTINUED RUTTING OF THE ASPHALT CONCRETE OVERLAY IN SECTION 3 AFTER 211,065 WHEEL LOADS--JULY 18, 1969. NOTE DEPTH OF PAVEMENT DEFORMATION.

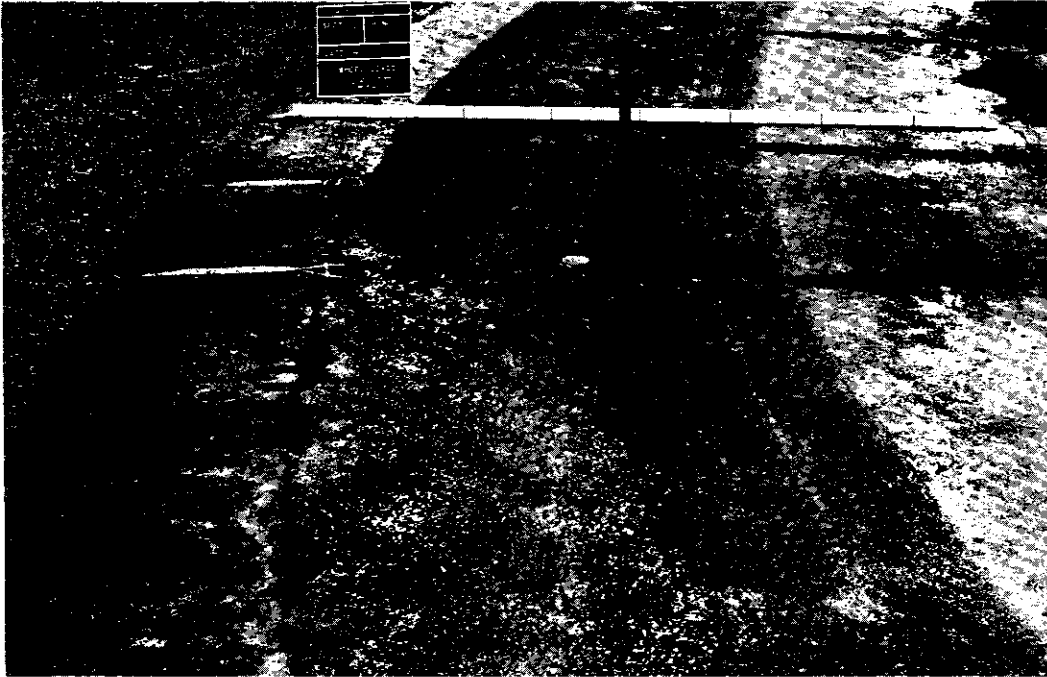
FIGURE 75. APPEARANCE OF SECTION 4, 8.0 INCHES OF SAB, AFTER 143,370 WHEEL LOADS AND PRIOR TO SPRING TESTING.

overlay. Tables 19 and 20 (p. 95) show the depth of the ruts. Figures 71 to 74 show the rutting as it progressed in section 3. Ruts of over  $2\frac{1}{2}$  inches developed without any visible cracking. Figure 74 (p. 78) shows that even with an asphalt concrete overlay the deformation continued. Figures 75 to 79 show how the ruts progressed with accumulated wheel loads in section 4 (p. 79). Figures 80 to 83 show the rutting with accumulated wheel loads in section 8. The extent and depth of ruts are shown in the individual photographs; Tables 19 and 20 give the depth of the ruts in the wheel paths of the sections.

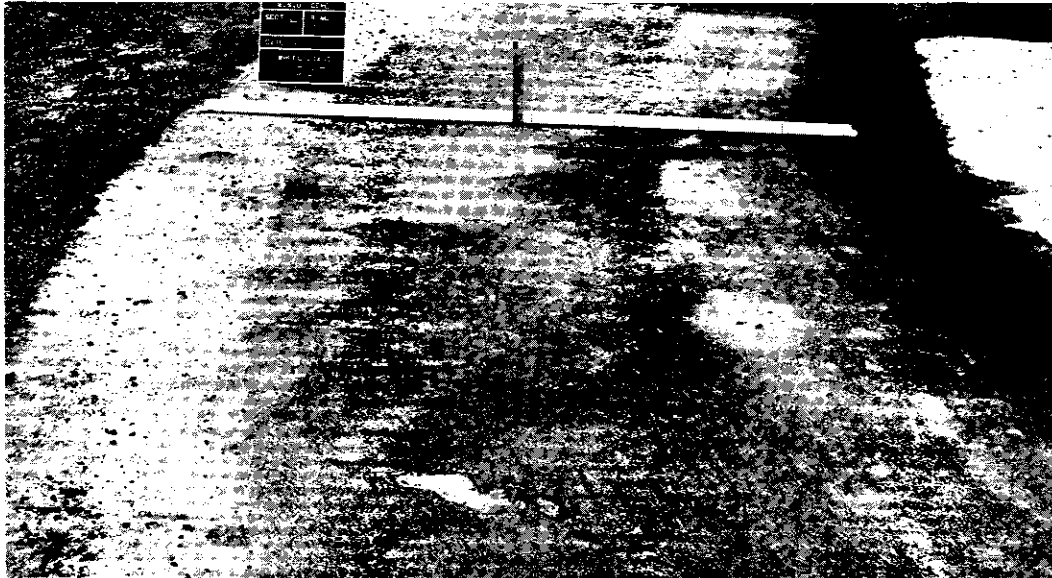
FIGURE 80. APPEARANCE OF SECTION 8, 5.0 INCHES OF CLASS "F" ACB, AFTER 143,370 WHEEL LOADS AND PRIOR TO START OF SPRING TESTING.
