Materials Report

PERMANENT LANE MARKING
(Recessed Lane Edge Stripe)

Washington State
Department of Transportation

WA-RD-46.1

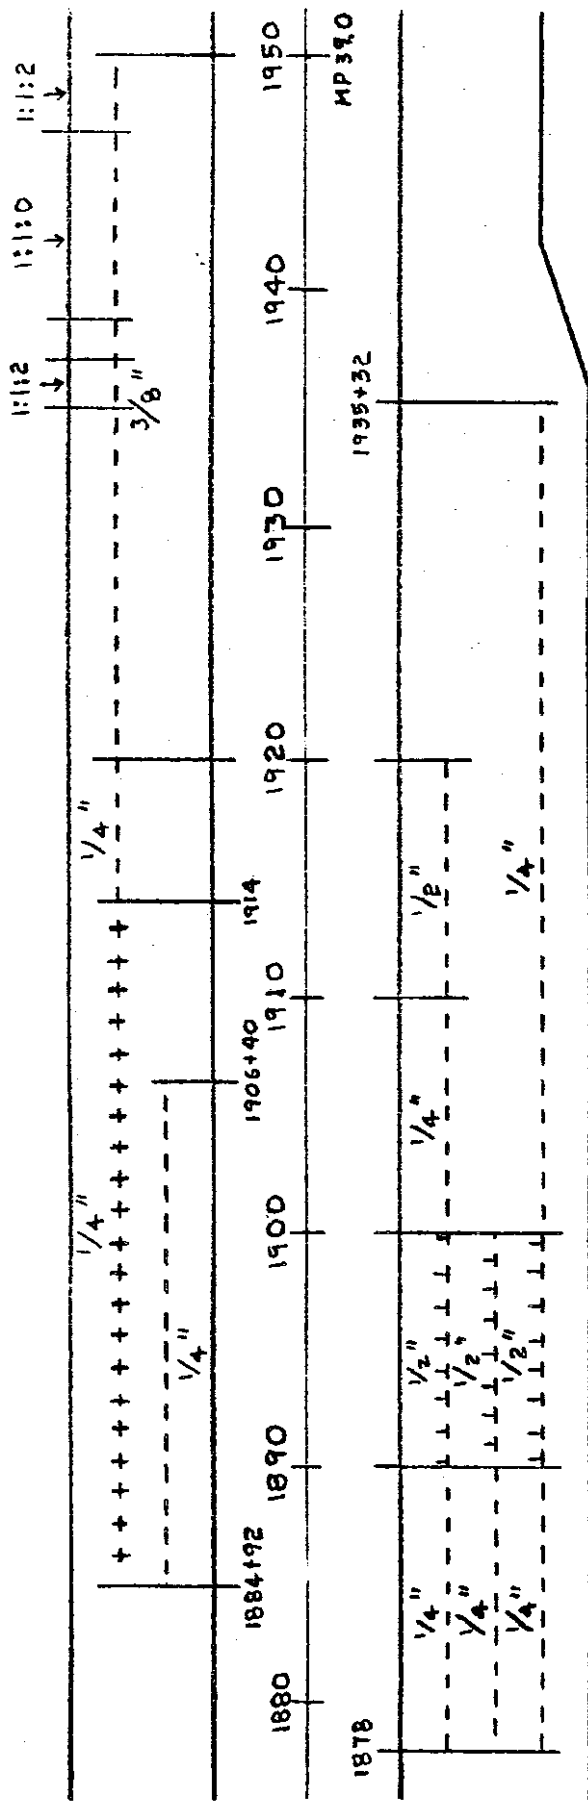
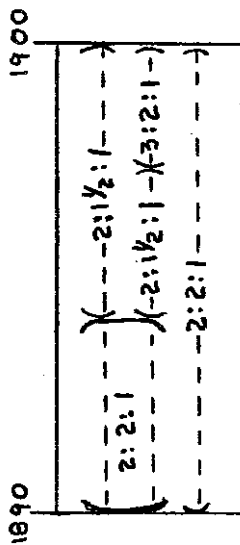
STRIP MAP

- Concrete 1064 -----
- Cleanoso! + + + + +
- White Cement Grout + + + + +

A strip map shows the areas of the project in which each of the three materials was placed. The white cement, Ottawa sand, and glass bead system was first installed in a 2 parts sand, 1 part cement, 1 part beads ratio on 20 sections. It became the consensus of the Contractor and State personnel that this mixture was too lean, so an adjustment was made to 2 parts sand, 1½ parts cement, and 1 part beads. The 20 sections filled with the 2:1:1 mixture were later removed and replaced with a 2:2:1 mixture. This same 2:2:1 mix was also used on 24 other sections, while six other sections were filled with a 3:2:1 mixture. The white grout system thus varied from 2:1½:1 to 2:2:1 to 3:2:1 in the components of sand, cement, and beads. The locations of each variation in mix proportions are shown on an inset on the strip map.

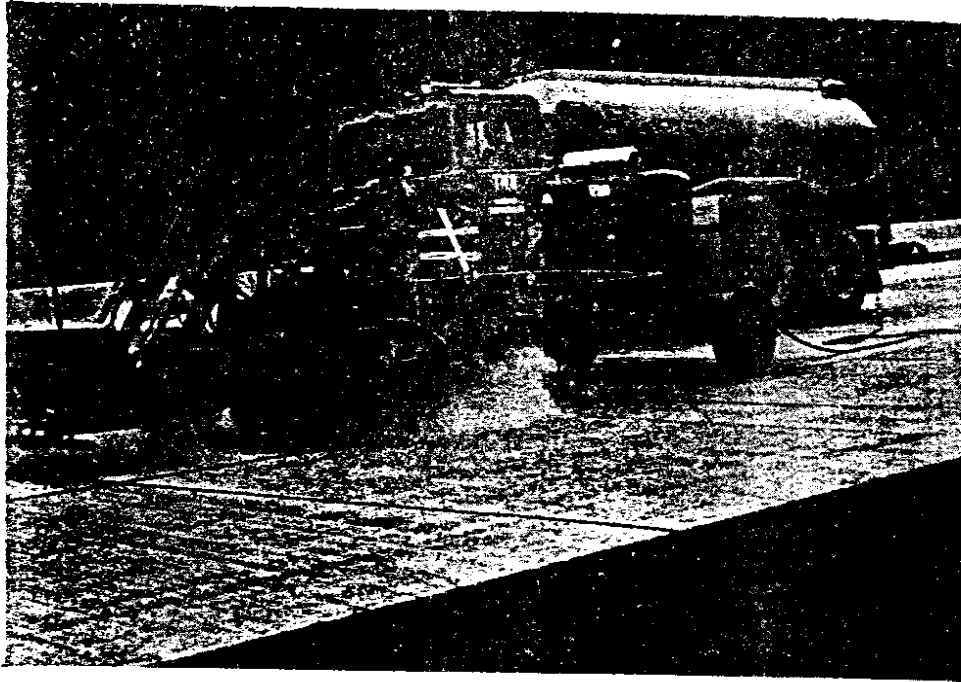
Figure 1. Flow Industries' water jet cutting system which includes a water truck, a trailer-mounted 60,000-psi intensifier powered by a diesel engine and an articulated front-end loader. The pressurized water is conveyed through a small pipe from the trailer to the cutting head.

The high-pressure water jet manufactured by Flow Industries was first to be evaluated. The equipment included a trailer-mounted 60,000-psi intensifier powered by a diesel generator. This was pulled by an articulated front-end loader which had the 4-inch-diameter, two-nozzle, rotating cutting tool. An externally mounted chain and sprocket regulated forward speed which in turn determined the depth of cut (see Figures 1 and 2).

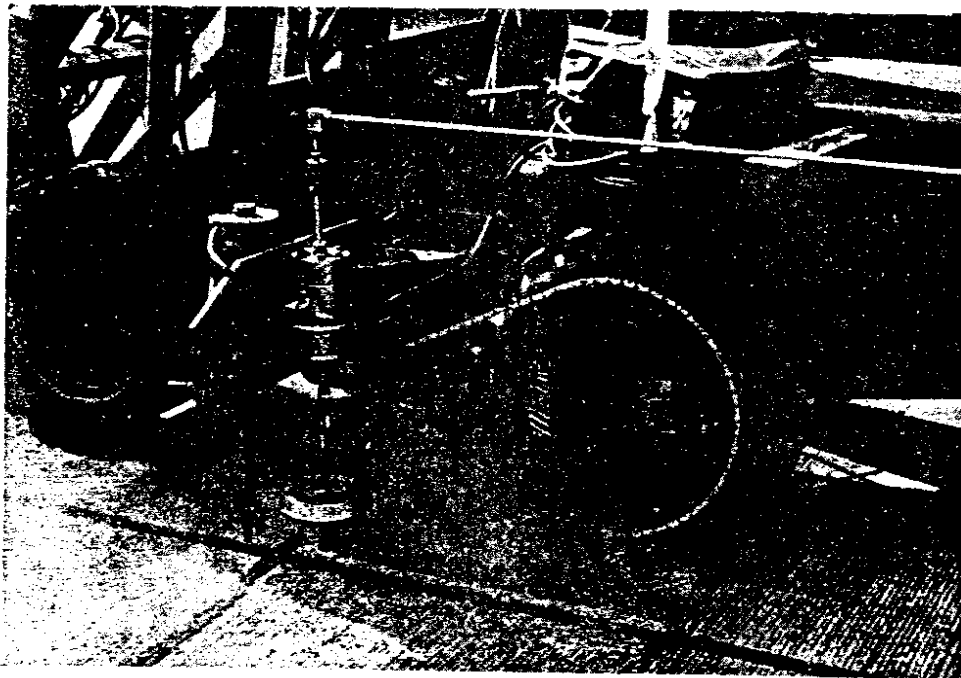
Figure 2. Close-up view of Flow Industries' cutting head and chain drive. The forward speed of the front-end loader regulates the depth of cut. This method is in the prototype stage.

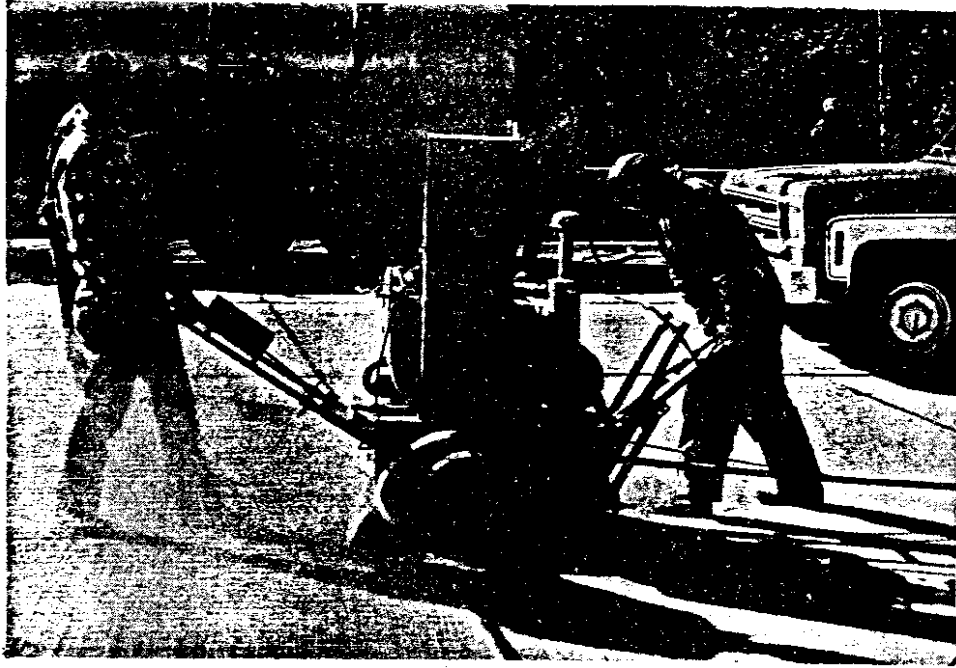
Figure 4. Tennant heavy-duty grinder (Model G). The operator of the machine could not keep true alignment; hence the laborer aided in guiding the machine.

The grinder, a Tennant Heavy-Duty Model G, was the second method tried. Figure 4 shows the operation of the machine which required two men due to the difficult job it is to control. The cutting head, Figure 5, has offset carbide-tipped star washers which chip at the pavement. These washers wear unevenly, resulting in an uneven fracturing of the pavement as shown in Figure 6. The first set of cutters was replaced after only 18 sections (180 lineal feet) of 1/2-inch grooving. In all, only 24 sections of 1/2-inch depth and 4 sections of 1/4-inch depth were accomplished in one day's work. A trial cut in the asphalt shoulder had equally poor results.

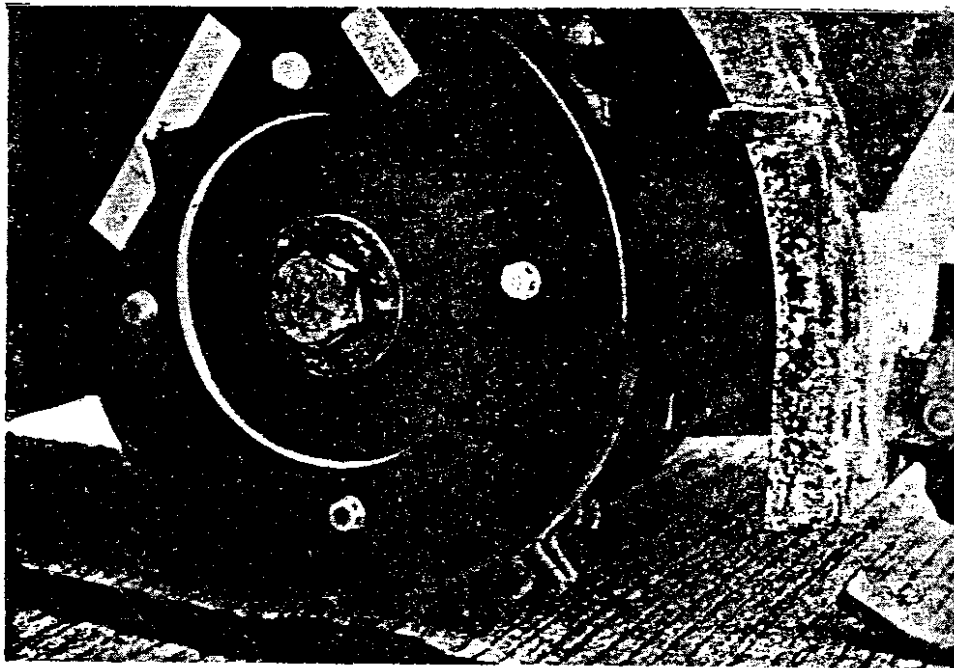
Figure 5. Tennant grinding head showing star washers which chip at the concrete. Edge alignment and depth of cut are extremely hard to control. The star washers wear unevenly which causes the machine to jump.

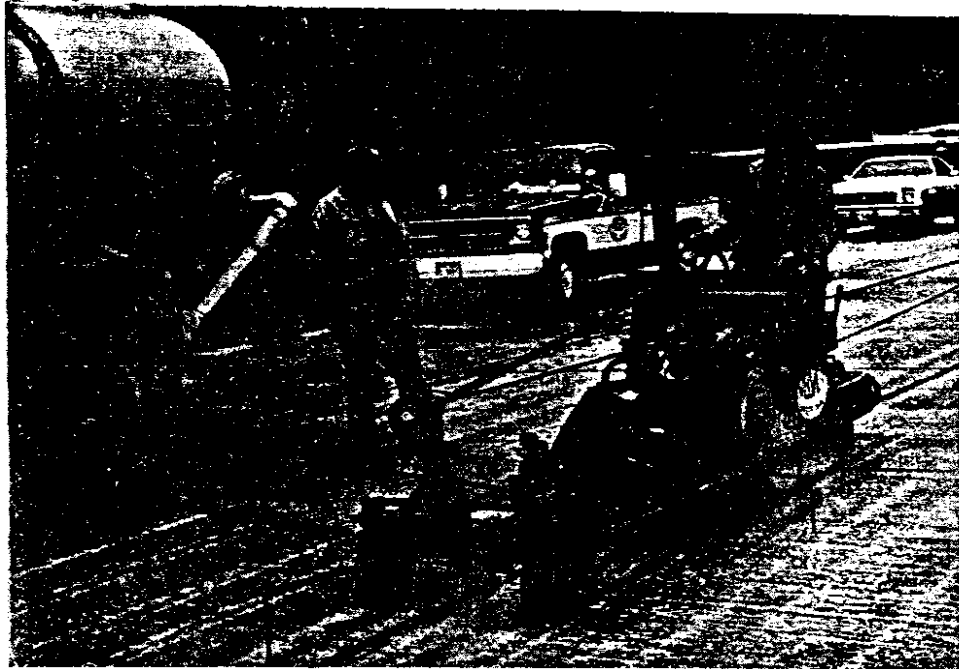
Figure 7. Concut diamond saw. This self-propelled machine was easy to operate, easy to keep in alignment, and made a very uniform recess. The truck on the left supplied the water to the saw via a hose.

cutting width. It was self-propelled, compact, and yet heavy enough to drag the water supply hose without affecting the alignment control (Figure 7). Production rates varied with the depth of cut, but for a 1/4-inch groove, it averaged 100 to 120 lineal feet (10-12 sections) per hour (Figure 8). All remaining grooving was accomplished with this method.

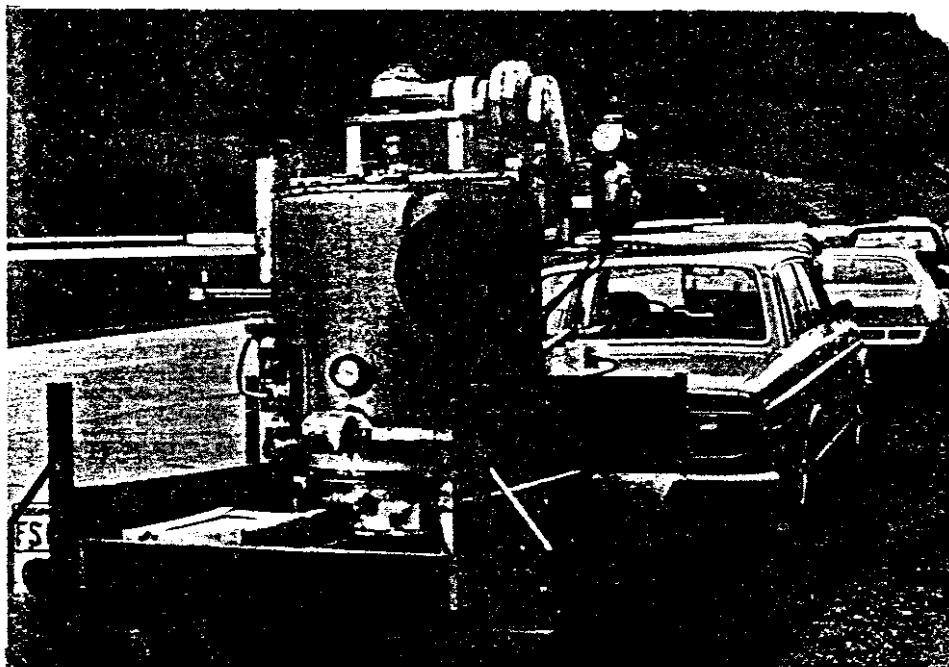
Figure 9. Trailer-mounted heating vat for liquifying Cleanosol. Solid ingots of Cleanosol are visible in the cardboard boxes behind the heater. The applicator machine is filled from the dispenser on the rear of the vat.

Cleanosol is a hot extruded thermoplastic product from Sweden. It comes as a solid component which is liquified by heat and dispensed at about 175°C into a small hand applicator as shown in Figures 9 and 10. A filling of the applicator would cover approximately 100 lineal feet of the 1/4-inch-deep recesses. The material cools rapidly to a solid and is ready to accept traffic in a very short time. A total of 75 sections was filled with the Cleanosol material, all 1/4-inch deep.

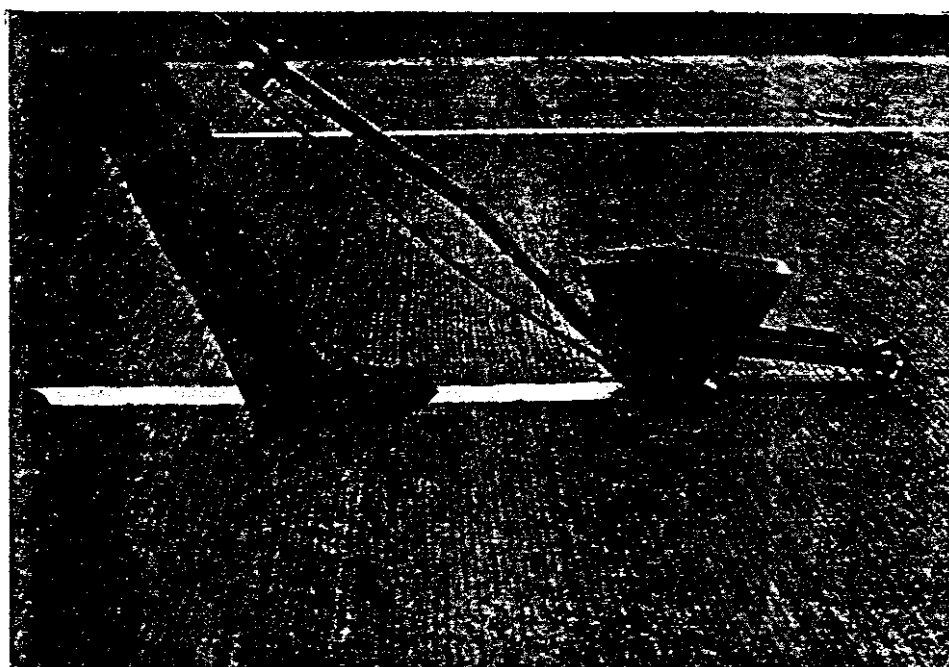
Figure 10. Placement of the liquid Cleanosol using the 4-in.-wide applicator. Forward speed determines the amount dispensed. An experienced operator can fill 10 sections in approximately 5 minutes. The Cleanosol solidifies rapidly and is ready for traffic in a matter of minutes.

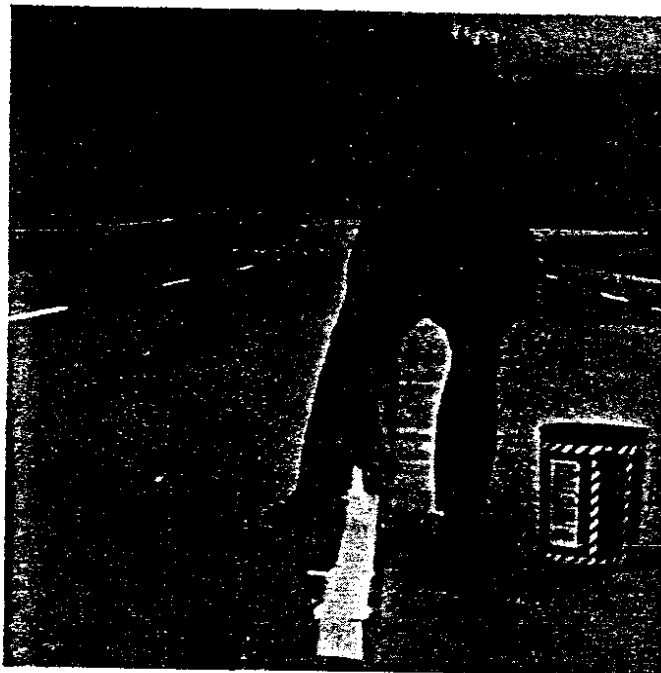
Figure 14. Workman sprinkling a topical application of glass beads over a completed section of Concrecive 1064. Cure time on the epoxy is temperature-sensitive which means more traffic disruption on cool days.

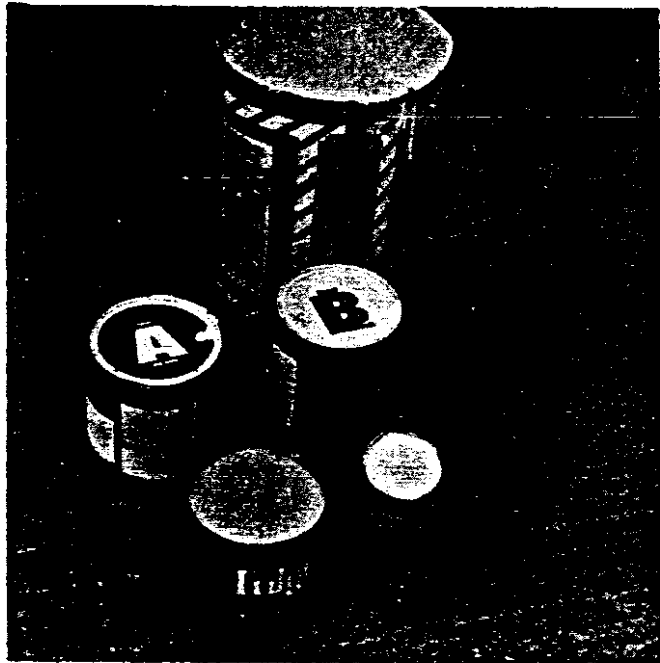
Figure 11. Two-part Concreative 1064 components, glass beads, and 5-gallon mixing bucket.

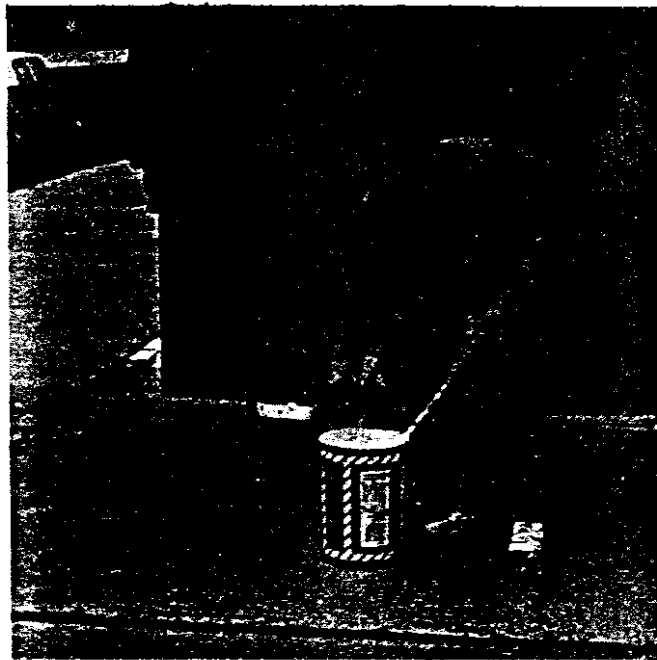
Figure 12. Mixing of Concreative 1064 components and glass beads using a drill with mixer attachment. A generator in the trailer provided the power for the drill.

The installation of the third material, Adhesive Engineering's Concrecive 1064 white, was delayed one year by our desire to have a two-white-component epoxy. The standard Concrecive epoxy mix is a combination of one black and one white component, yielding an end product which is grey in color. A special factory order had to be made with the two-white-component mixture because of our desire for the whitest stripe possible. This special order of material did not arrive on the project site until the late fall of 1977 which was past the time when daytime temperatures were warm enough to properly cure the epoxy mixture. In March and June of the following year, 371 sections (3710 lineal feet) were filled with the Concrecive 1064 mixture using the procedure shown in Figures 12, 13, 14, and 15.

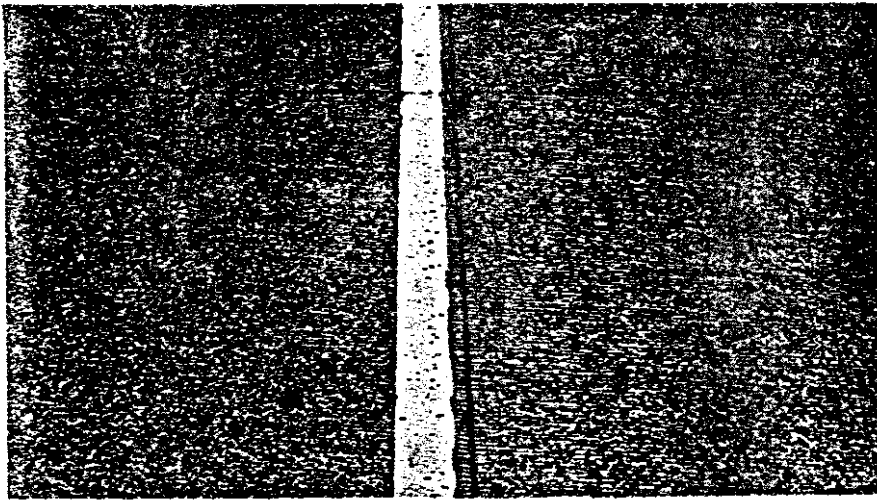
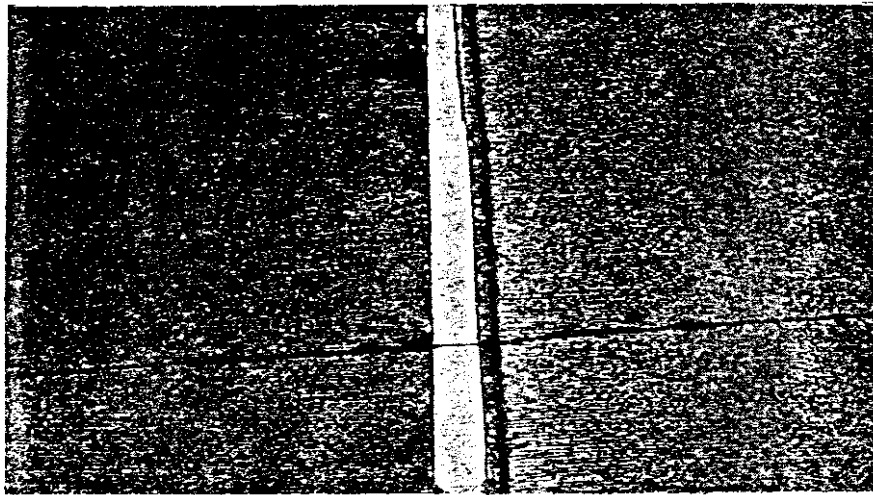
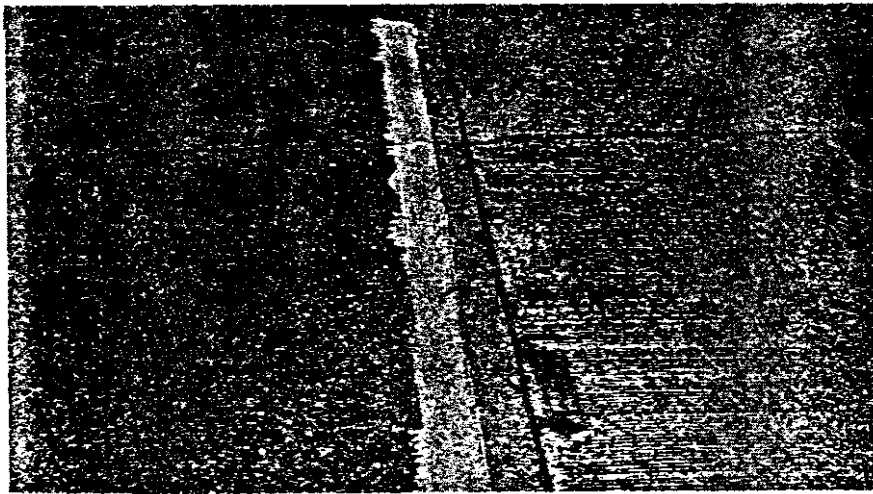
Figure 16. Comparison of backfill materials at the end of the evaluation period. Top to bottom: Cleanosol, white cement grout, and Concrecive 1064.

cement and Cleanosol systems, but after 1½ years it became discolored to a creamy white. The Cleanosol and white cement materials are now much whiter than the Concrevisive 1064 as shown in Figures 15 and 16.
