Thin Overlay

Naches River Bridge 82/115S Yakima River Bridge 82/114S

WA-RD 148.1

Post Construction Report
January 1989

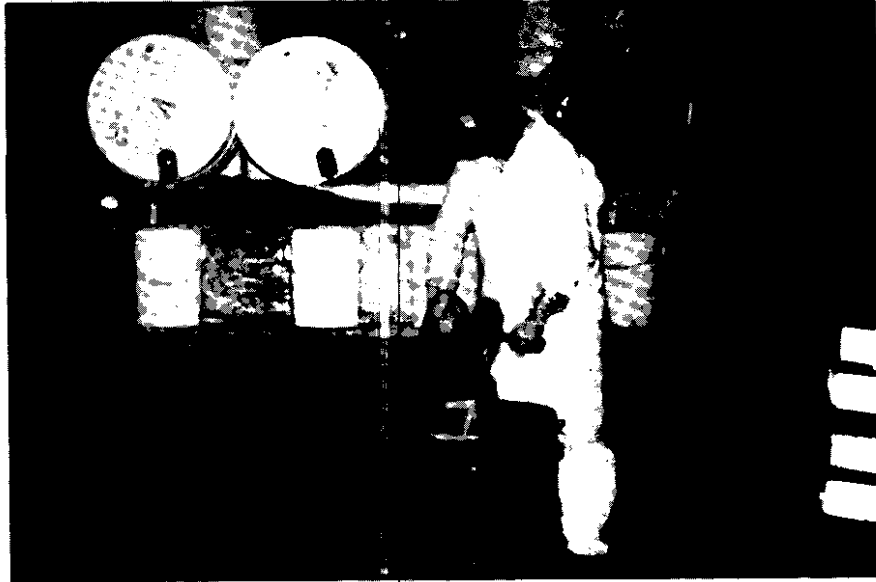
Mixing epoxy resin component A and B.

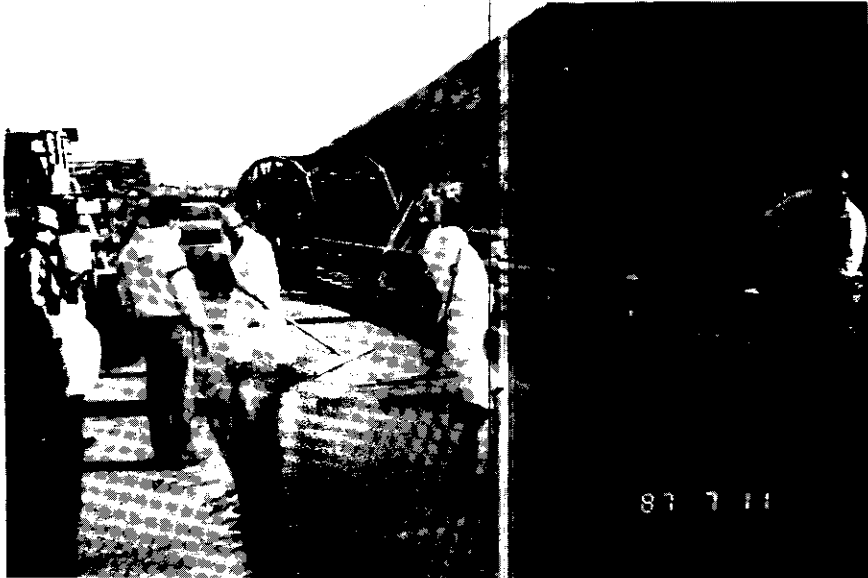
Spreading epoxy resin by squeegee.

Another view of spreading epoxy by squeegee.

All application procedures were the same as those used for the previous lifts. Epoxy was squeegeed and aggregate was broadcast by hand.
