Design of Continuous Bridges Using Precast, Prestressed Concrete Girders Without End Blocks

WA-RD 155.1

Final Report
October 1987

Washington State Department of Transportation
Planning, Research and Public Transportation Division

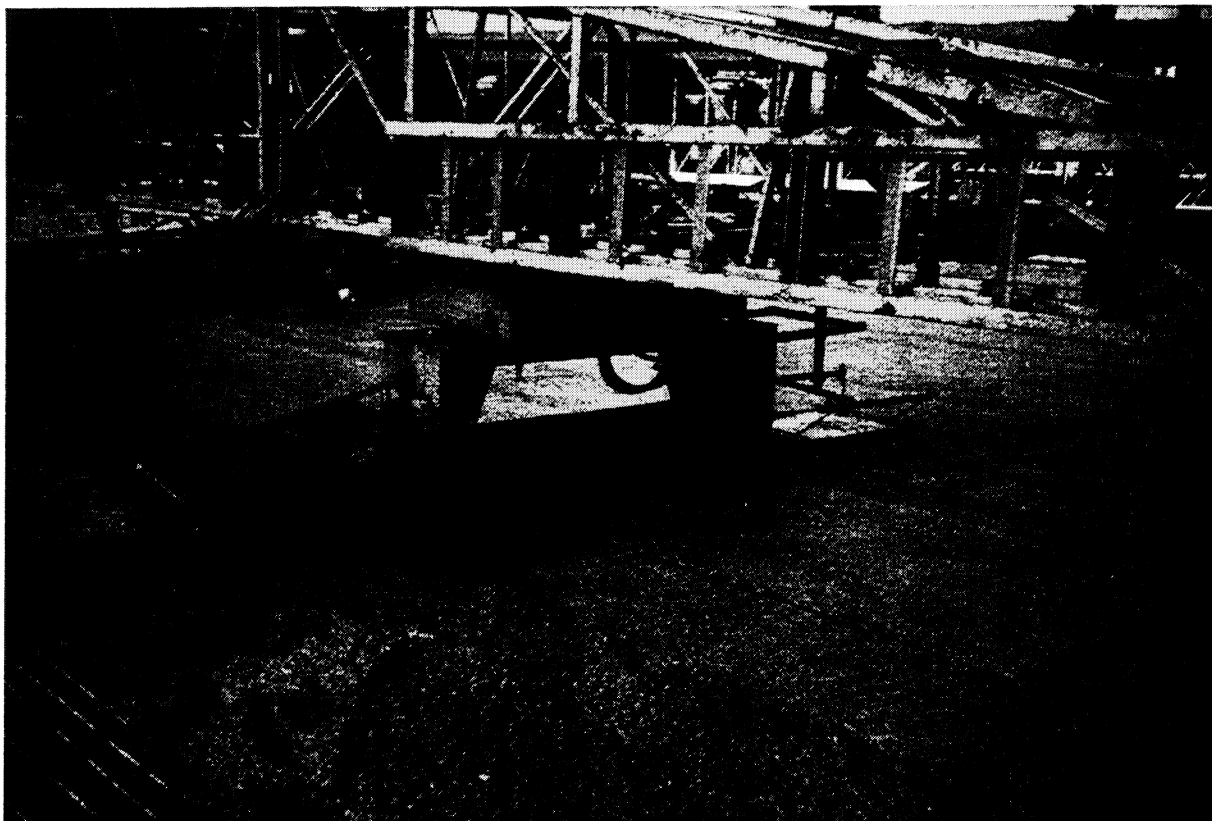
Figure 4.19 Field Test - Placing Concrete in the Roadway Slab

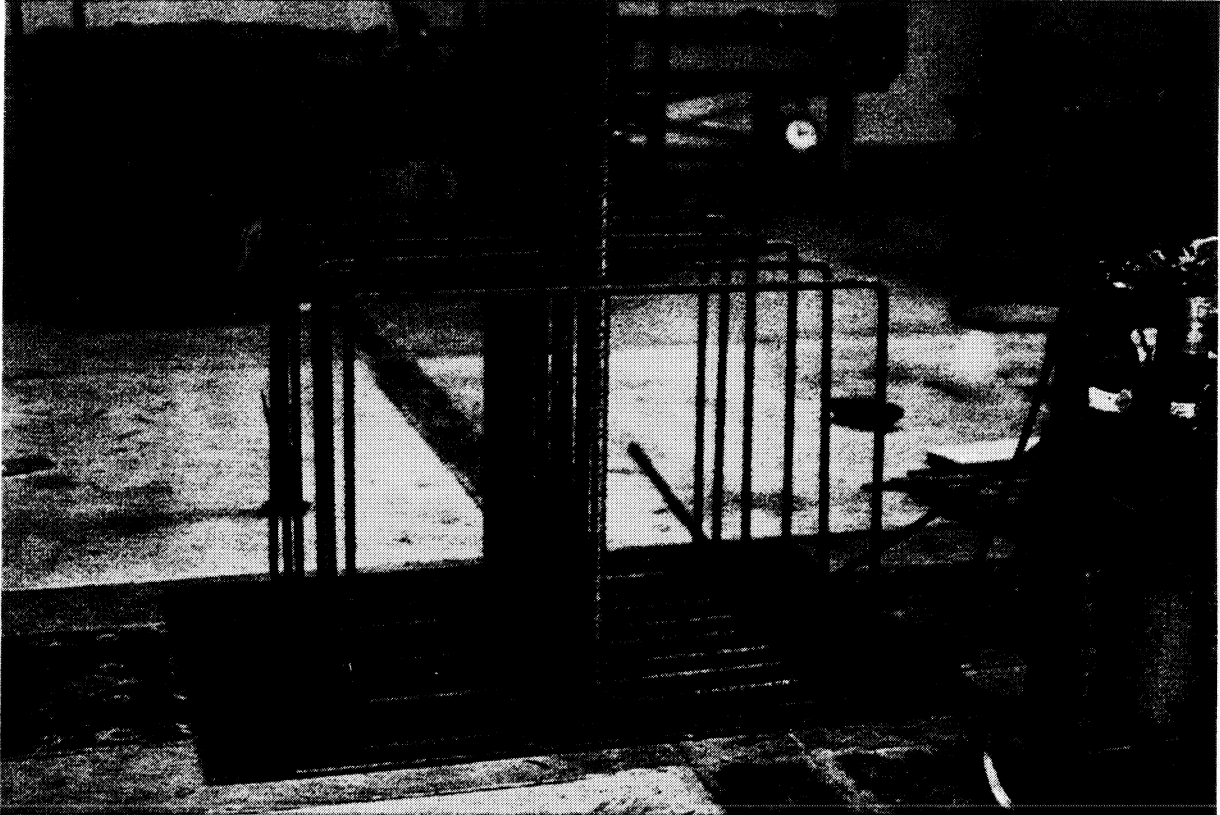
Figure 6.8 **Laboratory Test - Reinforcement in the Pedestal and the Hinge Bars**

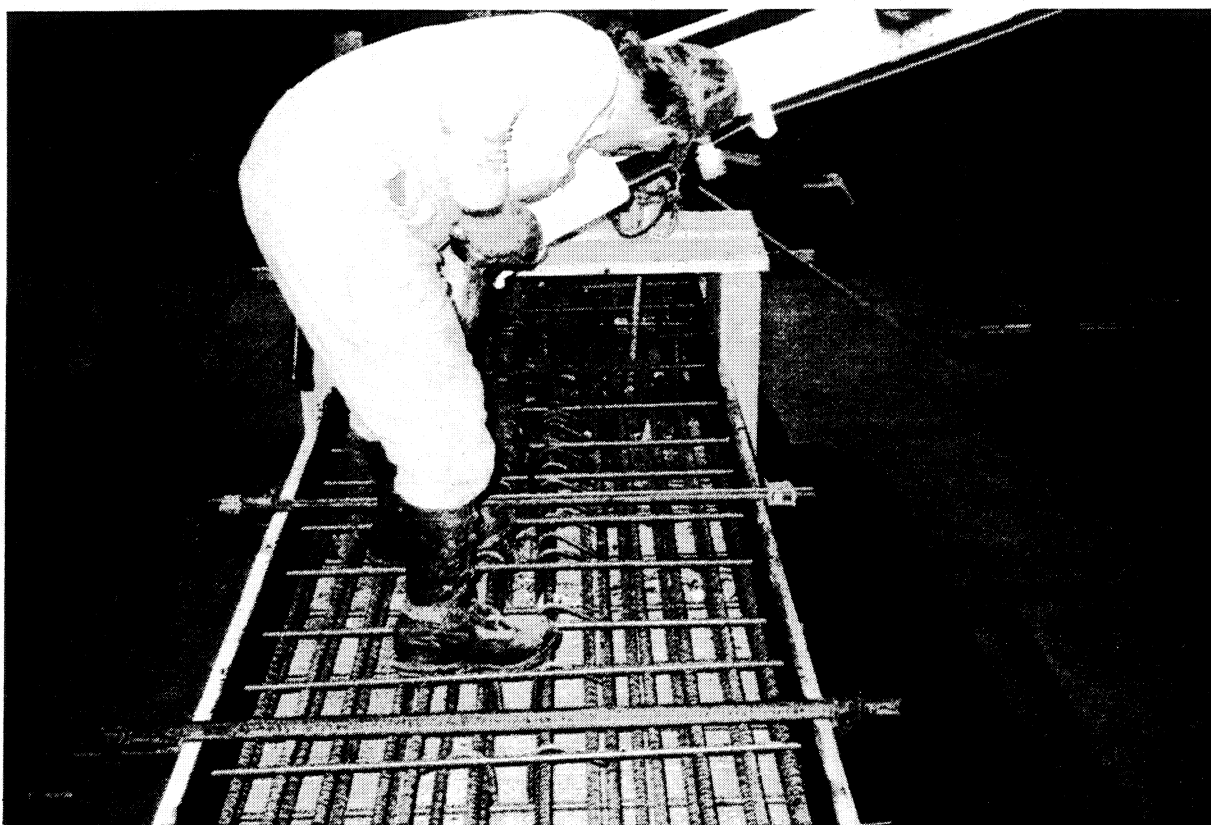
Figure 6.12 Laboratory Test - Placing Concrete in the Forms
