Research Project GC8719, Task 37
Bridge Full Scale Seismic Test

**LATERAL-LOAD RESPONSE OF A
REINFORCED CONCRETE BRIDGE**

1. REPORT NO. WA-RD 305.1		2. GOVERNMENT ACCESSION NO.		3. RECIPIENT'S CATALOG NO.	
4. TITLE AND SUBTITLE LATERAL-LOAD RESPONSE OF A REINFORCED CONCRETE BRIDGE				5. REPORT DATE August 1993

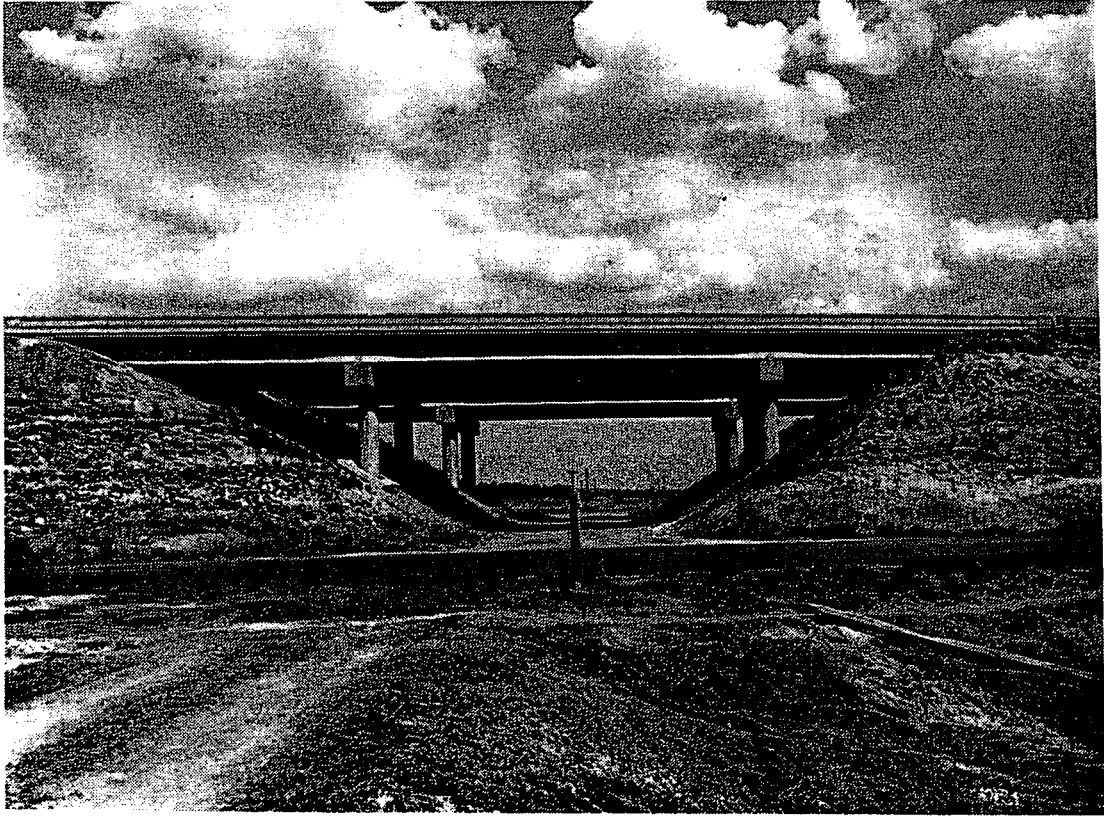
Figure 1.1. Photograph of Bridge

and footing dowels that are too short and are unconfined, and (3) a lack of top reinforcement in the footings. The bridge that was tested had all three of these detailing deficiencies.

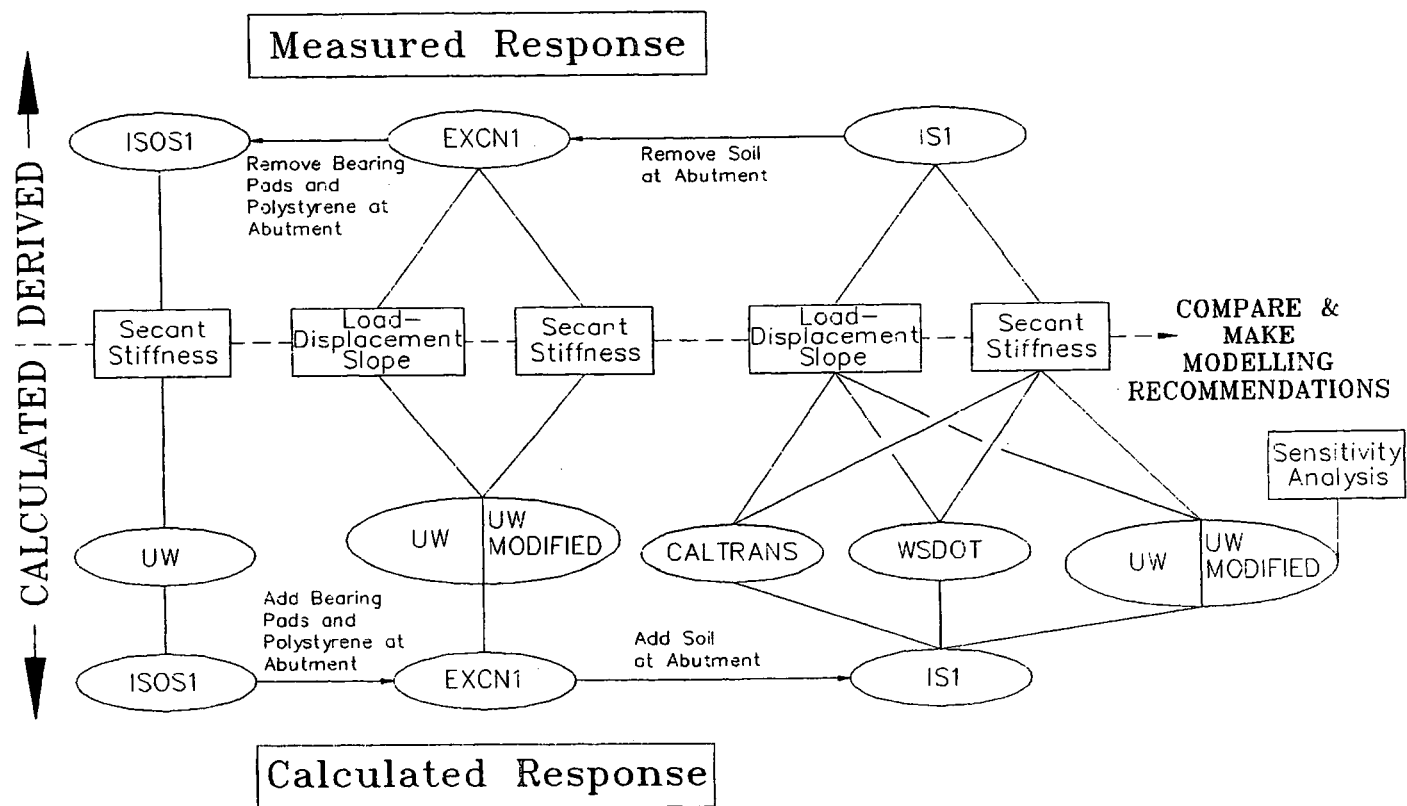
(CALTRANS). Figure 1.3 provides an overview of the Phase I analysis. Chapter 7 lists recommendations, based on the results of Phase I, for evaluating the seismic vulnerability of bridges.

Figure 1.3. Phase I Analysis

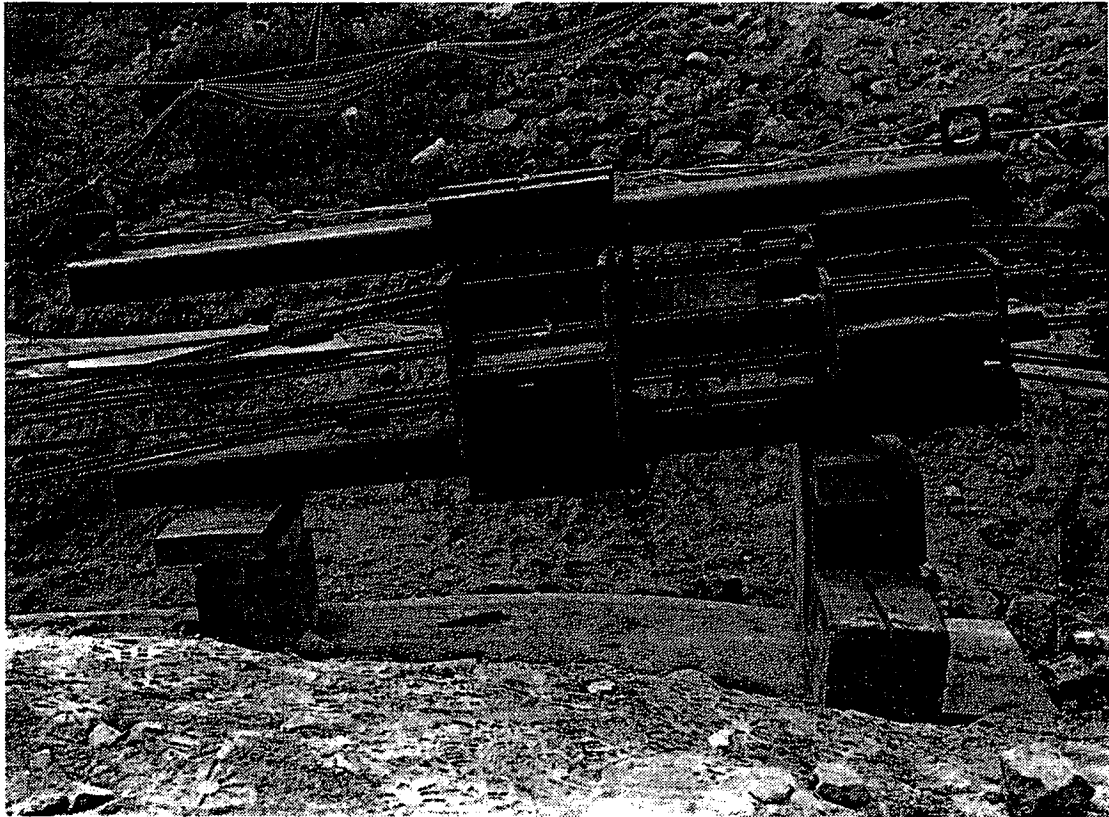
Figure 3.6. Photograph of Jacking Frame

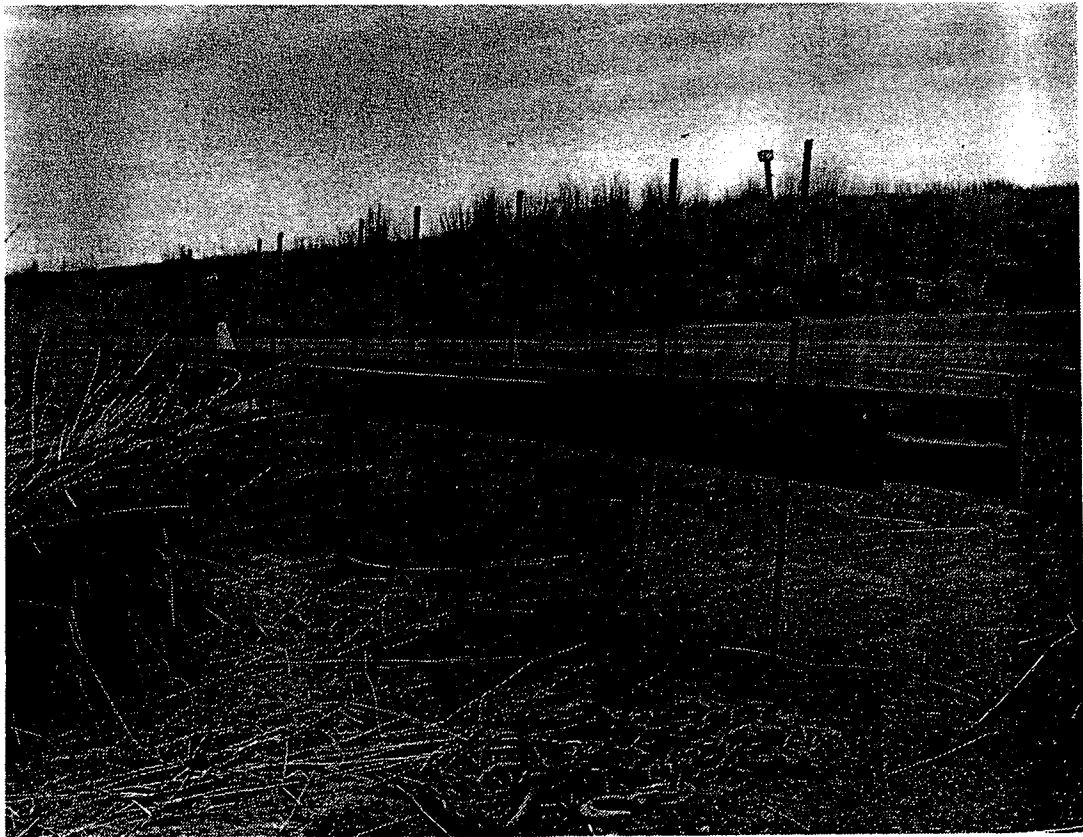
Figure 3.8. Photograph of Deadman
