# **LATERAL-LOAD RESPONSE OF TWO REINFORCED CONCRETE PIERS**

WA-RD 305.3

Final Technical Report  
March 1994

**Washington State  
Department of Transportation**

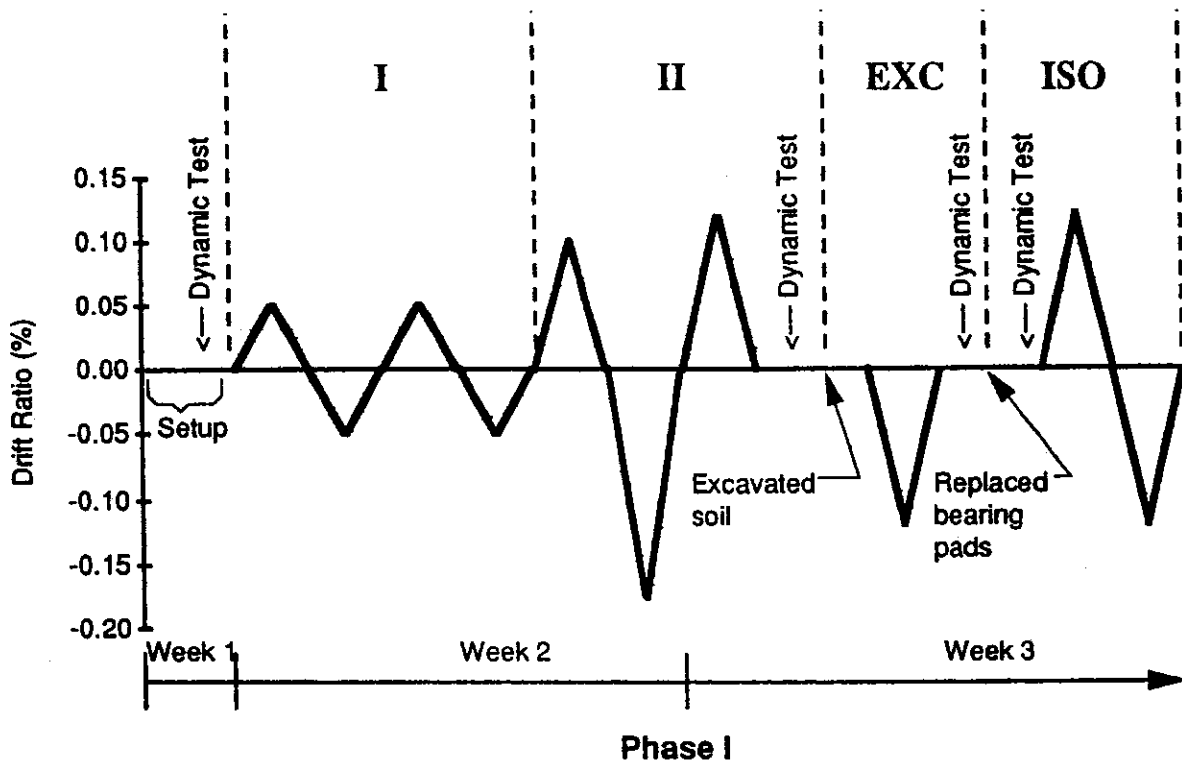
Figure 1.4. Loading History

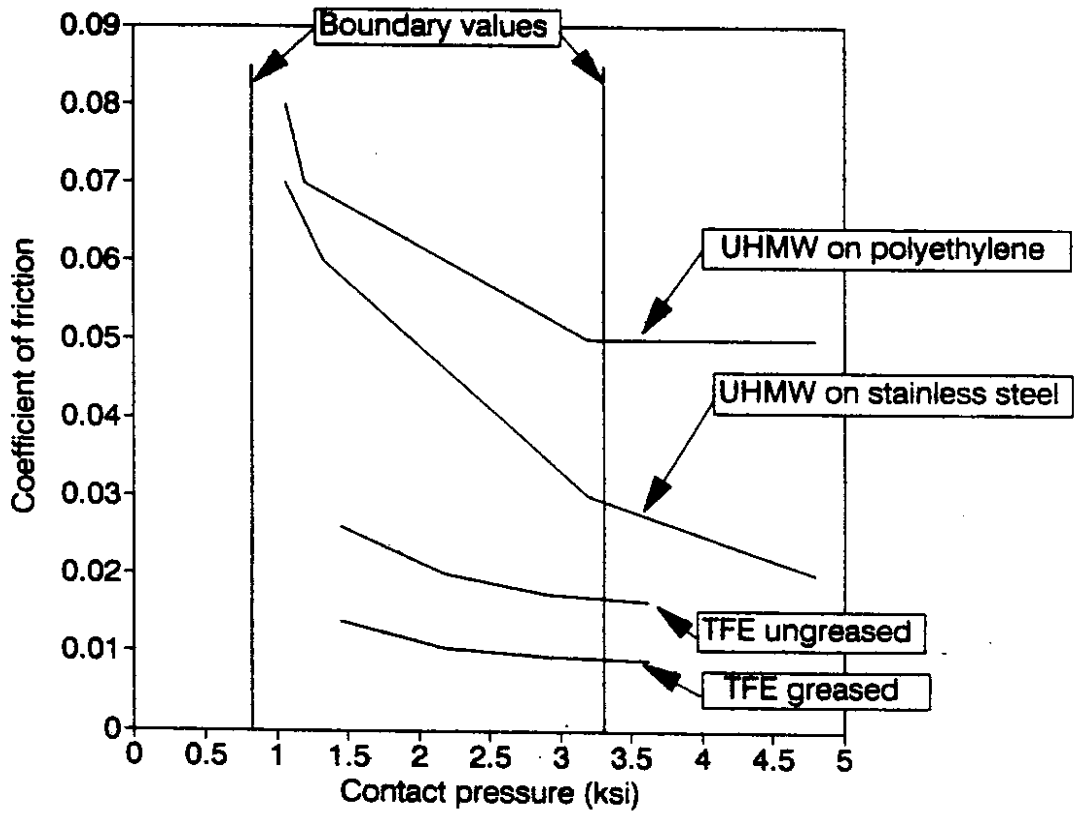
Figure 4.6. Measured Coefficients of Friction

On the basis of the laboratory measurements, the effect of the isolation-devices' friction was estimated. It was assumed that the normal force on the isolation devices

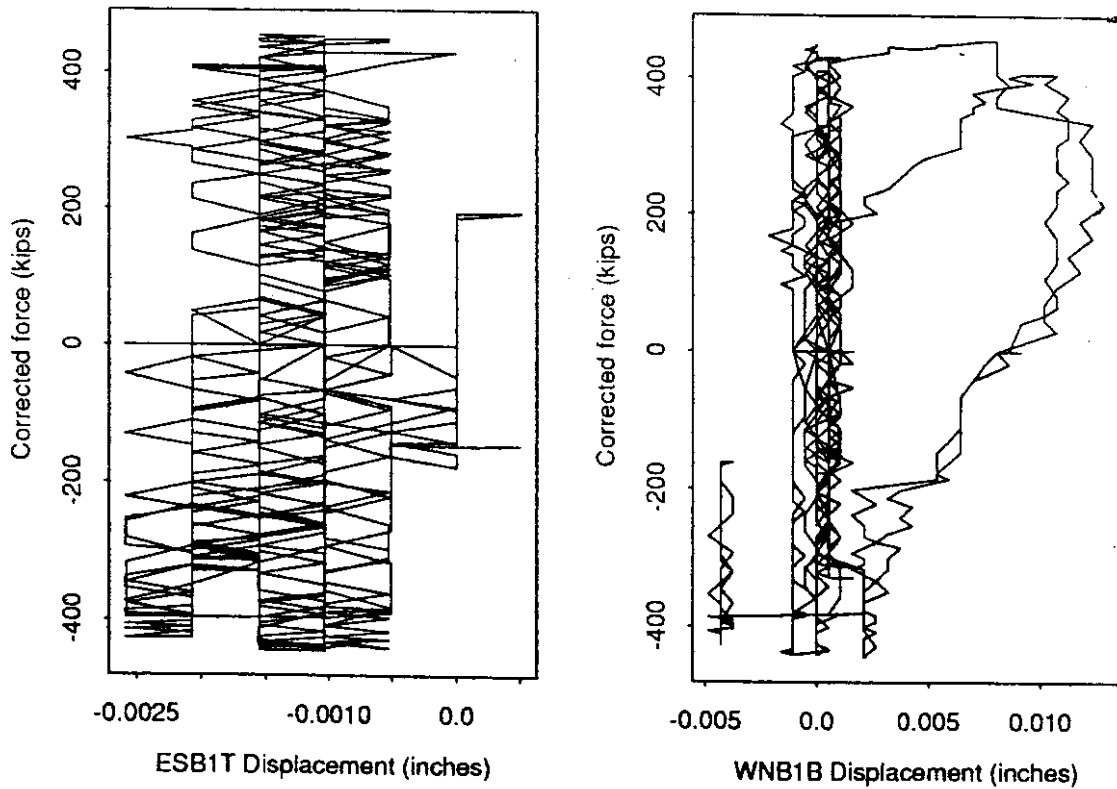
Figure 7.2. Measured Displacements for Crossbeam Instruments

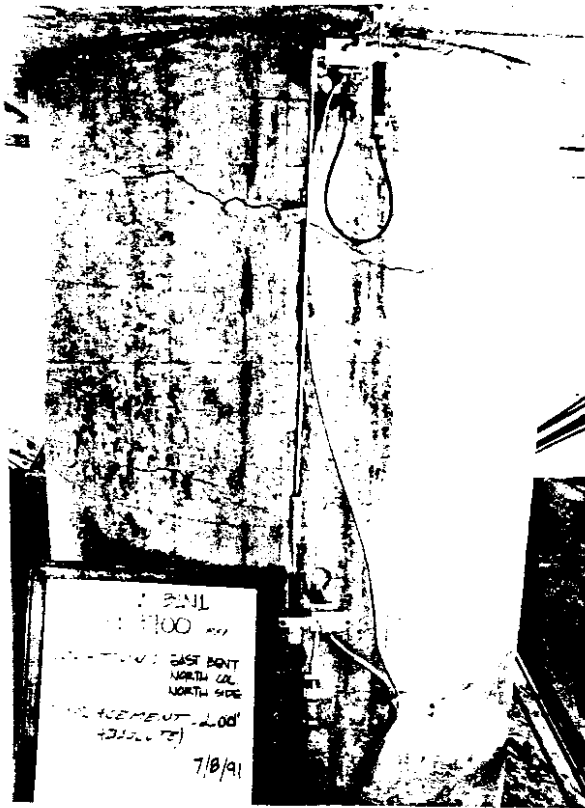
Figure 7.11. Photograph of Damage at 1.0 Percent Drift

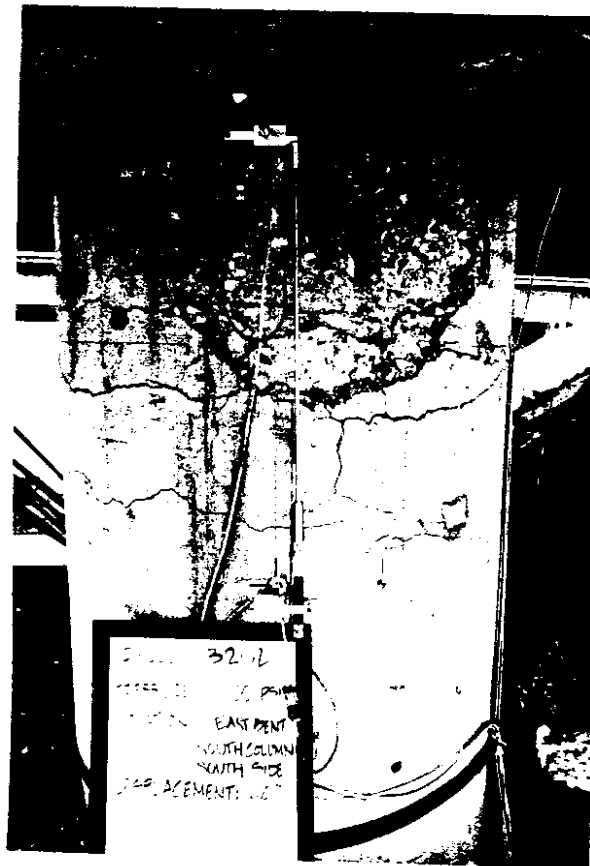
Figure 7.13. Photograph of Damage at 2.0 Percent Drift

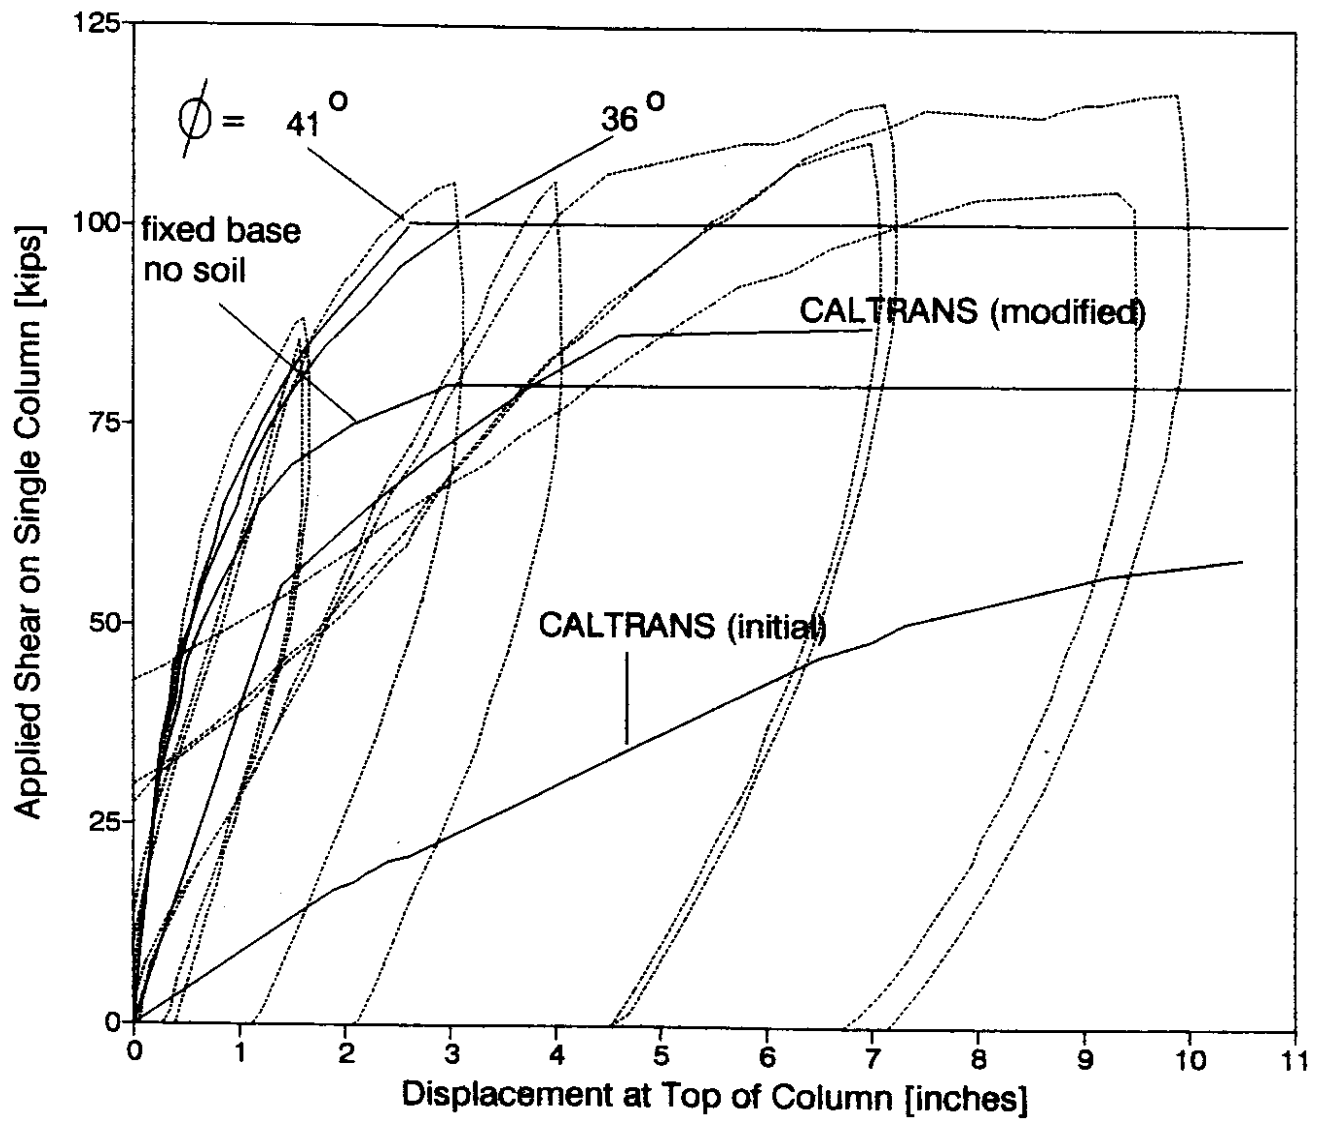
Figure 8.8. Calculated and Measured Response for Single Column

The model provided a good fit to the measured response, and the calculated load-displacement curves provided monotonic loading envelopes for the measured load-displacement curves from Phase II. Figure 8.8 shows that each load-displacement curve for angles of internal friction between 36 and 41 degrees was nearly the same. In comparison with the measured response, the model with no soil springs was too flexible and had a lower strength than was measured. For the model with the measured angle of internal friction, the column reached its calculated strength at an applied load of 100 kips and at a pier displacement of 2.7 inches. Because the analysis stopped when the column reached its ultimate curvature, the analysis did not estimate the system's displacement ductility.
