# **SEISMIC PERFORMANCE OF BRIDGE COLUMNS WITH INTERLOCKING SPIRAL REINFORCEMENT**

WA-RD 357.1

Final Report  
September 1994

**Washington State  
Department of Transportation**

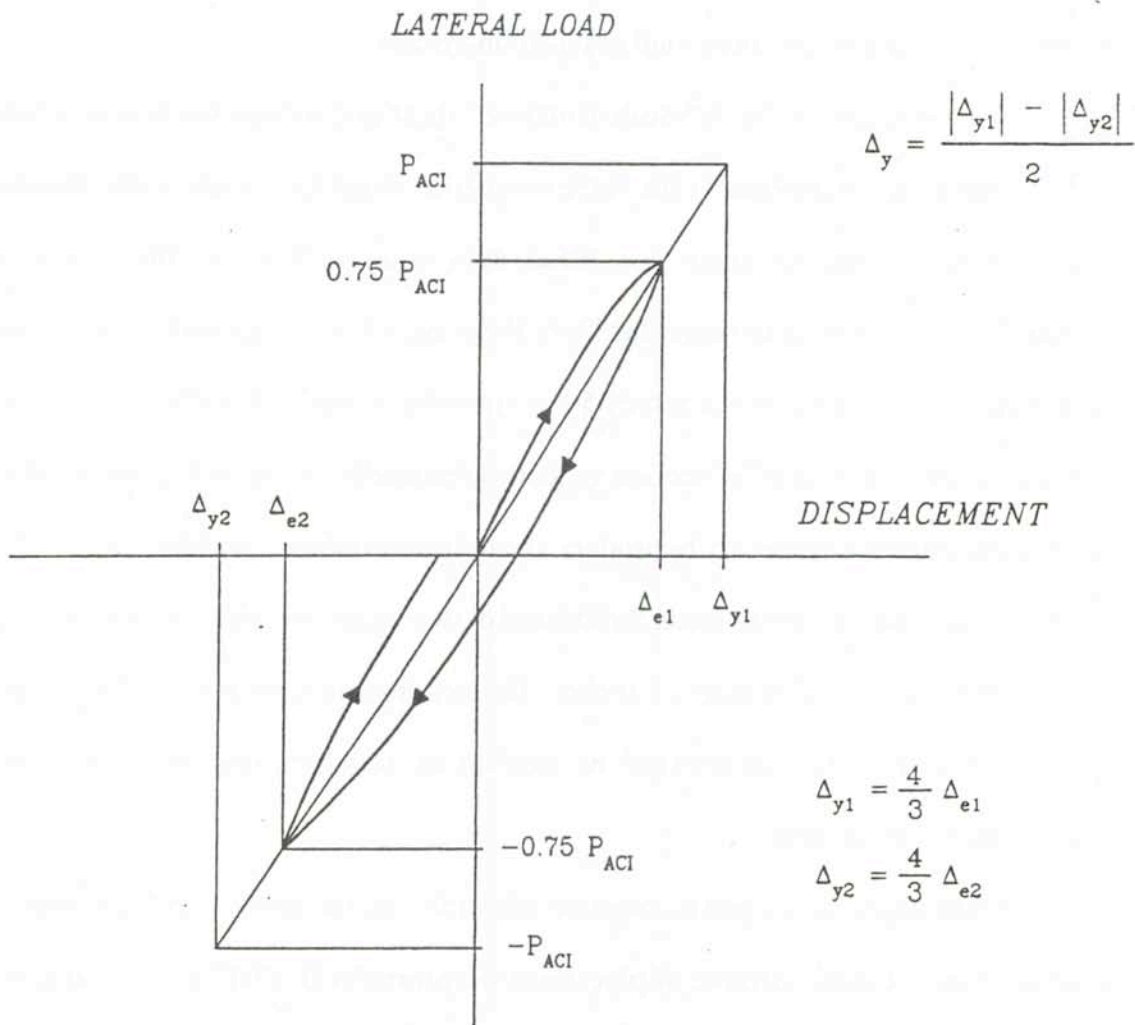
Figure 4 Determination of specimen yield displacement.

The method for determining the yield displacement for the 1/5-scale specimens is illustrated in Figure 4. The theoretical ACI ultimate moment strength ( $M_{ACI}$ ) of each column was determined using strain compatibility methods. The column was then subjected to  $\pm 75\% M_{ACI}$  under load control and the corresponding deflections of  $\pm \Delta_c$  were recorded. The yield displacement ( $\Delta_y$ ) was determined using the equation shown in Figure 4. The specimens were subjected to a simulated seismic loading pattern consisting of increasing multiples of  $\Delta_y$  in order to demonstrate the ductility and hysteretic behavior of the test specimens. The loading pattern for the flexure specimens consisted of two cycles at displacement ductility

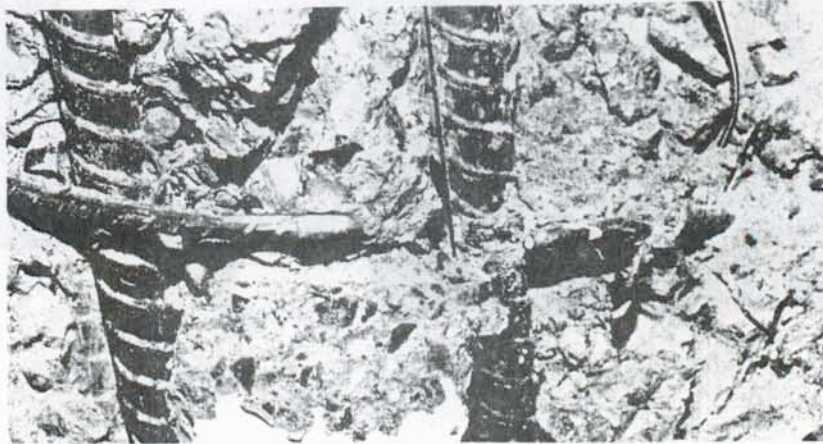
Figure 8 Photographs of Column 3 showing (a) crack patterns at  $\mu = \pm 2$  and (b) rupture of the spiral reinforcement.

Column 3 was constructed with an overlap percentage of 15 to examine the minimum overlap of 14.3% recommended by Caltrans (1). All of the longitudinal bars in the interlock zone were the same size as the bars used in the rest of the specimen. The initial cracking load and crack pattern exhibited in this specimen was similar to that described for Columns 1 and 4. However, crack widths in Column 3 at  $\mu = \pm 2$ , shown in Figure 8a, were significantly larger than those encountered in the previous two tests at the same level of displacement. Spalling of cover concrete in this specimen commenced in the latter stages of the  $\mu = \pm 2$  cycle and continued into the final two cycles at  $\mu = \pm 4$ . Rupture of the spiral reinforcement, shown in Figure 8b, occurred on the first cycle to  $\mu = +4$  at approximately 93% of full cycle displacement. The load-deflection plot for Column 3 is shown in Figure 6c. Decreases in the load carrying capacity of the column are detectable at every level

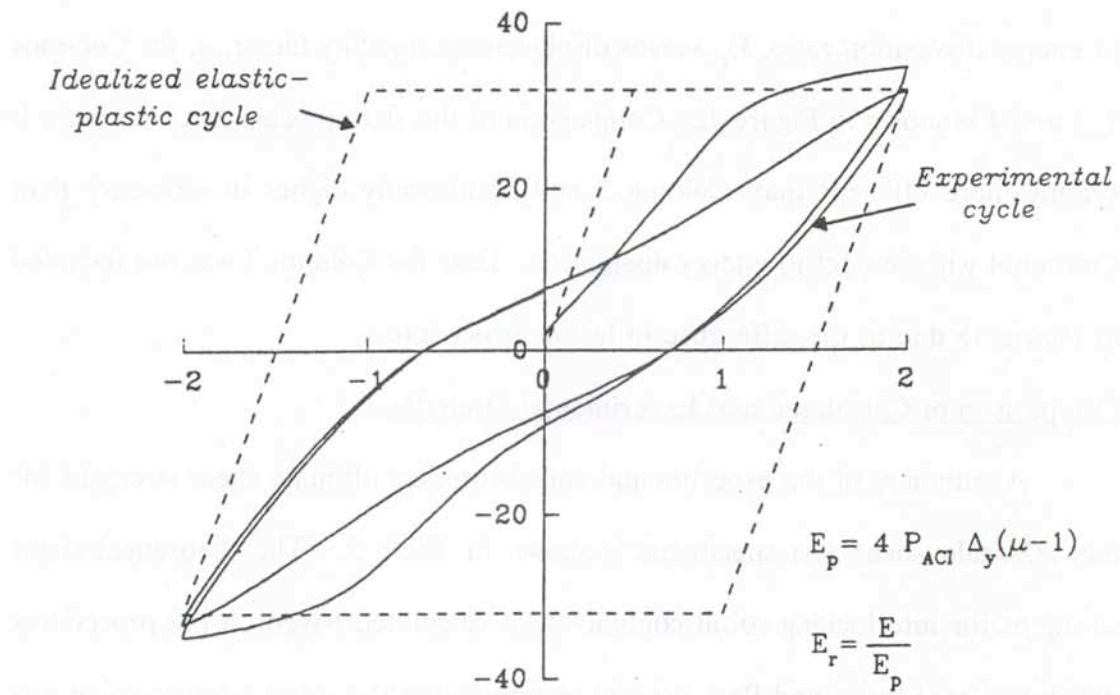
Figure 11 Definition of energy dissipation ratio,  $E_r$ .

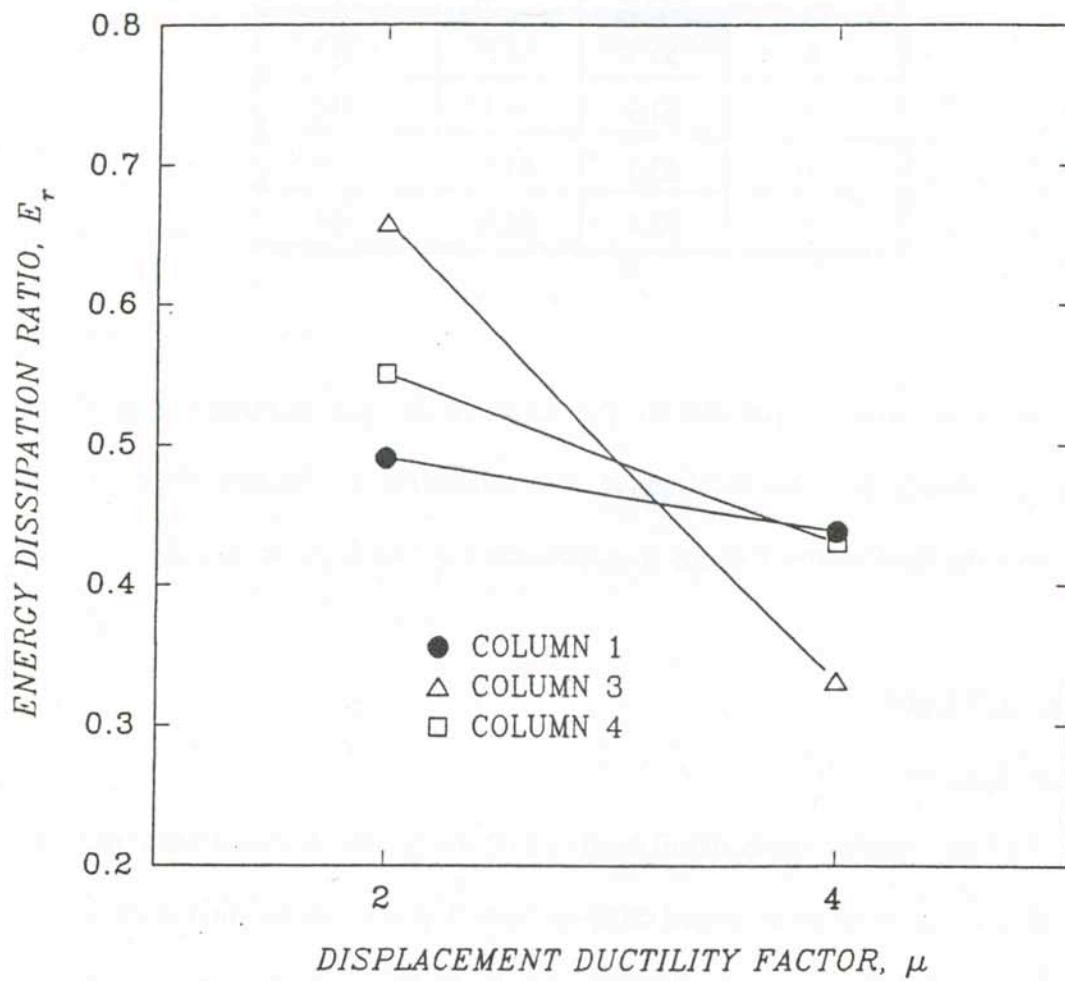
Figure 12 Energy dissipation ratio versus displacement ductility for shear specimens.

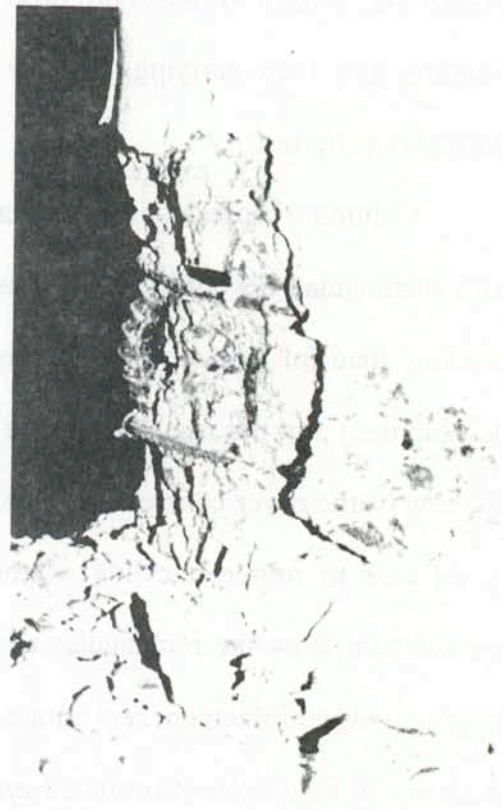
Figure 13 Photographs of Column 5 showing (a) damage at  $\mu = \pm 6$  and (b) buckling of the longitudinal reinforcement.

above the top of the footing occurred at  $\mu = \pm 4$  and eventually led to spalling in these areas at  $\mu = \pm 6$ , as shown in Figure 13a. On the final cycle to  $\mu = +6$ , the longitudinal bar shown in Figure 13b buckled outward between two sections of spiral reinforcement. Further cycling of the specimen resulted in fracture of this bar at  $\mu = -8$  due to fatigue stress. The load-displacement curve for Column 5 is shown in Figure 14a. Except for the sharp drop in lateral load at the point of longitudinal bar fracture, the load carrying capacity of the specimen remains nearly constant throughout the test.

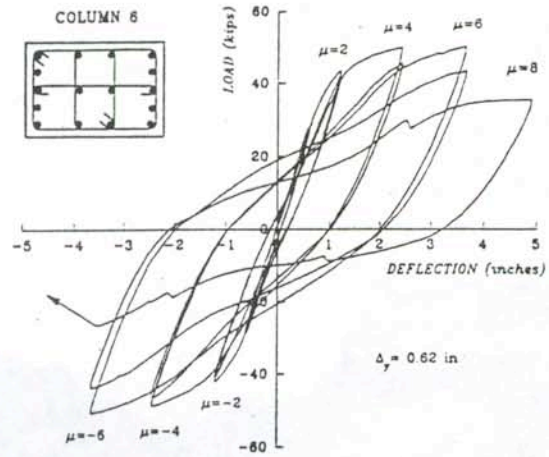
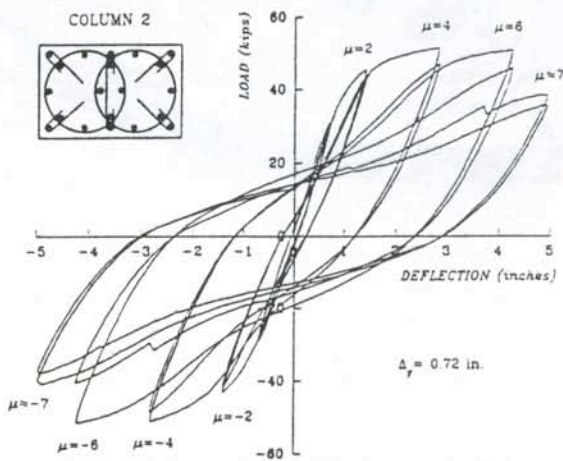
Figure 14 Load-displacement curves for the flexural test specimens.

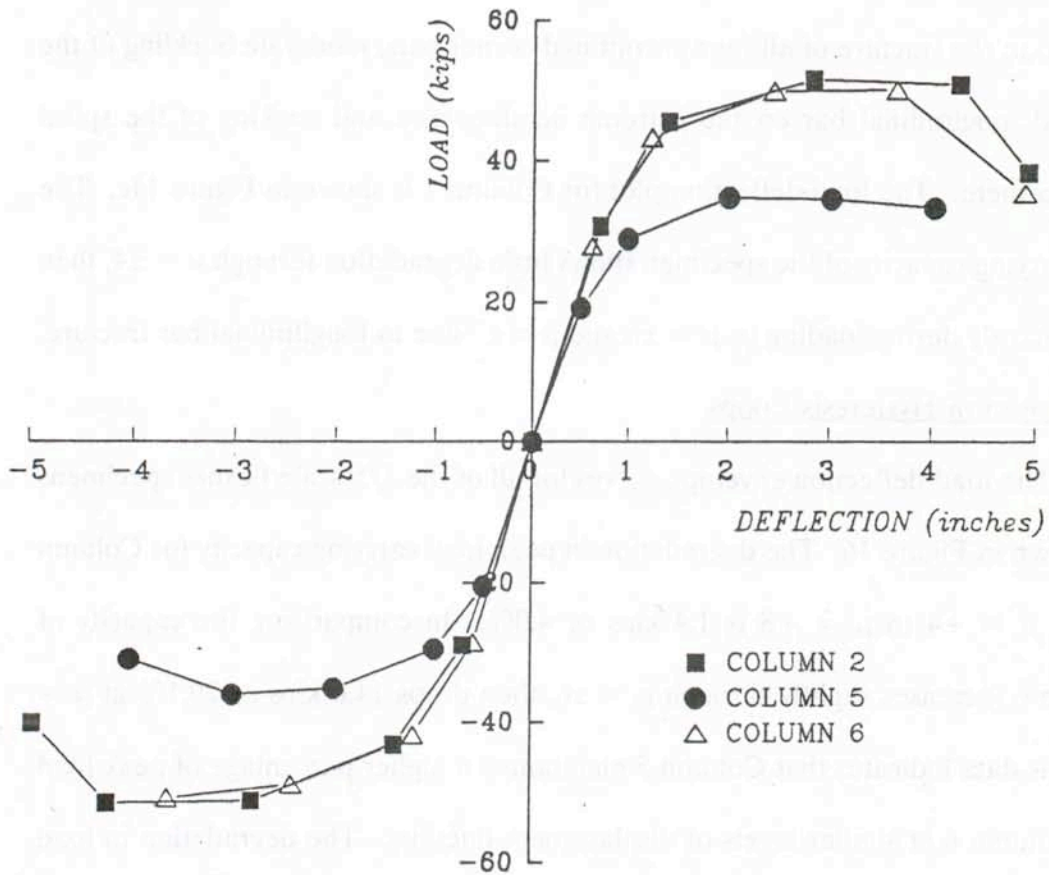
Figure 16 Lateral load-deflection envelope curves for flexural test specimens.

The load-deflection envelope curves for all of the 1/5-scale flexure specimens are shown in Figure 16. The degradation in peak load carrying capacity for Column 5 from  $\mu = +4$  to  $\mu = +8$  is 1.4 kips or 4.0%. In comparison, the capacity of Column 6 increases slightly through  $\mu = \pm 6$ , then drops 14.6 kips or 29.1% at  $\mu = \pm 8$ . This data indicates that Column 5 maintained a higher percentage of peak load than Column 6 at similar levels of displacement ductility. The degradation in load carrying capacity for Column 2 from  $\mu = +4$  to  $\mu \approx +7$  is 13.2 kips, or 25.6%, and is primarily the result of unconfined longitudinal bar fracture.

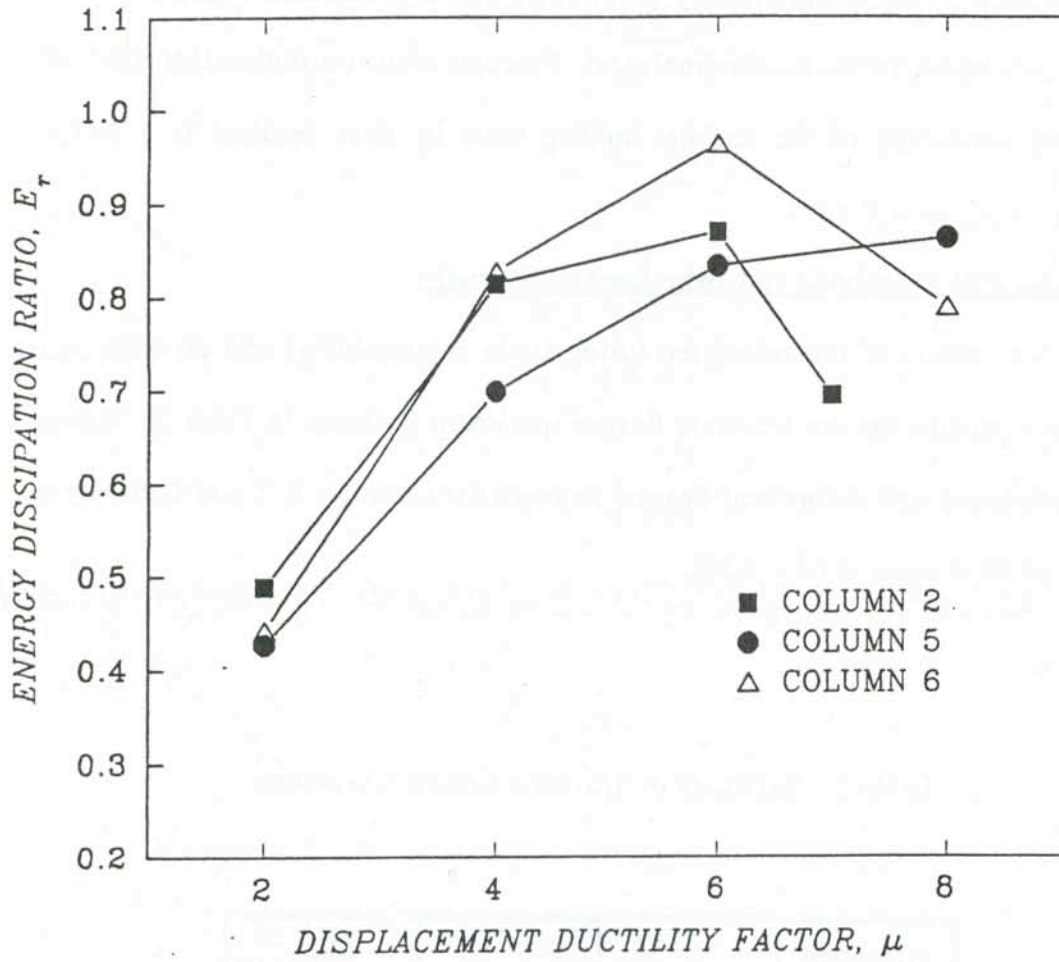
Figure 17 Energy dissipation ratio versus displacement ductility for flexure specimens.

A plot of energy dissipation ratio,  $E_r$ , versus  $\mu$  for Columns 2, 5 and 6 is shown in Figure 17. The energy dissipation of Column 5 increases at each successive

level of  $\mu$ , while Column 6 displays a decrease of 18.1% from  $\mu = \pm 6$  to  $\mu = \pm 8$ . A comparison of the two specimens indicates that Column 5 is more efficient than Column 6 with respect to energy dissipation. The increase in  $E_r$  for Column 2 from  $\mu = \pm 4$  to  $\mu = \pm 6$  is significantly lower than that for Columns 5 and 6 due to advanced buckling of the longitudinal steel. Fracture of the unconfined longitudinal bars and unraveling of the anchors holding them in place resulted in a 20.1% decrease in  $E_r$  at  $\mu \approx \pm 7$ .
