Research Report
Research Project WA-RD 491.1
Soil Bioengineering for Slopes

**SOIL BIOENGINEERING FOR
UPLAND SLOPE STABILIZATION**

February 2001

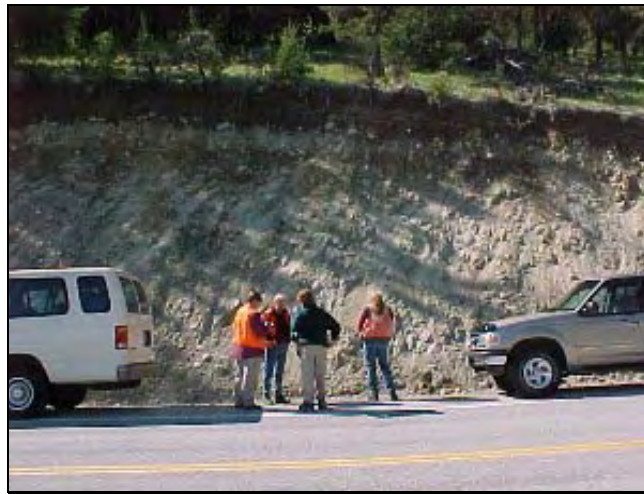
Figure 1. SR 971, Mile Post 8.22 vicinity, June 1999

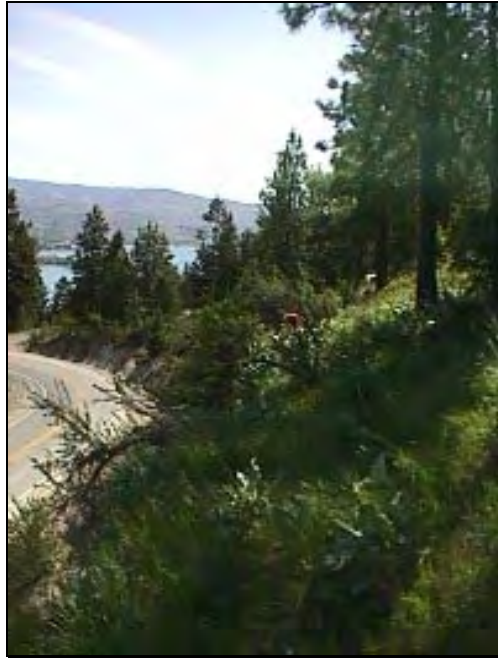
The slope above the vertical lip had an established ponderosa pine community. The vegetation, especially the mature trees, growing on the edge are at risk because of continual erosion (see Figure 2).

Figure 2. Vegetation community on stable soils

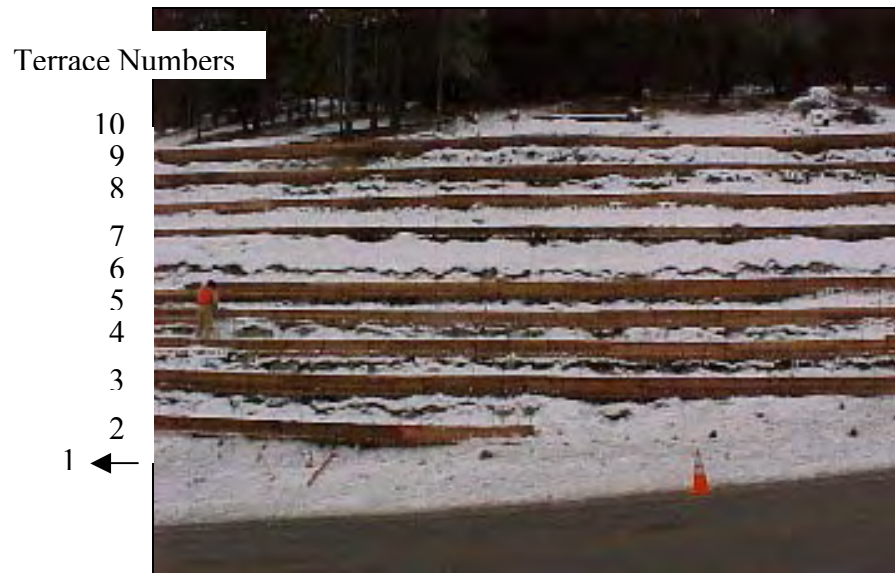
done until the terraces were constructed, and only in the terrace itself. The crew reported that constructing the terraces and pounding in the rebar was much easier after the application of the compost.

Figure 4. End of season - January 13, 2000

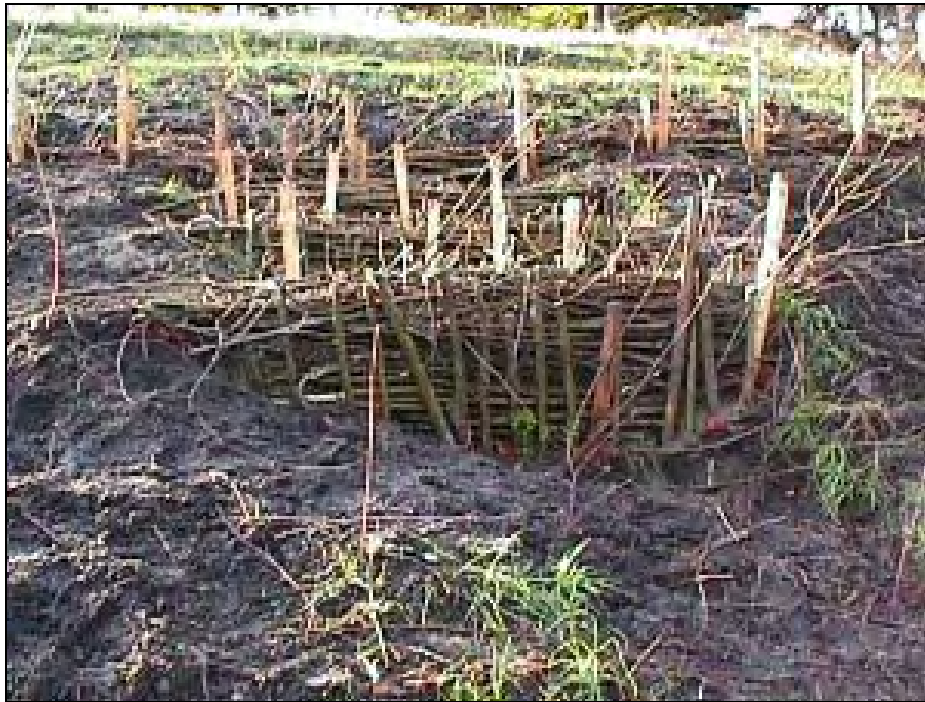
Because of the amount of surface water received by the gullies on Site 3, the original branch packing design washed out. Additional willow walls were constructed at the head of this gully, and the branch packing design was changed to the design seen in Figure 9.

Figure 9. Branch packing parallel to contours

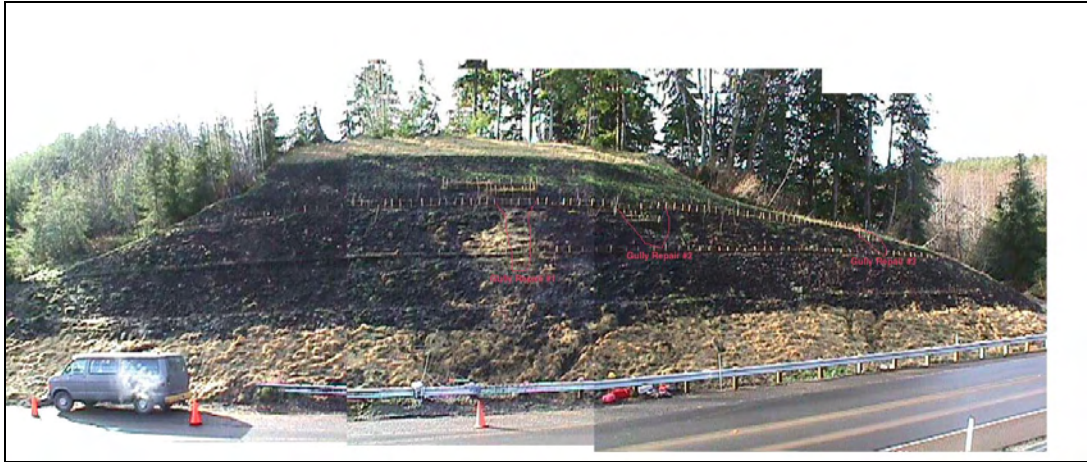
Construction concluded on Site 3 on January 27, 2000. Native vegetation was planted on Site 3 the week of January 24th. Figure 10 shows the site immediately after construction.

Figure 10. Site 3 immediately after construction

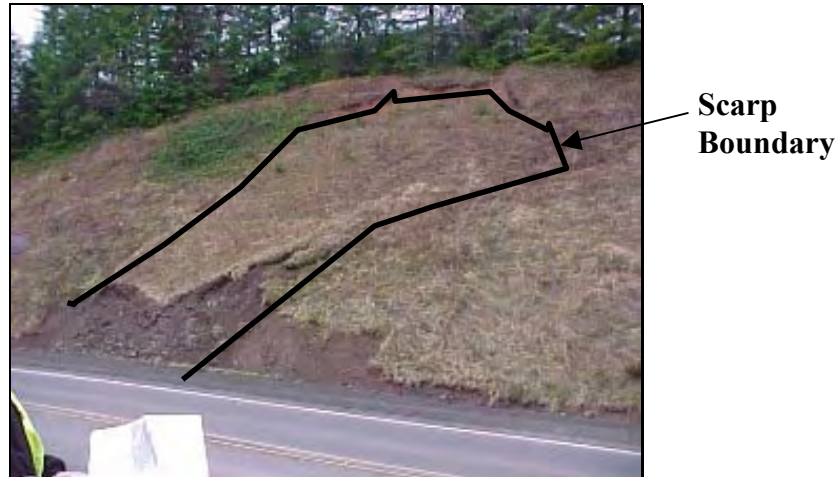
Soils on this 591-foot-long by 112-foot-high east-facing slope are composed of weathered marine sedimentary rocks. Small shallow, rapid landslides have occurred where these weathered clay layers left slope sections exposed to water movement. With excess surface and subsurface moisture, these layers slipped and moved downhill into the ditch. To manage stormwater runoff, maintenance activities required these plugged ditch lines to be cleared. In doing so, the base of the shallow rapid landslide was undercut, leaving a portion of the area with an exposed vertical face. During the year, the slope would “adjust,” move again into the ditch line, leaving a larger head scarp exposed to surface and subsurface water movement (see Figure 11).

Figure 11. Area of instability

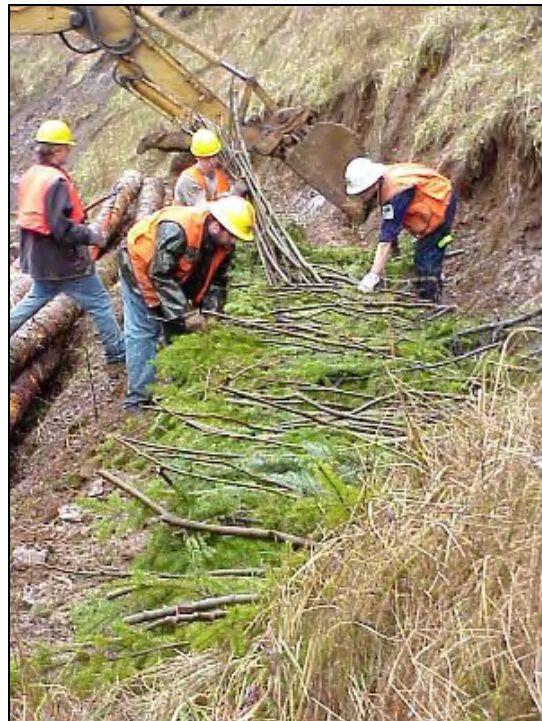
Construction began with region maintenance personnel using heavy equipment and two WCC crews using hand equipment on February 1, 2000. They began by excavating at the northern end of the site and installing the first cordon. Figure 13 shows the cordon construction after the bottom two logs had been placed in the terrace parallel to the slope.

Figure 13. Cordon construction

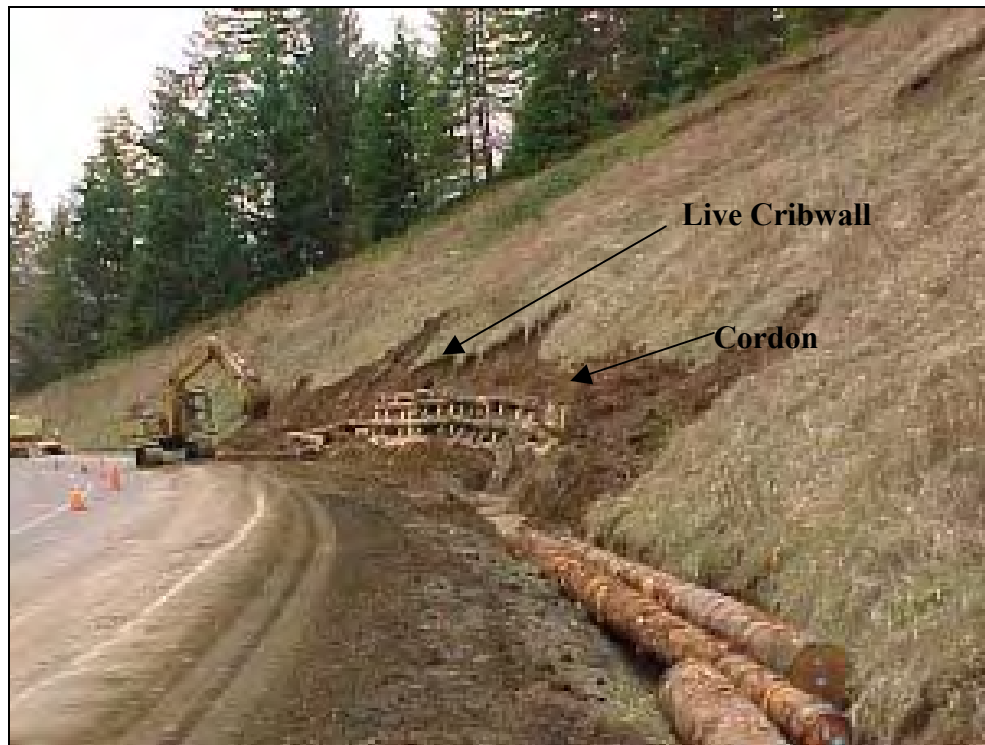
Figure 14 was taken on February 10, 2000. It shows cribwall construction at the end of the first week of construction.

Figure 14. End of first week of construction.

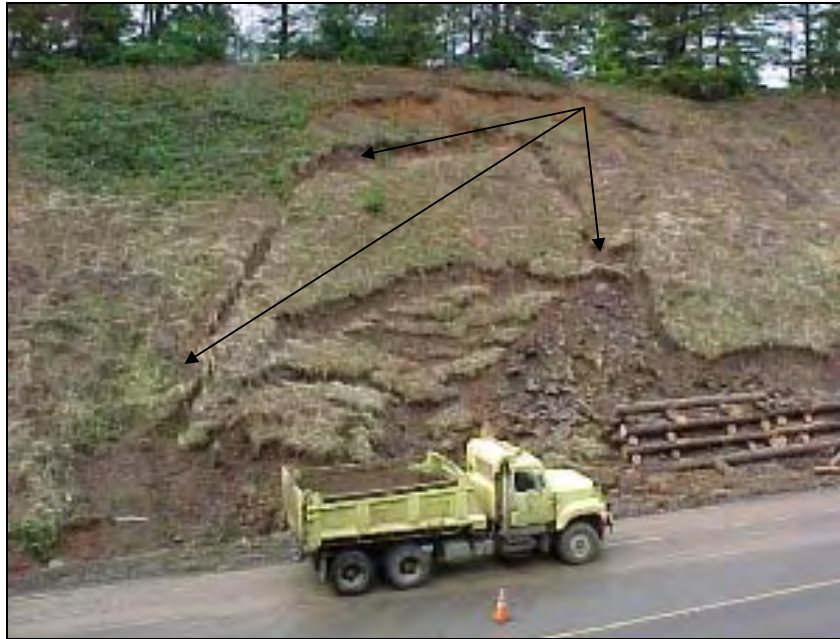
During site preparation for the base of the cribwall, the heavy equipment operator removed a portion of the slope toe. The fresh cut was left unsupported overnight, and when excavation resumed the next morning, the slope moved (Figure 15). The slope was oversteepened in the adversely oriented bedrock, causing failure of the bedrock and colluvial soils overlying the bedrock. In different material this might not have happened, and if the site had not been excavated and left exposed overnight, this slope movement might have been prevented. For future projects, on sites of this size and with propensity for large movement it is recommended that a slope stability analysis be a part of project design.

Figure 15. Slope failure

Construction on the Raymond project began January 31, 2000, and concluded March 23, 2000. The original design was altered because underlying sheets of bedrock failed when the toe was removed and left overnight without support. The principal design change was the off-site construction of the log cribwalls and their installation as modular 15-ft units. The slope was excavated in 15-ft sections, the cribwall units placed, cribwall units cabled to the adjoining unit, willow stakes placed, and the cribwall backfilled in approximately 2 hours per unit. This change allowed the project to continue

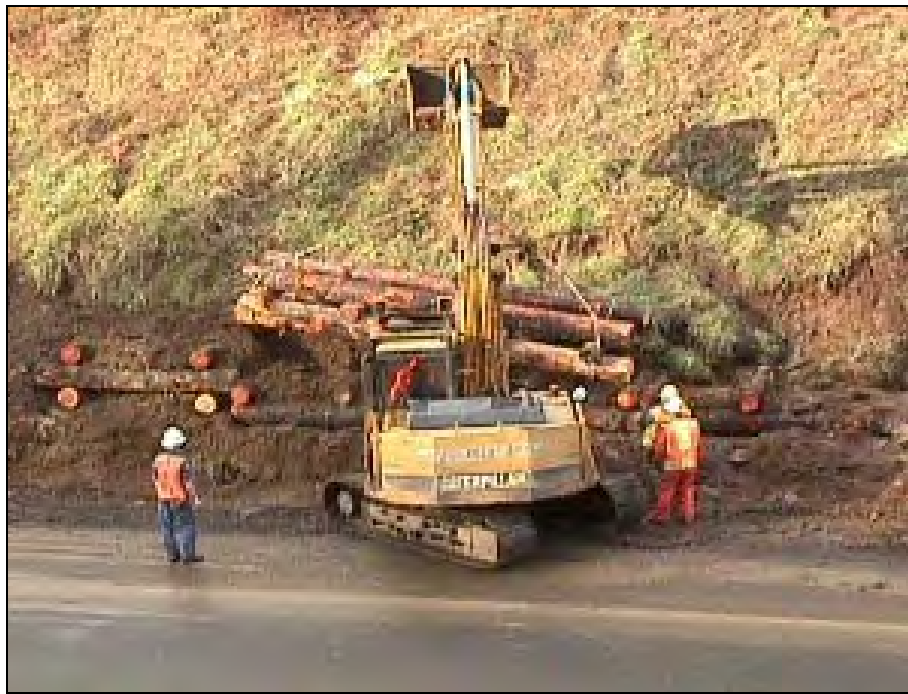
The modular cribwall frames were constructed off-site by February 28, 2000. They were installed in two vertical sections so that willow branches could be installed between the lifts, and soil could be added and compacted with the excavator bucket.

Installation can be seen in Figure 16. Each 15-ft cribwall framed section was cabled to the adjacent unit and to the ones above and below it.

Figure 16. Installation of modular live cribwall sections

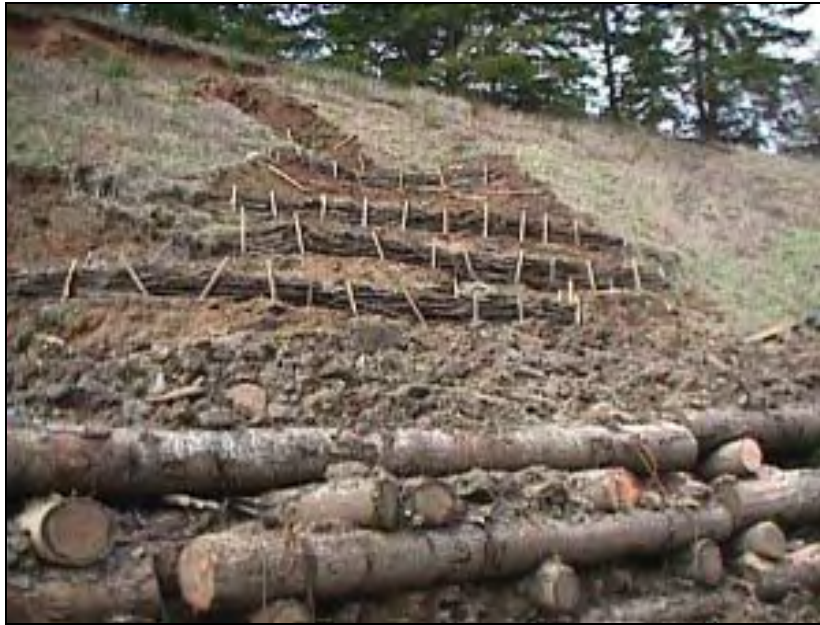
Figure 17. Live cribwall and willow walls

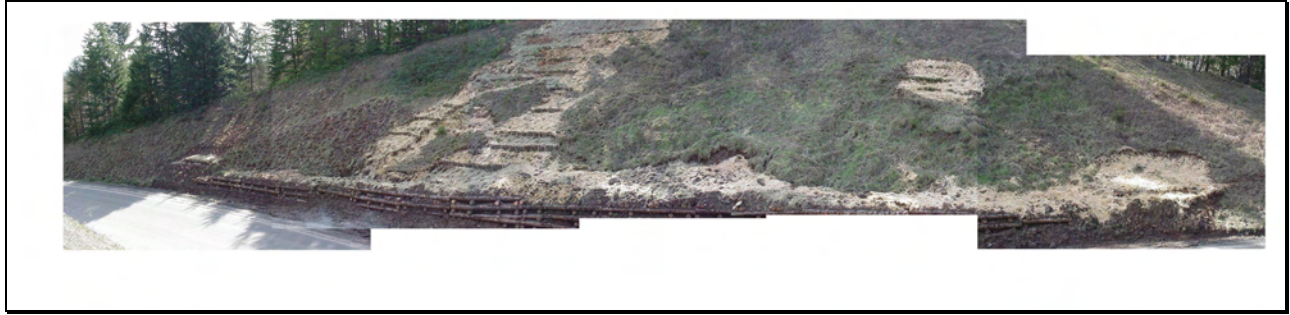
The live cribwall and cordon construction was completed with these changes on March 2, 2000. The crews finished the Raymond project, with willow wall construction further up the slope and with plantings and straw mulch application, on March 28, 2000. Figure 17 shows the willow walls constructed above the live cribwalls. Figure 18 shows the entire project after completion.

Figure 18. Completed soil bioengineering research site

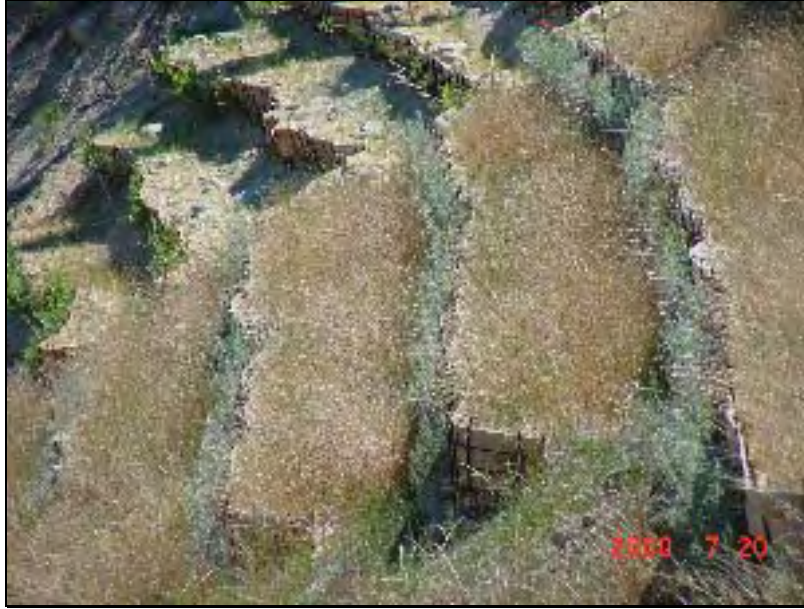
By the end of June 2000 the bender board appeared to have stabilized the surface erosion, and grass was growing on all terraces. However, where the composted biosolids had been applied, the annual rye was thicker, greener, and withstanding drought conditions better than the control section without compost, as seen in the Figure 19.

- Trend: improvement.
- There was slight evidence of continued surface erosion in unvegetated areas.
- The site supported 43 percent vegetative cover.

Figure 19. Grass communities differ with biosolids

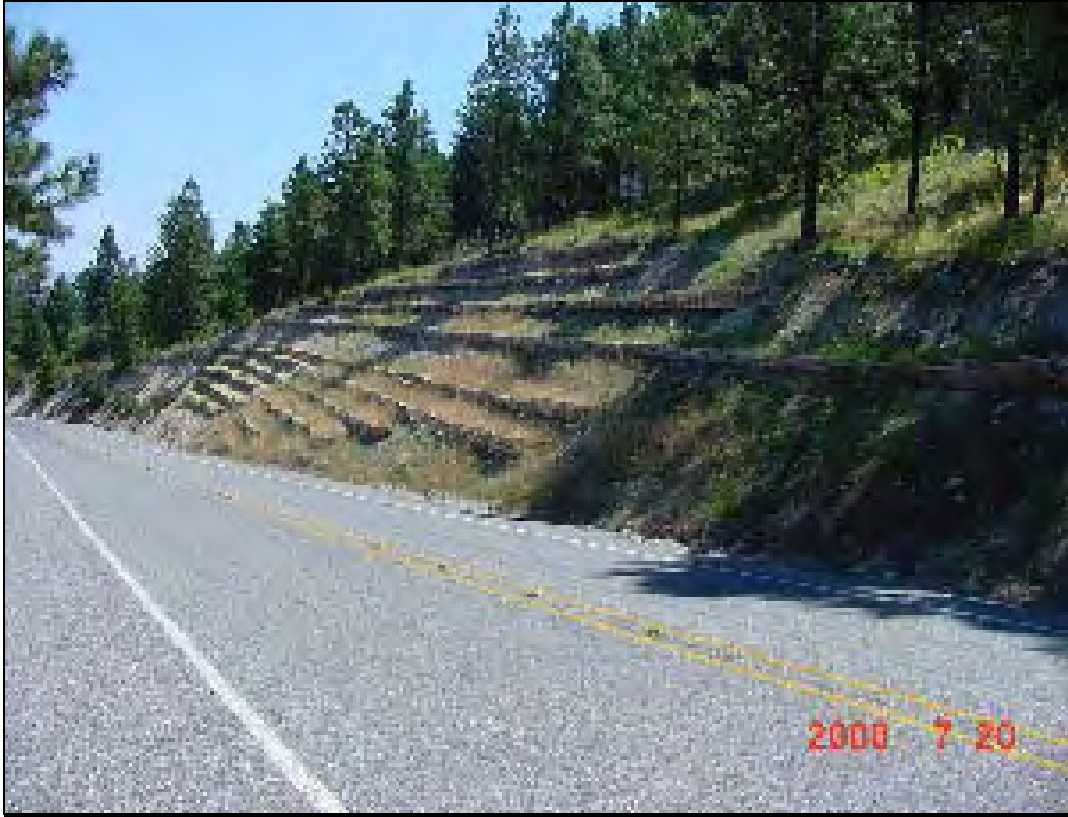
Long-term monitoring will allow WSDOT to determine long-term slope stability and to further understand the relationship between native plants, native soil, and biosolids. The status of this site in July 2000 is shown in Figure 20.

Figure 20. Chelan, July 20, 2000

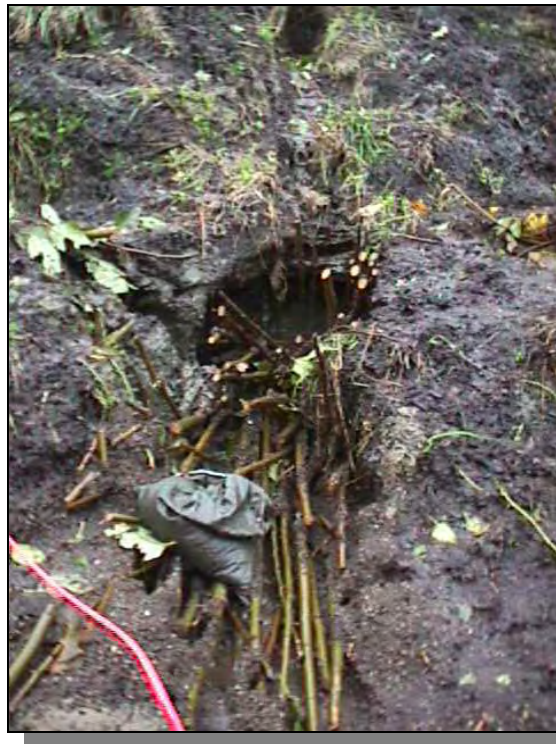
Construction on the Lost Creek project began October 25, 1999, and concluded December 27, 1999. The original design was altered because heavy rains caused springs to flow from areas in the slope, which drained directly through the conventional brush layers placed perpendicular to the slope contour, as seen in Figure 21.

Figure 21. Brushlayers failed when placed perpendicular to the slope.

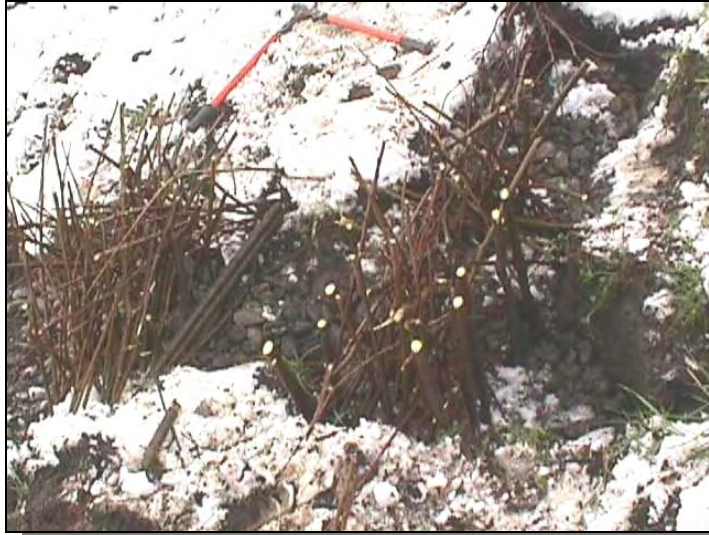
The design was changed so that the brush layers were laid parallel with the slope contour to better manage surface flow. This is shown in Figure 22.

Figure 22. Branch packing parallel to slope contours.

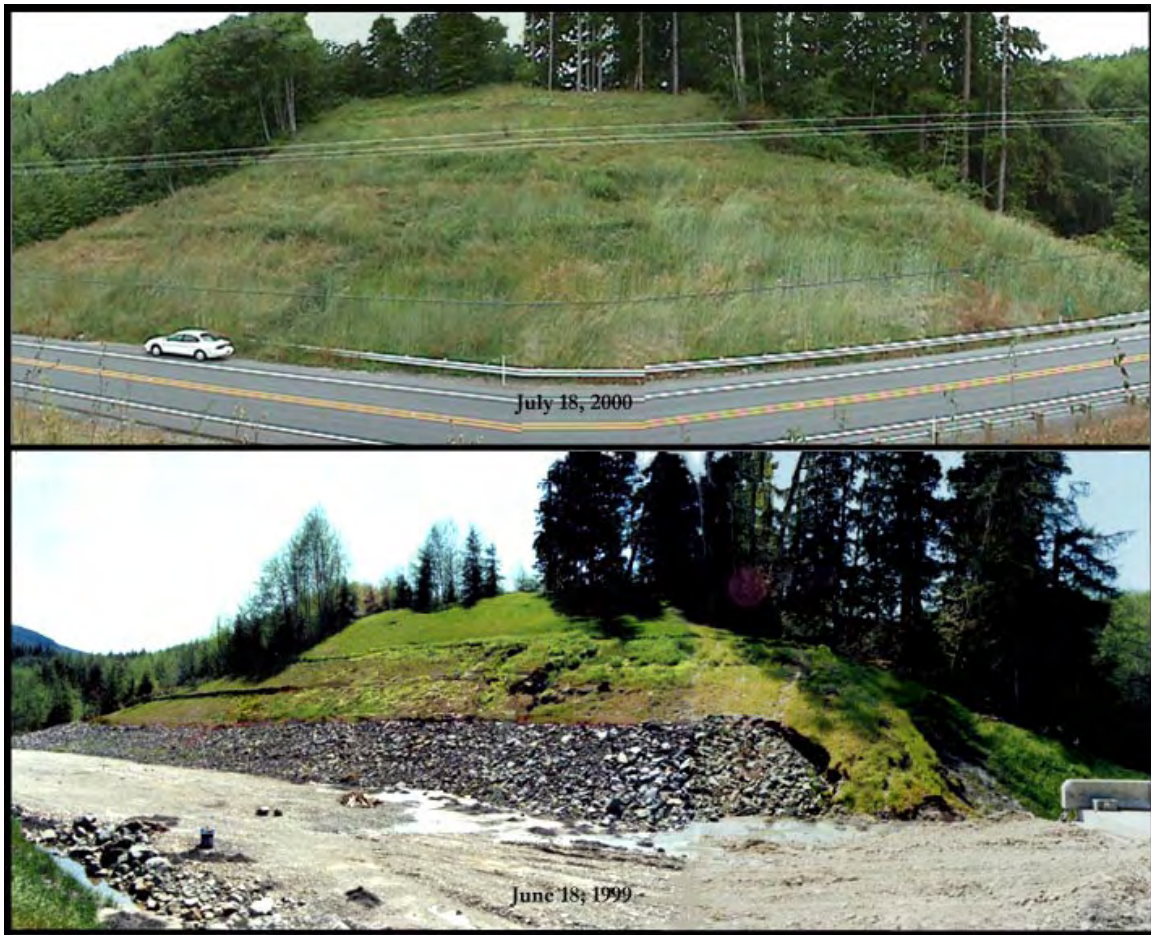
As of July 2000, the head scarp was stabilizing with grasses, shrubs, trees, and willow structures. The top photo in Figure 23 shows the site six months after construction. The lower photo shows the site before construction.

Figure 23. Site 3 Before and after soil bioengineering

- Trend: improvement to stability.
- There was no evidence of mass movement or gully erosion.
- The site supported 95 percent vegetative cover.
- Brushlayer survivability:
 - brushlayer structures – 80 percent show new growth
 - willow wall structures – 40 percent show new growth.
- Survivability of vegetation on terraces:
 - uniform survival above rock apron – 70 percent overall
 - uniform survival within the rock apron – 40 percent overall.

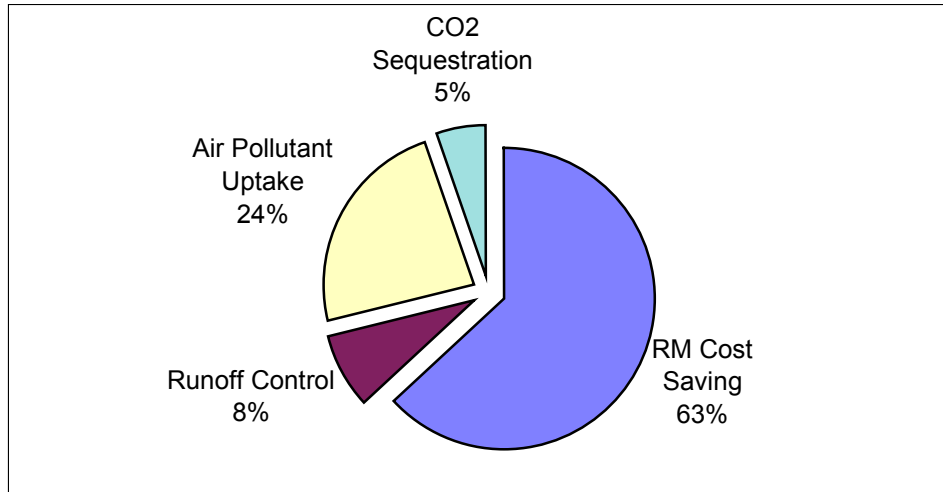
The benefits were broken into the categories seen in Figure 24 (RM stands for Roadside Maintenance). Cost savings were the dominant source of the benefits provided by soil bioengineering projects in comparison to traditional alternatives.

Figure 24. Benefit composition

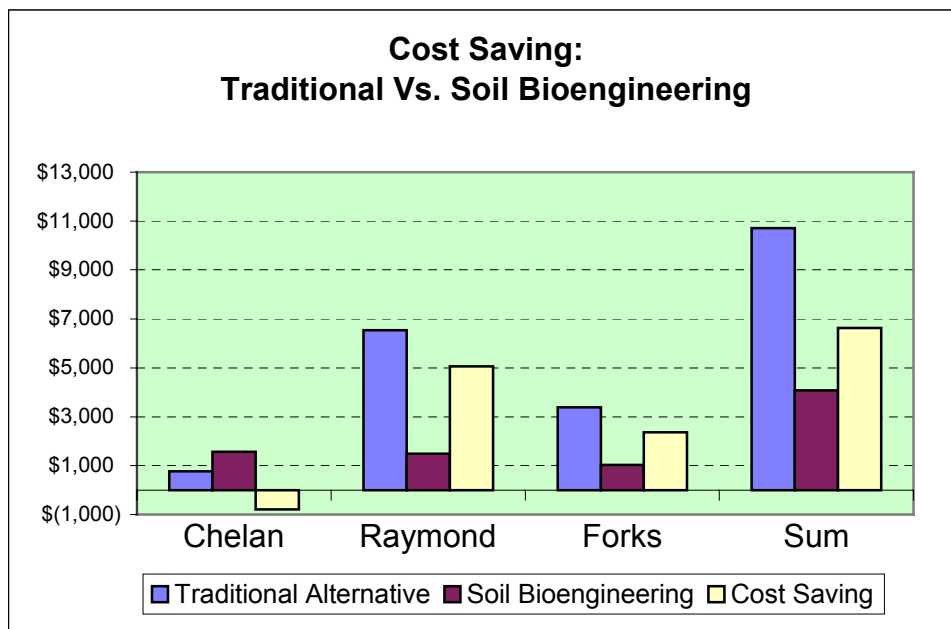
The initial construction costs for the three soil bioengineering research sites are shown in Figure 25 as they compare to the traditional engineering treatment that would have been used if WSDOT had chosen to stabilize those slopes. Annualized cost, which includes maintenance savings, between soil bioengineering and traditional engineering showed that all three projects were cost effective.

Figure 25. Initial construction cost saving

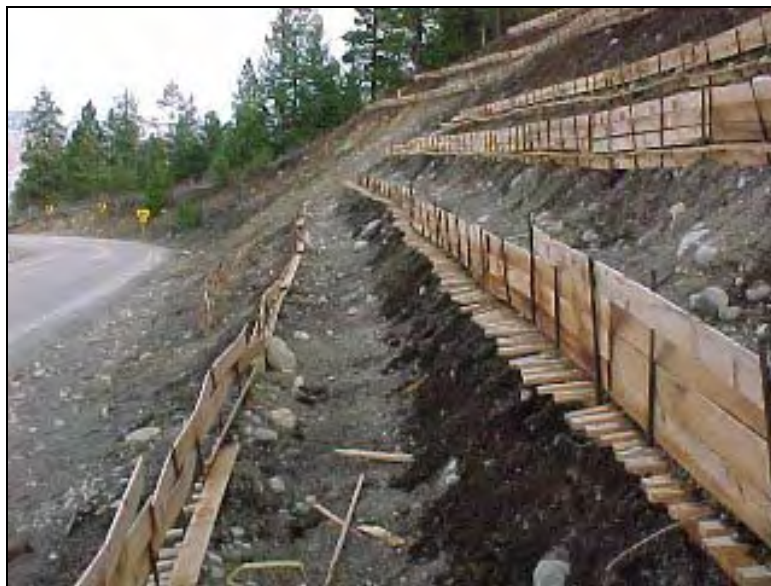
The Landscape Designer checked the site on March 15, 2000, to determine whether the soil had thawed and to check for disturbance to the site during winter. Without snow mixed into the soil, the soil had settled, allowing some of the boards to fall back onto the terrace. This can be seen in Figure F-2. With the addition of water, areas on the control section had liquefied and moved down slope. However, where compost had been applied, there was no visible movement of soil.

Figure F-6. Status before spring construction - March 15, 2000

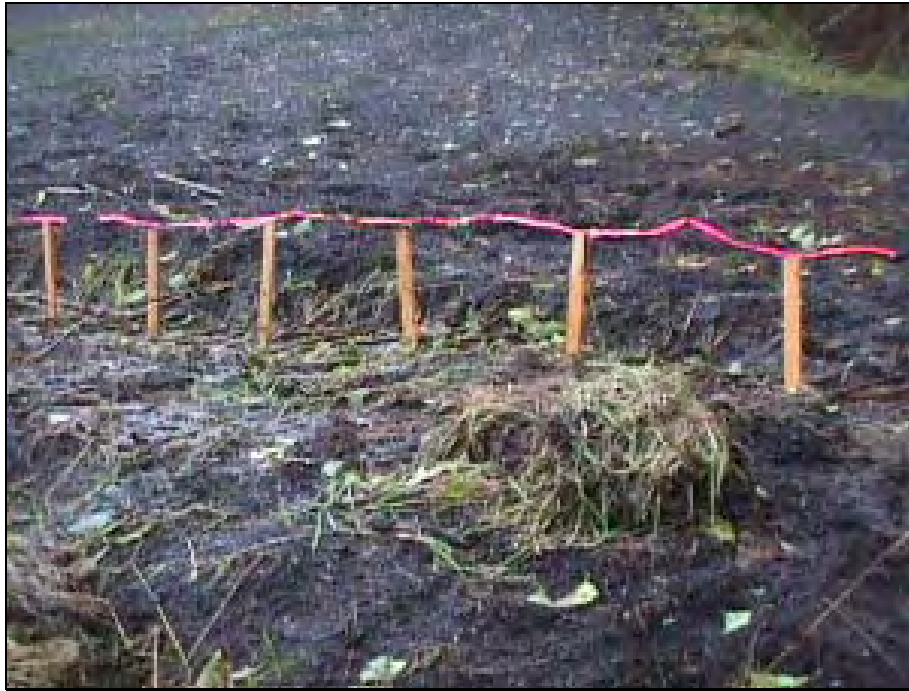
Figure F-3. Site 3 - Stakes placed below level terrace marking tape
