# **FATIGUE CRACKING OF RIVETED, COPEL, STRINGER-TO-FLOORBEAM CONNECTIONS**

WA-RD 494.1

Final Report  
March 2001

**Research Report**  
Research Project T9903, Task 98  
Bridge Fatigue Repair

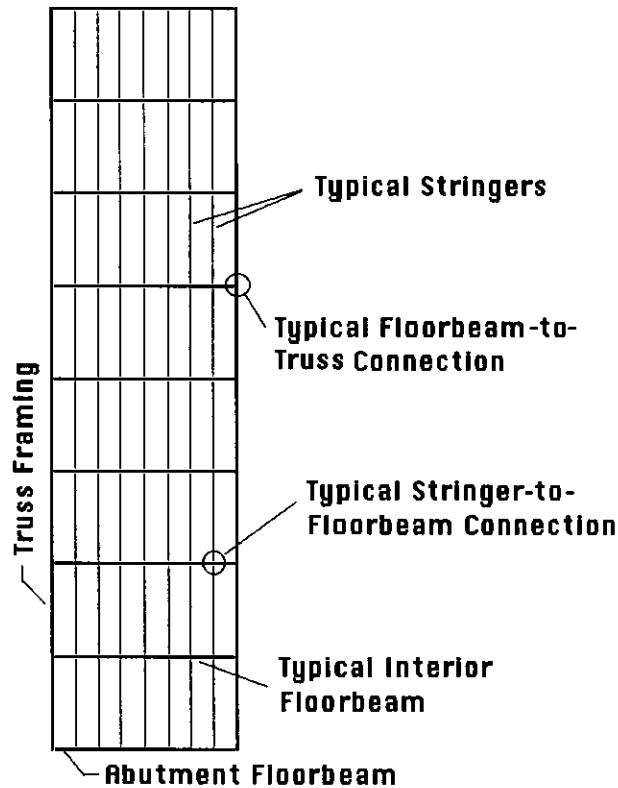
Figure 1. Typical Layout of Structural System for the Deck of Steel Truss Bridges

WSDOT has more than 150 steel truss bridges with deck framing, as shown in Figure 1. Coped stringer-to-floorbeam connections are used, because the top flange elevations are similar for both the longitudinal stringers and transverse floorbeams. Web-angle connections, as illustrated in Figure 2a, are used at most interior joints, but stiffened-seat connections, as illustrated in Figure 2b, are used at joints with limited movement requirements. Most of these bridges were built before 1970, and they employ riveted connections. Riveted construction is not normally regarded as sensitive to fatigue, but significant fatigue cracking has been observed, as illustrated in Figure 3.

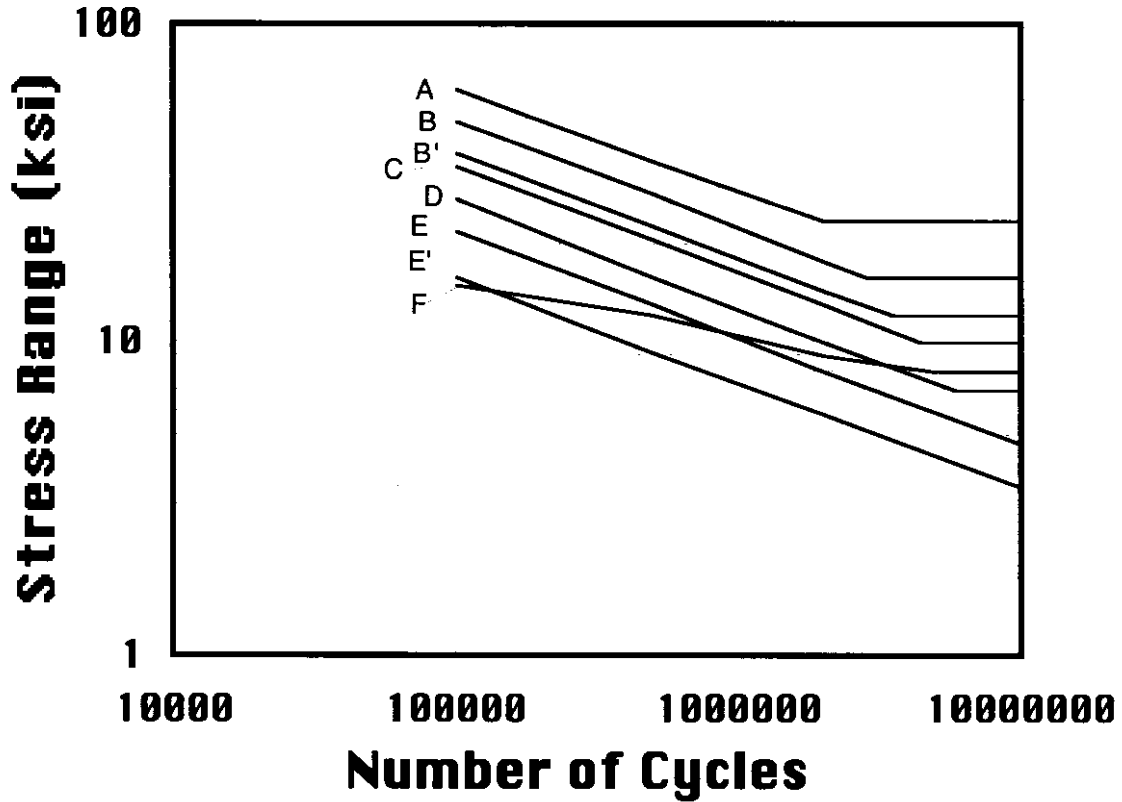
Category A reflects the fatigue life behavior for base metal with no holes, attachments, or section changes, and this curve permits relatively large stress ranges as a function of the number of cycles applied to the element. Increasing section changes are noted for elements as the stress range category progresses from A to E, E' or F, and significantly decreasing stress ranges are permitted for these more critical stress categories. The category assignments are based on the behavior observed in experiments from fatigue tests. The assignments are made through graphical representations of the loading and the connection detail. Most category assignments focus on welded structural details, and no categories are specifically assigned for riveted connections or for the coped stringer connection illustrated in Figure 2. Furthermore, the AASHTO fatigue categories were developed on the basis of observation of a visible crack approximately 25 mm (1 inch) long, and the S-N curves are defined to be approximately 2 standard deviations below the

Figure 7. S-N Curves as Commonly Used in AASHTO Specifications

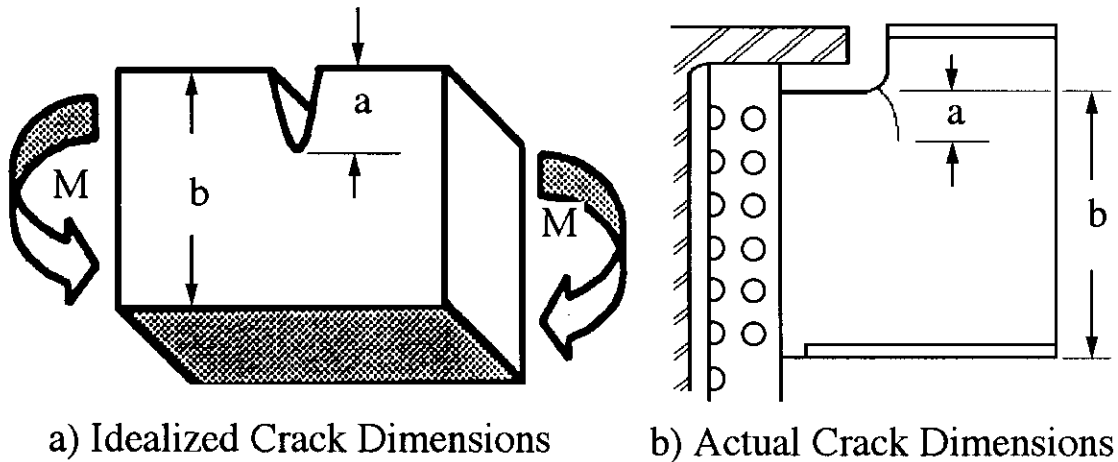
where  $a$  is the length of the crack, as depicted in Figure 10,  $C$  and  $n$  are empirical coefficients that depend upon the details of the loading and the specimen, and  $K$  is the stress intensity factor

Figure 10. Typical Crack Geometry

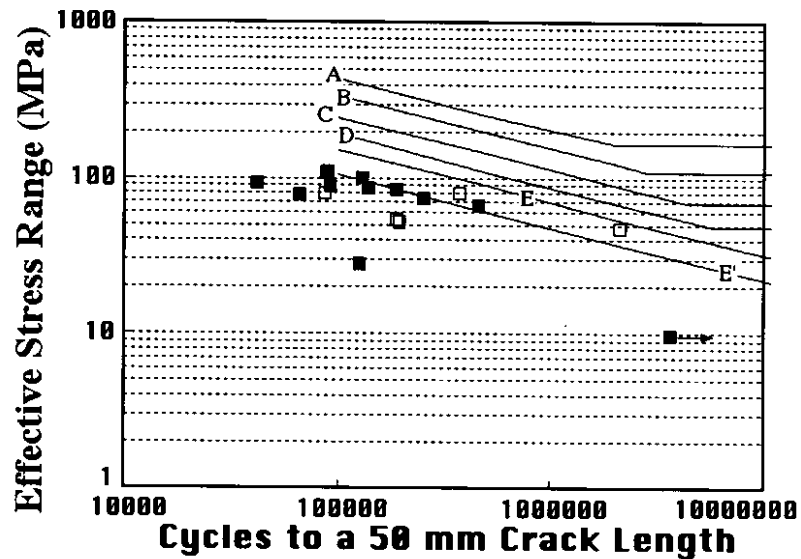
This estimate is conservative in that approximately 97.5 percent of comparable specimens should require a longer number of cycles for crack development, given the effective stress at the critical region of the coped specimen.

Figure 26. Number of Cycles Required to Develop a 50 mm Crack

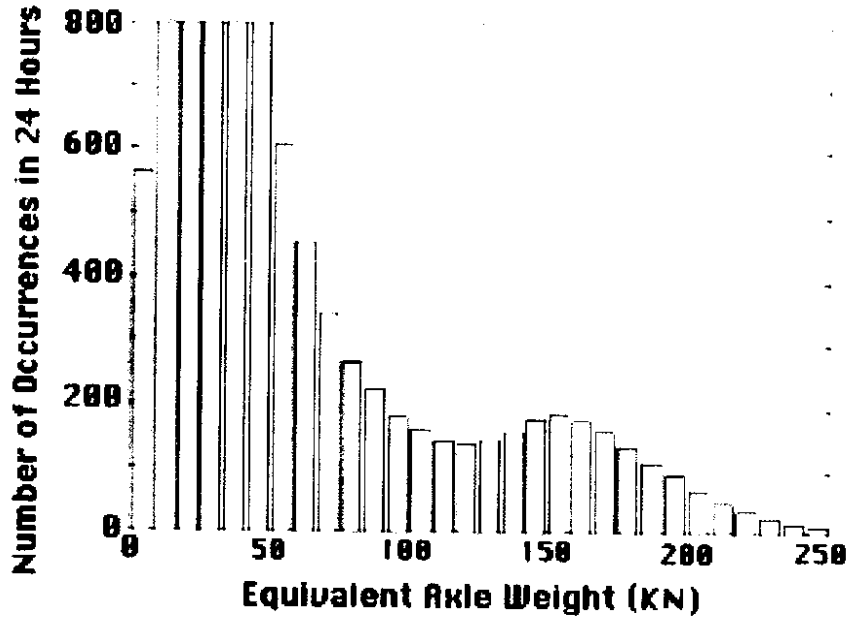
weights of less than 50 kN (11 kip) are ignored for this reason. Also note that an individual truck may contribute more than one cycle because of the multiple axles of many heavy trucks.

Figure 31. Histogram of Axle Load Variation Measured on the Lewis River Bridge

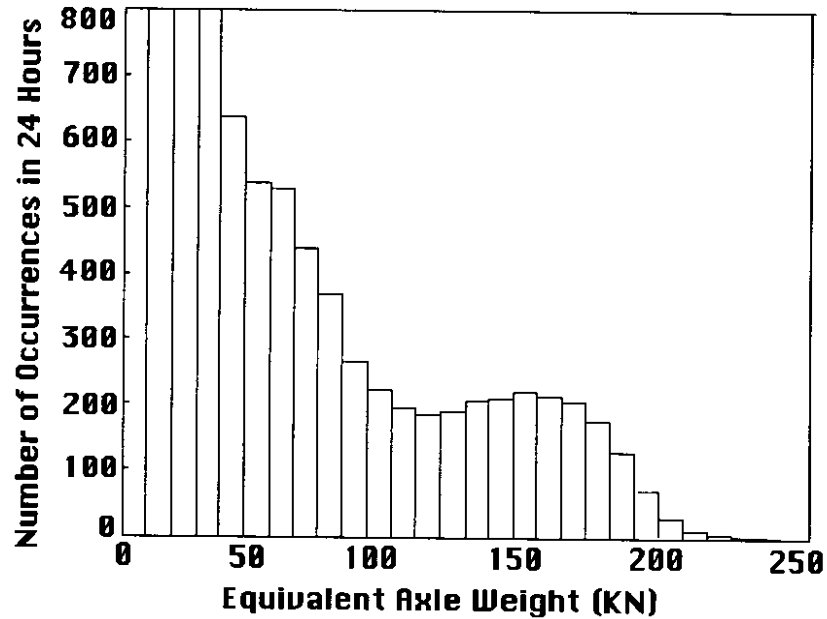
Similar axle load data were developed for the Toutle River Bridge, and these data are shown in Figure 32. These two histograms look different. However, the difference is misleading because they would both fall at similar positions relative to the S-N curves. The difference in histograms is a result of the trigger point used for the bridges in past studies. Both studies triggered their data acquisition to avoid many thousands of small or lightly loaded trucks, and these triggers were independent and slightly different. A larger number of the lighter trucks are included in the Toutle data, and this leads to the lower  $P_{eff}$  value with the larger number of cycles in the Lewis data. Fatigue evaluation with these two separate values will not lead to identical results, but they should lead to very similar results. This variability is appropriate because despite the measurement data, there is still uncertainty regarding the load history of individual bridges.

Figure 32. Histogram of Axle Load Variation Measured on the Toutle River Bridge

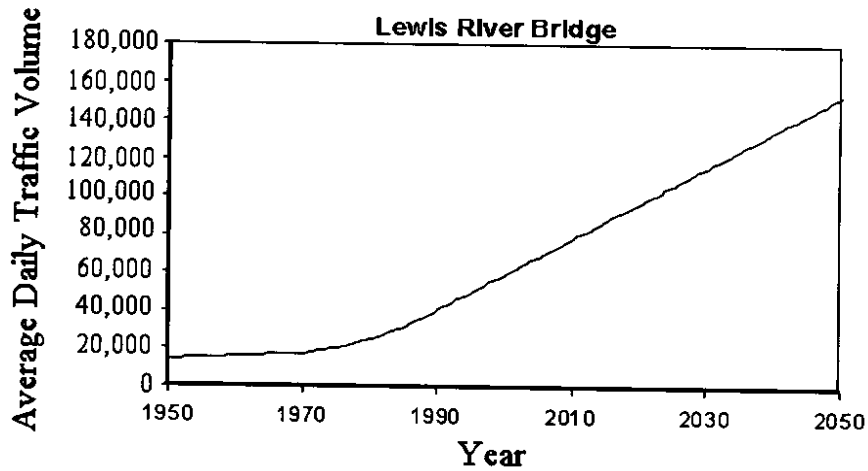
Figure 34. Total Vehicular Traffic vs. Time – Lewis River Bridge
