Research Report
Agreement T2695, Task 56
SR 7 Peds

**A MOTORIST AND PEDESTRIAN BEHAVIORAL
ANALYSIS ON SR 7**

November 2005

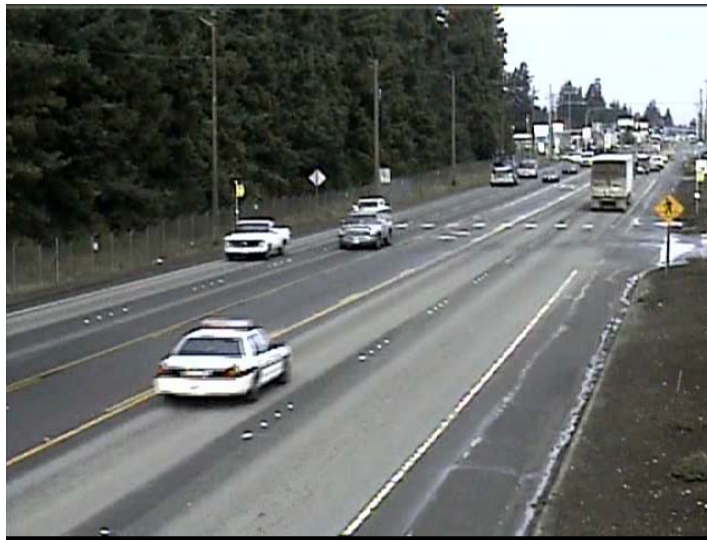
Figure 1. Camera view north of S. 180th Street

The *before* analysis focused on the marked crosswalks to the north and south of S. 180th Street. Figure 1 displays the camera view looking north. The crosswalk to the north of S. 180th Street is approximately 400 feet from the camera. The driveway near the crosswalk enters and exits a Kmart parking lot. Bus stops are on both sides of the crosswalk. The nearest signalized intersection is one quarter mile north at S. 176th Street.

The range of observations for the site is displayed in Figure 1 and Figure 2 in Section One. The observation boundaries for *before* data were limited by the available location for camera placement. During the *after* analysis, the camera was placed to the south of S. 180th Street, facing north. Figure 3 displays the observation boundaries for the *after* data collection.

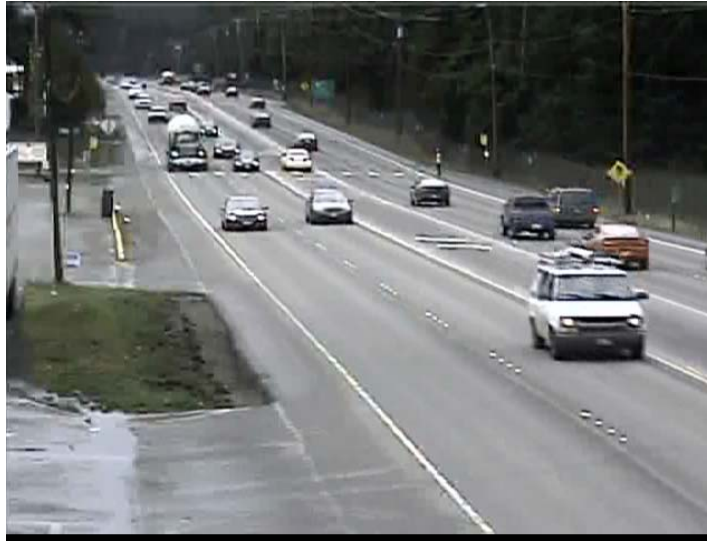
Figure 2. Camera view south of S. 180th Street

Figure 2 displays the camera view looking south. The crosswalk to the south of S. 180th Street is approximately 660 feet from the camera. The crosswalk is at the intersection of SR 7 and S. 182nd Street. There are bus stops on both sides of the crosswalk.

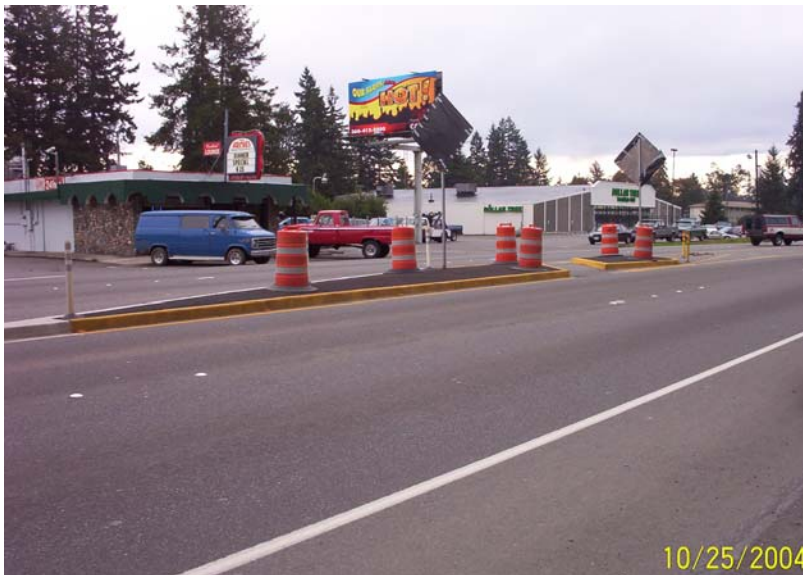
Figure 4. Pedestrian refuge islands at S. 180th Street and SR 7

In response to this behavior, WSDOT traffic engineers built raised median channelization for the left-hand turn from SR 7 onto S. 180th Street. Figure 4 displays the median.

A benefit of using a raised median channelization is the inclusion of a refuge for pedestrians. This median refuge can particularly aid older pedestrians who have slower walking speeds and thus have trouble crossing the road in one movement. Pedestrians can cross one direction of the roadway at a time and wait in the refuge for a break in

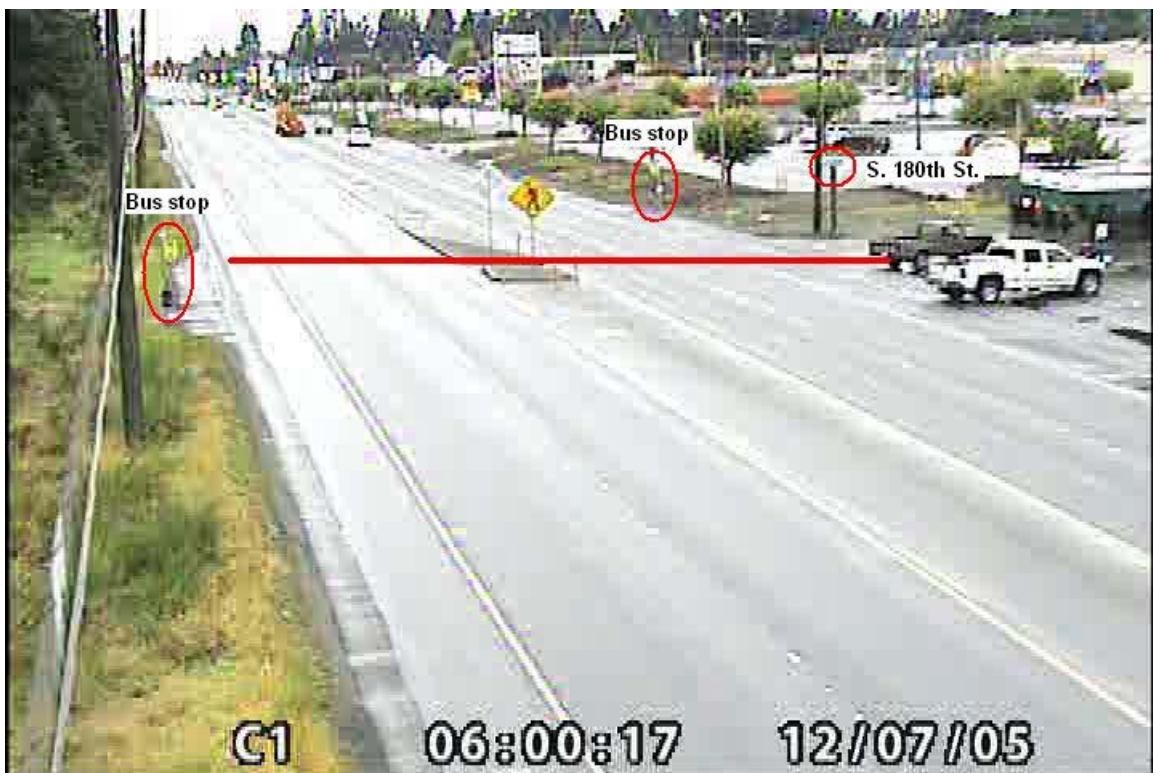
Figure 5. Transit stop locations at S. 180th Street and SR 7

The safety treatment at S. 180th Street also included new transit stop locations. Before the treatment, bus stops were located on each side of the marked crosswalks to the north and south of S. 180th Street. Figures 1 and 2 display the transit stop locations. With the installation of the new median, the four transit stops were consolidated to two stops on either side of the median. Figure 5 shows the locations of the bus stops in relationship to the median. The path across the roadway utilizes the refuge space in the median.

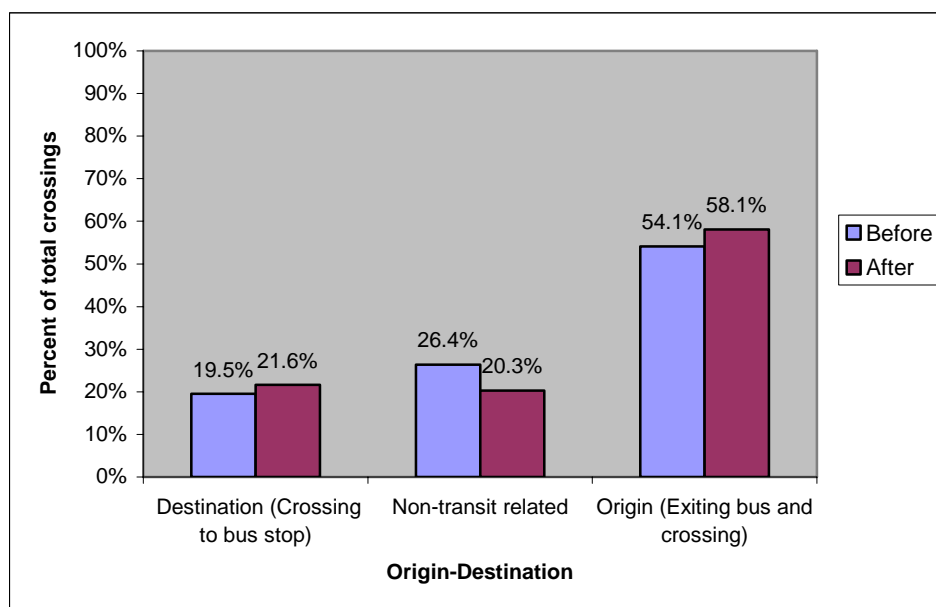
Figure 6. Percentage of transit related crossings

The data were also compared for transit related trips. The majority of pedestrian crossings at the site are transit related. Pedestrians either cross the street westbound to get to the transit stop, or they arrive on a bus and cross the street eastbound. Many of the non-transit related trips are cyclists. Figure 6 displays the proportion of transit related trips in the *before* and *after* data. The difference between the *before* treatment and the *after* treatment is not statistically significant.

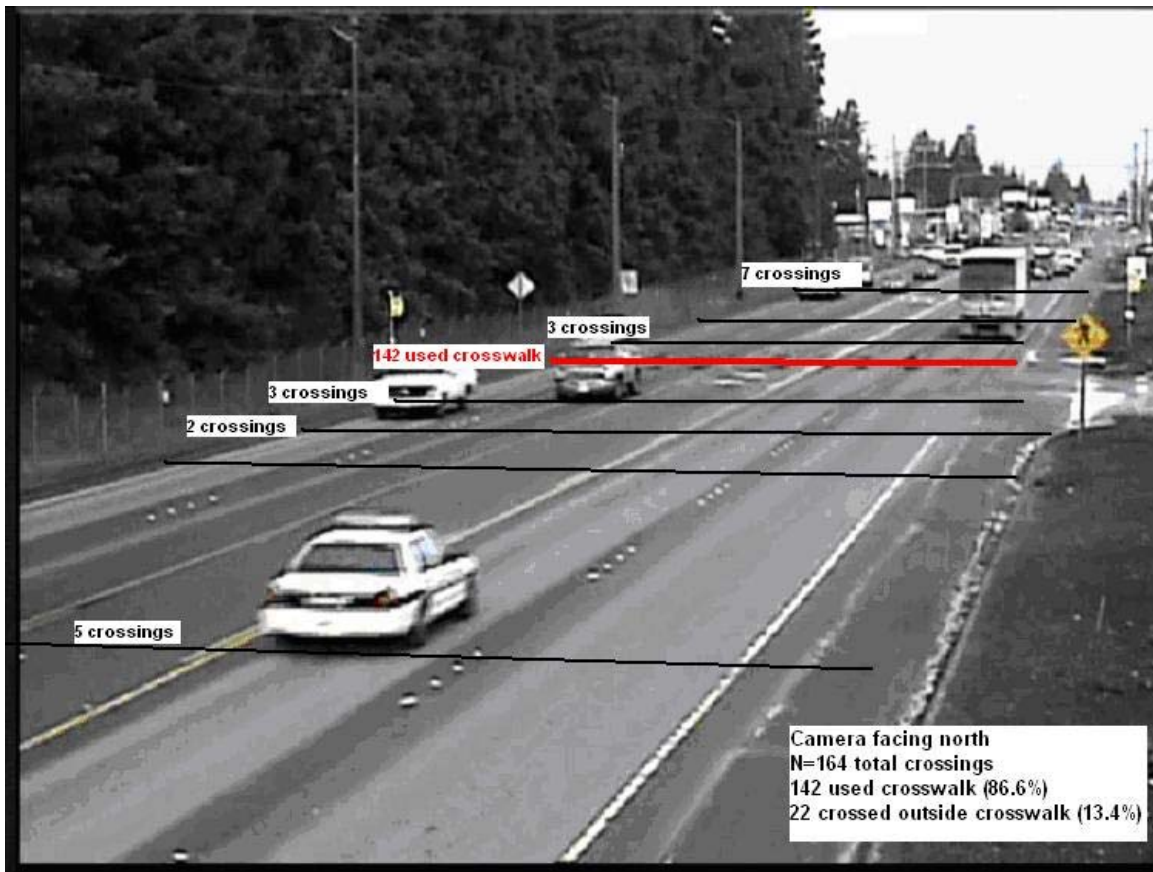
Figure 7. Pedestrian crossing paths to the north of S. 180th Street

The *before* study showed that the majority of pedestrians crossed within the marked crosswalks. Over 85 percent of the crossings to the north of S. 180th Street were within the crosswalk. Over 65 percent of the crossings to the south of S. 180th Street were within that crosswalk. When the crossing data for both directions were combined, over 80 percent of the crossings were within the two marked crosswalks. Figures 7 and 8 display the crossing paths of the pedestrians in the *before* study.

The paths are labeled with the number of crossings at that location. If a path is not labeled, it means that only one crossing occurred there. The factors that affected how pedestrians crossed included the origins and destinations of the observed pedestrians and whether there was a gap in traffic for crossing.

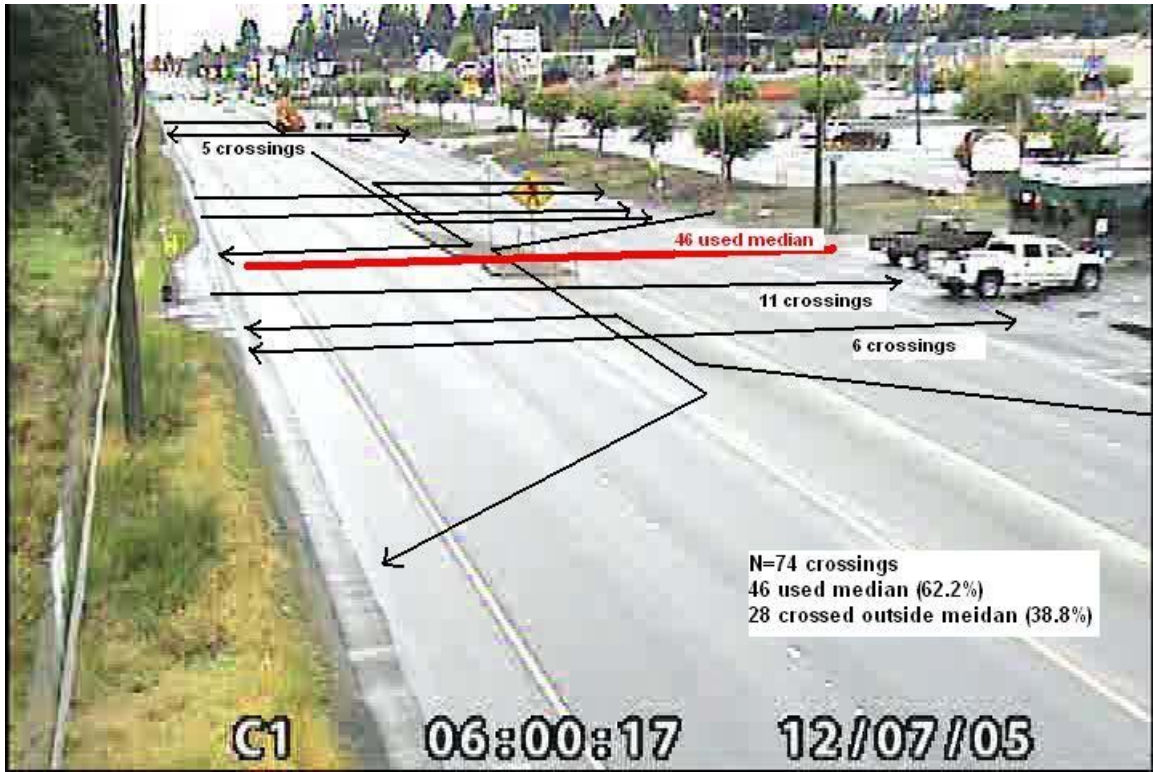
Figure 9. Pedestrian crossing paths after median treatment

The installation of the pedestrian refuge did not funnel pedestrians to that crossing location. After the treatment had been implemented, about 60 percent of pedestrians used the median refuge area. Figure 9 displays the crossing paths after installation of the median. Note that an additional 15 percent of the crossings occurred just to the south of the median (path labeled “11 crossings” in Figure 9). The transit stop on the west side of street is not parallel with the refuge area, and these additional 11 crossings occurred at the point where the pedestrians exited the bus. These pedestrians were protected somewhat by the median but did not follow the designated refuge path.

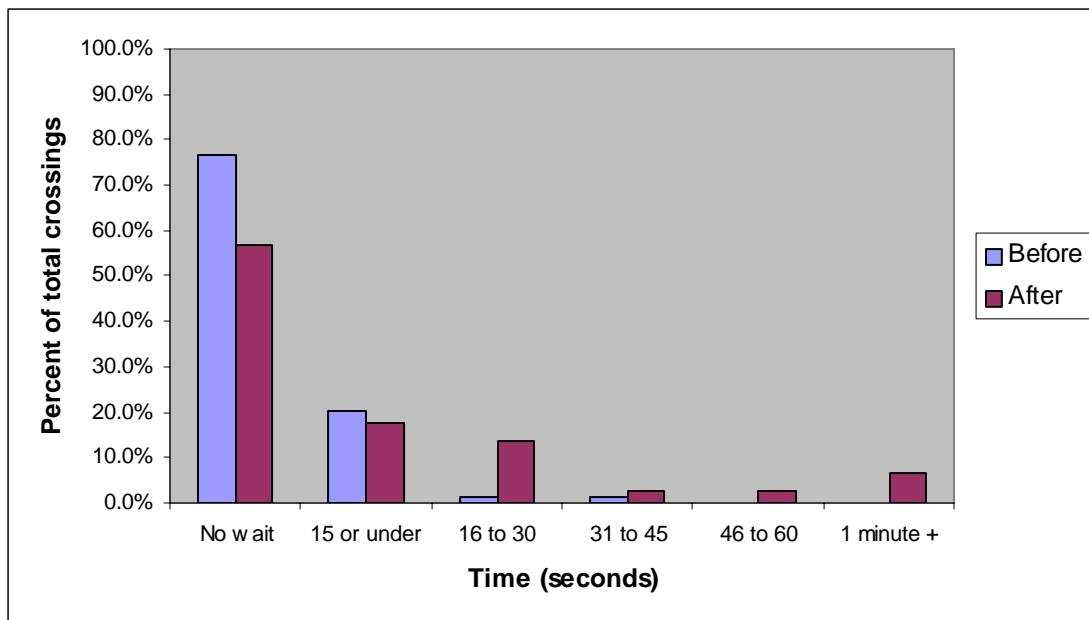
Figure 11. Pedestrian wait time in the center lane / median

The significant number of vehicles in both directions made it difficult for pedestrians to get completely across the roadway in one motion. Occasionally, pedestrians were required to wait in the center lane or in the median refuge before completing their crossing. Figure 11 displays pedestrian wait times in the center lane or median.

The installation of the median resulted in a statistically significant increase in mid-crossing delay: the average wait time increased from approximately 2 seconds to about 15 seconds. Note that a few outliers in the *after* data may have skewed the average value, but when it is calculated without wait times over 1 minute, the average delay is still over 7 seconds. The statistically significant increase in the percentage of pedestrians who had to wait in the center lane or median after the median installation may correspond

to a decrease in motorist yielding in the *after* phase. It is also possible that some pedestrians felt more comfortable taking their time while waiting in the median refuge than while standing in the center lane.

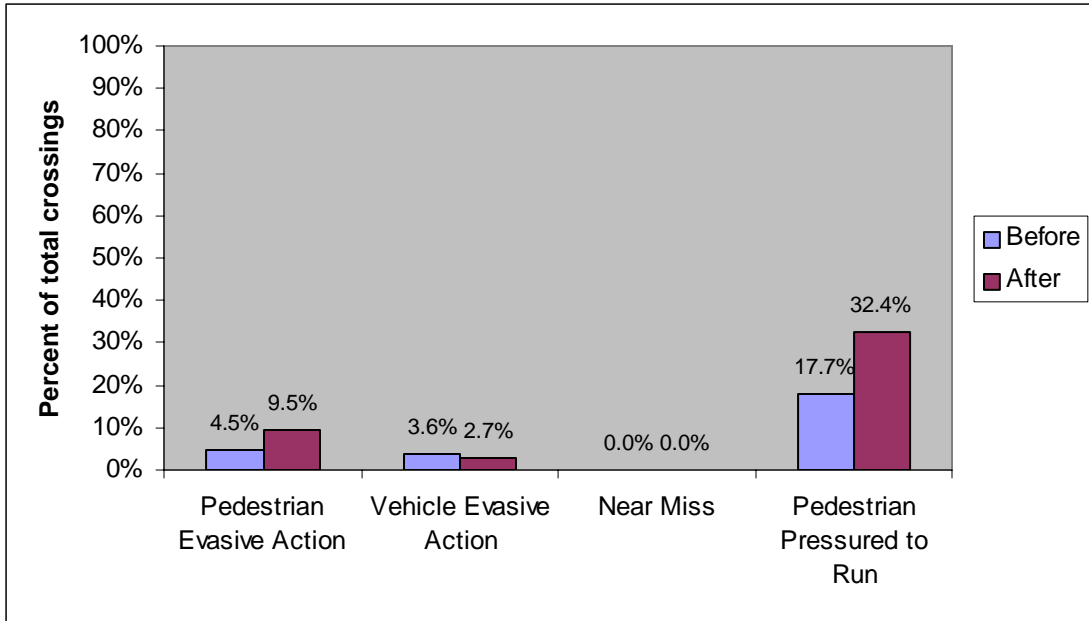
Figure 12. Pedestrian and vehicle evasive action

Figure 12 displays the percentage of occurrences of these performance measures per total pedestrian crossings.

The results in Figure 12 are also summarized in Table 9. This table also shows when the differences between the *before* and *after* phases were statistically significant. As mentioned, pedestrian and vehicle evasive actions were relatively infrequent because pedestrians were very cautious. The data suggest that pedestrians felt more pressured to run after the median was installed.
