**RESEARCH REPORT**

**RAPIDLY CONSTRUCTIBLE LARGE-BAR PRECAST  
BRIDGE-BENT SEISMIC CONNECTION**

October 2008

1. REPORT NO. WA-RD 684.2		2. GOVERNMENT ACCESSION NO.		3. RECIPIENT'S CATALOG NO.	
4. TITLE AND SUBTITLE RAPIDLY CONSTRUCTIBLE LARGE-BAR PRECAST BRIDGE-BENT CONNECTION				5. REPORT DATE October 2008

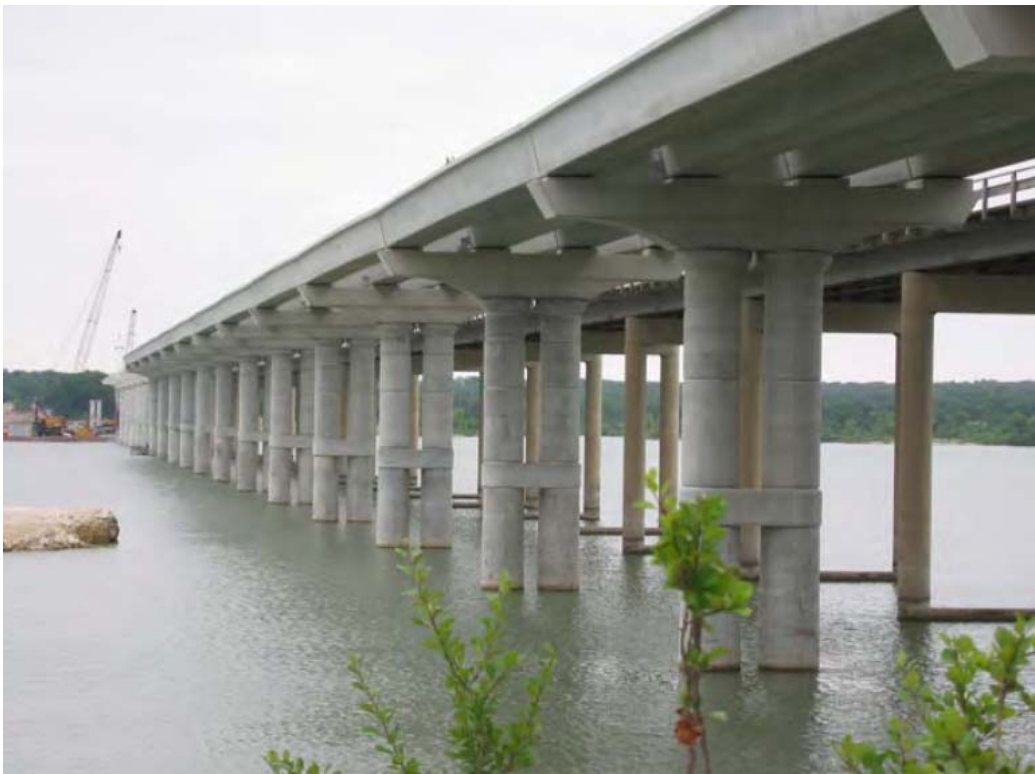
The original 50-year-old, two-lane Lake Belton Bridge on SH 36 had numerous problems, including a deteriorating superstructure, narrow travel width, and guard rail damage (Brenes et al. 2006). Therefore, it was replaced in 2004 with a 3,840-foot long bridge structure, adding two additional lanes of traffic. Construction of the bridge is shown in Figure 2-3. The bridge superstructure was constructed of prestressed U-beams with typical spans of 120 feet. The substructure comprised twin circular cast-in-place columns supporting a massive precast hammerhead bent-cap. Sixty-two identical bent caps were precast.

**Figure 2-3: Construction of Lake Belton Bridge (Brenes 2006)**

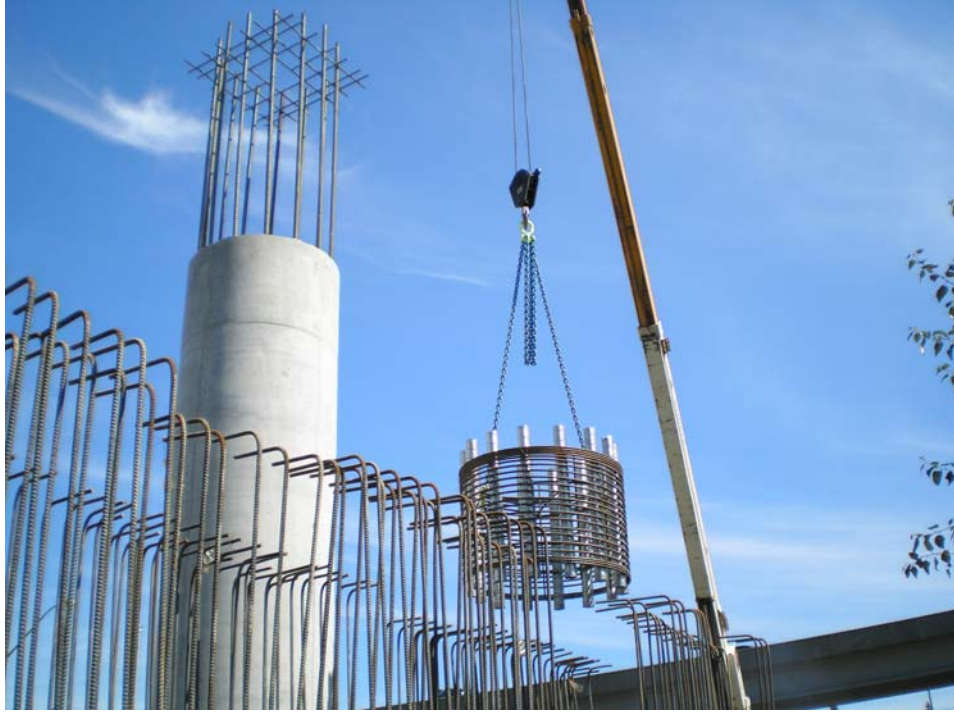
The design of the bent cap was accepted on the condition that the arrangement of bars in the original cast-in-place design was not altered and that AASHTO and ACI development length requirements were met. These requirements made it necessary to use small diameter ducts and to continue the column longitudinal bars high up into the superstructure. Until then, WSDOT had never used precast bent-caps to construct the substructure because no formal design guidelines or detailing requirements have been established for this type of application, and limited information about its seismic performance exists.

**Figure 2-7: Template used to align the ducts and bars (WSDOT 2007)**

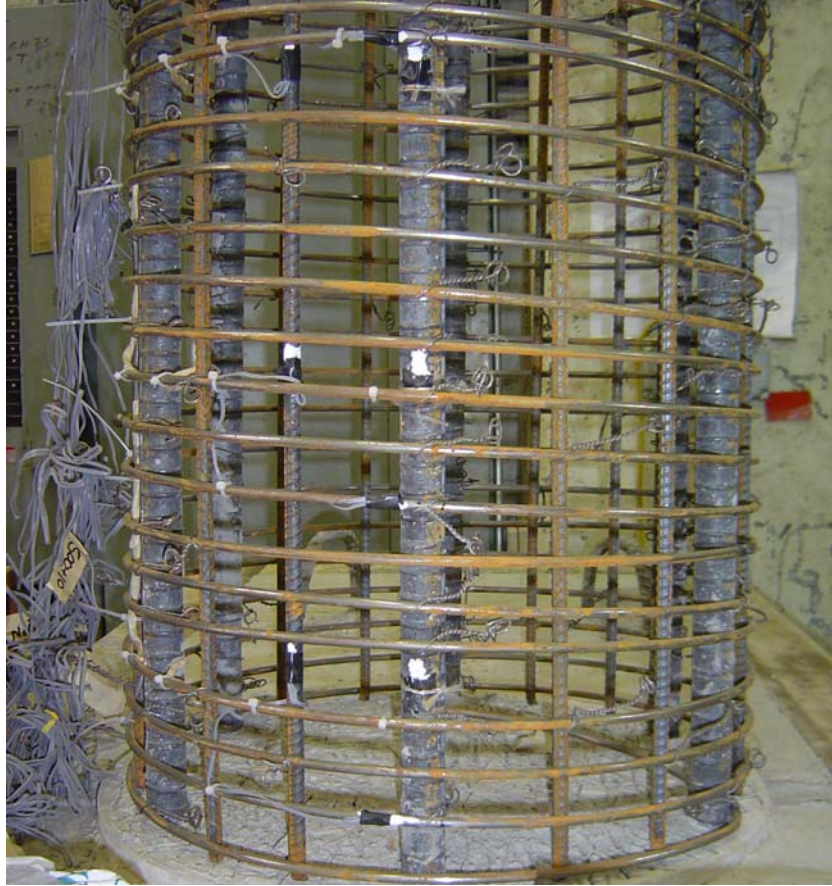
**Figure 3-12: Strain gages located in the column**

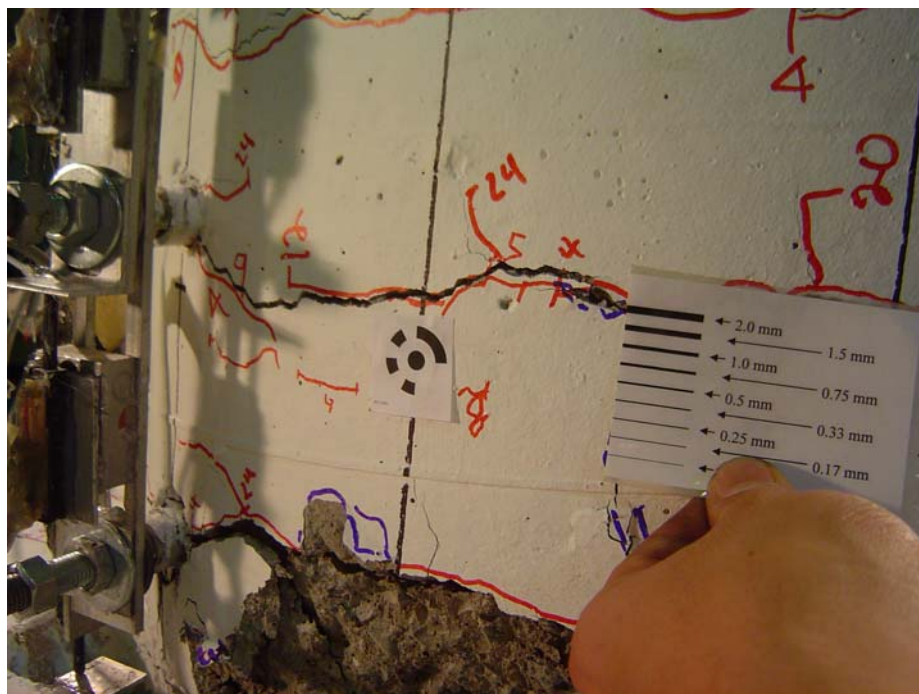
**Figure 4-6: Crack localization in Specimen DB5-RE at Cycle 25 (2.96%/-3.02%)**

In contrast, in Specimen DB5-RE the curvature was more evenly distributed over the bottom 22 inches of the column (Figure 5-21), as is common in cast-in-place systems. At similar drift levels, the second, third, and fourth segments above the interface had considerably more average curvature than that measured in specimens LB8-FB, LB8-D1, and LB8-D2. The crack width at the interface was about the same as that of some of the flexural cracks above. The first segment was much shorter (2 inches) than the segments above (5 to 10 inches), so even though the crack widths were comparable, the curvature in the first segment was larger than that above. The average curvature in the third segment was nearly two times more than the segment directly below. This behavior was attributed to the large cracks that formed in the third segment (seen in Figure 4-6 and Figure 4-7).

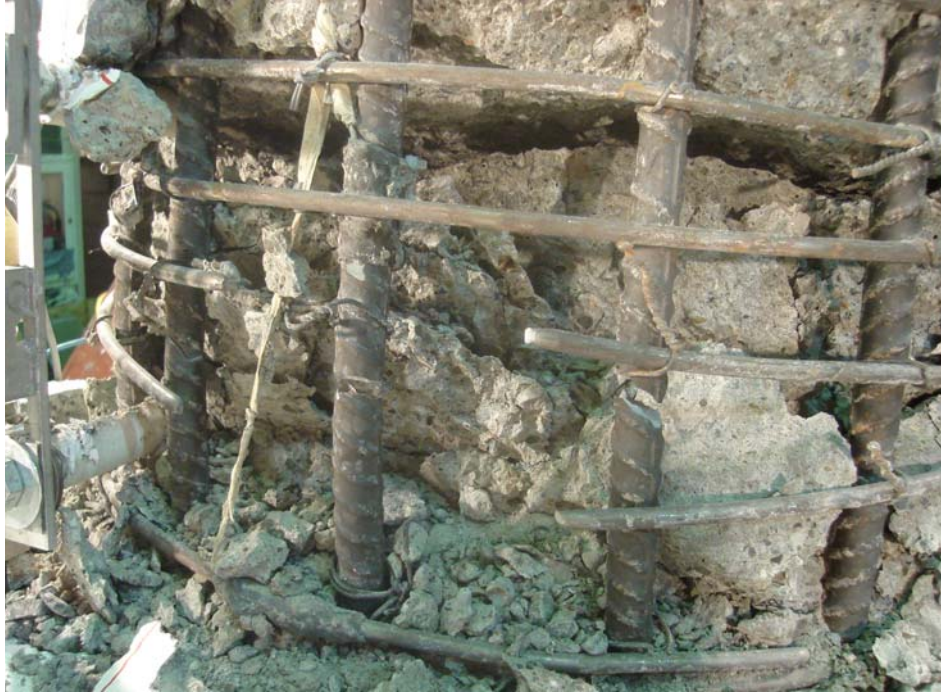
**Figure 4-11: Bars 1, 2, and 16 fractured in Specimen DB5-RE at Cycle 36 (8.83%/-8.44%)**

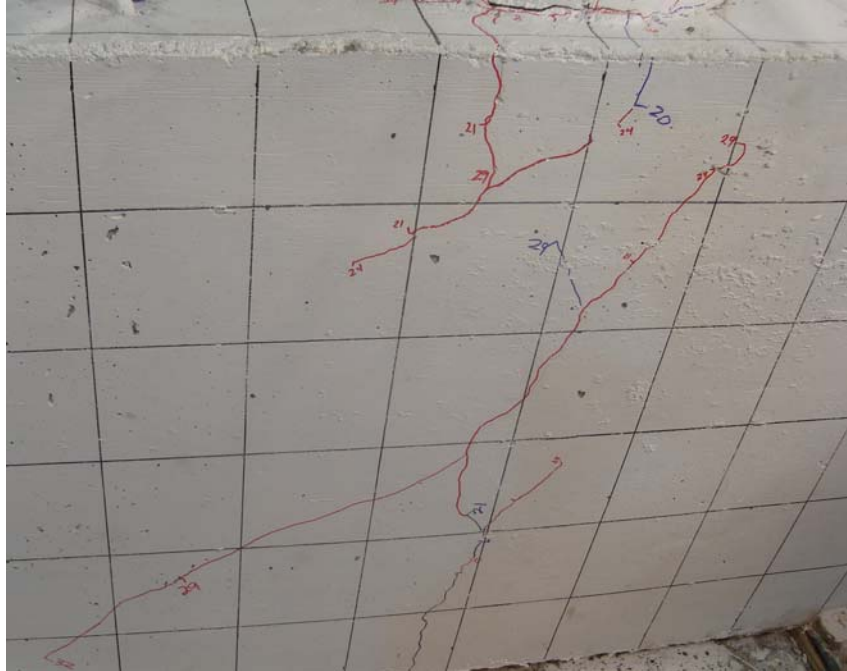
**Figure 4-13: Damage to the west face of the cap-beam and diaphragm in Specimen DB5-RE at the end of testing**

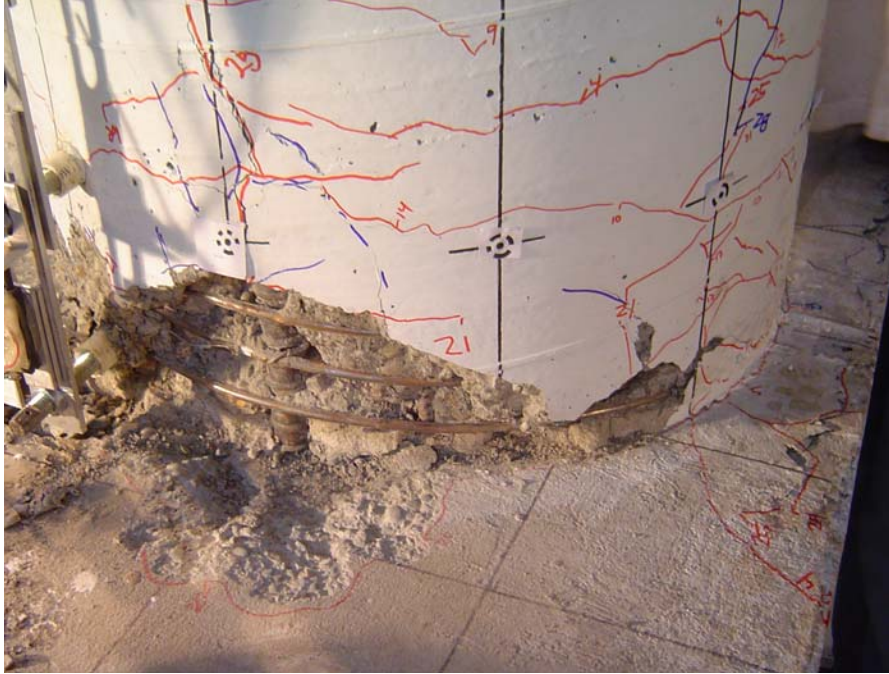
**Figure 4-22: Spalling in the cap-beam and column in Specimen LB8-FB at Cycle 26 (2.92%/-2.85%)**

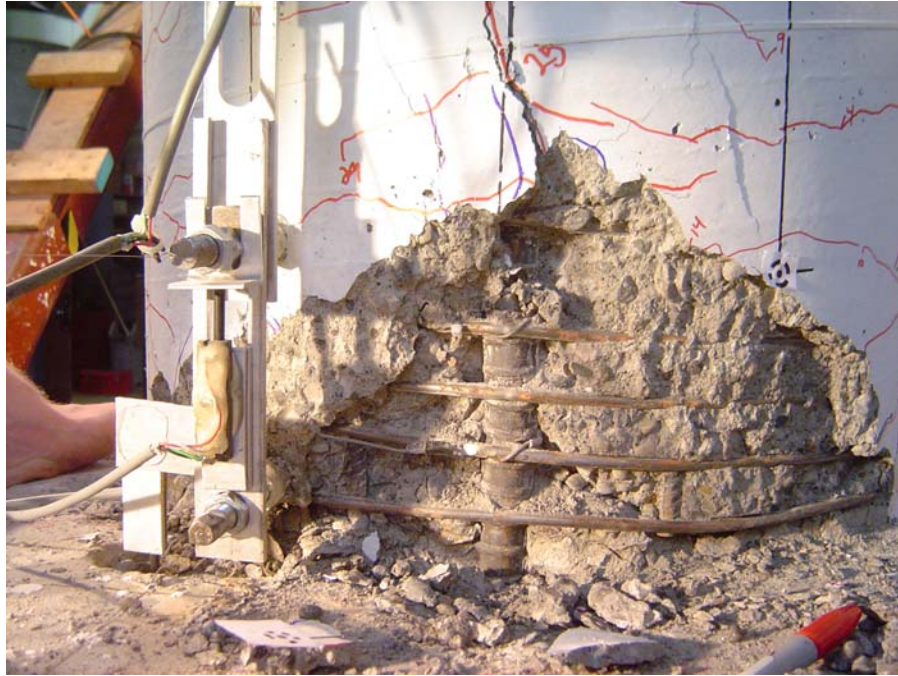
**Figure 4-24: First observation of bar buckling of Bar 1 on the north side with two spirals necked in Specimen LB8-FB at Cycle 32 (5.42%/-5.10%)**

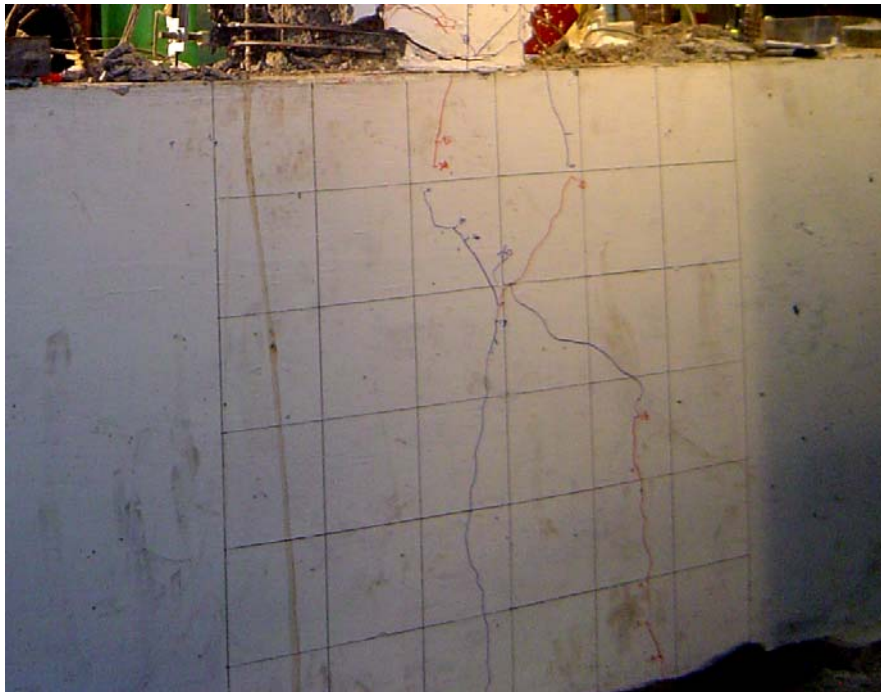
**Figure 4-27: Cracking in the cap-beam in Specimen LB8-FB after Cycle 34 (6.81%/-6.40%)**

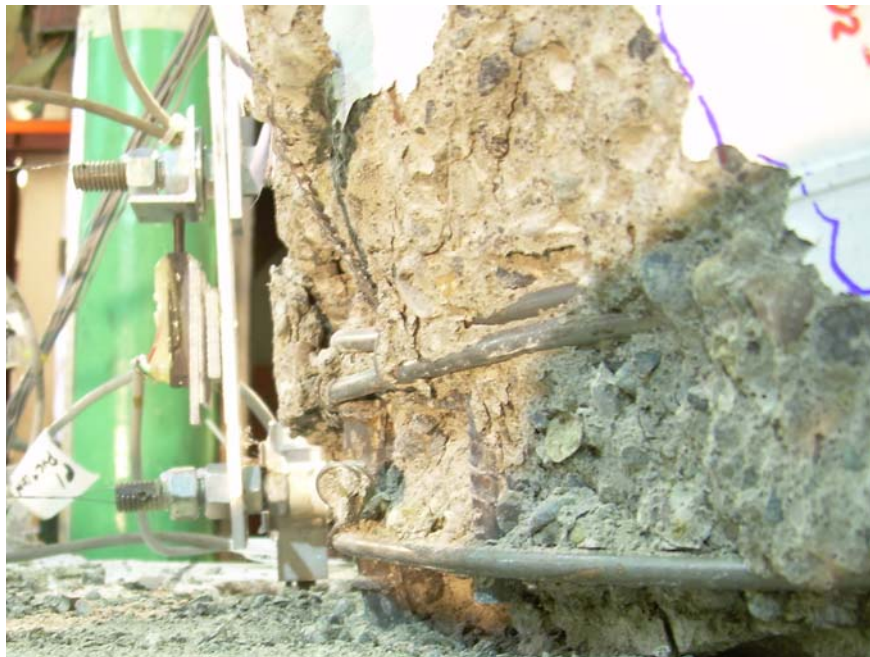
**Figure 4-36: Bar 1 buckling in Specimen LB8-D1 during Cycle 32 (5.77%/-5.67%)**

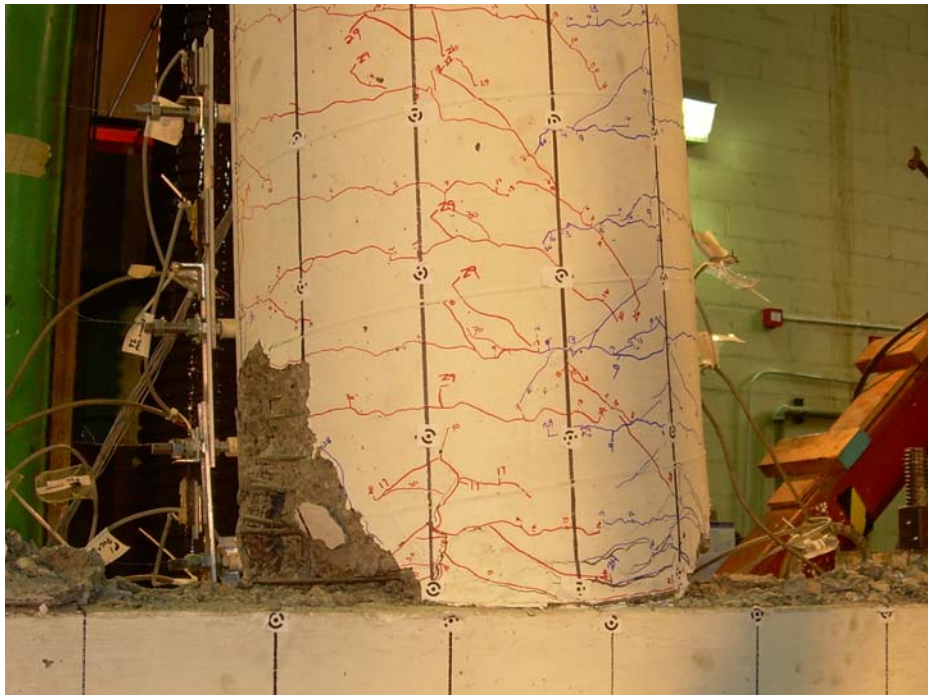
**Figure 4-38: Fully spalled (10 inches) on the north face in Specimen LB8-D1 at Cycle 33 (7.11%/-6.93%)**

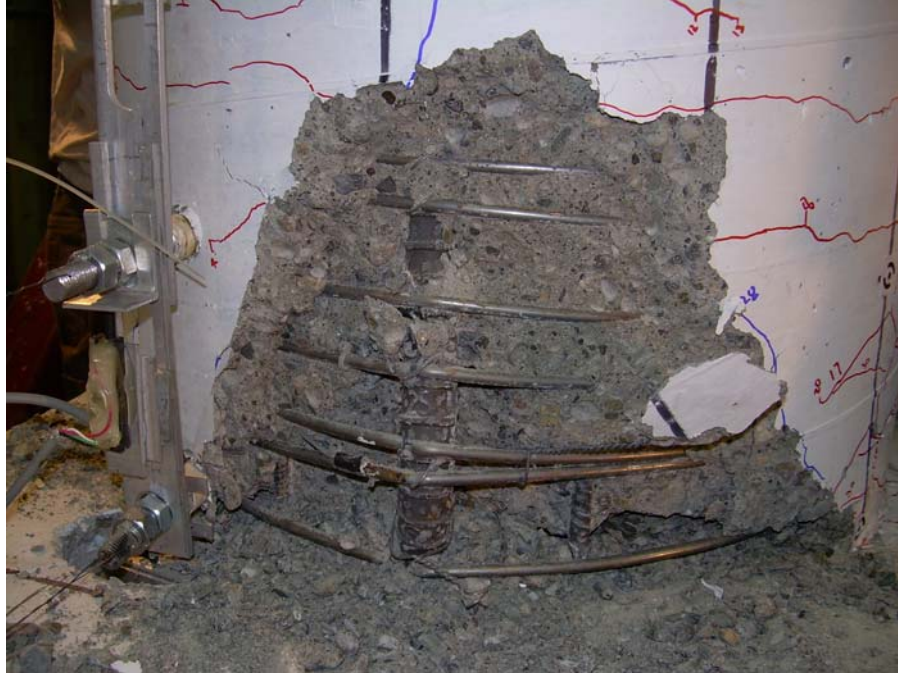
**Figure 4-39: Bar 1 buckled and spirals fractured in Specimen LB8-D1 during Cycle 33 (7.11%/-6.93%)**

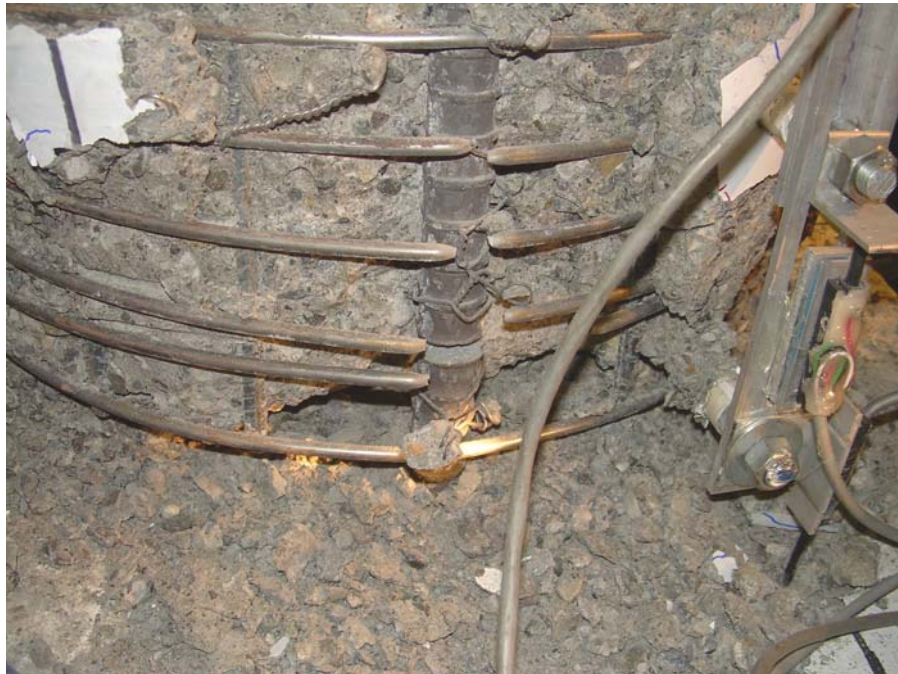
**Figure 4-40: Bar 4 fractured in Specimen LB8-D1 during Cycle 34 (7.20%/-7.06%)**

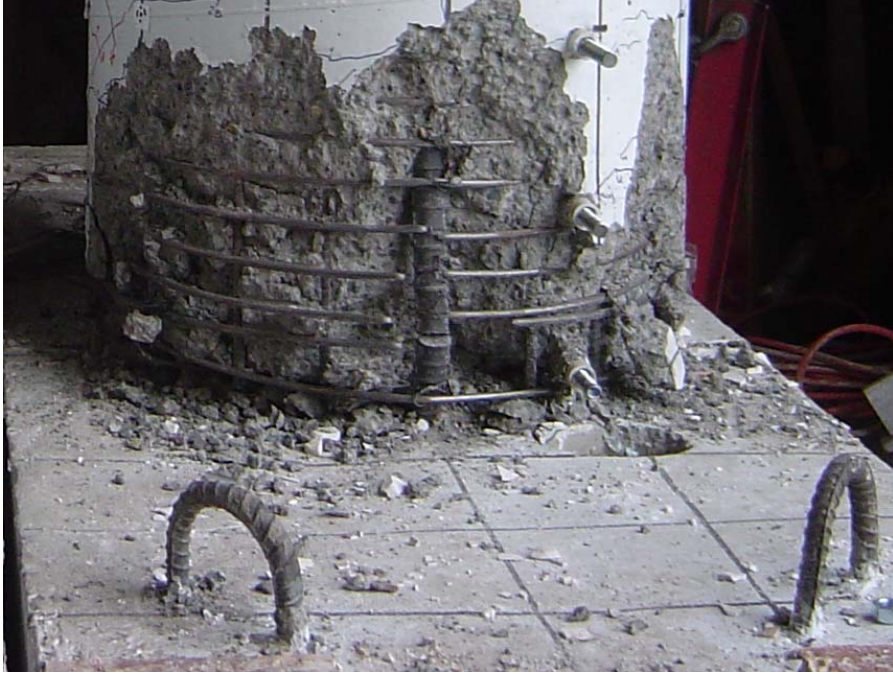
**Figure 4-43: Damage to Specimen LB8-D1 at the end of testing**

Damage to the joint region and cap-beam was minimal, consisting of diagonal cracks on the east and west faces. After the axial load had been applied, two off-center cracks formed on the bottom on each side of the cap beam. The cracks propagated diagonally to the top of the cap-beam, as seen in Figure 4-42. No damage or cracking occurred on the surface of the cap-beam or in the grouted ducts. The final damage state of Specimen LB8-D1 is shown in Figure 4-43.

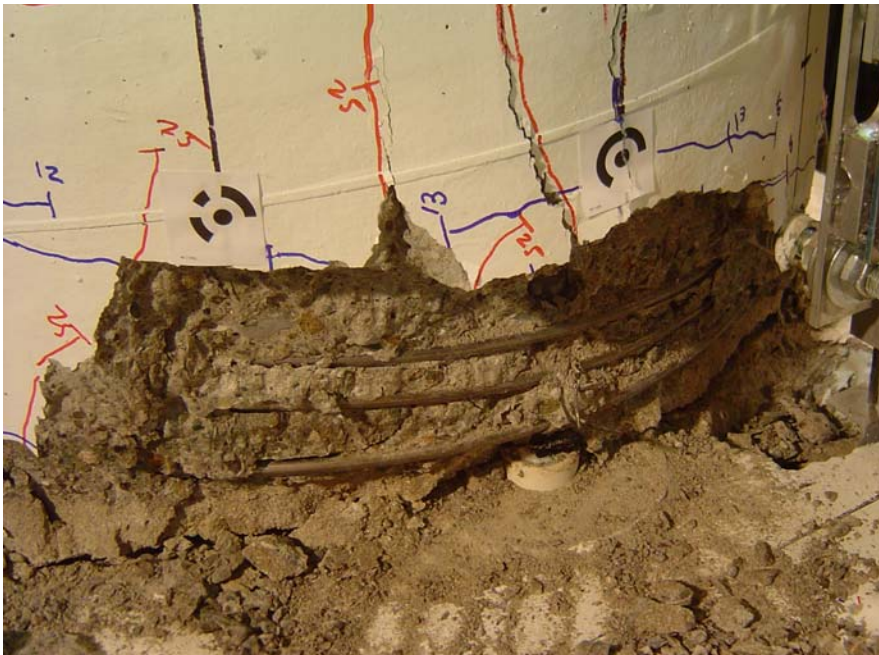
**Figure 4-40: 5 inches spalled on the south face in Specimen LB8-D2 at Cycle 29 (4.70%/-4.63%)**

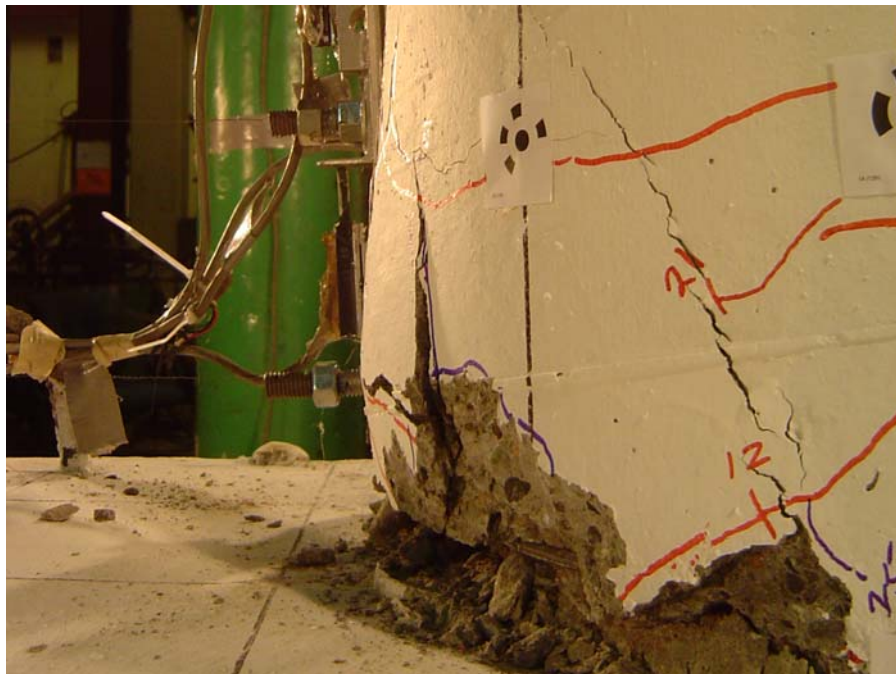
**Figure 4-52: A bulge in the concrete cover indicates possible bar buckling in Specimen LB8-D2 during Cycle 30 (4.73%/-4.66%)**

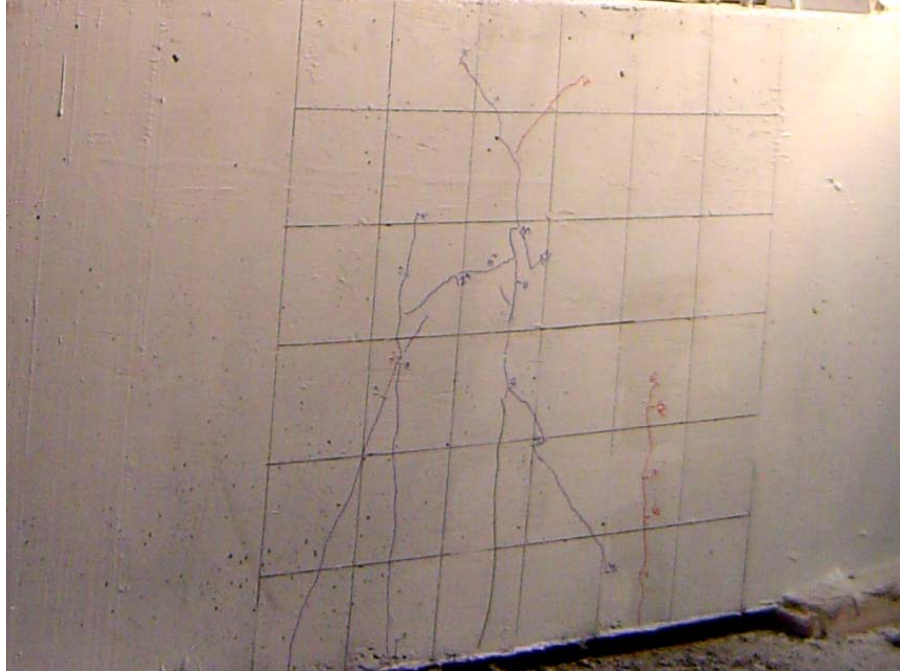
**Figure 4-57: Damage to the cap-beam in Specimen LB-D2 after Cycle 34 (7.41%/-7.17%)**

Damage to the cap-beam and diaphragm was minimal, consisting of diagonal cracks on the east and west faces (see Figure 4-57). After axial load had been applied, two approximately centered cracks formed on the bottom on each side of the cap beam. Cracks formed on the bottom of the beam roughly 12 inches from the center. These cracks propagated diagonally to the top of the cap-beam through the test. The crack widths did not exceed 0.007 inches. No damage or cracking occurred on the surface of the cap-beam or around the grouted ducts (see Figure 4-58 and Figure 4-59). Cracks formed in the grouted duct (see Figure 4-58) from the buckled bars pushing laterally against the grout in the debonded region. The final damage state of Specimen LB-D2 is shown in Figure 4-59.

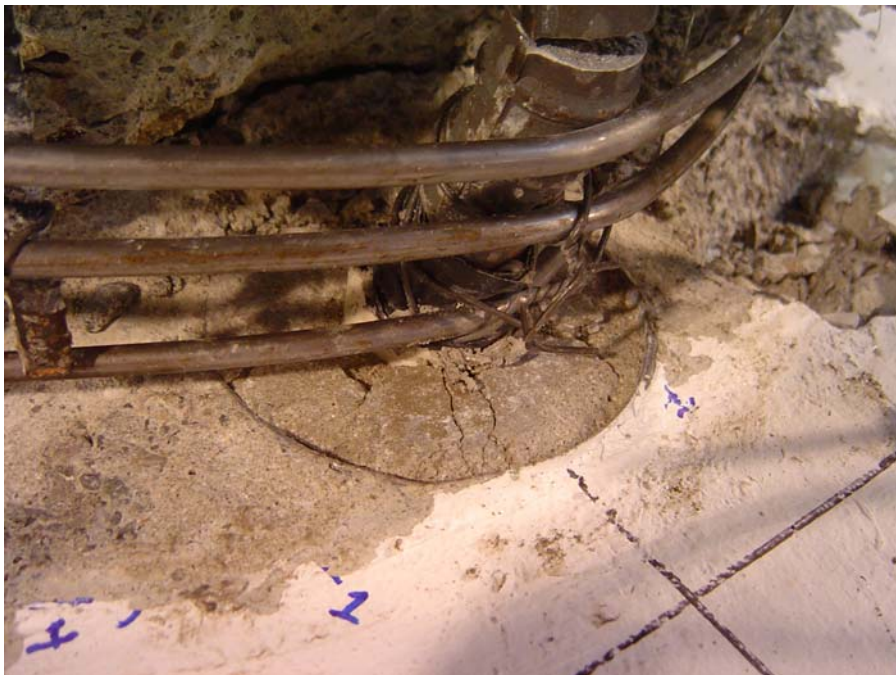
**Figure 4-58: Specimen LB8-D2 with no spalling in the cap-beam; radial cracks in the grout at the end of testing**
