RESEARCH REPORT

**AN EVALUATION OF ENGINEERING TREATMENTS
AND PEDESTRIAN AND MOTORIST BEHAVIOR ON
MAJOR ARTERIALS IN WASHINGTON STATE**

September 2008

1. REPORT NO. WA-RD 707.1		2. GOVERNMENT ACCESSION NO.		3. RECIPIENT'S CATALOG NO.	
4. TITLE AND SUBTITLE AN EVALUATION OF ENGINEERING TREATMENTS AND PEDESTRIAN AND MOTORIST BEHAVIOR ON MAJOR ARTERIALS IN WASHINGTON STATE				5. REPORT DATE September 2008

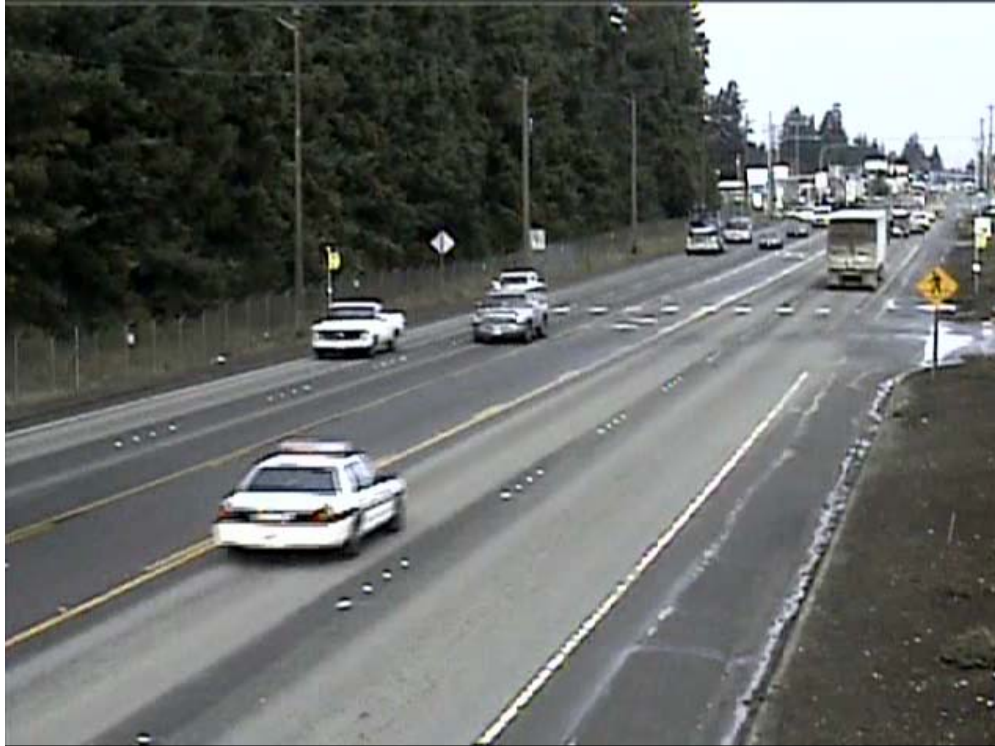
Figure 2.1. Observation boundaries north of S. 180th Street—*before* phase—Spanaway (Kopf and Hallenbeck 2005)

The *before* analysis focused on the marked crosswalks to the north and south of S. 180th Street. Figure 2.1 displays the camera view looking north. The crosswalk to the north of S. 180th Street is approximately 400 feet from the camera. The driveway near the crosswalk enters and exits a Kmart parking lot. Transit stops are located on both sides of the crosswalk. The nearest signalized intersection is one quarter mile north at S. 176th Street.

The safety treatment at S. 180th Street also included new transit stop locations. Before the treatment, bus stops were located on each side of the marked crosswalks to the north and south of S. 180th Street. Figures 2.1 and 2.2 displayed the original transit stop locations. With the installation of the new median, the four transit stops were consolidated to two stops, one on either side of the median. Figure 3.2 shows the new locations of the bus stops in relationship to the median. The path across the roadway utilizes the refuge space in the median.

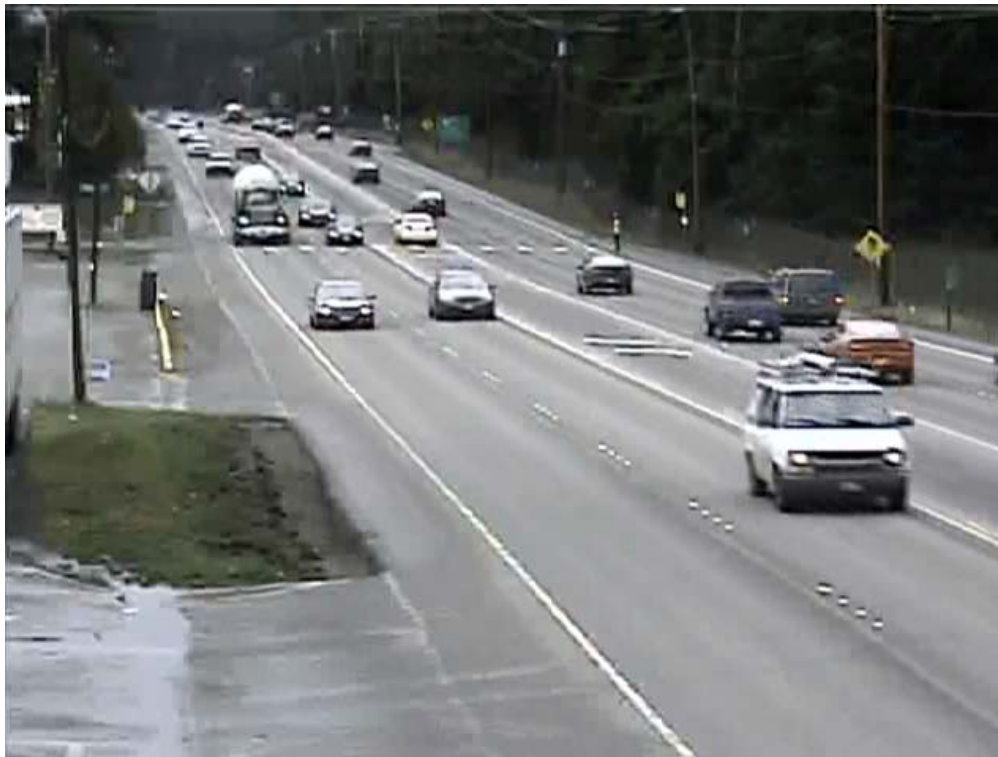
Figure 2.2. Observation boundaries south of S. 180th Street—*before* phase—Spanaway (Kopf and Hallenbeck 2005)

Figure 2.2 shows the camera view looking south. The crosswalk to the south of S. 180th Street is approximately 660 feet from the camera. The crosswalk is at the intersection of SR 7 and S. 182nd Street. There are bus stops on both sides of the crosswalk.

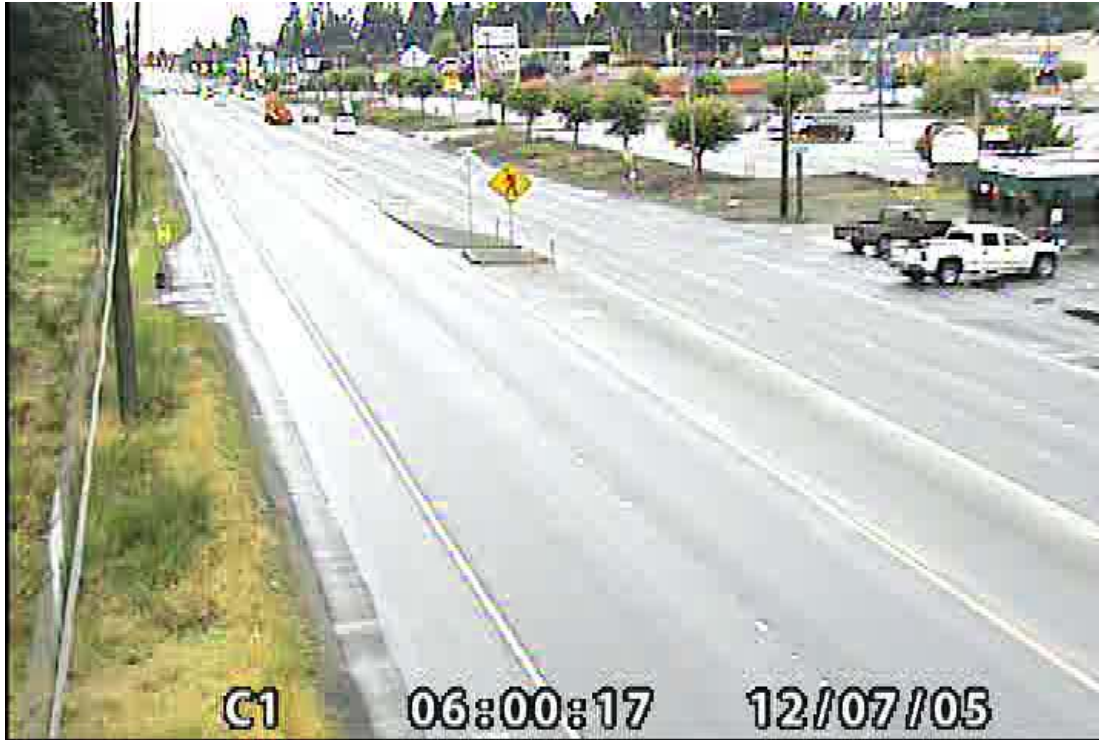
Figure 2.3. Observation boundaries for *after—phase I* data collection—Spanaway (Kopf and Hallenbeck 7)

During the *after* analysis, the camera was placed to the south of S. 180th Street (this time on the west side of the street), facing north. Figure 2.3 displays the observation boundaries for the first phase of the *after* data collection.

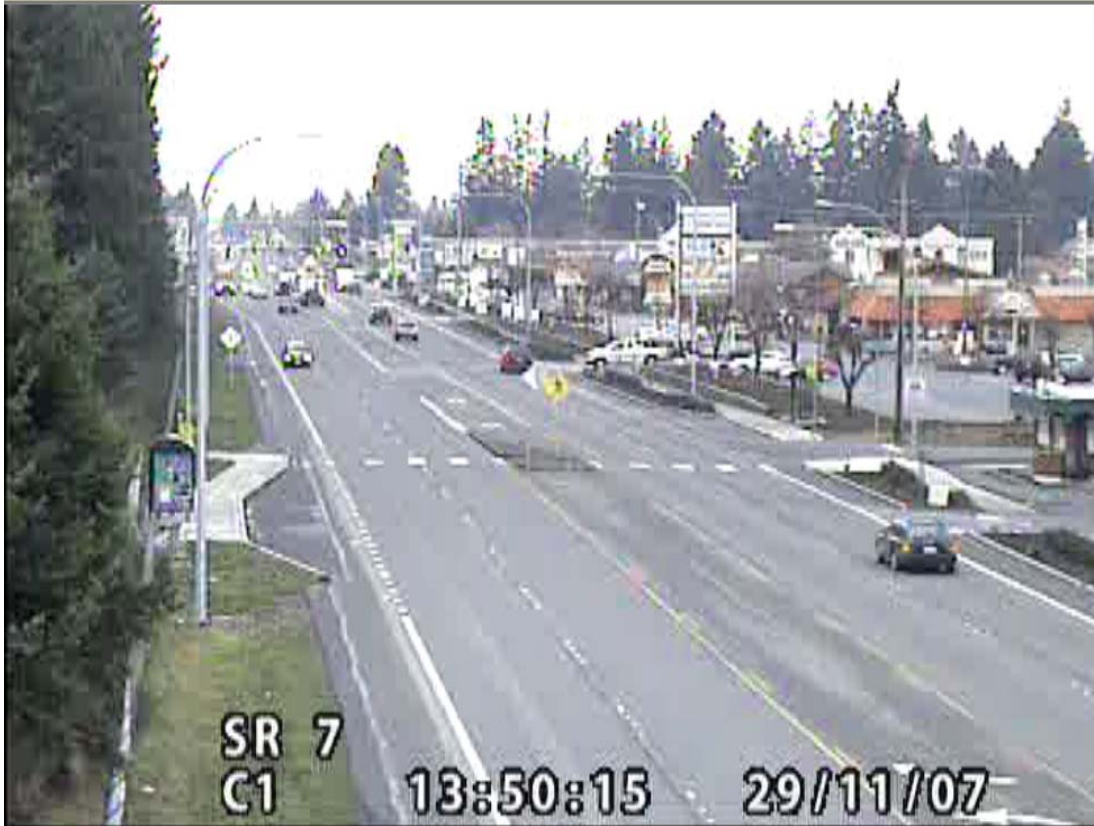
Figure 2.4. Observation boundaries for *after—phase II* data collection—Spanaway

Figure 2.4 shows the observation boundaries for the second phase of the *after* data collection.

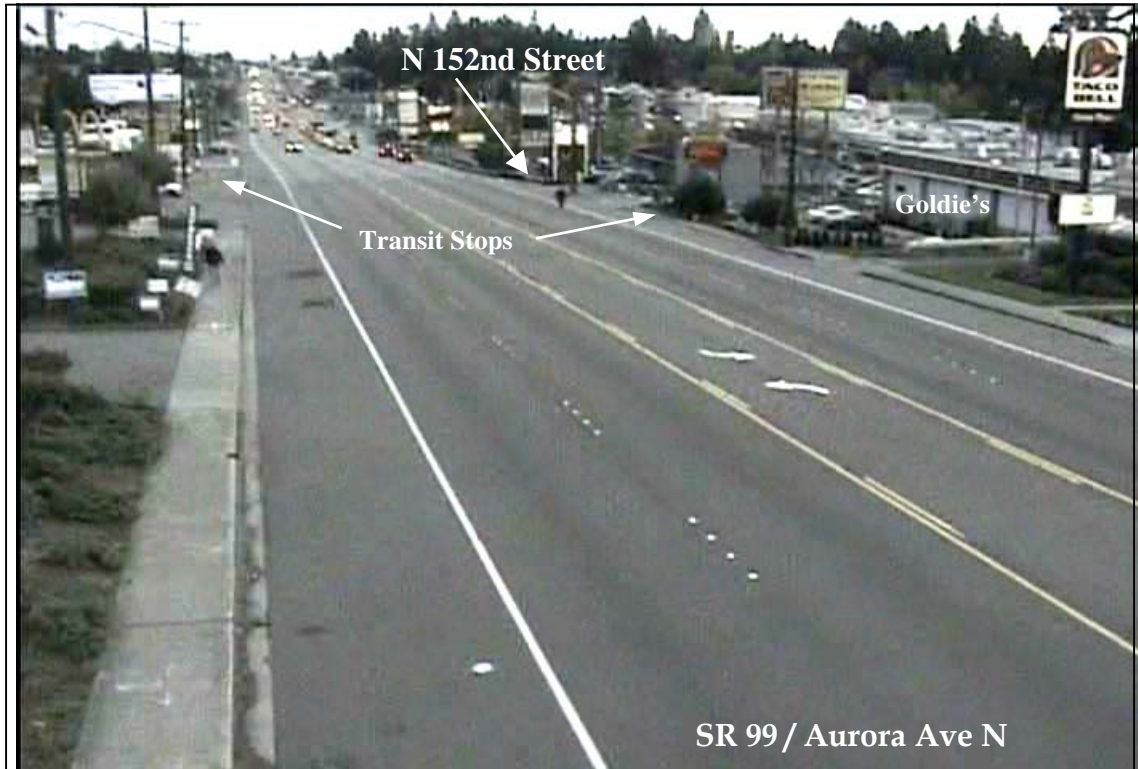
Figure 2.6. Observation boundaries, SR 99 south of N 152nd Street—before improvements—Shoreline

The site analysis focused on the unmarked crosswalks at North 152nd Street. Figure 2.6 shows the camera view looking north along SR 99. The camera is approximately 320 feet south of North 152nd Street. Bus stops are located on the north corner of North 152nd Street in the southbound direction of SR 99 and 100 feet south of the intersection in the northbound direction. Signalized intersections are located one sixth of a mile to the north at North 155th Street and one third of a mile to the south at North 145th Street. Commercial properties in the area consist of several restaurants and fast food establishments (Goldie's, Shari's, McDonalds), two strip mall-type developments housing many small shops (Parkwood Plaza and Westover Plaza), and

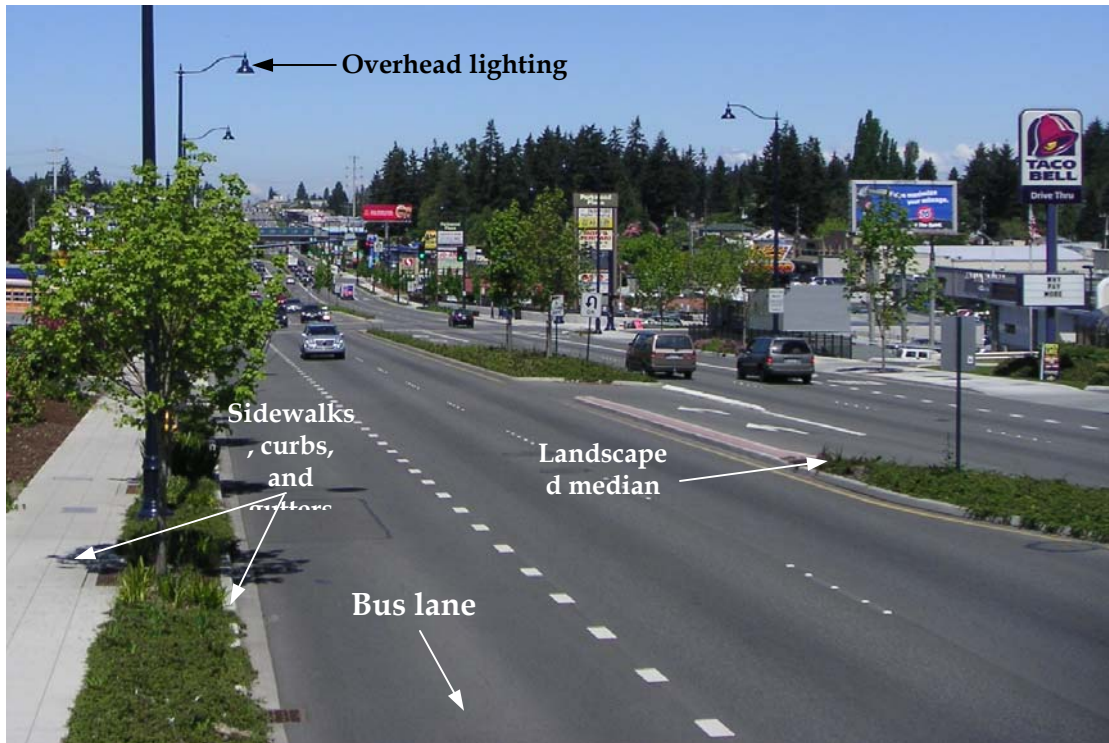
Figure 2.8. View of the improvements made to the project and surrounding area, SR 99 and N 152nd Street—Shoreline

Because of construction and project schedules, no *after* study was performed at this site. Figure 2.8 shows the site as it existed as of the writing of this report. Additional research at this site would be beneficial to determine the effects of the improvements on vehicle and pedestrian behavior, especially the landscaped median and the traffic signal that was added at North 152nd Street.

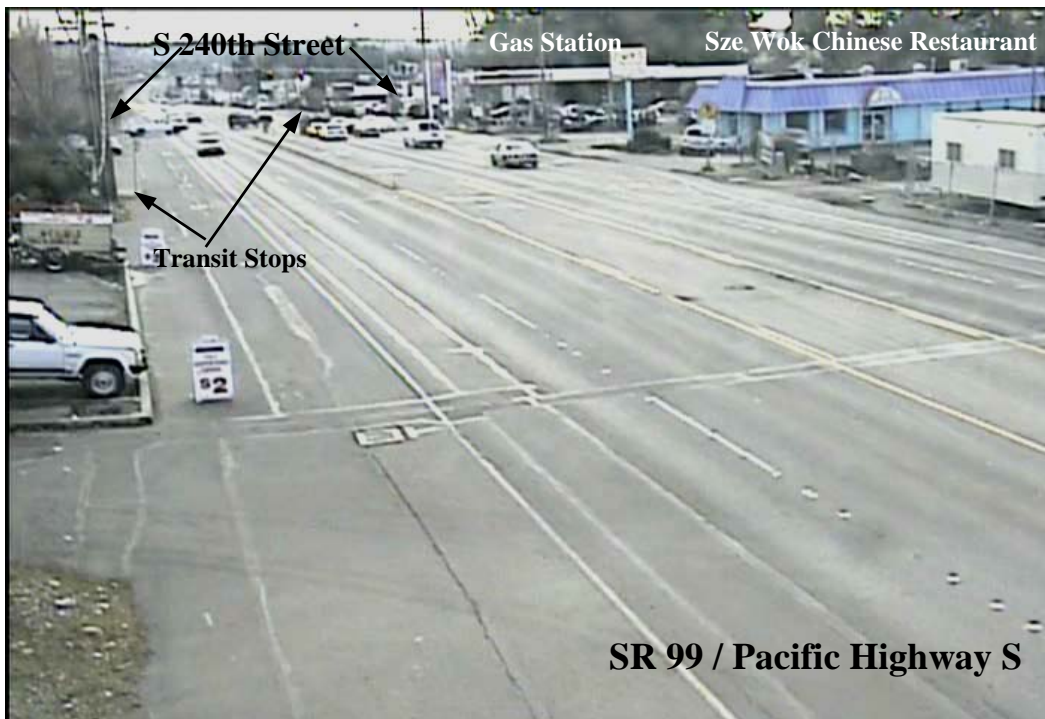
Figure 2.9. Observation boundaries, SR 99 north of S 240th Street—*before* conditions—Kent

The *before-after* analysis focused on the midblock crossings made between South 240th Street and the camera location. Figure 2.9 shows the camera view looking south along SR 99. The camera is approximately 450 feet north of South 240th Street. A bus stop is located 275 feet north of the intersection with South 240th Street in the northbound direction and 325 feet south of the intersection in the southbound direction. Signalized intersections are located less than one tenth of a mile to the south at South 240th Street and four tenths of a mile to the north at South Kent-Des Moines Road (SR 516). Commercial properties in the area consist of restaurants (JJ's Bar and Grill, Sze Wok Chinese Restaurant), gas stations/mini-markets, a three-story office building, and detached retail facilities (Bucky's Brake and Muffler, Midway Tropical Fish and Pets). A mobile home park is located on the east side of SR 99, next to Bucky's Brake and Muffler; single family residential neighborhoods lie one to two blocks to the west of SR 99; and several multifamily apartment buildings lie one block to the east of SR 99.

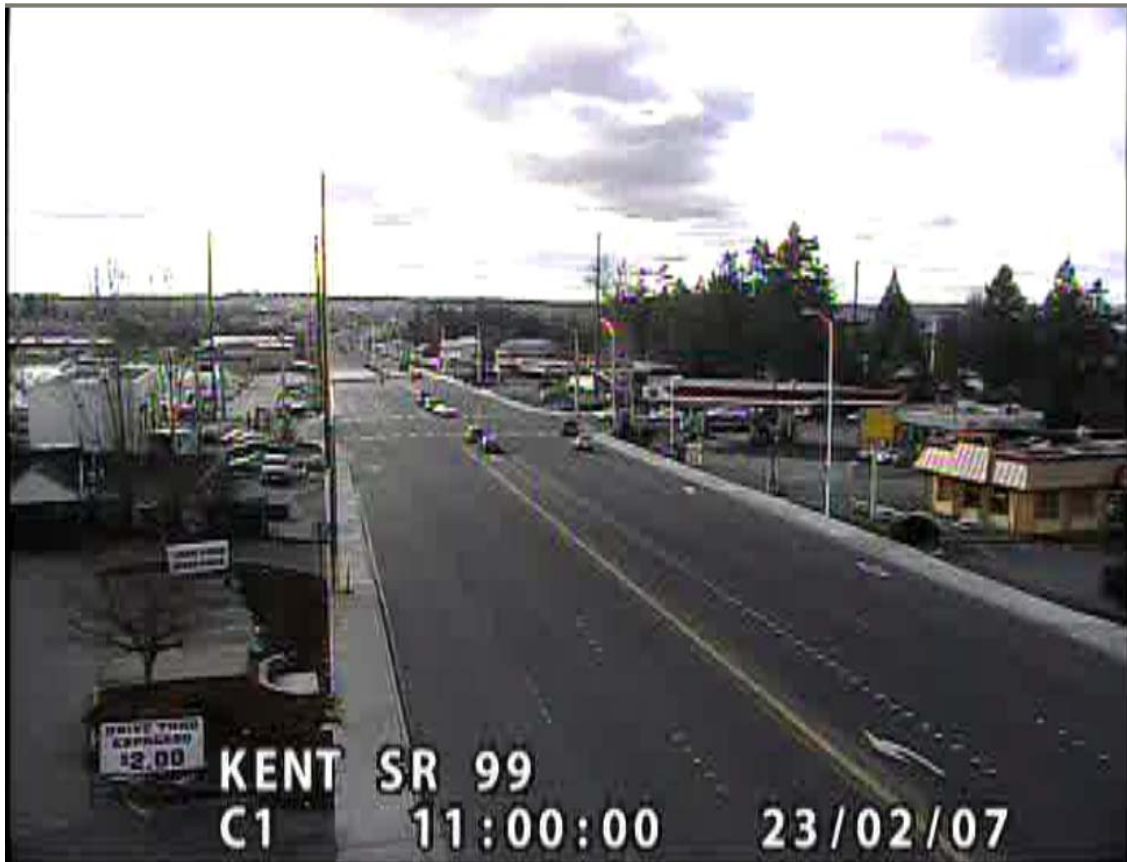
Figure 2.10. Observation boundaries for the *after* data collection—Kent

The camera view used in the *after* study is shown in Figure 2.10.

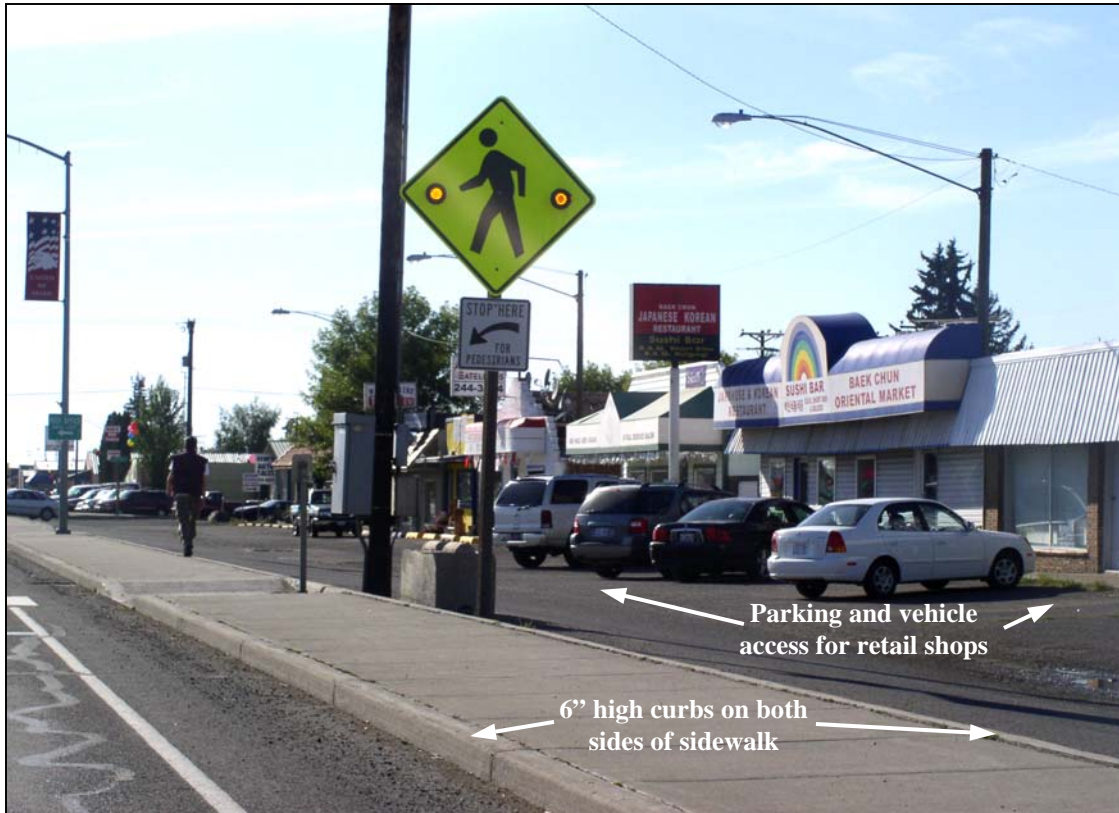
Figure 2.12. SR 2 sidewalk and parking detail (looking west)—Airway Heights

The study site was located on SR 2, a five-lane facility with two general purpose lanes in each direction, a center two-way left turn lane, and 4-foot wide shoulders on both sides of the roadway. There are sidewalks, with 6-inch high curbs on both sides of the sidewalk (shown in Figure 2.12). The sidewalks are on both the north and south sides of the street, with occasional driveways on the north side to commercial properties. While there are no driveways on the south side of SR 2 in this area, West 14th Street runs parallel to SR 2, approximately 50 feet to the south and provides access to the commercial properties located on the south side of the highway. Single-family housing and apartment buildings are located on the north side of SR 2, less than a block from the highway. Light poles are installed approximately every 240 feet on both sides of the roadway. The posted speed limit for the corridor is 35 mph. The average daily traffic

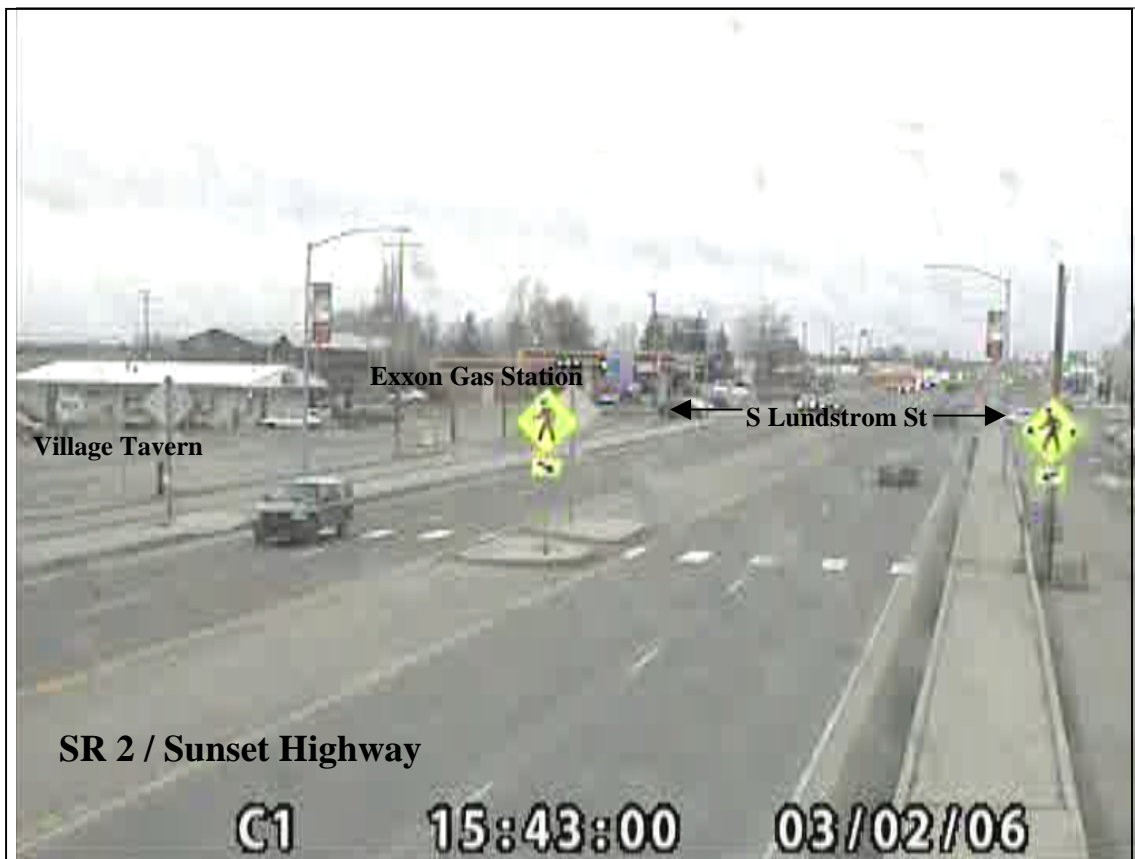
Figure 2.13 Observation boundaries, SR 2 west of S. King Street—*before* configuration—Airway Heights

Figure 2.13 shows the camera view that was used in the *before* portion of the study.

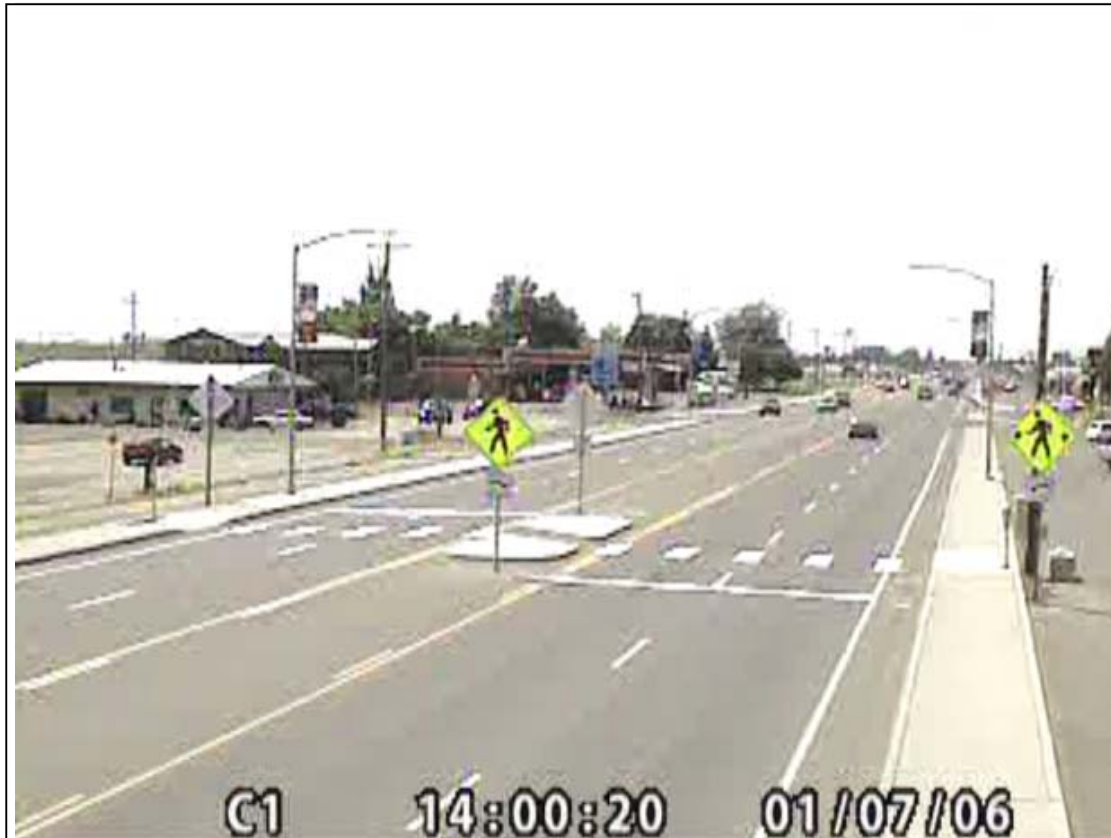
Figure 2.14. Observation boundaries for the *after* data collection—Airway Heights

At this site, the data collection was centered on the marked crosswalk, but other crossings made near the intersection at Lundstrom Street were also included. The total observed distance was roughly one tenth of a mile. At this site, the only differences between the *before* and *after* pedestrian treatments were the stop bars that were added in advance of the crosswalks, the slightly different signage and sign locations that are shown above, and the reduction in number of functioning in-pavement lights.

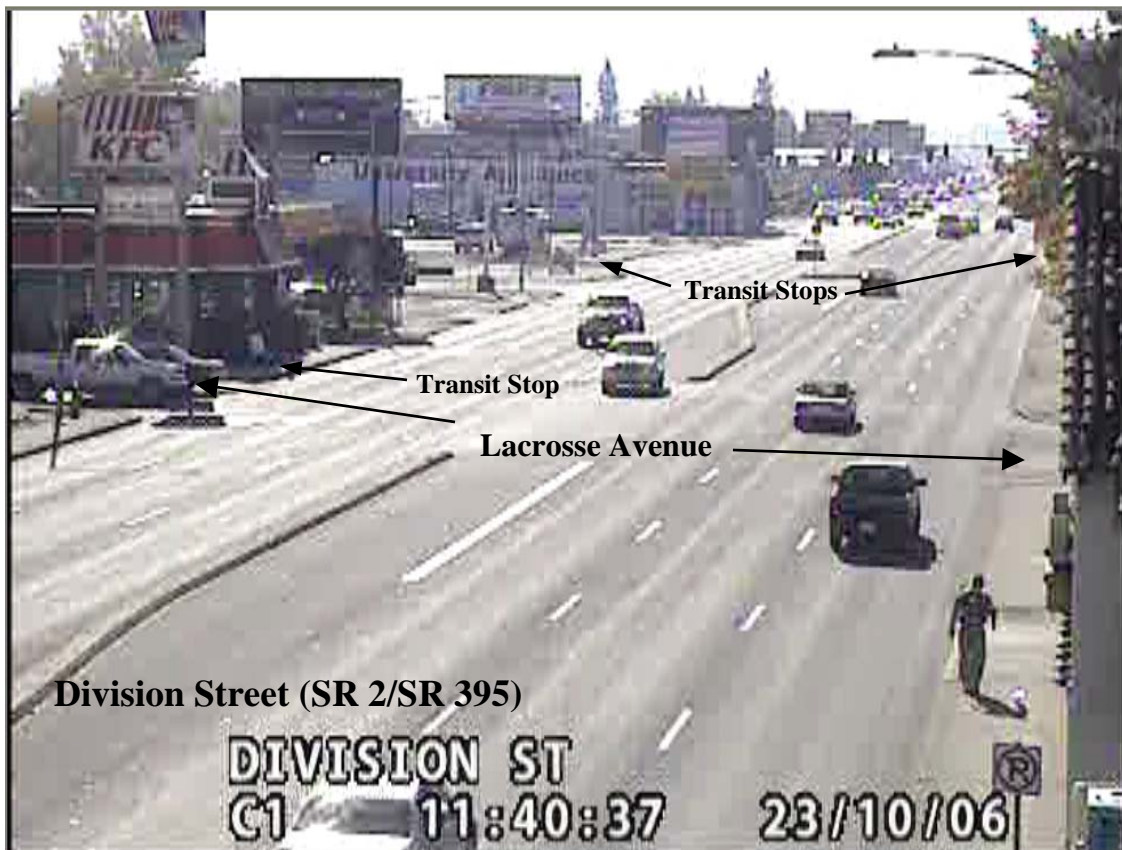
Figure 2.17. Observation boundaries, SR 2 north of Lacrosse Avenue—Spokane

The site analysis focused on the crossings made between East Garland Avenue (two blocks south of Lacrosse) and the camera location. Figure 2.17 shows the camera view looking south along SR 2. The camera is approximately 300 feet north of Lacrosse Avenue. There is a near side (before the bus passes through the intersection) bus stop located at Lacrosse in the northbound direction and bus pullout stops 450 feet south of the intersection in both the northbound and southbound directions. The total usable distance observed by the camera was roughly one tenth of a mile.

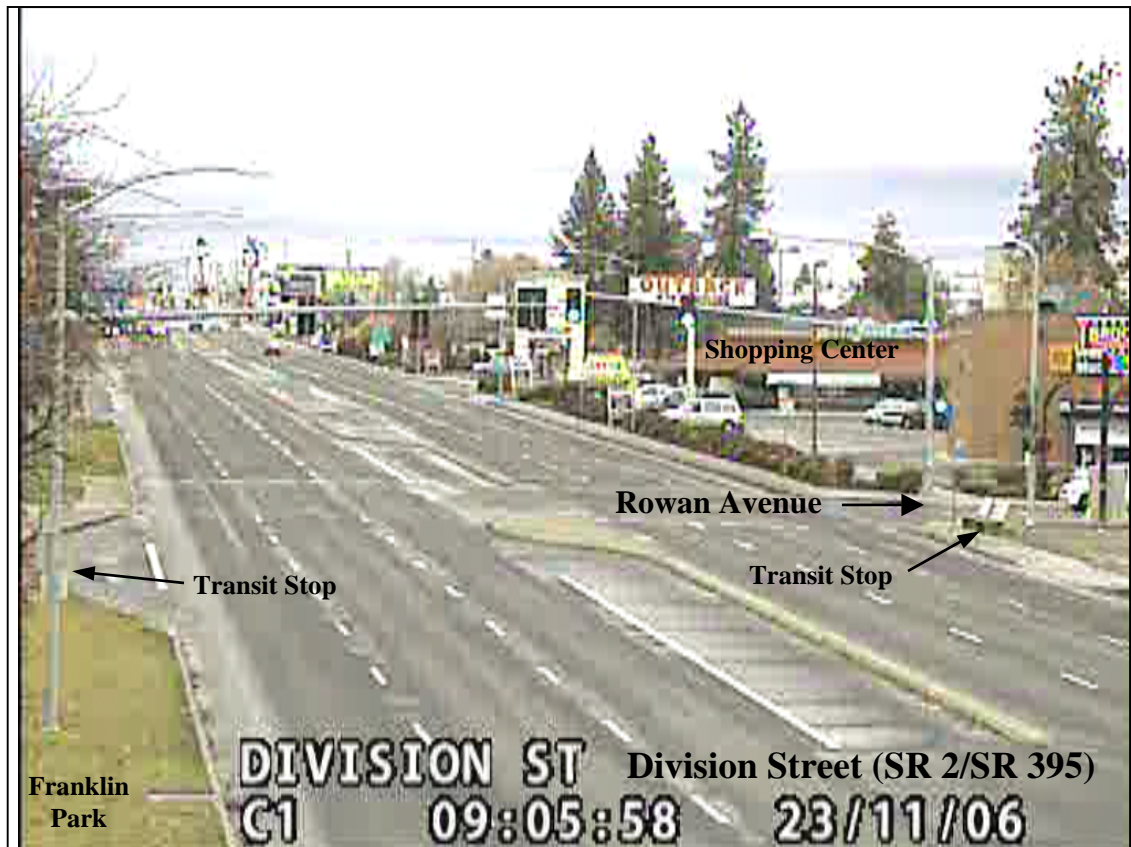
Figure 2.19. Observation boundaries, SR 2 south of East Rowan Avenue—Spokane

The site analysis focused on the crossings made between West Nebraska Avenue to the north and the camera location. Figure 2.19 shows the camera view looking north along SR 2. The camera is approximately 250 feet south of West Rowan Avenue. There is a near side (before the bus passes through the intersection) bus stop located at the intersection with Rowan in the northbound direction and a bus pullout stop 100 feet south of the intersection in the southbound direction.

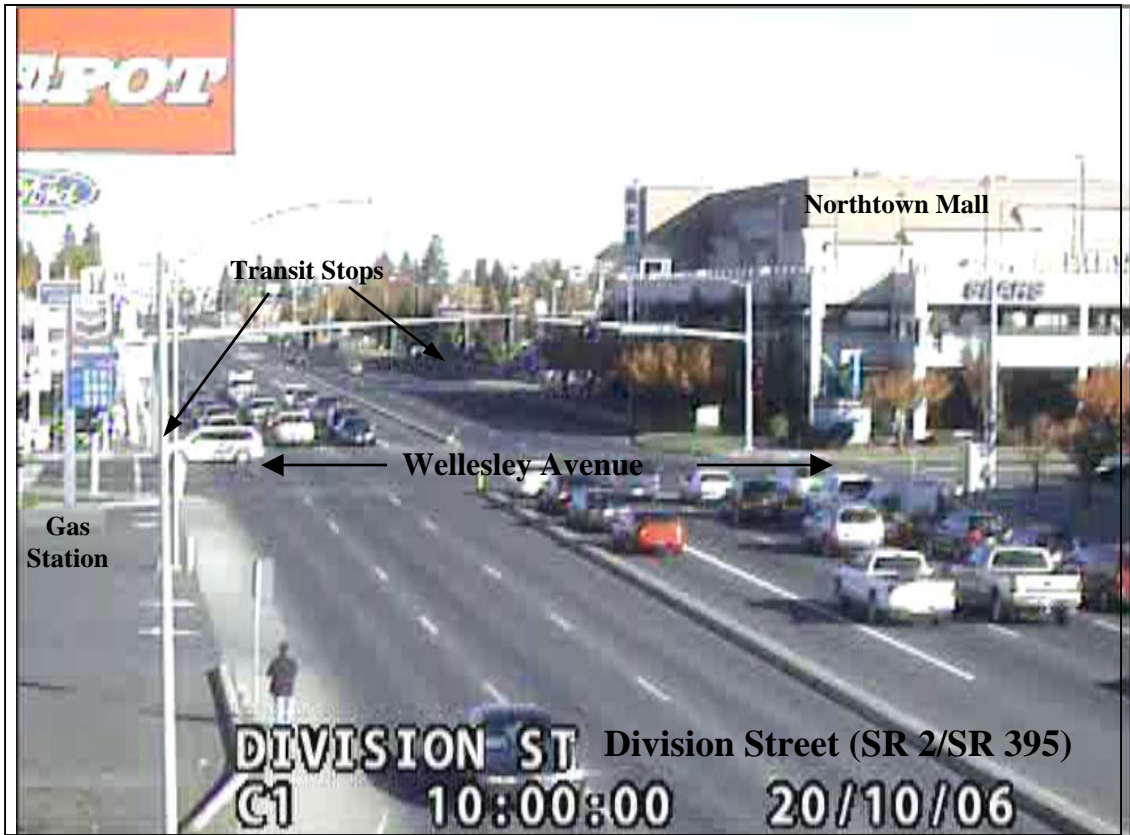
Figure 2.21. Observation boundaries, SR 2 south of Wellesley Avenue—Spokane

The site analysis focused on the crossings made between the northbound bus stop 320 feet to the north of Wellesley Avenue and the camera location. Figure 2.21 shows the camera view looking north along SR 2. The camera is approximately 380 feet south of Wellesley, located at a southbound transit stop.

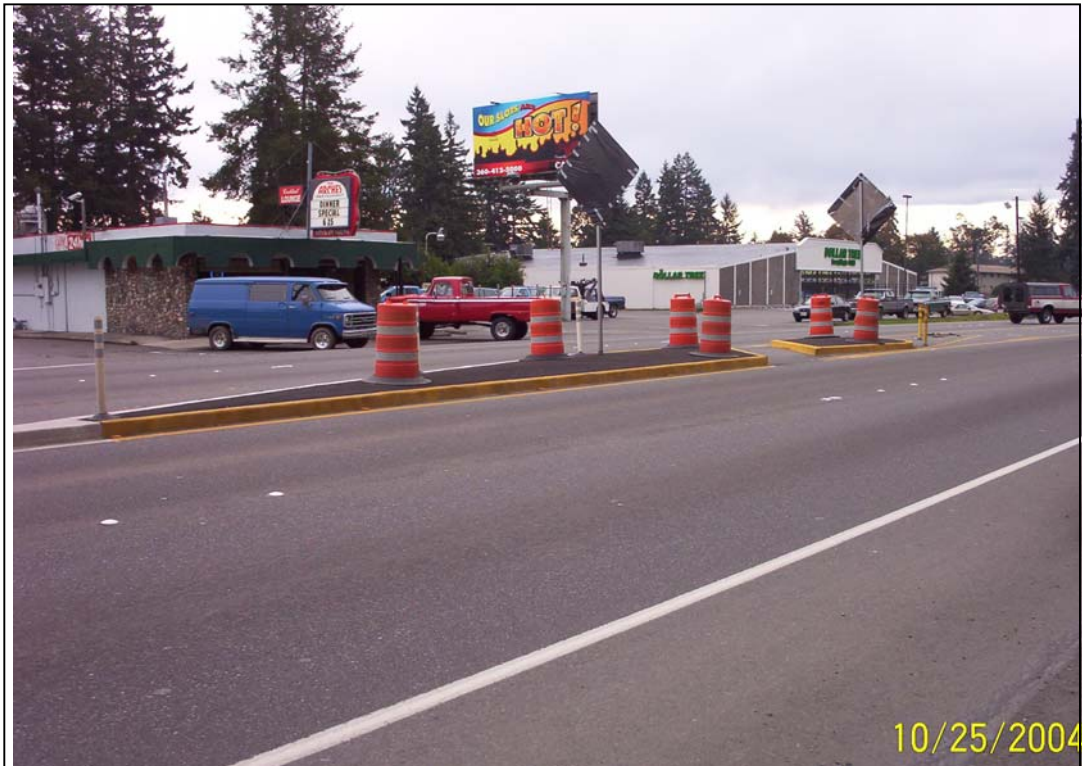
In response to this behavior, WSDOT traffic engineers built a raised median channelization island for the left hand turn from SR 7 onto S. 180th Street. Figure 3.1 shows the median.

A benefit of using a raised median channelization island is the inclusion of a refuge for pedestrians. This median refuge can particularly aid older pedestrians who have walk more slowly and thus have trouble crossing the road in one movement. Pedestrians can cross one direction of the roadway at a time and wait in the refuge for a break in traffic in the other direction. In addition, the channelization for left turns can make drivers feel safer because they do not have to worry about traffic in the center lane.

**Figure 3.1. Pedestrian refuge islands at S. 180th Street and SR 7—Spanaway
(Kopf and Hallenbeck 2005)**

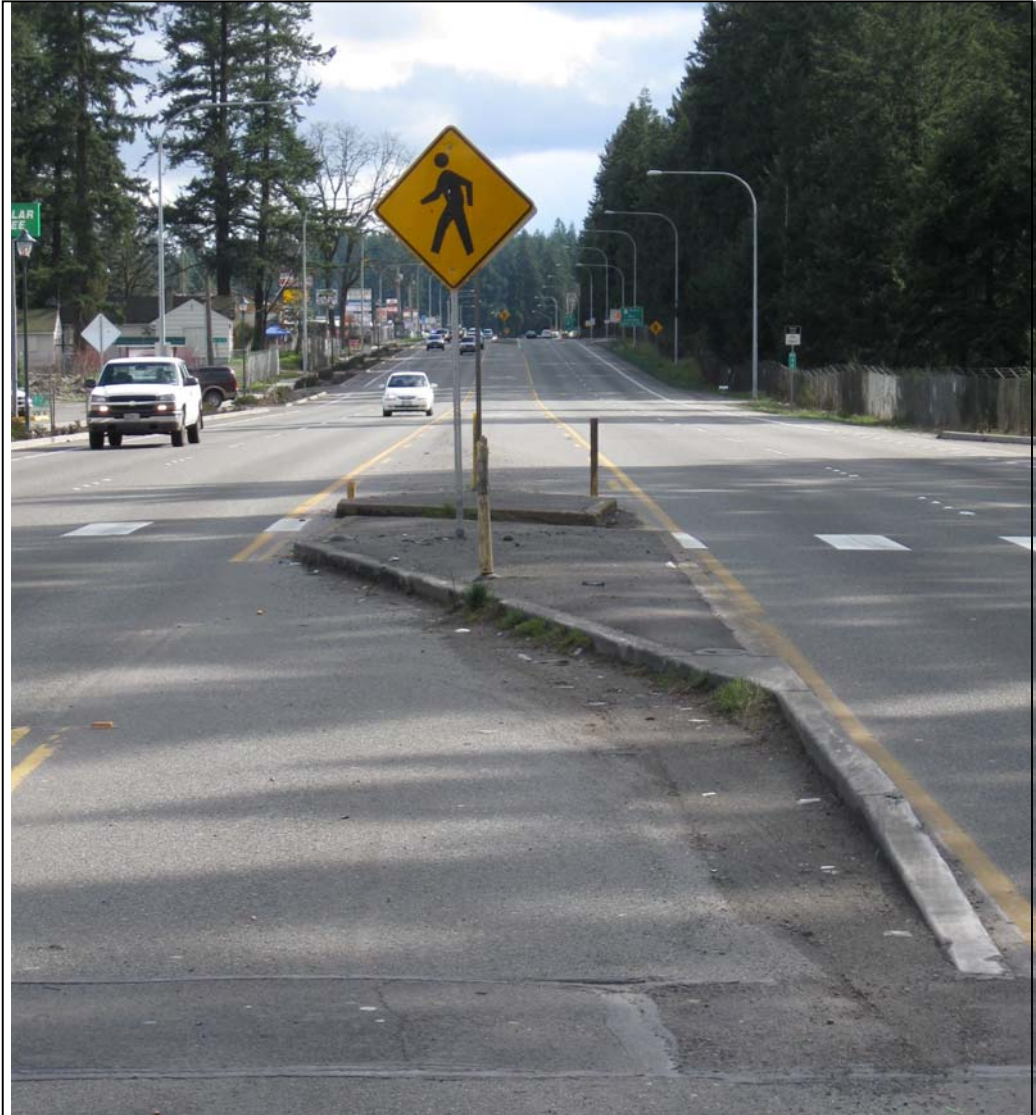
Figure 3.3. Front view of median with crosswalk markings—Spanaway

During the second phase of improvements, sidewalks, curbs, gutters, and overhead lights were installed. New crosswalk markings were placed in line with the crossing path provided by the refuge island (shown in Figure 3.3). Transit stops were enhanced with shelters to improve the comfort of the riders while waiting for the bus to arrive.

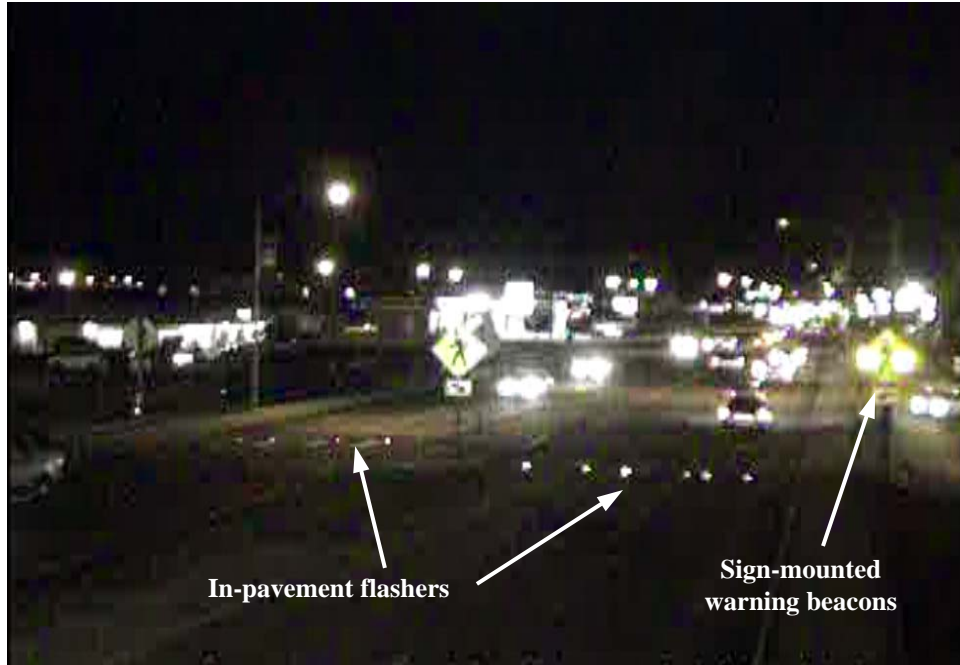
Figure 3.5. Warning lights lit for pedestrian crossing—*before* condition—Airway Heights

Figure 3.5 and Figure 3.6 show the camera view of a pedestrian crossing SR 2 at night with the flashers. The video quality is somewhat better in Figure 3.6, which depicts the *after* condition, but one can see the approximate degree to which the in-pavement flashers are functioning in each scenario.

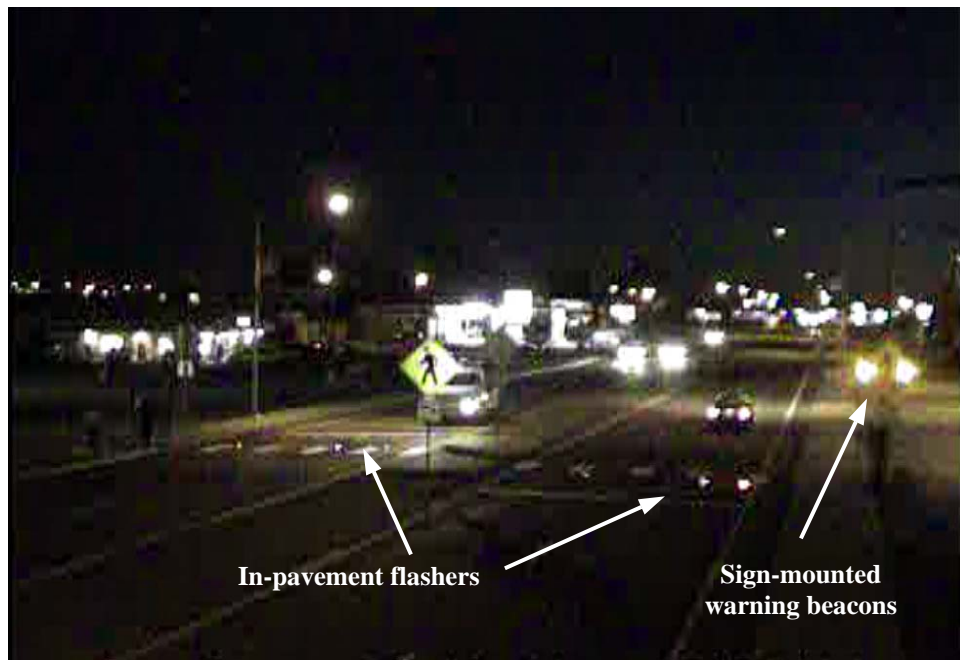
Figure 3.6. Warning lights lit for pedestrian crossing—*after* condition—Airway Heights

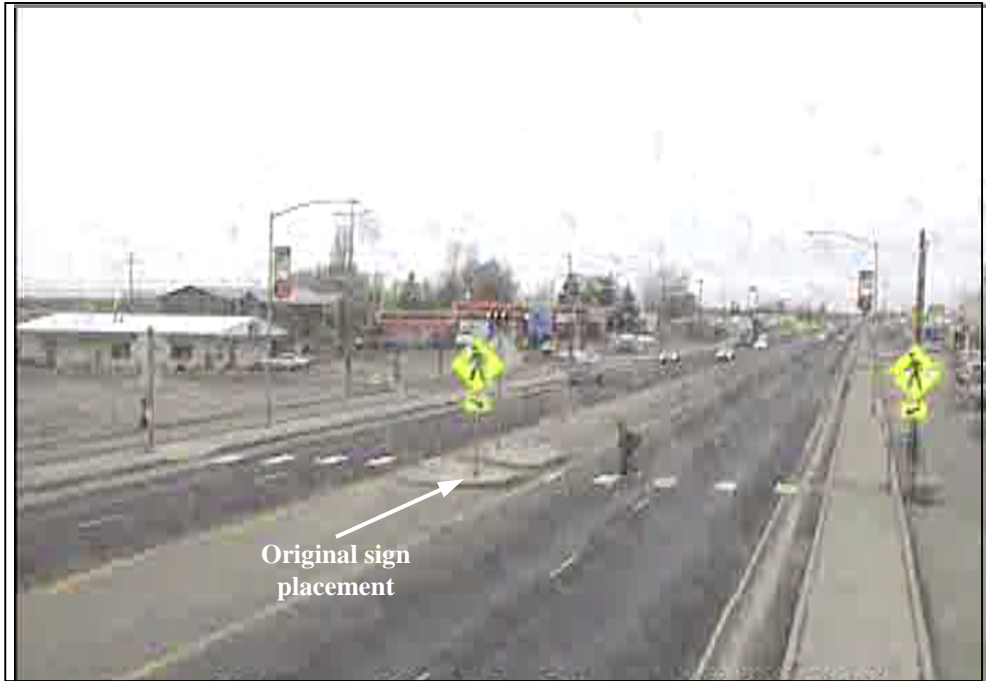
Figure 3.9. Median sign placement—*before* condition—Airway Heights

Stop bars were added for the *after* condition. They were located 20 feet upstream from the leading edge of the crosswalk in each direction. When this change was made, the signs on the side of the street and in the median were changed slightly. The diagonal down sloping arrow signs that pointed to the crosswalk were changed to “Stop Here for Pedestrians” signs, with arrows pointing to the stop bar. The addition of the stop bars also required the pedestrian crossing signs to be moved from the raised median to the center left turn lane. The goal of the addition of the stop bar was to increase driver awareness and pedestrian safety, as well as to move stopped vehicles farther from the crosswalk, thus increasing sight distance. The changes described can be seen in Figure 3.9 and Figure 3.10.

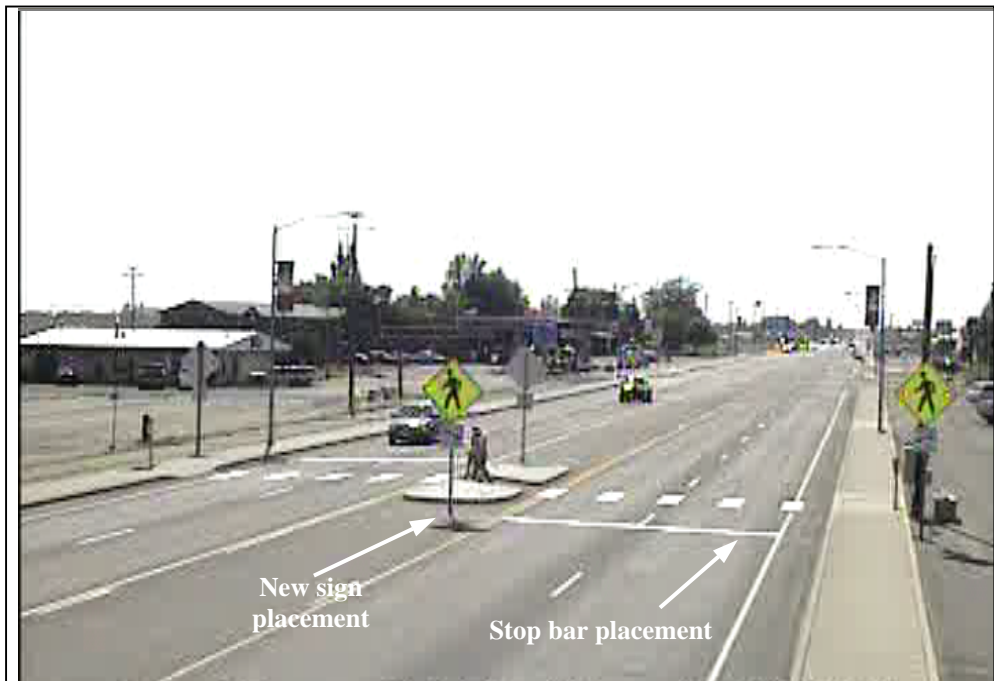
Figure 3.10. Median sign and stop bar placement—*after* condition—Airway Heights

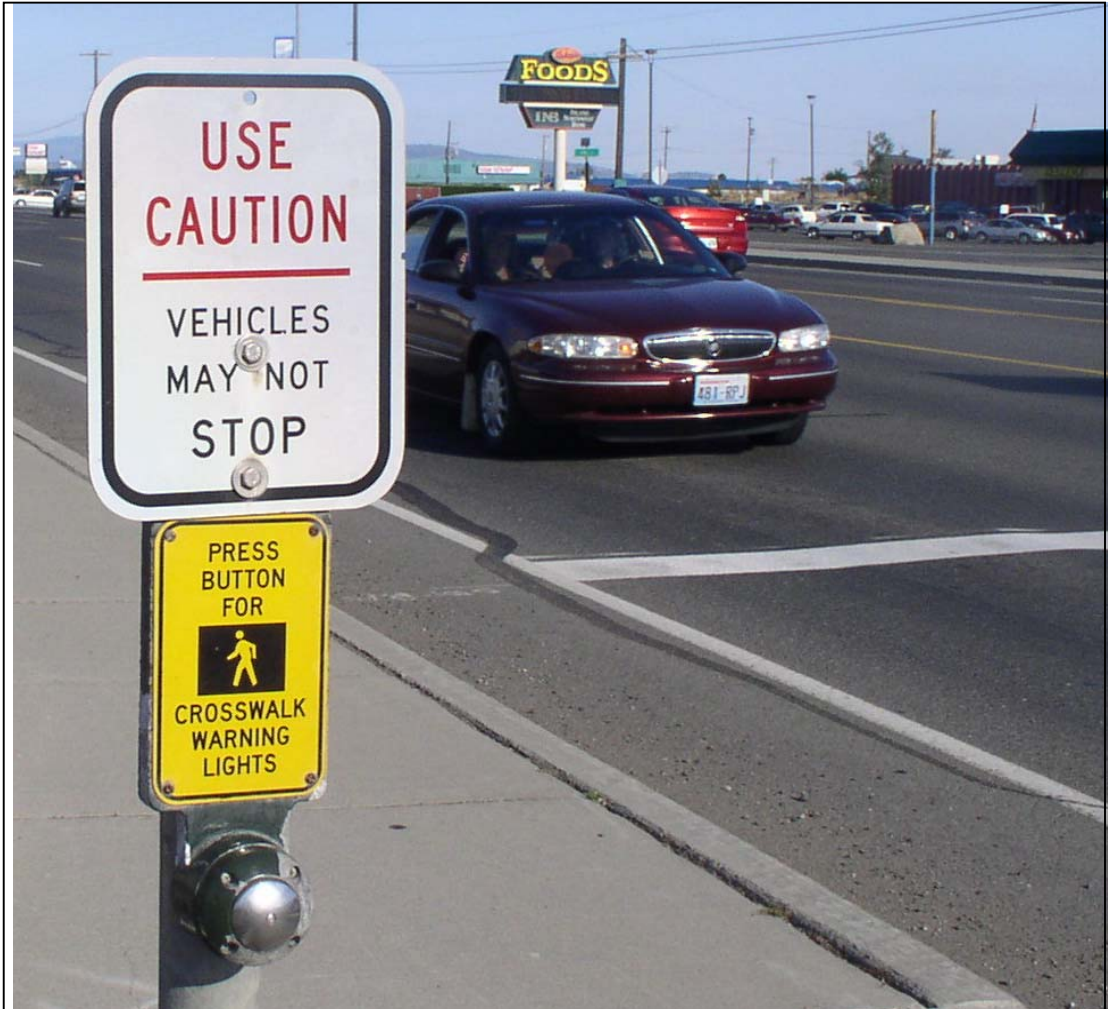
Figure 3.11. Signs present at the pedestrian actuation button—Airway Heights

Signs located at the pedestrian actuation buttons were present during both the *before* and *after* studies. An example of these signs is shown in Figure 3.11.

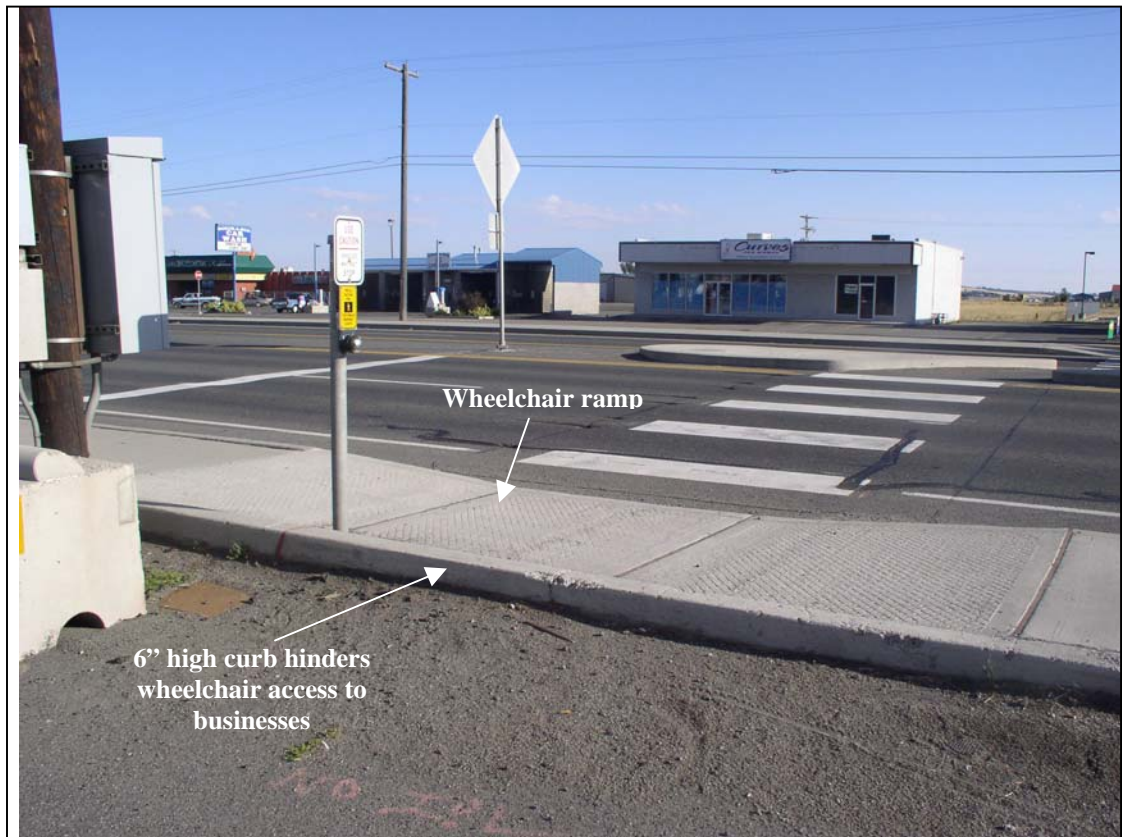
Figure 4.1. Wheelchair ramp on SR 2 between King and Lundstrom Streets

Sidewalk/curb design—The current design allows at-grade pedestrian access to the sidewalk at wheelchair ramps and driveways. However, no wheelchair ramps have been built on the far side of the sidewalk (away from the highway). They are located only at the street corners—see Figure 4.1. This may present a tripping hazard to some pedestrians and prevent others from accessing the sidewalk, causing them to have to travel through the parking areas of retail establishments until the next access point, which could be dangerous.
